THE HEXAGON (Ephraim Shay House) Harbor Springs, Michigan

Tech Notes

In-Kind Replacement of Historic Stamped Metal Exterior Siding

Rebecca A. Shiffer
Mid-Atlantic Regional Office
National Park Service

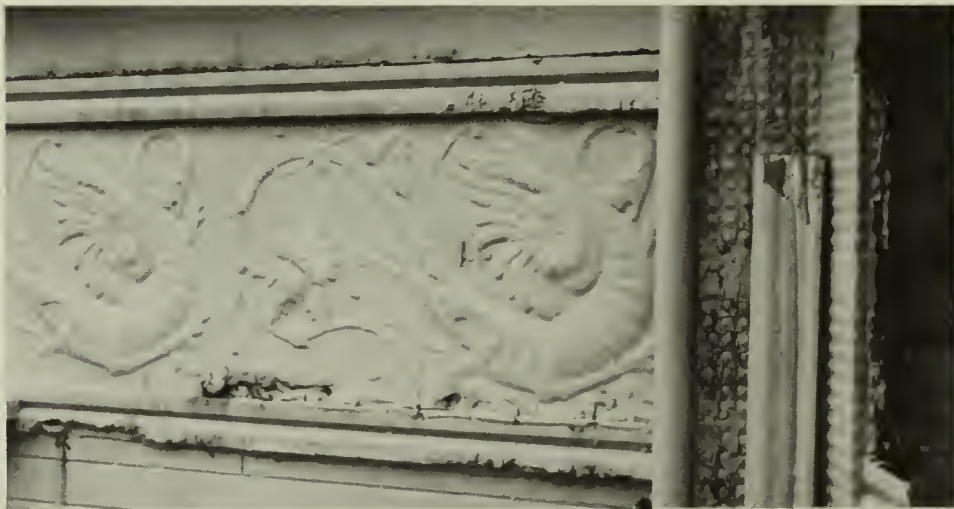
The house had been poorly maintained for several decades and, more recently, had been unoccupied. The asphalt shingle roof that replaced the original standing seam metal roof leaked badly, allowing water to penetrate into the wall cavities behind the stamped metal siding. Due to neglected repairs and cleaning, the original drainspout system failed to divert rainwater away from the house (*see figure 3*). In some places, rainwater

3. Stamped metal siding simulating brickwork covered most of the exterior of the house. Pebbled corner pieces and several ornamental bands added decorative details. Deteriorated drainspout and original plank wall sheathing are at right. Photo: Richard Hiler.

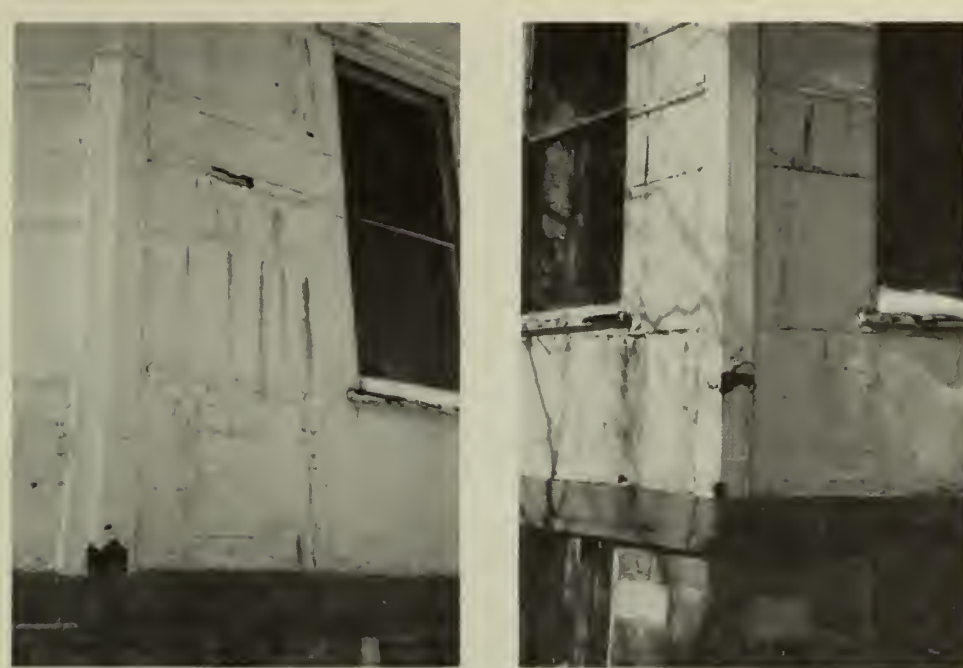
Although the original galvanized (zinc-coated) steel and zinc siding had been back-primed, long-term water infiltration caused the siding to corrode from the inside toward the face. The location of the building at Little Traverse Bay also contributed to the slow deterioration of the siding. In extremely deteriorated areas, the metal had been reduced to an easily breakable, crusty mass. An assessment of the exterior revealed that nearly 90% of the stamped siding had moderately or severely deteriorated to the point that replacement was required (see figure 4). Since only a small percentage of the siding was salvageable and all needed to be removed to facilitate other project work, the decision was made to replace all of the metal siding.

4. Rust stains indicate where corrosion, caused by water infiltration, are breaking through the metal from the rear. Rust and separation are also evident at seams between sheets of stamped metal. Inspection determined that nearly 90% of the stamped metal siding had to be replaced. Photo: Richard Hiler.

Five exterior sheet metal patterns required replacement: the brick pattern that covered more than half of the exterior, two ornamental band patterns, the wall corner pattern, and the molding that separated the ornamental bands from the brick pattern (see figure 5).

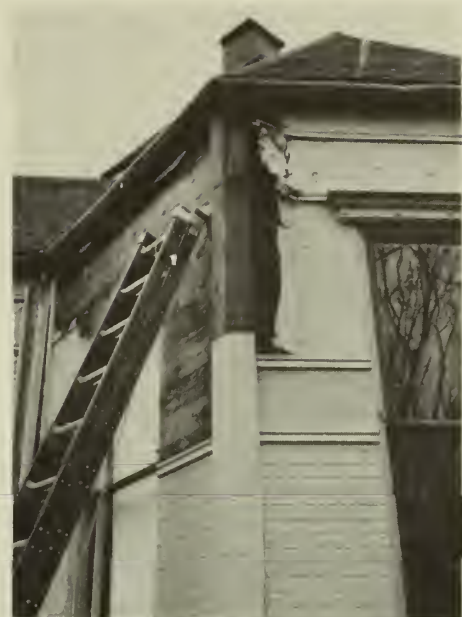
9. Original exterior siding was removed, revealing the exterior plank wall sheathing, which was also removed in order to install additional insulation and a vapor barrier. Photo: Mary Cay Bartush Jones.

After ordering the replacement metal siding, the contractor waited approximately three months for its arrival at the job site. During this time, a new metal roof was installed and the walls were prepared to receive the new siding. The total replacement of the siding provided an opportunity to add wall insulation for enhanced energy efficiency. Insulation was installed from the exterior to avoid damage to the stamped sheet metal covering the interior walls and to permit installation of a vapor barrier. This required removal of all the exterior plank sheathing, some of which was also deteriorated (see figure 9).

Removal of the plank sheathing also permitted repair and replacement of some deteriorated original framing, primarily on the south side of the house and at the lower portions of the walls. A vapor barrier was installed against the back of the interior plank sheathing. Sheets of 3-1/2" fiberglass

insulation were placed in front of the vapor barrier, and 3/4" plywood was installed as an exterior sheathing in place of the original planks.

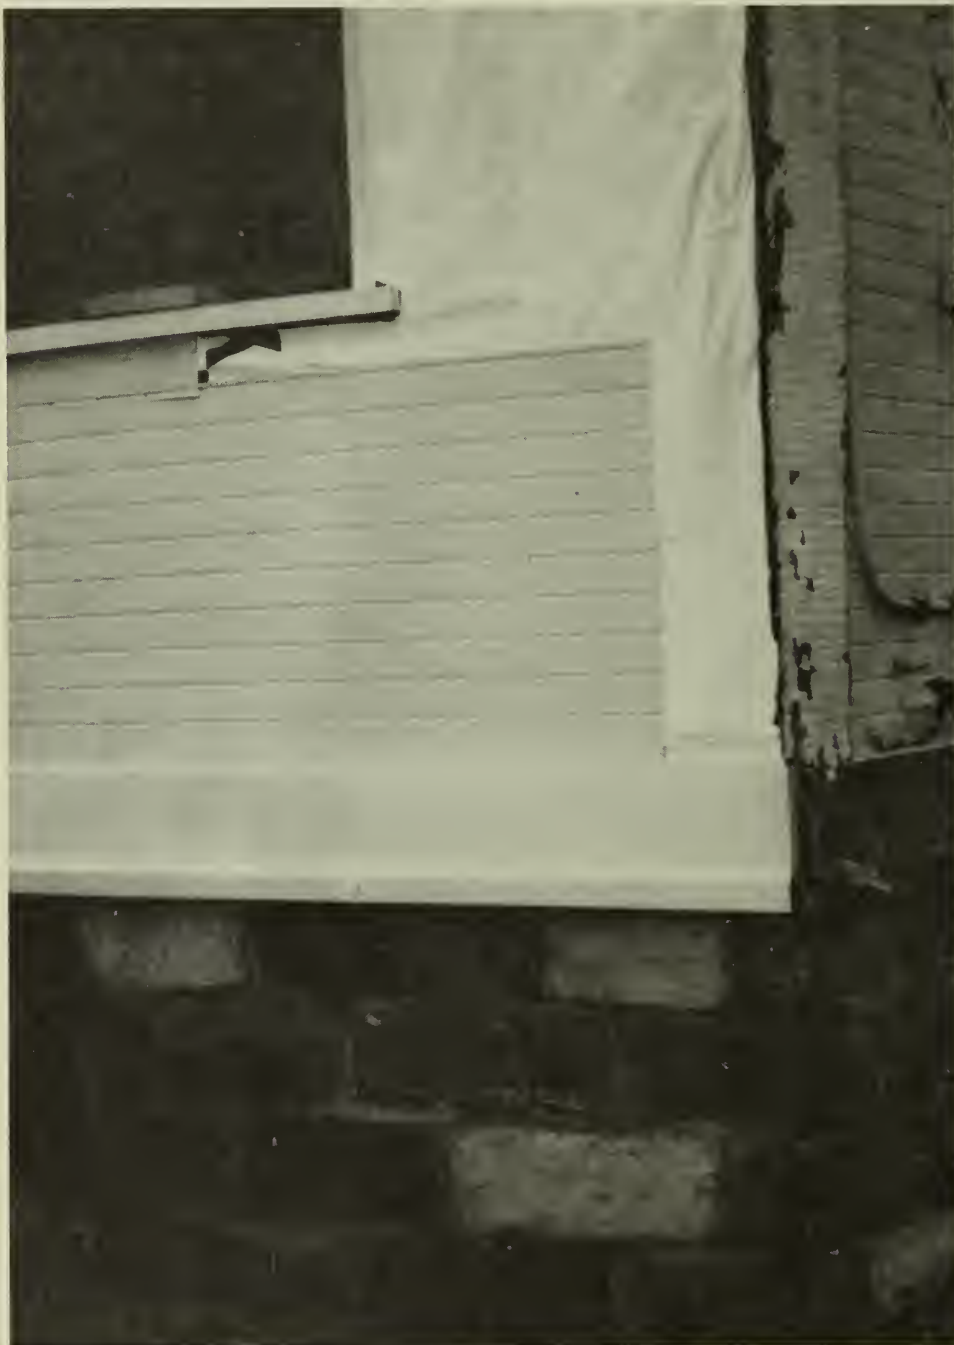
10. Installation of siding began at the base of each story of the building. Corner pieces were installed first, followed by the base flashing, and the stamped brick siding. Care was taken to match the patterns from one elevation to the next around the building. Photo: Mary Cay Bartush Jones.

On each story, installation began at the bottom and proceeded upward toward the roofline (see figure 10).

Each piece of siding lapped over the piece of siding below it and was face-nailed to the house's wood frame. The siding also lapped over the already installed corner pieces. Since the new sheets and bands of siding were identical in size to the originals, only minor trimming was required.

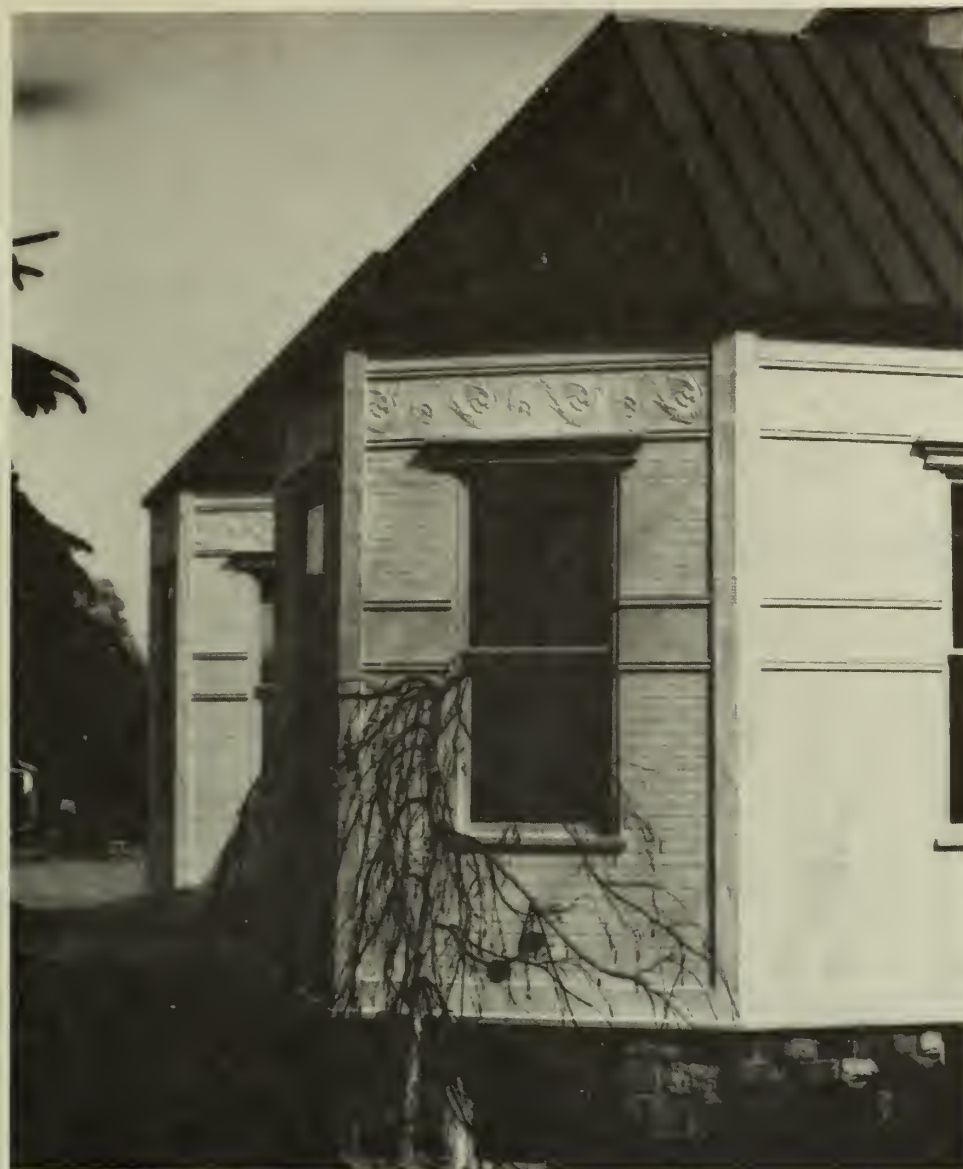
11. Finished appearance of several elevations. Siding has been face nailed to underlaying materials and second coat of paint has been applied. Each piece of siding laps over the piece below it, and all overlap the corner pieces. Photo: Richard Neumann.

In the original construction of the Hexagon, the siding had been installed before the windows had been set into the walls. During this project, the window frames were retained in place, so the new siding was bent around and tucked back alongside them. A quarter-round molding was then installed and the edges sealed with a silicone-based caulk. The window hoods were reinstalled after the siding was in place (see figure 11).

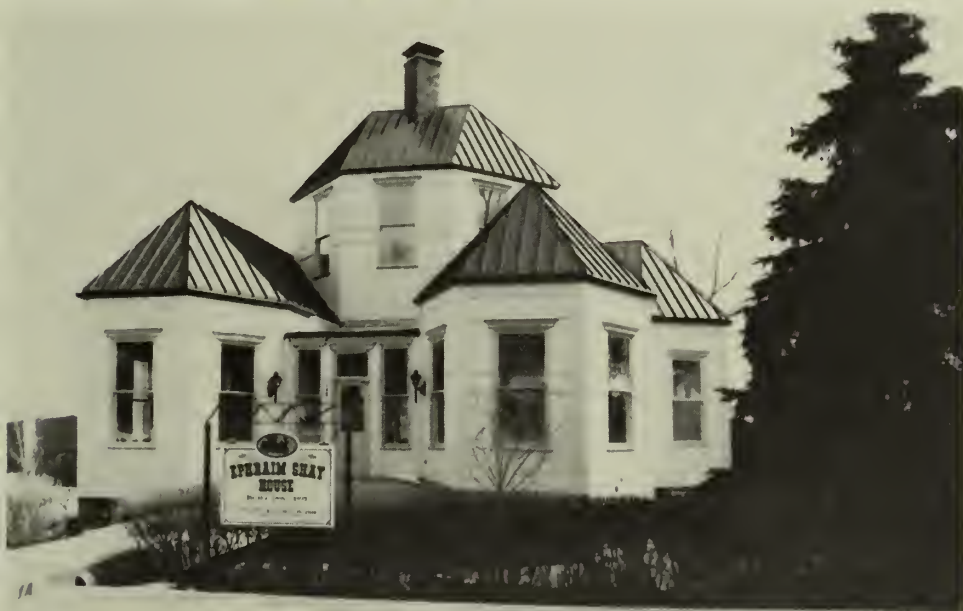
12. The replication of the stamped metal siding has restored the Hexagon to its historic appearance. A new metal panel roof system that duplicates the appearance of the original standing seam roof also contributes to the restoration. Photo: Richard Neumann.

The work on the Hexagon also demonstrates that custom pressed metal work can be both the practical and the appropriate preservation solution for even small projects where historic stamped metal siding is an important feature of the building (see figure 12). When special molds are necessary to duplicate a specific pattern, additional planning time may be required. However, stock patterns, such as the simulated brick siding on the Hexagon, may be available, allowing for quicker delivery and cost savings. Properly prepared, finished, and maintained, galvanized and zinc pressed metal can have a long useful life.
