A REPORT ON
NONDESTRUCTIVE TESTING
AND
STRUCTURAL ANALYSIS
ON
ELEVEN IRON CASEMATE
CARRIAGES AND CHASSIS

FORT SUMTER NATIONAL MONUMENT

Charleston, South Carolina

April 2, 1979

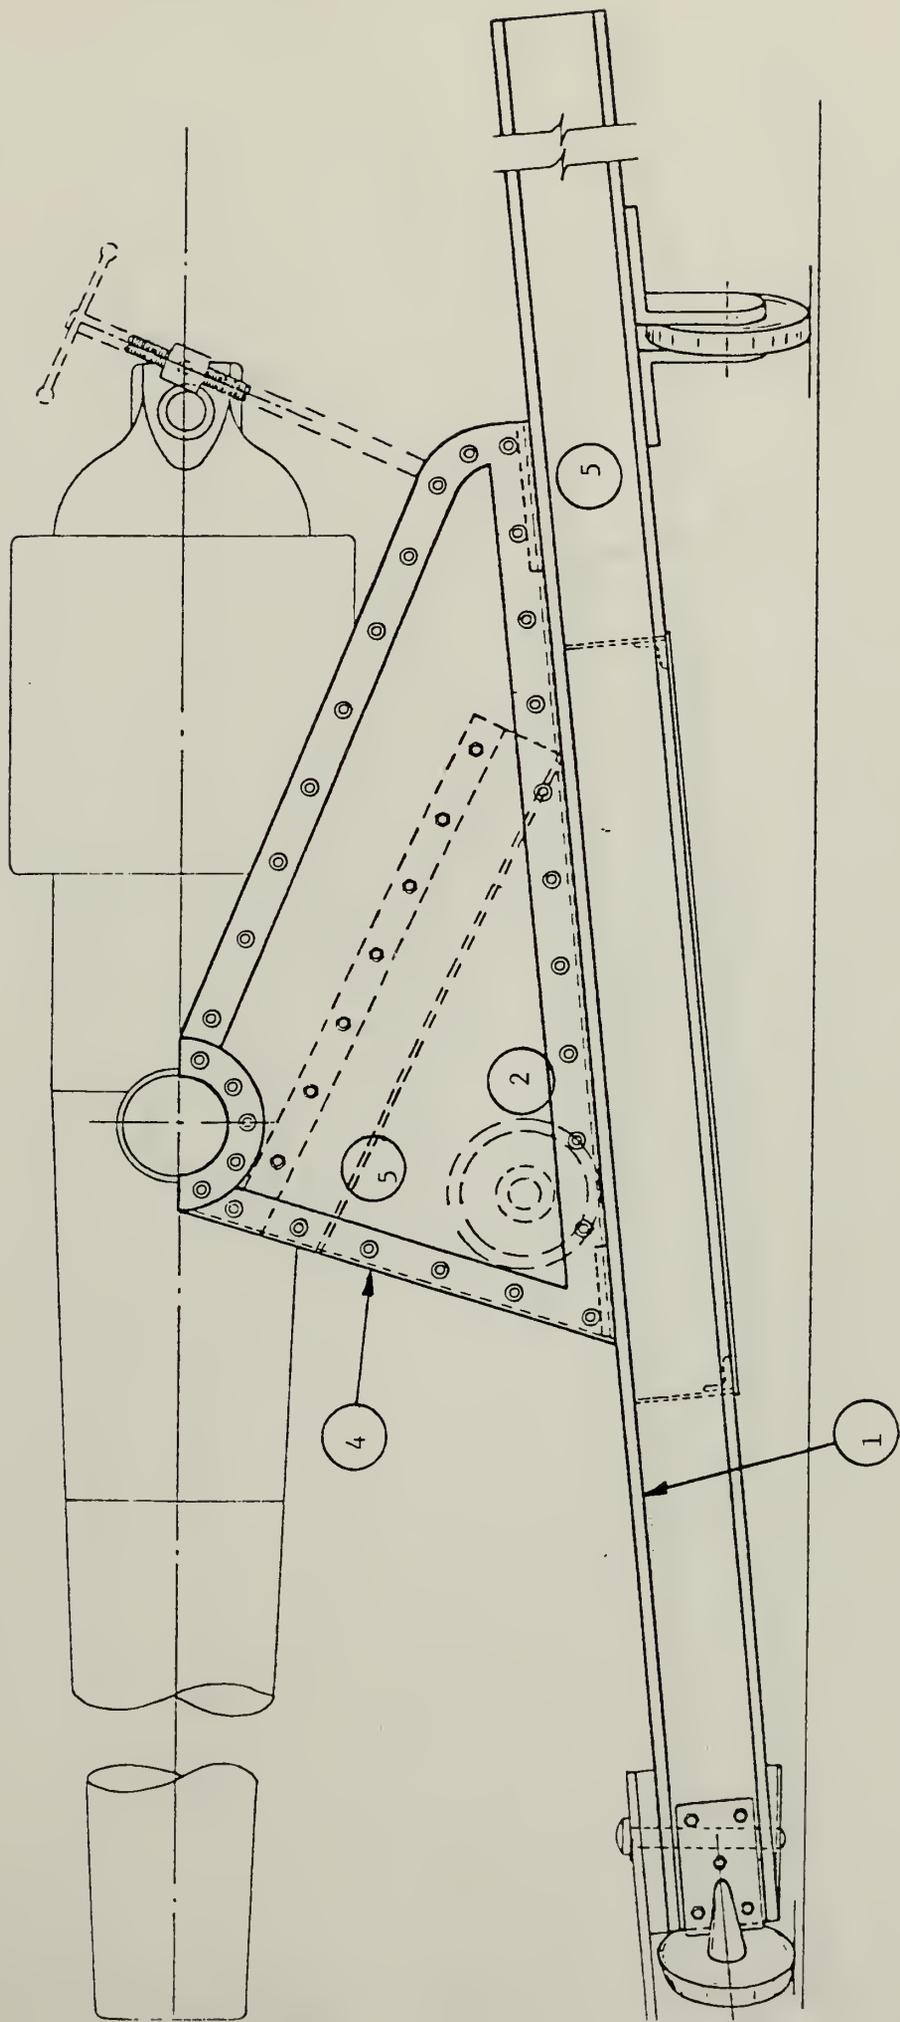
Cannon Number One

- 1) View 1 revealed crack indication
as marked on radiograph.
- 2) View 7 & 8 revealed several areas
of excessive corrosion (as marked)
that appear to be thru the metal.
