16 December 2010

US Department of Interior/ National Park Service
Fort Sumter National Monument
1214 Middle Street
Sullivan's Island, SC 29482

Reference: Fort Sumter Masonry Conditions

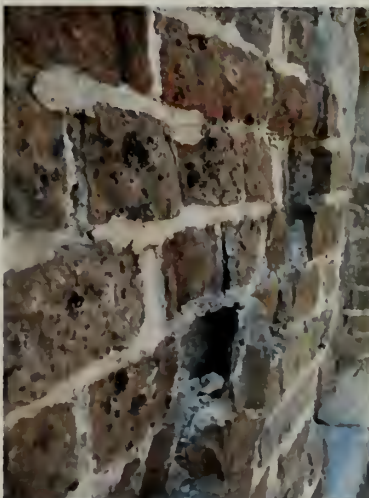
Peeling and Spalling of Brick Surfaces-

We found many zones in the exposed wall construction where bricks have been surface-spalling in successive layers, often with entire partial-wythe sheets of brick which remain bonded together peeling off of the walls.

In these zones the mortar and the bricks appear to be of the same relative permeability and strength. Consequently, there does not seem to be one acting sacrificially for the other, rather they both seem to compete equally and both fail at the same time.

Sections or portions of walls that are badly joint eroded or spalled should be cut and repointed and where needed, reconstructed. Loose and/or unstable elements should be removed and either reattached, or replicated or rebuilt.

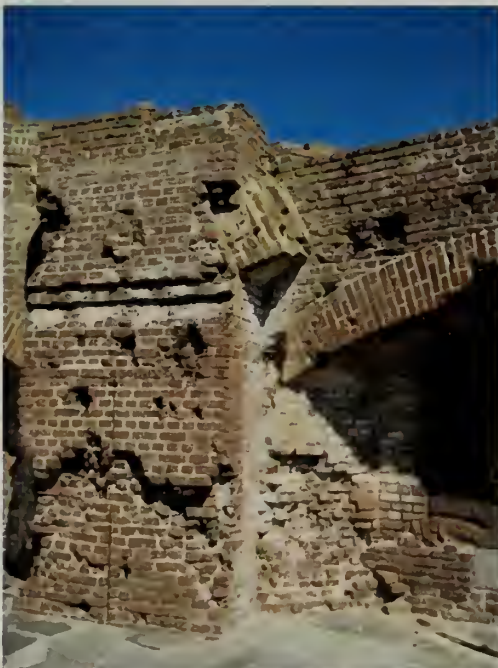
Separation and Delamination of Brick Wythes-

We also found areas, particularly at the Parade side of the scarp walls where the wythes of brickwork seemed to be separating from each other while the actual brick units remain intact. The mortar between at least the first and second brick wythe and in some cases the second and third, have lost all binder and remain as uncemented damp sand. Tapping with a hammer can actually push the outer bricks slowly inward as the unbound collar joints compress.

This condition typically occurred where the mortar seemed softer than the bricks, effectively causing saturation and deterioration at the surface, while cryptoforescing salts caused damaged deeper within the walls.

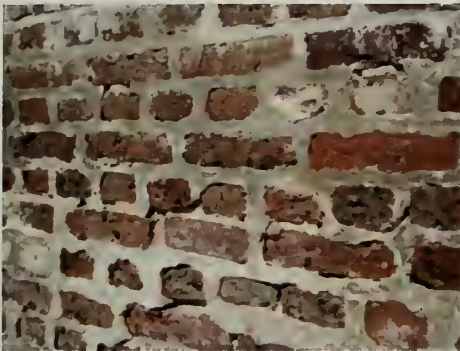
Individually Eroding or Spalling Bricks Surrounded by Raised Ridges of Mortar-

These are areas where the brick is softer and more breathable than the mortar. Vapor transfer and cryptoflorescence is occurring through the bricks, which are sacrificing themselves to the mortar. A clear indication of this is where the header bricks, which run deeper into the wall construction than the stretchers, fail the most. This is due to the bricks acting as wicks, drying out the interiors of the walls.

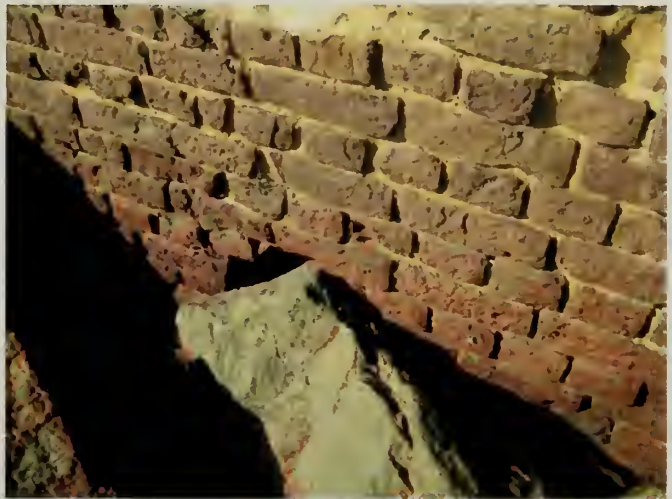
Riprap Abrasion-

Many of the stones that form the breakwater are leaning against the perimeter walls in a somewhat unstable fashion and obviously move around when impacted by waves. This causes the contact points to abrade the wall surfaces and over time, grind depressions or divots into it, in some cases, as much as 6 to 8 inches deep. Proof of how much some of these stones actually moved was exemplified by our discovery of a

late model tire that had been wedged beneath one of the larger stones.

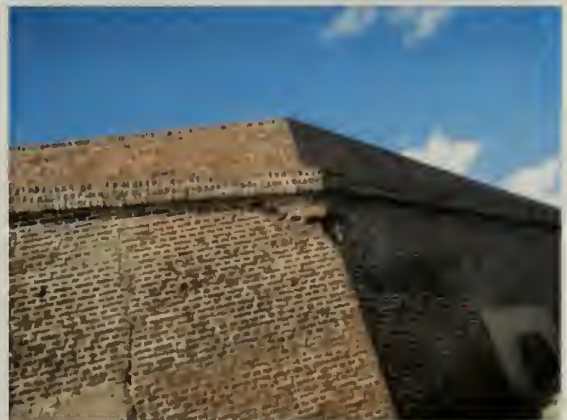
Differential Thermal Movement and Moisture Growth-

The combined effects of thermal strain and moisture growth result in lengthening of long stretches of brick masonry, particularly the upper portions of the Fort where the brickwork heats up and expands more, is subject to more frequent wettings, and is in many places of a later construction than what is beneath. This means that the upper masonry elongates more than the lower masonry with a ratcheting effect causing cracks and the upper portions of corners to bend outward. Although moisture growth takes place shortly after the brickwork is installed, the debonding and cracking that often results allows less constrained movement under temperature fluctuations that continue to occur

throughout the structure's life, thus increasing the total amount of movement and damage.

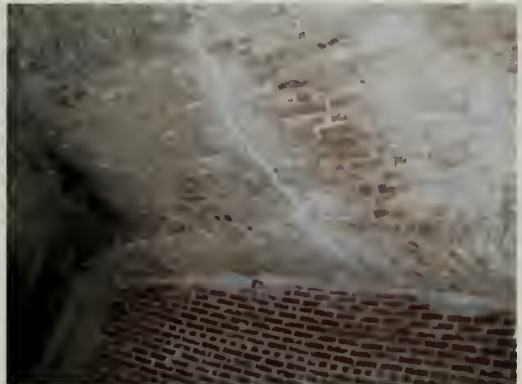
Spreading Arches-

There are vertical cracks running through the center of many of the transverse arches that support the casemate vaults. While in the typical spans these are small, they are considerably larger in the radially oriented arches that fan the corners of the Fort and have longer spans. This is probably due in part to the fact that these are longer spans, with higher total span loads, and in part to the fact that these occur at corners where there is less direct horizontal restraint.

Structural cracks should be excavated to a depth of at least two wythes, cleaned, flushed out, and then injected with a fluidified version of a compatible mortar (or grout). The excavations should then be stitched back together with as many as possible of the same, original brick.

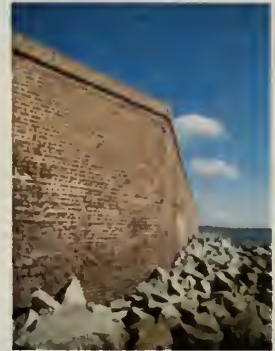
Outward Moving Corners of Walls-

Coupled with the wider cracks in the radially oriented arches are diagonal shear type cracks in the supporting piers and walls, and noticeable outward sweeping and leaning of the perimeter walls at corners.

The unrestrained spreading forces at the ends of the long arches (please see "Spreading Arches", above) has caused the corners of the Fortress to lean outward. The actual leaning has been allowed by forced foundation settlement, as the resulting stress distributions on the bottoms of the footings would be unbalanced, and by cracking in the walls and longitudinal corner movements noted below.

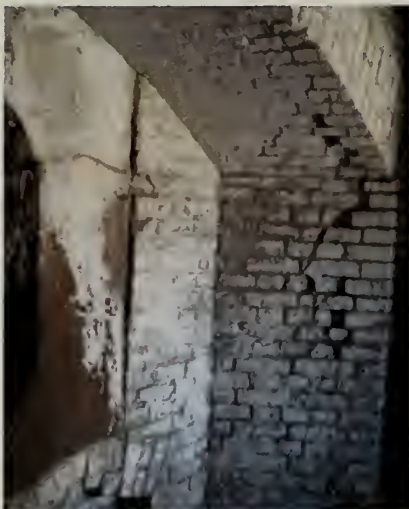
Cracked and Spalled Piers-

As a response to the "negative" bending rotation at the ends of the spreading arches and the outward movements of the supports, vertical and diagonal cracks have formed in supporting piers and the ends of arch spans which have been forced to change shape as a result of the movements. At some locations concentrations of compression stress at the hinge points of the arches have caused the brick masonry to spall.

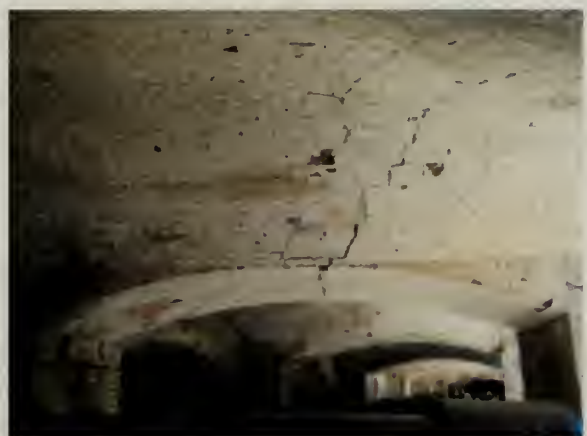
Shear-Cracked Vaults-

There are also transverse and diagonal cracks in many of the vaults that are likely the result of the arch spreading and wall-lengthening movements described above. As rigid, horizontal shear resisting diaphragm elements, the vaults have attempted to resist the longitudinal and outward corner

movements of the walls (please see “Outward Moving Corners of Walls”, above), however their in-plane shear capacities (diaphragm resistance) have been exceeded, resulting in cracks.

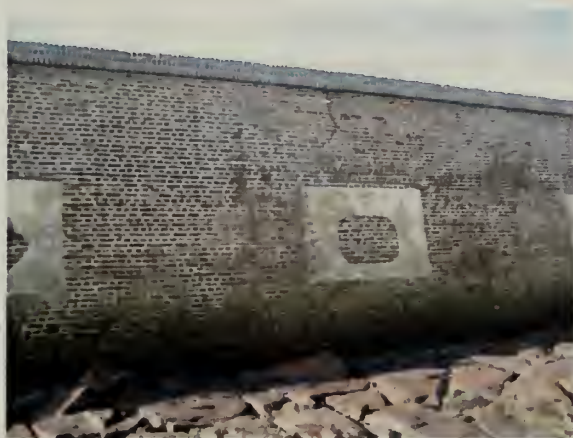
Repetitively Cracked Walls-

As a result of unbalanced moisture growth and thermal strains, horizontal cracks have formed between different behaving portions of walls, often resulting in diagonal cracks at the ends and/or vertical cracks along their lengths.

The most obvious location where this has occurred is at the right flank wall where there is a large diagonal crack and a planar shift at the east end. This was caused by the expansion of the newer brick cap that was added atop the wall, dragging the corner along by its outward movement.
