QUALITATIVE EVALUATION OF THE EFFECTS OF CHANGING WATERSHED LAND USES  
ON THE  
HYDROLOGY, CHANNEL MORPHOLOGY AND HISTORICAL USES OF VALLEY CREEK,  
VALLEY FORGE NATIONAL HISTORICAL PARK, PENNSYLVANIA

William B. Reed

Technical Report NPS/NRWRD/NRTR-90/08

October 1990

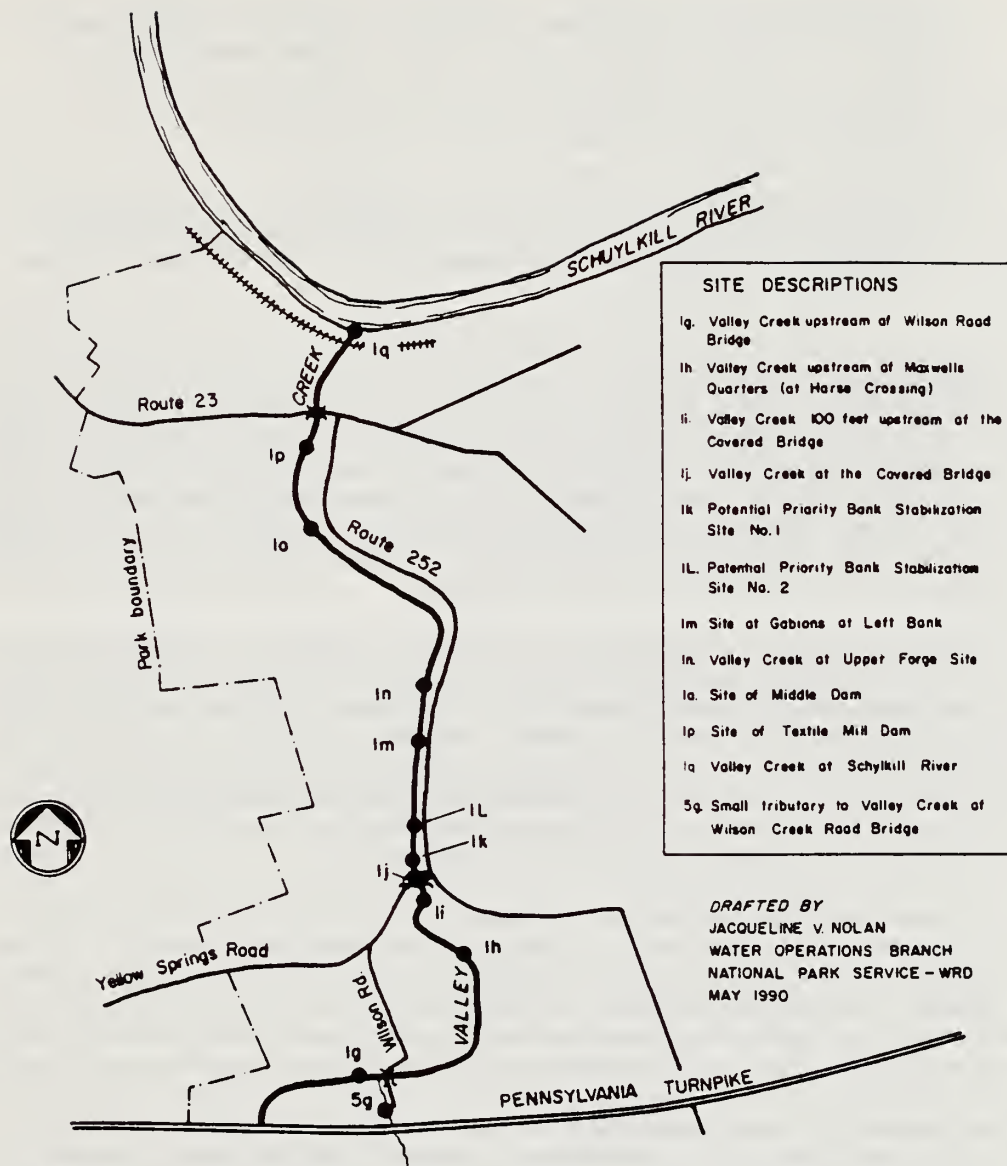
Figure 2. FIELD OBSERVATION SITES ALONG VALLEY CREEK WITHIN VALLEY FORGE NHP

During this phase (1800s), the two-story high textile mill dam (site 1p on Figure 2) was constructed upstream of present-day Route 23. This dam (the largest ever constructed on Valley Creek) pooled water as far upstream as the covered bridge (site 1j on Figure 2). Although, the pond behind such a dam would have been below the present-day elevation of Route 252, the middle dam and upper forge sites were inundated (Figure 3). The stream banks between site 1i and site 1p are composed of unconsolidated highly erodible sediments which were deposited behind this dam during this phase of high sediment loads.

At the beginning of phase 4, the textile mill dam was destroyed, leaving the sediments that had deposited behind the dam exposed. These sediments had accumulated over approximately 90 years (from about 1830 to about 1920) and would have been deposited from the dam site to 100 feet upstream of the covered bridge (site 1i on Figure 2). After the dam was destroyed, the stream would have reestablished a channel by cutting down through these sediments. Because the sediments were unconsolidated, this process would have likely taken only a few years. This resulted in a reach with relatively high stream banks. As stated above, the present-day stream banks between site 1i and site 1p are highly erodible remnants of this era.

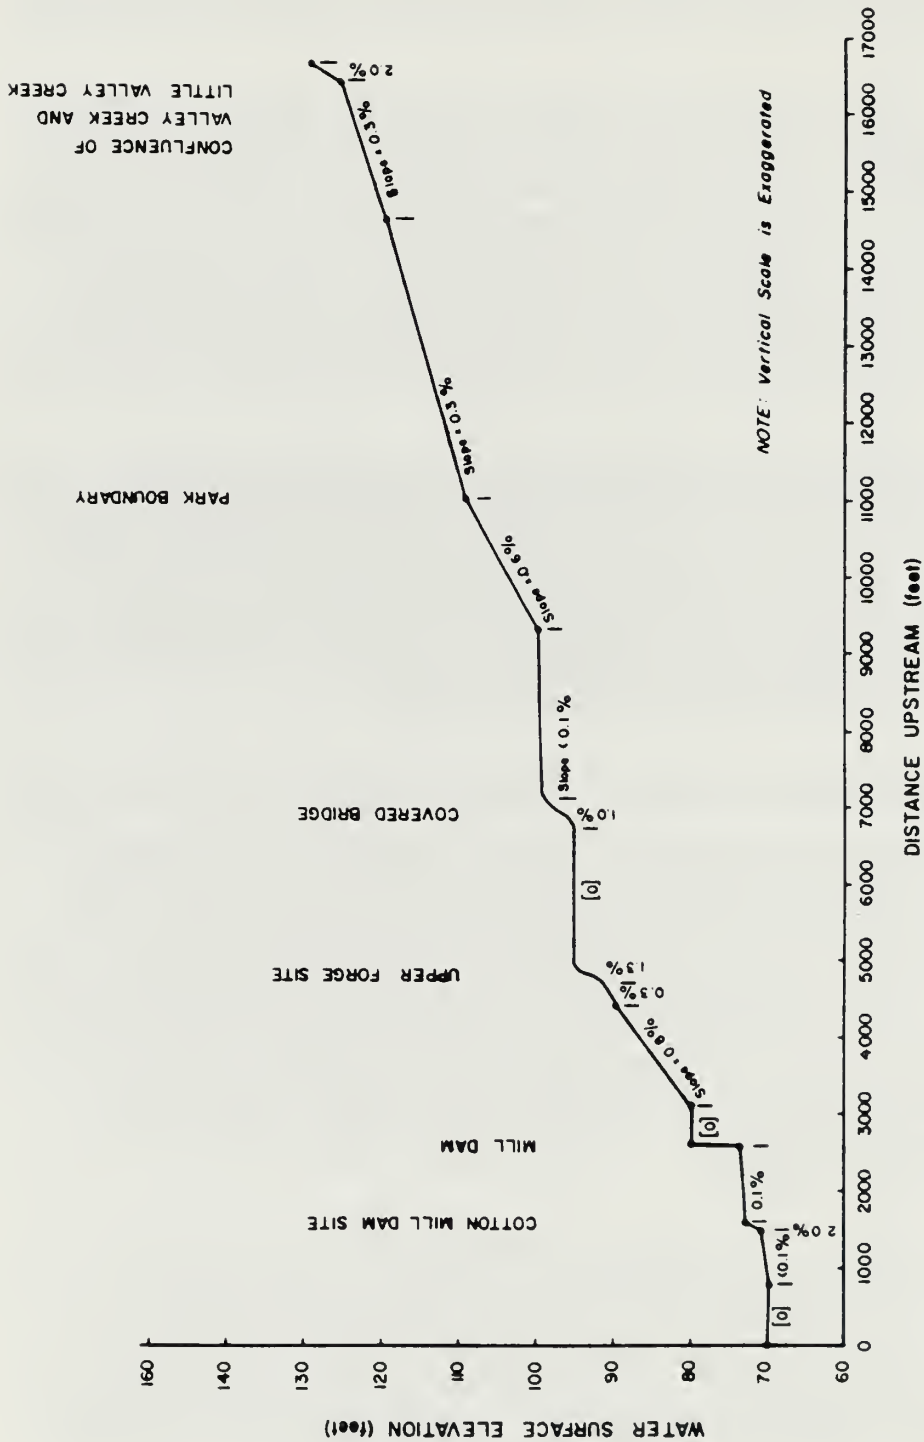
Figure 4. WATER SURFACE PROFILE--EXISTING CONDITIONS, VALLEY CREEK, VALLEY FORGE NHP

channel away from the upper forge site. Later, in 1931, the middle dam was reconstructed. This dam, although small by comparison with the former textile mill dam, does provide base control, i.e., it is a structurally controlled break in the water surface profile (Figure 4).

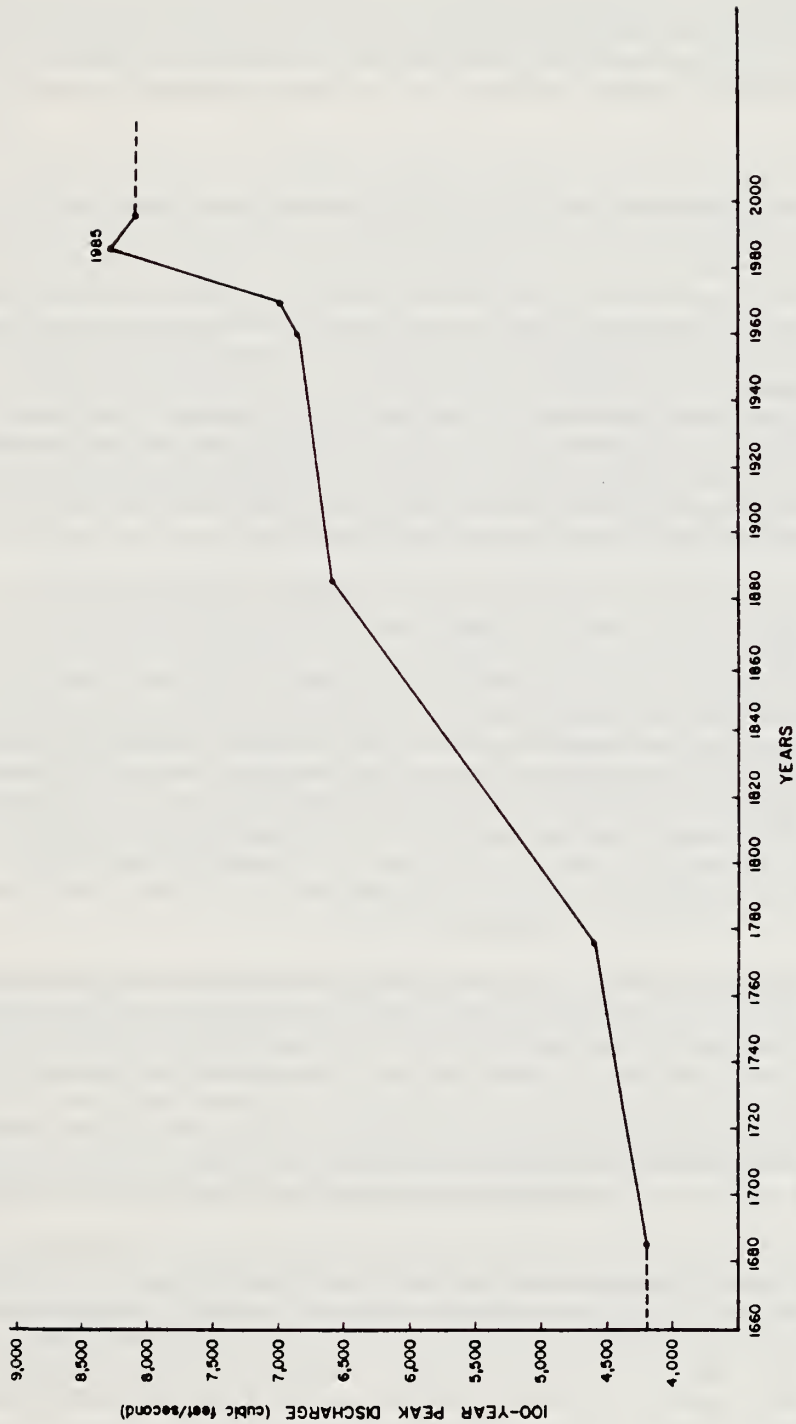
Figure 5. 100-YEAR PEAK DISCHARGES -- 1685 to 1995, VALLEY CREEK of SCHUYLKILL RIVER, VALLEY FORGE NHP

The effects of changing land uses on the flood hydrology of Valley Creek at Schuylkill River has been to increase the magnitude of floods, e.g., the magnitude of the 100-year flood increased from 4,200 cfs to 6,600 cfs over the 200-year period from 1685 to 1885. Another way to interpret this hydrologic trend, is that a given magnitude flow now has a more frequent (smaller) recurrence interval and thus, a higher probability of occurring. For example, a flow with a magnitude of 6,600 cfs would have been a flood with a recurrence interval (or return period) slightly greater than the 500-year flood in 1776, but would have been only a 100-year flood in 1885. And if a flood of this magnitude was to occur today, it would be only a 50-year flood (Appendix C). One result of this trend is that although the covered bridge may have been designed (by chance or on purpose) for the 100-year flood at the time of its construction (1851), that it now has a conveyance (below low steel) roughly equal to the 50-year flood.

In general, over the 300-year period from 1685 to 1985, the peak discharges were doubled. This is typical of changes in stream hydrology for a moderately developed watershed, i.e., increased peak discharges about 2 to 5 times higher than pre-development conditions (Schueler, 1987). Essentially, half of the increase occurred over the 100-year period from 1785 to 1885 and half occurred over the 100-year period from 1885 to 1985. Most of this latter increase has occurred since 1970. As modeled, the present trend in land use changes may actually cause a slight decrease in current (1985) peak discharges (Figure 5). This is because I assumed that in the future stormwater runoff would be better managed, i.e., I assumed that future land uses would have a lower curve number than the current land uses they replaced.

An analysis using the storage routine for the TR-55 computer program indicates that even for relatively small events (e.g., the 2-year storm), the amount of storage required to reduce peak flows from projected 1995 peaks to modeled 1885 conditions would be considerable. Reducing the discharge of the 2-year event (24-hour rainfall of 3.2 inches) from 1,350 cfs to 800 cfs would require a detention basin storage volume of 205 acre-feet.
