BOOTT COTTON MILLS (The Boott Mills) Lowell, Massachusetts

Tech Notes

NUMBER 18

Aluminum Replacement Windows With True Divided Lights, Interior Piggyback Storm Panels, and Exposed Historic Wooden Frames

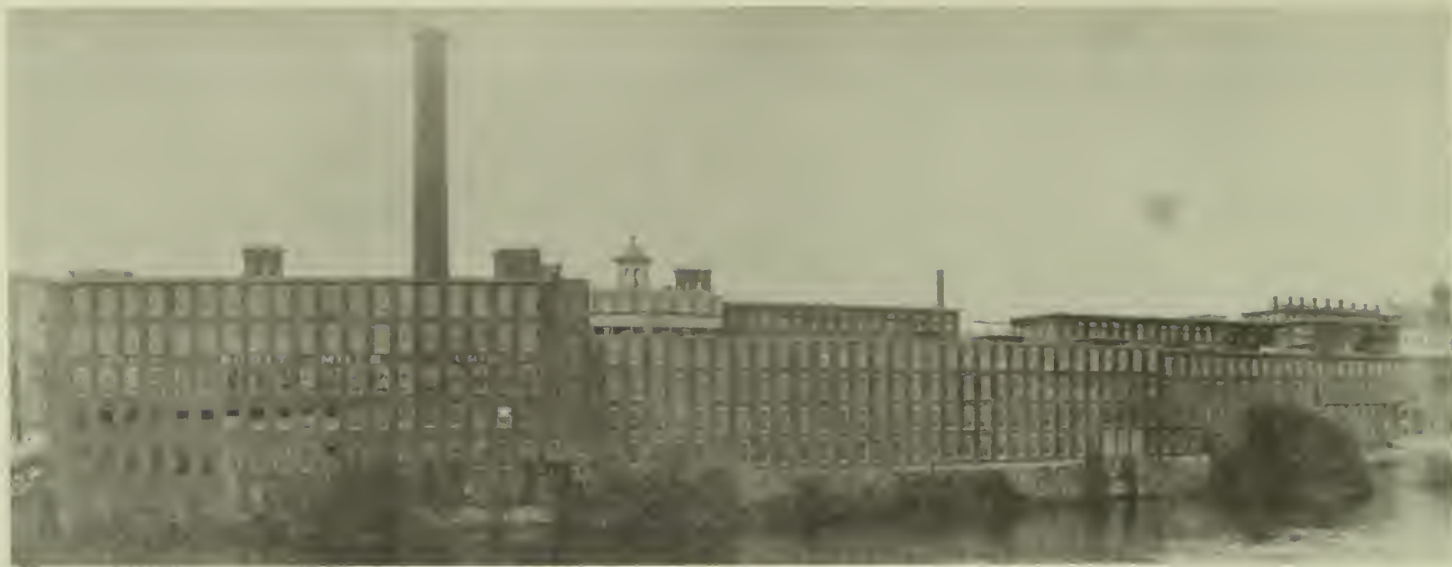
Figure 1. The windows are the dominant element of detail and decoration in the Boott Cotton Mills. Photo: Courtesy of the Center for Lowell History

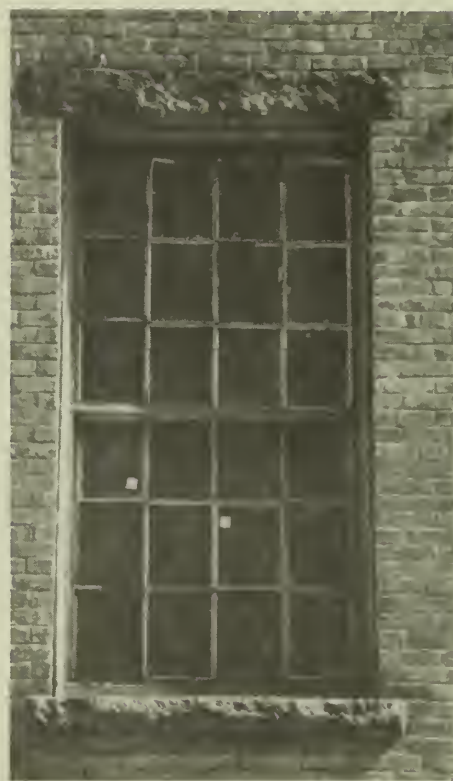
Figure 2. Because of the historic character and significance of the complex, replacement sash needed to have true divided lights and the dimensions and profiles of visible elements needed to be close copies of the originals. Photo: Courtesy of Huygens DiMella Shaffer

The projected three-phase, \$63 million rehabilitation of the Boott Mills involves 700,000 square feet of space. An appropriate window treatment was foremost among several important preservation design problems. The developer and the historic review commission agreed that one-over-one aluminum replacement windows with exterior muntin grids were not desirable. Because of the significance of the complex, it was established that the windows needed to have true divided lights and that the dimensions and profiles of all visible elements would be near copies of the originals (see figure 2).

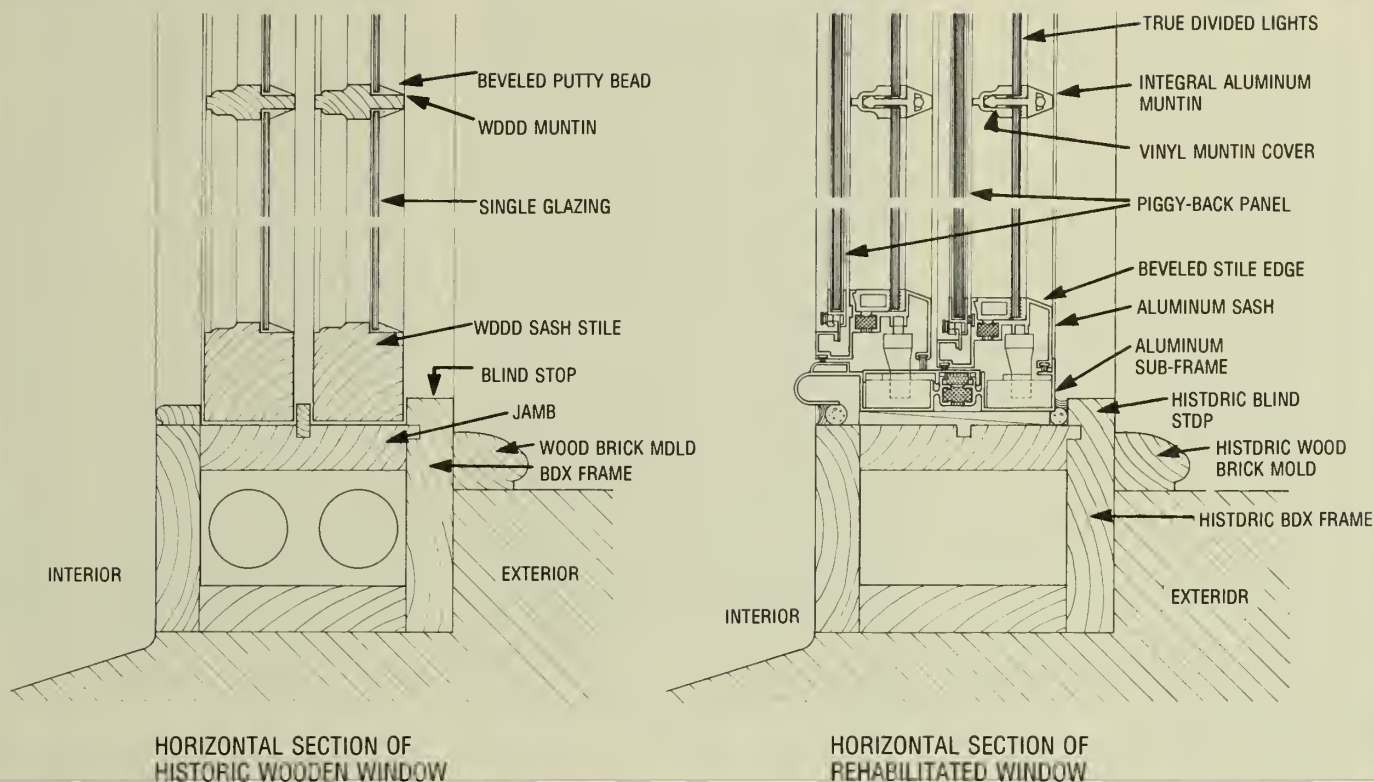
Figure 3. Horizontal section of the window shown with old and new sash. Drawing: Timothy Buehner

Boott Mills, it was necessary to limit the muntin-supported glass panes to single glazing, as in a historic window, and to achieve double glazing with a secondary window system (see figure 3). This secondary window consisted of a "piggy-back" interior glazing panel, which left exposed on the exterior the multiple facets of the true divided lights so characteristic of historic multiple-pane windows. The interior glazing panel was attached to the room side of the sash. It was also decided that the existing wooden frames would be retained and used to receive the aluminum sub-frame for the new window. Finally, new aluminum extrusions were to be made for all members to ensure a very close match to the historic units.

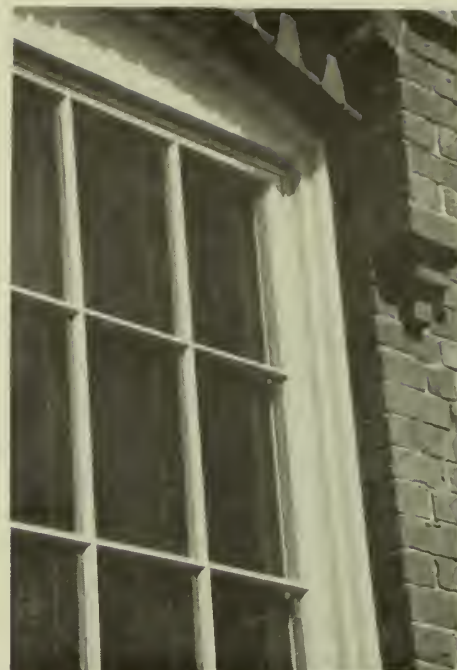
dow work during the waning textile operation at the mill resulted in the spot replacement of many of the 12 light sash with 6 light sash. Virtually no work, including painting, had been done on the windows following the cessation of textile production in 1954. The one exception was the replacement of several hundred windows on the exposed river elevations that had been destroyed by an off-site explosion in 1976 and replaced with inexpensive aluminum double-hung, single light sash.

Figure 4. The decision to use an integral muntin for the outer glazing and a piggy-back interior glazing panel was an important component of the successful window solution. Sash shown before and after rehabilitation. Photos: Charles Parrott

was narrowed and profiled to approximate the beveled glazing bead and sticking of the historic wooden muntins. However, it was found that the technology of the 1985 three-piece muntin system could be reduced only to about $\frac{7}{8}$ " in thickness. A new two-piece true muntin was then developed by the manufacturer that met the general dimensions and profile of the putty-glazed historic muntin; it provided the needed strength and proved to be simpler in design and less expensive to fabricate. This muntin consisted of an aluminum tee extrusion with a trapezoidal flange and a web terminating in a triangle-shaped point over which a profiled cover of extruded rigid PVC was snapped to hold the glass panes in place. Plastic was used for this cover to provide the flexibility needed to remove the cover in case of glass breakage and to provide the thermal break to insulate the aluminum tee member. The snap cover extrusion was to be made in the pre-selected custom color chosen for the window (see figure 4).

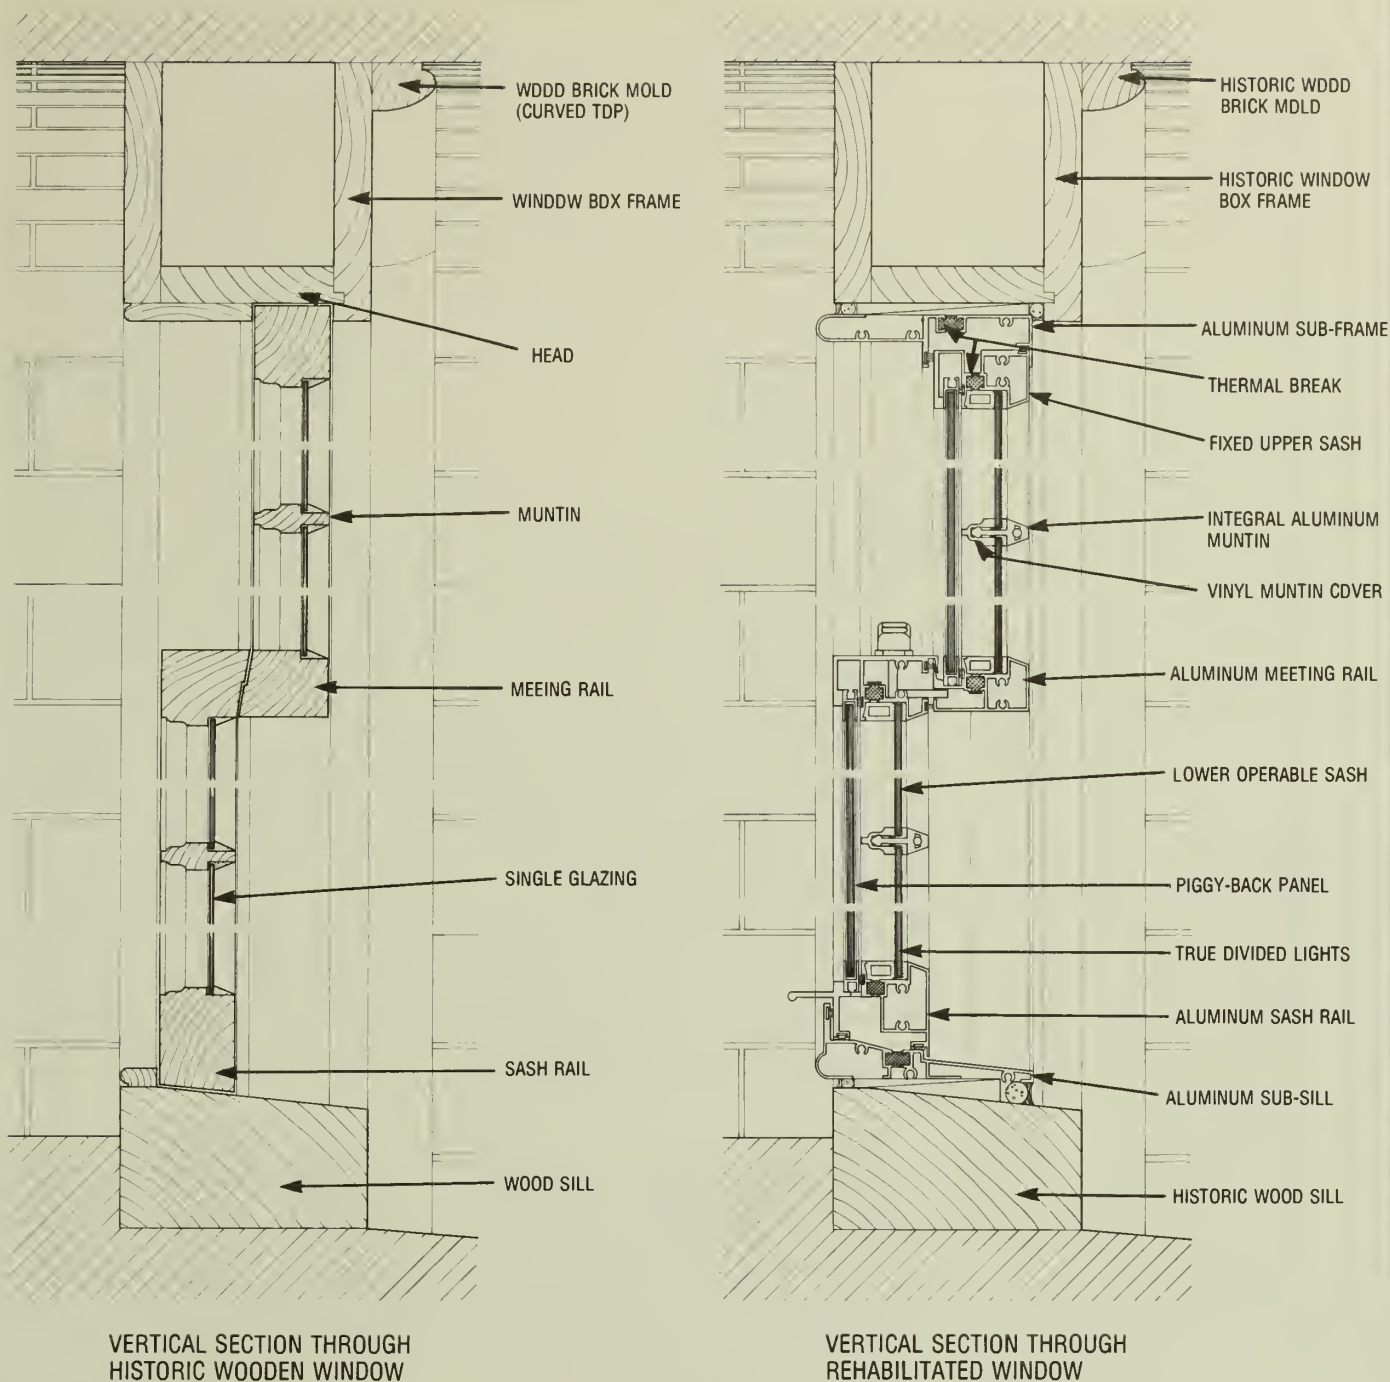
Figure 5. Vertical section of the window shown with old and new sash. Drawing: Timothy Buehner

On the sub-frame, a drip edge that broke the sight line at the head was eliminated as unnecessary. The detailing of the sub-frame was also revised to facilitate installation into the existing frame from the building interior. This resulted in a cleaner interior finish; however, it also increased the height of the sub-sill, making it somewhat more visible on the exterior. The overall depth of the early design was also reduced, resulting in a final depth only about $\frac{1}{2}$ " larger than the historic window. Because the muntin had to clear the piggy-back panel behind it, the overall muntin depth was to be $1\frac{1}{16}$ ", just $\frac{3}{16}$ " less than the historic ones (see figure 5).

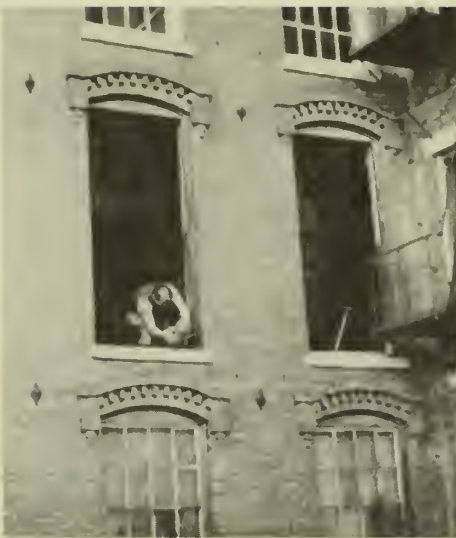
Figure 6. Work on the frames consisted largely of making dutchman repairs to the pulley stiles where required; renailing or replacing brick moldings; replacing some sills; and surface preparation. Photo: Charles Fisher

The exterior of the wooden frames were not to be panned or covered in aluminum. Thus it was important both for aesthetic consideration and good paint performance that the wood frames be repaired and surfaces properly finished. Work on the frames consisted largely of making dutchman repairs to the pulley stiles where required; renailing or replacing brick molding; replacing some sills; and scraping, filling and sanding wood surfaces. Painting consisted of priming and two coats of alkyd oil paint (see figure 6).

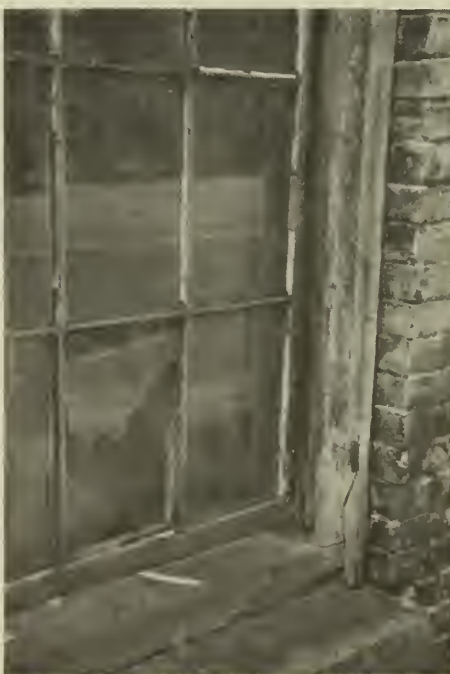
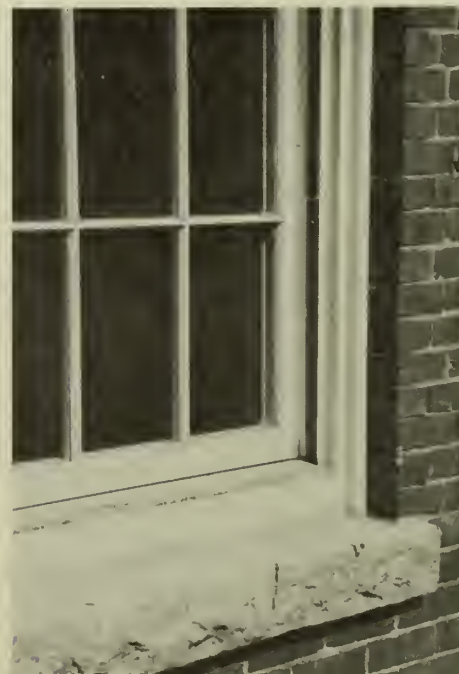
Figure 7. The retention of the exposed outer face of the historic wooden frame and the sill detailing were important qualities of the window treatment. Before and after photos: Charles Parrott

Installation of the new sash went quickly and smoothly. First, the sub-frame was inserted in the prepared opening from the room side, shimmed to plumb, line and level before attaching screws through the head and jambs into the old frame. The sash were then installed and the windows were caulked on both the interior and exterior to complete the work (see figure 7).

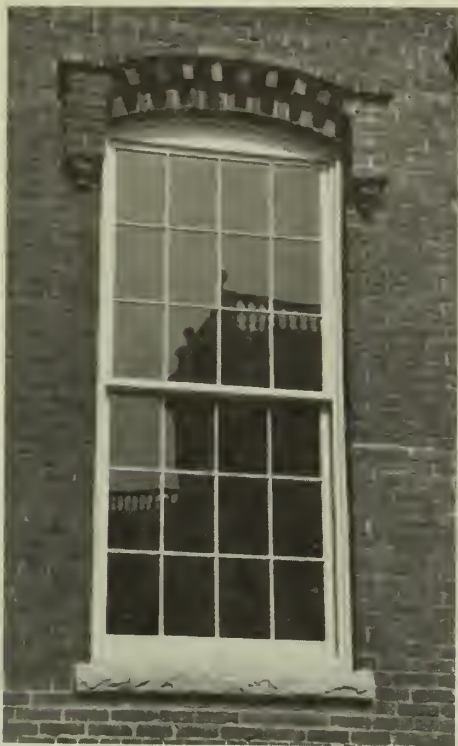
Figure 8. Replacement window sash after installation. Photo: Charles Parrott

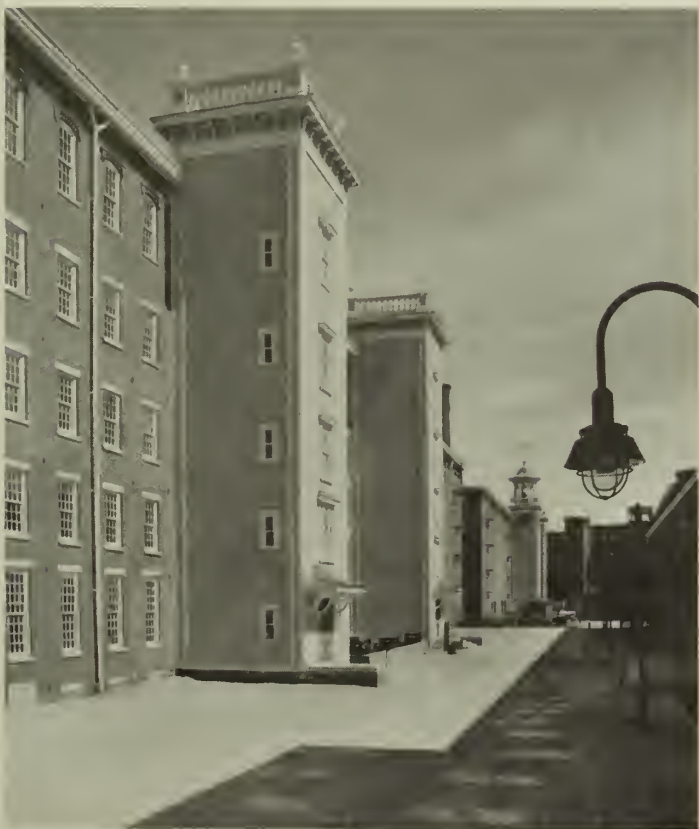
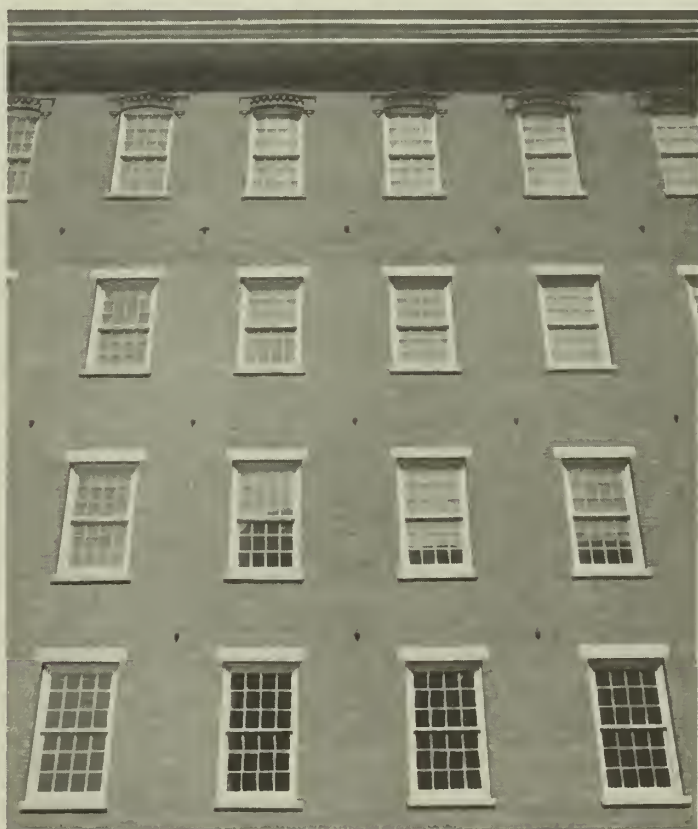
Figure 9. The window solution represents an important advance in the way in which aluminum windows can be designed to capture more fully the appearance of historic windows in larger buildings. Right photo shows wood sash in bottom row and aluminum in the upper three rows. Photos: Jim Higgins ©
