Submerged Cultural Resources Study

USS ARIZONA MEMORIAL

PEARL HARBOR NATIONAL HISTORIC LANDMARK

**DANIEL J. LENIHAN, EDITOR
SUBMERGED CULTURAL RESOURCES UNIT
NATIONAL PARK SERVICE**

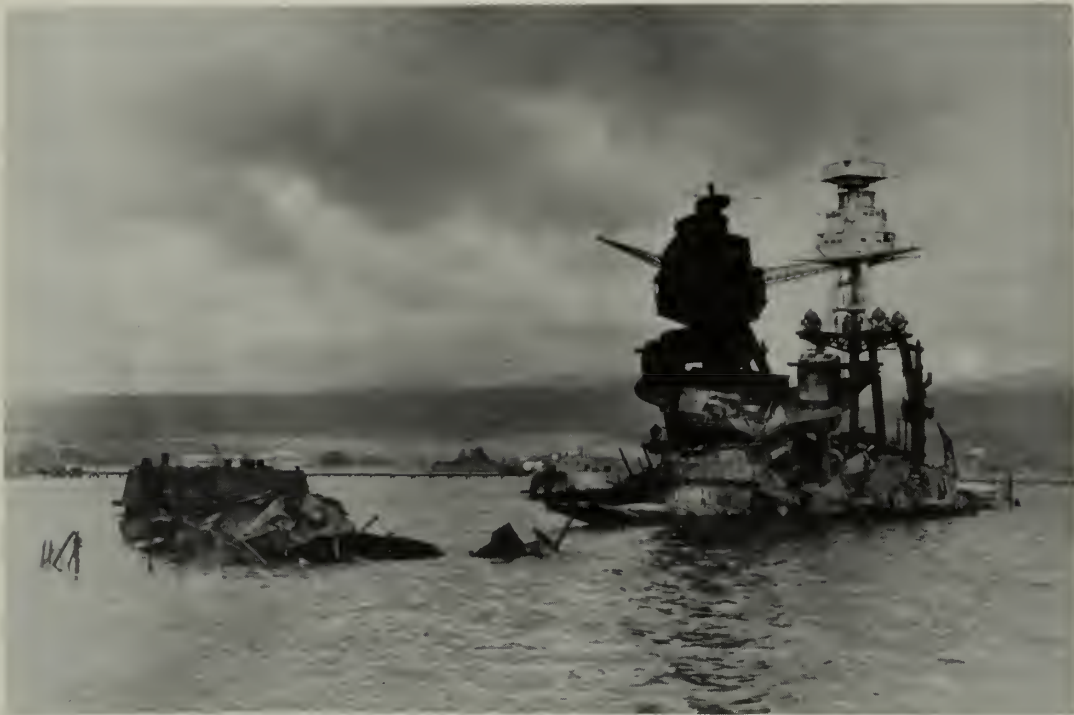
Figure 2.22. Aftermath: December 1941, the USS ARIZONA from port bow looking aft. (NPS: USAR collection)

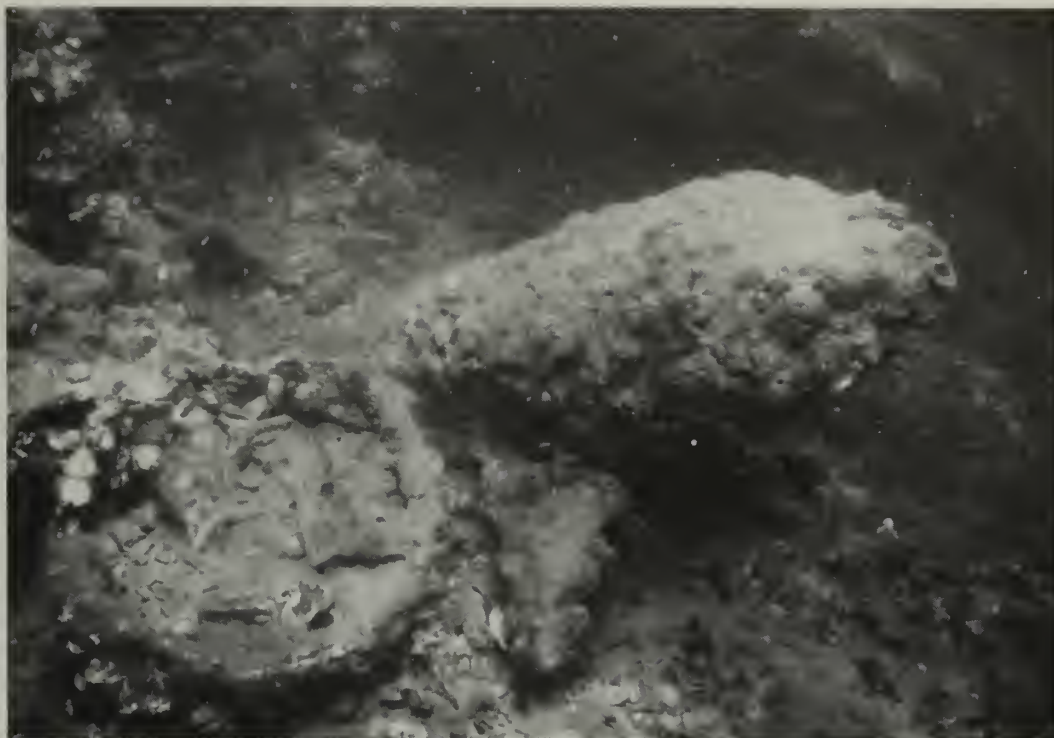
Figure 3.13. Air cylinder protrudes from debris on deck of USS ARIZONA. US Navy EOD divers were called in to rupture the bottle in case it was still under pressure. (NPS photo by Larry Murphy)

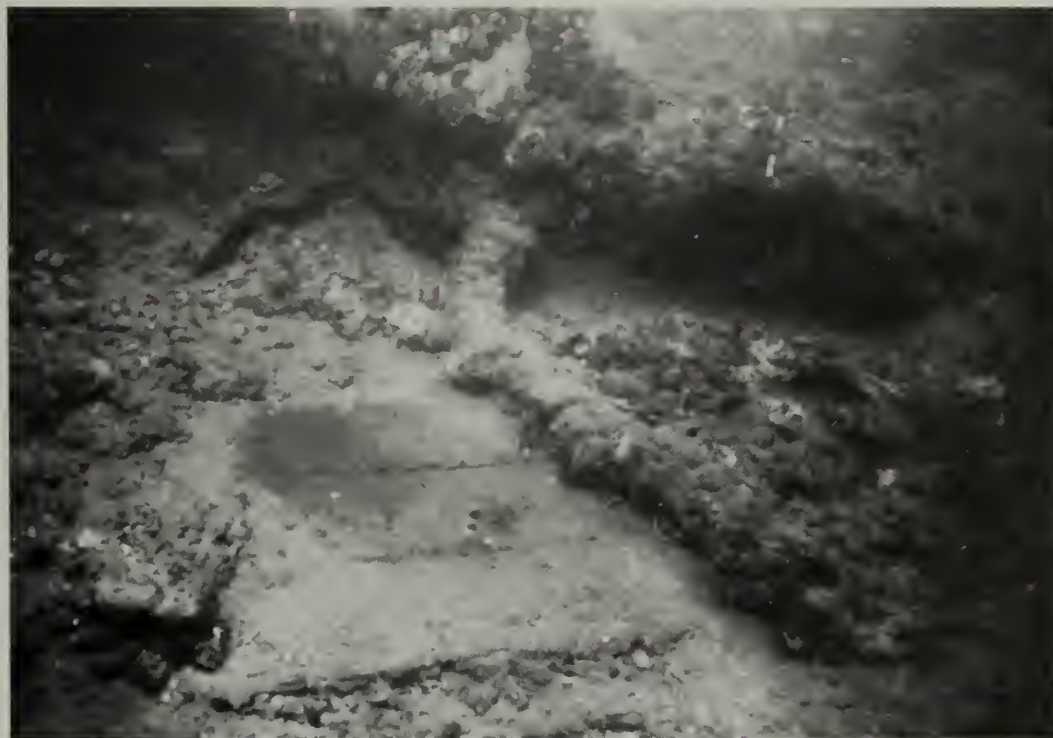
Figure 3.14. Intact teak decking is exposed on USS ARIZONA. (NPS photo by Larry Murphy)

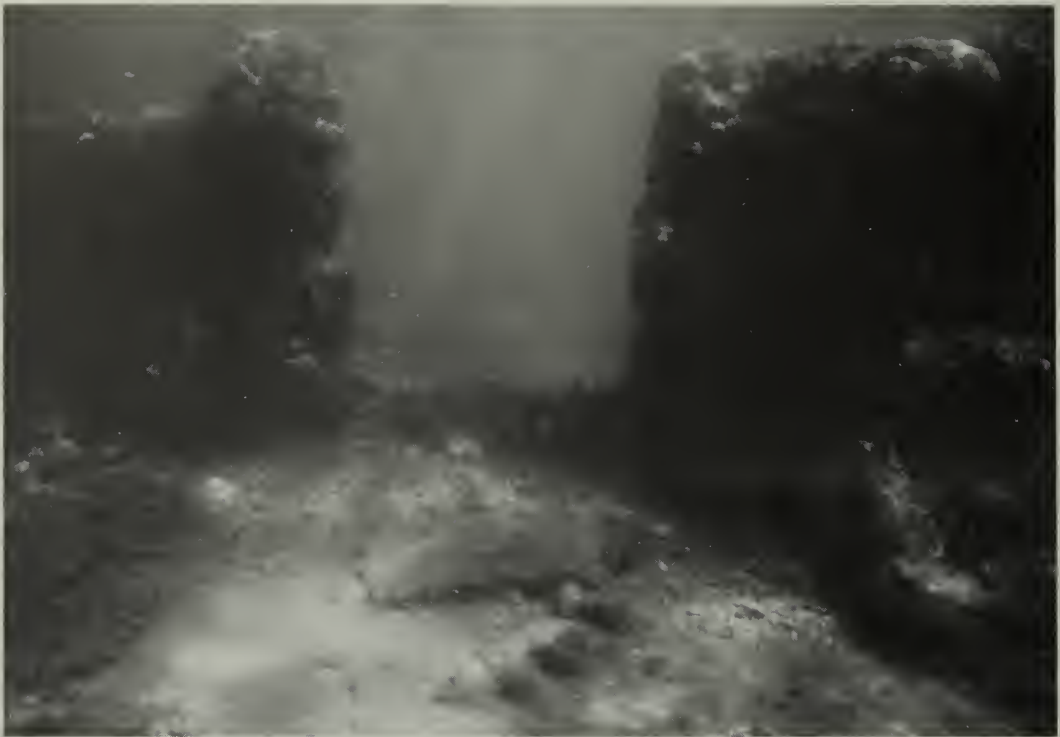
Figure 3.15. Entryway to galley and mess area , with bulkheads partially removed . (NPS photo by Larry Murphy)

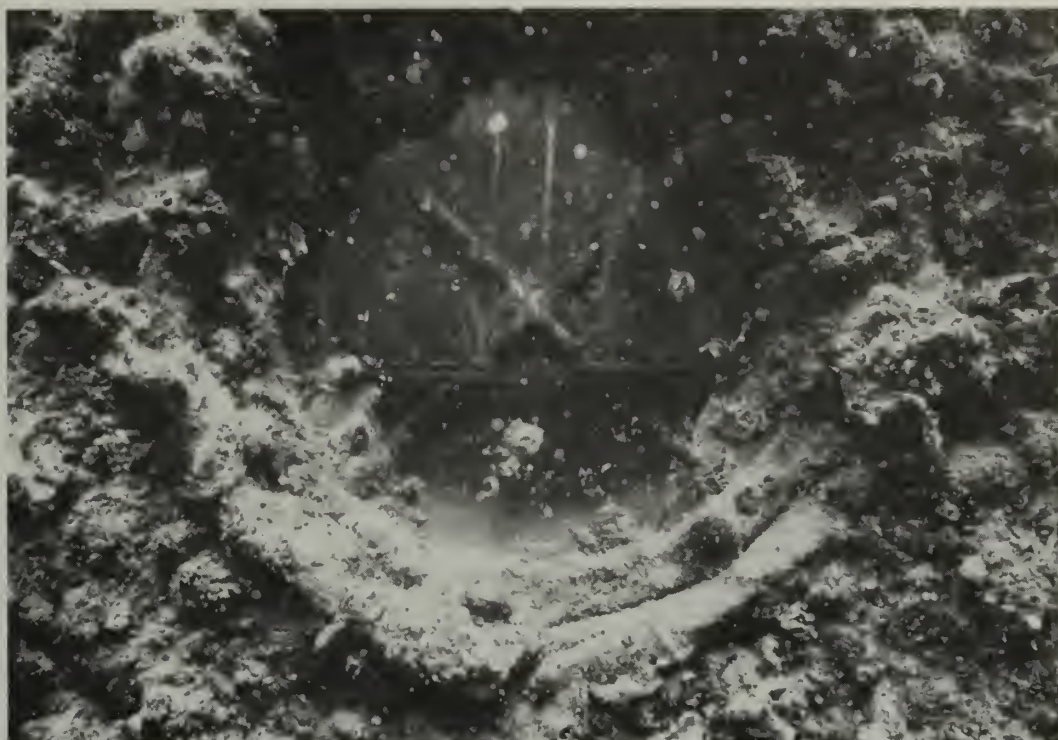
Figure 3.21. Air is trapped between porthole blackout cover and glass on USS ARIZONA. (NPS photo by Larry Murphy)

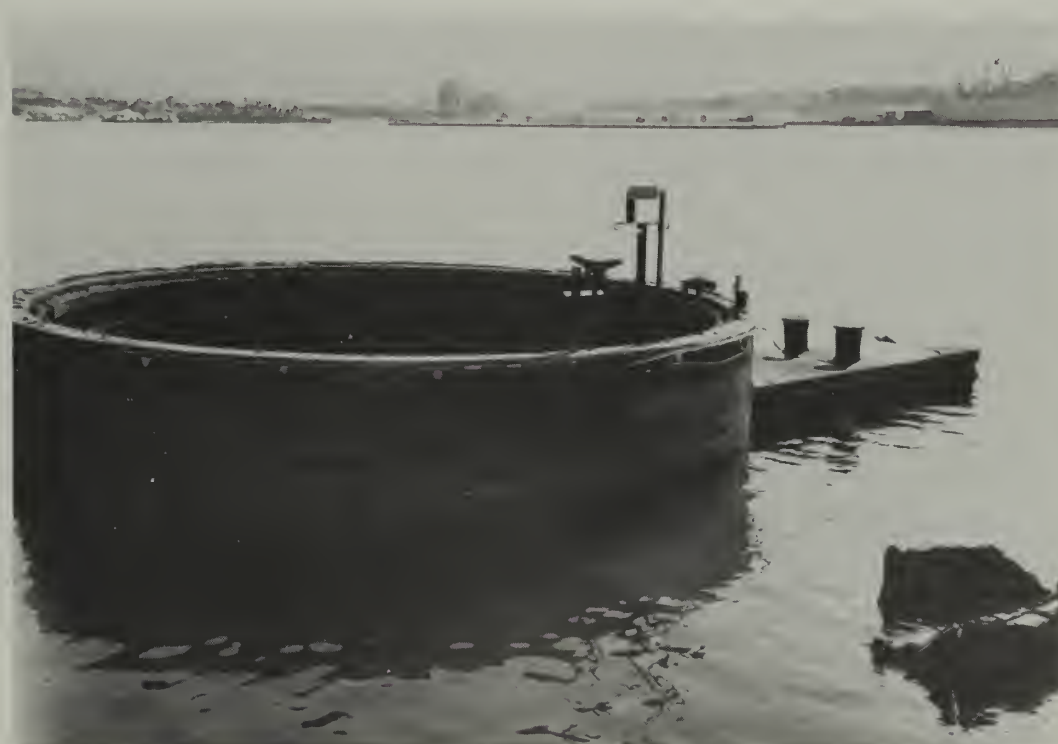
Figure 3.22. No. 3 barbette protrudes higher than any other feature of the ship. (NPS photo by Larry Murphy)

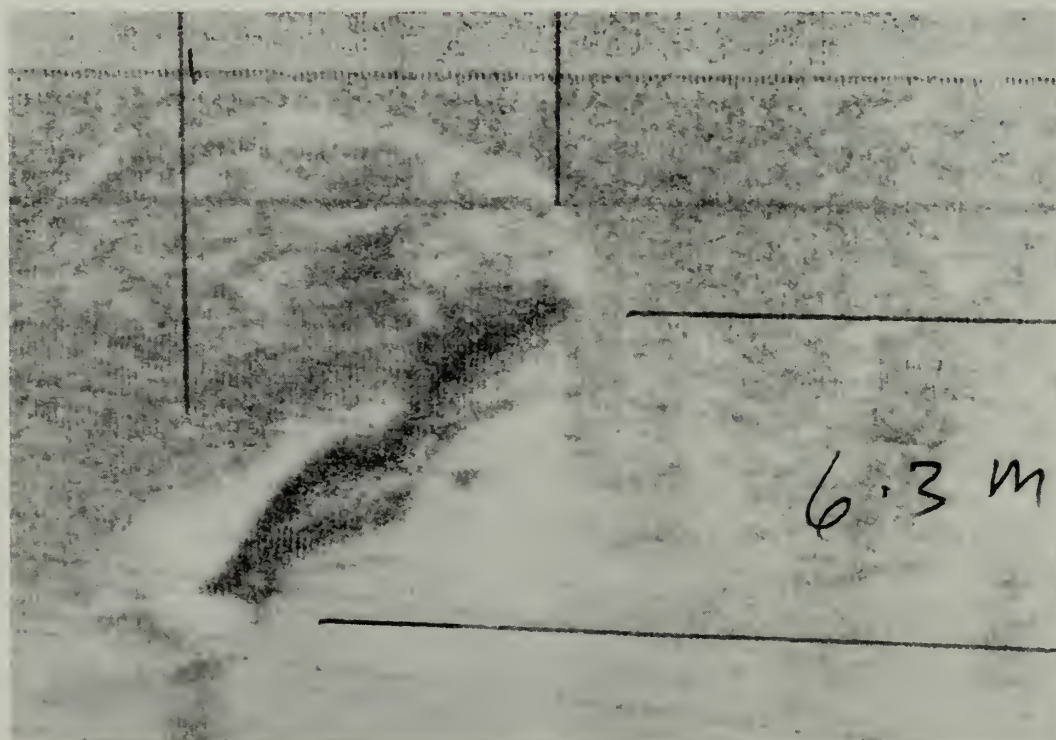
Figure 3.38. Side-scan sonar contact from NPS/Navy survey outside harbor mouth in almost 900 feet of water. (Photo of side-scan record by Mark Hertig)

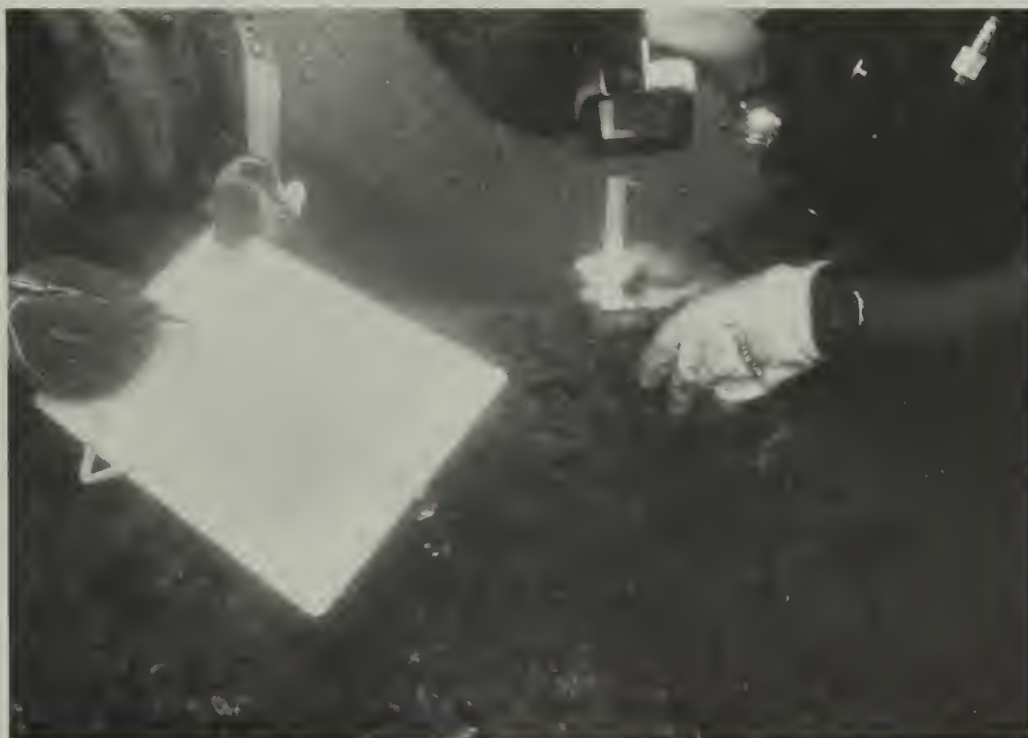
Figure 4.5. Thickness of corrosion and biofouling was measured at selected sampling stations on USS ARIZONA. (NPS photo by Larry Murphy)

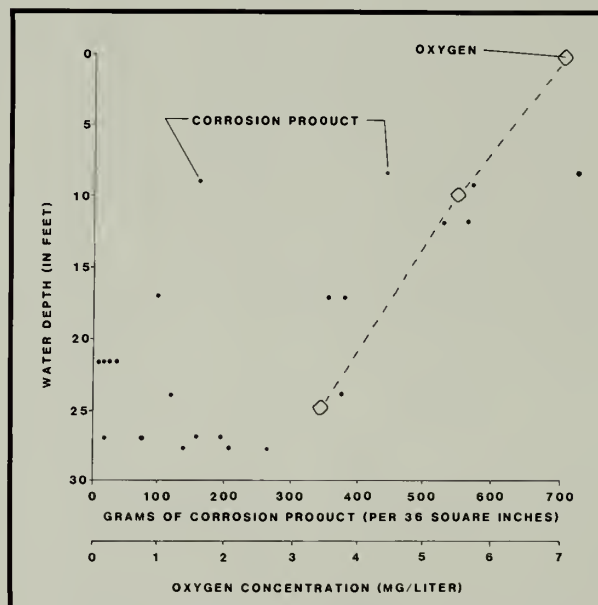
Figure 4.6. Plot of water depth versus grams of corrosion product removed from 36-inch square areas of steel surface at vertical photostations on the USS ARIZONA. For comparative purposes, typical oxygen concentrations that occur at surface and two midwater depths (R.S. Henderson, unpublished Pearl Harbor survey data, 1978-1986) are provided.
