REPORT  
GEOLOGIC HAZARD EVALUATION  
ALCATRAZ ISLAND  
GOLDEN GATE NATIONAL RECREATION AREA  
FOR THE NATIONAL PARK SERVICE

OCTOBER 29, 1982

JOB NO. 2050-064-03

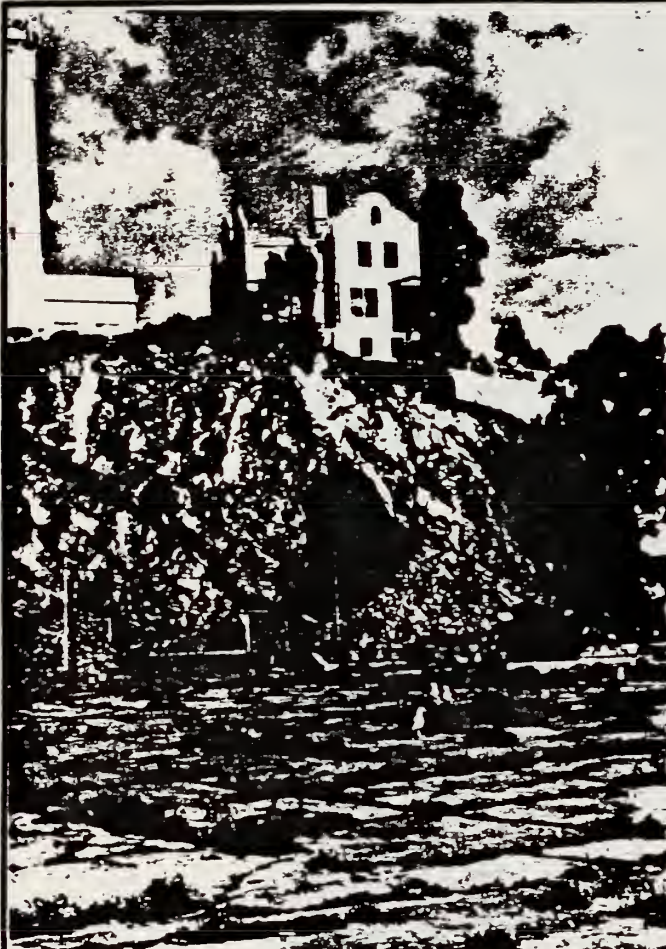
A.

The steep dips of the joint surfaces and their intersection (which are the surfaces of failure) suggest that ravelling and small rock slides are likely to be the most common modes of failure in the future. Failures up to several feet in depth (similar to that which occurred in January 1982 and slightly larger) can occur, however, and must be protected against if the Warden's Residence is to be maintained.

STEEP ROCK FACE ADJACENT TO WARDEN'S RESIDENCE

NOTE RECENT ROCKFALL AND MISSING SECTION OF WALL

Rock bolts would be installed, probably in a regular pattern to a prescribed depth and tensioned to a prescribed load. The face could be sheathed with wire mesh and/or gunite to retard the effects of weathering. Details of the actual remedial solution should be developed during a design study. The bolting should extend across the portion of the cliff closest to the lighthouse in order to protect the roadway from continued slope degradation which could ultimately cut access to the lighthouse and endanger the structure.

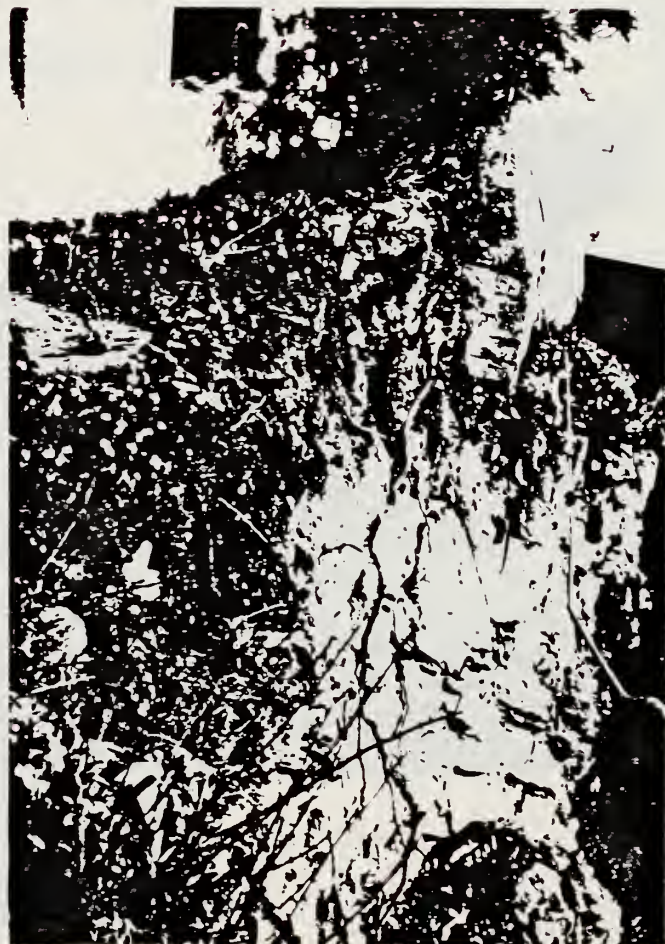
B.  
DETAIL OF TOP OF STEEP ROCK FACE AT  
LOCATION OF RECENT ROCK FALL

NOTE MISSING SECTION OF WALL AND  
PROXIMITY OF FAILURE TO WALL OF  
WARDEN'S RESIDENCE

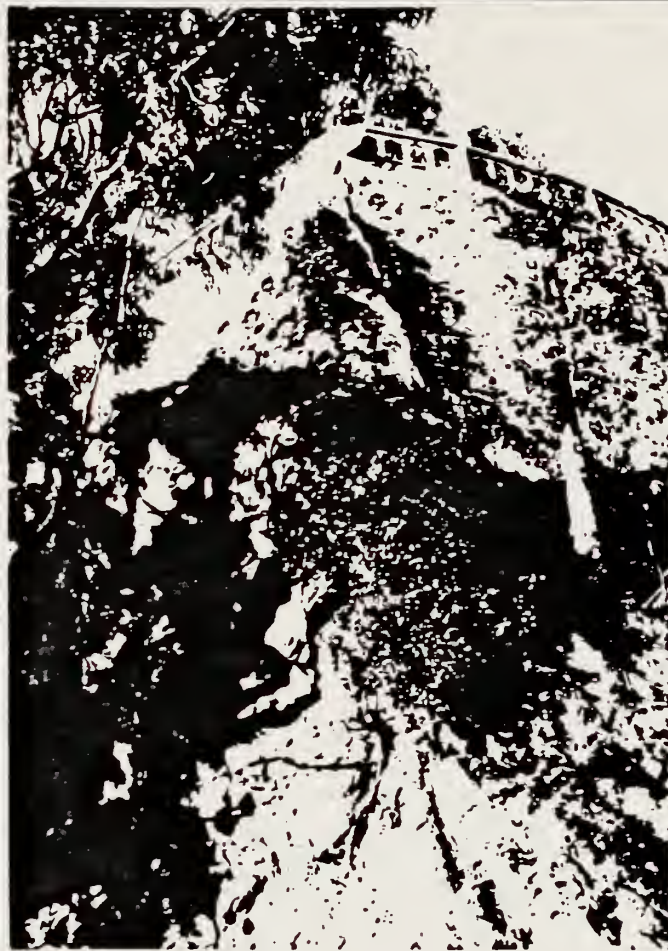
Based on the results of the hand auger holes, we anticipate that the wedge of fill behind the retaining wall has a maximum thickness of about 15 feet. Pictures taken in 1946 indicate that the crack in the southeastern corner of the retaining wall was present at that time, which suggests that failure of the wall may not be imminent. A similar crack on the extreme northerly corner of the wall suggests that the entire mass may be moving slowly as a unit.

A. CRACK IN GARDEN RETAINING WALL NEAR WARDEN'S RESIDENCE

The wall has not been investigated in detail, but in all likelihood it consists of unreinforced rubble masonry with very little structural integrity. Therefore, options 1 and 2 would also necessarily involve some overall structural support such as wire mesh and gunite to allow the transfer of stresses from the anchors or cables across the wall as a unit.

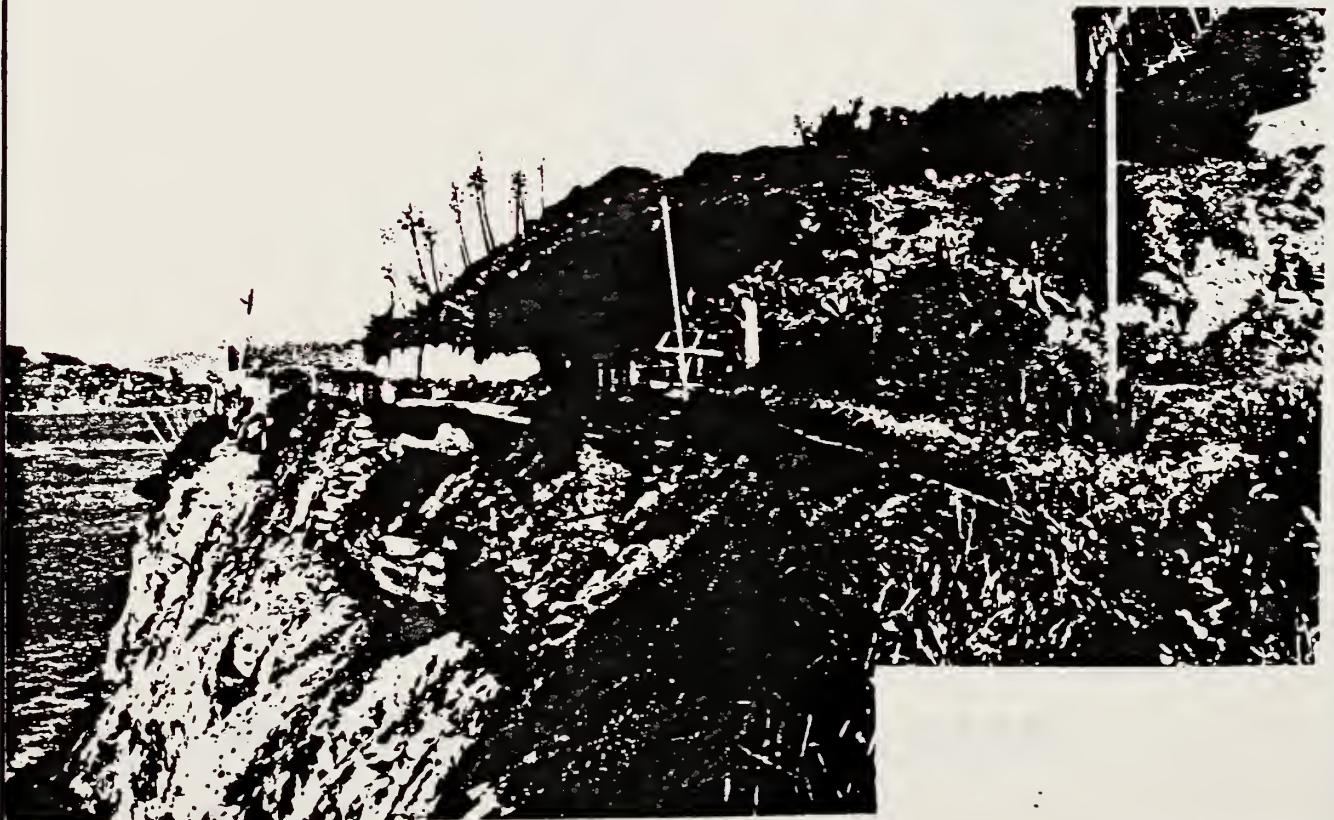
The West Road is being currently undermined along sections which are built across fill. Continued undermining could completely destroy the southern 80 feet of the road. Undermining of the northern 80 feet is not considered likely to affect the entire width of the road because the inner portion is believed to be founded on stable bedrock.

B. DAMAGE DUE TO UNDERMINING OF WEST ROAD

1. Northern Half If the inner portion of the road in this location is founded on bedrock as expected, then the most cost effective means of stabilizing the road is to support the outer portion on drilled piers. Relocation of the road inland is possible but would involve extensive excavation.
2. Southern Half The most cost effective means of stabilizing this section of the road would be to relocate the road inland. This approach assumes that slightly inland from the road's present location, the new road could be founded on bedrock. This assumption seems reasonable based on older topographic maps and the fact that this area is a quarried plateau. Other possibilities include structurally bridging across the old filled zone, but costs would be significantly higher for this approach.

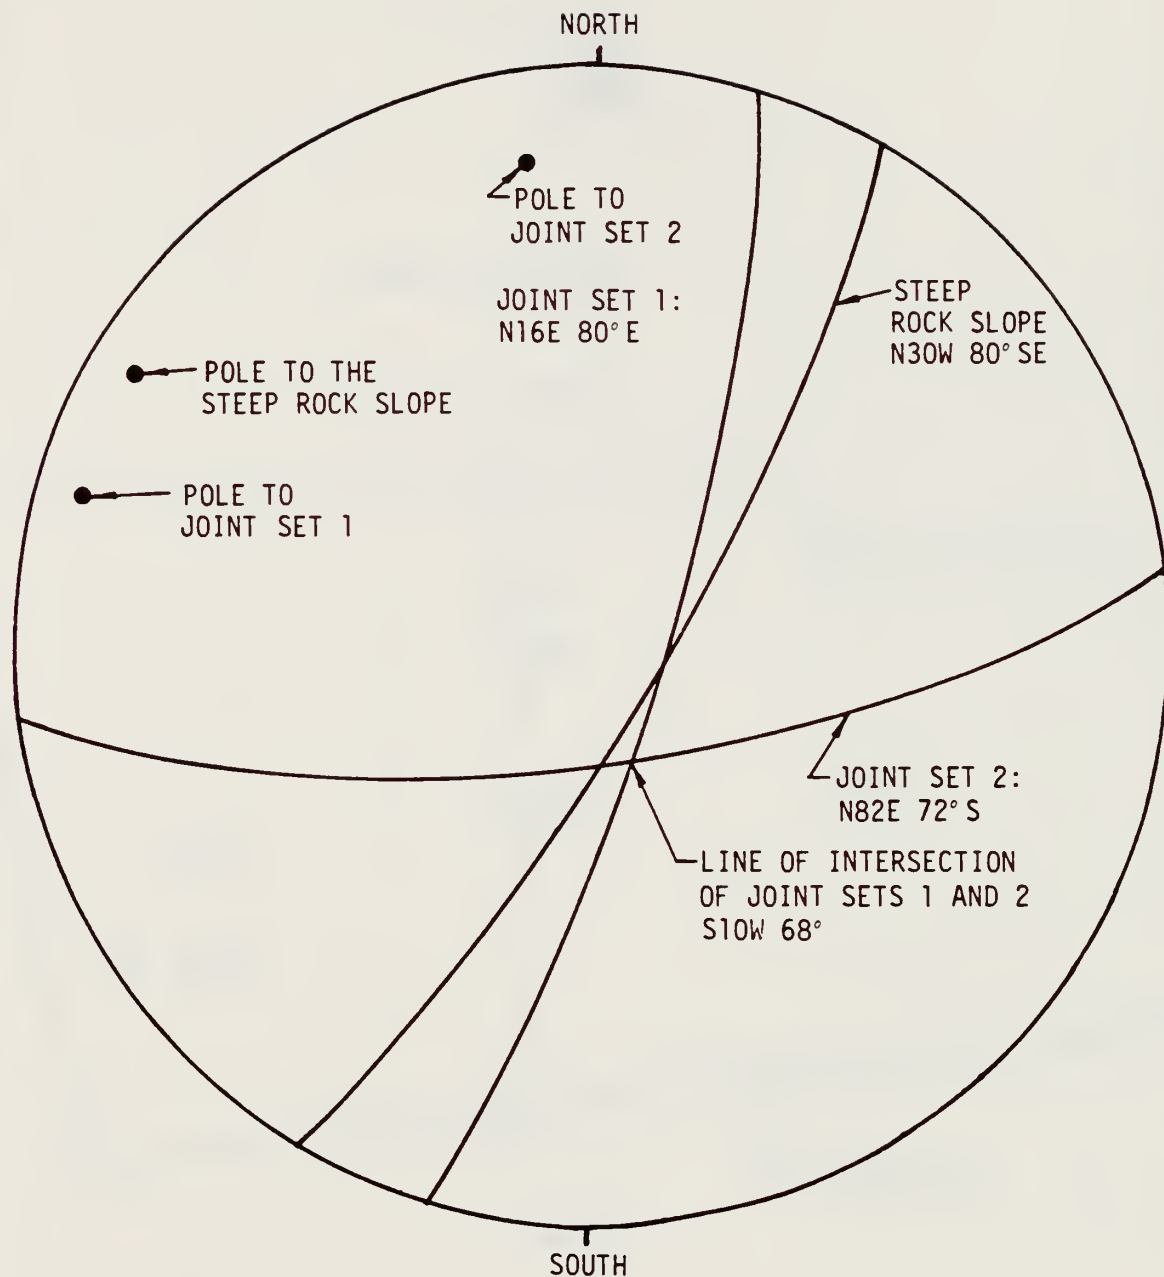
# STEREOGRAPHIC PRESENTATION OF CUT SLOPE AND CRITICAL PLANES

Based on these analyses and the results of field observations, the critical unstable surfaces were identified. There are two dominant joint sets whose intersections appear to be the primary location of wedge-type failure; these sets have the following orientations: 1) striking N16°E and dipping 80° E; and 2) striking N82°E and dipping 72°S; the data are synthesized on Plate 6.

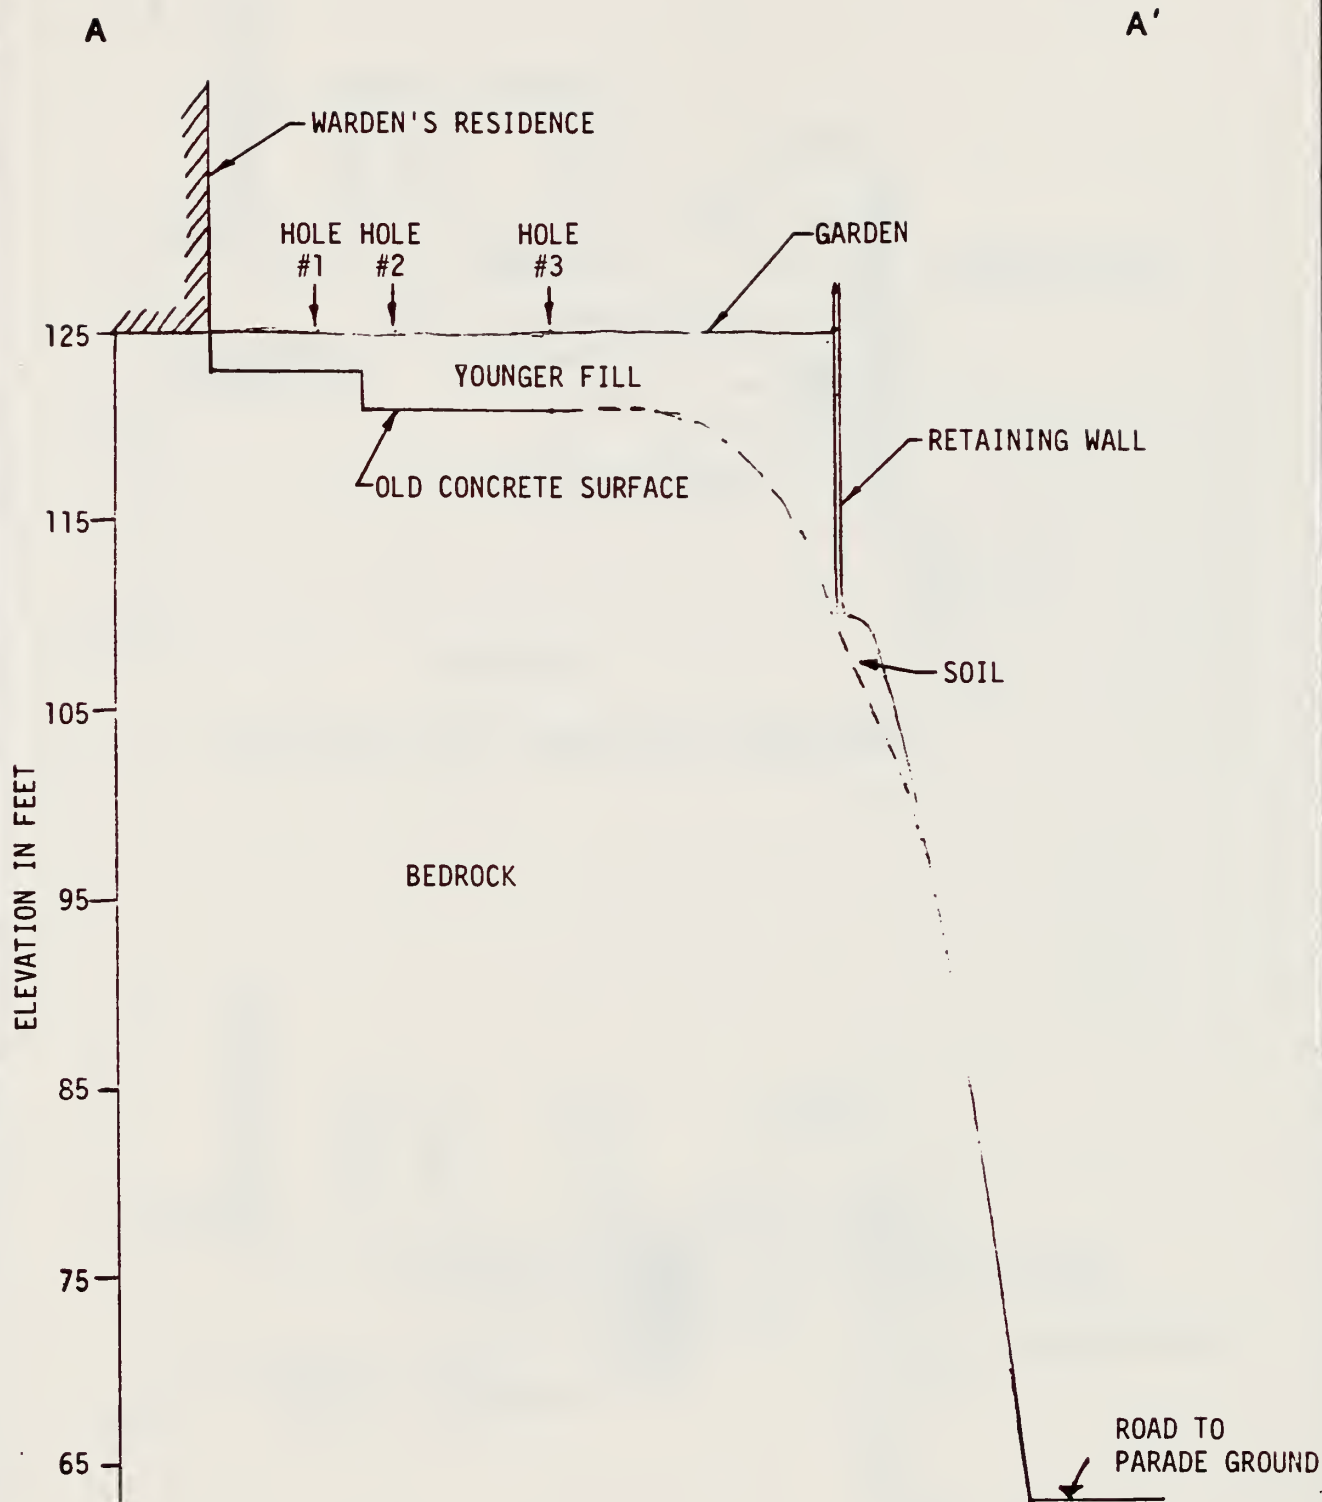
INTERPRETIVE  
CROSS SECTION A-A'

Six hand auger holes were drilled in the garden area adjacent to the Warden's Residence at the locations shown on Plate 7. Holes 1,2,3 and 5 encountered concrete at depths of 1.9, 4.1, 4.1, and 2.5 feet, respectively. These data suggest the presence of a previous platform or slab in this area. Hole 4 encountered sandstone at a depth of 4.1 feet which suggests that the older platform or slab is founded on bedrock. Hole 6 encountered brick, sandstone and concrete at a depth of 2.3 feet which may represent a wall associated with the older structure, or newer fill. A cross section through the garden and the retaining wall showing this older feature and the estimated bedrock surface is presented on Plate 8.
