**BOSTON**  
CHARLESTOWN NAVY YARD  
THE RAILROAD TRACKS

HISTORIC STRUCTURE REPORT  
Architectural Data Section

THE RAILROAD TRACKS  
CHARLESTOWN NAVY YARD  
BOSTON NATIONAL HISTORICAL PARK  
Charlestown, Massachusetts

**REPORT OF SELECTED ALTERNATIVES  
INVESTIGATION AND EVALUATION  
OF  
RAILROAD TRACK**

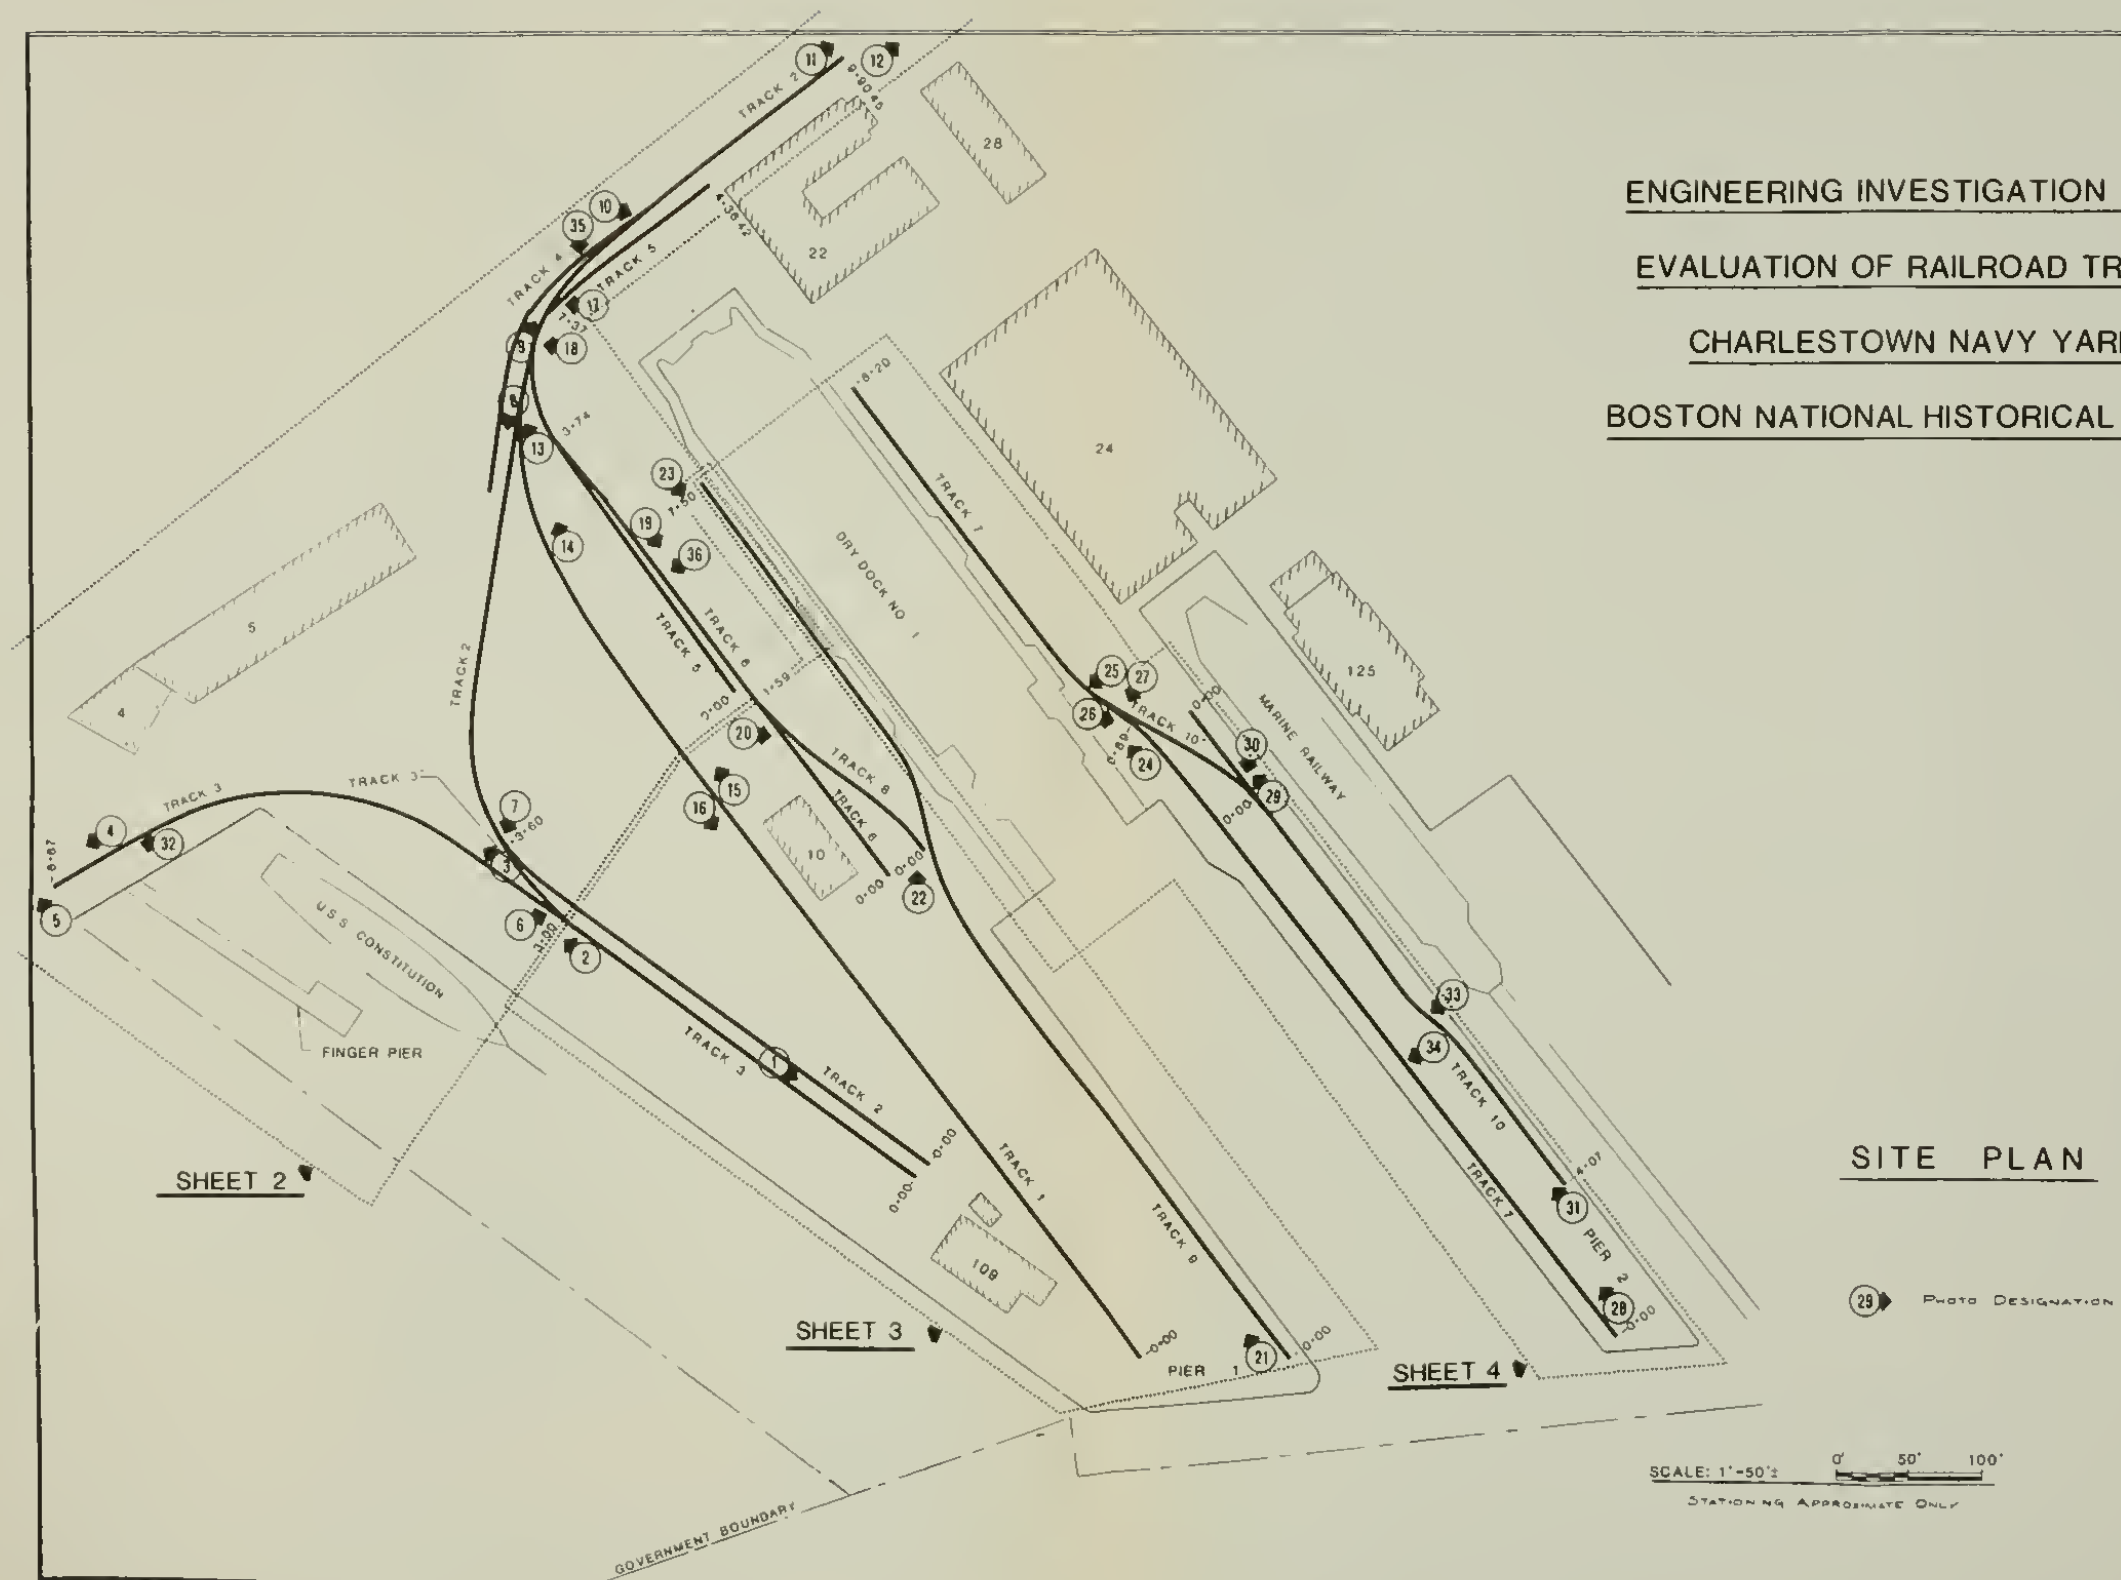
SITE PLAN

SWITCH E: SWITCH  
LEVER MISSING, FIXED  
WITH CRUSHED STONE

STA 7+05 6" SEGMENT  
OF RAIL MISSING.
