# GENERAL PHILIP SCHUYLER HOUSE

Saratoga National Historical Park  
Schuylerville, New York

Historic Structure Report  
Volume I

**2003**

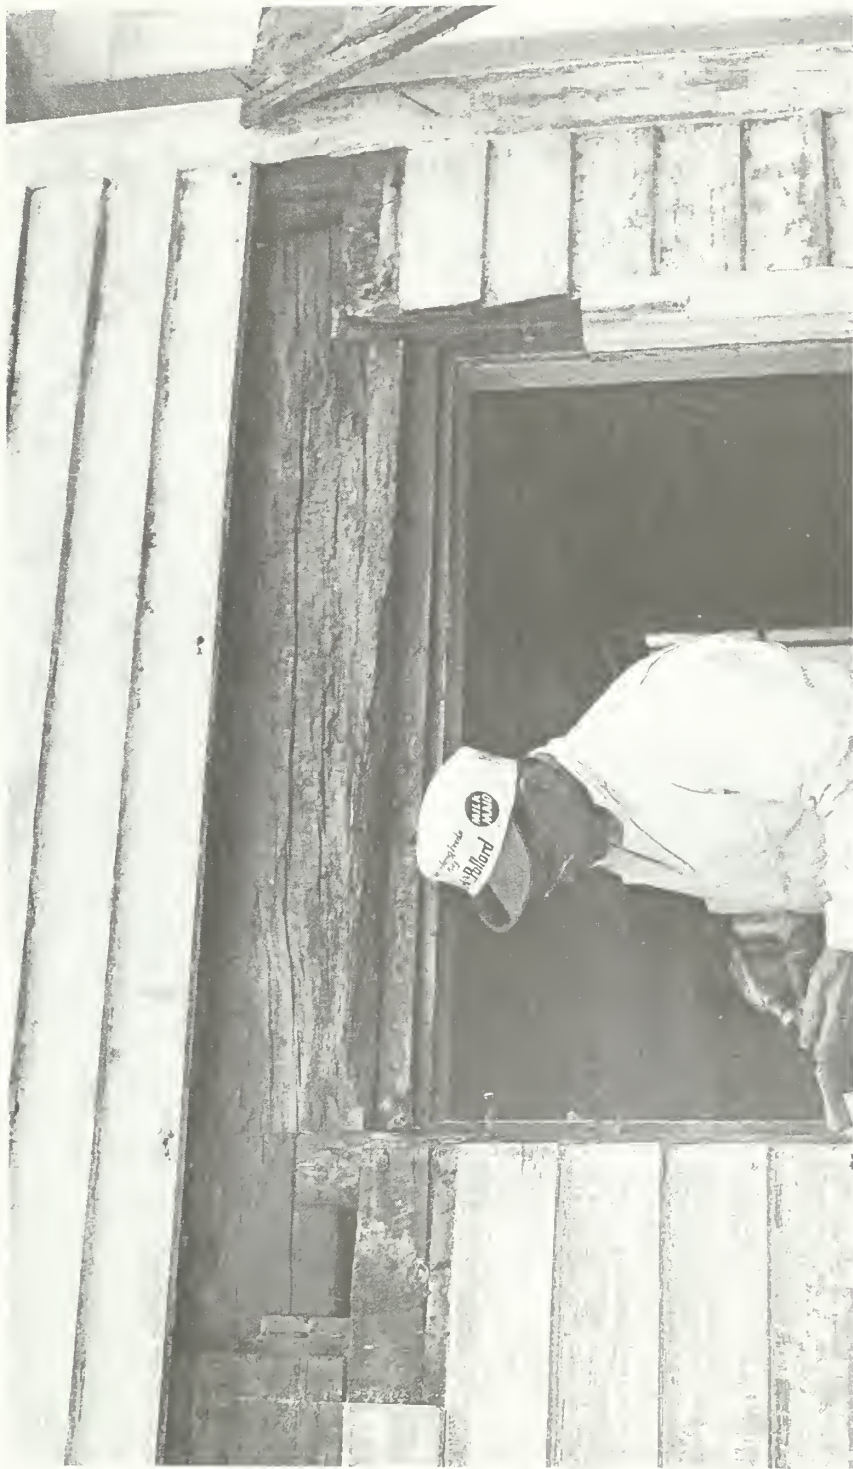
Figure 38. Schuyler House: Northwest corner, window W112 repairs (ca. 1955).

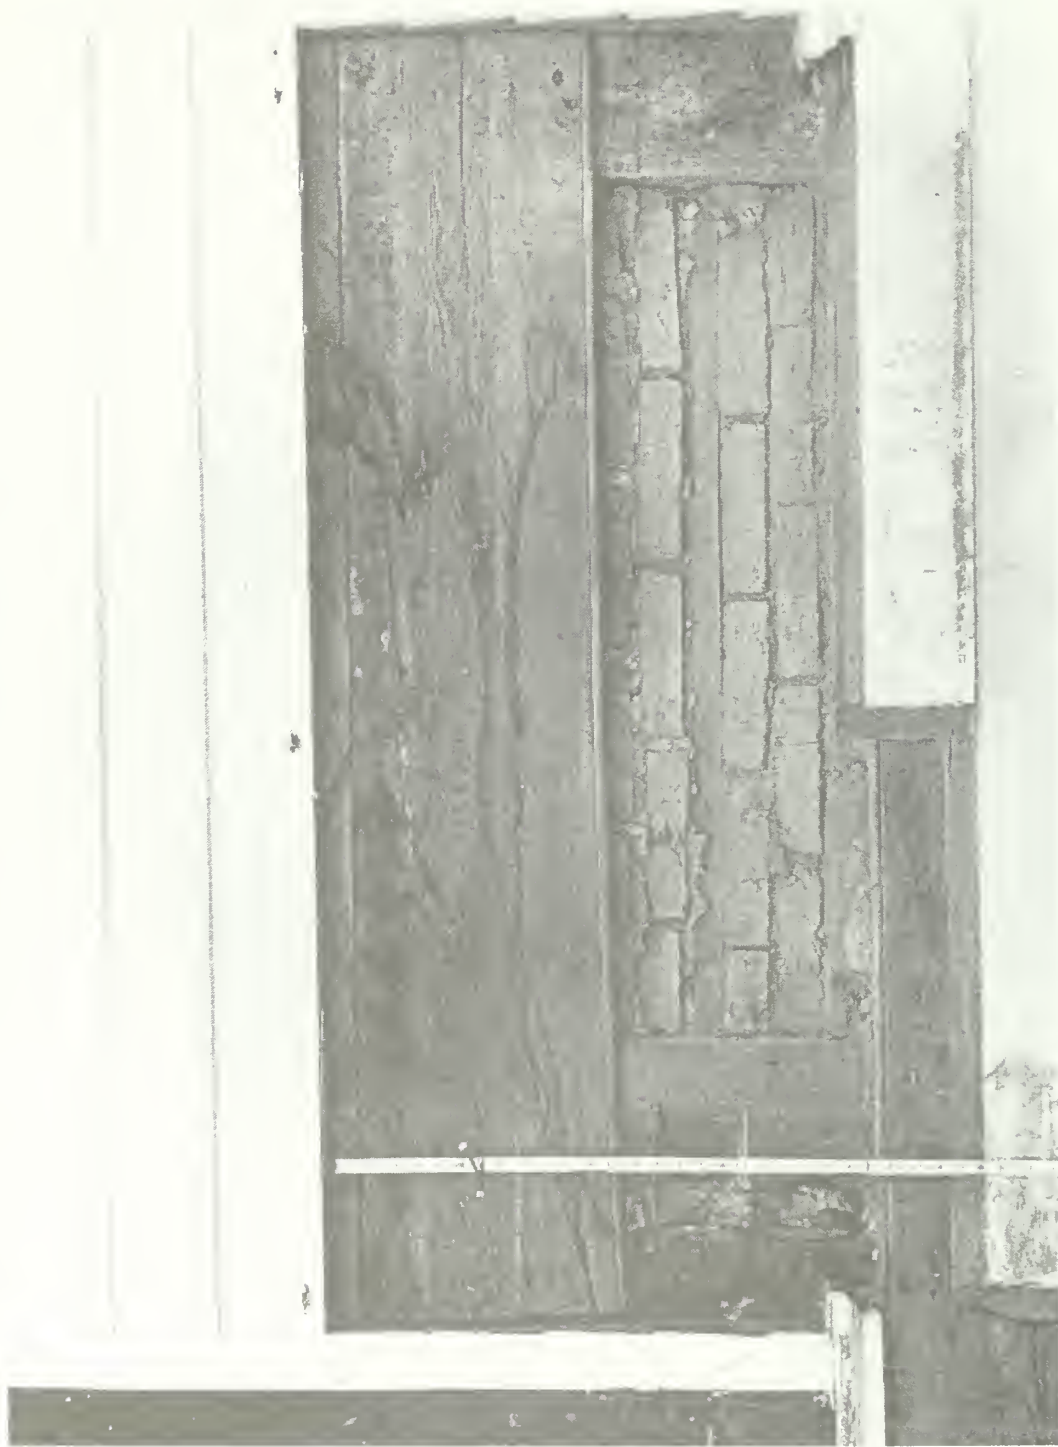
Figure 39. Schuyler House: Exposed sheathing (original weatherboarding) and nogging (1958).

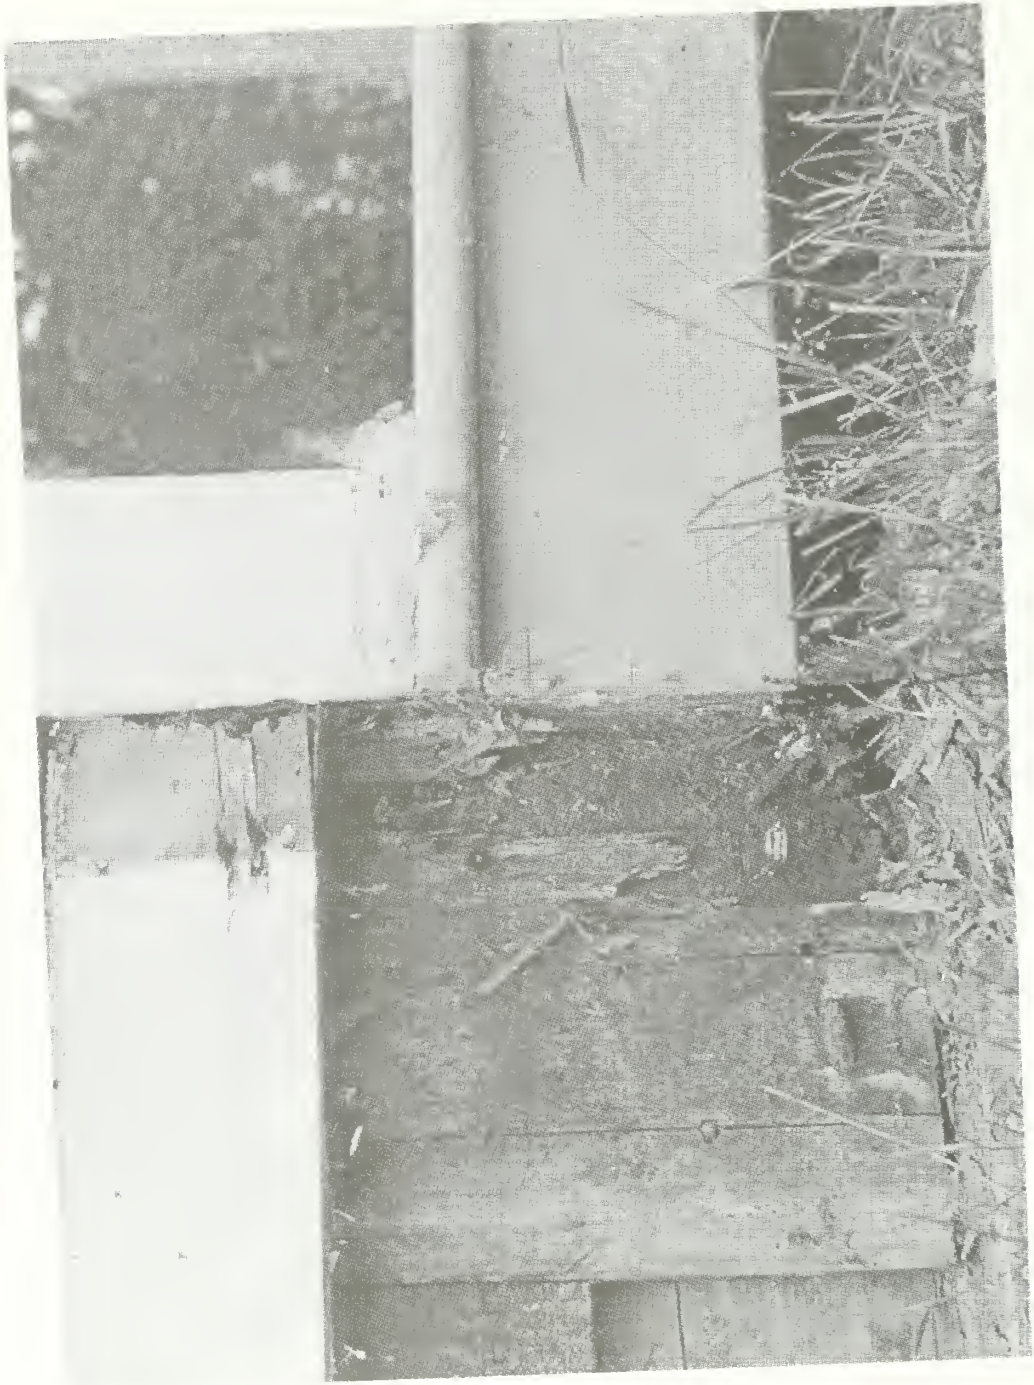
**Figure 43.** Schuyler House: Northwest corner, deteriorated sill (1958). Note embedded pencil.
