AN EVALUATION OF EXPERIMENTAL
REHABILITATION WORK,
REDWOOD NATIONAL PARK

TECHNICAL REPORT
JULY 1987

Redwood National Park Watershed Rehabilitation
Technical Report Number 19

National Park Service
Redwood National Park
Arcata, California
July 1987

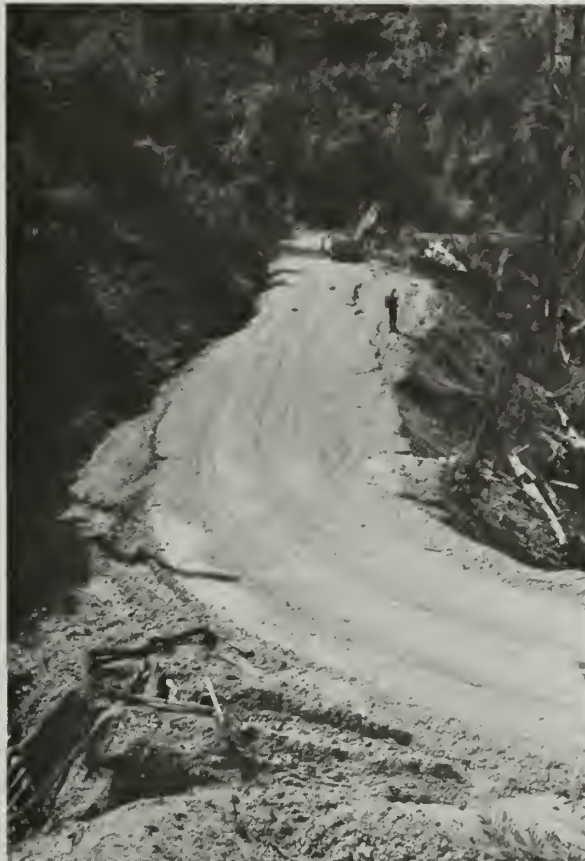
Fig. 3. Tension cracks in the fill slope, L-1-5 logging road.

runoff diverted from an upslope area. Several hundred cubic yards of earth and debris slid directly into a perennial tributary (north of location R4, Figure 4). Third, numerous skid trail stream crossings on steep slopes above the L-1-5 road showed signs of impending failure. Some fills were gullied. Others threatened to fail by debris torrent as supporting organic debris decomposed and fills became saturated during winter storms. At other locations, streamflow deflections were causing erosion of adjacent stream banks. Stream diversions were likely to occur at several locations.

Outsloping the L-1-5 road was necessary to avoid eventual failure of unstable road fill material into Bond Creek. However, a short segment of stable road between two ridges east of road crossing R4 could have been effectively treated by ripping and constructing cross-road drains. This would have resulted in a small savings in road removal cost.

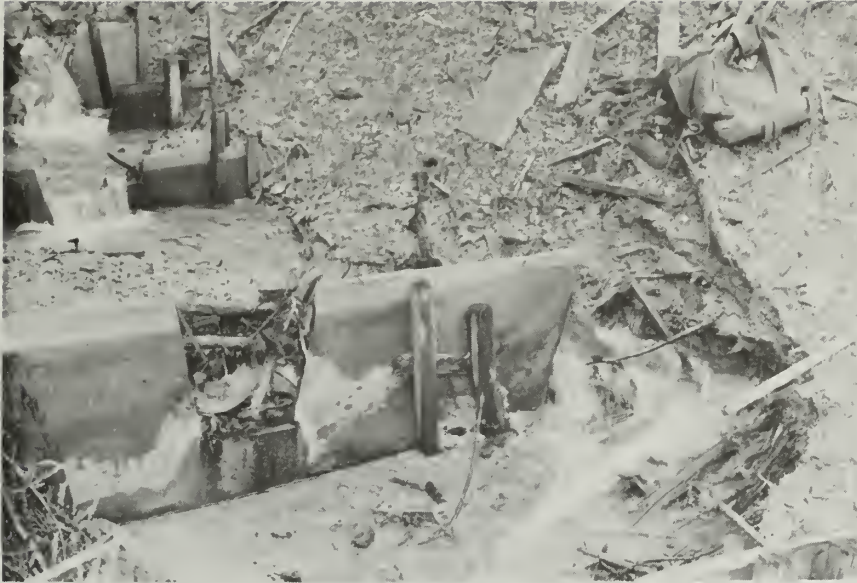
Fig. 12. Washed out checkdam. Organic debris plugged the spillway, diverted streamflow against the left bank and caused lateral scour around the structure.

Maintenance of erosion control devices during the winter immediately following rehabilitation consisted of repairing a washed-out checkdam (worksite S2) and clearing debris from checkdam spillways which were partially clogged (Figure 12). There was no need for maintenance during the winter of 1980-1981. Maintenance in 1981-1982 consisted of minor shovel work at worksite R3 and repair of one waterbar. Minor problems such as non-functional submerged spillways still exist on the site, but continued maintenance is not needed since they present minimal erosion problems.

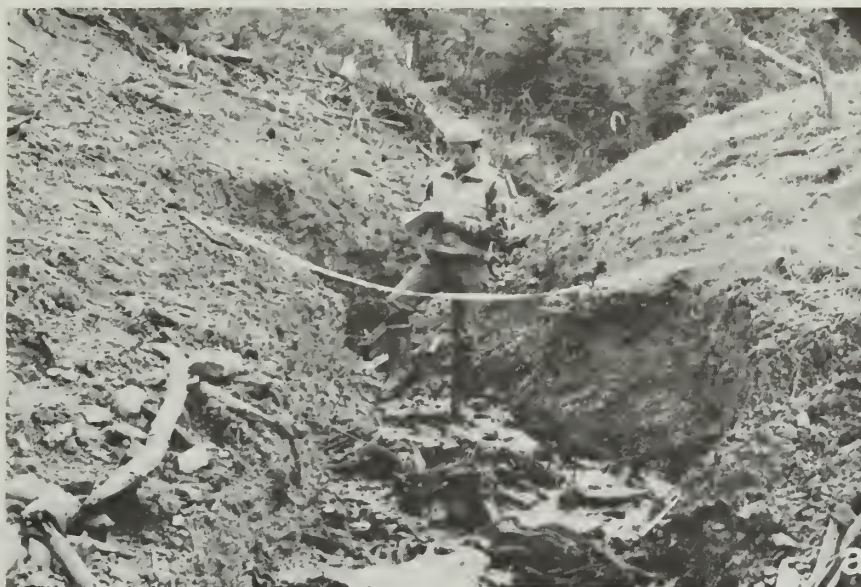
Most techniques used to control stream channel erosion worked well, preventing both downcutting and bank erosion. Checkdams were particularly effective, as demonstrated at worksite R2 (Figure 15). Runoff from early October storms downcut an average of two feet, eroding 22 cubic yards from the unprotected channel. Checkdams were then installed in the actively eroding channel. They succeeded in preventing further erosion and caused local aggradation of the streambed. Representative cross-sections (Figure 16) of worksite R2 demonstrated channel conditions which existed prior to the first winter storms, following the storm runoff and after installation of the checkdams.

Fig. 15. The effect of checkdam construction on excavated stream crossing R2. Note down-cutting in the unprotected, excavated crossing following the first significant runoff of the 1979-80 winter (15A). A measuring tape is draped across the channel at the location of the former excavated ground surface. In 15B, the series of checkdams installed in the eroded channel caused aggradation and stabilization of the channel bed and banks.

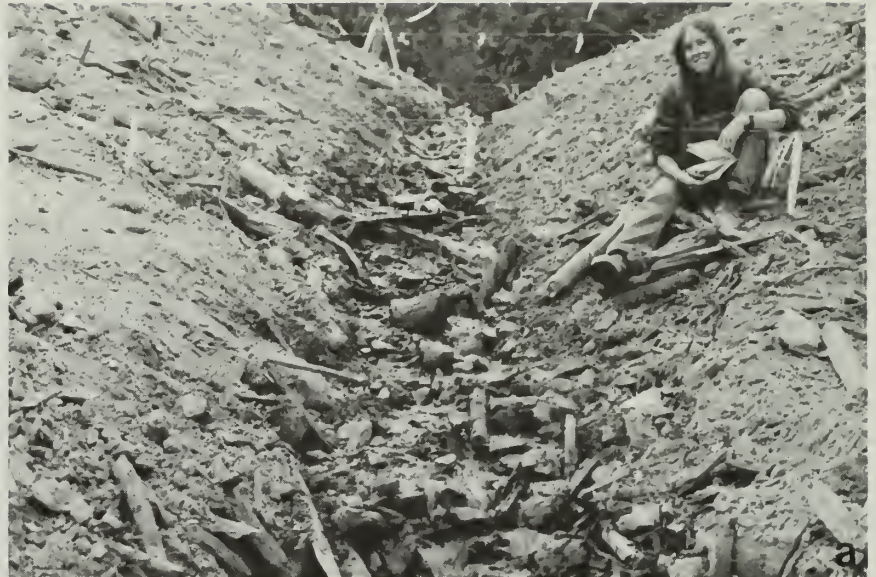
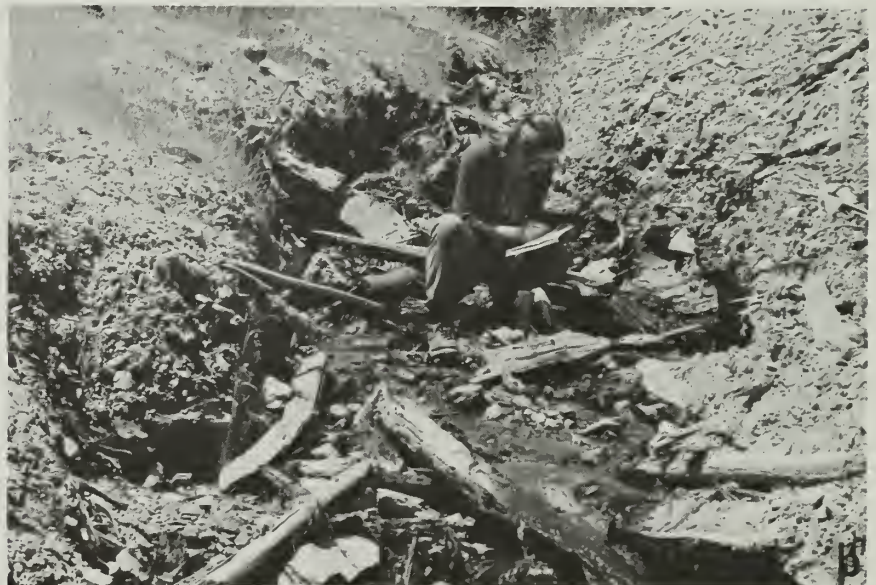
Fig. 17. Serial photographs of channel changes at the excavated stream crossing R1. Even though the crossing had not been fully excavated, abundant concentrations of organic debris buried in the fill helped minimize subsequent channel erosion. Figure 17A: October 1979; Figure 17B: June 1980.

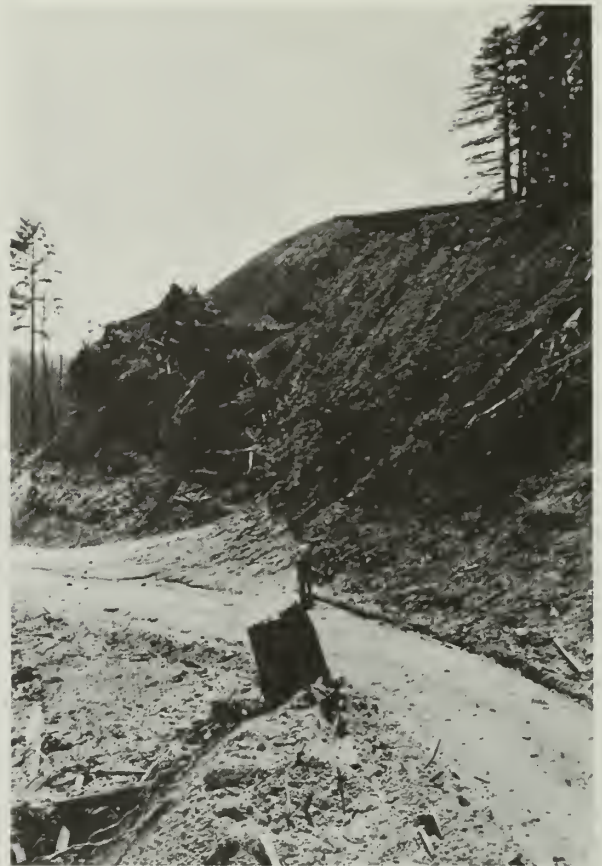
Fig. 23. Alluvial fan created by runoff from improperly drained yarder pad above the M-7-5-1 road.

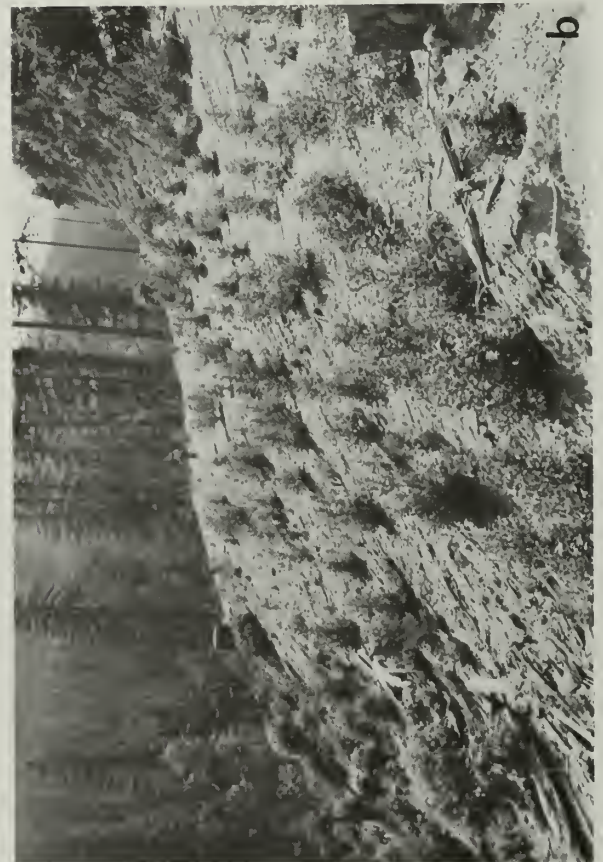
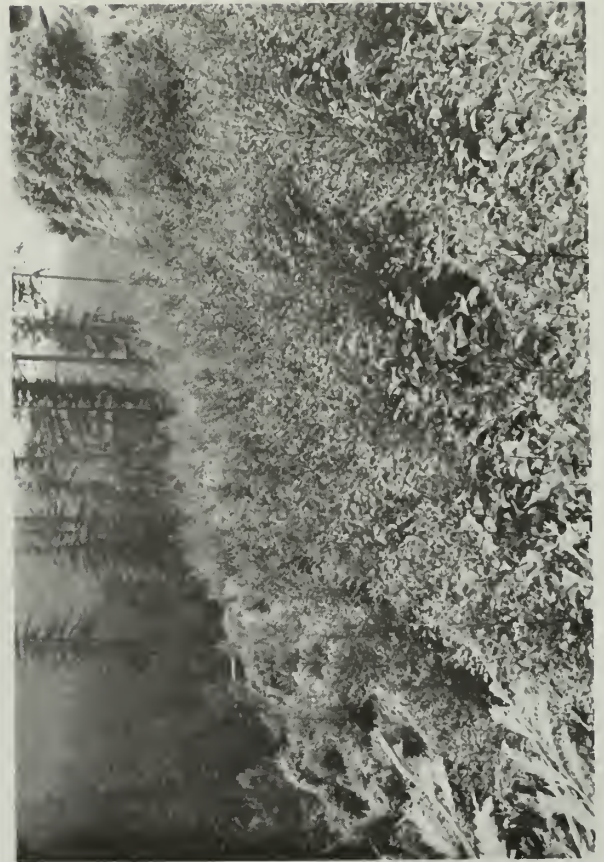
Fig. 31. Erosion of rock armored stream crossing R6. Sediment loss was caused by the presence of oversized rocks which diverted flow into and caused undercutting of the adjacent channel banks. Crossing R6 A) before heavy stream flows (October 1979) and B) after several winters (July 1982).

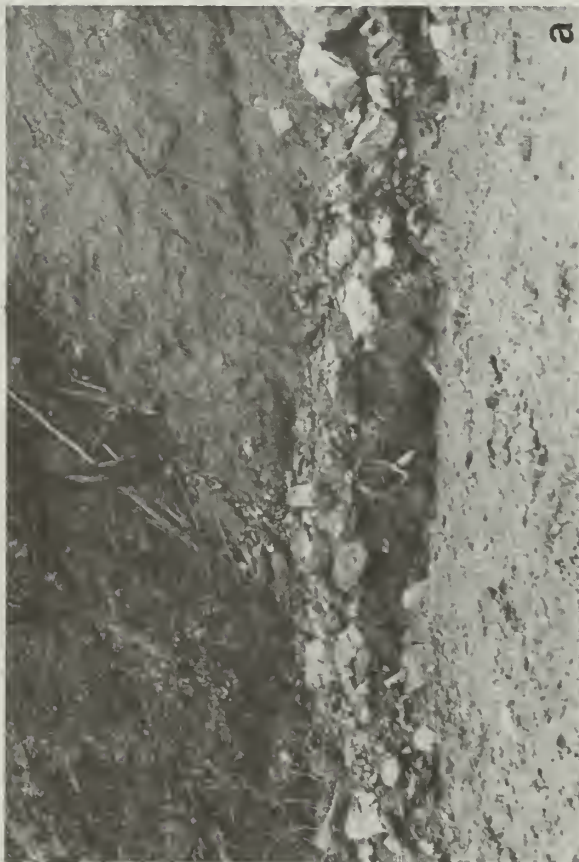
Fig. 32 (left). Excavated stream crossing R6. The two photos show views from A) top left edge of crossing, showing downcutting and terrace development along the right channel bank (rock armor is stranded above the new thalweg) and B) top right bank, showing consequent undercutting of the adjacent channel base. Photos taken October 1979.

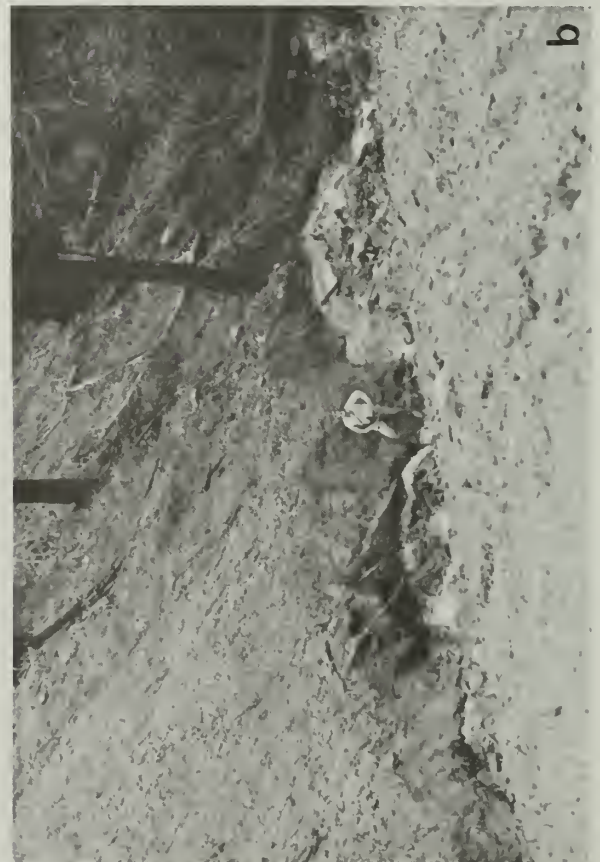
Fig. 33 (below). Small landslide caused by deflection of streamflow around large rock armor, crossing R6 (October 1979).

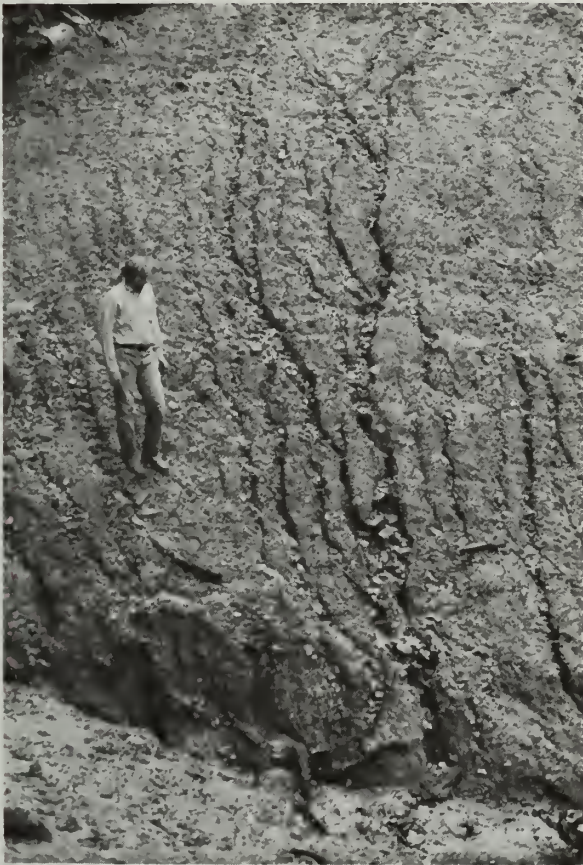
Fig. 34. Early winter rilling on the steep side slope of excavated stream crossing R7. Photo was taken prior to application of straw mulch and jute netting (October 1979).

Fig. 36 (left). Surface erosion control on excavated stream crossing R7. The most cost-effective treatment for controlling surface erosion was the liberal application of straw mulch, secured by jute netting on slopes steeper than 70 percent. Photo shows same slope depicted in Figure 34.

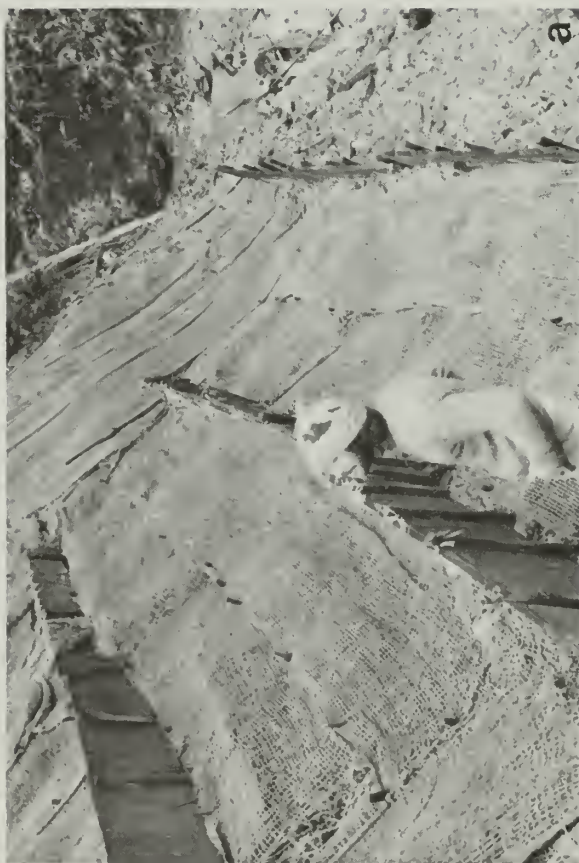
Fig. 38. Ravel catchers and jute-covered straw mulch on crossing R9. A) ravel catchers and jute-covered straw mulch were placed on the steep right bank of excavated stream crossing R9. B) following a small cutback failure on the former logging road at the top of the excavation, soil and rock passed over the jute (with no apparent damage) and either filled or toppled the ravel catchers.

Checkdams installed on the drain at stream crossing R9 also became nonfunctional due to spillway plugging and scouring around the dams. Presently, water is flowing alongside most of the dams and does not constitute a serious erosion problem. In retrospect, the installation

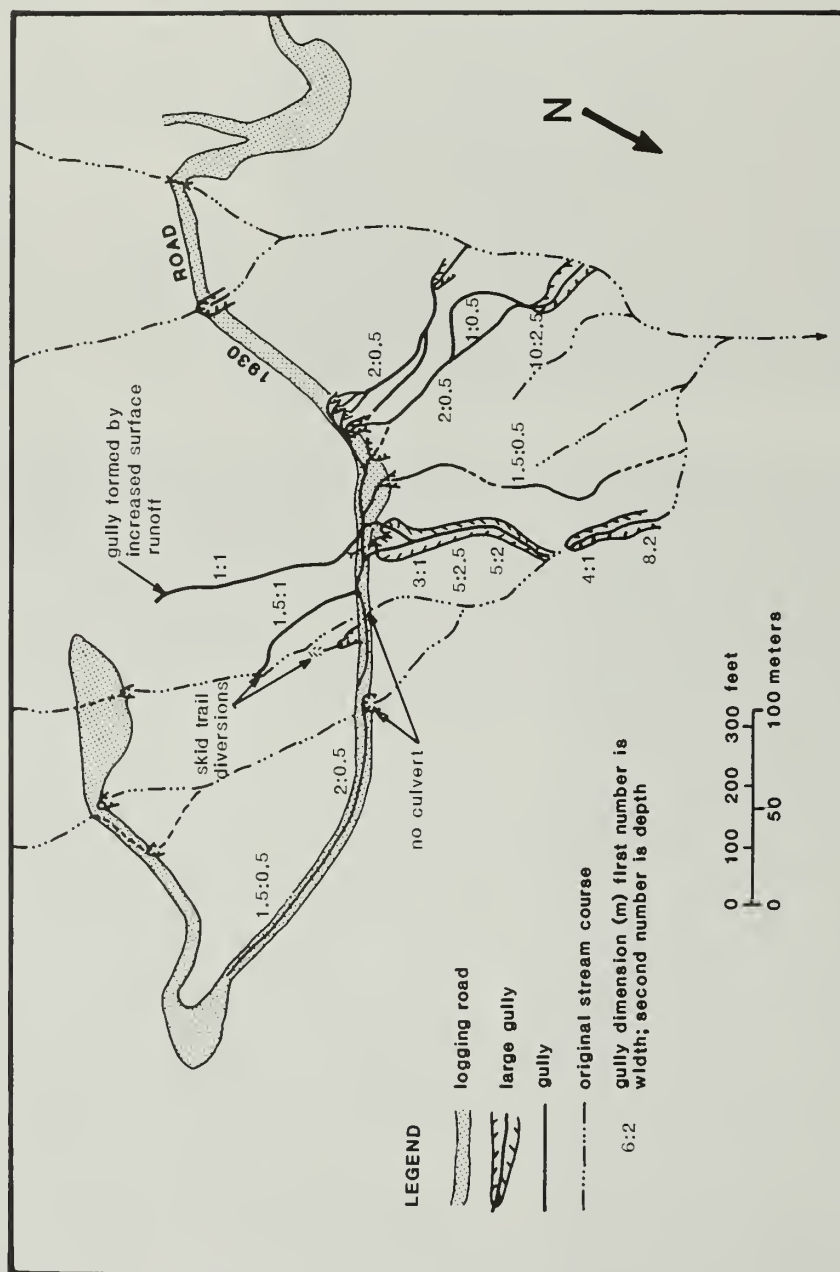
Fig. 48. Gully network mapped adjacent to the 1930 logging road. Gullies developed from increased surface runoff on skid trails and logging roads, stream diversions at skid trail watercourse crossings, stream diversions caused by plugged culverts on logging roads and stream diversions at road locations where culverts were never installed.

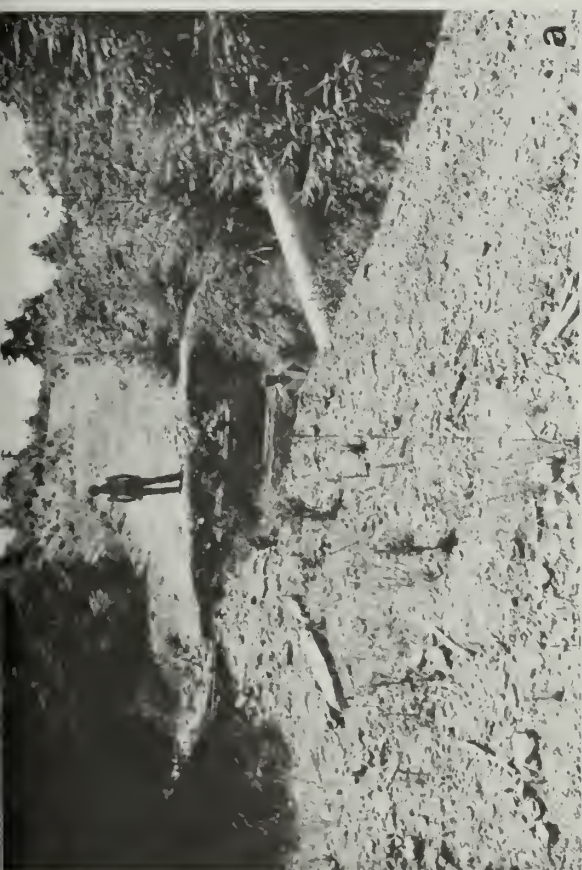
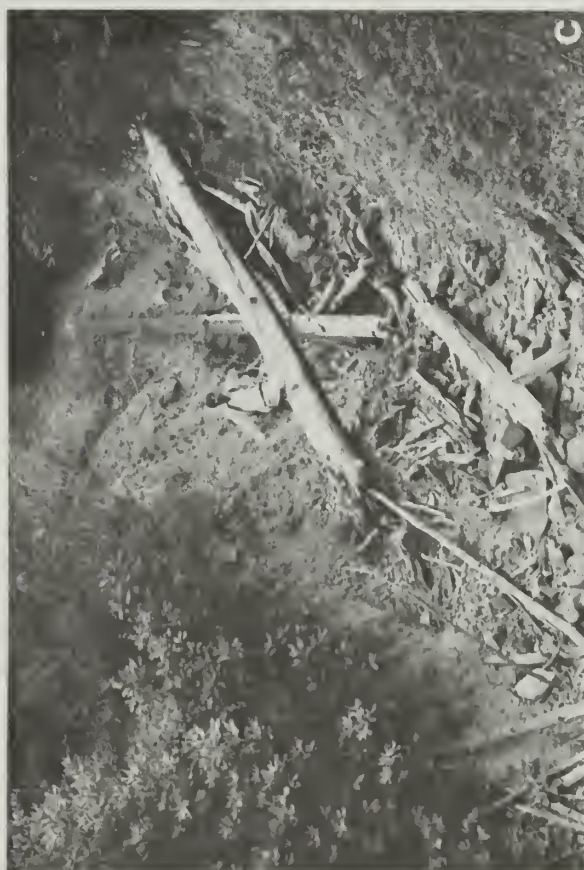
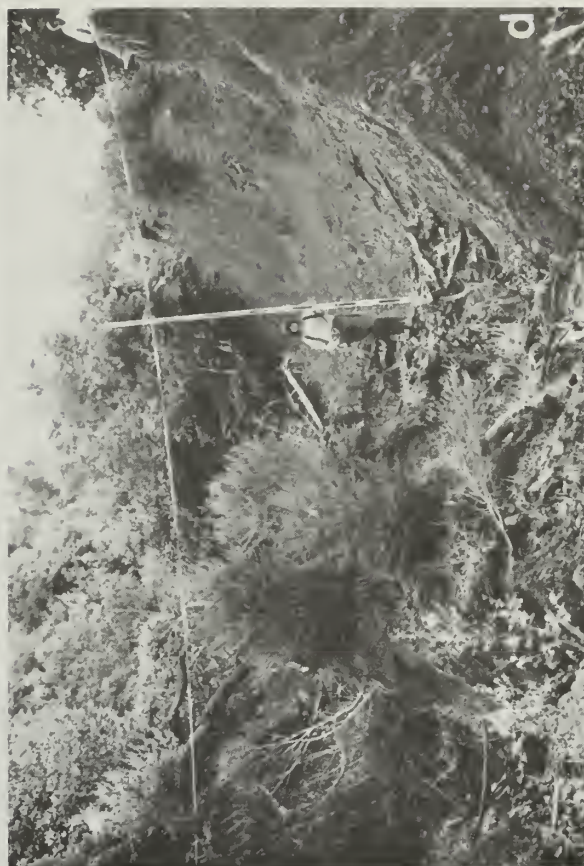
Fig 49. Examples of gully erosion on the Copper Creek rehabilitation unit. A) partially eroded stream crossing. B) severely gullied skid trail. C) gully headcut on hillside and D) large gully formed by stream flow diverted out of its natural channel at an upslope logging road stream crossing.

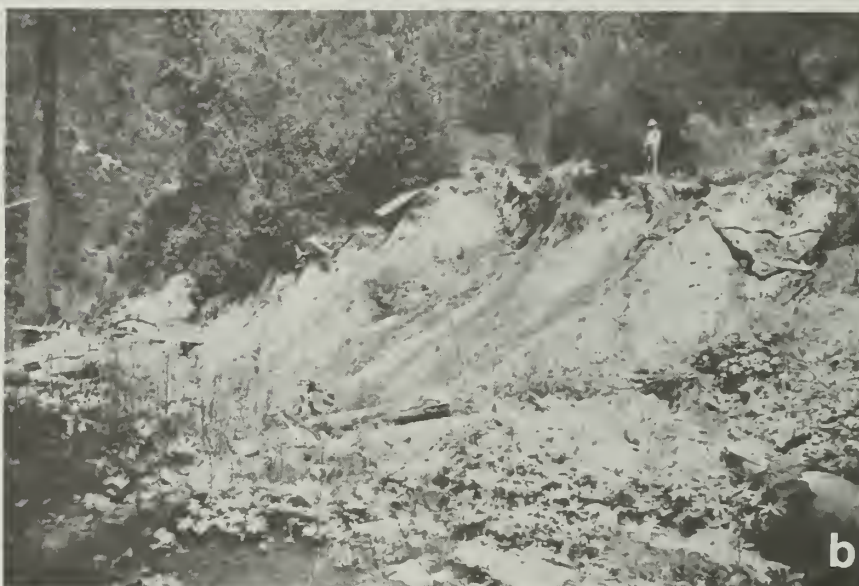
Fig. 50. Examples of hill-slope failures on the Copper Creek rehabilitation unit. A) slump, B) debris slide.

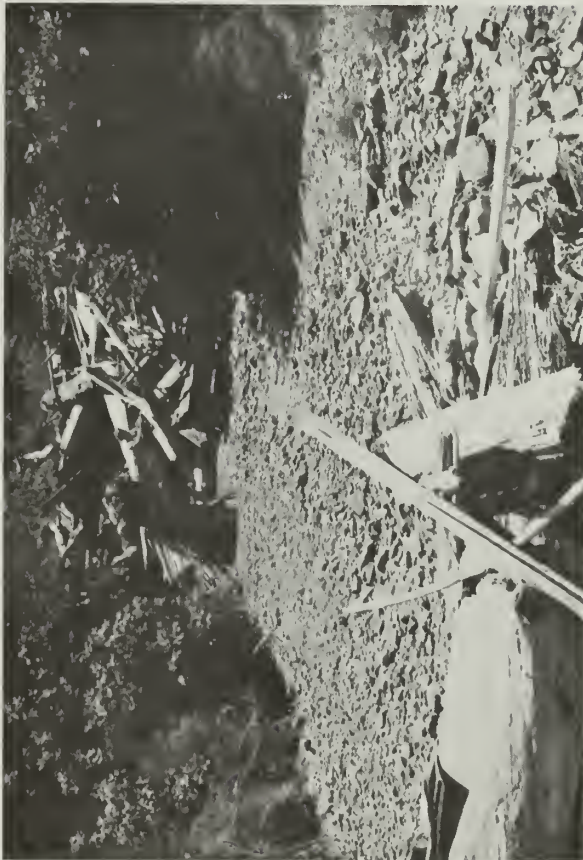
Fig. 69. Channel view from the top of the middle log jam step, looking upstream at the upper log jam step. A) before treatment, large quantities of sediment stored in the channel behind the middle step (foreground) have partially buried the base of the upper log jam; B) same view following the first winter after treatment, note the rip rap placed against the right bank (left of photo) and the nickpoint forming where additional organic debris is being exhumed; C) three years following log jam removal (September 1983) note the persistent step in the channel profile created by the remaining organic debris (this step is graphically shown at station 250 feet on Figure 68).
