# historic structure report

SEAWALL  
FORT McHENRY

NATIONAL MONUMENT AND HISTORIC SHRINE / MARYLAND

HISTORIC STRUCTURE REPORT  
Administrative, Historical and Architectural Data Sections  
Seawall

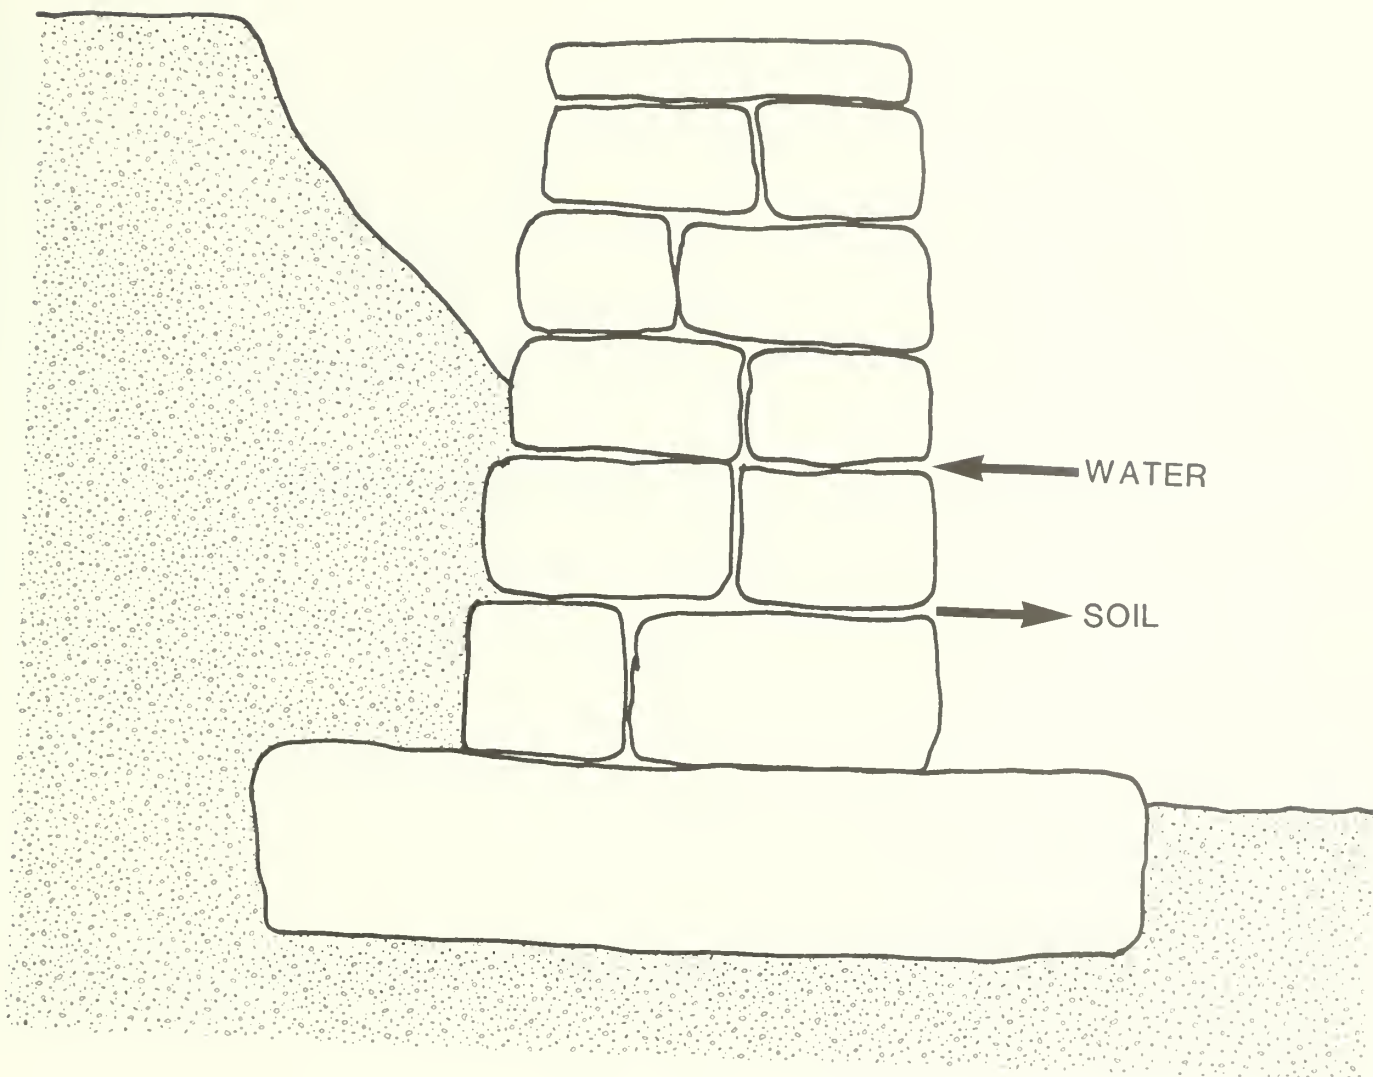
Figure 1: Soil flushed out from behind wall and resulting void

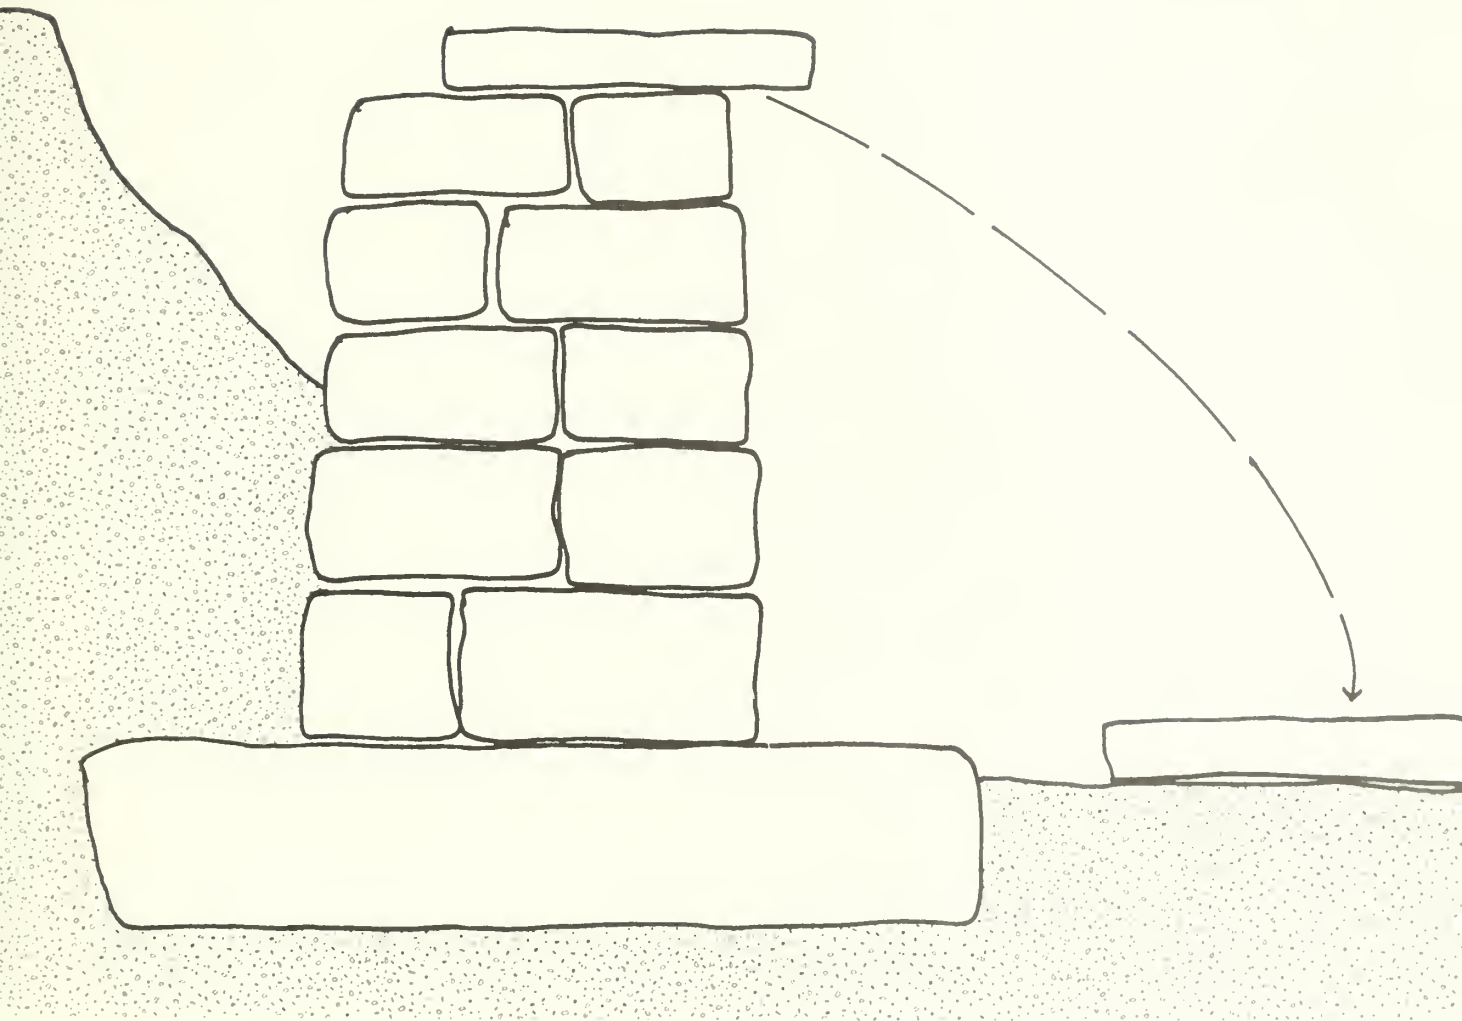
Figure 2: Capstone displaced and toppled into harbor

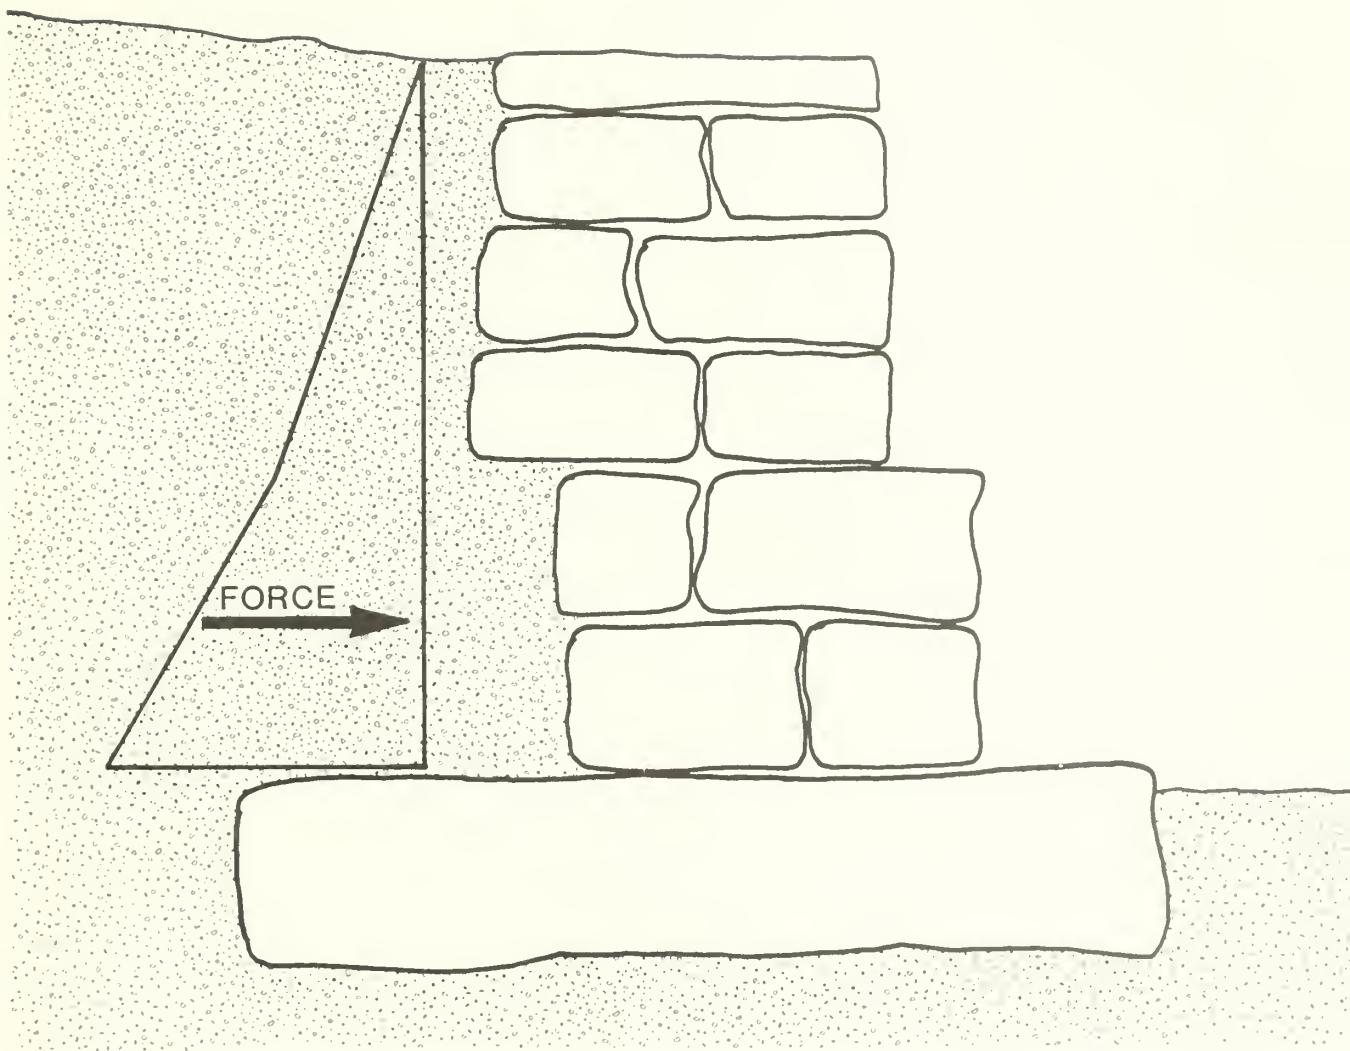
Figure 4: Lower third of wall displaced due to force created by water and plastic soil behind wall

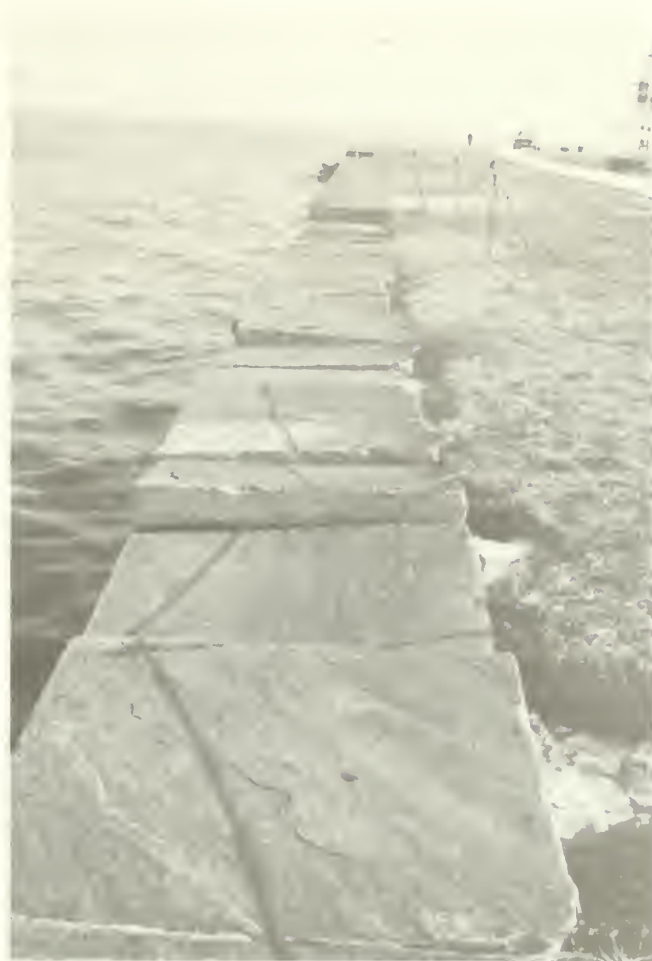
Photograph 1: Station 11 + 97.05 looking south capstones  
displaced due to loss of soil

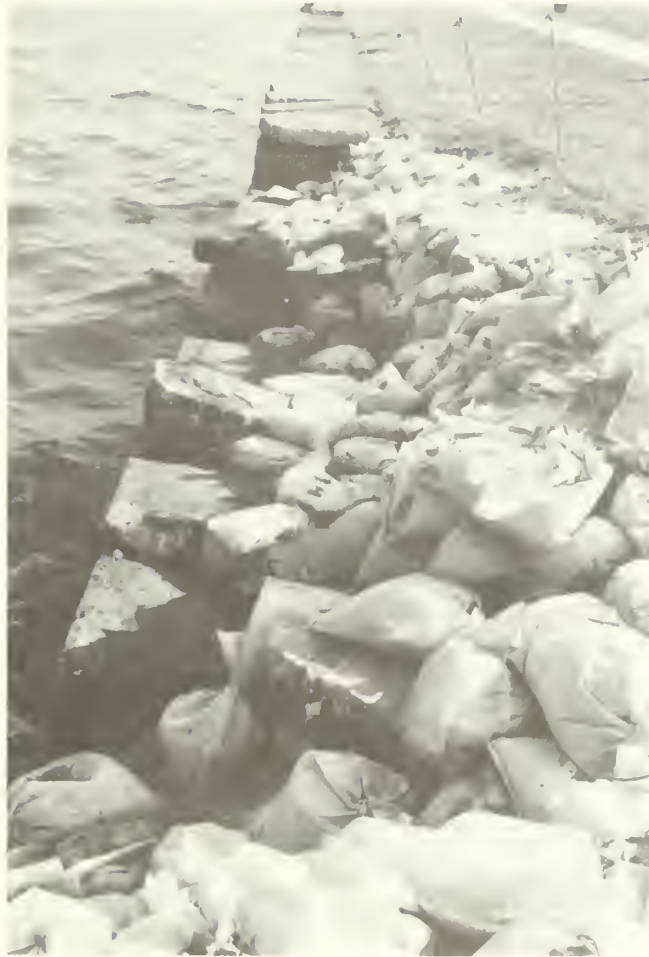
Photograph 4: Station 13 + 17.05 - Station 13 + 84.05.  
Unraveled section of wall

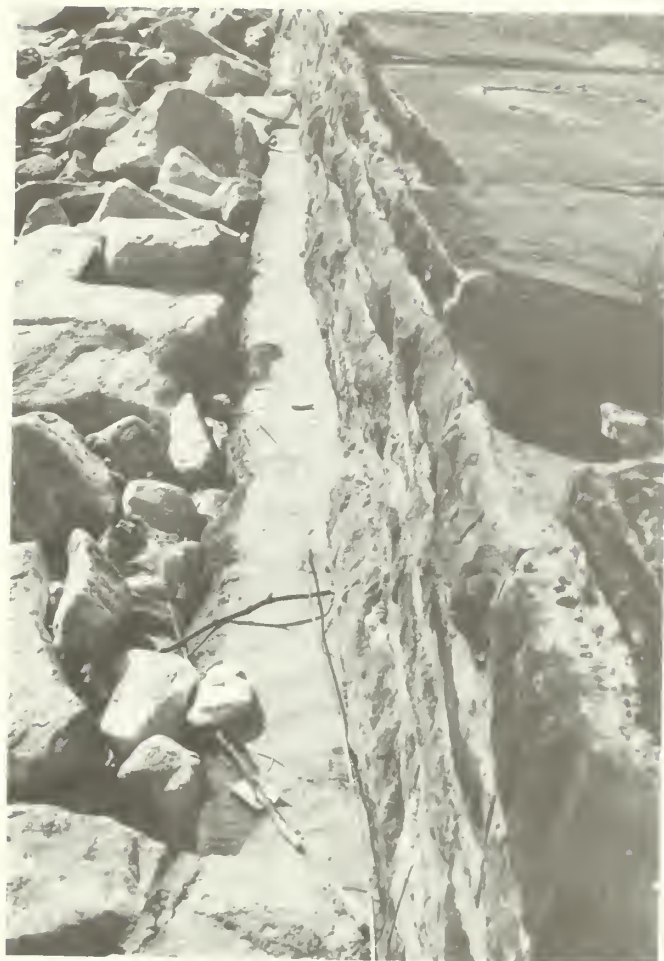
Photograph 5: Station 18 + 00. Protruding lower third of wall

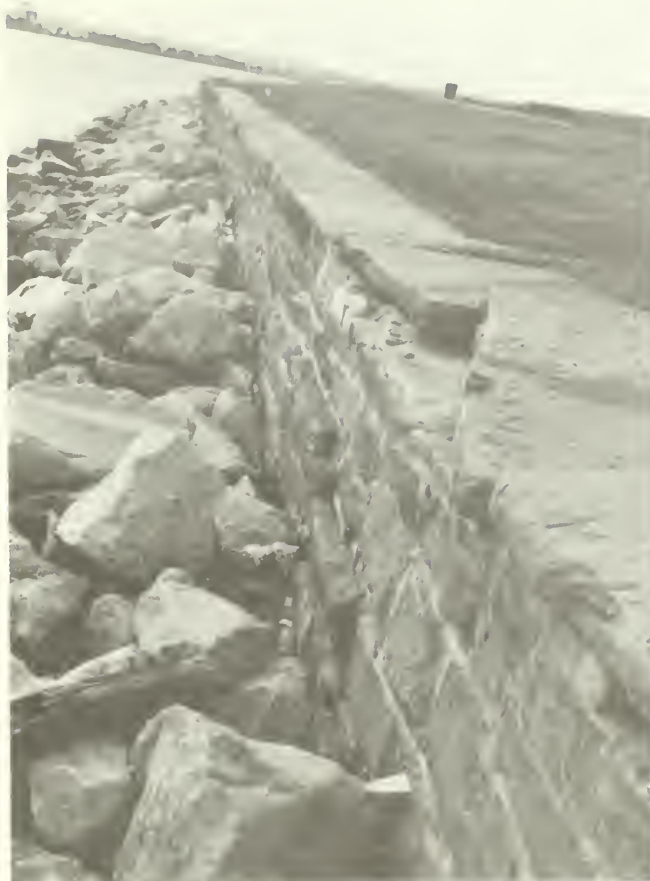
Photograph 6: Station 16 + 39.04 looking south.  
Protruding lower third of wall

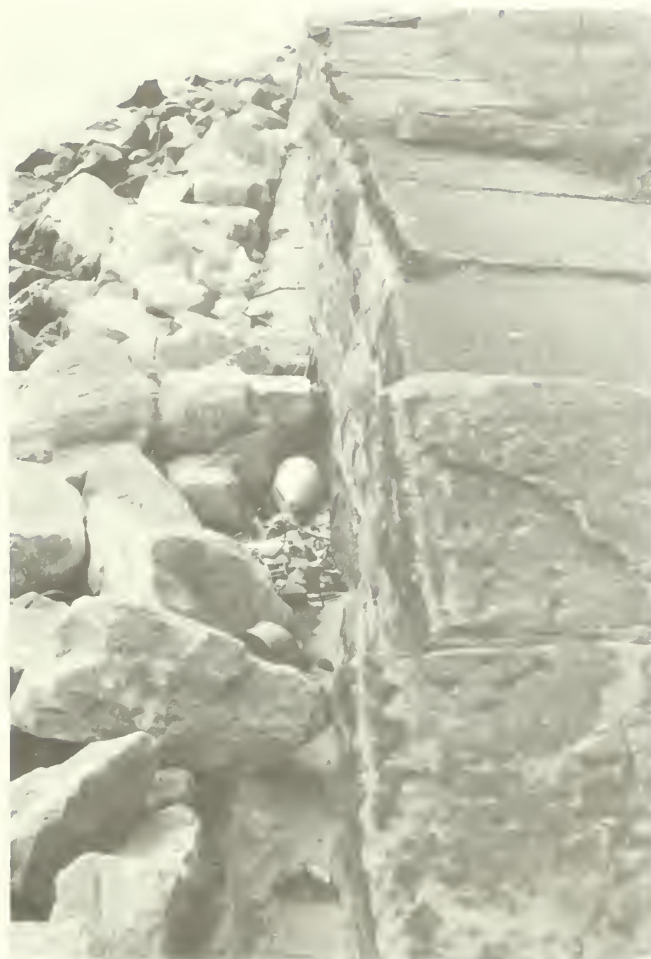
Photograph 7: Station 18 + 00 looking south.  
Protruding lower third of wall
