Preservation Case Studies

Main Street Historic District

Van Buren, Arkansas

Using HCRS Grant-in-Aid Funds for Storefront
Rehabilitation/Restoration Within a Districtwide Plan

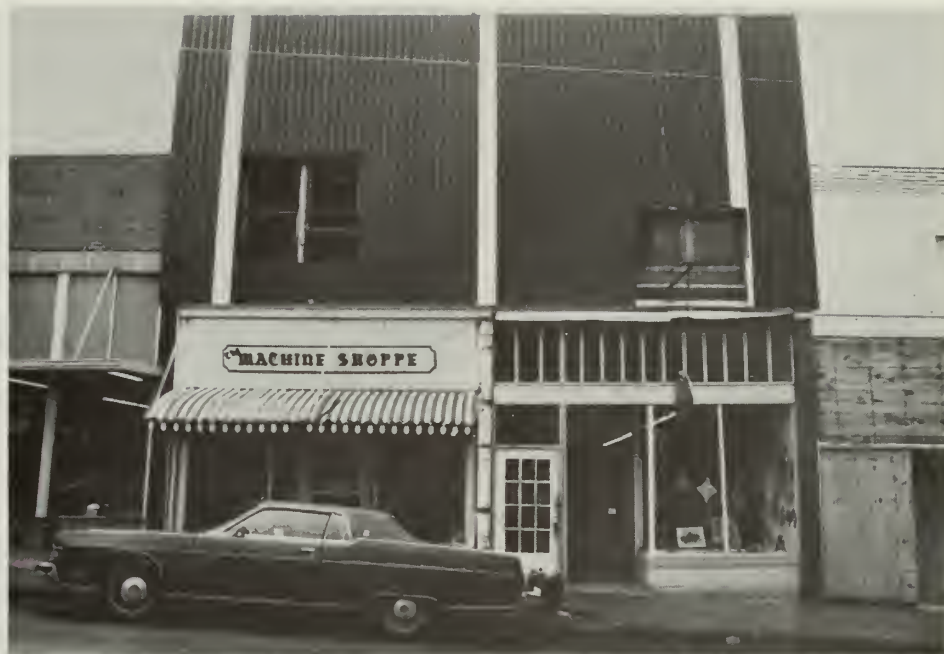
Figure 3. 700 Block of Main Street showing storefront almost totally obscured by inappropriate metal siding. Credit: Bob Dunn

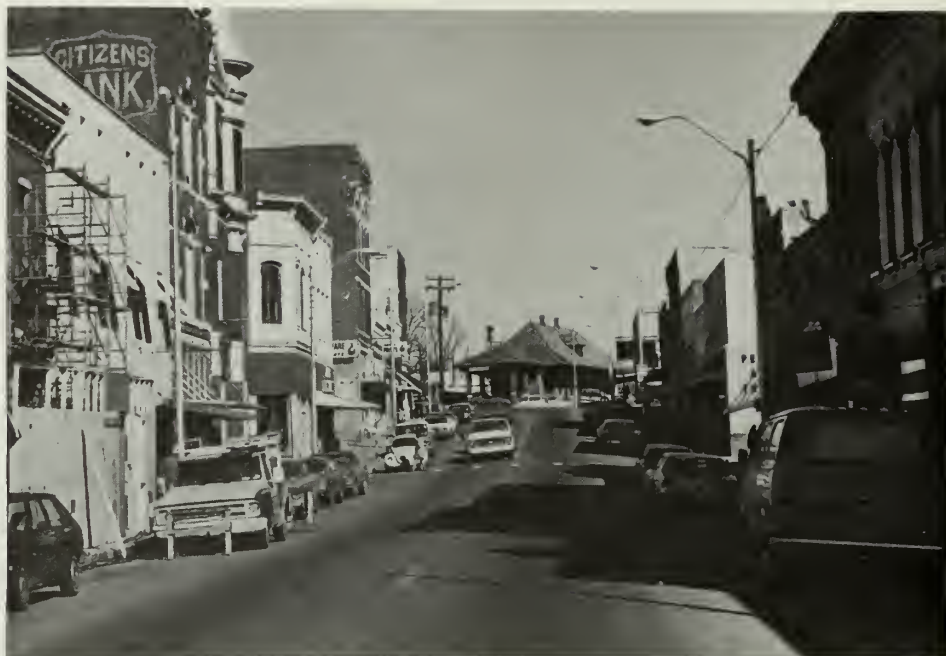
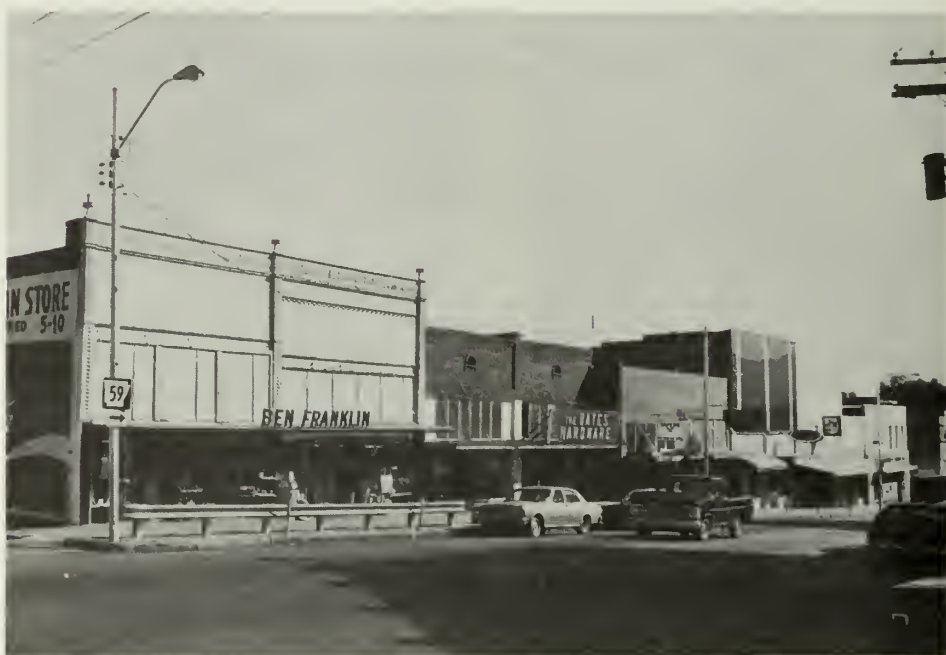
Figures 4 & 5. Views of Main Street showing storefront, signage and canopy alterations.
Credit: Bob Dunn

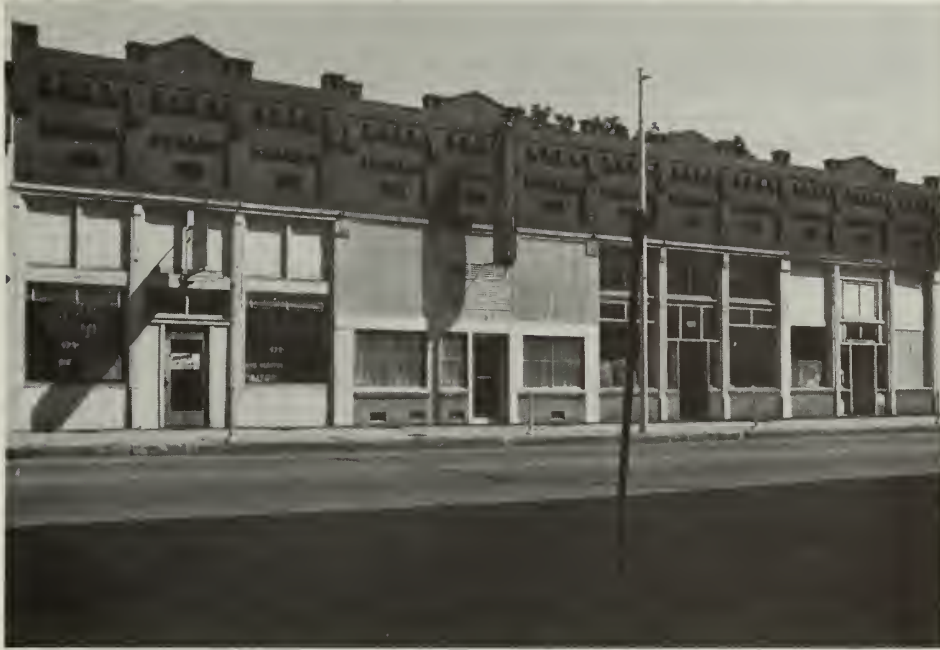
Figure 6. 400 Block of Main Street showing alteration of storefronts and retention of elaborate brick cornice and parapet, 1979. Credit: Bob Dunn

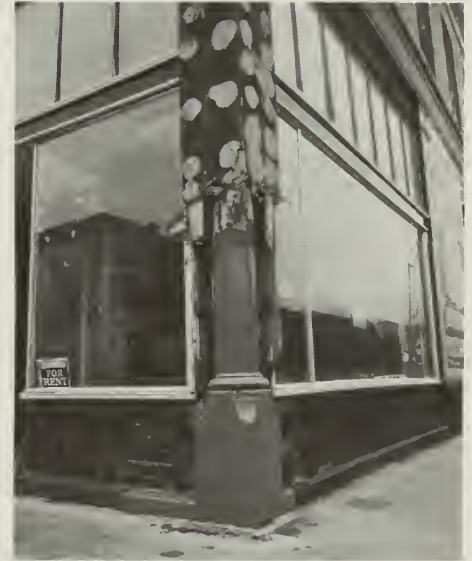
Figure 8. 600 Main Street showing decorative iron column found intact within later enclosure. Credit: Bob Dunn

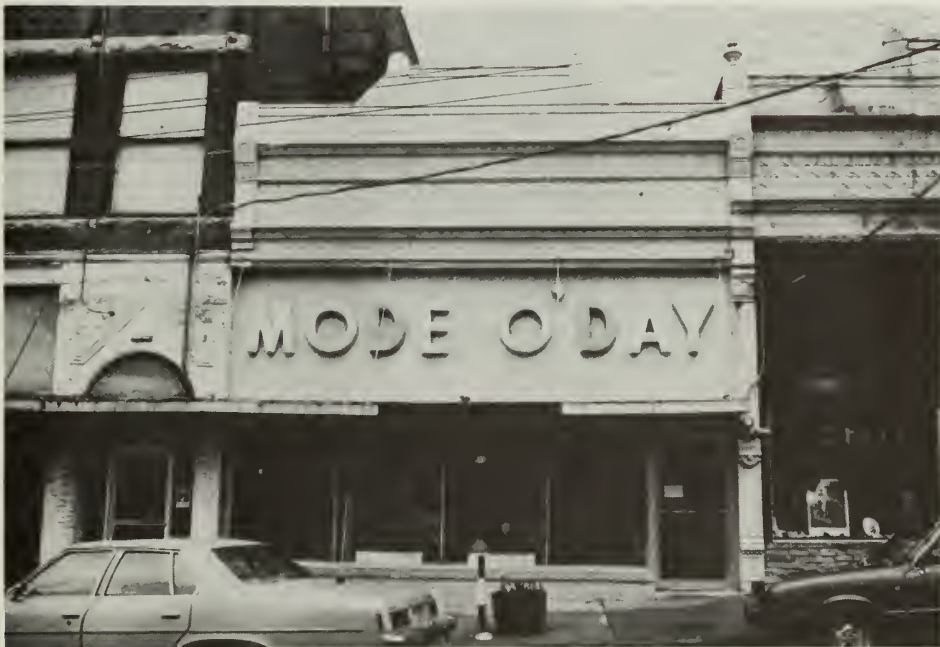
Figure 7. 713 Main Street showing inappropriate signage and canopy treatment, alteration of storefront, and intact pressed metal cornice, 1979. Credit: Bob Dunn

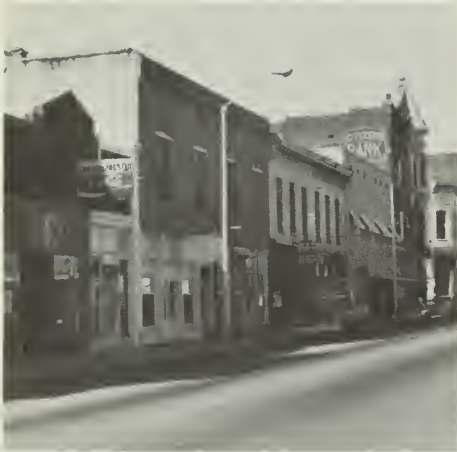
Figure 10. 600 Block of Main Street showing its appearance prior to any rehabilitation/restoration efforts. Credit: Bob Dunn

Figure 11. Rendering showing rehabilitation/restoration proposal for 600 block of Main Street. Credit: David Fitts

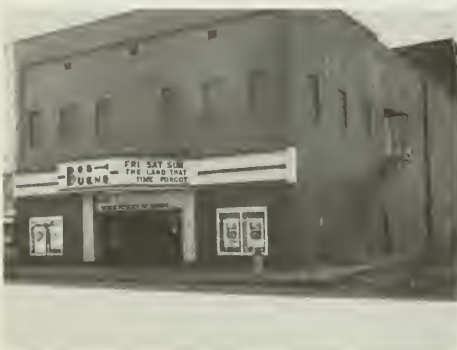
Figure 12. King Opera House prior to its acquisition and restoration by the City. Credit: Bob Dunn

5. Acquire/restore the King Opera House: On January 1, 1978, the city was awarded a HUD Urban Development Action Grant (UDAG) to be used to acquire and restore the King Opera House as an attraction for residents and tourists. These funds, in combination with U.S. Department of Health Education and Welfare Comprehensive Employment Training Act Title VI Special Project Funds, are being used for investigatory and restoration activities. Because the structure was found to be in much worse condition than initially thought, the city is seeking additional public and private funds for the project's completion (see figure 12).

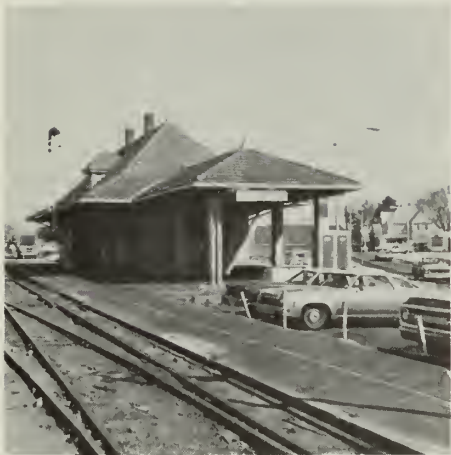
Figure 13. Frisco Railroad Depot prior to its acquisition and rehabilitation/restoration by the city. Credit: Bob Dunn

Figure 14. Frisco Railroad Depot after its acquisition and rehabilitation/restoration by the city. Credit: Bob Dunn

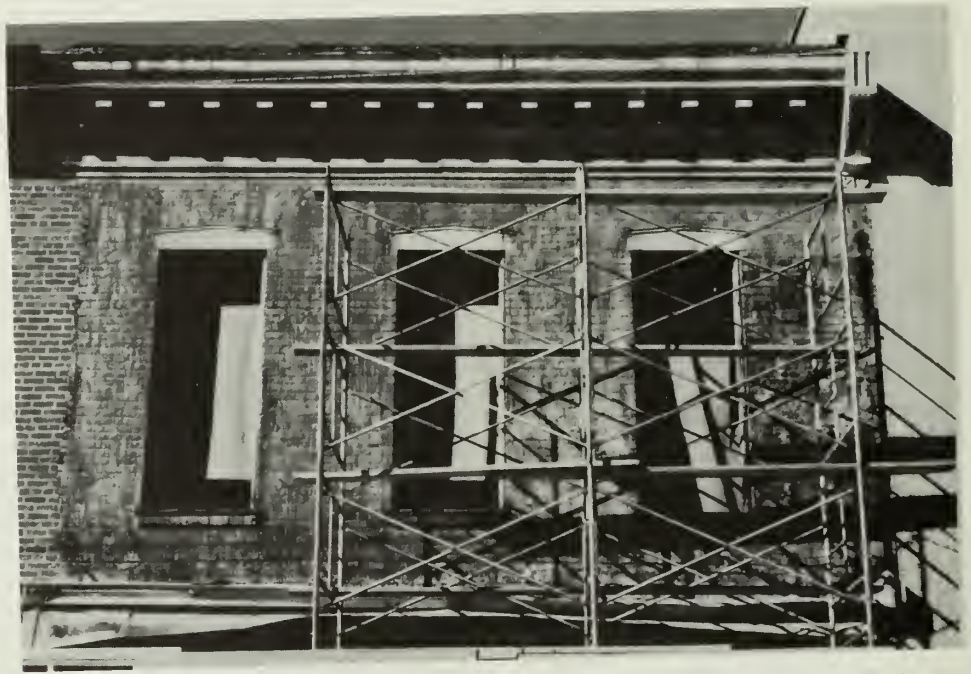
Before an effective method was found for removing the paint from brick on the exterior surface of the Frisco Depot, several types of strippers were tried. The building had three layers of paint: (1) a latex tan, which was easily removed; (2) an oil base gray, which was the most resistant to strippers; and (3) red, which was more like a stain than a paint, having penetrated into the pores of the brick and mortar.

Figure 17. 615A Main Street during paint removal process showing appearance of brick facade prior to water washoff. Credit: Bob Dunn

A completely successful method of removing the paint was finally found by using a caustic paint remover. With one application and a water wash-off the next day, over 90 percent of the surface was cleaned (see figure 17). Additional spot applications of the paint remover followed by water washes removed most of the

remaining paint. All streaks and stains caused by the softened paint were removed by this final treatment.

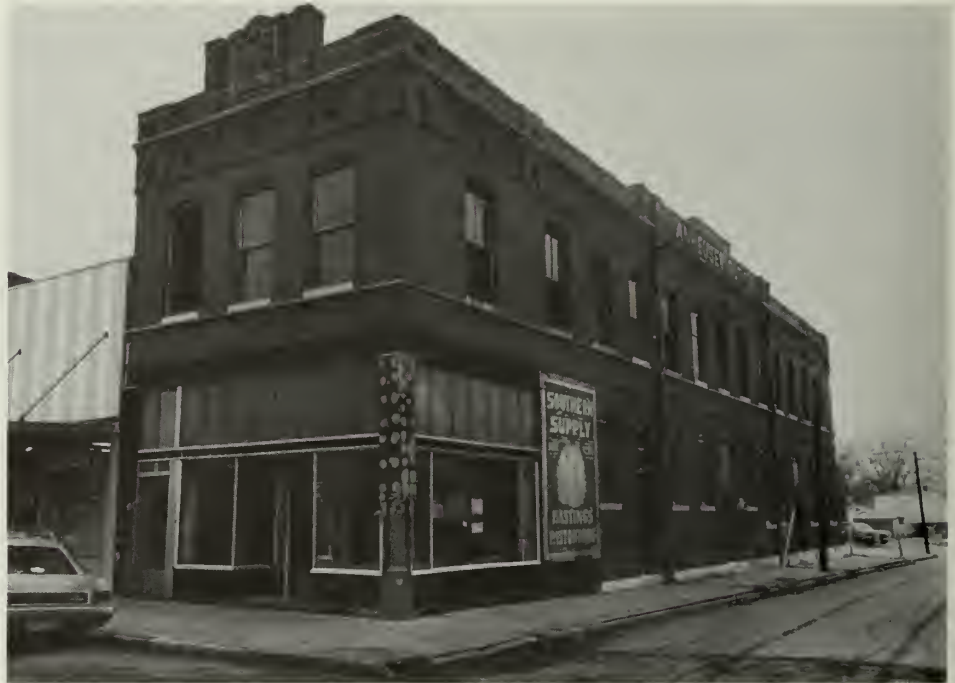
Before

- Decorative corner column obscured by inappropriate enclosure
- Original corner entrance eliminated with later infill
- Original storefront rearranged creating inappropriate window and door proportions
- Overall lack of maintenance and parapet deterioration

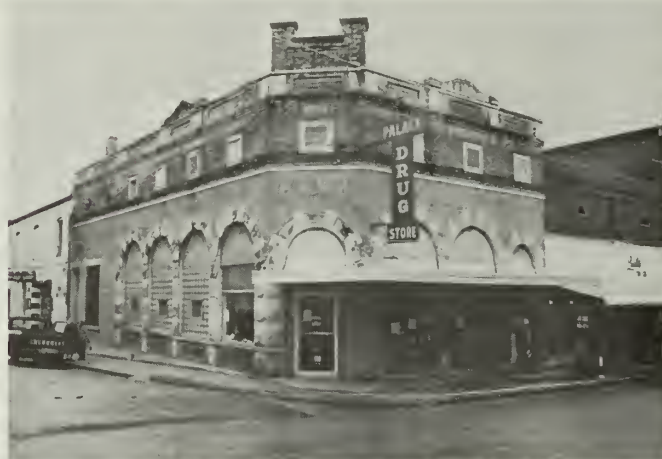
Before

- Scale and design of facade changed by addition of canopy and alterations to windows and doors
- Stone and brick of facade badly discolored and stained
- Inappropriate projecting sign

- New stained glass windows reproduced and installed to match original design
- Canopy removed
- New storefront windows installed throughout to replace inappropriate glass block and plywood infill
- New doors to match original
- Projecting sign removed
- Entire facade cleaned and repointed preserving the ghosts of the original bank graphics
