Historic Structures Report
Architectural & Historical Data Section

Clubhouse, Brown Cottage, Moorhead Cottage,
and Clubhouse Annex

**SOUTH FORK FISHING
& HUNTING CLUB**

ST. MICHAEL • PENNSYLVANIA

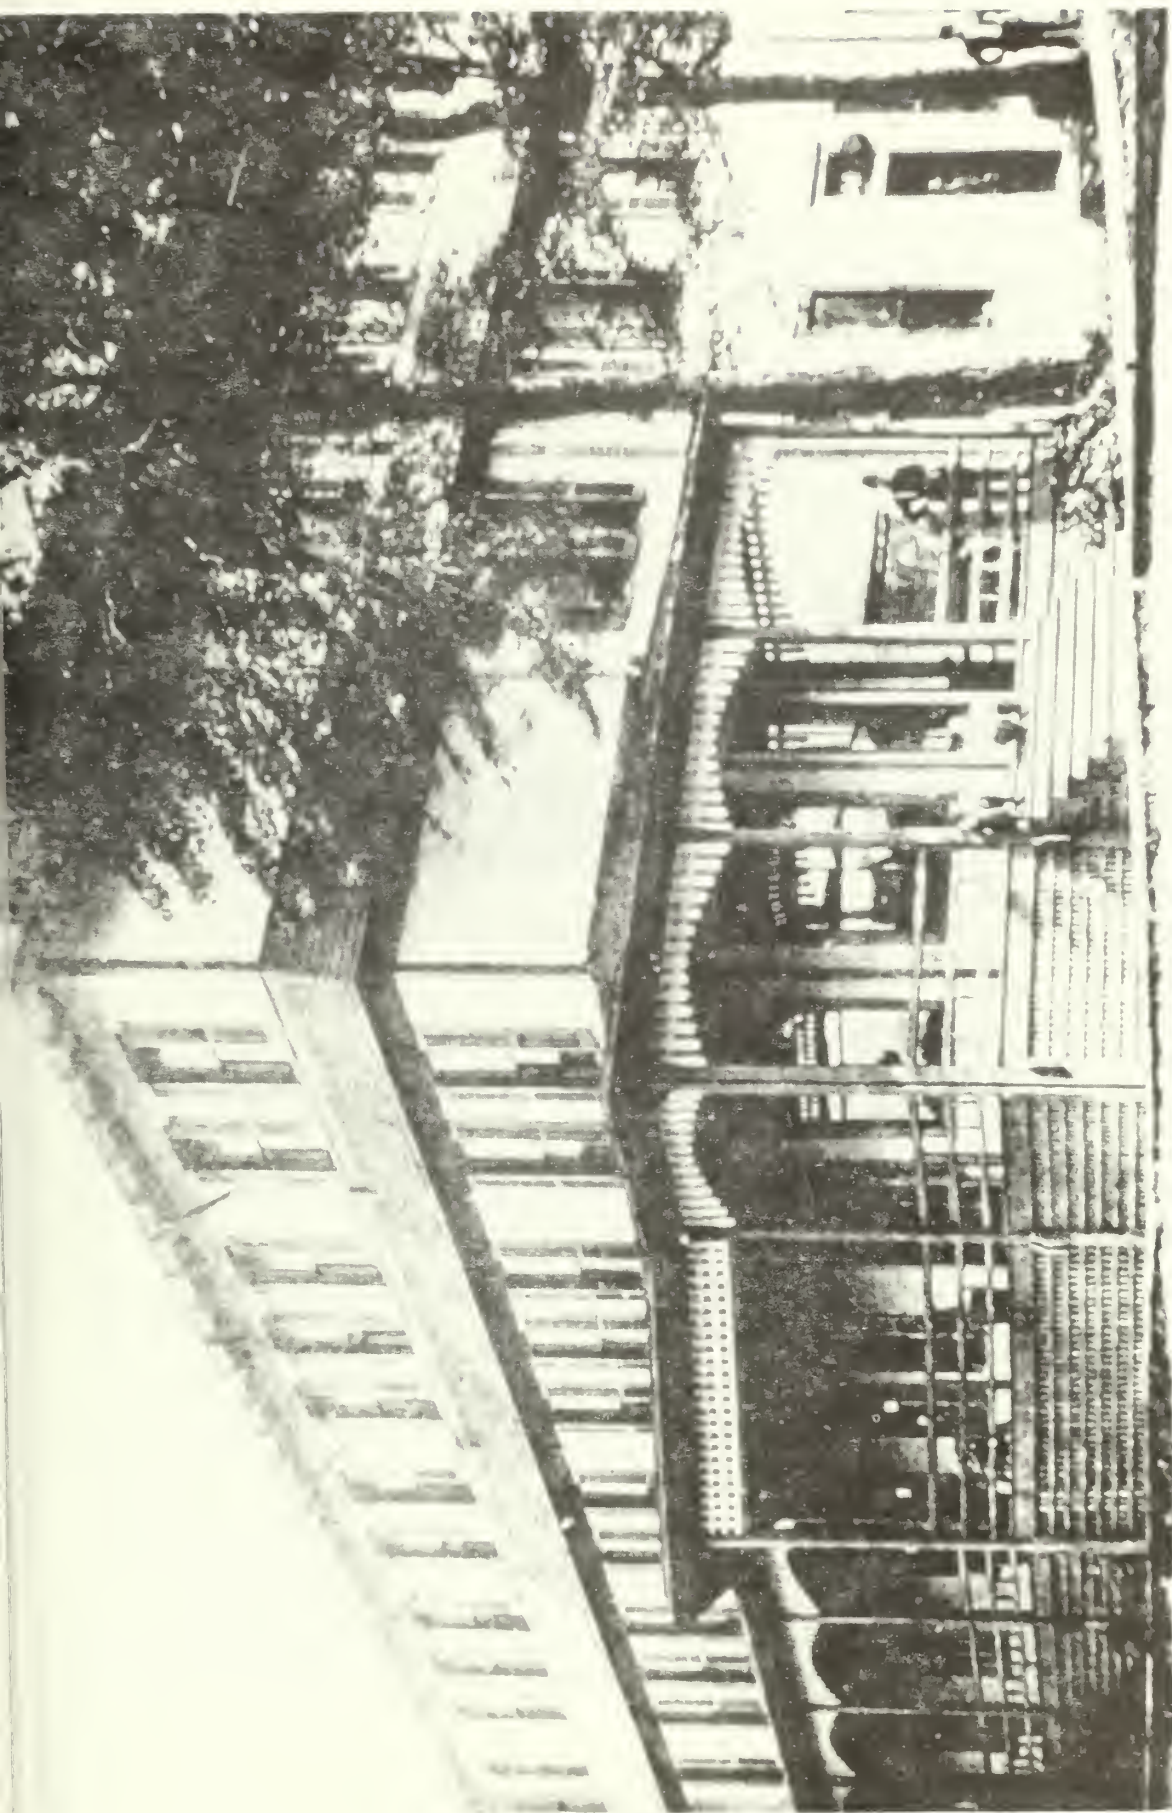
Photo E-9 View of east and south elevations.
Clubhouse 1992

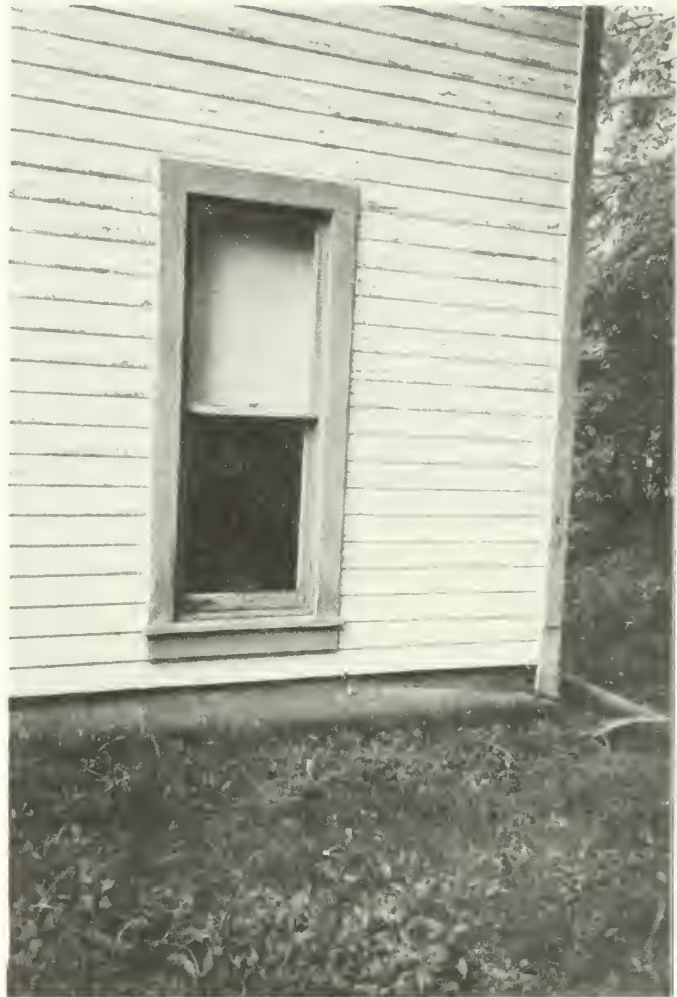
Photo E-36 View of west wall and concrete foundation.
Brown Cottage 1992

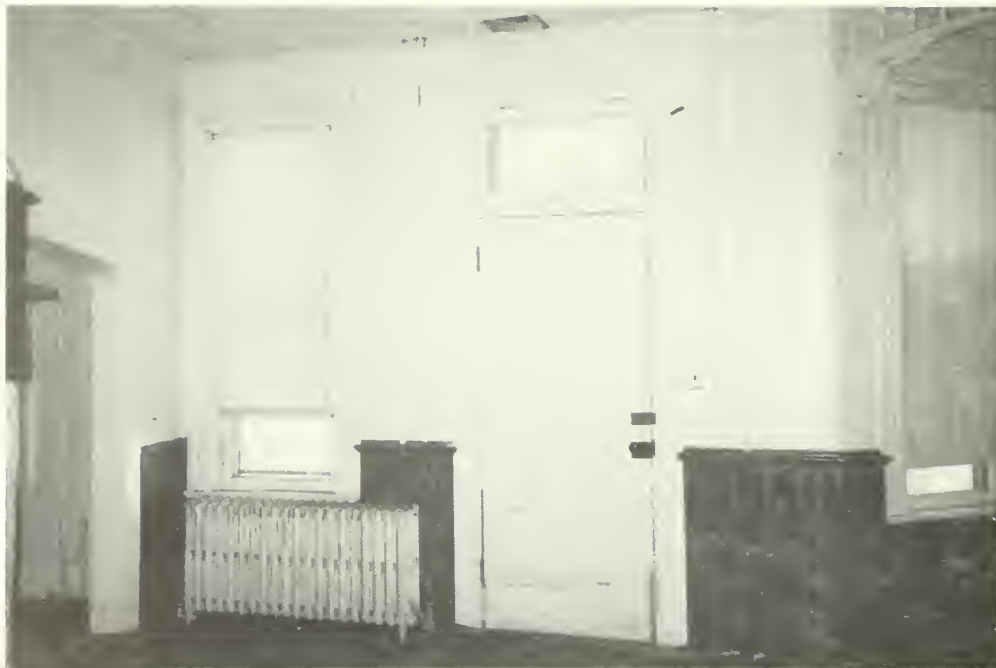
Photo E-41 North wall of room 106. Although the wood wainscot is original, the original entry door has been replaced.
Brown Cottage 1992

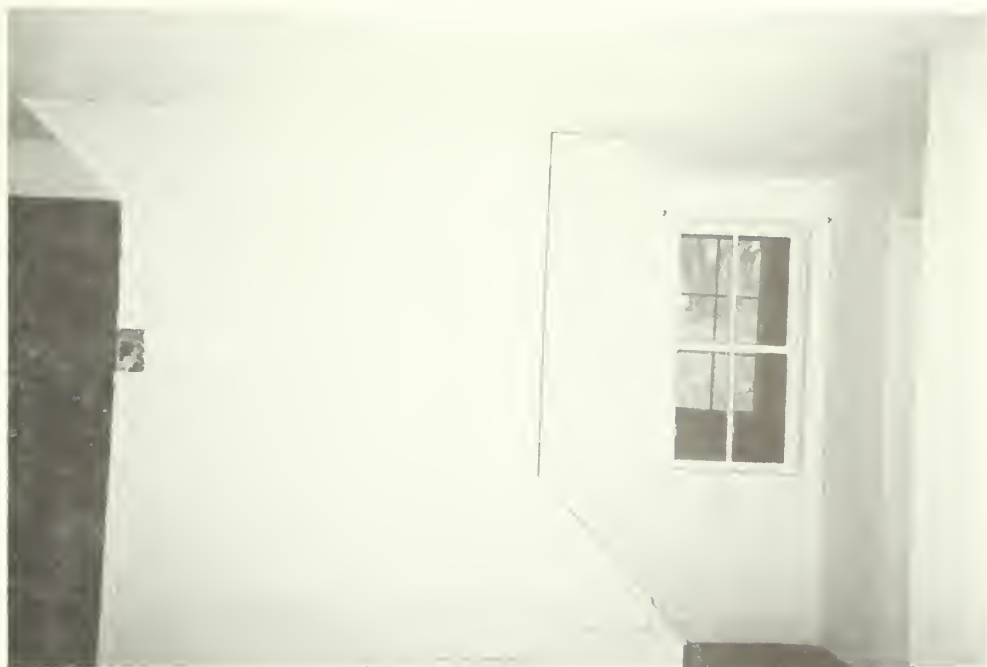
to E-79 South wall of room 106 showing paneling at stairway installed from another location. The window to the right of the stair replaces an original door. Moorhead Cottage 1992

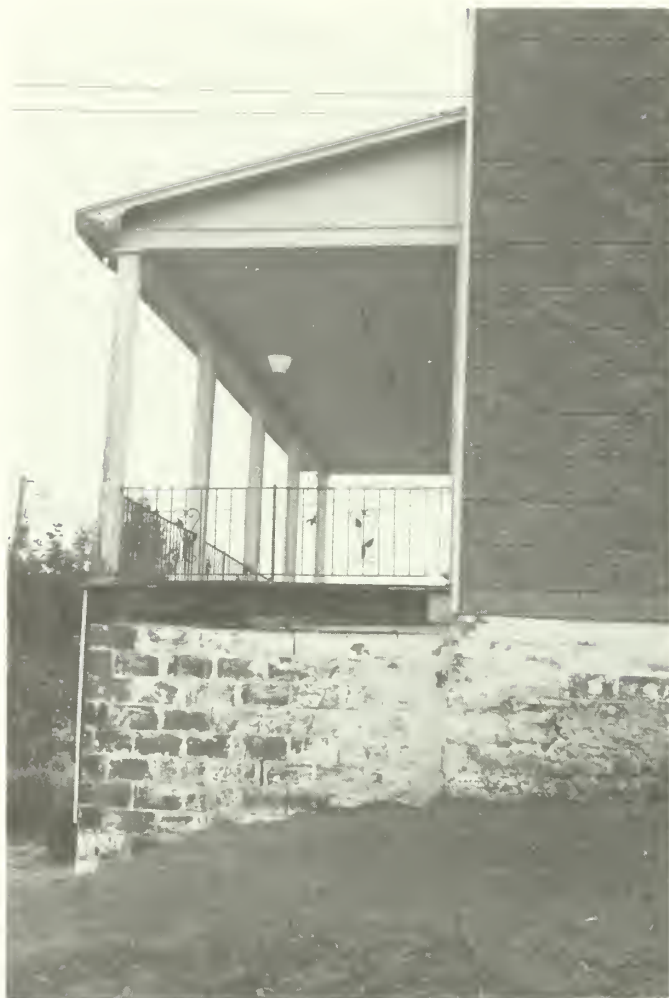
Photo E-97 Detail of the north foundation wall showing original stone foundation with brick and concrete block infill above.
Clubhouse Annex 1992
