## LIPPINCOTT PRESS BUILDING

# Tech Notes

### NUMBER 17

### Repair and Retrofitting Industrial Steel Windows

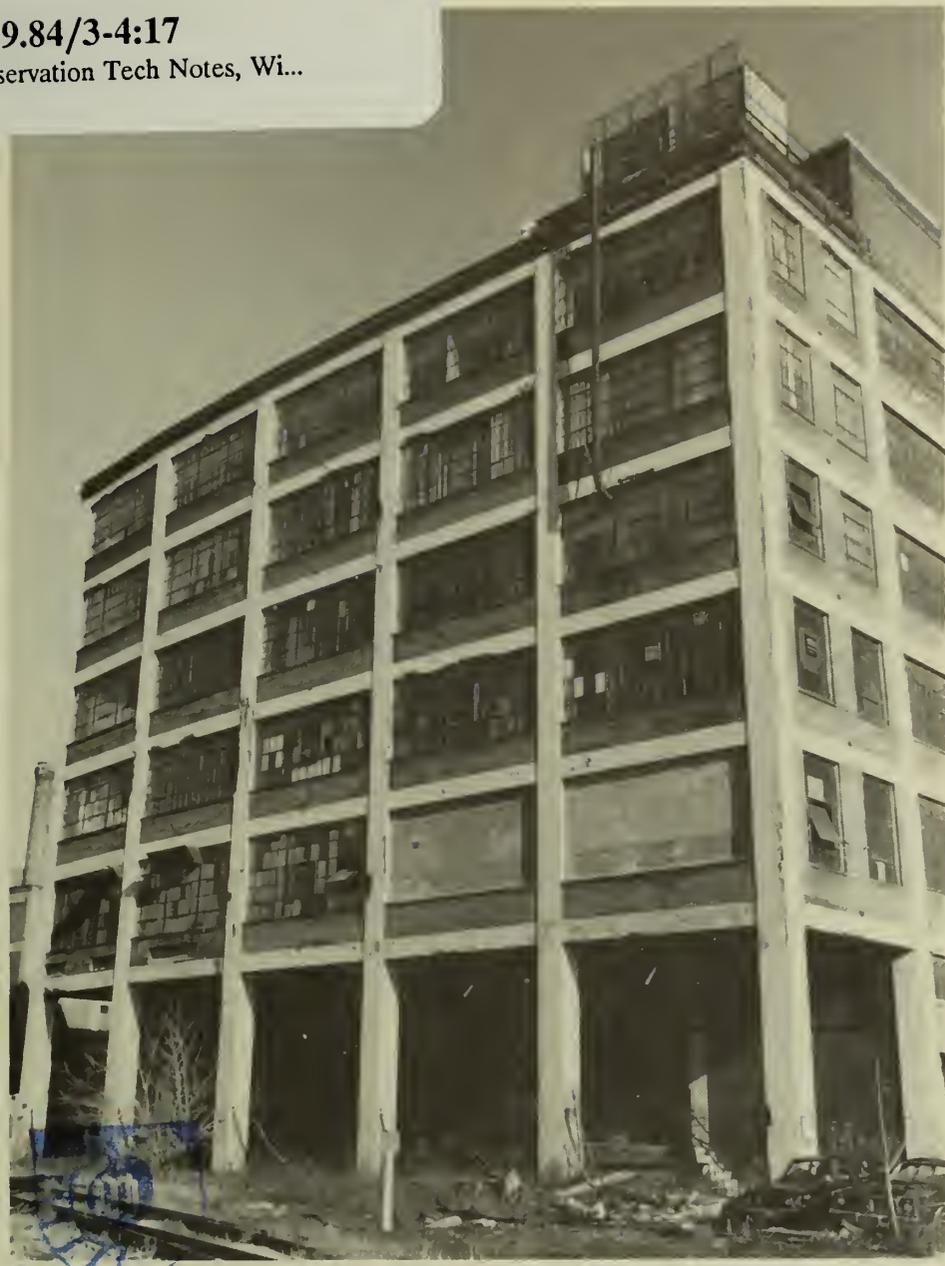
Since the Lippincott Building was used for a long time as a storage facility, the windows had not been painted, oiled, reglazed, or caulked, nor had missing or damaged parts been replaced in well over twenty years (see figure 1). Naturally, many of the windows exhibited problems typically found on inadequately maintained steel windows, including corrosion, bent and bowed metal sections, non-operable ventilators, missing or non-functional hardware and broken glazing. Furthermore, some of the original windows had been removed and replaced with double-hung aluminum windows, and other window openings had been infilled with glass and concrete block, metal louvered air vents, ductwork and other mechanical equipment (see cover photo).

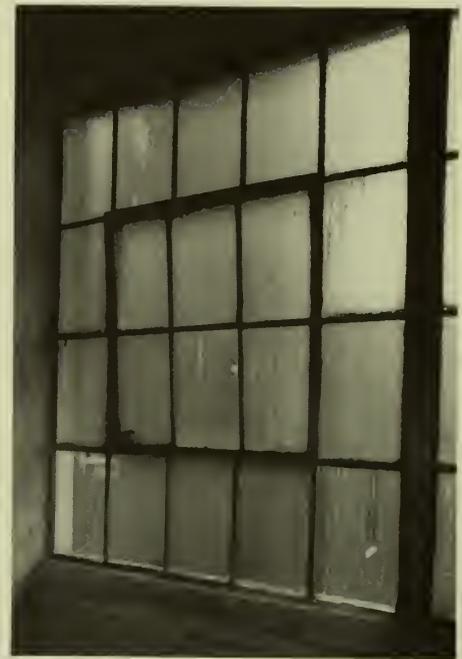
Figure 1. Typical multi-light steel window with ventilator as seen from the interior. This window exhibits typical pre-rehab conditions including sill corrosion, missing hardware and a poorly operating ventilator. Photo: Clio Group.

The rehabilitation included replacing the deteriorated steel sections, particularly in the sill areas, and replacing the missing and nonrepairable windows with new single-glazed steel windows similar in profile and configuration to the existing windows. As part of the repair process, the existing ventilator windows would be modified from center pivoting sash to projecting sash (to meet Philadelphia code for emergency egress), and both the repaired and new steel windows would receive interior storm windows to bring the windows into compliance with the Pennsylvania State Energy Code requirements for heat loss, air infiltration, and other energy/comfort criteria.

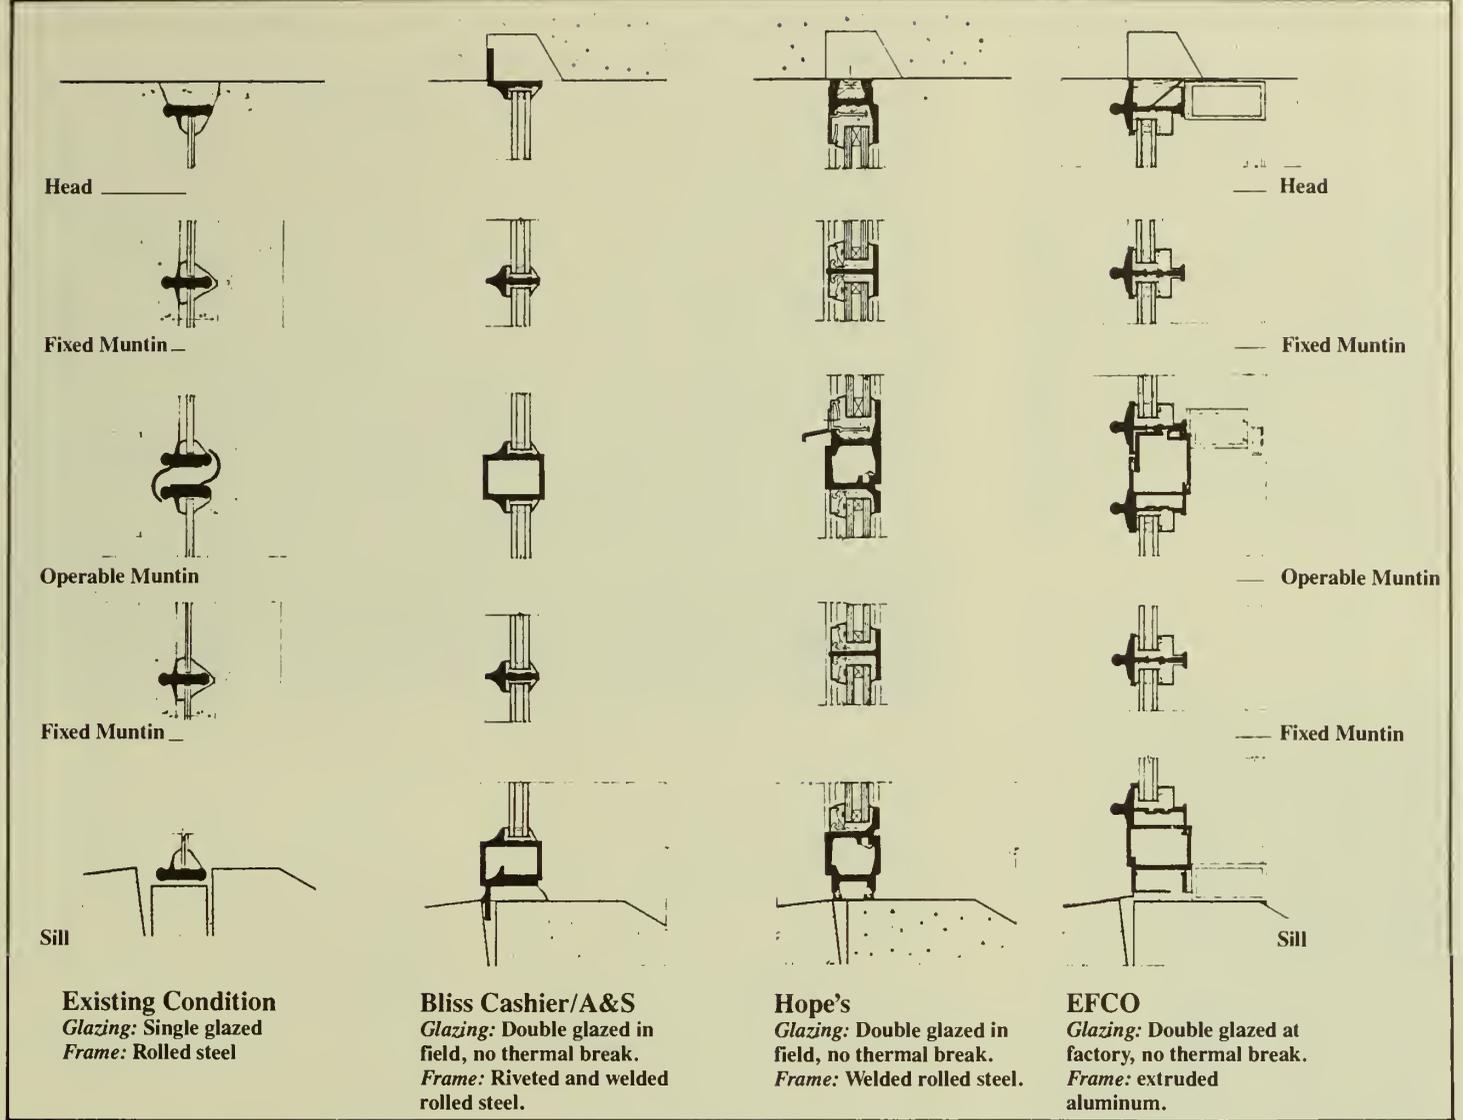
Figure 3. Comparative window sections showing the existing steel window on the left and the three thermally glazed replacement proposals on the right. Drawing: H2L2 Architects.

As seen in the comparative drawings and as evident from the mock-ups, the new double-glazed windows did not match the proportions, dimensions, thin profiles and sight lines of the historic steel windows due to the increased dimensions of the new window members. Thus, although the new proposed windows promised increased energy performance, the installation of these non-matching windows would

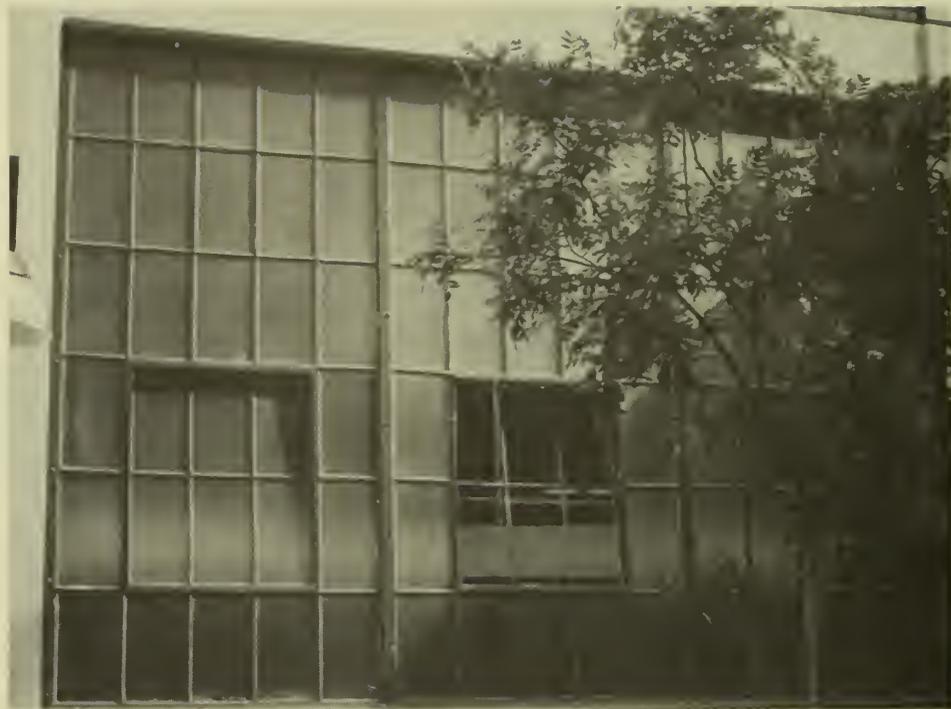
Figure 4. First floor, garage level showing the frosted glass and the center ventilator without glazing. Photo: Robert Powers.

To accommodate the first floor lobby and parking garage, the decision was made to repair and reglaze with frosted glass the existing steel windows in the garage area, and to install new windows in the newly created lobby area where no windows previously existed. The garage windows retained their operable pivoting sash, since compliance with energy requirements was not applicable. To provide for adequate garage ventilation, glazing was omitted from a number of the ventilators (see figure 4).

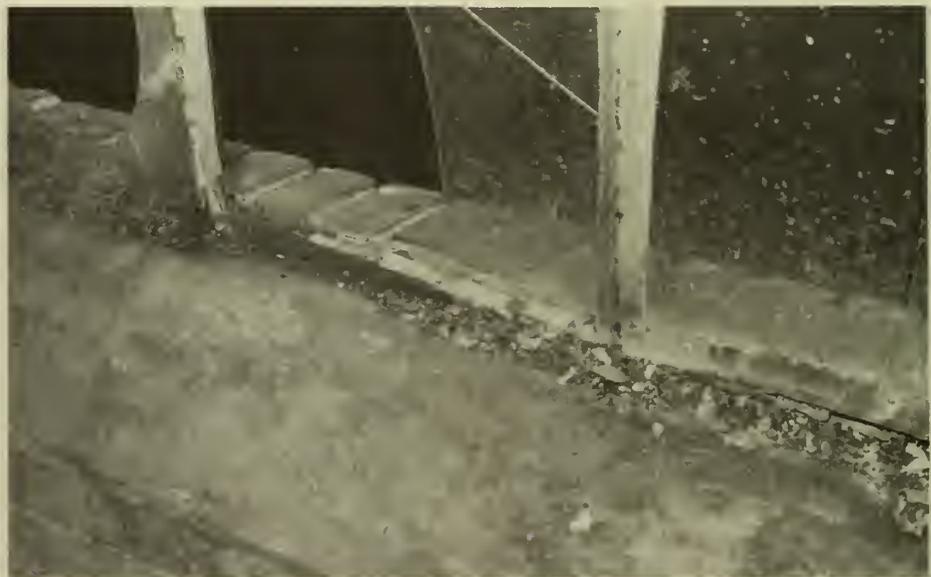
Figure 5. Sill corrosion typically found on 95% of the windows. Photo: Clio Group.

Generally employing three crews of three to four men, each contractor began by cutting out all the severely corroded and/or heavily bent metal sections from each window. Severe corrosion occurred primarily in the sill areas where the original steel sill section was embedded in concrete—a condition existing in approximately 95% of the window sills to be repaired (see figure 5). The spalled concrete and the corroded metal sill sections were chopped out with a portable band saw. In addition to the corrosion in the sill areas, extensive deterioration typically extended up the window muntins approximately three to six inches. These members were cut at a 45 degree angle with a five-inch grinding wheel using a five-inch disk, usually at a point four to seven inches from the sill or where the steel was no longer corroded.

Once the muntins and mullions were set plumb, the final steps in the steel repair process began. In most of the sill areas, lengths of new steel sections were installed to replace the original corroded members. The new cavetto-shaped steel sections did not match exactly the bullnose profile of the historic windows (see figures 9 and 10). However, the original profile was no longer available and the new profile was close enough so that the overall proportions, profile, and shadow lines were compatible with the historic window appearance. The new steel sections at the sill and the lengths

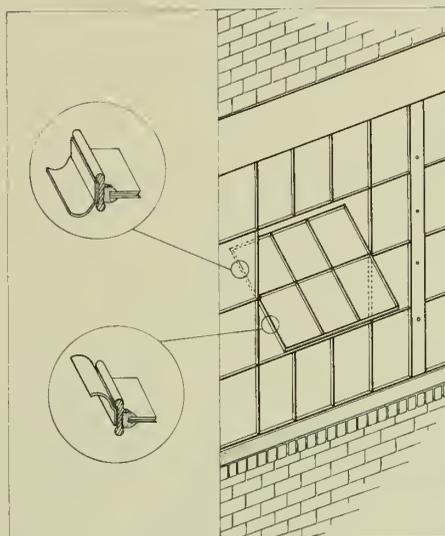
**Figure 6.** Pivot ventilators prior to retrofitting on the upper floors. Bullnose trim pieces to be modified as part of the retrofitting from pivot to projecting ventilators.

Concurrent with the cutting out of the window's corroded steel members, each of the existing pivot window ventilators on floors two through six were cut from their jambs, labeled and brought to an on-site work station. At the work station, the pivoting ventilators were modified to operate as projecting windows (see figure 6). This was accomplished by cutting off the bullnose outside face of the side and bottom rails on the sash and riveting a new water-shed steel angle at the same locations. To allow the ventilators to swing out, two 16", heavy duty, 6 bar, zinc chromate plated steel, TRUTH hinges were screwed to each ventilator (see figure 7). New right-hand, cast iron, bronze lacquered, locking handles were installed on the bottom rail by face-mounting and screwing to each ventilator.

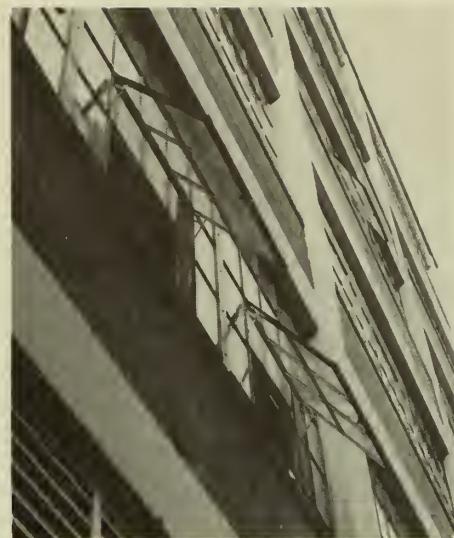
**Figure 7.** Retrofitting projecting ventilator with the TRUTH hinges. Photo: Robert Powers.

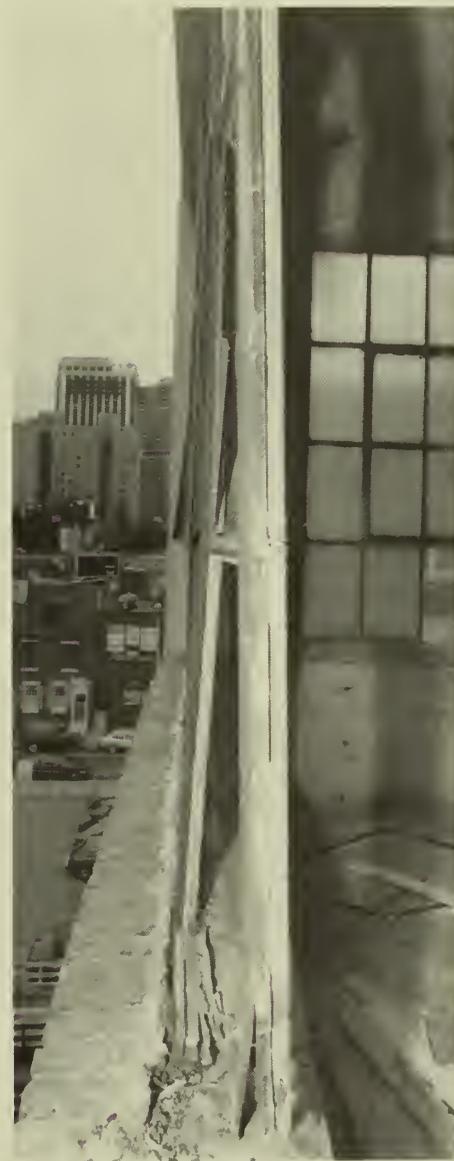
In addition to the retrofitting of the ventilators, many of the window muntins and structural mullions needed to be straightened, patched and repaired (see figure 8). Members that were seriously bowed and could not be adequately straightened were cut off using grinding wheels and salvaged;

**Figure 8.** Bowed and corroded window during construction. Photo: Clío Group.

replacement members were welded into place. Two relatively simple techniques were used to straighten the less seriously bent and bowed steel members. With mullions, a wooden brace (usually a two-by-four) was attached to the mullion; a wire cable was wrapped around the wooden brace and the mullion; and slowly the cable was pulled with a "come-along" winch hooked to the ceiling of the building. Since the mullions had typically bowed toward the exterior, the member was pulled in the direction opposite its bowing, towards the inside of the building. To straighten out bent and bowed muntins, the contractor applied constant pressure through the use of 14" bar-type clamps on the muntin. All indentations and gouges left in the steel members were filled with an auto-body patching compound containing steel fibers and an epoxy binder, sanded smooth and primed with a rust-inhibiting primer.

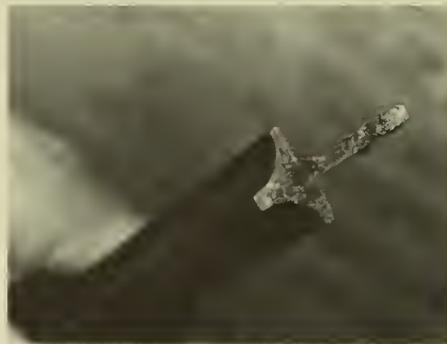
Figure 10. Replacement steel window section used primarily in the sill areas. Photo: Clio Group.

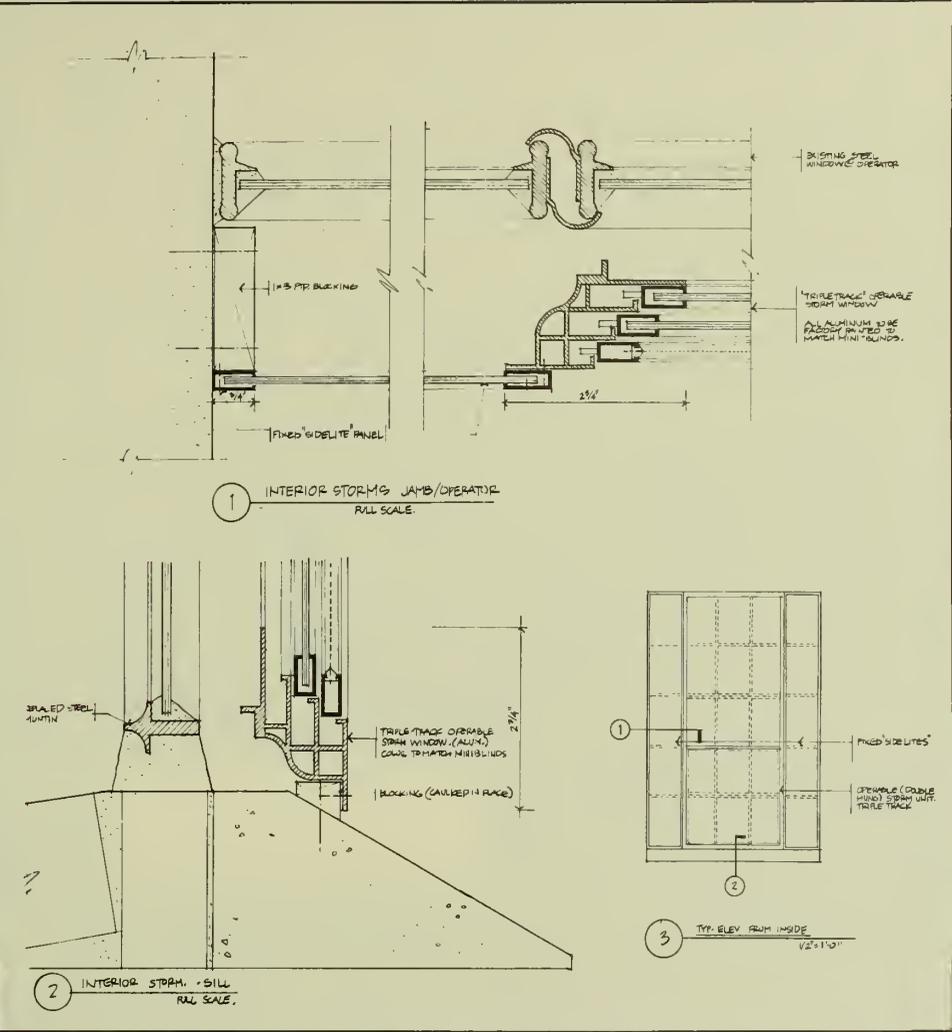
Figure 11. Interior storm window drawings, showing the alignment of the storm and steel window members. Drawings: H2L2 Architects.

the existing steel windows in and of itself was not sufficient in bringing the windows up to code. The development of an interior storm window system provided the additional thermal performance for code compliance. The solution involved an aluminum, triple-track, interior storm unit with flanking, fixed "sidelites" (see figure 11). A major consideration in the development of this storm system was the desire to minimize the outside visibility of the storm unit by aligning as closely as possible the meeting rails and other aluminum members with the steel window members (see figure 12). The exterior face of the storm windows was painted the same color as the steel windows so as to be as inobtrusive as possible (see figure 13). Although, the aluminum members do not match exactly the width of the opposite steel members, the storm windows were not readily visible from the exterior.

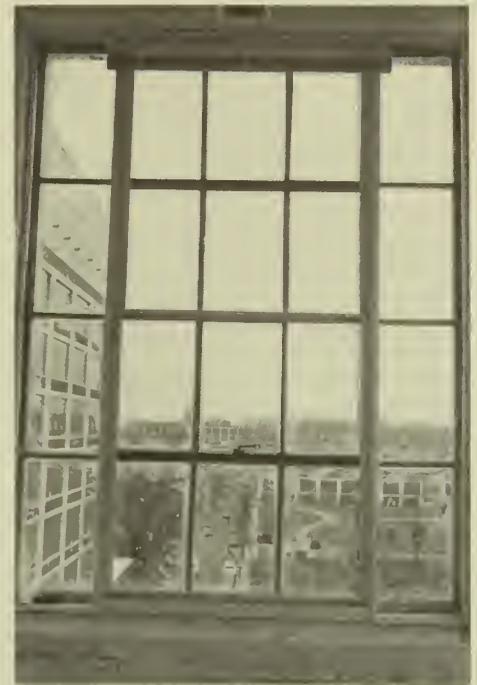
Figure 12. Installed interior triple-track storm window with fixed sidelights. Photo: Clío Group.

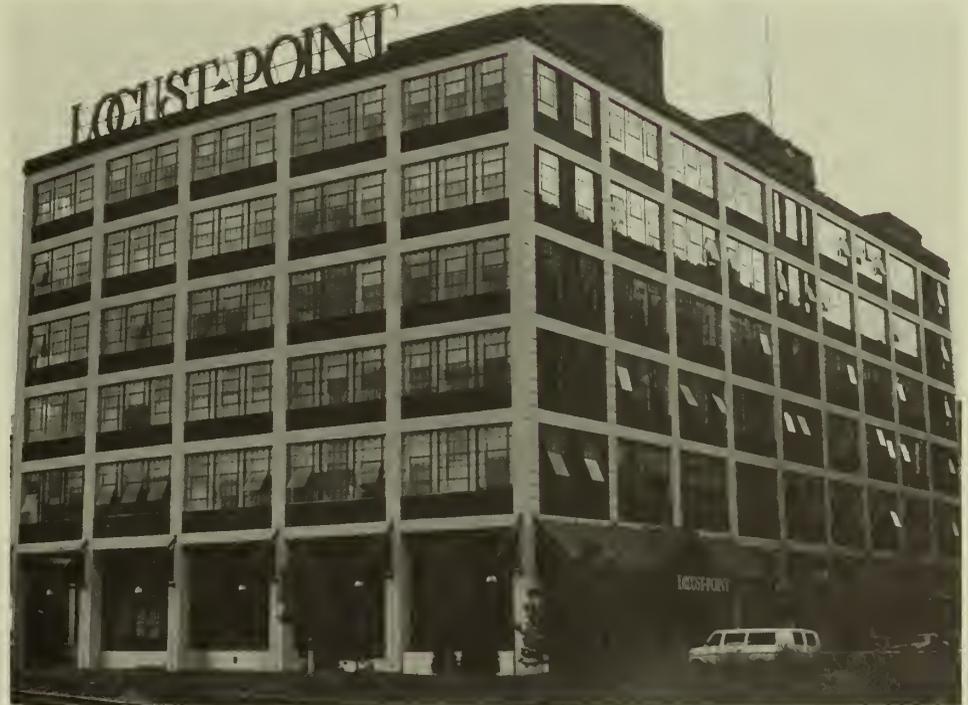
Figure 13. Lippincott Press Building (now Locust Point) after repair of the multi-light steel windows. Photo: Robert Powers.
