# Improving Thermal Efficiency: Historic Wooden Windows

## The Colcord Building Oklahoma City, Oklahoma

**The Colcord Building  
Oklahoma City, Oklahoma**

**Sharon C. Park AIA**

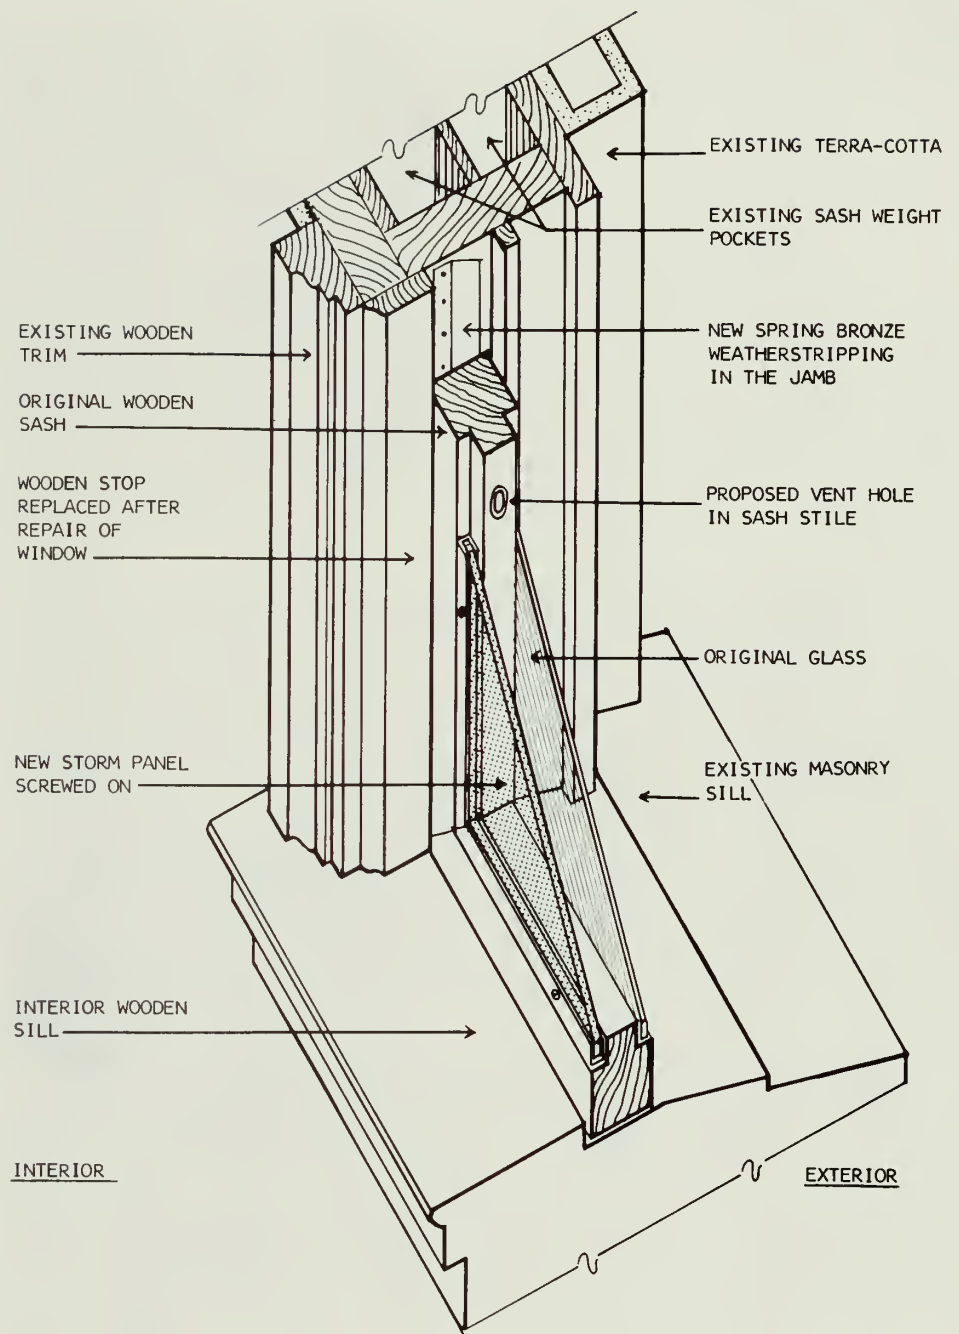
The architect's two concerns were the routing, or rabbeting, of the windows' wooden rails and stiles and the impact the additional weight of the storm panels would have on operating the windows. The cross-section of the sash rails and stiles was 1 7/8 by 2 inches of solid wood in good condition. The proposed rabbet of 1/2 by 3/8 inch was, therefore, not substantial enough to weaken the windows. This rabbeting would still allow a thermal cavity of a full inch between the glazing layers. The second concern was whether the existing sash weights could tolerate the additional weight of the storm panels. The Colcord Building windows vary from 22 by 66 inches to 48 by 66 inches and are composed of an upper and lower sash. The corresponding weight of the storm panels was approximately 3 to 8 pounds. The architect determined that the existing sash weights were adequate and specified that the pulleys of the sash chains be lubricated during the retrofitting to ease operating the heavier windows. (see figure 3)

moist air from penetrating into the cavity between the two layers of glazing. The vent holes, drilled laterally through the sash stiles, were to provide a minimum amount of circulation within the cavity to reduce condensation. (see figure 3)

Figure 3. Cutaway view of the window showing the proposed interior storm panel in place. Note the new weather stripping on the frame of the window and the proposed vent hole on the wooden sash stile.

Each window sash was taken, in turn, to the workbench where it was prepared for the new storm panel. The glass was carefully removed and set aside. Then a 1/2 by 3/8 inch rabbet was cut from the inside surface of the wooden sash to receive the recessed storm panel (see figures 3 and 4). The loose paint and any remaining dry glazing putty was scraped and removed from the sash. The glass was then reinstalled with a modern glazing compound and a new piece of spring metal weatherstripping was applied to the underside of the lower sash rail before it was returned to its frame (see figure 5). The original window sashes were equipped with sash locks at the head and sill, and the architect determined that these locks should be kept fastened at all times to insure that the windows would remain tight in their frames.

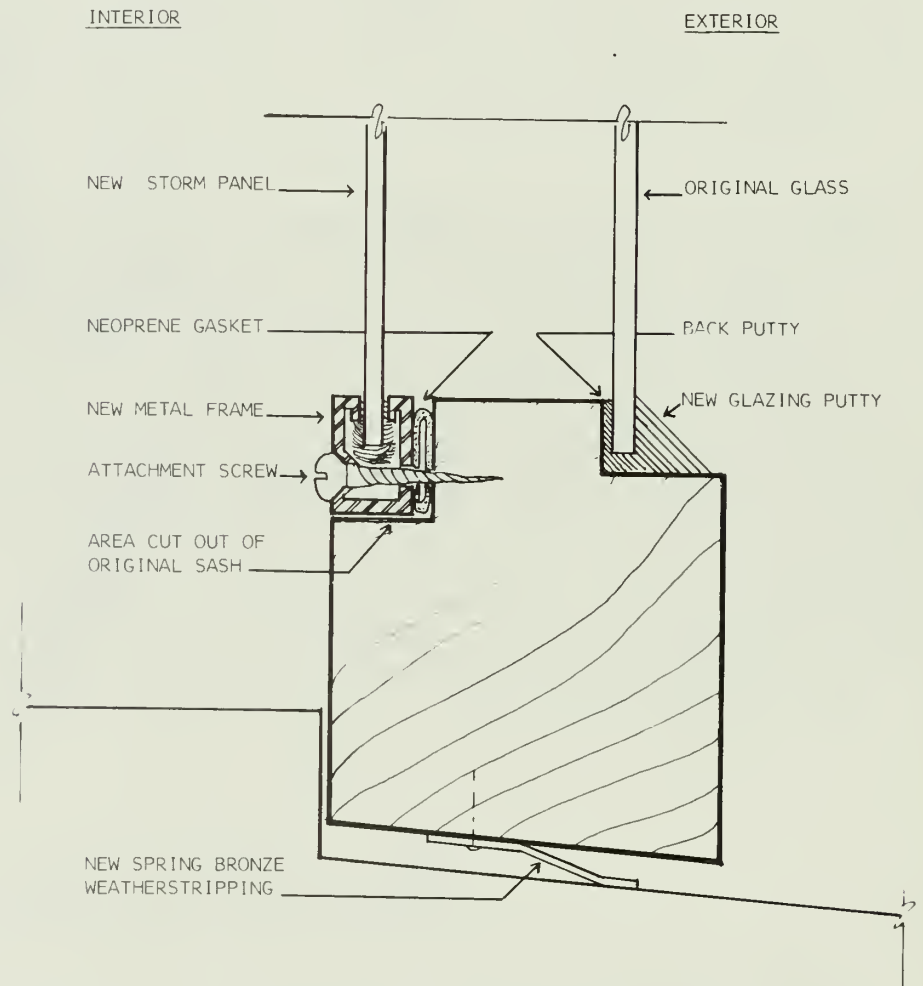
Figure 4. Detailed section through the wooden sash rail with storm panel in place. Note the small area of wood cut out to recess the new storm panel. The cavity left between the two glazing layers is 1 inch which is within the optimum range on 1/4 inch to 1 1/4 inch for insulated glazing. Note the neoprene gasket that acts to seal out moist air between the storm panel and the wooden window.

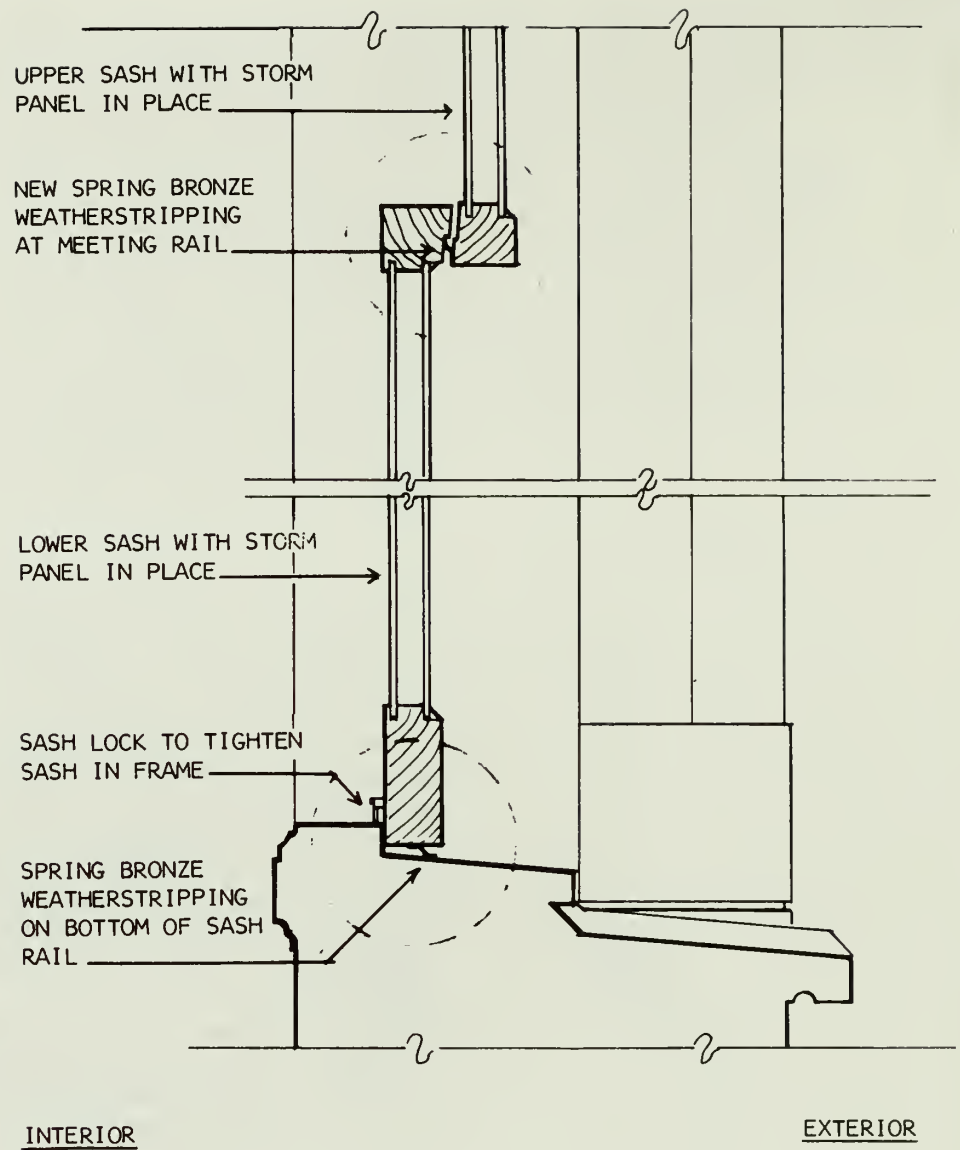
**Figure 5.** Section through the window showing areas of weather stripping. Note that new weather stripping was also added between the sash and the wooden frame, or jamb.

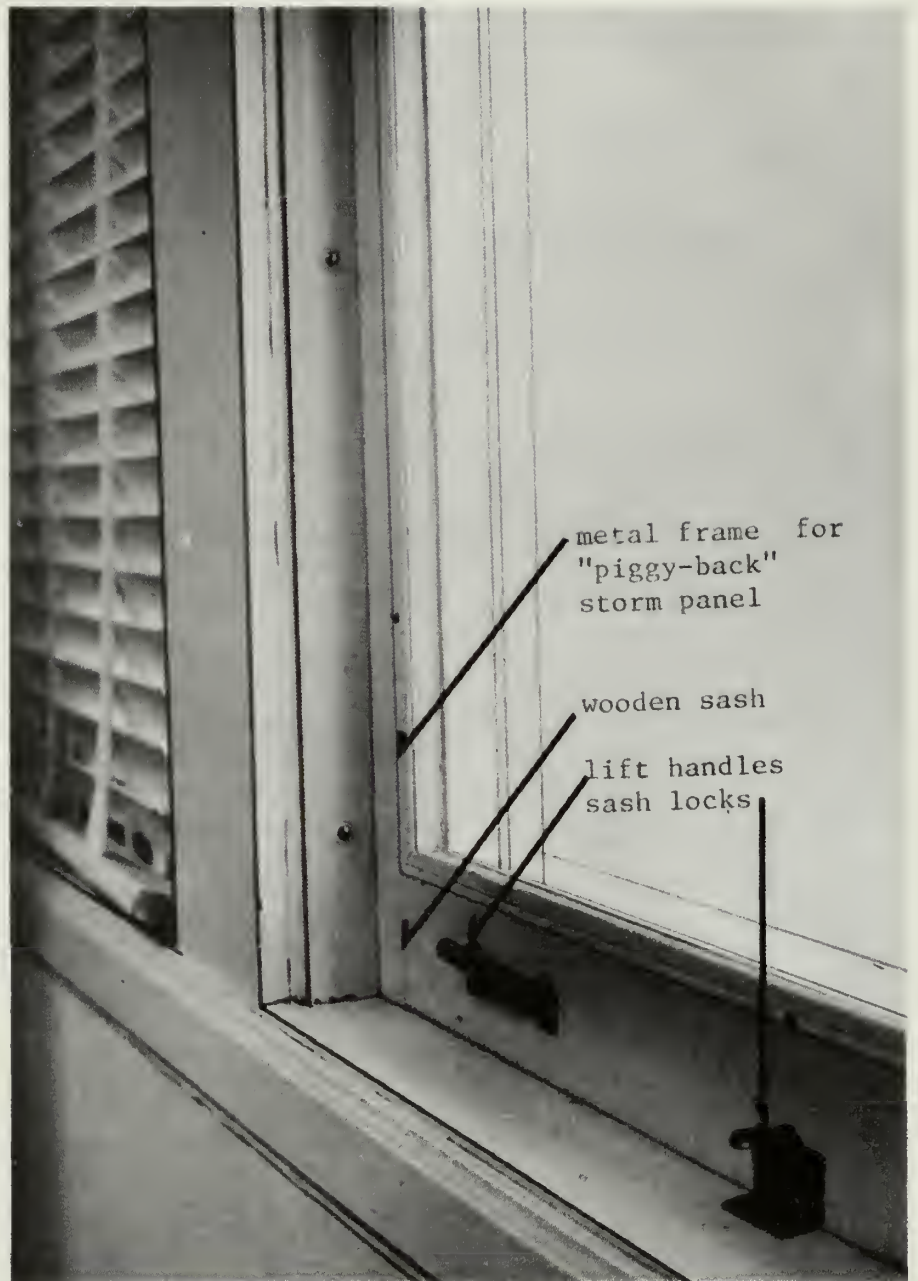
Figure 6. *New interior storm panel in place. Note that the storm panel was recessed into the wooden sash. This allows full operability of the window as the lower sash is raised without hinderance from the storm panel on the upper sash. The interior storm panels were affixed with screws and will be removed only for maintenance. (Photo: Tamara Coombs)*

The storm panels were installed by the crew floor by floor. The routed openings of the sash were measured and then float glass was cut in a basement workshop. Sections of extruded metal with an enamel coating were cut to the appropriate length and affixed to the glass with a hand crimping tool. The storm panels were then screwed into place (see figure 6). Because the storm panels were fabricated on the site, there was no need to keep a complicated inventory of window sizes, location, and so forth. There were also none of the problems associated with the transport and storage of such a large order.
