Bathhouse Row Adaptive Use Program

The Superior Bathhouse: Technical Report 2

hot springs national park

June 1985

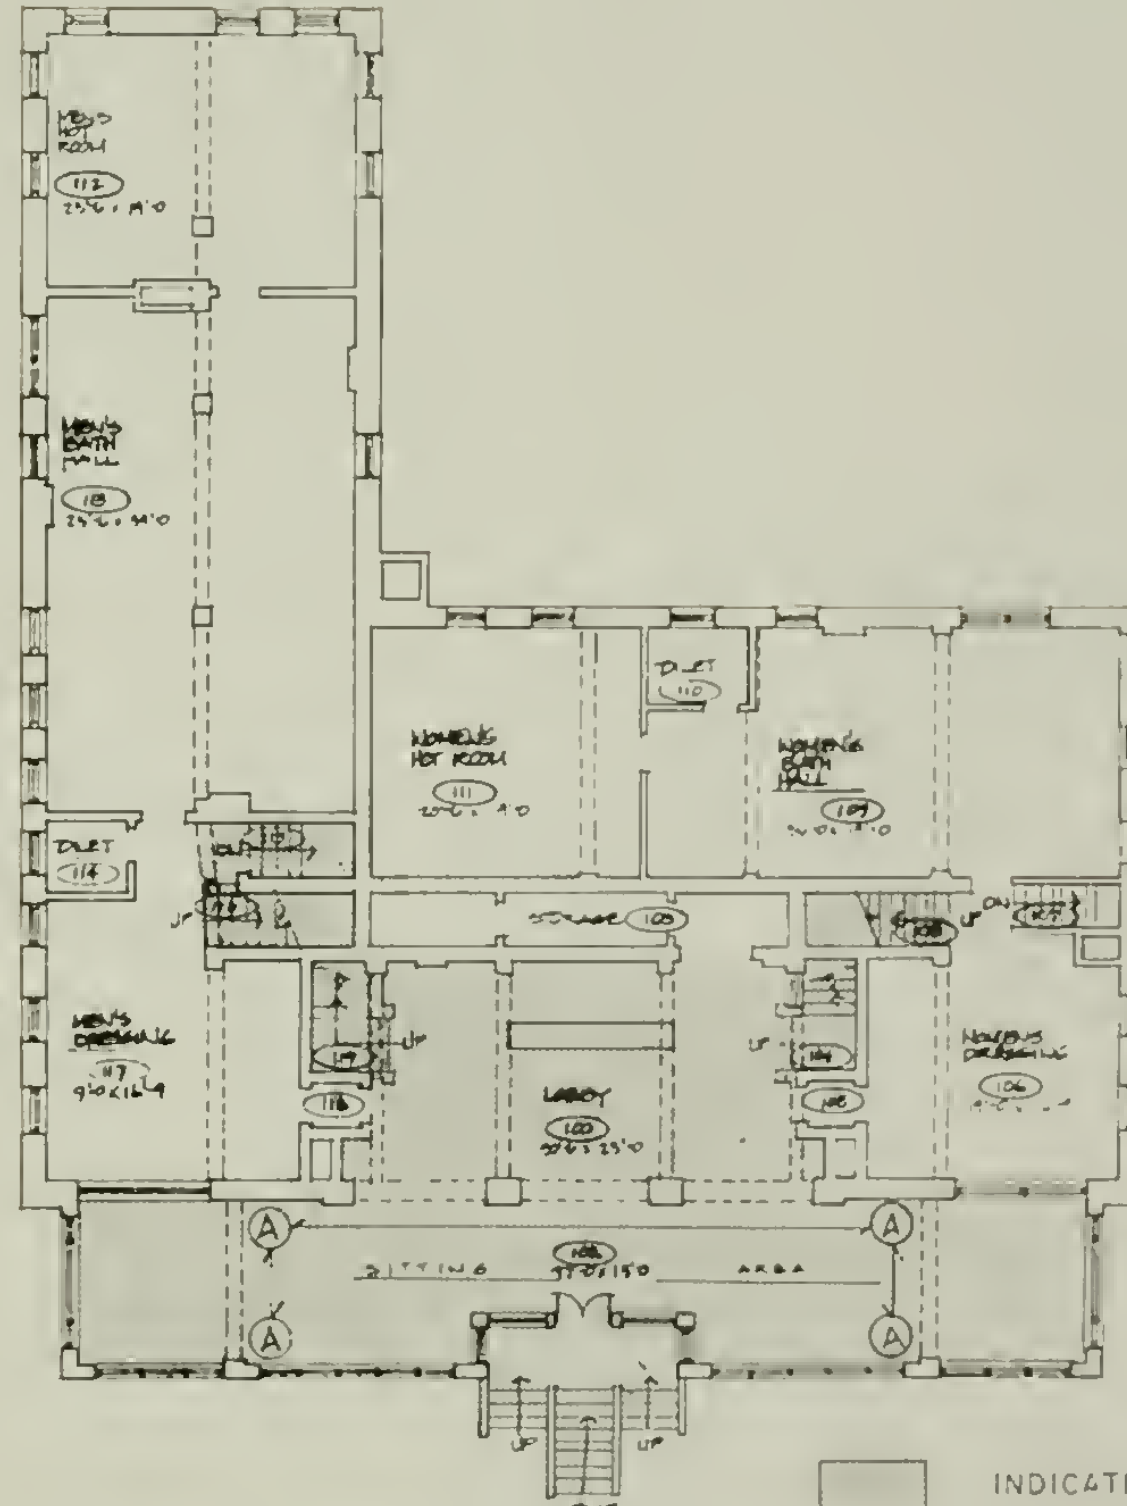
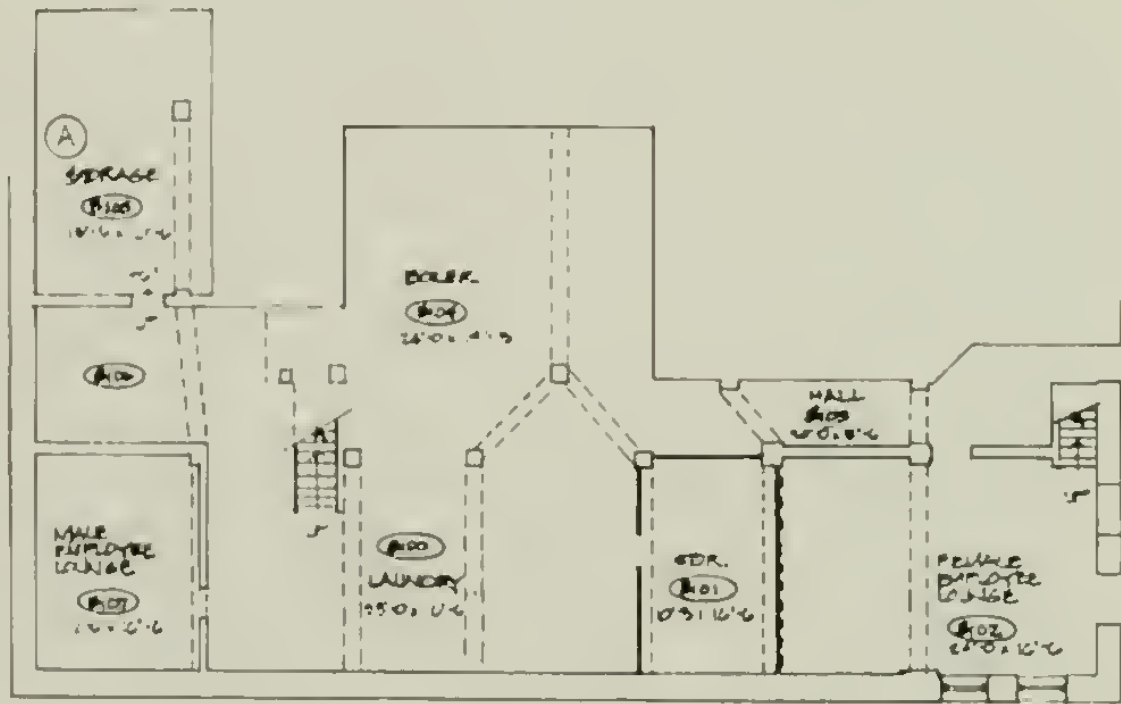
Figure 4

[Note: The capital letter symbols are cross references to the bathhouse floor plans, figure 4 and 5.]

<u>1973 Historic Structures Report</u>	<u>Investigative Study of Five Bathhouses</u>
Basement	A	Ceiling crack.	Stress-relief crack. Stable.
First Floor	A	Crack around sitting area.	This could be a settlement crack or a stress-relief crack. It looks stable and probably has not changed much since 1973.
Second Floor	A	Wall crack in a pattern which indicate settlement.	This is a masonry crack caused by the curling of the concrete slab. There is no indication of foundation settlement in the basement nor on the second floor.
	B	Crack near ceiling which extends the length of the wall.	These must be stress-relief cracks in the walls or caused by plastic creep in concrete supporting beam. The structural slab on both sides of this wall were load tested. Therefore, it is structurally sound.
