Bathhouse Row Adaptive Use Program

The Hale Bathhouse: Technical Report 3

hot springs national park

June 1985

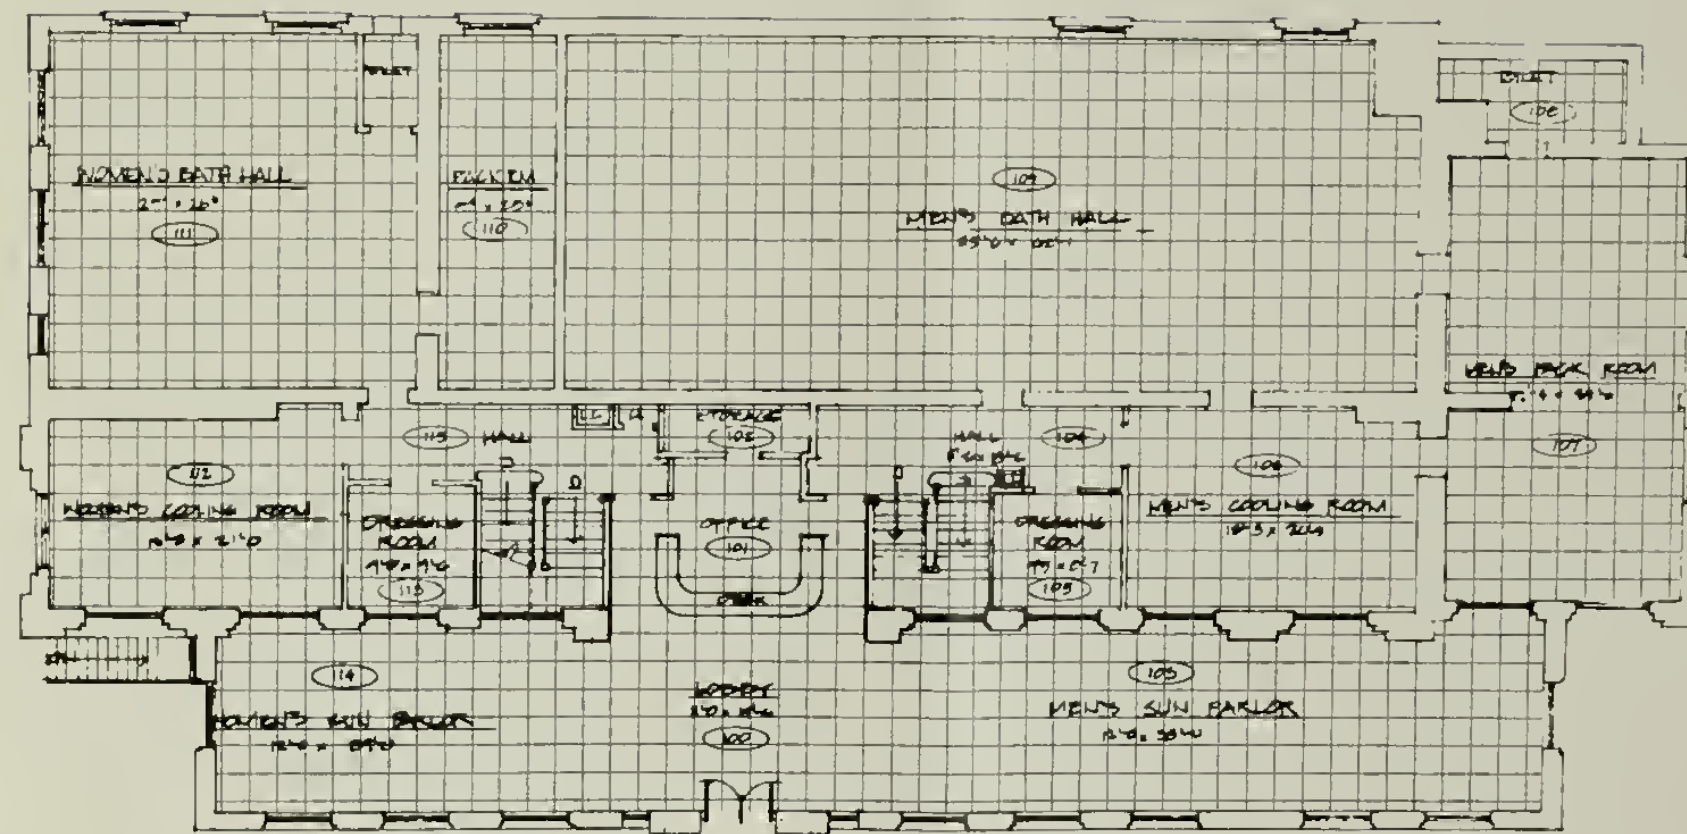
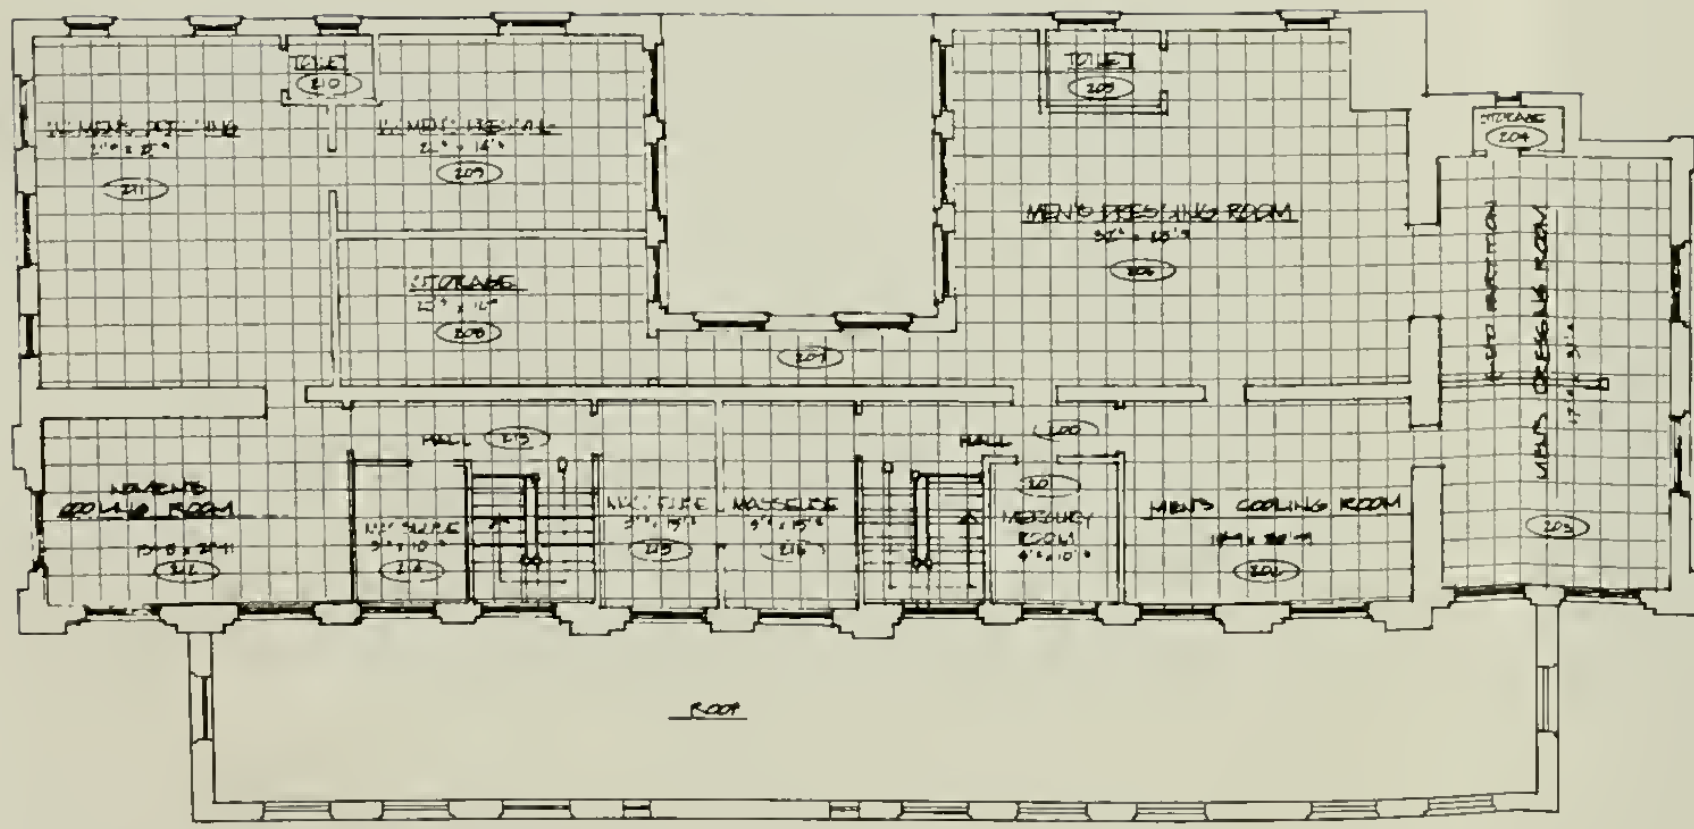
Figure 21

RECOMMENDED STRUCTURAL CAPACITIES

LEGEND
90 psf
