# Bathhouse Row Adaptive Use Program

The Quapaw Bathhouse: Technical Report 6

HOT SPRINGS NATIONAL PARK  
Garland County, Arkansas

June 1985

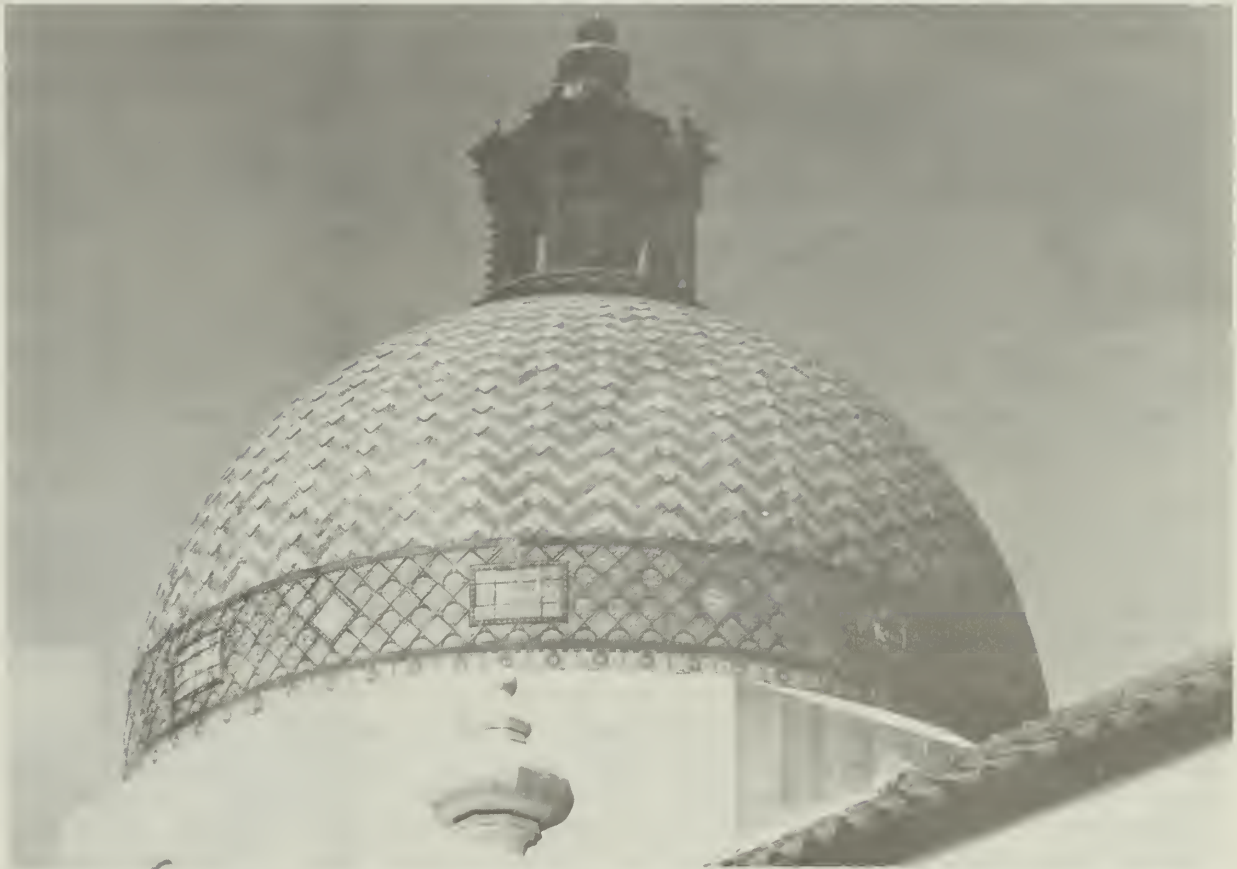
Figure 6: Quapaw Bathhouse Dome, 1984 (Source: Historic American Buildings Survey)

- b. The lantern atop the dome is made of sheet copper that has been shaped, riveted and soldered together to form an intricate design. Water may be seeping into the tile setting bed through some of the broken soldered joints. The copper is oxidizing similar to that experienced on the Fordyce marquee. A makeshift cover over the lantern access opening is not adequately keeping rain and pigeons out of the attic.

- c. The upper portion of the ceramic tile dome, which has less slope, is severely weathered. The grout between the tiles is eroding away, allowing water to penetrate the setting bed through the broken solder joints of the lantern. The erosion caused by this water and its subsequent freezing and thawing have broken many tiles and caused large sections of the tile to delaminate from the setting bed. This area can be identified by the five color glazed tile layed in a undulating pattern around the base of the lantern. A large sample of these tiles was easily taken. From inside the dome, water can be observed to penetrate the scratch coat on rainy days. Some of this water is collected on the tops of the two inch plaster channels and is transferred down to the top of the octagon base wall. The steel plaster channel framework is only slightly oxidized. This steel is probably protected by the basic solution created by the portland cement plaster and is no worse than might be expected if the ceramic tile were not leaking. No deterioration was observed in the metal lath, in the scratch coat or in the setbed. Sunlight does not shine through the severely damaged areas of the dome as previously reported in our "Status Report,

- d. The middle and largest section of the dome is layed with a radiating pattern of four inch (4") square floral tiles superimposed on a two-color chevron pattern of tile. The base of the dome is a band of multi-colored four inch (4") square tile. All of this tile is tightly affixed to the setting bed. It does have hairline stress relief cracks that radiate from the lantern. They occur at about twenty-two and one-half (22.5) degree intervals, which places them approximately over every other two-inch plaster channel. A lime like material can be observed to be leaching from some of the cracks in the chevron patterned area. A few tile samples were taken from this area, with difficulty.

- e. No significant damage, caused by the infiltration of water, was noted in the poured-in-place concrete base wall. Some of the corrugated metal used to form the concrete transition from the octagonal base to the spherical dome has rusted and fallen away. This is only forming material and will not affect the integrity of the wall.

- a. Remove copper lantern. Clean and repair prior to reinstallation.
- b. Clean entire mosaic tile dome using low to medium pressure spray equipment, stiff bristle G.I. brushes, water and detergent.
- c. Remove and replace the five-color, undulating patterned, glazed tile around the base of the lantern. Use the methods and tile sources suggested by James H. Dixon of Mid State Tile Co. Appendix "F".
- d. Replace loose tiles in the two-color chevron pattern. Do not attempt to replace broken tile that is tightly affixed to the setting bed.
- e. RegROUT all tile joints and cracks with a latex modified grout.

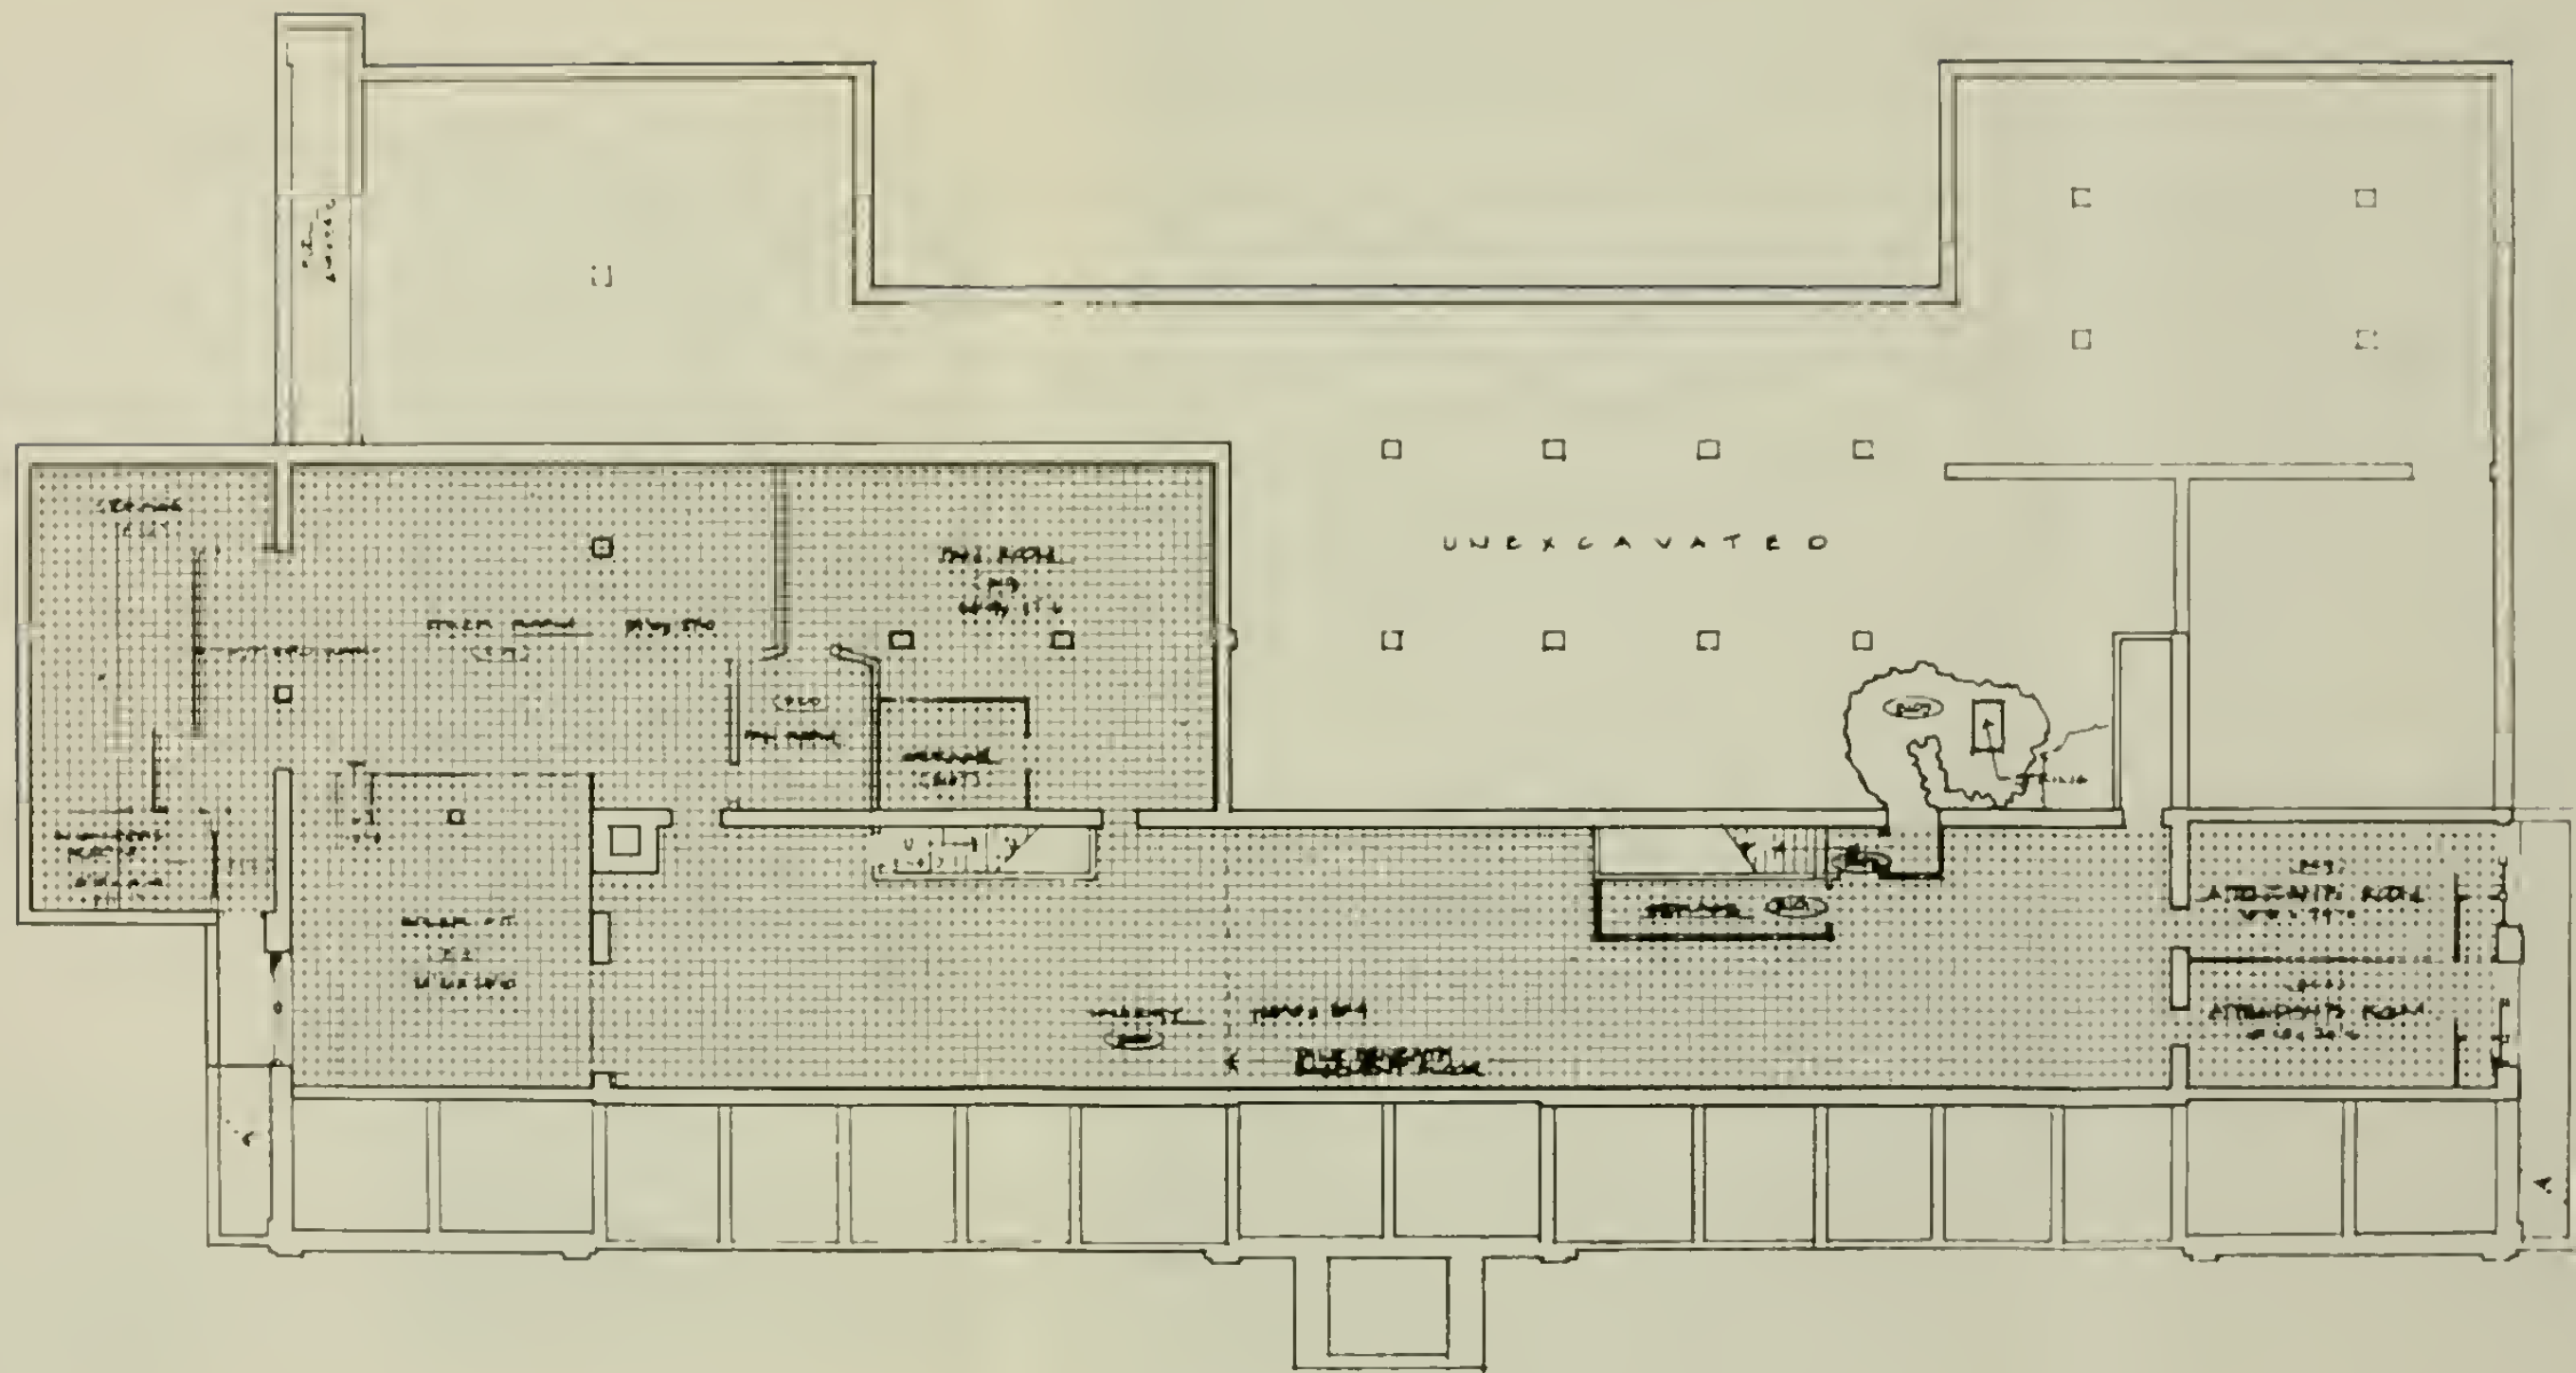
Figure 17

**RECOMMENDED STRUCTURAL CAPACITIES**

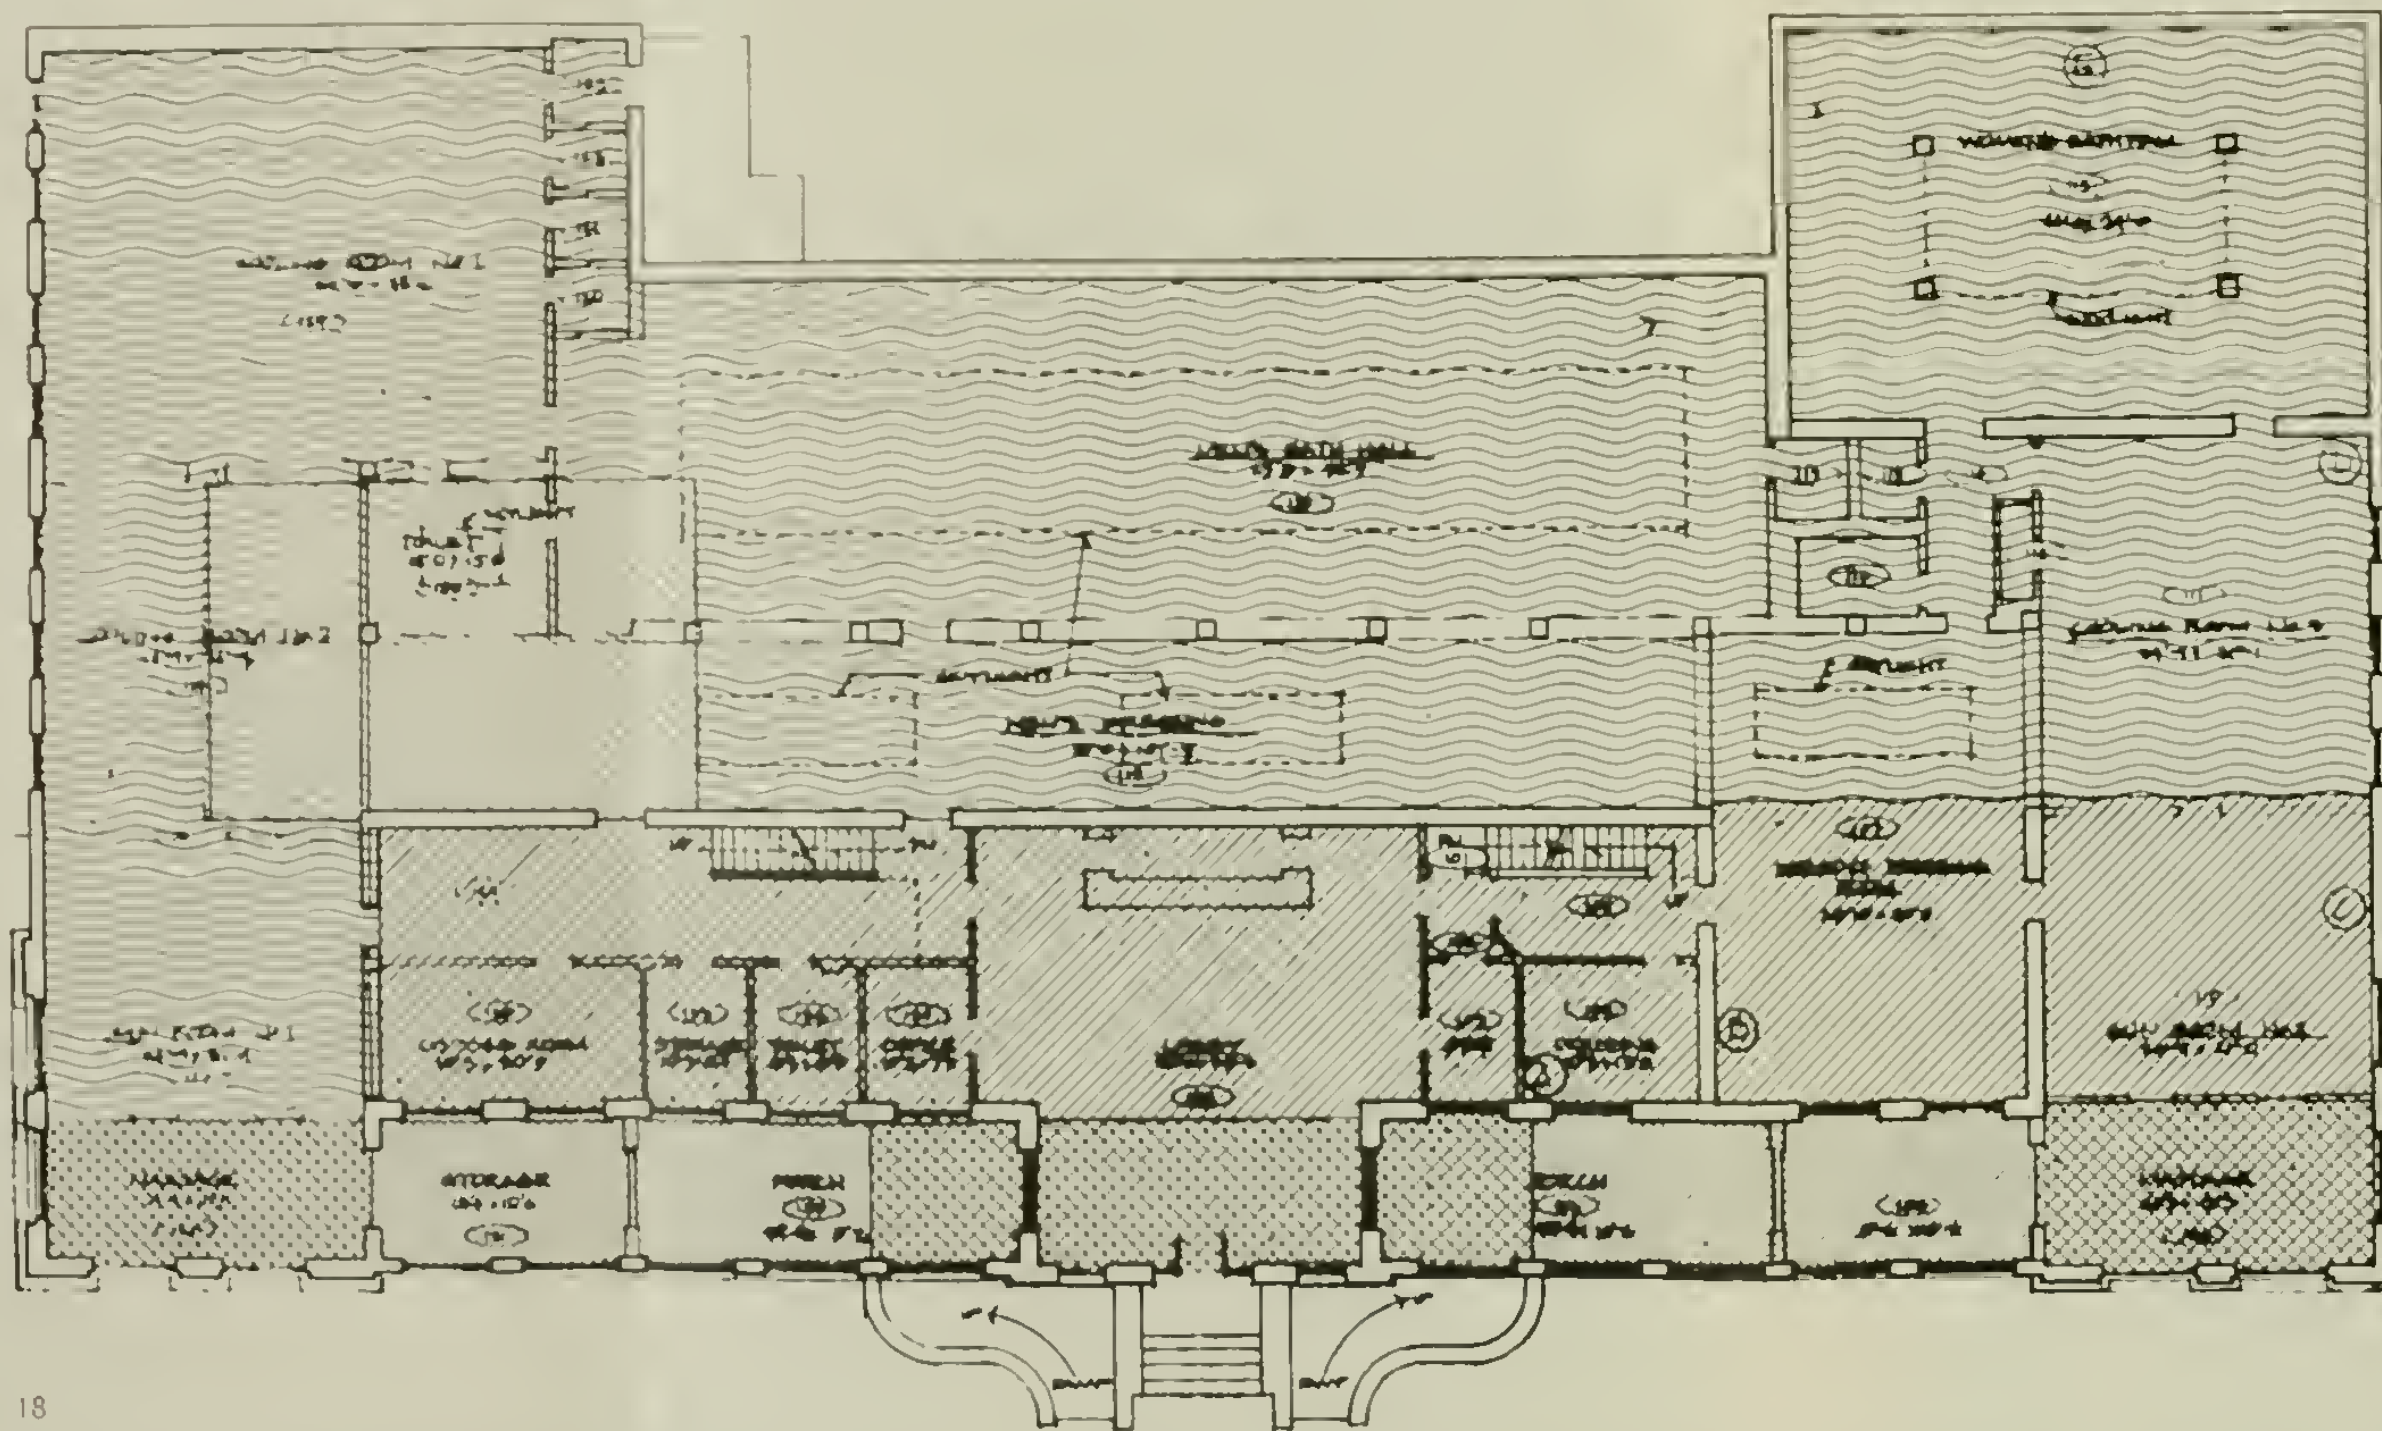
40 psf
	65 psf
	70 psf
	80 psf
	91 psf

RECOMMENDED STRUCTURAL CAPACITIES
