The Fordyce Bathhouse: Technical Report 5

hot springs national park

BATHHOUSE ROW ADAPTIVE USE PROGRAM
THE FORDYCE BATHHOUSE: TECHNICAL REPORT 5

June 1985

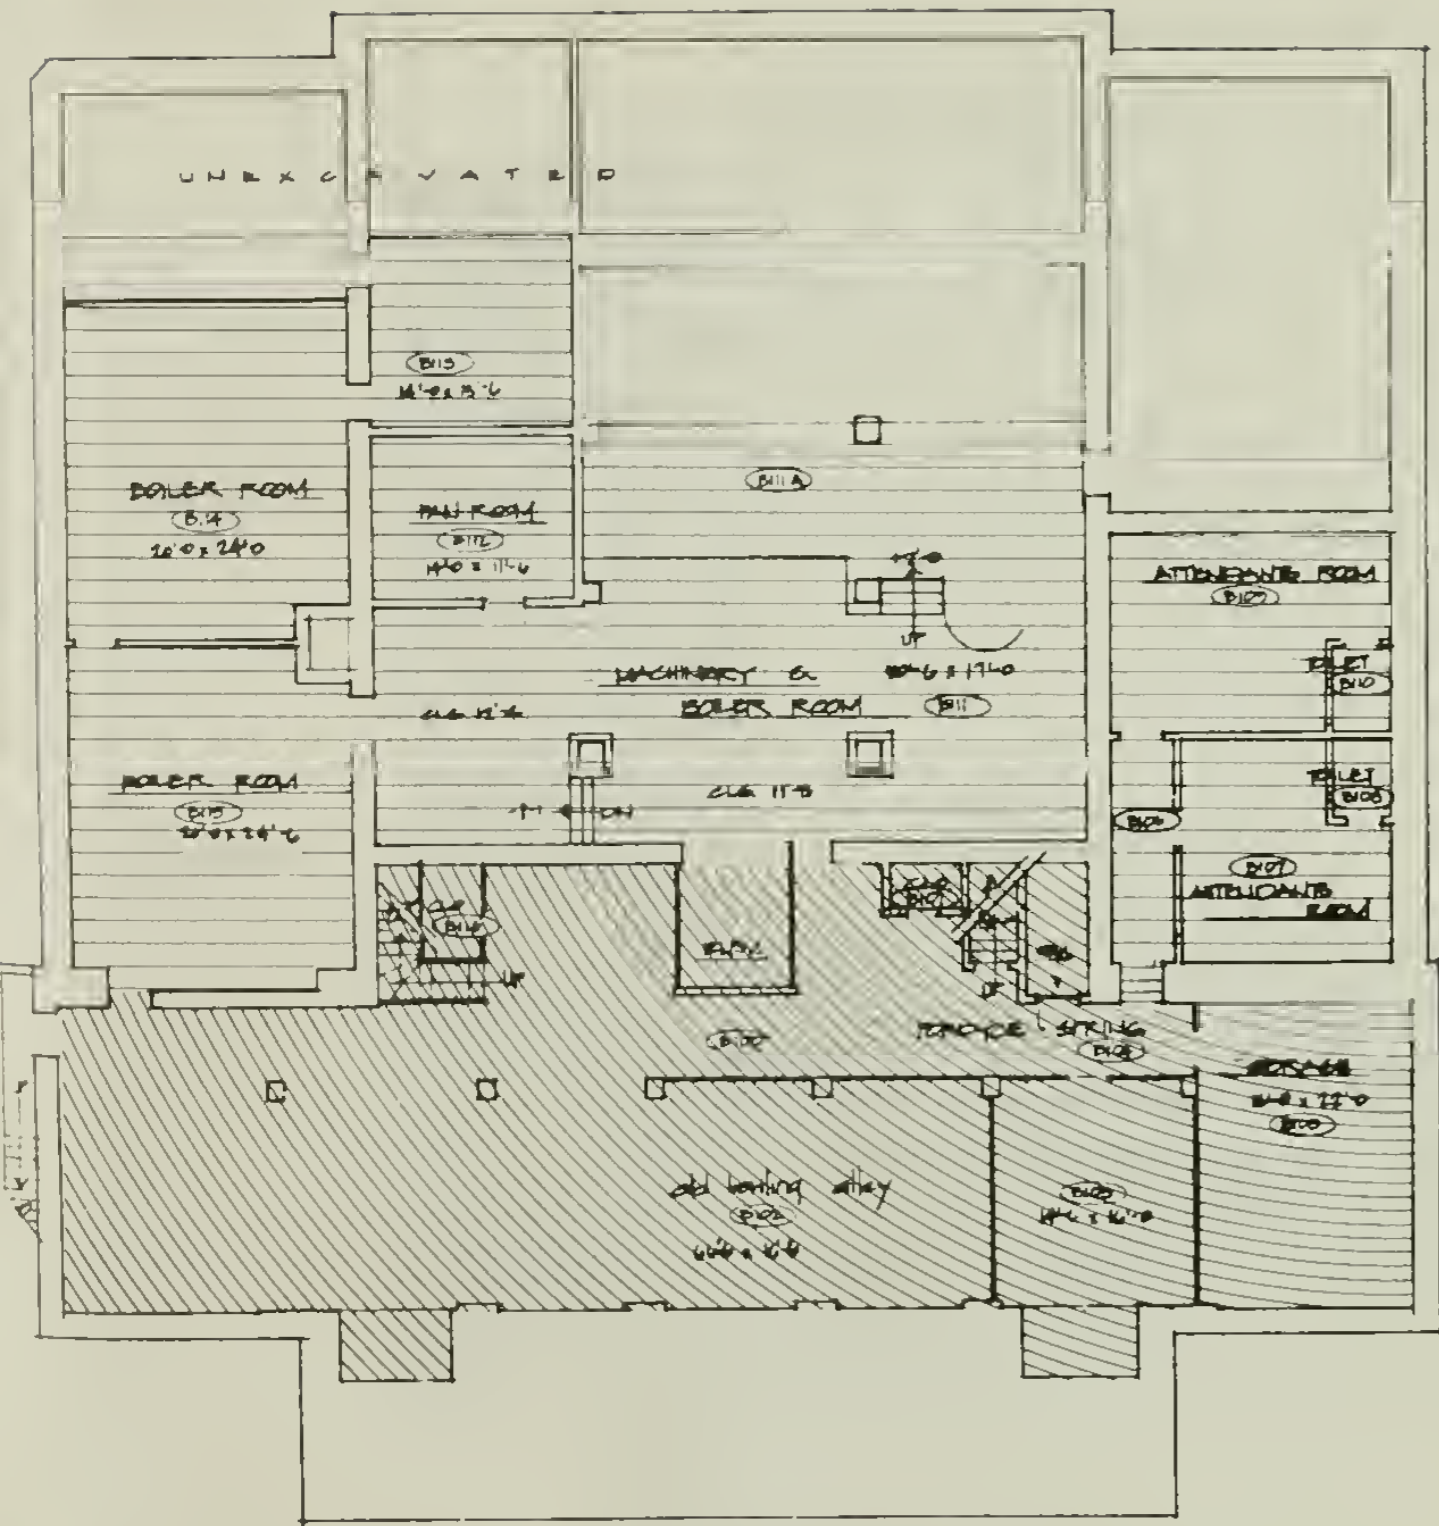
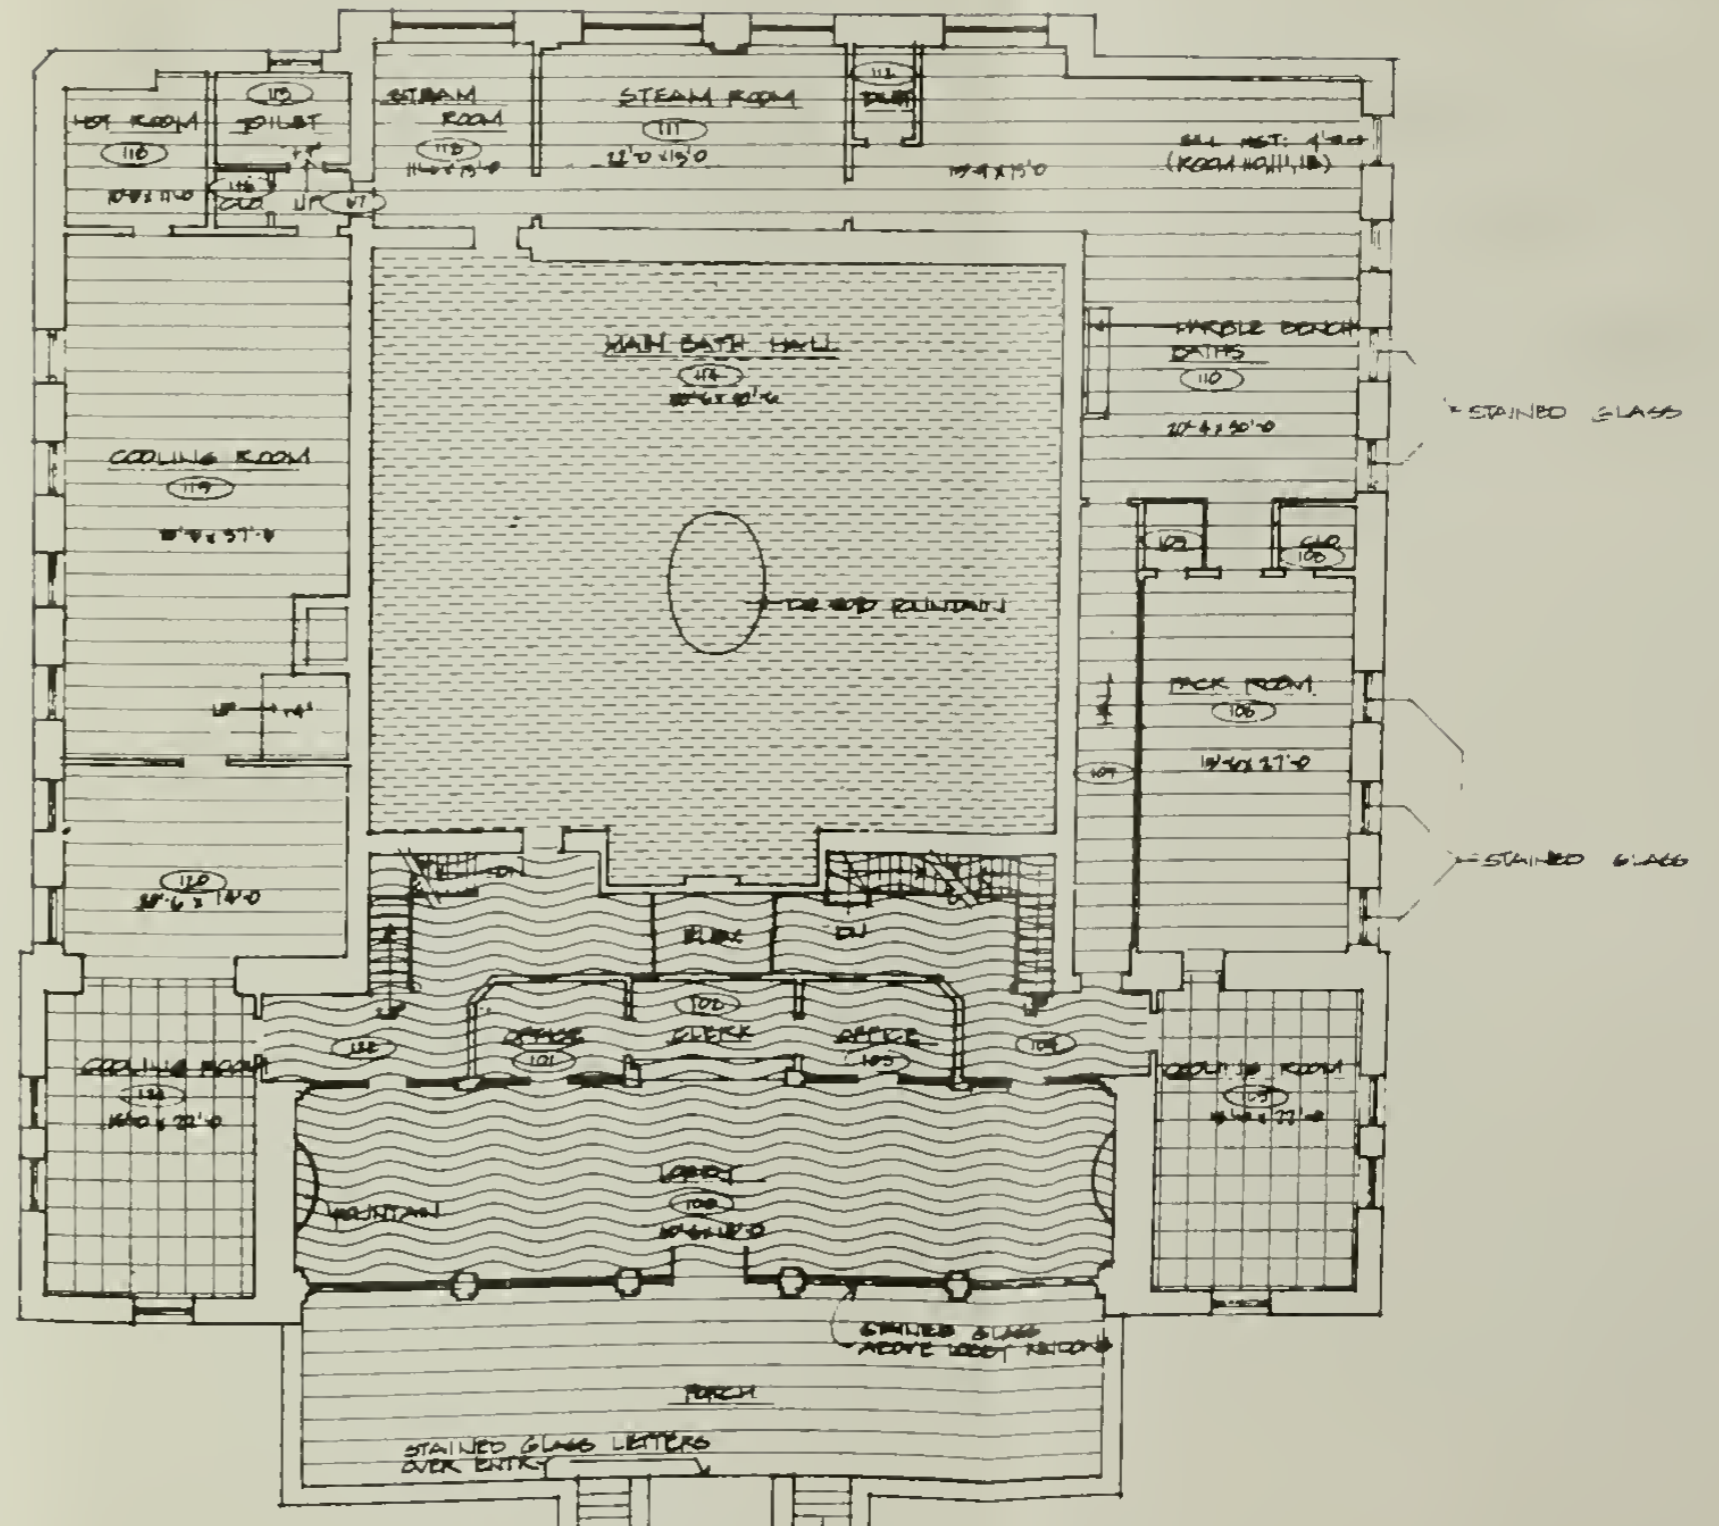
Figure 34

The structural capacities recommended in the Pitts report for the Fordyce Bathhouse are depicted on figures 34 and 35. Engineering drawings showing structural systems and details at 1/4 scale are available at the park. The Appendix contains excerpts from the Pitts report which describe existing conditions at the Fordyce Bathhouse in three parts:

RECOMMENDED STRUCTURAL CAPACITIES

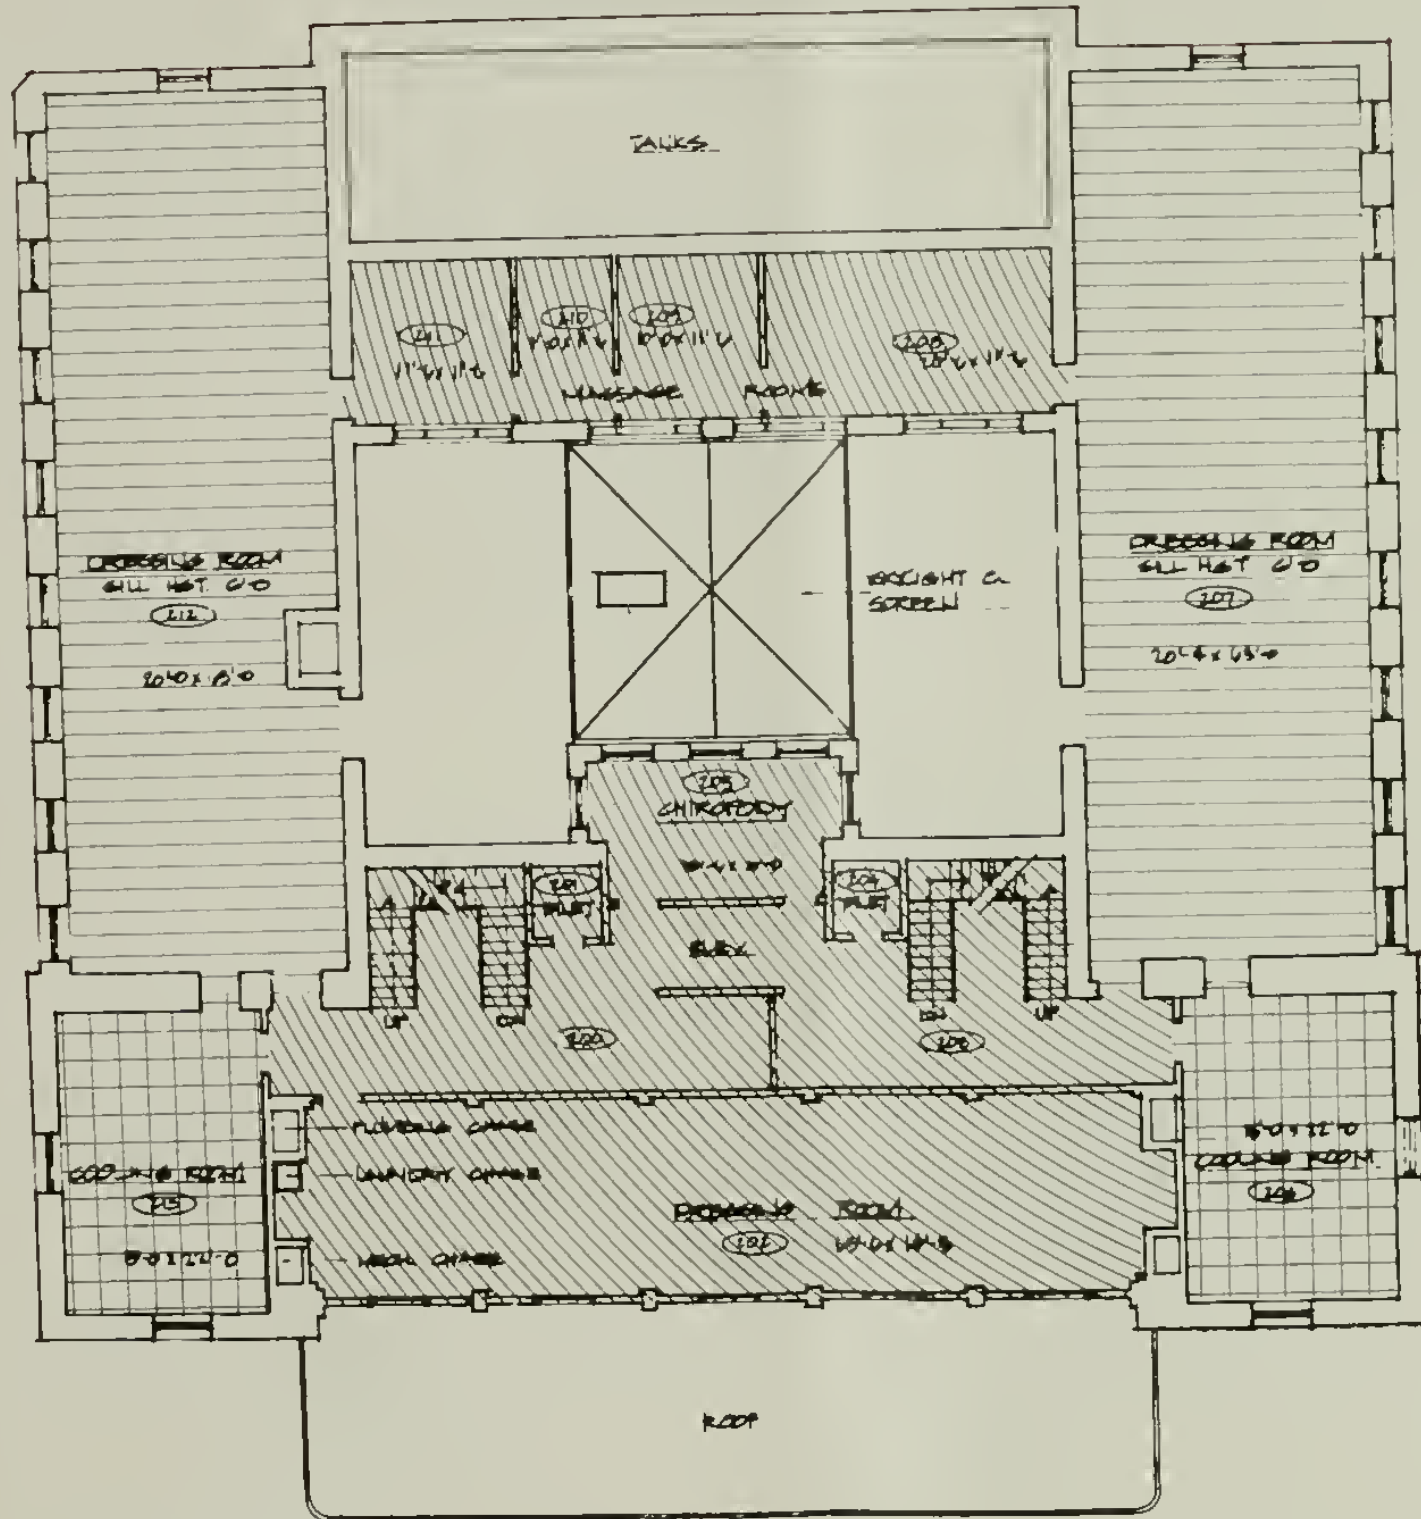
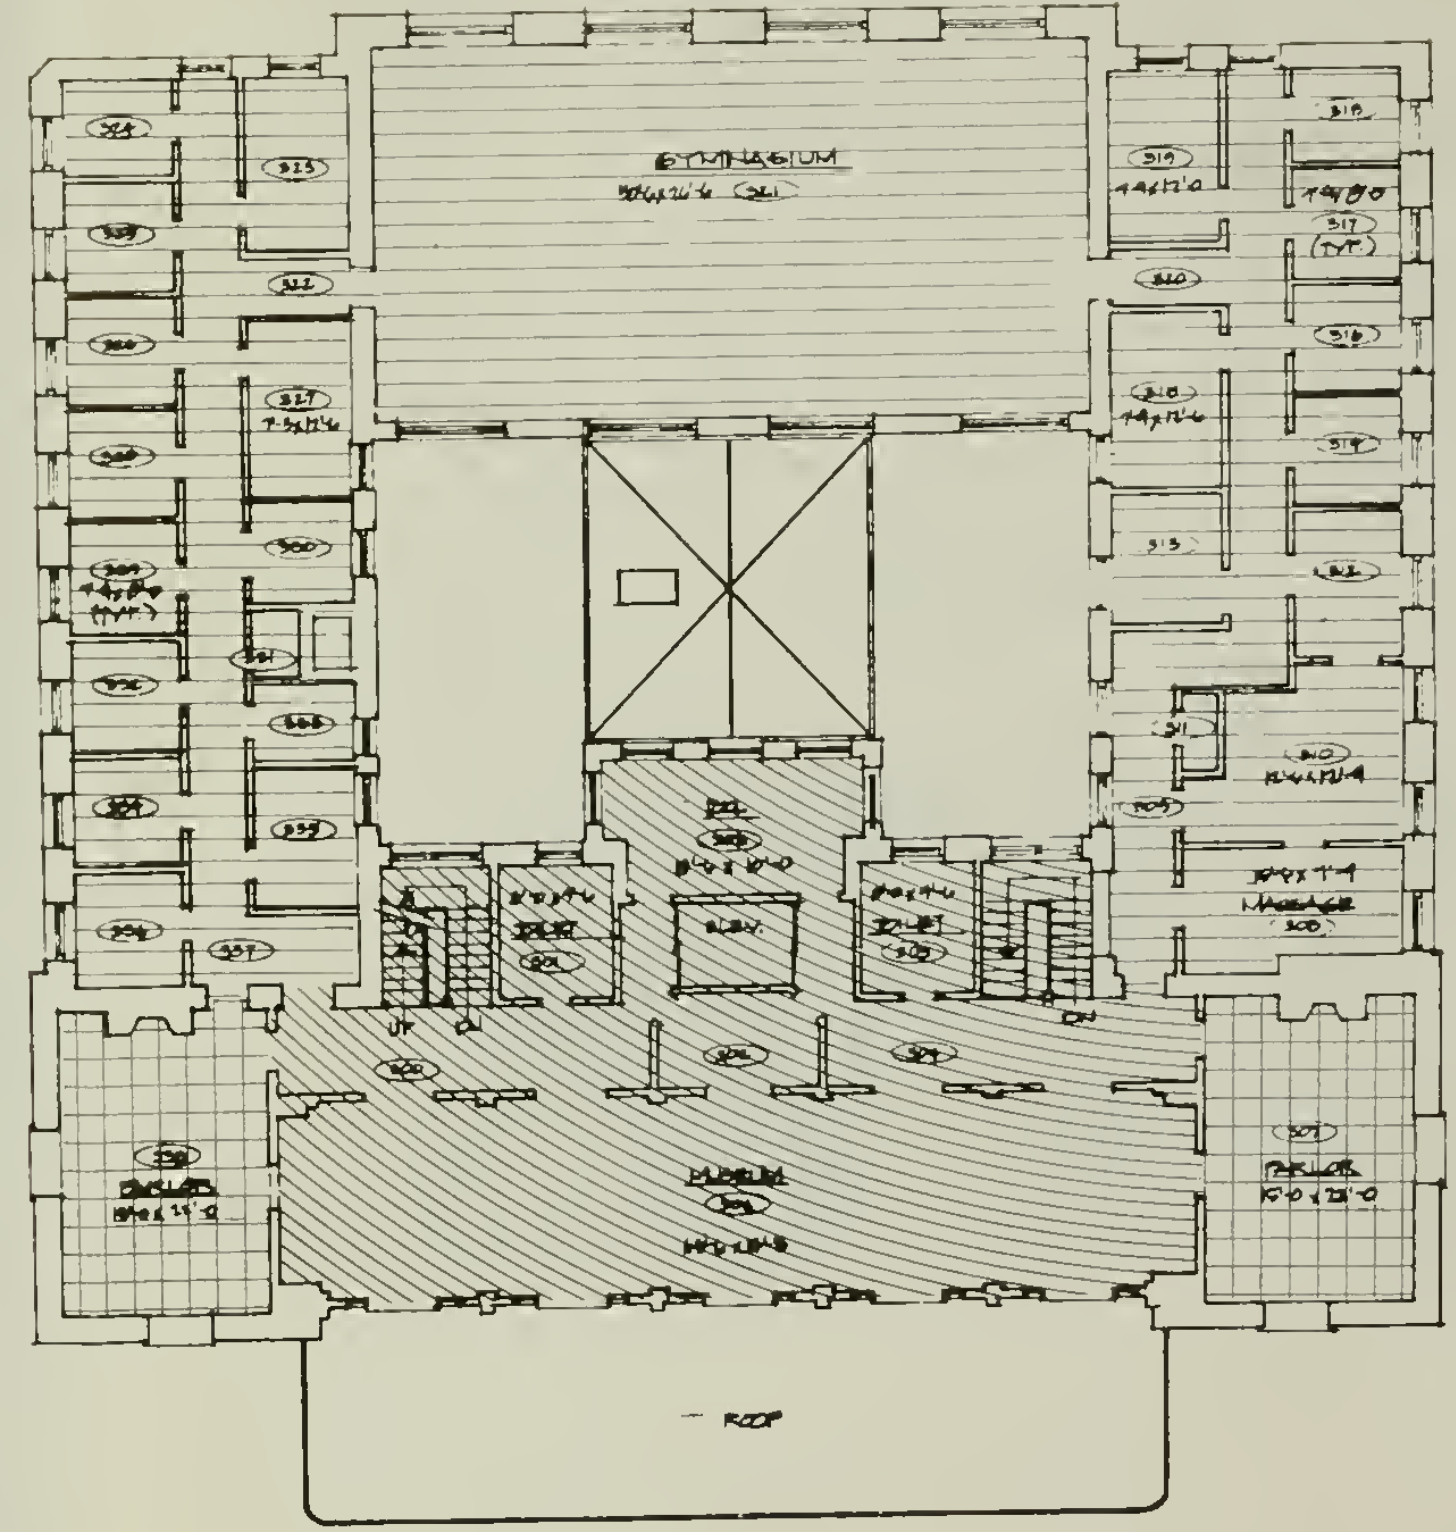
1 2nd FL. STRUCTURAL PLAN
F-2

RECOMMENDED STRUCTURAL CAPACITIES
