UNITED STATES DEPARTMENT OF THE INTERIOR
NATIONAL PARK SERVICE

OUTLINE REPORT OF
ARCHITECTURAL WORK
ON THE RESTORATION OF THE
CHESAPEAKE AND OHIO CANAL
FOR RECREATIONAL USE
(GEORGETOWN, D. C., TO SENECA, MD)

1939

Dallas D. L. McGrew
Associate Architect

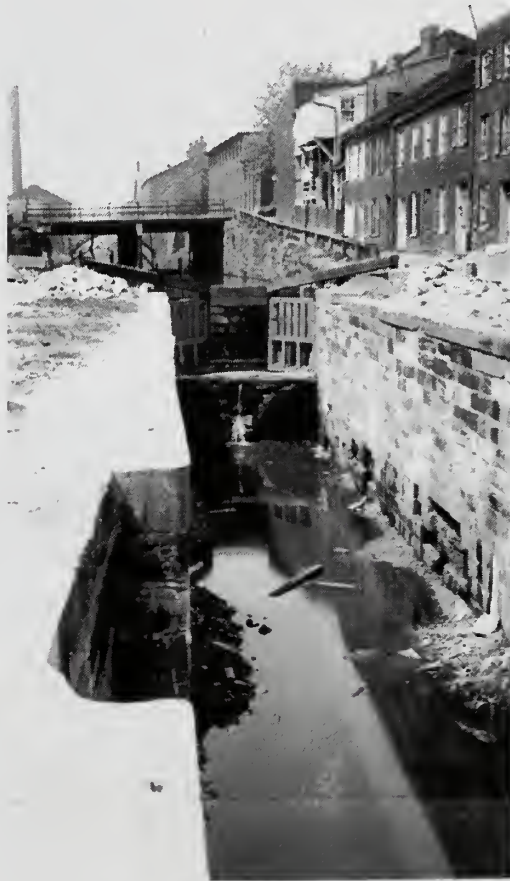
Photograph 1: Swing Gates. Lock No. 4, in Georgetown, shows also the character of the Lock masonry and the dam at head of the Lock. Composed of heavy planks lowered into slots cut in the stone. This served to hold back water during repairs. The curve of the arch of the Wisconsin Avenue Bridge appears in the background.

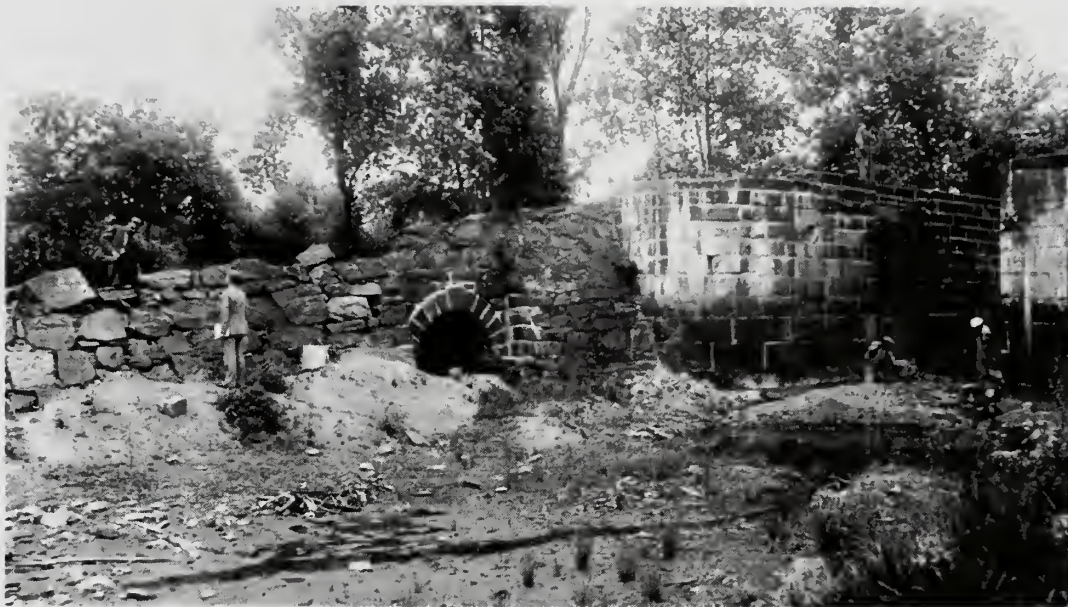
Photograph 14: Spillway culvert, south end of Lock No. 18, carrying excess water under the towpath to the River. This masonry has been repointed.

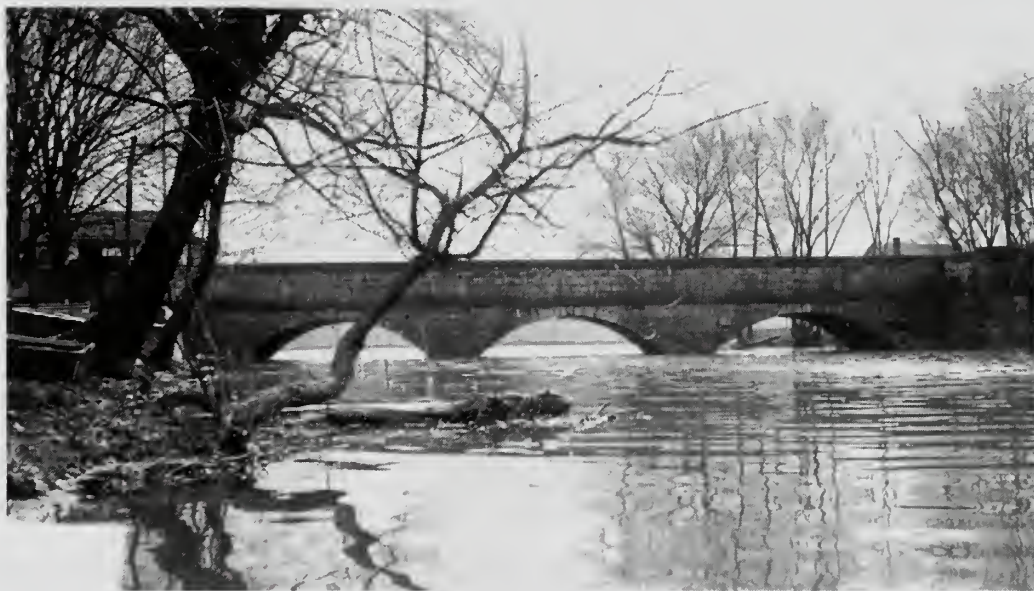
AQUEDUCT: Although it is outside the scope of the present project, an aqueduct crosses Seneca Creek at Lock No. 24. This is illustrated here because it is a substantial and handsome structure of three segmental arches and abutments built of cut Seneca sandstone. It is in fair condition and can be used without repairs.

Photograph 15: Seneca Aqueduct, looking from Seneca Creek toward the Potomac. Although this is beyond the present restoration project, it is easily accessible from Lock No 23 and is so handsome and sturdy a structure, typical of such work throughout the length of the canal, that it is illustrated here.

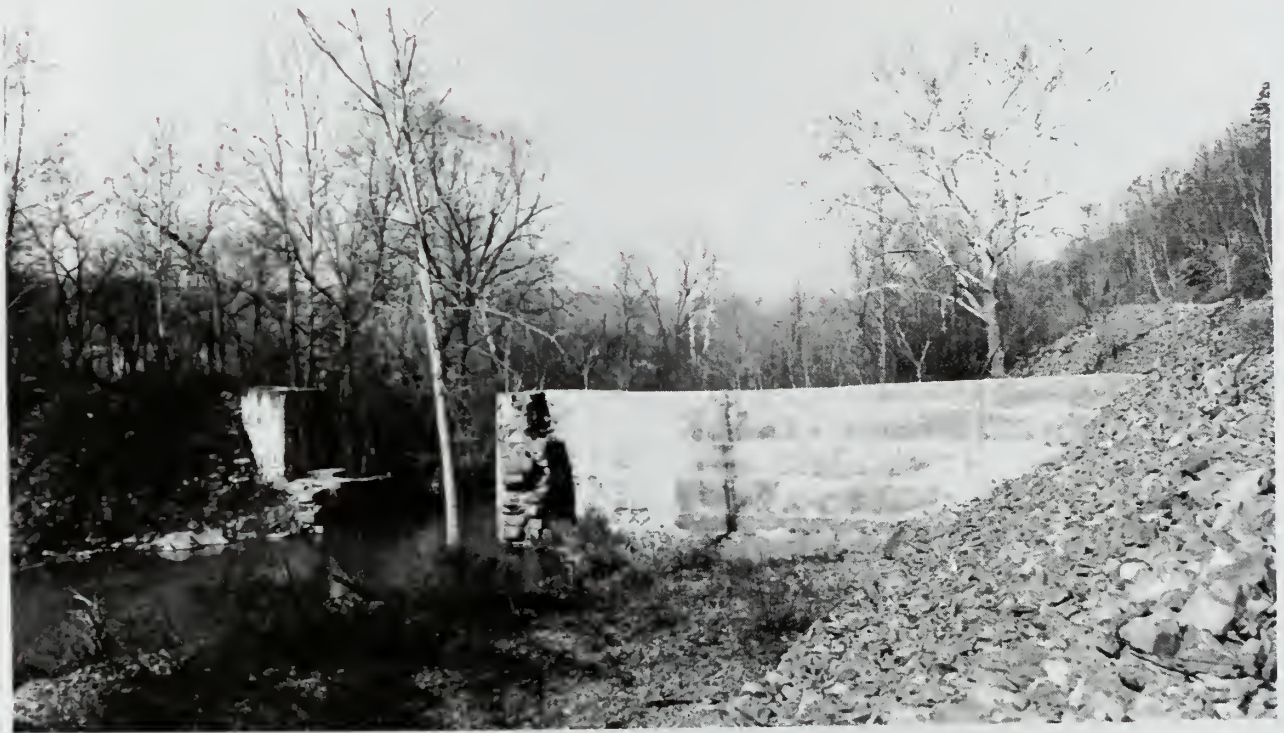
STOP LOCK: Of this structure only the abutments, one considerably damaged, survive. The dam also was washed out in places – especially at the bermside end. A concrete core wall has been built, covering the old masonry core, and considerable work is required here to put the structure in useful condition. The building that sheltered the operation of this Stop Lock was long since washed away and no record of it has been discovered. At Dam No. 4, below Williamsport, Maryland, however, there is a structure serving a similar purpose, and this has been studied to provide a knowledge of its operation. On the basis of this evidence a building of the same structural system and architectural character, logically adapted to the different conditions of the site, has been designed for the Stop Lock at Lock No. 16. In this building it is planned to install the original hoisting machinery from Dam No. 4, the later being outside the present program. Thus the old equipment will be both preserved and also used in a practical demonstration of considerable historical interest. The building is to be covered with well weathered siding taken from another Canal building, of no particular significance, and will therefore start with an appearance of mellow age.

Photograph 20: Stop Lock above Lock No. 16, showing the abutments and the new concrete core wall covering the old masonry core at the Berm, or east end.

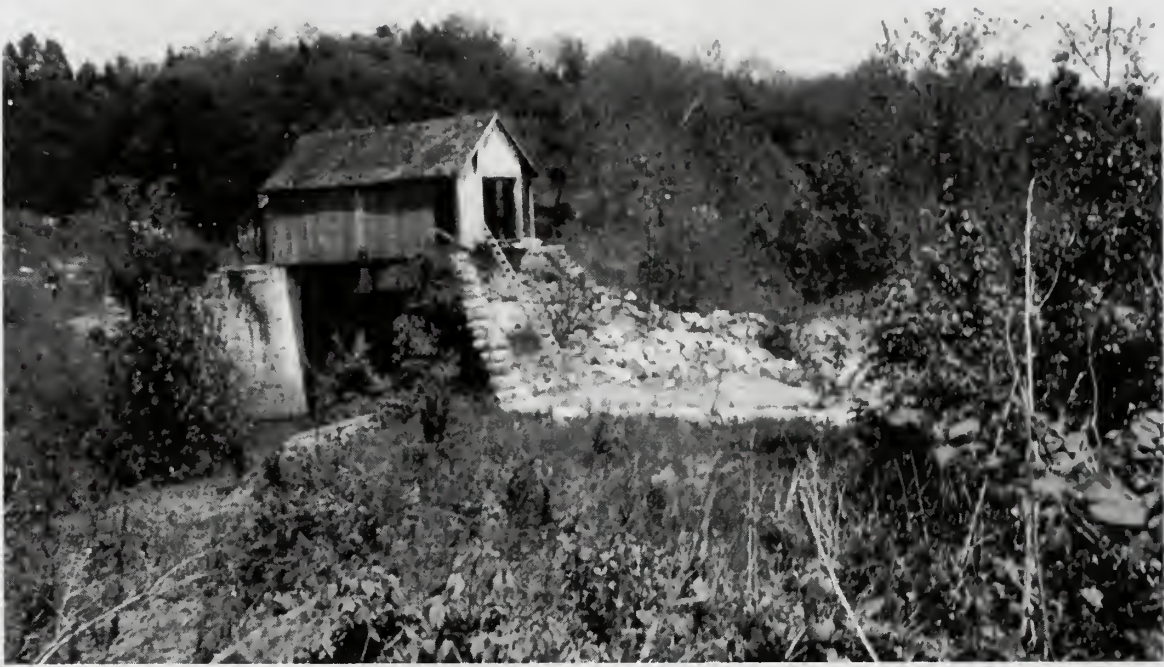
Photograph 21: Stop Lock and building at Dam No. 4 below Williamsport, Maryland. It is reported that in the great flood of 1936, that destroyed this section of the dam, this little building was submerged to within eighteen inches of its ridge and survived. The girders forming the temporary dam between the stop lock abutments can be seen in place, below the building.

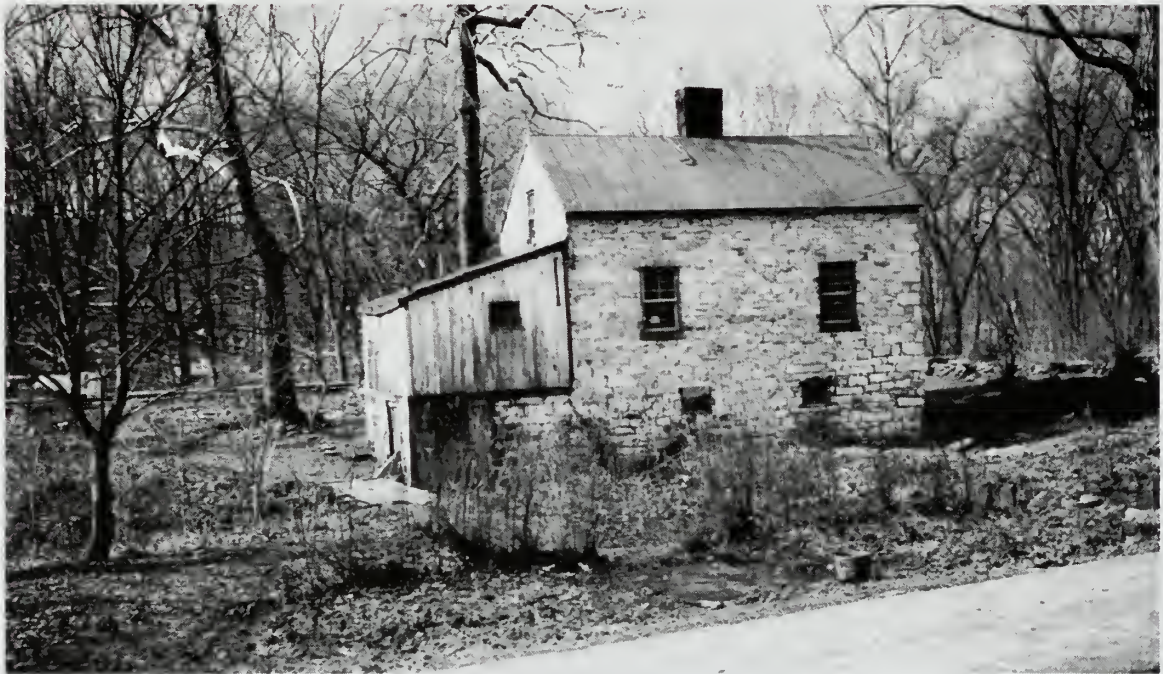
At Lock No. 6 is the first of the typical stone houses built from the specifications laid down by the Canal directorate in 1828. It is interesting to note that these houses were expected to cost, under contract, about \$700 each, and most of them were completed at about that figure. The records show that this house, built in 1848, was the second on this site, the first one having been so seriously damaged by flood in October 1847, that it was considered cheaper to build anew than to repair. Here, as elsewhere, slight individual variations from type appear, caused by small differences in conditions. In this case variation is in the projecting side walls at the south end to form the foundations for a wooden kitchen. This building is sound and in usable condition.

Photograph 28: House at Lock No. 6 has kitchen built partly on projecting stone walls. The line of the lock appears in the background. This photograph shows excellently the texture of the old masonry as well as the adaptation of the specified type to differing conditions of site.

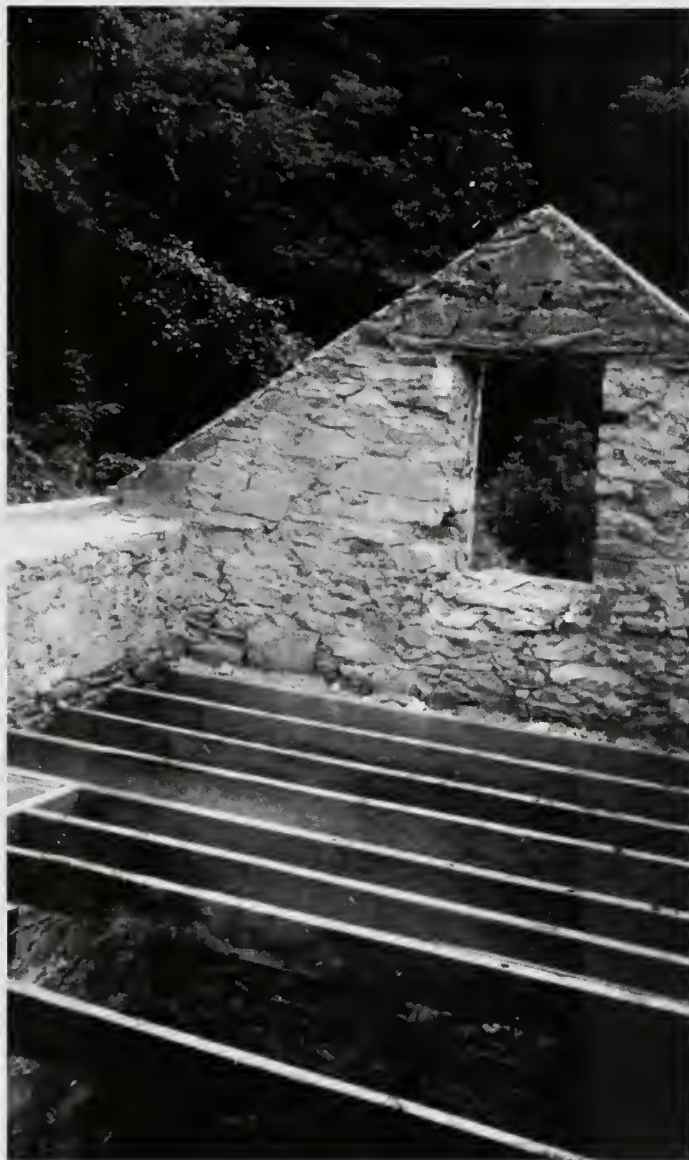
Photograph 30: The masonry of house at Lock No. 7. This shows the plate resting on the stone wall without the wooden grounds called for by the specifications; also the joists are built into the masonry.

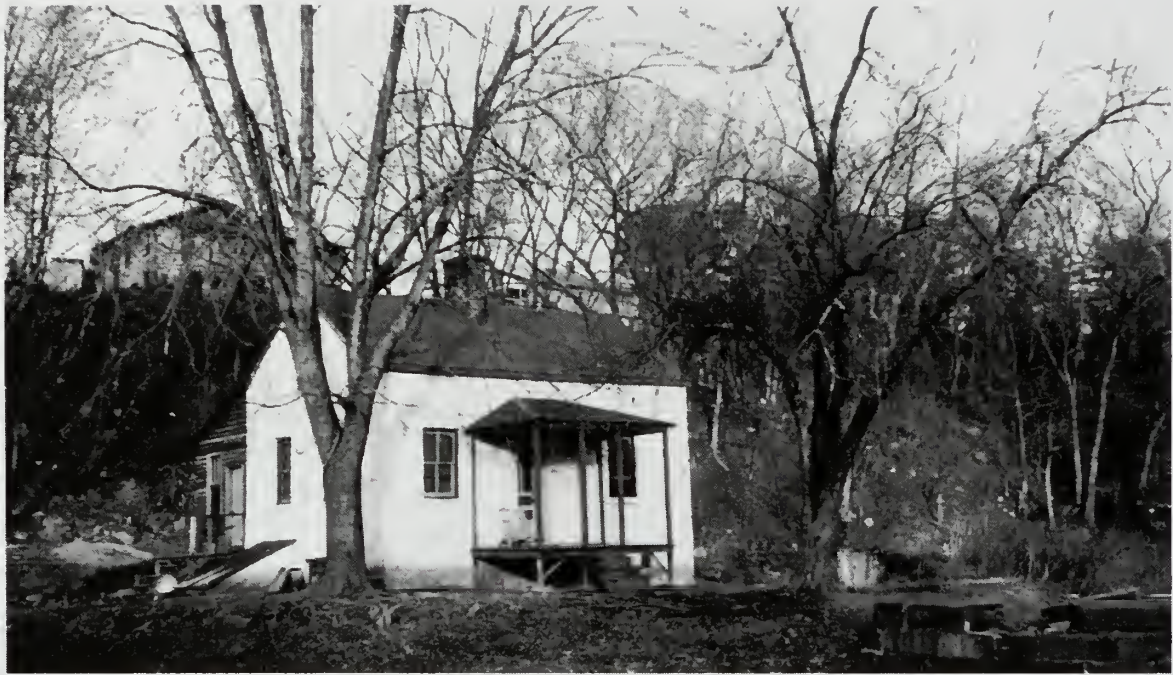
At Lock No. 8 is another stone house of the usual type, still usable in the condition to which it was brought by the repairs authorized in 1868.

Photograph 31: House at Lock No. 8. Lock wall in foreground at right. The walls of all the houses are to be whitewashed as in this case. In most instances the lock houses are flanked by a pair of fine trees, here maples.

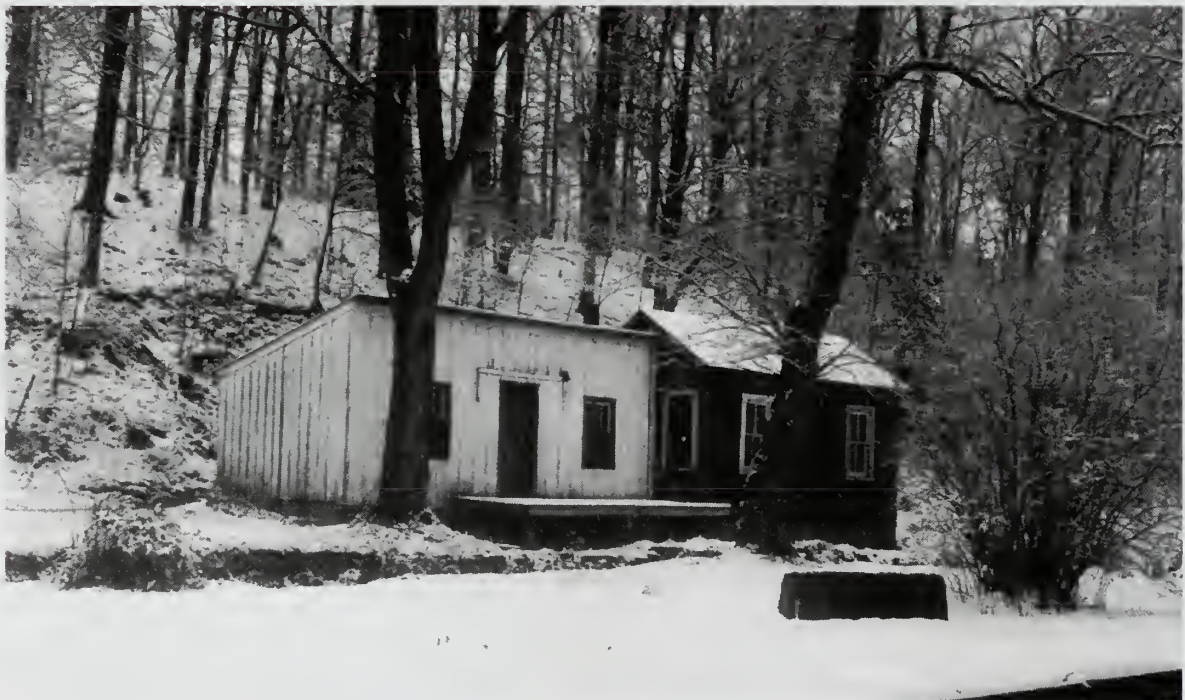
The building at Lock No. 9 is a light wooden structure erected on stone foundations. There is no record of its history, and it seems to be of comparatively recent date, with an even later addition. It is hardly usable without repairs.

Photograph 32: House at Lock No. 9. This building is a piece-meal structure of uncertain date, hardly usable in its present state, except for the new, shingled addition.

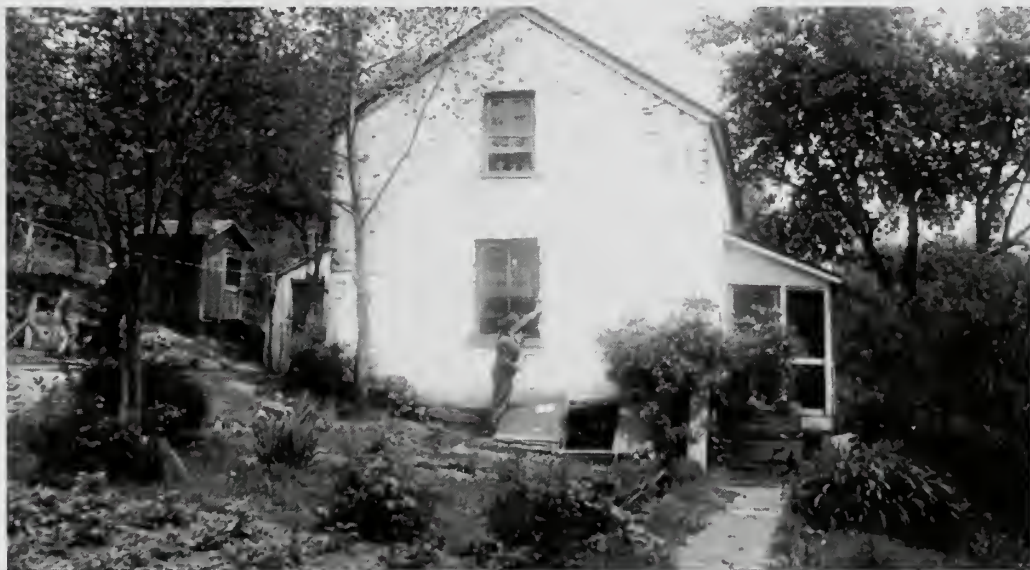
Photograph 34: The same house, showing bulkhead entrance to cellar, typical whitewashed masonry and the corner of the wooden kitchen addition. This building is being restored in the same manner as the houses at Locks No. 7 and No. 5.

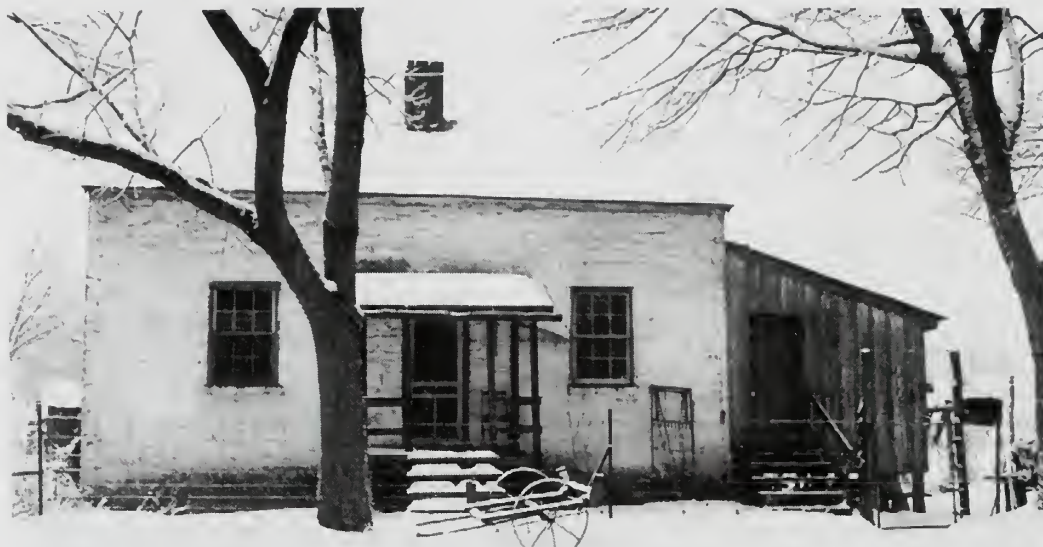
Photograph 35: House at Lock No. 11. This house on the towpath side has a small shed addition; it is in fair condition, and will continue in use as it is.

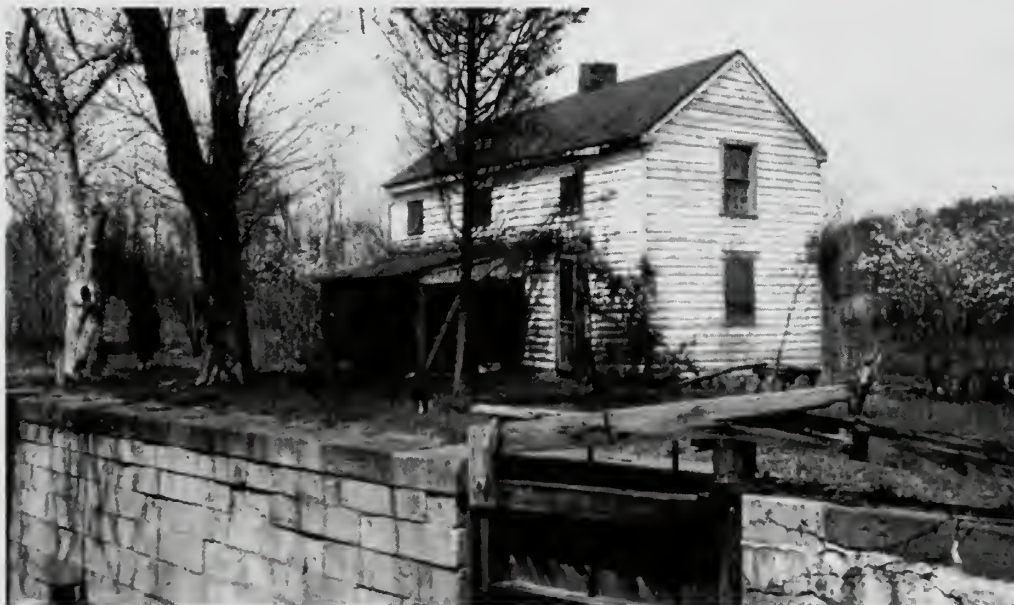
The house at Lock No. 12 is a departure from type, being a frame building on shallow stone foundations, and a little larger than the earlier houses. It is in poor condition and, if ever needed in the operation of the Canal, it will have to be entirely rebuilt.

Photograph 36: House at Lock No. 12. A frame building differing from the established type. There are only shallow foundations, no cellar. If the building is to be used it virtually will have to be rebuilt. The lock wall appears in foreground.

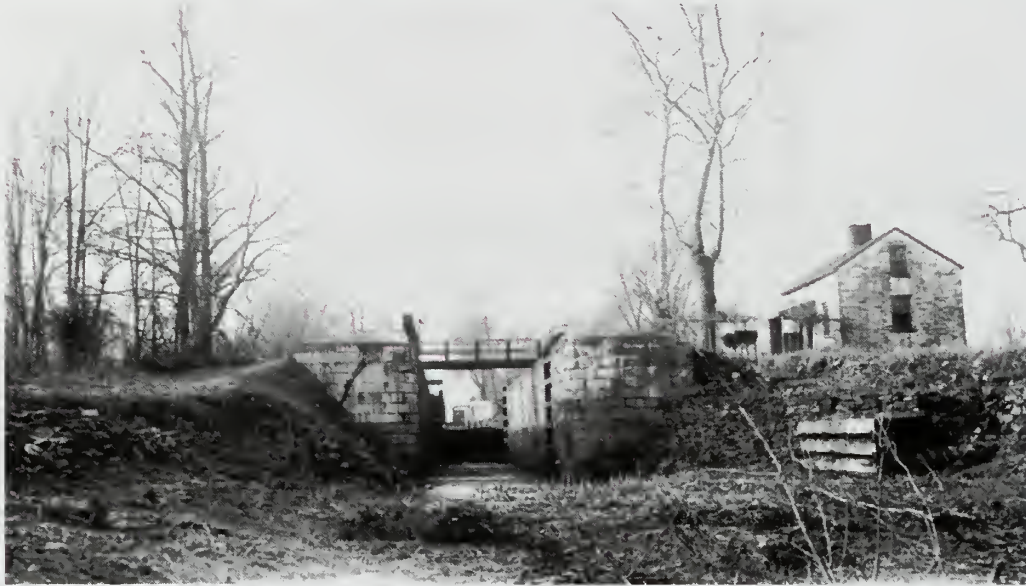
At Lock No. 13 stands another typical stone house, in fair condition. No work has been done.

Photograph 37: House at Lock No. 13 shown in relation to the Lock. As both gates are open, Lock No. 14 can be seen in the background. The house is in usable condition and continues to serve.

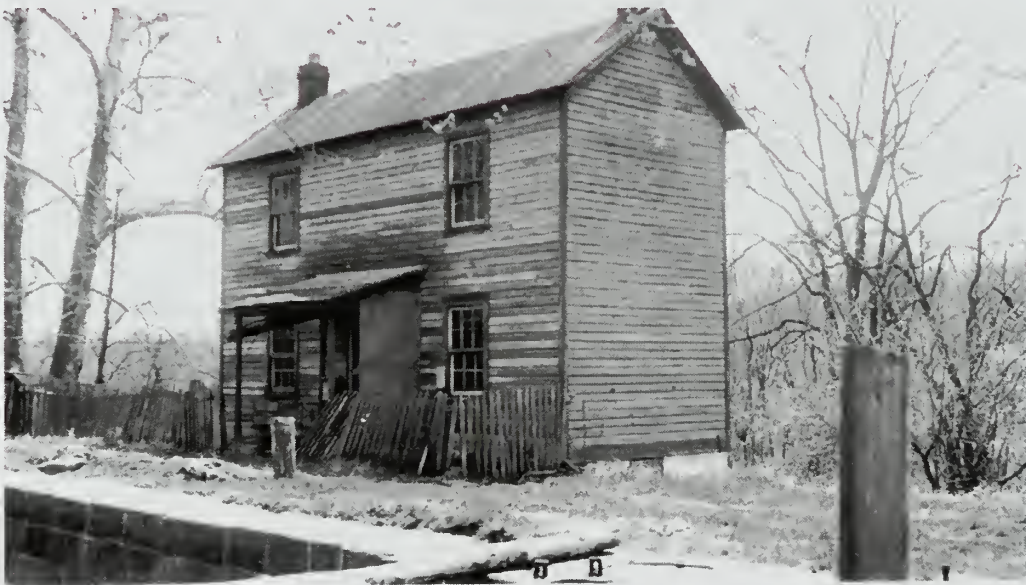
Another typical house is at Lock No. 14. On characteristic stone foundations with concrete additions of later date the frame building is hardly in condition for use, but no work is contemplated on it.

Photograph 38: House at Lock No. 14. A departure from type. Frame structure on the towpath side. Substantial repairs will be needed here if this house is to be used.

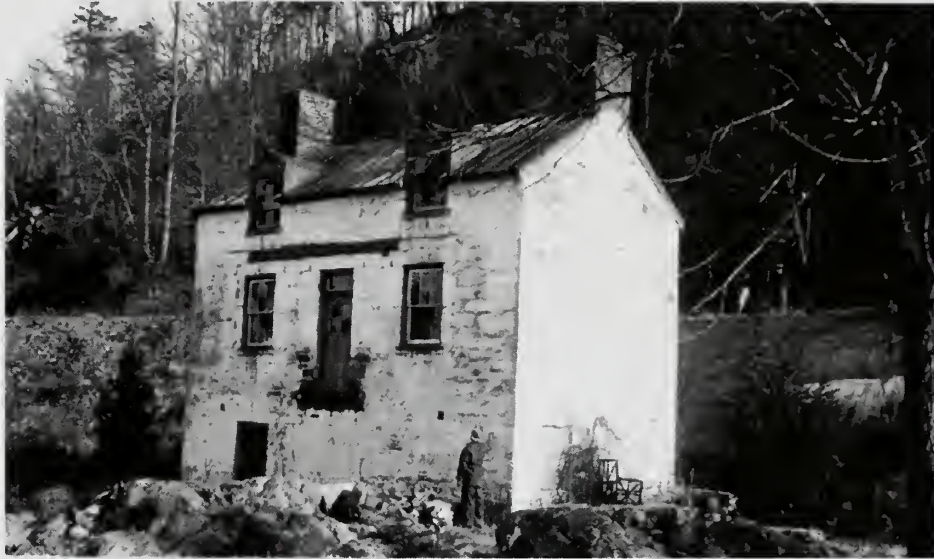
On a rocky ledge overhanging Lock No. 16 is a stone house having two stories and an attic with dormers, and a chimney at each end. This was built from a second specification, adopted in 1836. The building is in sound condition, being out of reach of all but the highest floods, but considerable work would be required to render it habitable.

Photograph 39: House at Lock No. 16. The first house built from the second or 1836 specifications. It stands on a rock ledge well above the lock. This building cannot be used without considerable reconstruction of the interior.

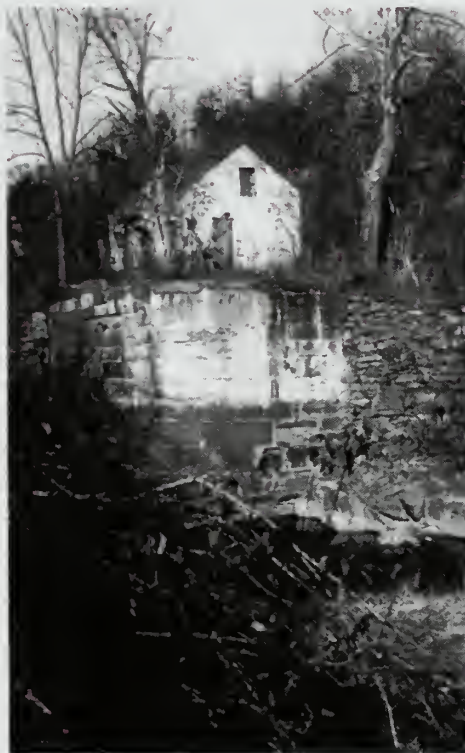
The walls of another stone house stand at Lock No. 18. This structure was gutted by fire not many years ago, but the standing masonry walls are a picturesque ruin, and will be preserved in this condition.

Photograph 42: House at Lock 18. Gutted by fire; will be kept in this condition. Lower end of the lock walls in foreground.

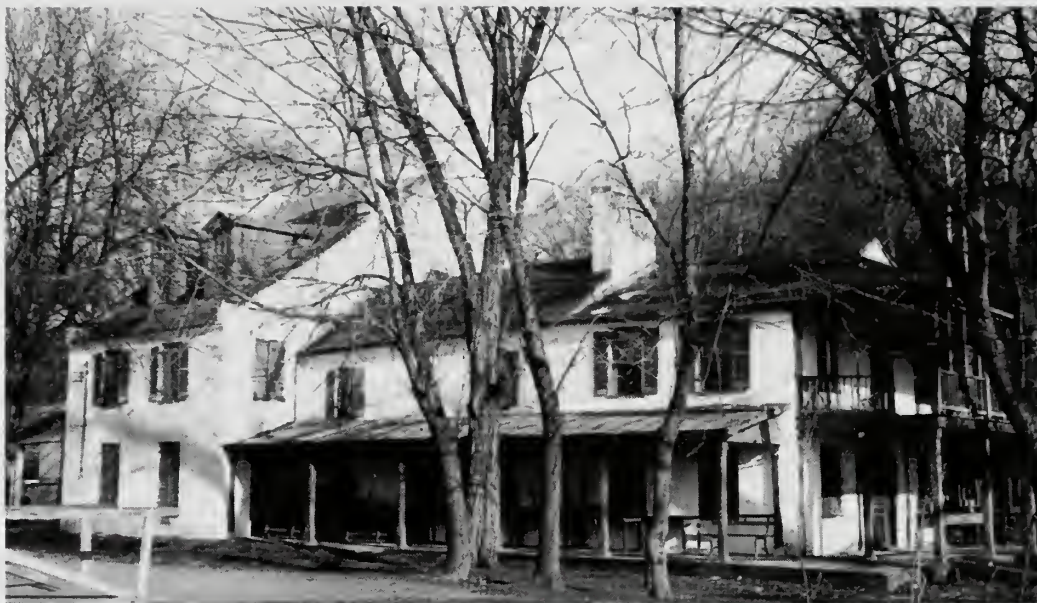
Photograph 45: Tavern from the southwest. Part of this brick addition of 1832 is in bad condition and repairs are to be made. This tavern has served its purpose almost continuously for more than a century, operated by the members of one family since the Civil War.

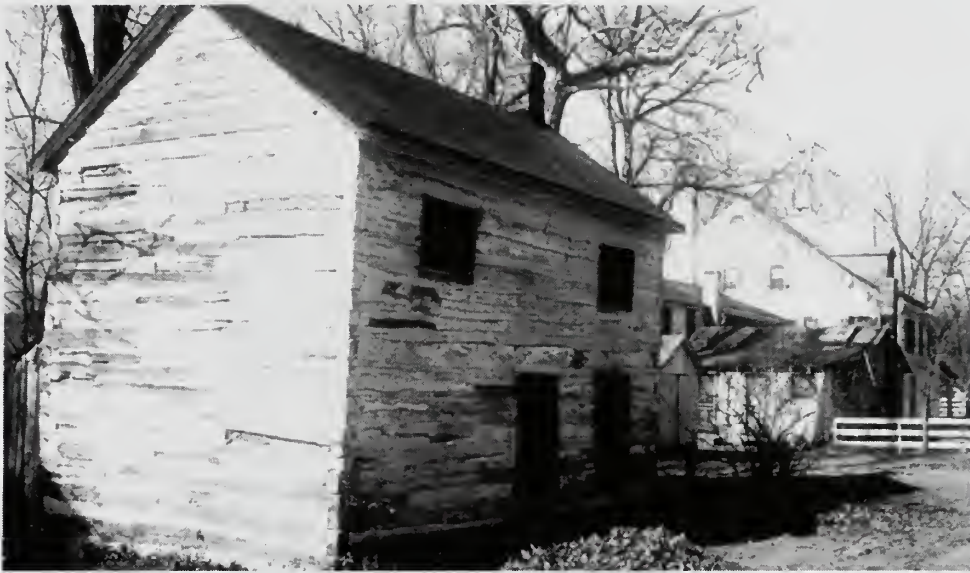
Near the Tavern stands a log house built about 1884 and used since as a tender's dwelling. This small building is being put into good condition and will continue to serve its original purpose. It is interesting to note that the occupant of the log structure considers it most comfortable, as the thick logs keep it cool in summer and warm in winter.

Photograph 47: The Log House south of Tavern, built of hewn logs about 1884. This is to be repaired for use as a Lock Tender's House. It is described by those who live in it as particularly cool in summer and warm in winter.

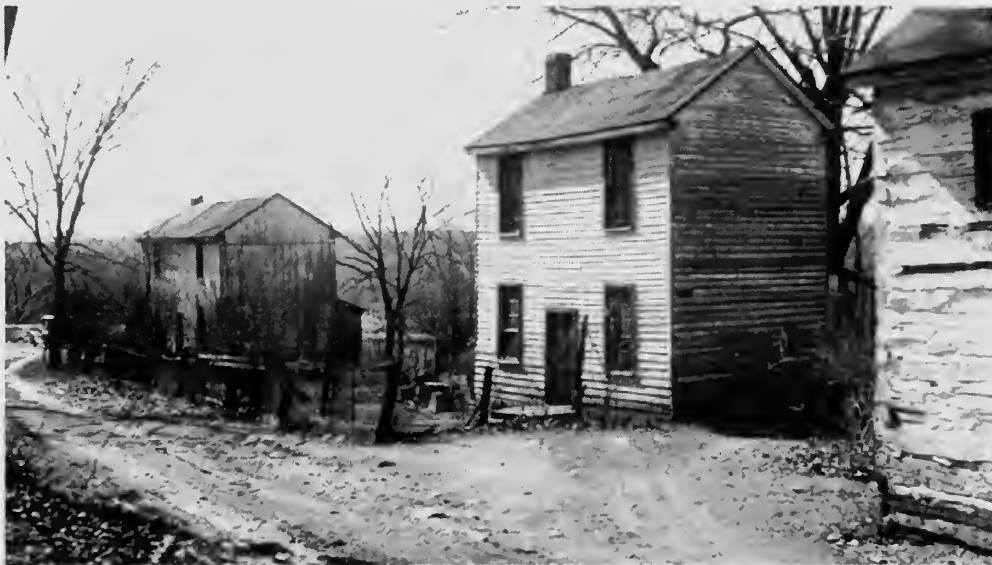
Photograph 48: A corner of the Log House in foreground and beyond it frame Houses No. 1 and 2, built about the same time. They are of little value and will probably be demolished and the material salvaged for use elsewhere on the canal.

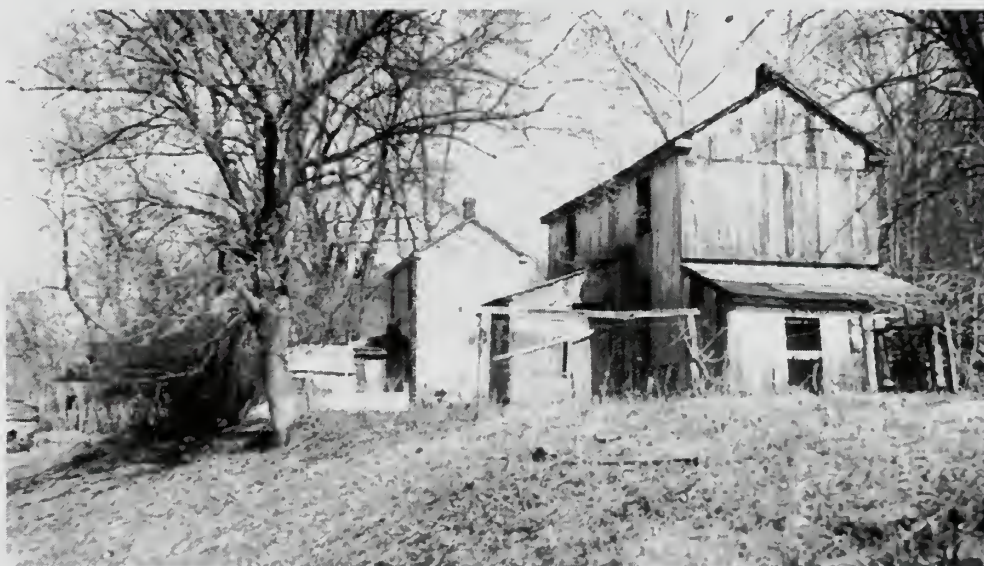
Photograph 50: Frame House No. 2 at Great Falls, from the Canal bank. Some of the material in these buildings will be salvaged for use. The siding from this house will probably be used on the structure at the stop lock above Lock No. 16.

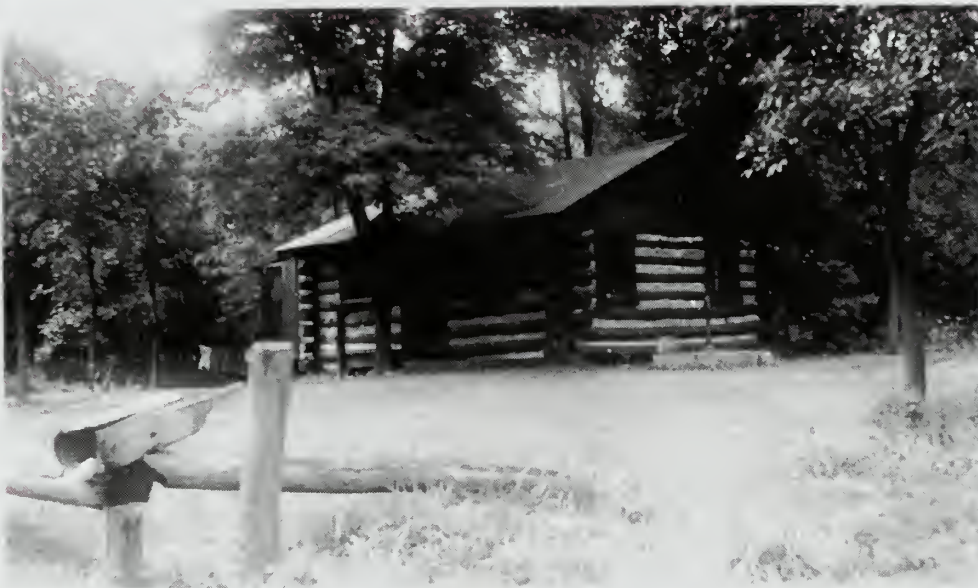
Photograph 52: New log house on foundations of Lock Tender's house at No. 23, burned a few years ago. Although the building is out of character with the other Canal structures it will continue in use.

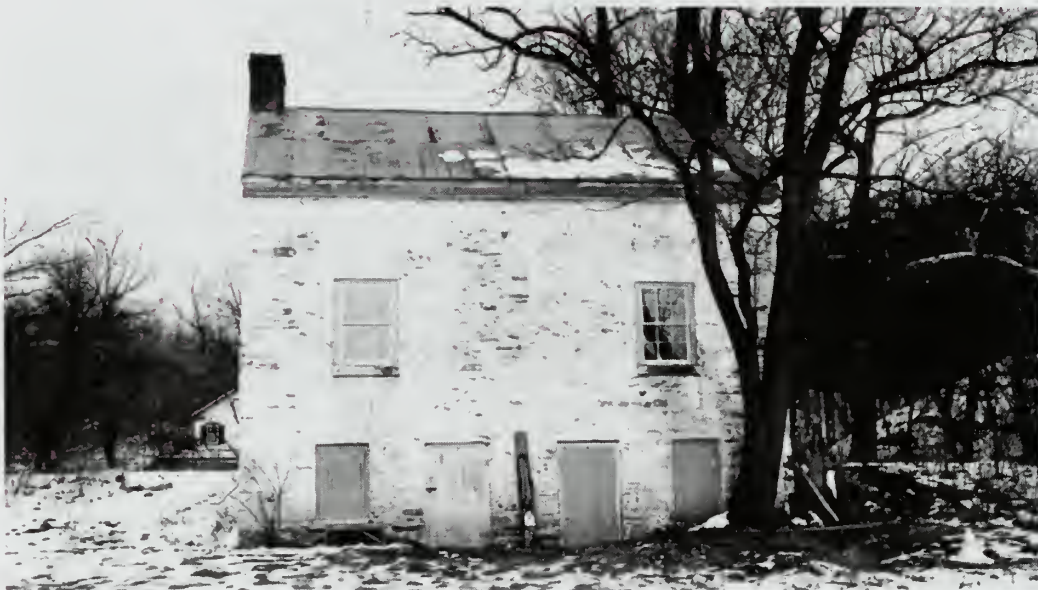
Lock No. 22 has a house of the type built from the 1836 specification, in good condition and needing little or no repair work.

Photograph 54: Standing on sloping ground the house has another full story at the rear. This building is in good condition and can be used as is.
