A Report on the Structural Issues at

Fort Sumter National Monument

Charleston, South Carolina

Wednesday, July 8, 2009

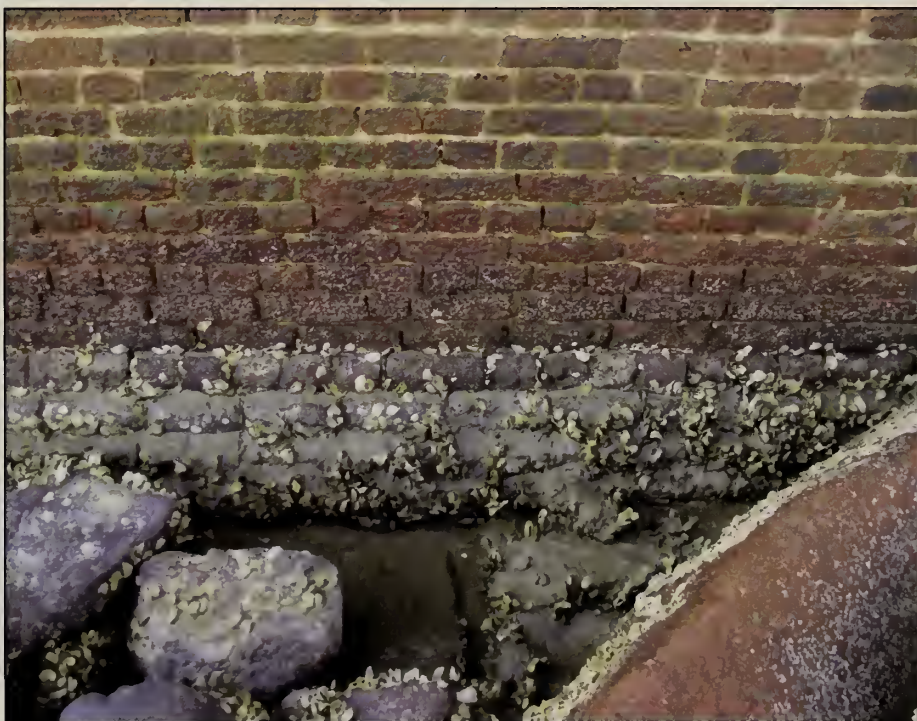
Erosion along the exterior scarp wall varies across the fort. Along the base of the wall, uniform softening and erosion of mortar has occurred below the high water mark (Fig. 3). Erosion is worst where granite revetment blocks rest against the wall (Fig. 4). Above the high water mark, erosion of the face of the wall was most severe on the Salient, Right Face, and Right Flank which face the shipping channel (Fig. 5-6). In some locations, previous repointing with Portland cement has helped to accelerate the loss of the brick face (Fig. 7). Loose bricks along the cornice were also noted along the exterior (Fig. 8).

Severe erosion has also occurred at the base of the wall, where continued exposure to water has eroded the mortar (Fig. 3). In locations where the granite blocks of the revetment touch the brick wall, erosion has been accelerated (Fig. 4). The granite affects the flow of water around the stone, causing excess friction against the brick wall. Mechanical erosion caused by small movements of the blocks as the tide flows in and out could also contribute to the heavier areas of damage. These two factors would account for the large discrepancy in the speed of brick and mortar erosion in these locations versus areas where the granite does not touch the bricks. Furthermore, the granite blocks make it difficult to repair the bottom portion of the wall, so erosion has never been slowed by repointing.

FIGURE 3: Erosion of mortar below high water mark, Left Face, March 2009

Mortar repointing and replacement of severely deteriorated or missing bricks should be conducted along the exterior wall. Granite blocks along the revetment that touch the exterior wall and increase erosion of the bricks should be permanently moved away from the wall, but should remain part of the revetment. Blocks that prevent repair to the base of the wall should be moved back from the scarp while repairs are conducted. These can be placed back in their original locations once repairs are completed, or they may be rearranged to facilitate future repairs.

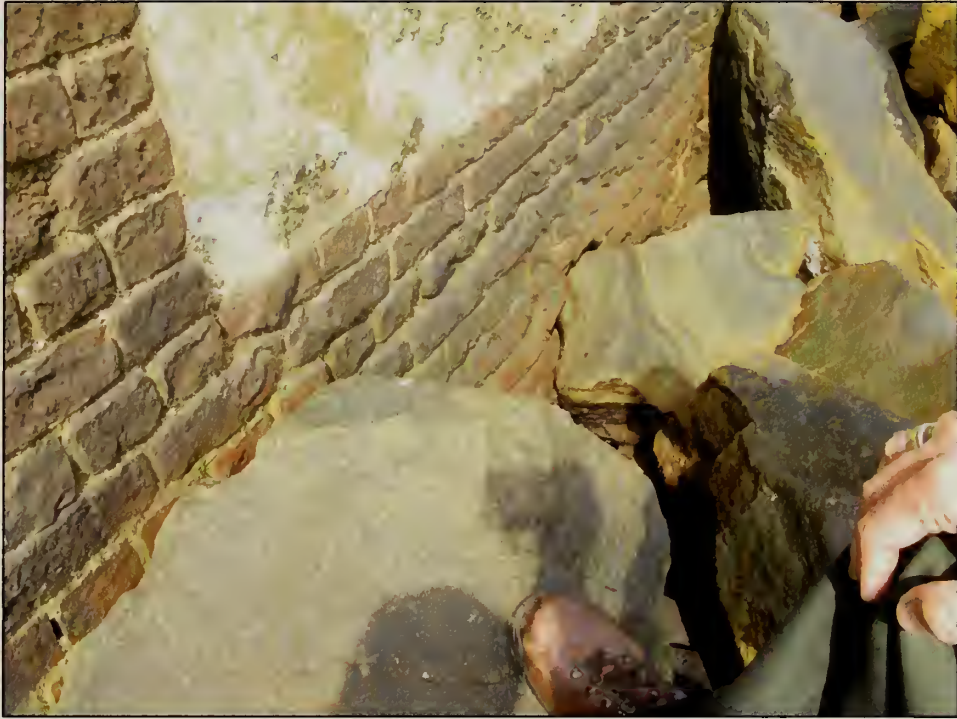
FIGURE 4: Accelerated erosion around granite blocks, Right Face, March 2009

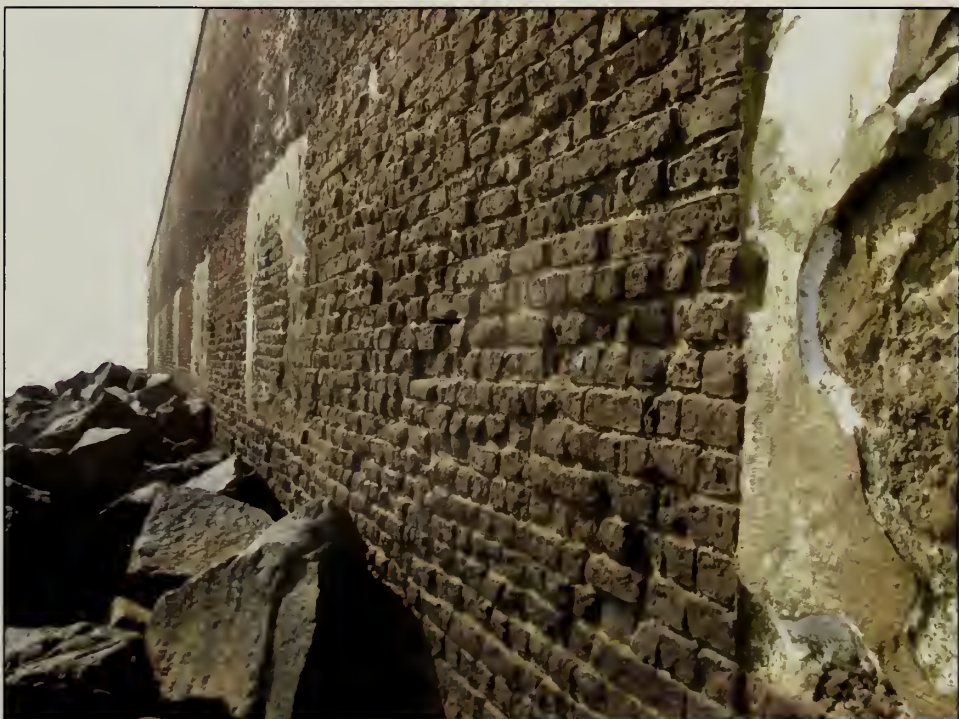
Erosion of mortar and the outer wythe of bricks is a threat to the long term health of Fort Sumter. This erosion has been caused by sand and other debris carried by wind and water. The subsequent damage to the surface allows for the introduction of excess water and chlorides to the inner wall, eventually weakening the wall and leading to structural distress. In several places, mortar that was too strong has accelerated the erosion of the face of the brick (Fig. 7). In other places, mortar that was too soft has disintegrated, leaving large holes between bricks, compromising the structural integrity of the outer skin of bricks and allowing water behind it (Fig. 6).

FIGURE 5: Erosion of wall surface, Right Face, March 2009

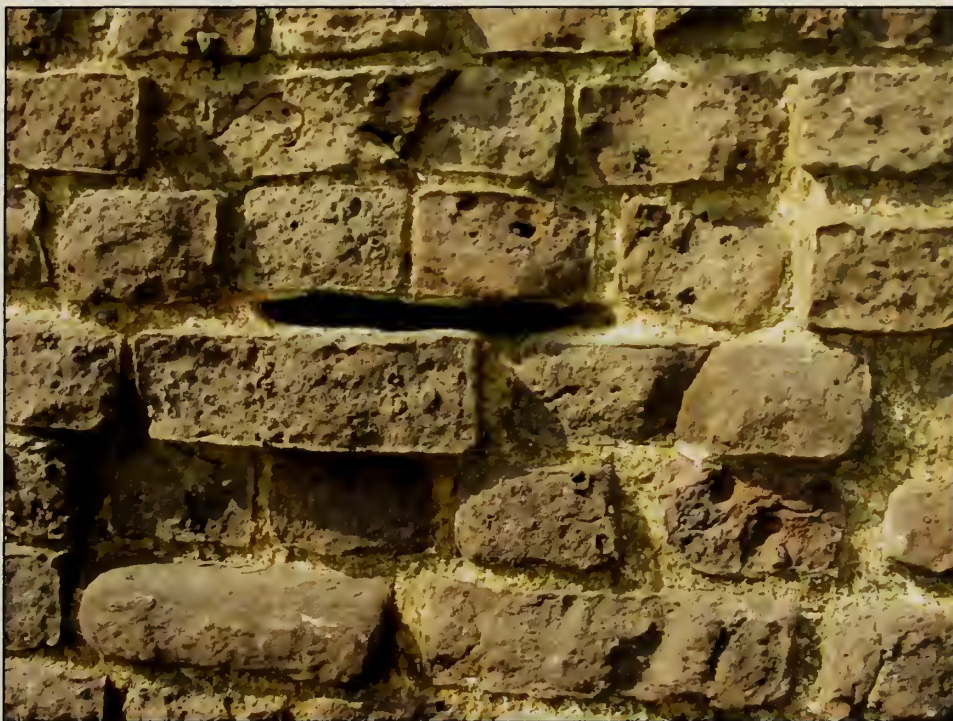
FIGURE 6: Erosion of wall surface and mortar, Right Face, March 2009

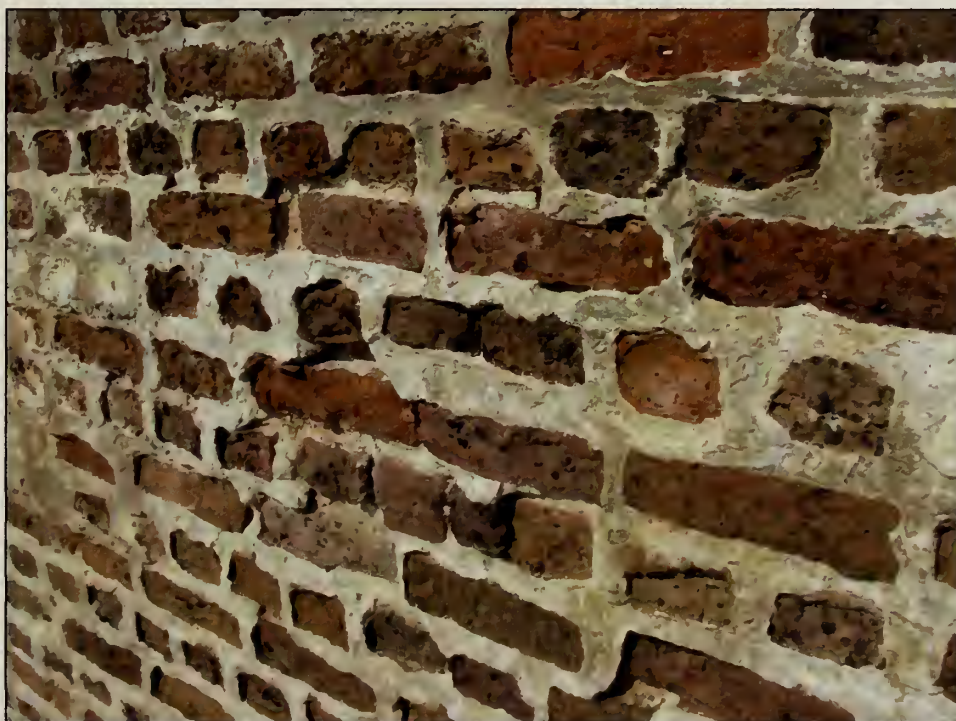
FIGURE 7: Portland cement used for repointing, Right Flank, March 2009

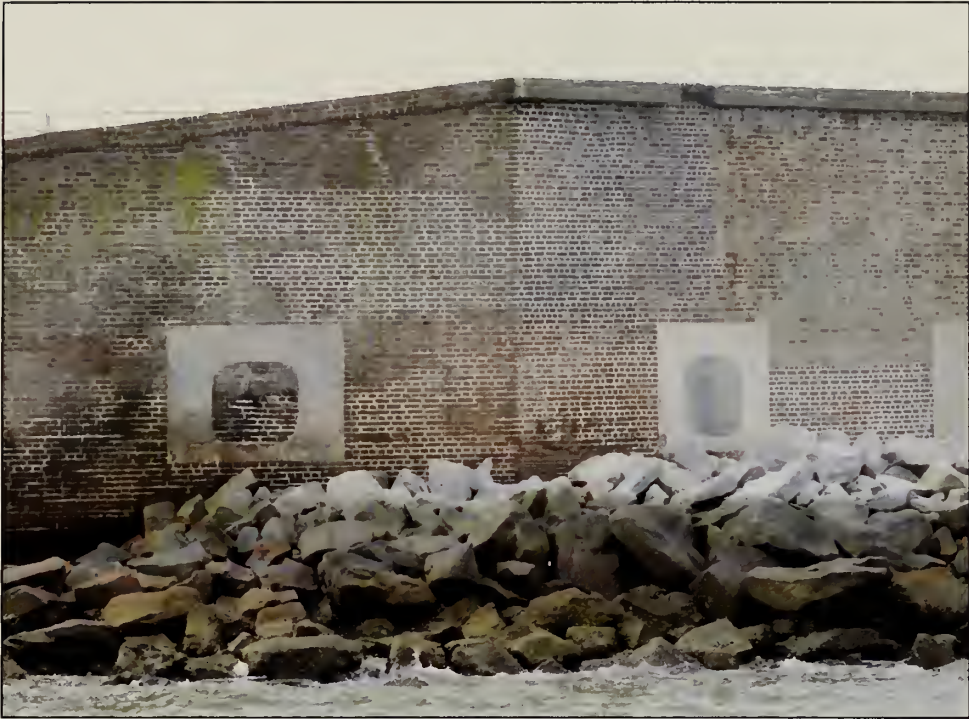
Also noted during the course of this inspection were two issues that present safety concerns. Loose bricks along the edges of broken vaults, arches, and the cornice could fall, injuring a visitor or employee (Fig. 8, 29). Also, severe cracks in the concrete over the cistern near the Left Face indicate that there is the possibility of localized catastrophic failure (Fig. 30). Visitors are currently allowed to walk over and stand on this cistern.

Loose bricks in several locations throughout the fort present a threat to life safety. The broken vaults along the Left Face are prime locations for this problem. The cornice also shows signs of distress in many locations. Though visitors are not allowed on the revetment, employees and workers hired to repair damage on the wall will be subjected to the danger from falling bricks. The cistern also shows signs of failure and potential collapse.

FIGURE 8: Loose section of parapet/cornice, Left Flank, March 2009

Of utmost concern are any elements that compromise life safety at the fort. We recommend that all bricks held in place only by tension stress in the mortar be checked for a tight bond to the substrate. All loose bricks should be carefully removed and stored for use in future repair work. Any cracks through the cornice or around single or small groups of bricks should be monitored for loosening. We also recommend that the cistern near the Left Face be blocked off so that visitors cannot stand on the concrete in that area until it has been examined and either deemed safe or repaired.

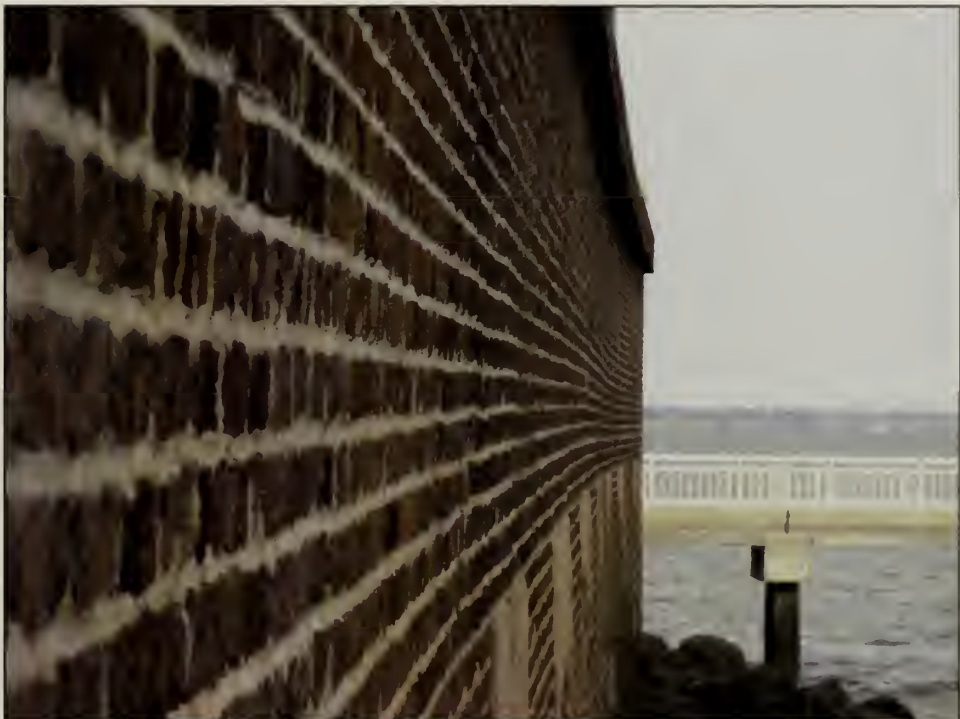
To varying degrees, it appears that the long walls of the fort bow outwards as they approach the shoulders, gorges, and Salient. This is clearly discernible in Figures 9 through 12. If the wall were in plane, the mortar lines could be traced along a straight line. In these photographs, there is an obvious curvature of the mortar lines between courses of brick, indicating that the walls themselves are bowing along that arc.

The bowing of the walls visible on the exterior of the fort appears to be the result of the unresisted thrust of the arcades along the interior, and is exacerbated by moisture-fueled brick expansion. As each arcade reaches its end at each of the fort's shoulders, the thrust is not adequately counteracted, and therefore pushes the walls outward and breaks the arches near the ends. The cracks along the exterior walls are seen mostly at the ends of the walls, which is further indication that the arcades are the cause of distress. In addition, newer bricks in areas of reconstruction (Fig. 31-32) may cause damage through differential expansion, as these sections would behave slightly differently than the older brick. Other cracks may be caused by interior drainage elements, stress from expanding brick and deteriorated mortar, or weight from the earth on the interior of the fort along the Right Flank and Right Gorge.

FIGURE 9: Bowing, Left Face, March 2009

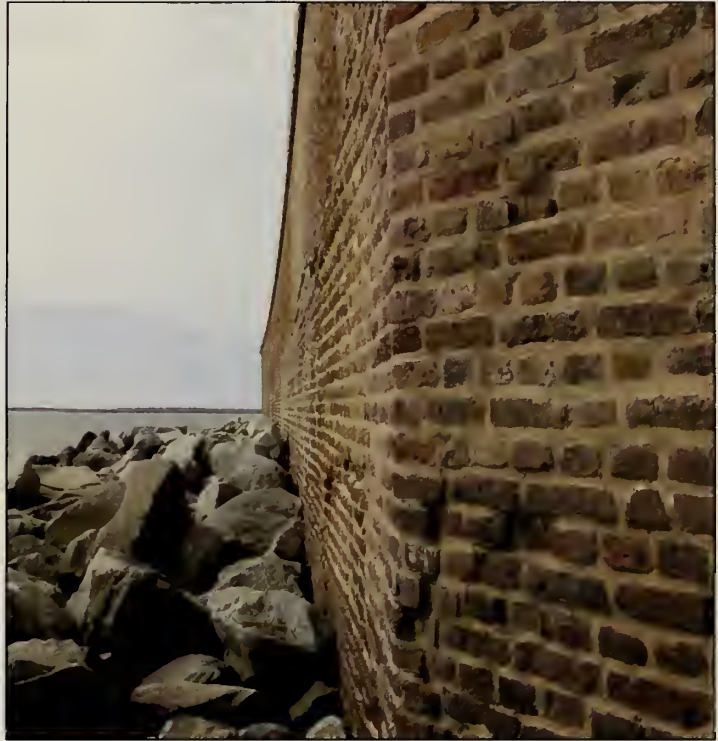
FIGURE 10: Bowing, Right Flank, March 2009

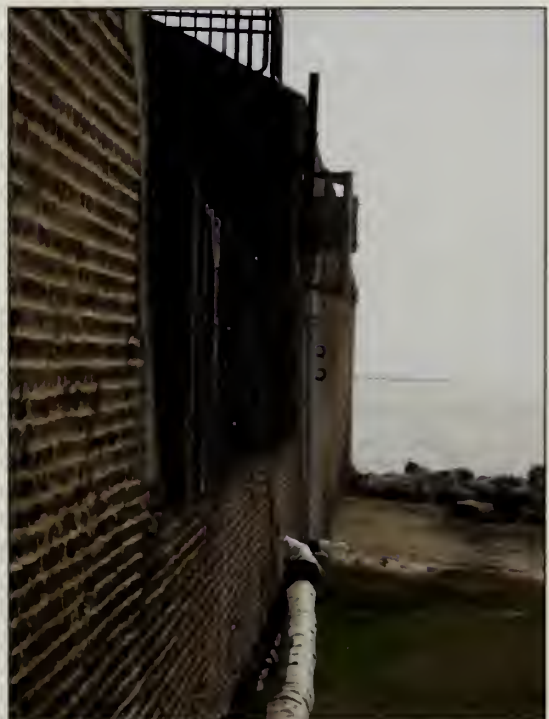
FIGURE 11: Bowing, Gorge Wall, March 2009

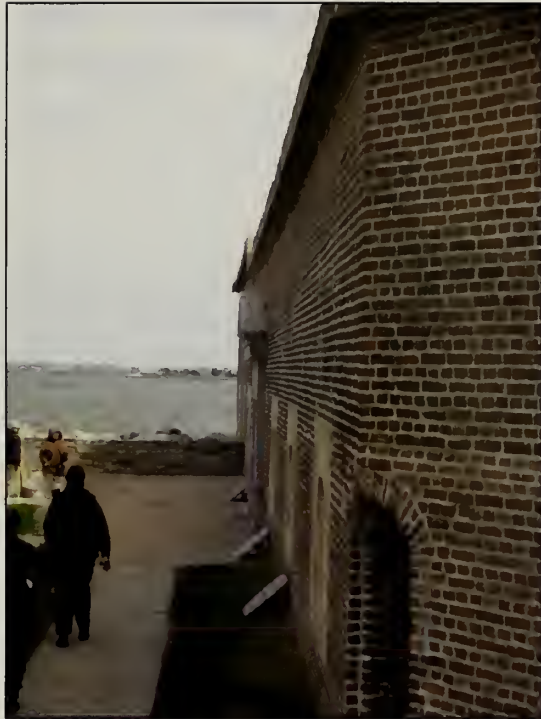
FIGURE 12: Bowing, Left Flank, March 2009

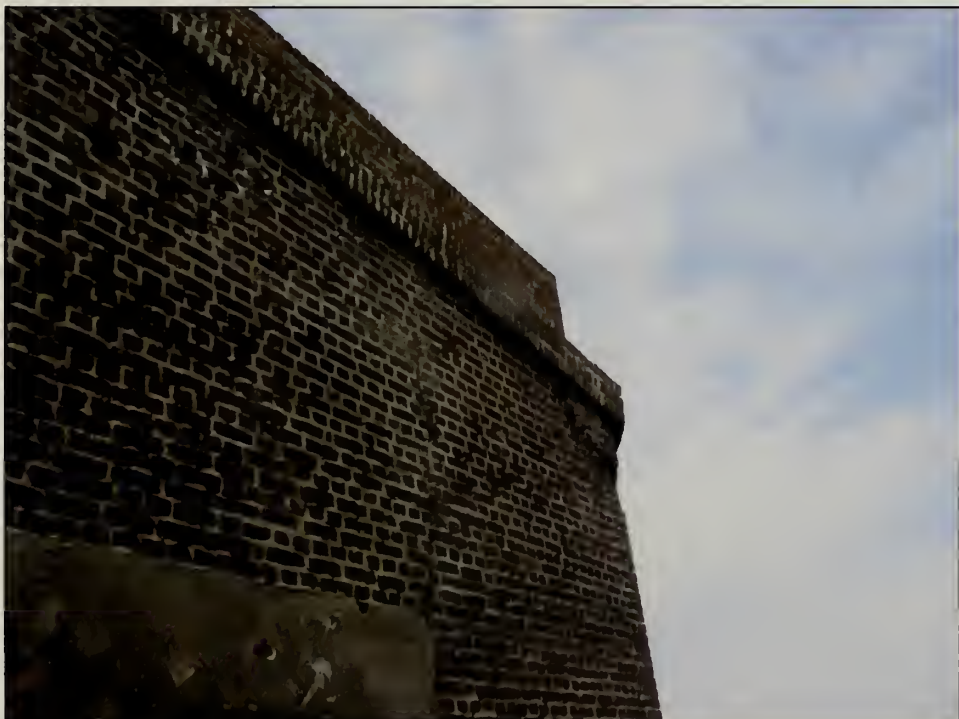
Several masonry cracks were found along the exterior of the fort. The cracks seemed to be focused towards the ends of the long walls and on the shoulders (Fig. 13-18). Several of these cracks extended from the top of the wall to below the revetment. Others started at the top of the wall and stopped at a corner before reaching the base of the wall. The Right Face and Right Flank contained the majority of the cracks noted on this site visit.

FIGURE 13: Masonry cracks, Right Face at Salient, March 2009

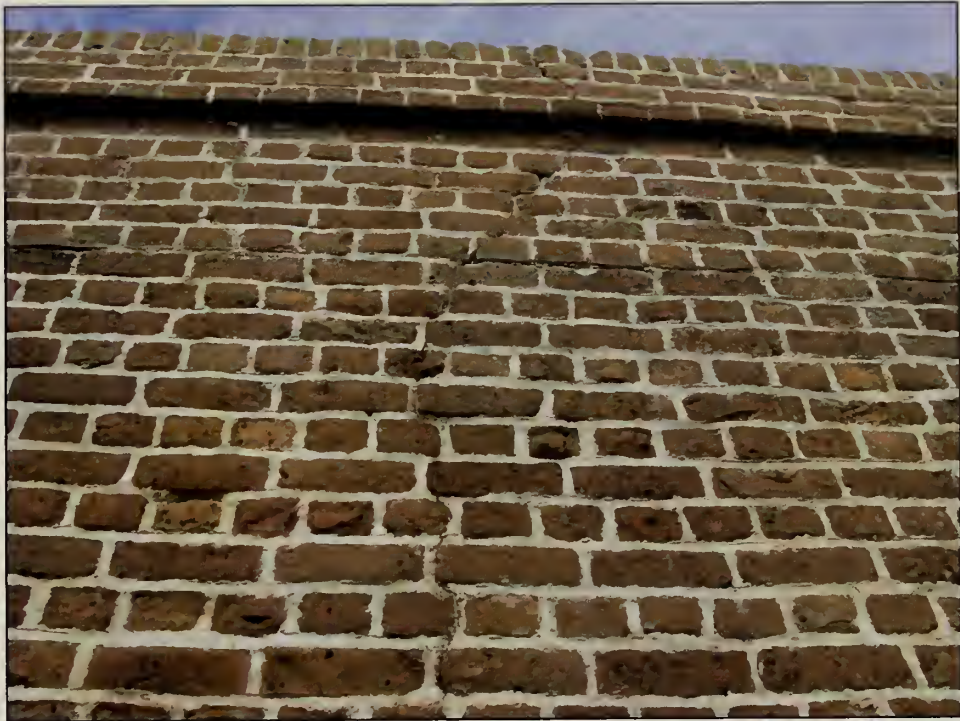
FIGURE 14: Masonry crack, Right Flank, March 2009

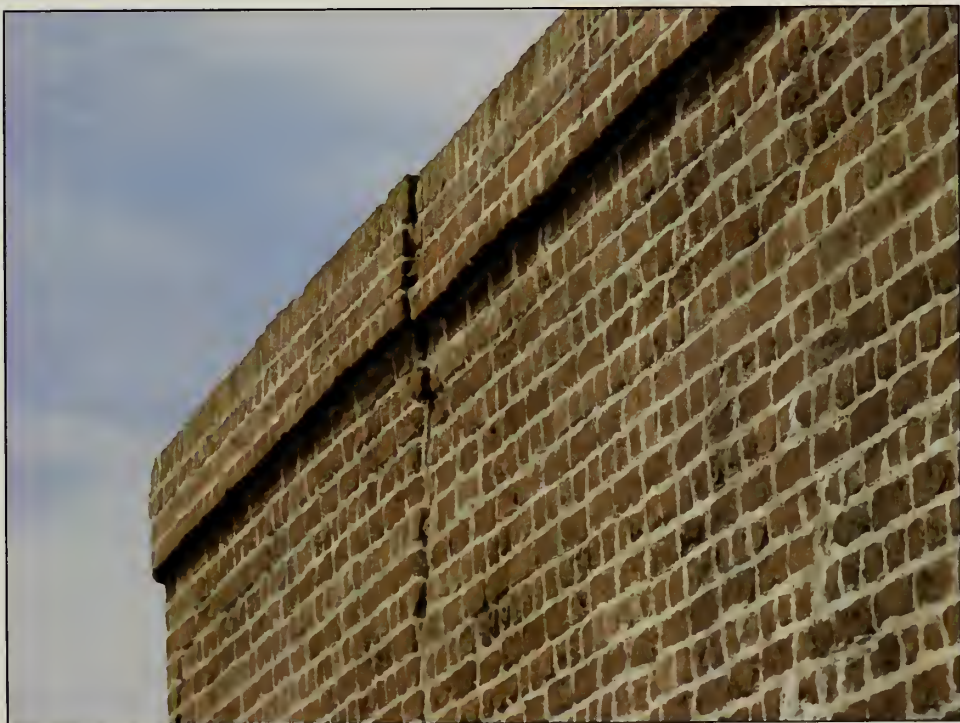
FIGURE 15: Masonry crack, Right Flank at Right Gorge, March 2009

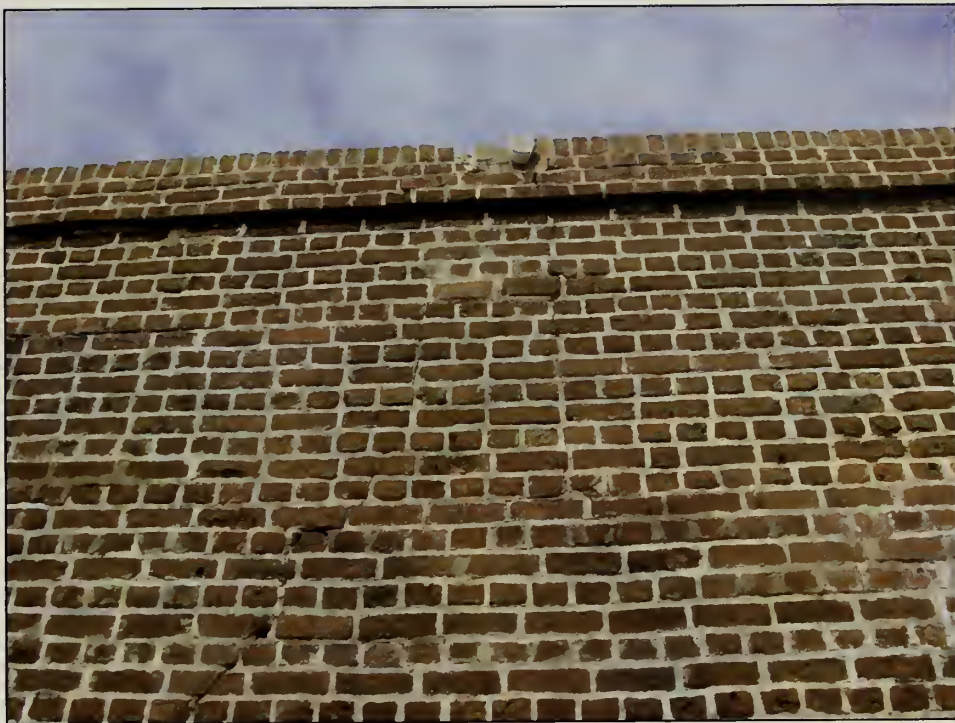
FIGURE 16: Masonry crack, Right Flank, March 2009

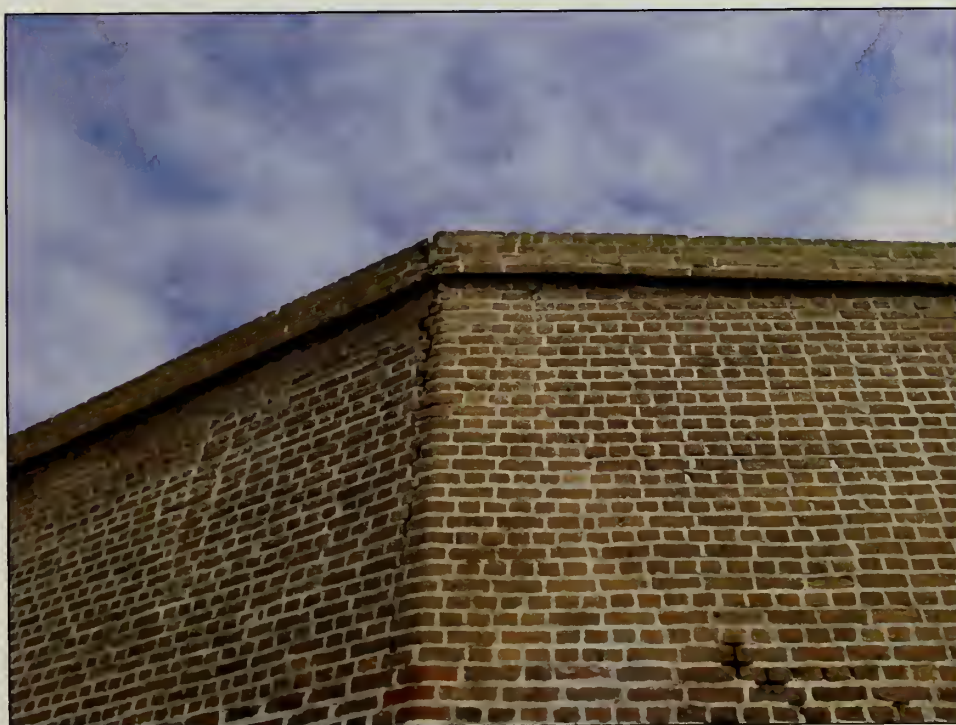
FIGURE 17: Masonry crack, Gorge Wall and Right Gorge, March 2009

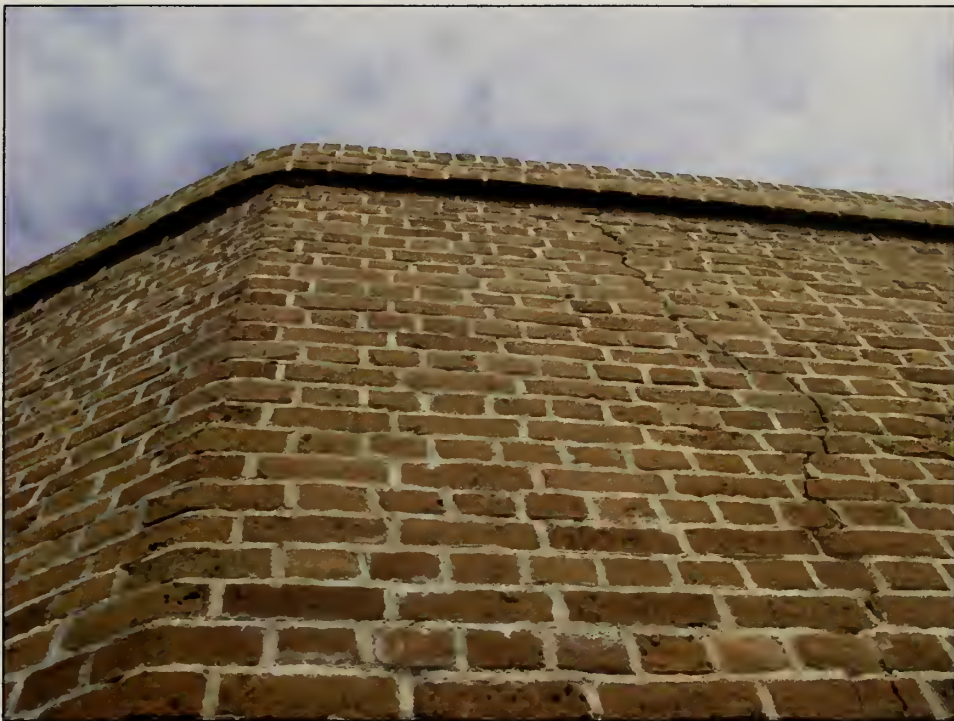
FIGURE 18: Masonry crack, Right Gorge and Right Face, March 2009

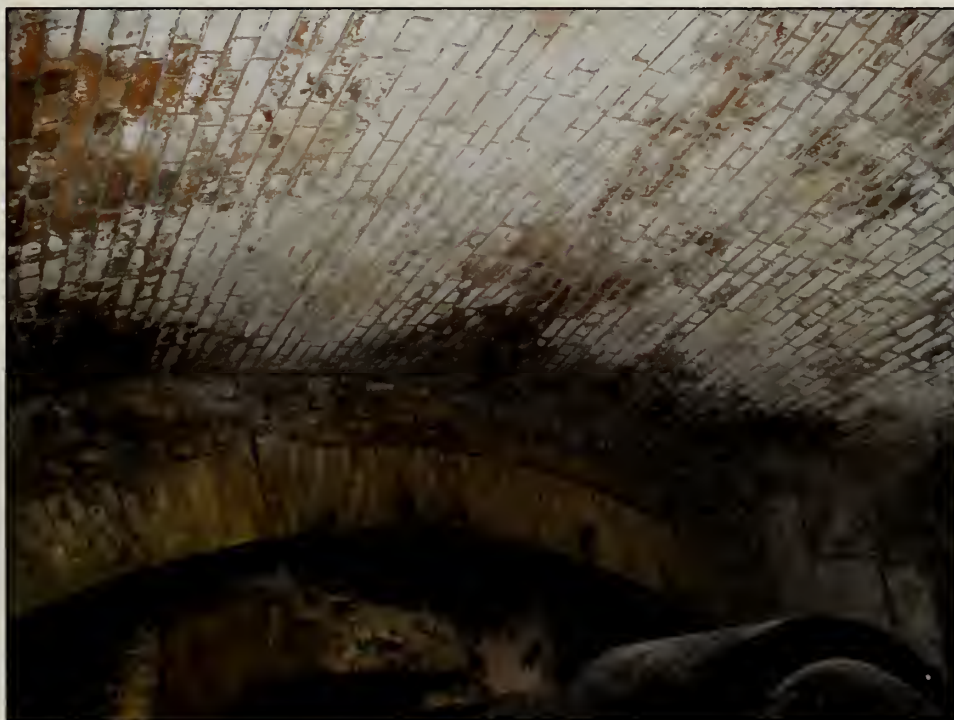
Inside the fort, much of the visible damage consisted of cracked arches and vaults. A number of arches in the arcades are cracked, especially at the ends of each arcade (Fig. 19-20). Many of vault-supporting arches are also cracked; both vertical and horizontal cracks were found in a significant number of these arches (Fig. 21-22). Some of the abutments also showed signs of movement (Fig. 23).

Cracks observed on the interior supporting arches are due to a lack of support: it appears that the piers, abutments, and perimeter walls do not adequately resist thrust. Many of these cracks can be found near the end of arcades or where an arcade has been broken by demolition. One good example of this phenomenon is illustrated by Figure 23. This arch is broken in two locations,

FIGURE 19: Cracks through arch, Right Face arcade, March 2009

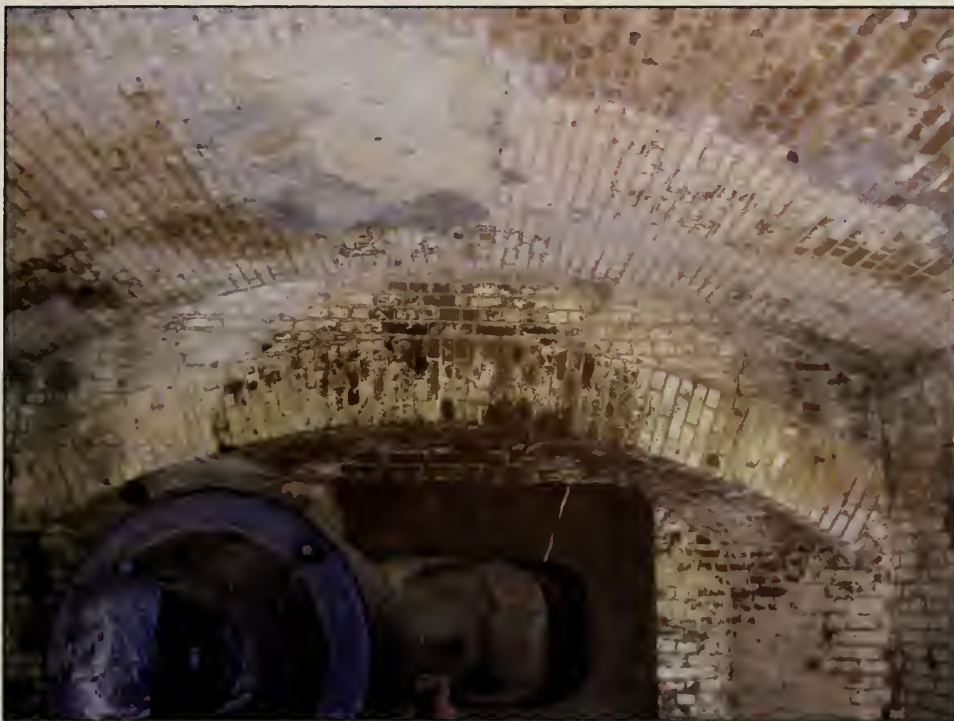
FIGURE 20: Cracks through arch, Right Face arcade, March 2009

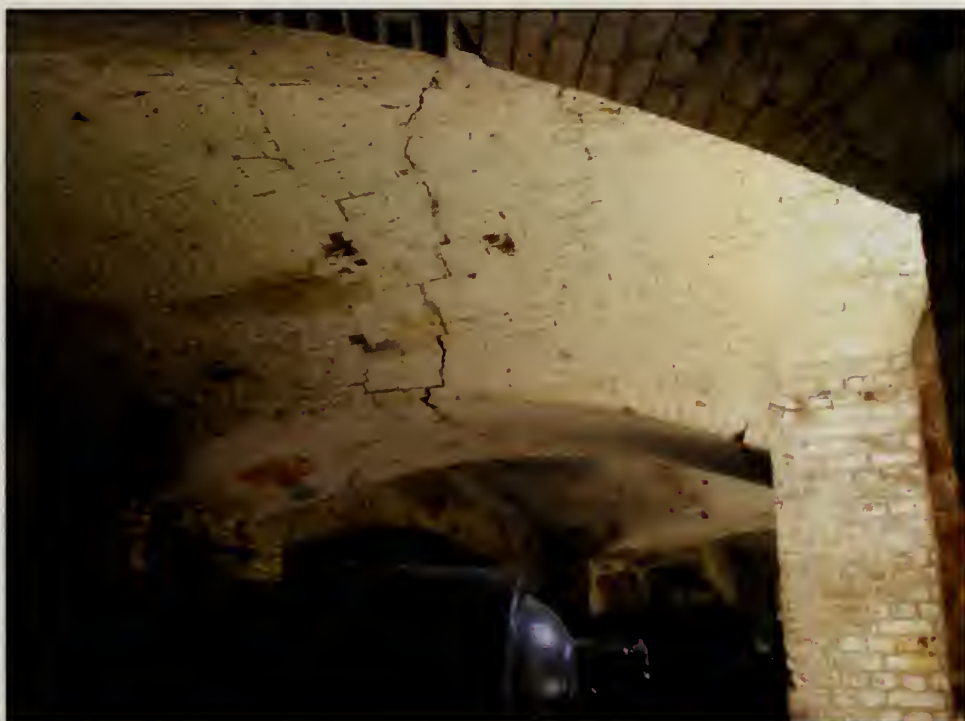
Each of the casement vaults that were examined as a part of this site visit has a crack running perpendicular to its axis (Fig. 21-22, 24-25). The cracks are of varying sizes, and fluctuate in location slightly, but tend to be close to the center of the span of the vault. In one vault along the Right Face, cracks run in both directions, and one section of the vault is dropping below the rest (Fig. 26). Many of the cracks in the vaults have been filled with epoxy and/or mortar (Fig. 24-25). In some locations, the filled crack has reopened or a new crack has formed adjacent to the repair (Fig. 25).

The cracks recorded in the vaults may result from the movement of supports, causing the vaults to act as a beam between the inner and outer arcades rather than transferring load to the single arches at each end of the vaults as designed. Other possible causes include differential settlement or differential expansion of the bricks.

FIGURE 21: Crack running through vault and supporting arch, Right Face, March 2009

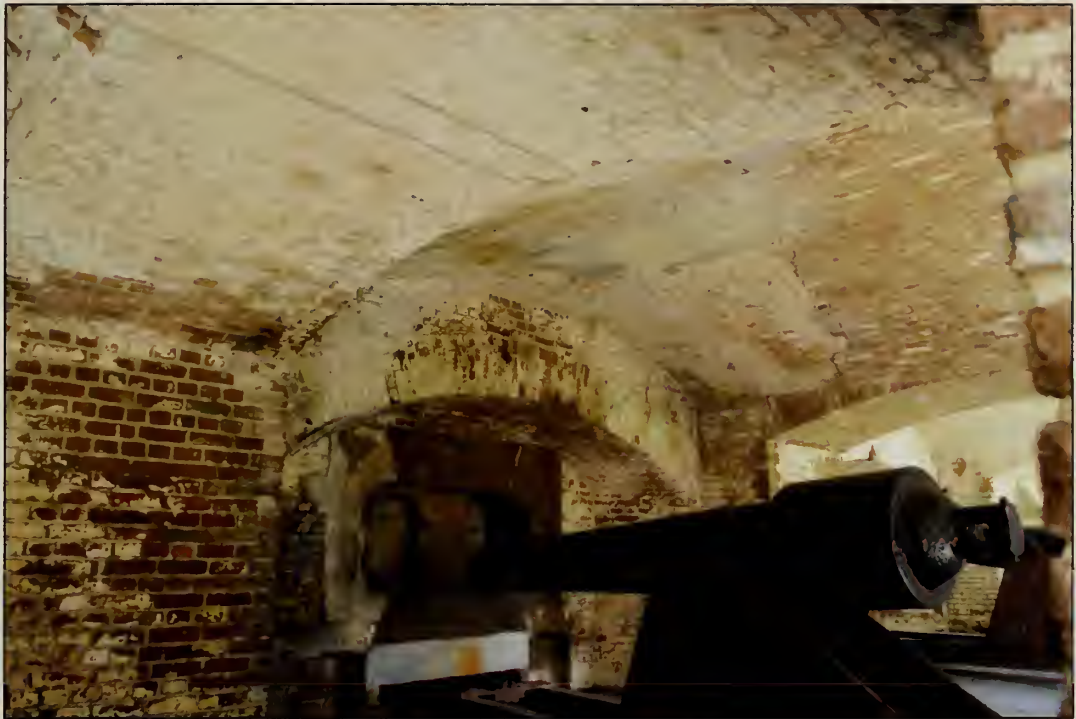
FIGURE 22: Crack extending through vaults and supporting arches, Right Face, March 2009

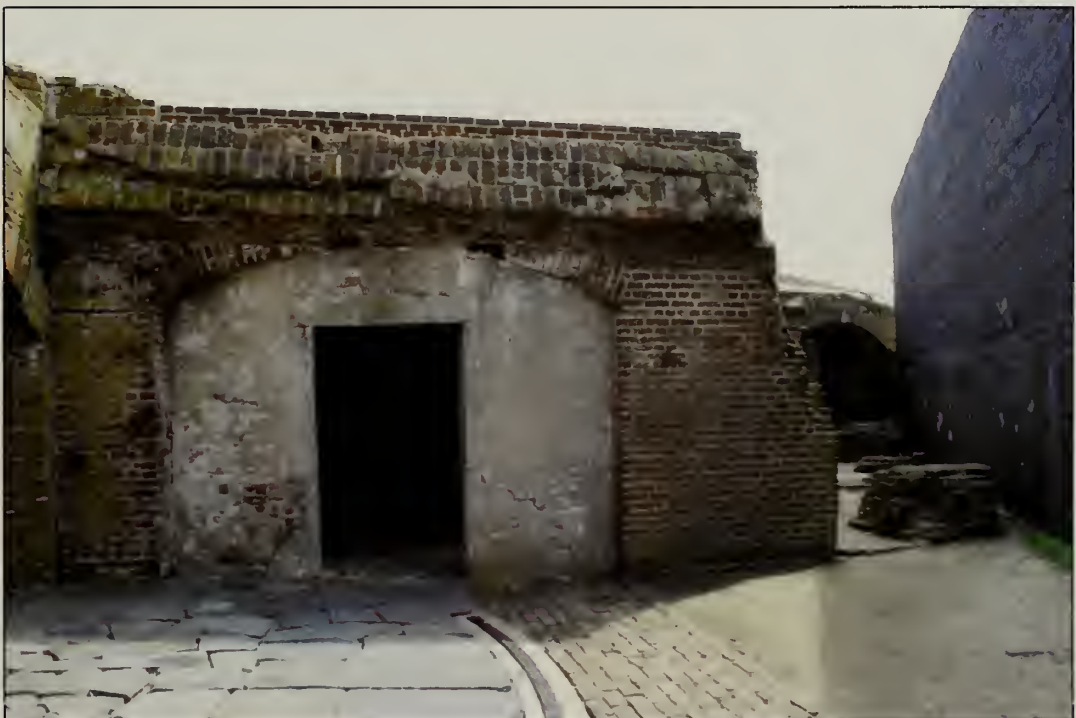
indicating that the thrust is not being adequately resisted by either of the abutments. In this particular case, the structure once giving additional stiffness to the interior abutment has been destroyed, weakening the system. The exterior abutment is located at the salient wall and at the end of an arcade, where resisting forces are weakest. Furthermore, a large horizontal crack through the upper abutment on the exterior side illustrates the force of the outward thrust of the arch. While this example of vault support movement is extreme, similar damage was observed throughout the fort.

FIGURE 23: Several cracks are visible on this supporting arch at the Salient, March 2009

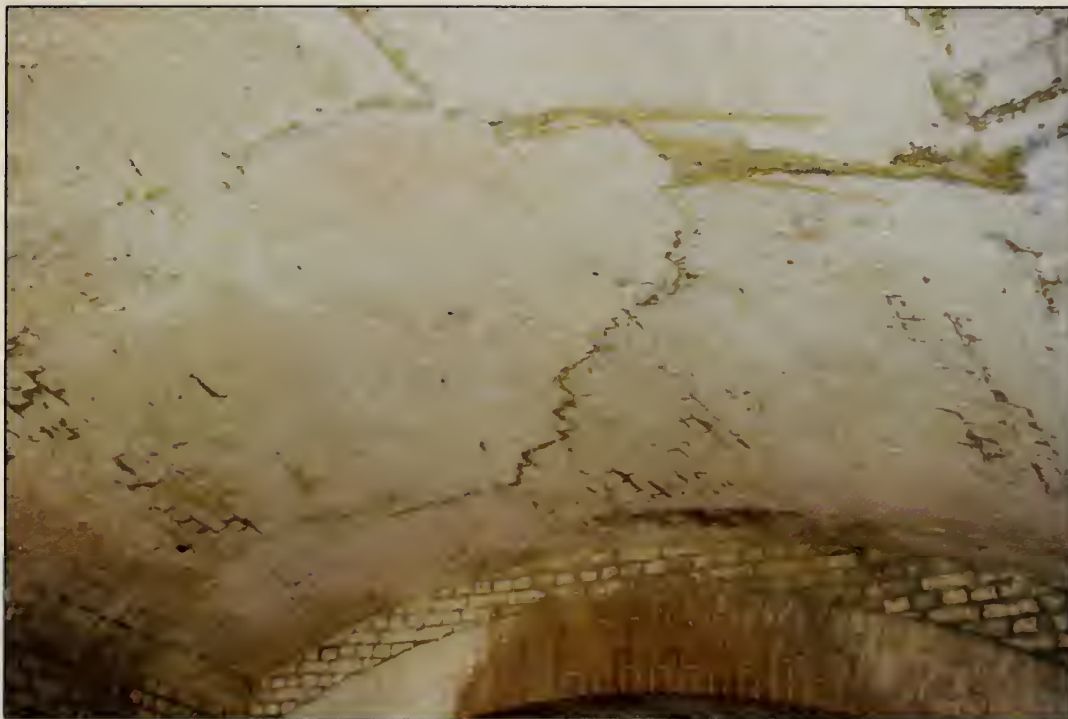
FIGURE 24: The crack in this vault has been repaired with epoxy, Left Flank, March 2009

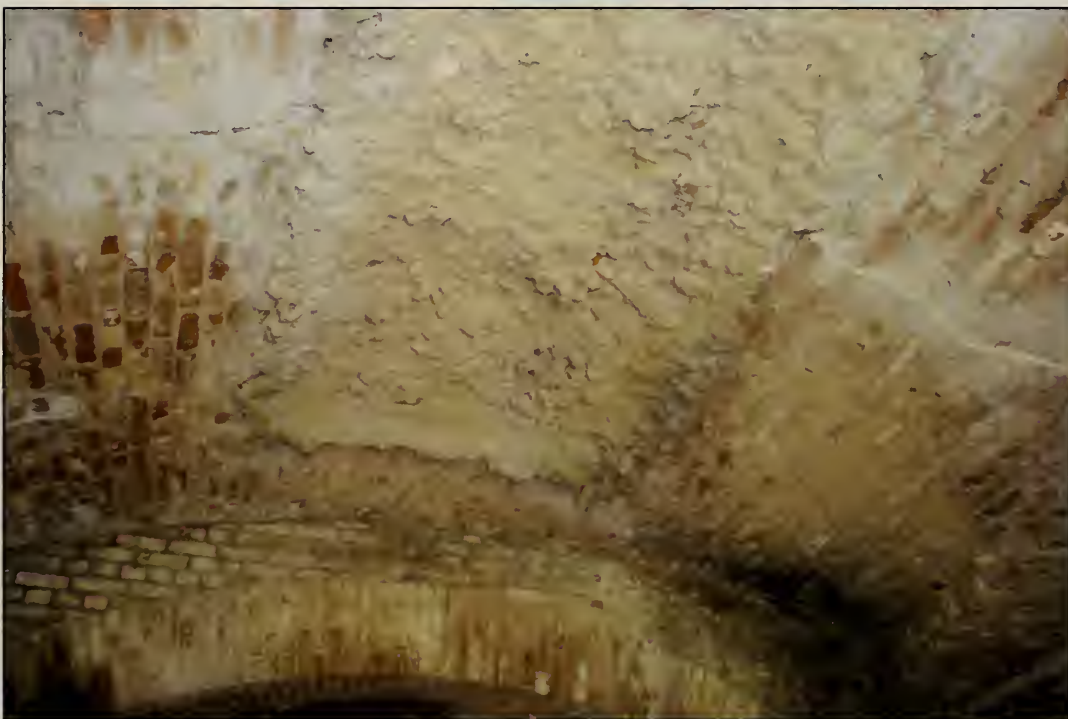
FIGURE 25: The crack in this vault has been covered with concrete, but that patch has also cracked, Left Shoulder, March 2009

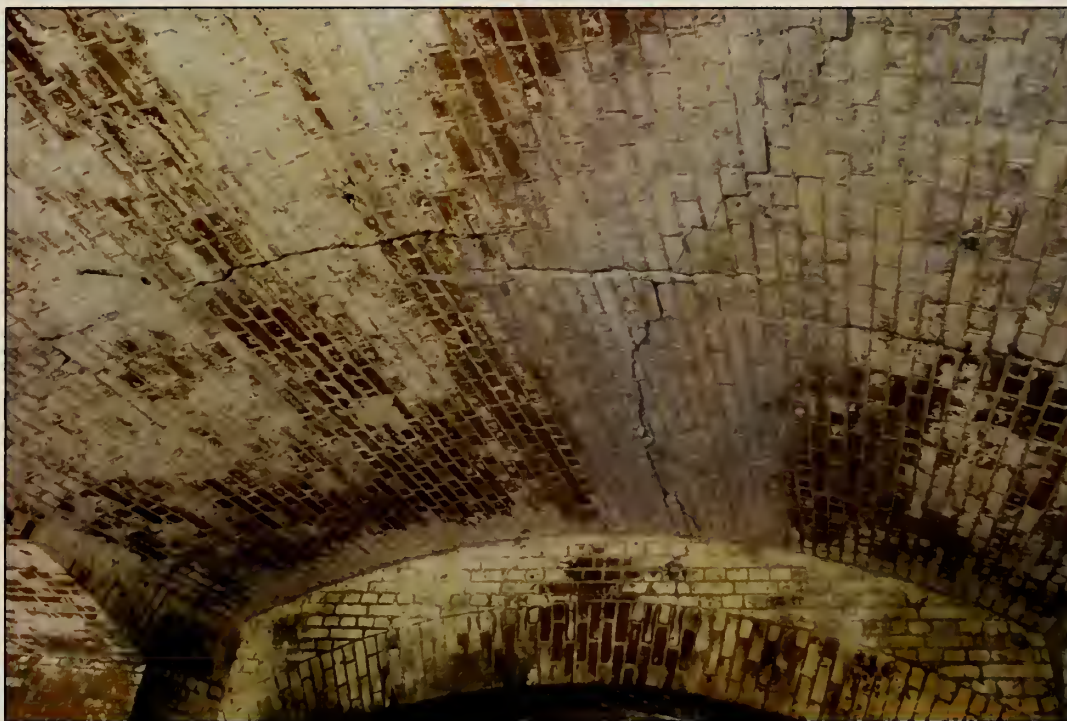
FIGURE 26: This vault has cracked in both directions, Right Face, March 2009

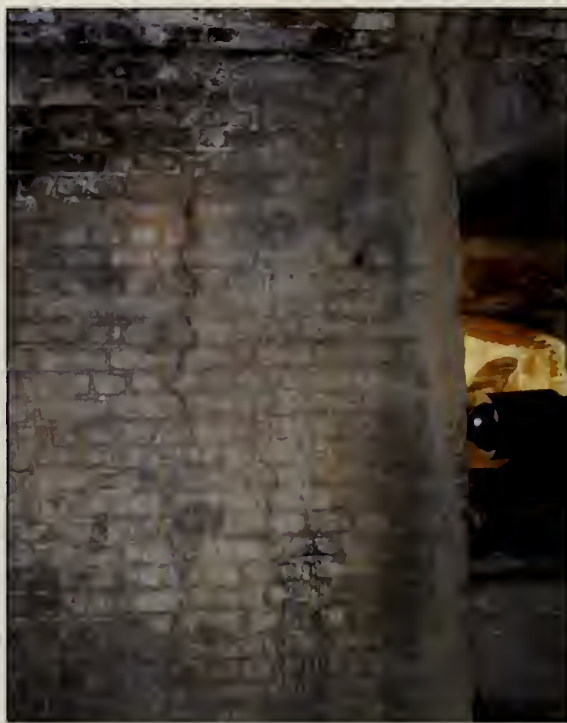
Other cracks can be found throughout the fort with varying causes (Fig. 27-28). These should be evaluated individually to determine overall stability of the fort and to establish whether the damage represents any broad themes of structural distress.

FIGURE 27: Cracks caused by internal pipe, Right Face, March 2009

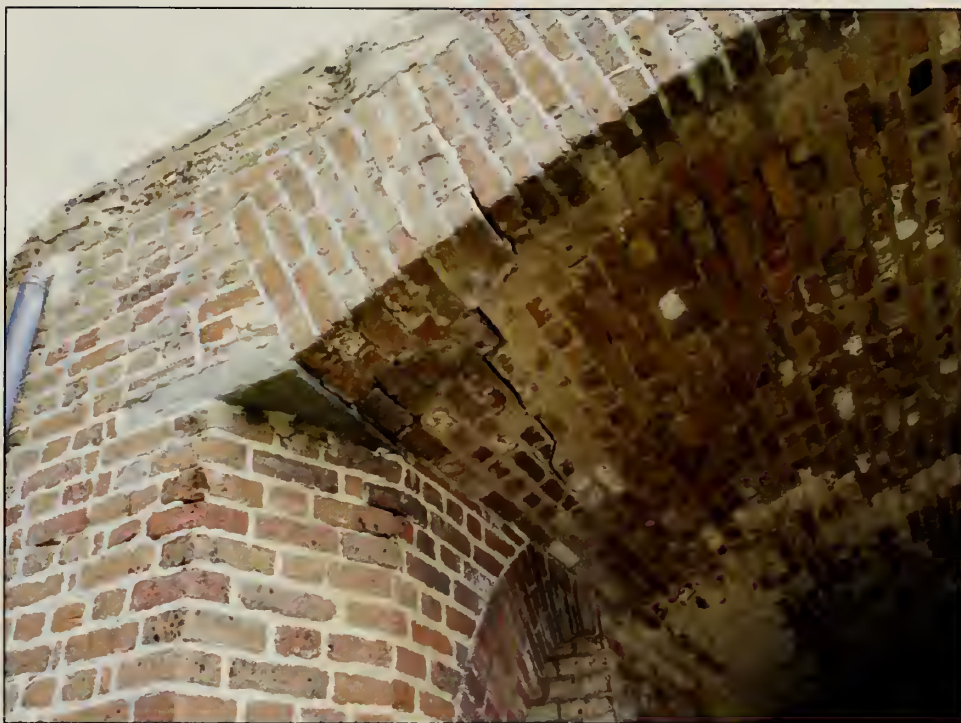
FIGURE 28: Crack through corner of arch, Right Face, March 2009

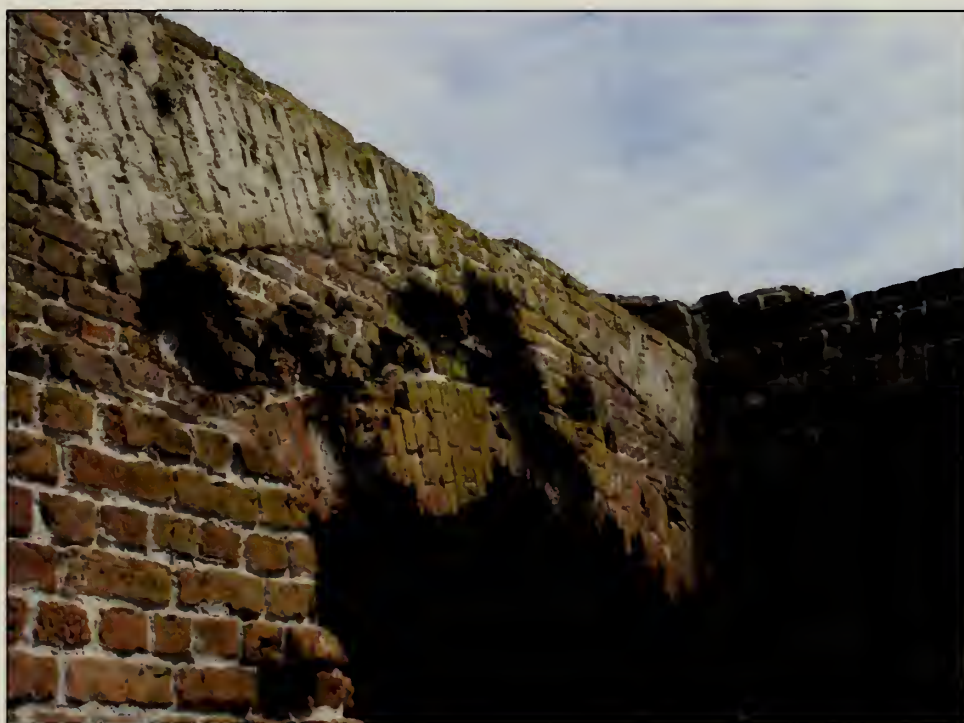
FIGURE 29: Loose bricks inside fort, Left Face, March 2009

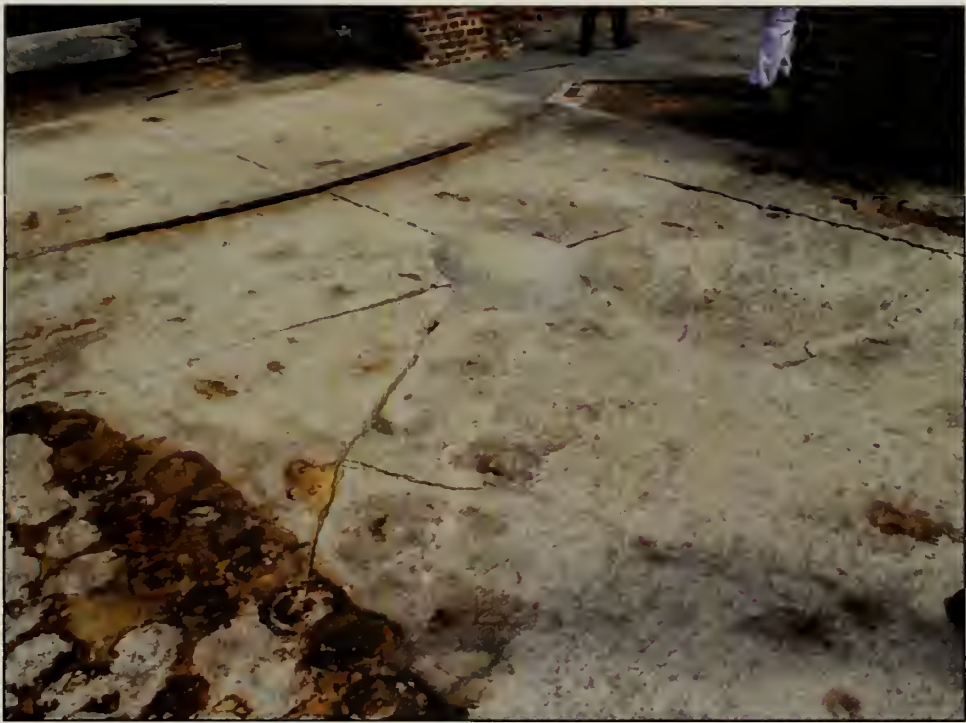
FIGURE 30: Cistern, March 2009

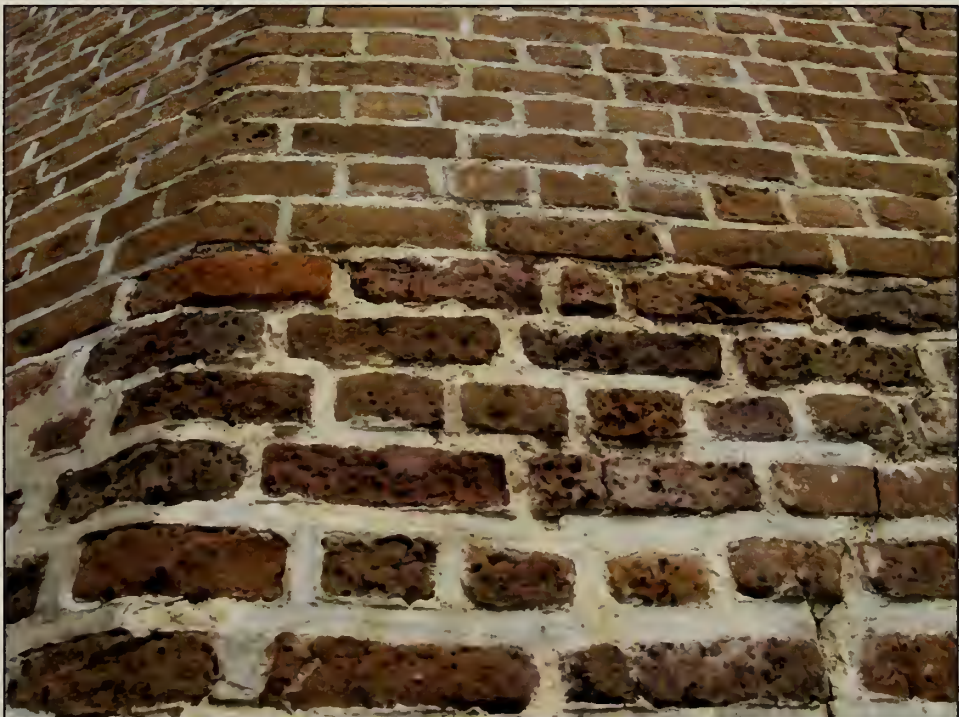
FIGURE 31: Original and rebuilt sections of the Right Gorge, March 2009

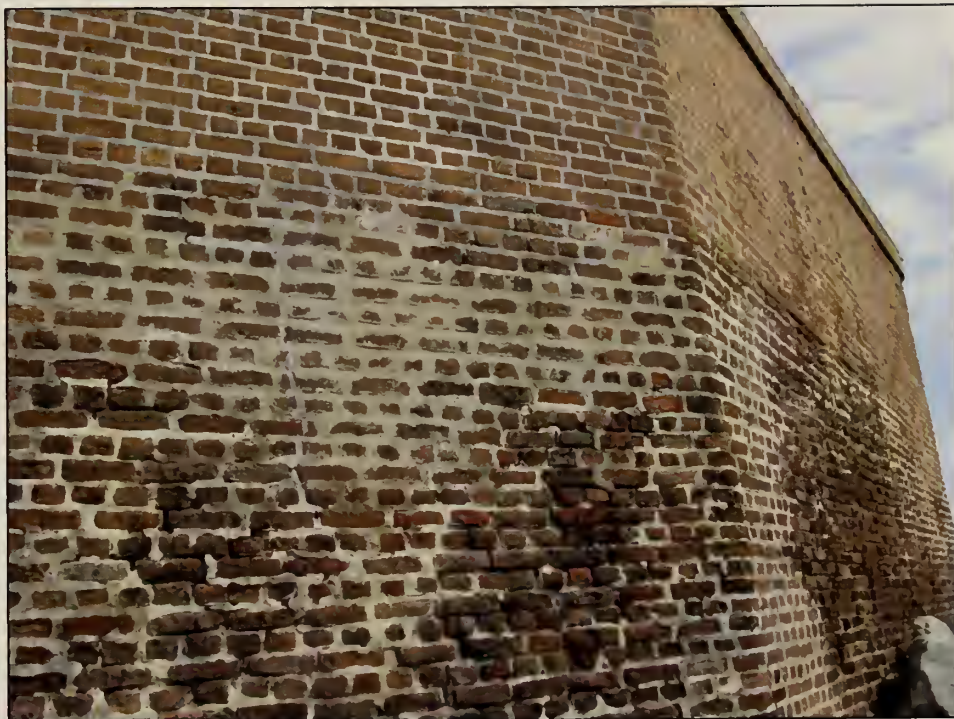
FIGURE 32: Original and rebuilt sections of the Right Gorge and Gorge Wall, March 2009
