CHANNEL CHANGES IN THE MERCED RIVER FOLLOWING THE JANUARY, 1997 FLOOD

Mary Ann Madej (1), Vicki Ozaki (2), Carrie Jones (2), and Gregory Gibbs (1)

United States Department of the Interior
1-U.S. Geological Survey Biological Resources Division
2-Redwood National and State Parks

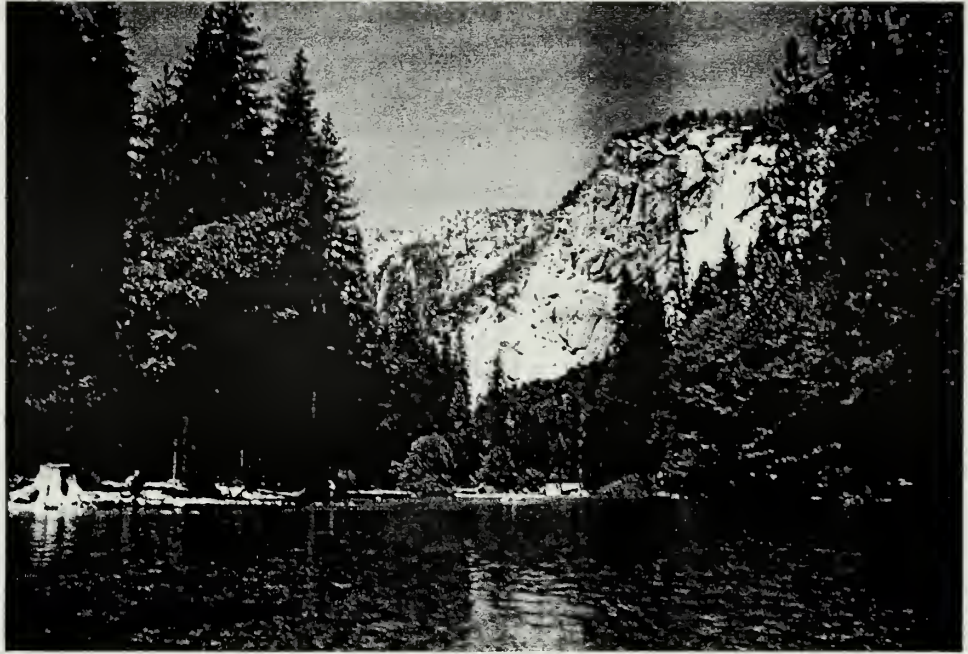
Figure 8: Looking upstream in the Merced River from Cross Section 12 towards Clarks Bridge, showing a wide, shallow channel and low streambanks. The stump at the left side of the photograph is in the active channel and provides evidence of past bank erosion.

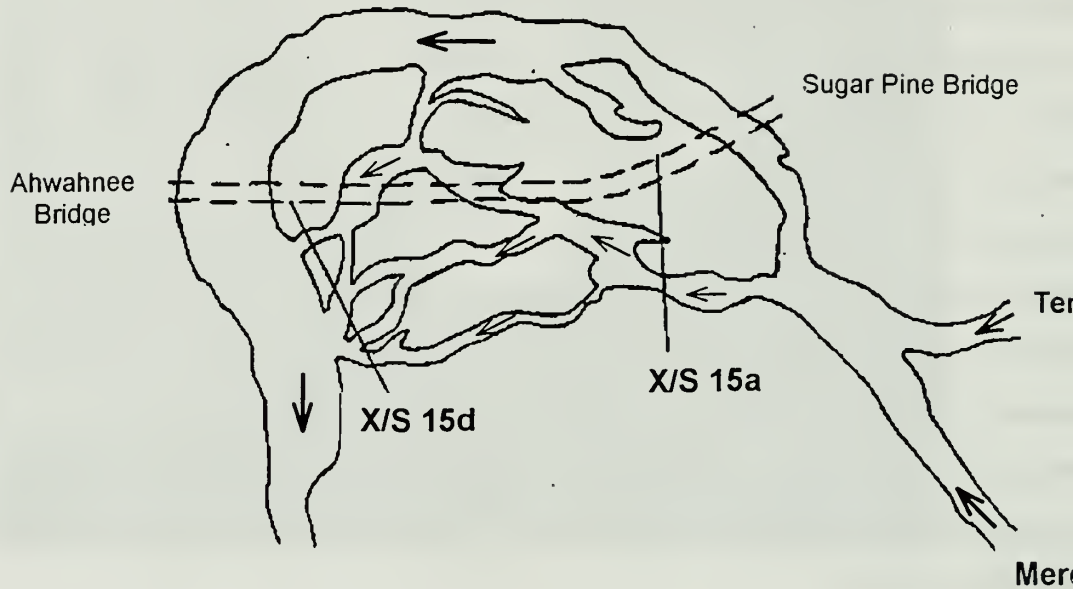
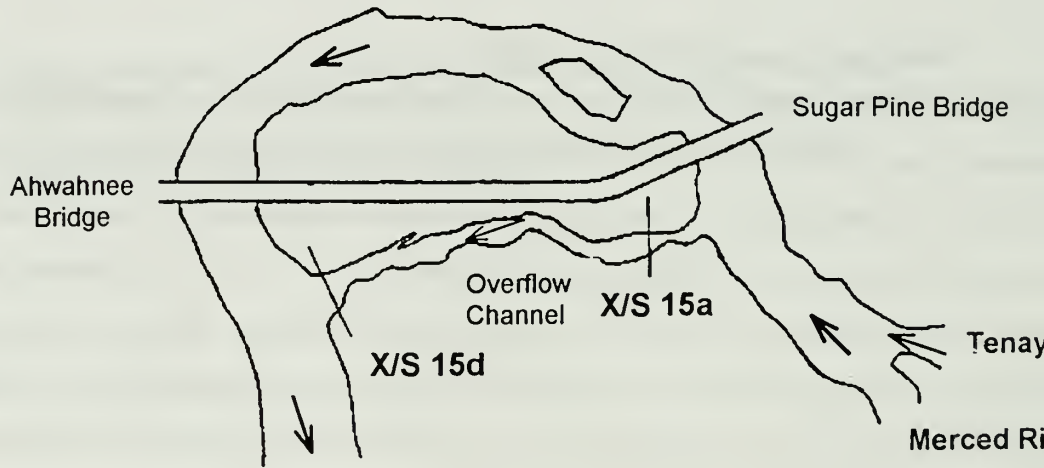
Figure 9: Plan map of the Merced River and overflow channel downstream of Tenaya Creek.

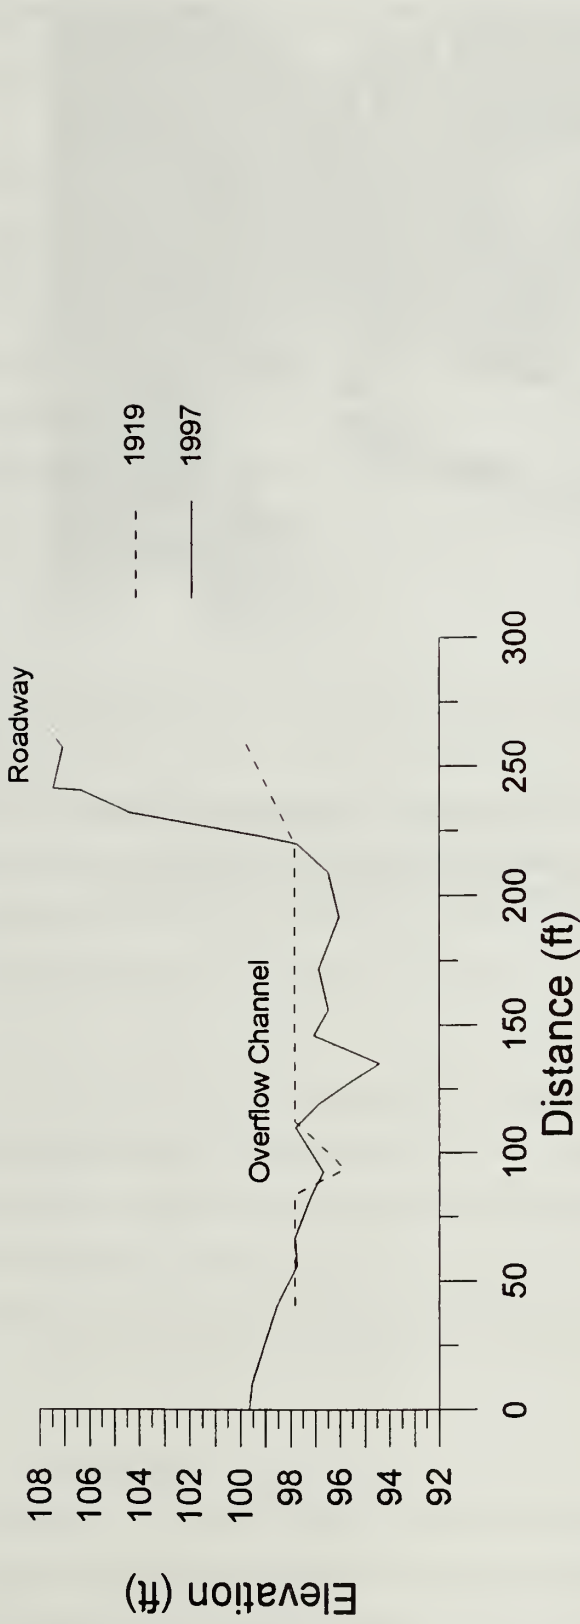
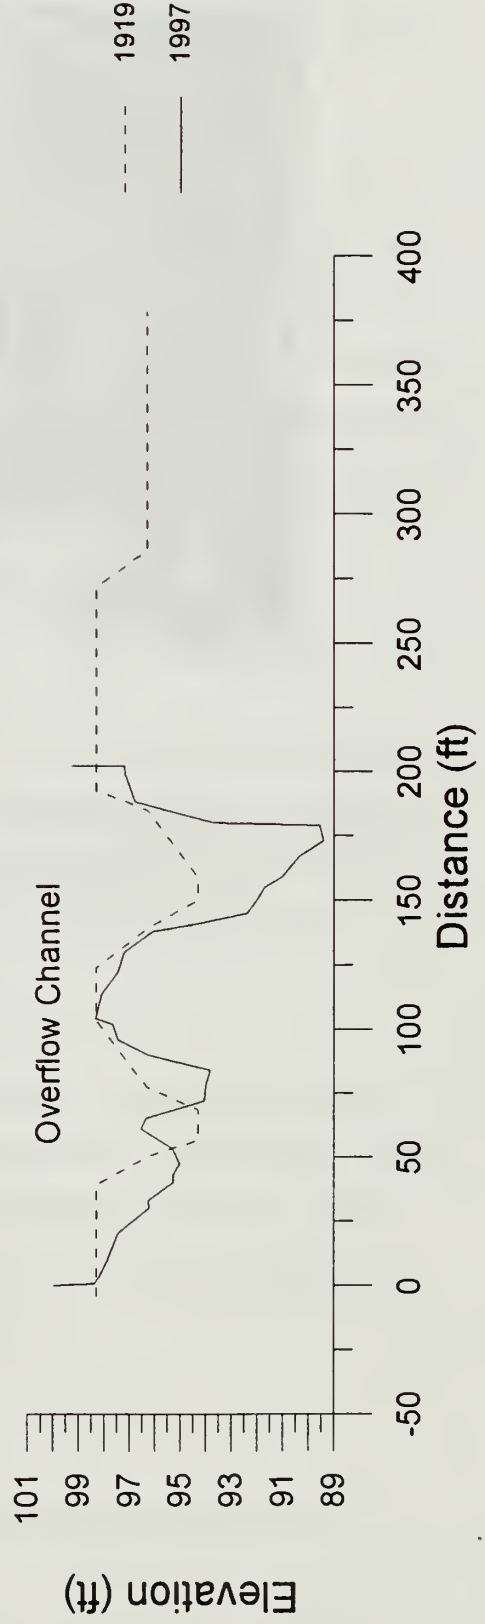
Figure 10: Plots of Cross Sections 15A and 15D in overflow channel, constructed from 1919 maps and 1997 surveys

The 1997 flood caused only minor changes at Cross Sections 15a and d. Because the entire floodplain was inundated in this area, floodwaters were spread out across the valley floor, and little bank erosion occurred in the overflow channel. Large woody debris (discussed later) can cause bank erosion or channel scour, but little new debris entered the overflow channel. A large debris jam was deposited near the head of the overflow channel, but did not substantially change the flow patterns. If the woody debris had blocked Sugar Pine Bridge or had lodged directly in the overflow channel, bank and bed erosion would have been more extensive.

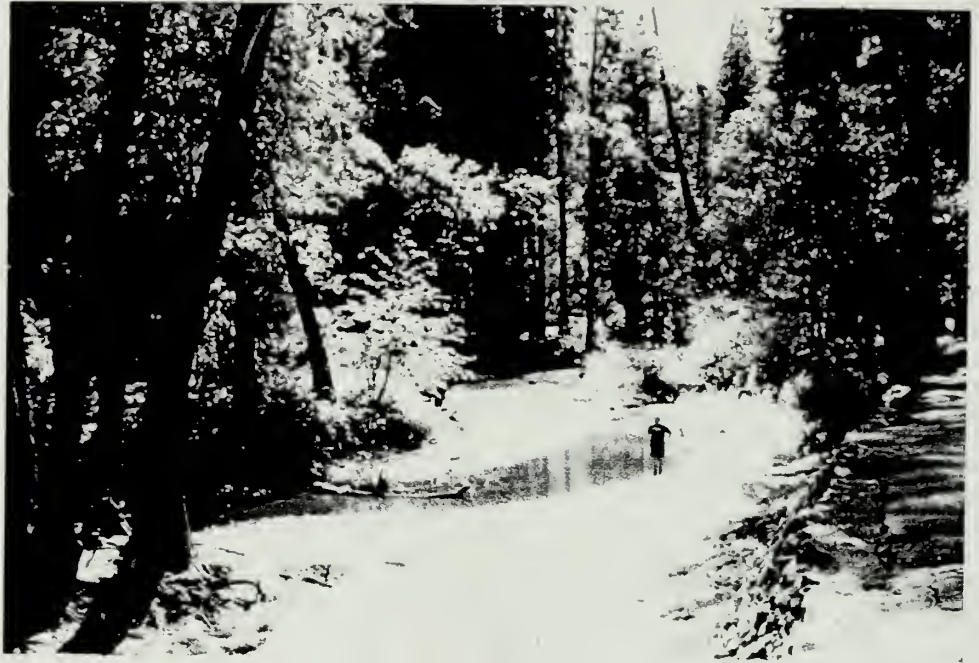
Figure 11: Looking downstream in the overflow channel near Sugar Pine Bridge. The road fill (right side of photograph) forms an artificially high, hardened bank. This channel has enlarged considerably since 1919.

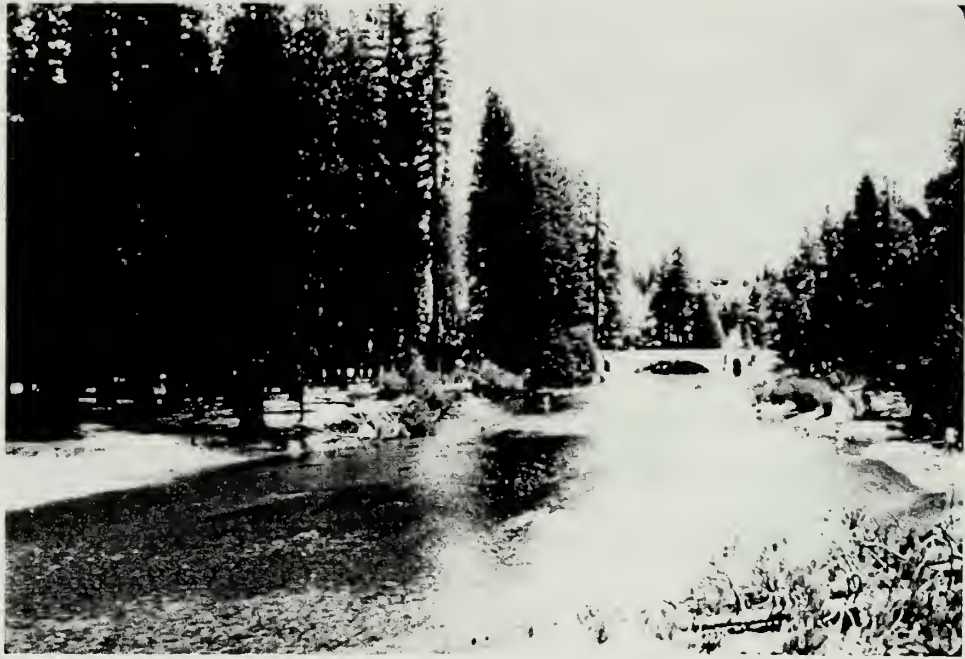
Cross Section 26 is in a straight section of river downstream of Stoneman Bridge and the restoration site (Figure 12). Only minor changes occurred at Cross Section 26 during the 1997 flood. The left bank is cohesive and relatively resistant to bank erosion. Minor deposition

Figure 12: Looking upstream from Cross Section 26 towards Stoneman Bridge. A streambank restoration site is on left side of photograph, where scattered vegetation is growing on the banks.

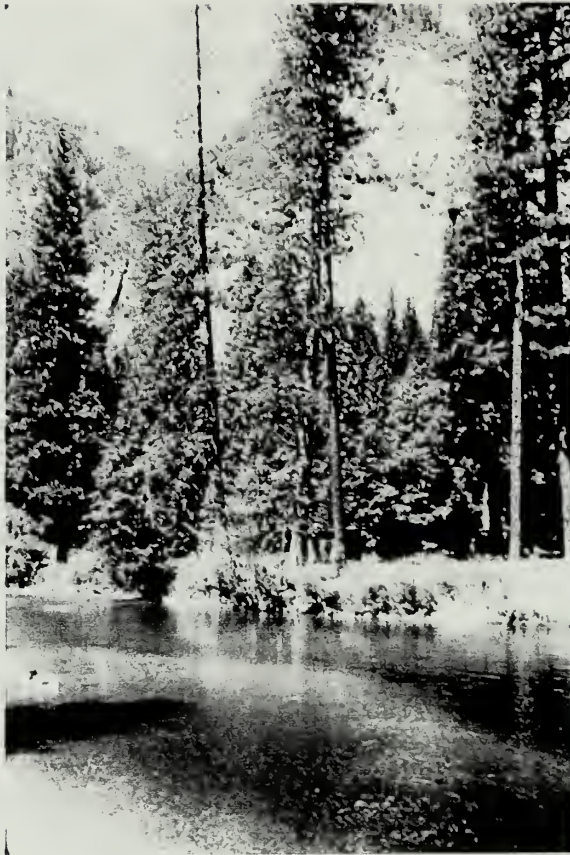
During the floods of 1997, no significant changes occurred on either bank. Willows growing on the right bank withstood the flood well (Figure 13). Cross Section 28 is located downstream of the scour pool at Housekeeping Bridge. Here, the section of channel bed extending from the center of the channel to the base of the left bank aggraded, and the thalweg elevation increased 1.5 feet. Cross Section 29 is located several hundred feet downstream of Cross Section 28 in a straight reach, and showed no significant change.

Figure 13: Looking downstream from Housekeeping Bridge, towards right bank of the Merced River. Willow plantings on the right bank survived the 1997 flood with little damage.

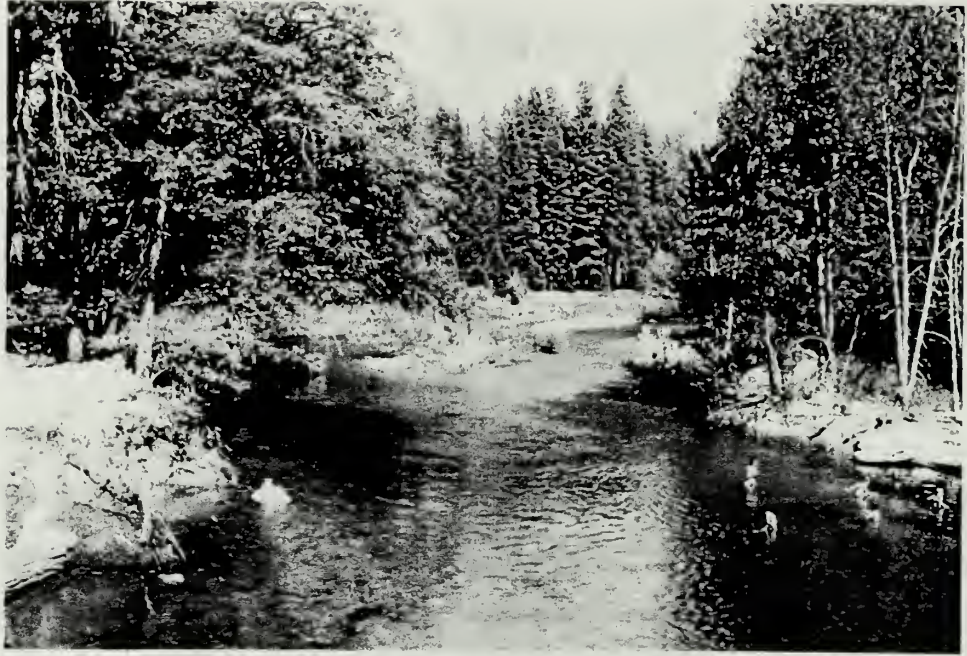
Figure 14. Looking upstream from the newly constructed Sentinel Bridge and Cross Section 40. Although most of the streambanks are well vegetated, high visitor use in localized areas results in some bare, trampled areas.

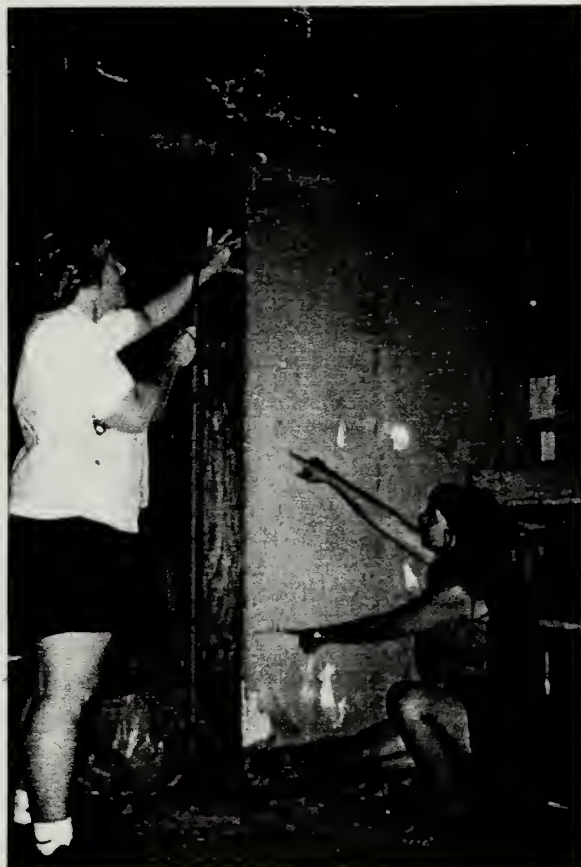
Near this restoration site, a valuable record of previous flood inundation levels was found marked on a garage wall near the old Superintendent's House near Yosemite Creek (Figure 15). The 1997 flood level was higher than any of the previously marked floods. As buildings are modified in post-flood reconstruction, it is important to clearly document these flood levels to be used in future studies. We recommend the installation of inconspicuous crest staff gages at various locations in the floodplain to help determine the extent and depth of future flooding.

Figure 15: A record of high water marks from past floods on the garage wall of the old Superintendent's House (Residence 1) had been kept by Yosemite National Park staff. Fingers point to high water marks from (bottom up): 5-16-96, 12-23-41 (44" above floor), 11-19-50 (66"), 12-23-55 (70"), 1983 - Hole in top of doorway, and 1-2-97 - Ceiling of garage.

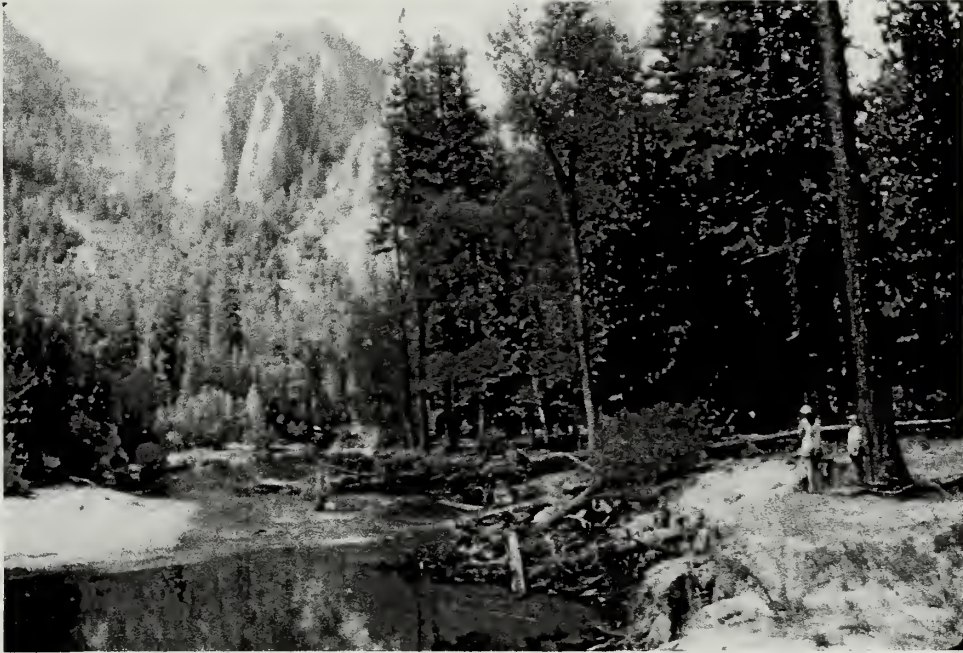
The most significant channel changes due to the 1997 floods were observed in this reach. In general, cross sections scoured in this reach and significant bank erosion occurred on the right bank at all the cross sections in the area of the El Capitan picnic and dump restoration site (X/S 30-34). The average bank erosion at five cross sections in this reach was 21 ft, and the maximum bank erosion observed in the reach was about 43 ft. Figure 16 shows the erosion and treefall that was typical along the right bank in this reach.

Figure 16: Looking downstream at the El Capitan Restoration Site. During the 1997 flood, a new sand and gravel bar built out along the left bank and about 30 ft. of the right bank eroded. Woody debris accumulated along the right bank, where trees fell and logs floated in from upstream reaches. Floodwaters overtopped the right bank and flowed across the floodplain, resulting in some sand deposition and minor gulying on the floodplain surface.

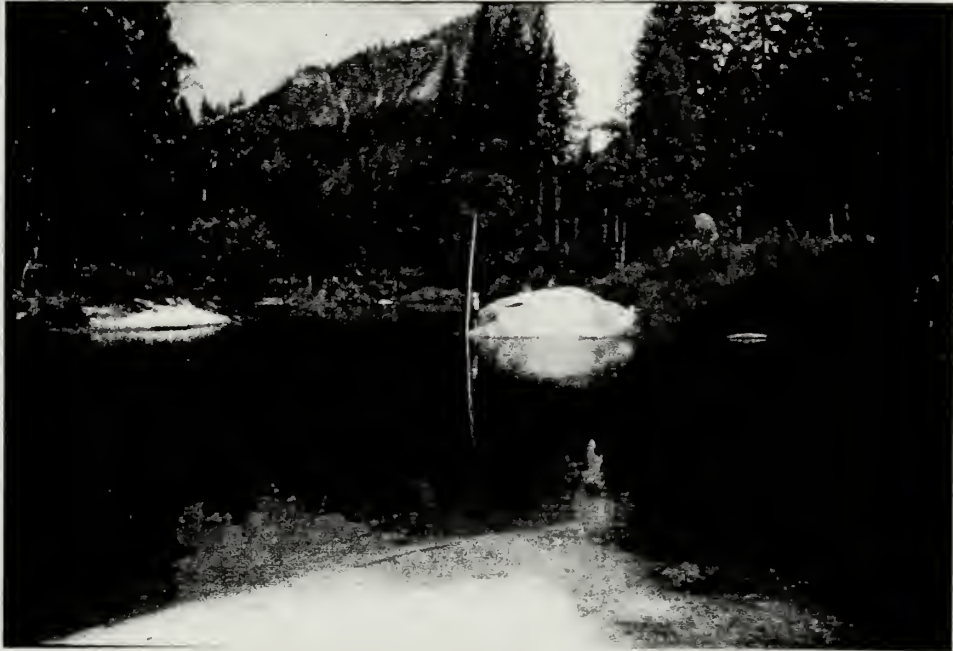
Figure 17: Looking downstream from Cross Section 36 in the Devils Elbow Reach. Person is holding a stadia rod vertically as a scale. Pool depth at the large boulder is 14 ft. during summer low flow. Willows planted along the right bank in the fall of 1993 withstood the 1997 flood with little damage.

In 1997, the middle two cross sections filled, the upstream-most cross section scoured, and the downstream cross section showed no significant change. No major channel changes occurred in this reach, and the plantings on the right bank survived the flood with little damage (Figure 17). In general, the total amount of fill at cross sections was about equal to the total amount of scour for the reach. More detailed mapping of this reach was conducted in 1997 by the USFWS (in progress). Less erosion occurred at this restoration site than at the El Capitan site. There are several possible reasons for the success of this site. Vegetation was better established at this site because of irrigation of the young plants (Yosemite National Park, personal communication).

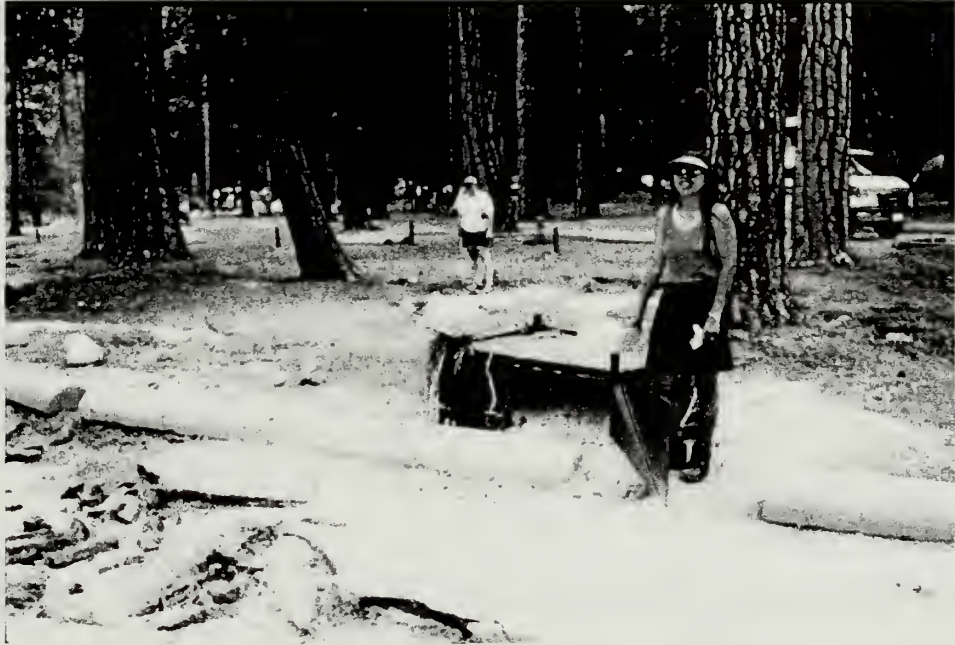
Figure 21: The Lower Pines Campground was severely damaged by overbank flooding. Asphalt roads and parking sites were ripped up, and picnic tables and restrooms were damaged. The person is standing next to a heavy metal food cabinet with four cement footings that was completely overturned during the flood, and filled with sand and gravel. Such evidence attests to high flow velocities in this area during the flood.

Commonly floodplains have higher roughness values (Manning's $n = 0.7$ to 0.9) due to thick vegetation (Barnes, 1977), and floodwaters do not have such high velocities. Nevertheless, the flood velocities estimated here are not unrealistic, considering the smooth campground surface, the lack of resistance from bushes or other understory vegetation, and the relatively steep floodplain surface (compared to large, lowland rivers). The high velocity of floodwaters through the campground was responsible for much of the damage to the infrastructure, and there is the risk of periodic flood damage to infrastructure in the future. Park management should acknowledge this risk, anticipate high velocities in future overbank flooding, and relocate critical facilities outside of these high velocity areas.
