TUGBOAT HERCULES

Historic Structure Report

1990

Prepared by
Tri-Coastal Marine, Inc.
200 Burrows Street
San Francisco, California 94134

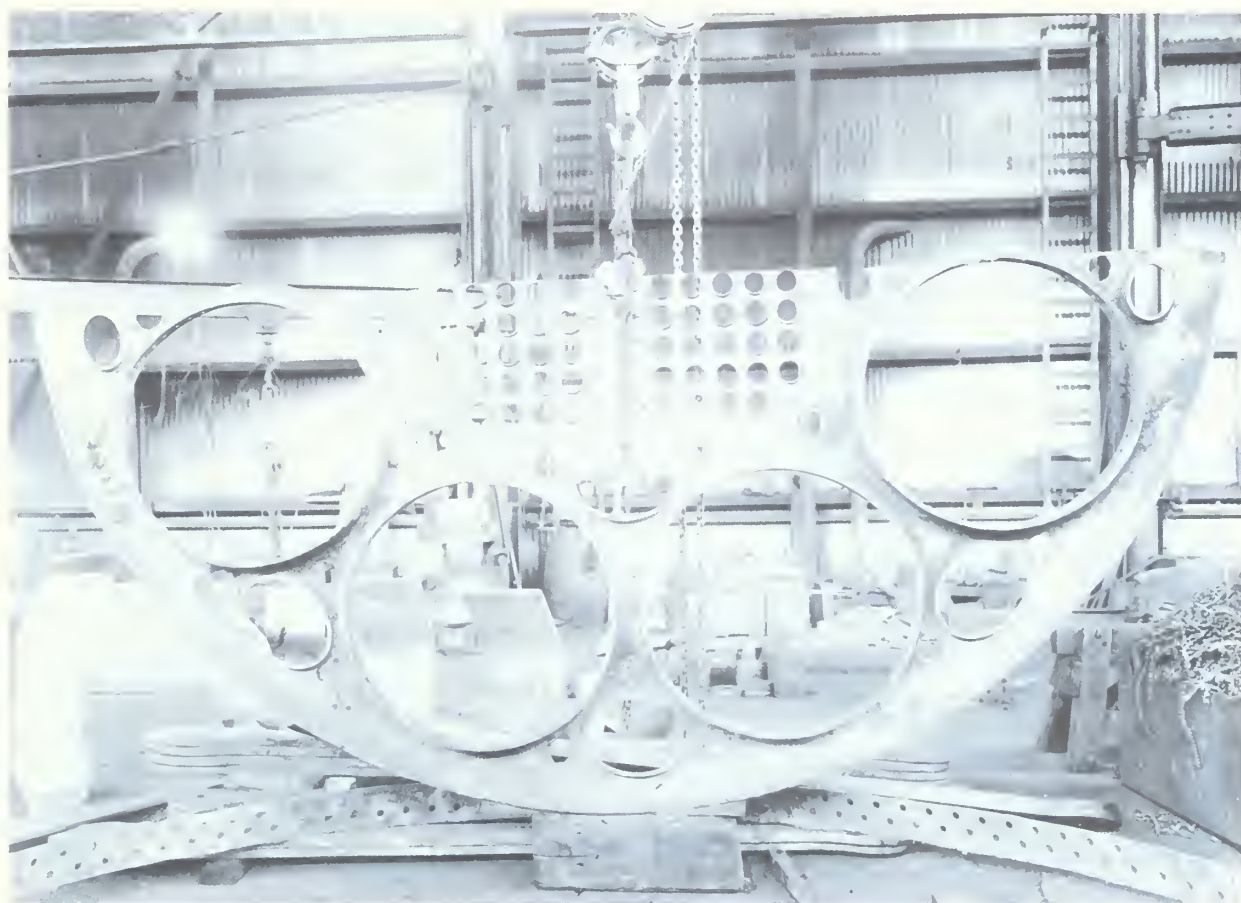
Fig. 6. "Tug HERCULES owned by Rolph Navigation & Coal Company. Showing lower front head removed from boiler. Repairs being made by the Moore Shipbuilding Company. Oakland. Cal. Oct. 2, 1919." (Photo Caption)

Boiler disassembled for major repairs.

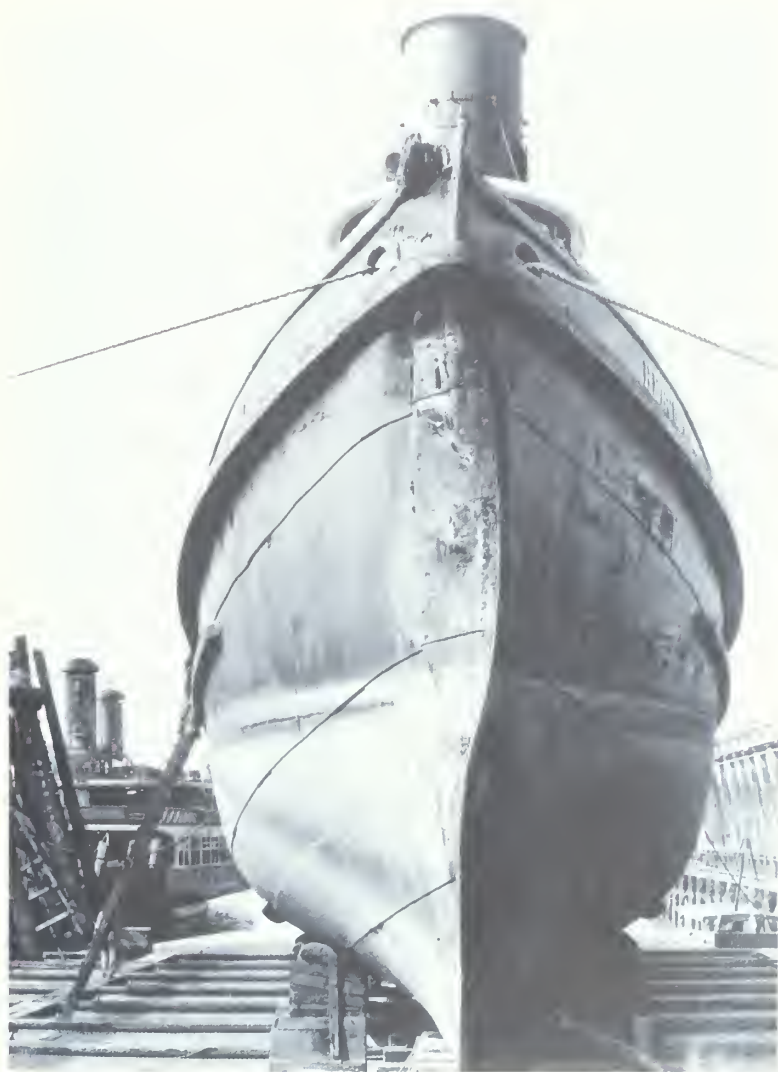
Fig. 9. HERCULES on dry dock following collision with steamer SAN PEDRO, 9 May 1933.

HERCULES in collision with McCormick lumber steamer POINT SAN PEDRO near Grove Street Terminal, San Francisco; tug sustains considerable damage to bow, propeller, stern frame, and rudder. Hauled out at Moore Drydock for repairs.

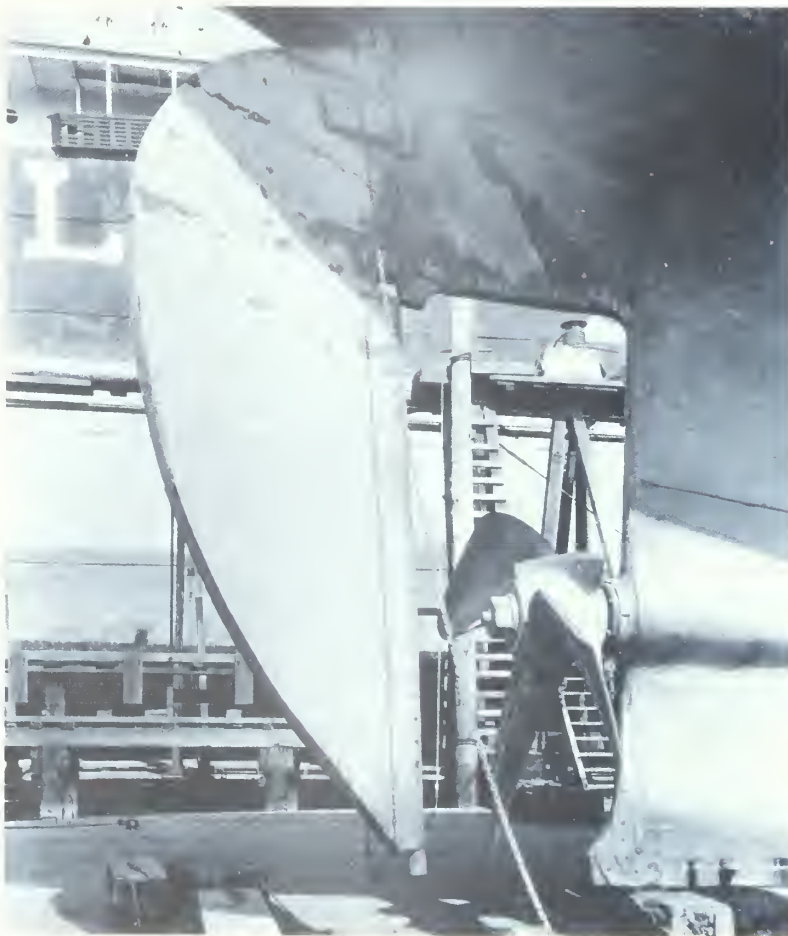
Fig. 10. Rudder and propeller damage resulting from collision with steamer SAN PEDRO.

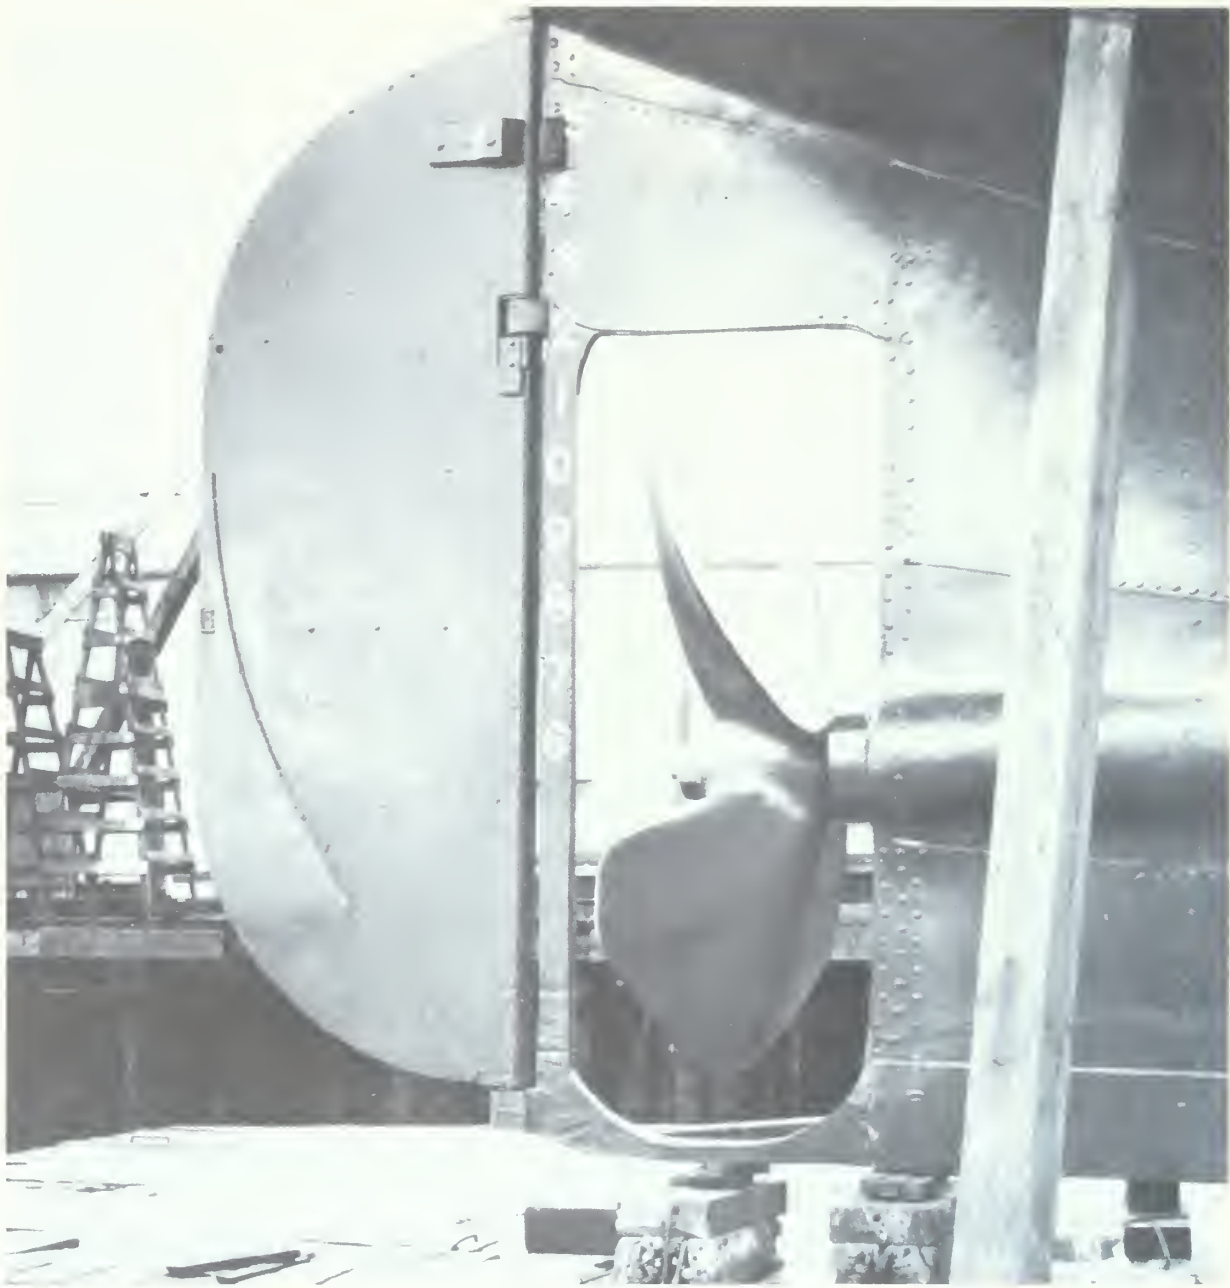
Fig. 17. HERCULES in drydock for enlargement of her rudder, Oakland, California, February 1940. Added portion can be seen at lower left side of rudder.

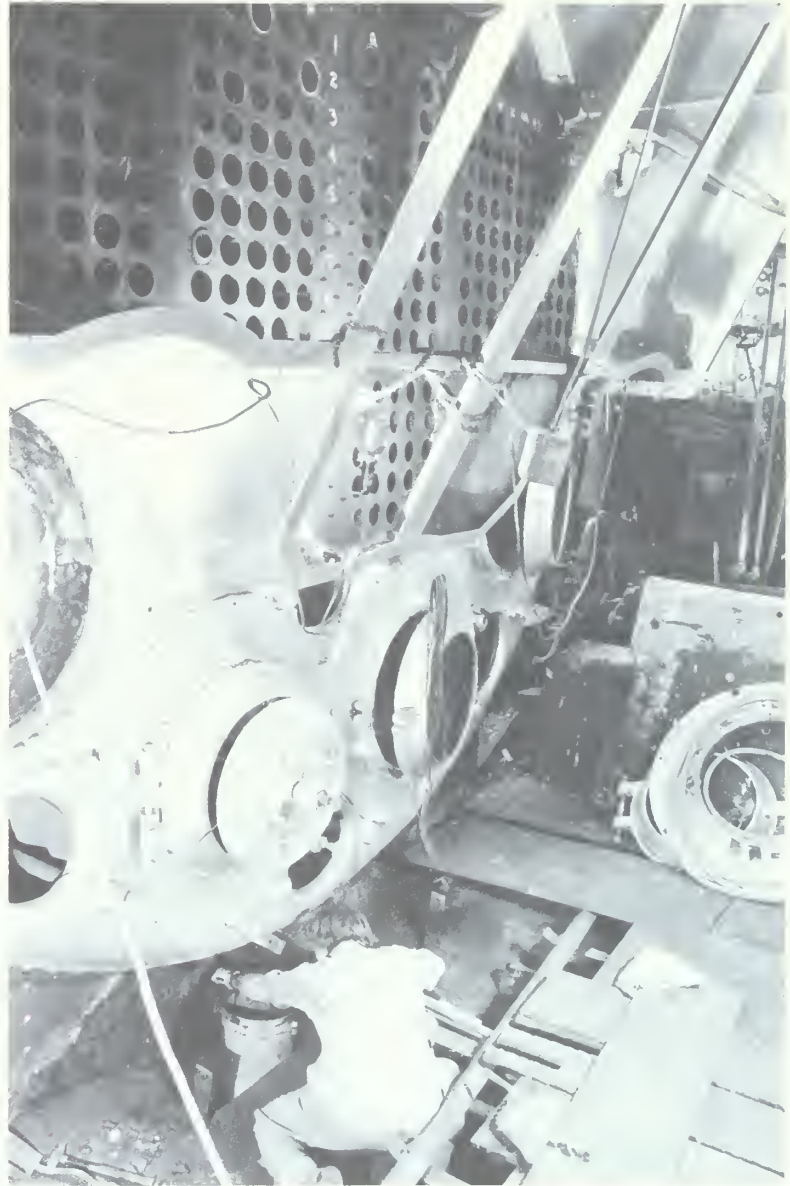
Fig. 22. View of the front end of HERCULES' boiler during restoration in the mid-1980s. Doors of the "front connection" have been removed for replacement of fire tubes.

- Research, preparation, and considerable work in returning the boilers to steaming condition, including removal of lagging, scaling of boiler shell, re-tubing of boiler and repair of boiler saddles

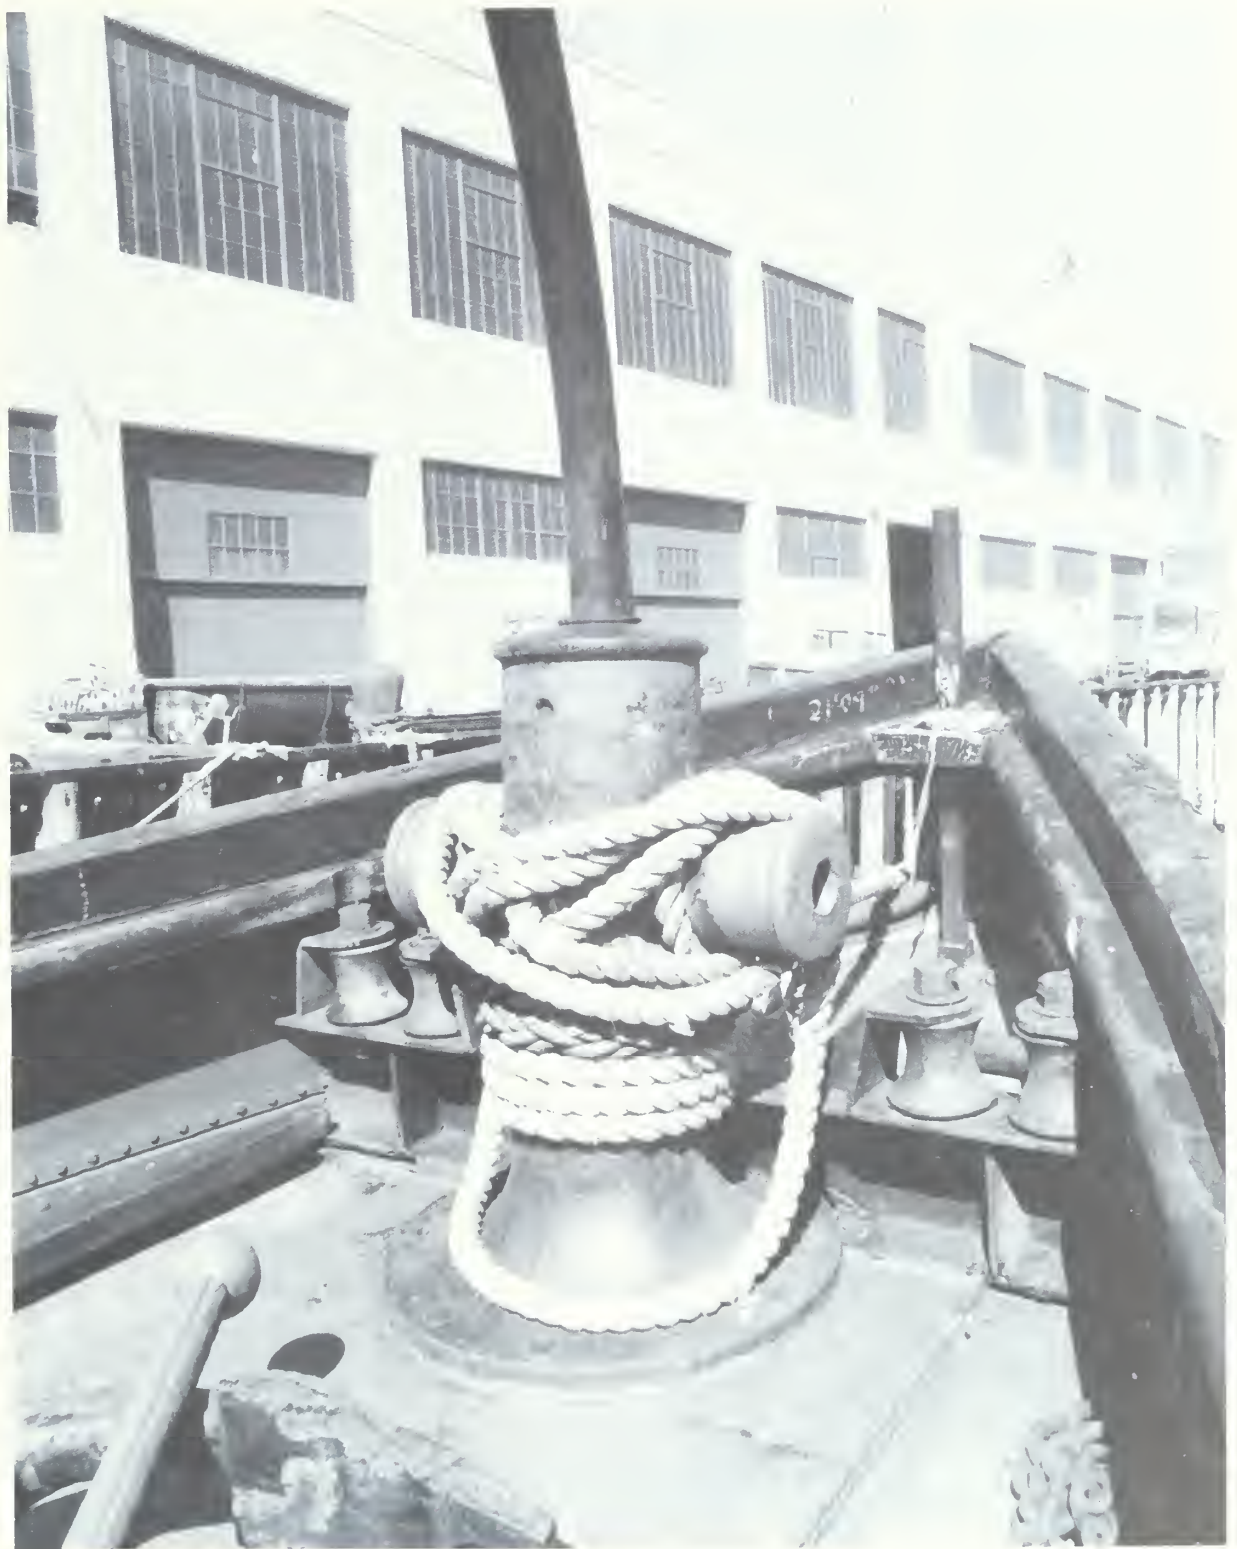
Custom Deck Fittings, Including Bow Bitt, Mooring Bitts, and Towing Bitts: Intact and original, with exception of the anchor davit mounted on the bow

Fig. 24. Kingpost bitt on foredeck, one of several original custom-made items HERCULES is fitted with. Roller-chocks to port and starboard of the bitt are a later addition.

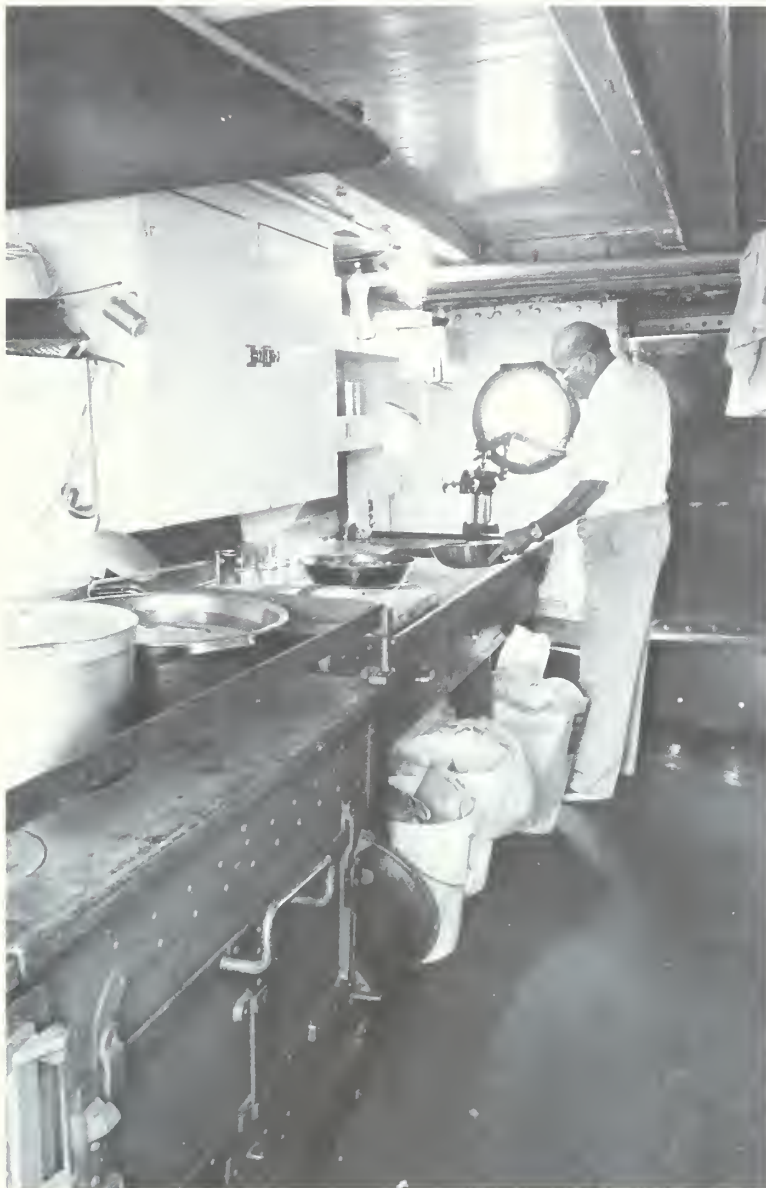
Fig. 28. The galley, as seen from the starboard entrance. The stove, sink, hand pump are operational.

Galley: Restore to configuration from oceangoing era after repair of steel deck beneath.
