FURE'S CABIN

HISTORIC STRUCTURE REPORT

KATMAI NATIONAL PARK & PRESERVE

PREPARED BY

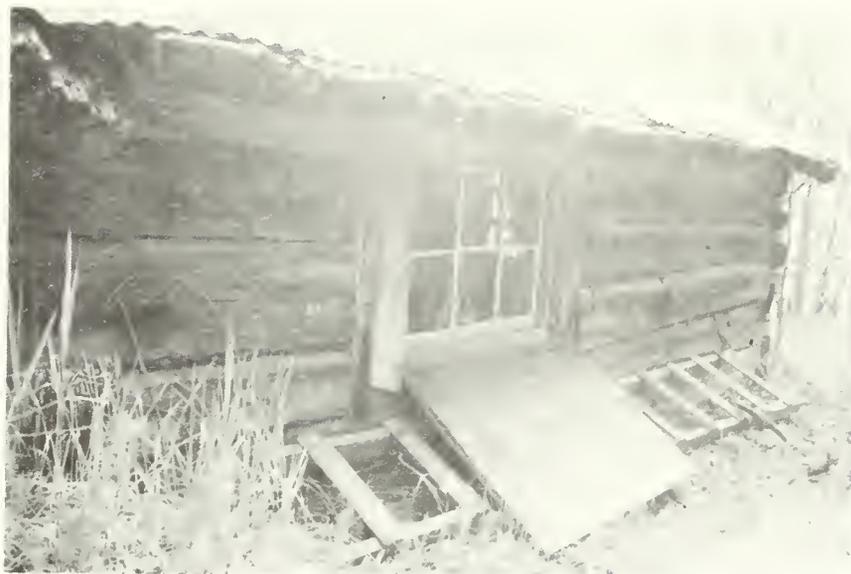
Photograph 3
West Elevation: Note Deteriorated Condition of
Roof Planks
6/82 D. Snow

- 9) Once corrugated roofing is removed, inspect roof planks for extent of deterioration.
- Roof Repair 10) Replace with new ones any roof planks that have lost structural integrity (loss of more than 30% of thickness). Hand hew new planks on the exposed underside. Retain roof planks judged in acceptable condition and remove dry rot with hand tools.

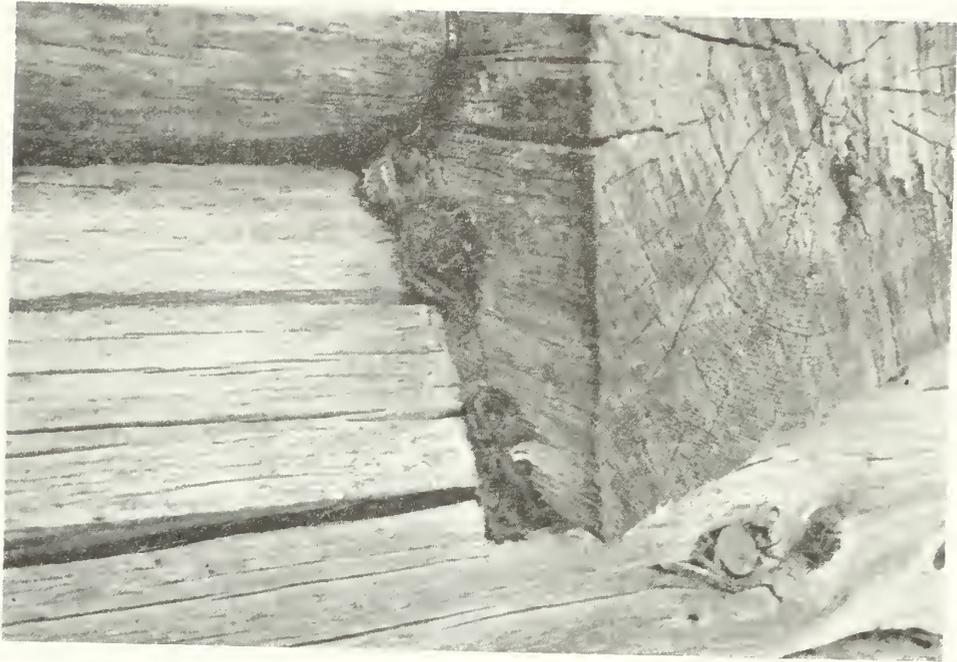
Photograph 43
Typical Dovetail Joint: Note
Paint on End Grain
6/82 D. Snow

- 13) Paint all dovetail end grain with red oil base paint after priming with mixture of 50% boiled linseed oil and 50% turpentine.
- Window Repair 14) Repair all existing windows by replacing broken glass and repairing or restoring sash. Paint red restored sashes and glazing compound. (Several weeks may be required for glazing compound to set up.)

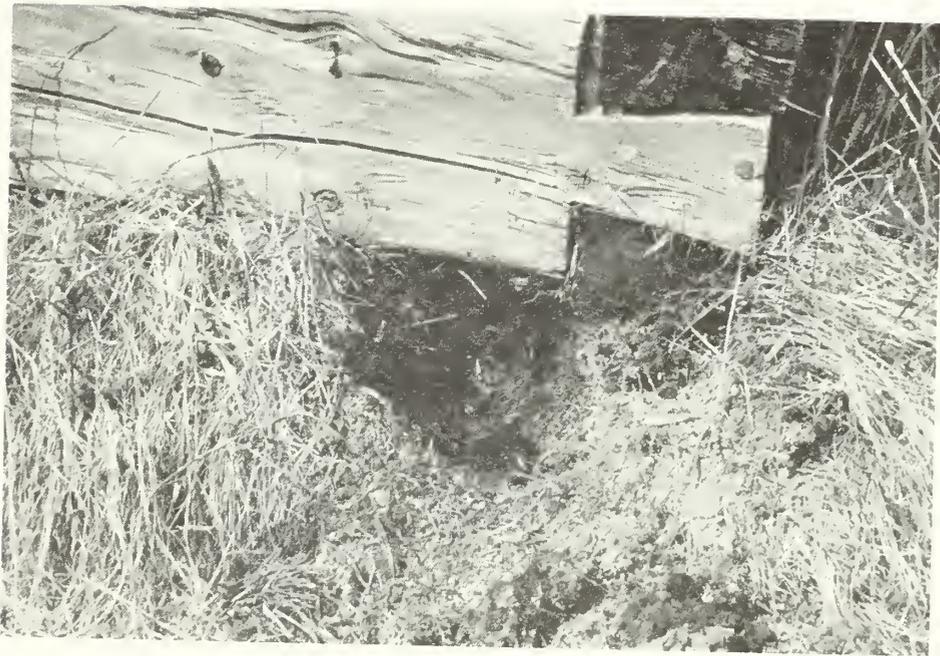
The existing condition of the sill logs is obvious because they have been in constant contact with the soil since the cabin was constructed. There is uniform dry rot primarily below the grade. This problem is compounded at the north elevation and the north end of the west elevation because the structure is built into the hillside. At least three courses of these wall logs, above the floor level, are in direct contact with soil at their exterior face.

Photograph 44
Northeast Corner: Note
Rotted Sill Log
6/82 D. Snow

2) Remove sill logs that have lost their structural integrity and replace with pressure-treated timbers (Douglas Fir) as indicated in Stabilization Drawings. |
