HOME AND OFFICE OF FREDERICK LAW OLMSTED

Frederick Law Olmsted
National Historic Site

THE BARN, SHED, AND FENCES

FREDERICK LAW OLMSTED NATIONAL HISTORIC SITE
HISTORIC STRUCTURE REPORT

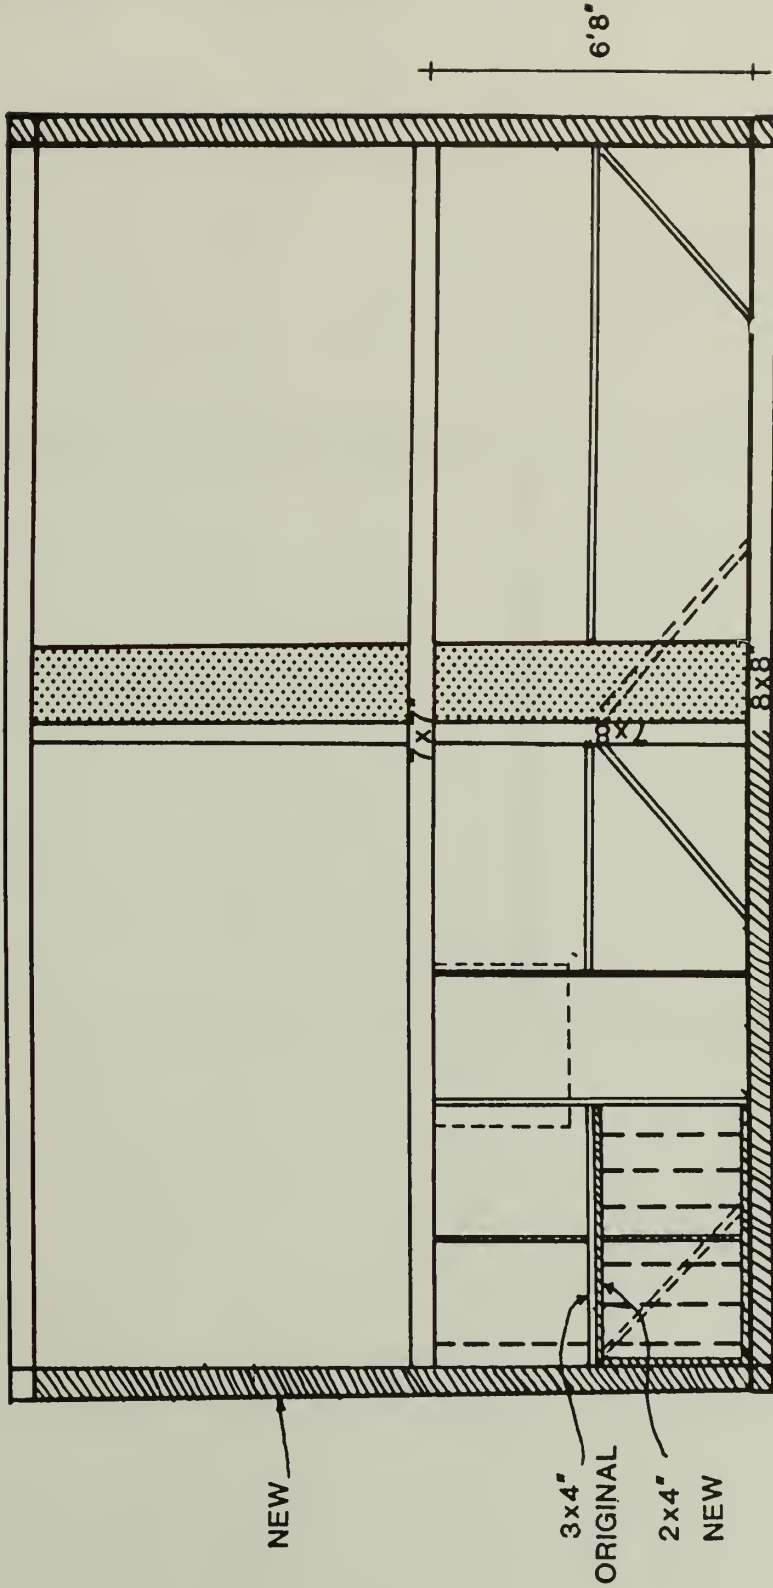
Figure 7. Barn: "Framing - South Elevation."

Sheathing boards on lower half west side door
Replaced February 1982. These had been replaced previously,
probably when barn moved c.1883

Members replaced or added 1981-82

Figures 7-8 includes structural repairs made to the barn in 1981-1982. Extensive structural repairs were made to the carpentry shop in 1982-1983. The south, west, and east sills were replaced, along with the west half of the north sill. Floor joists were replaced at the north end of the shop. New floor joists, subflooring, and finish flooring were installed at the west end of the shop, where the original floor materials had been removed in 1960 during the installation of a cement base for the pool pump. The carpentry shop roof, originally covered with canvas, was stripped and given a four-ply built-up asphalt felt roof with bitumen surface in 1982.

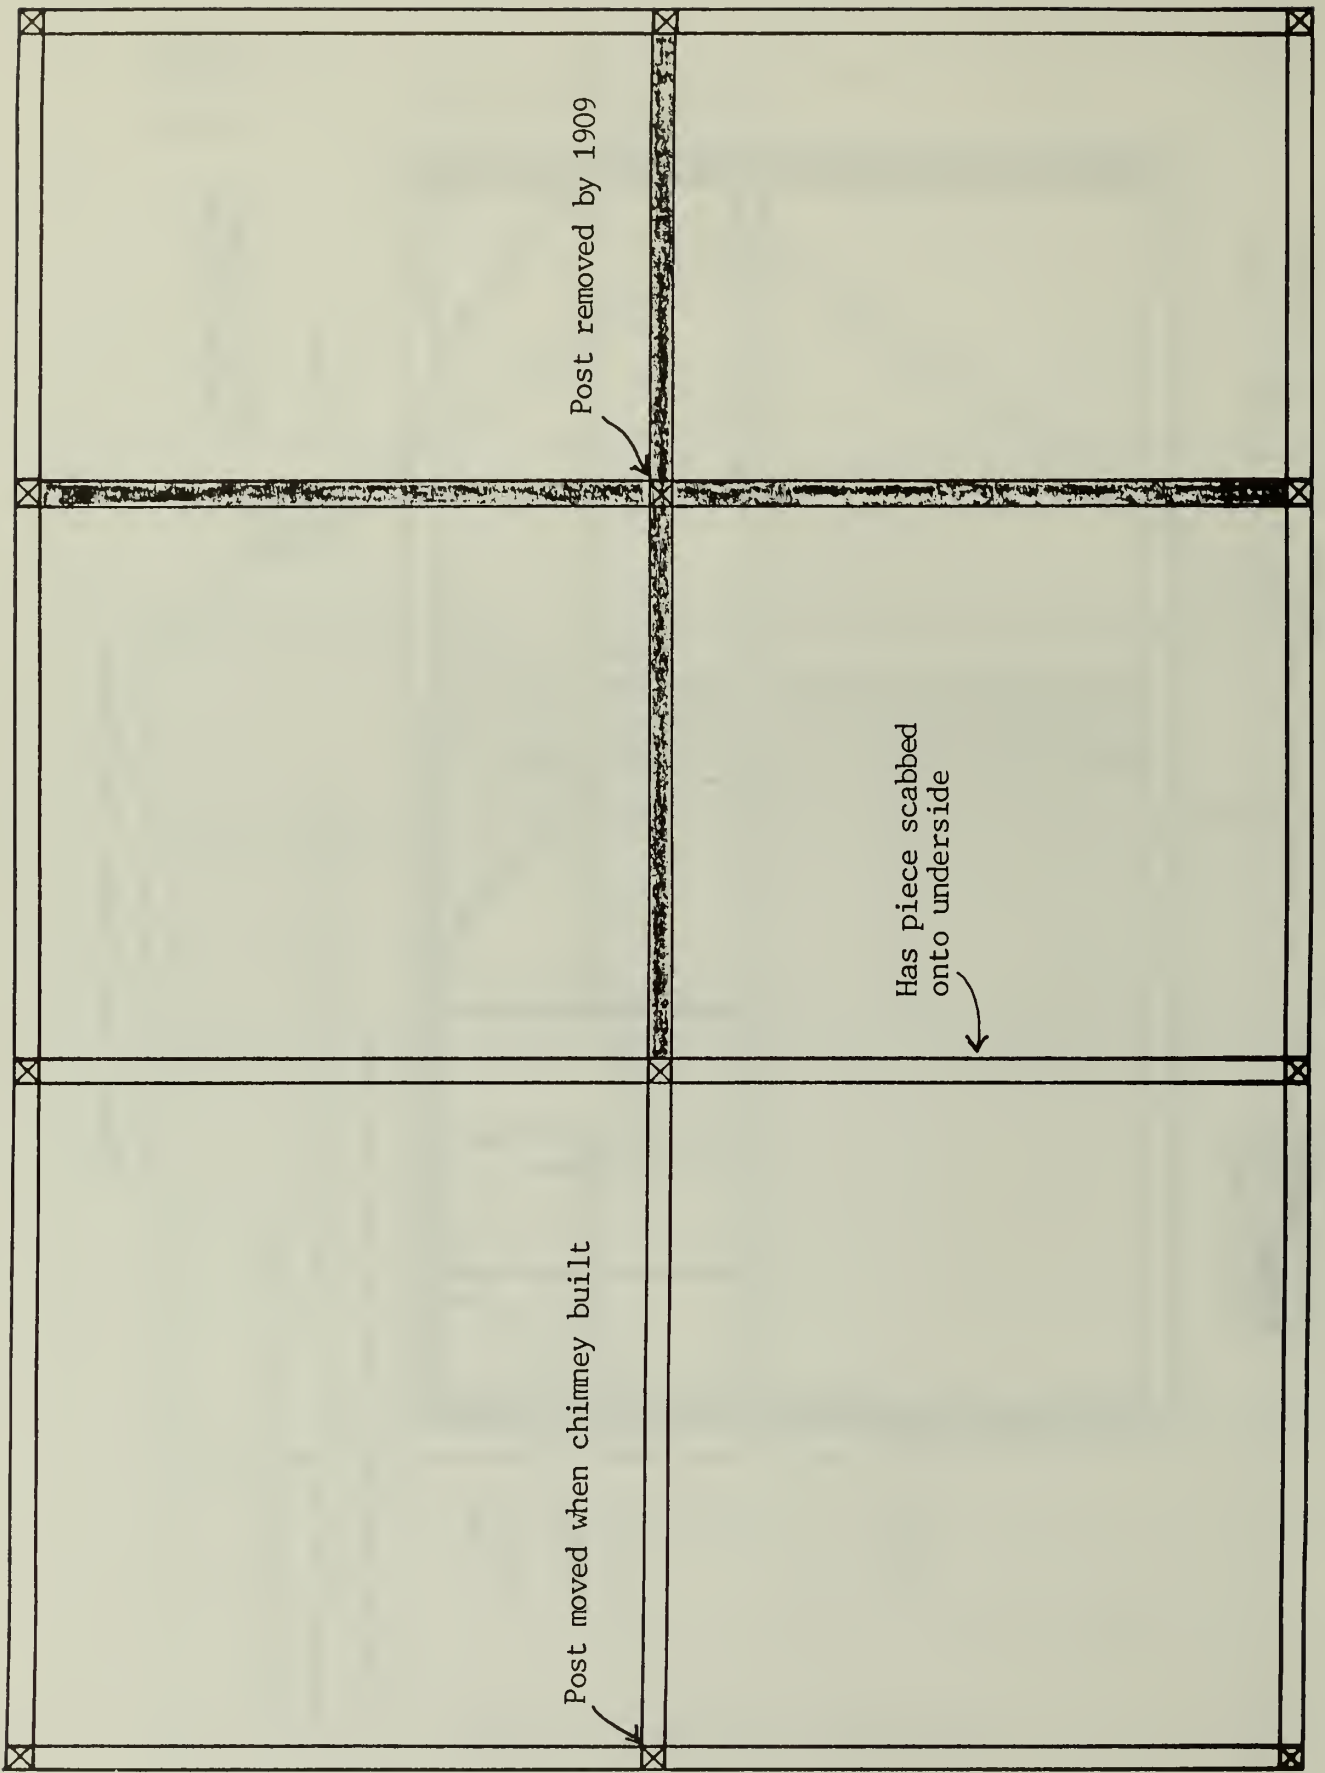
Figure 8. Barn: "Plan - Second Floor Framing."

Post removed by 1909

Post moved when chimney built

Has piece scabbed onto underside

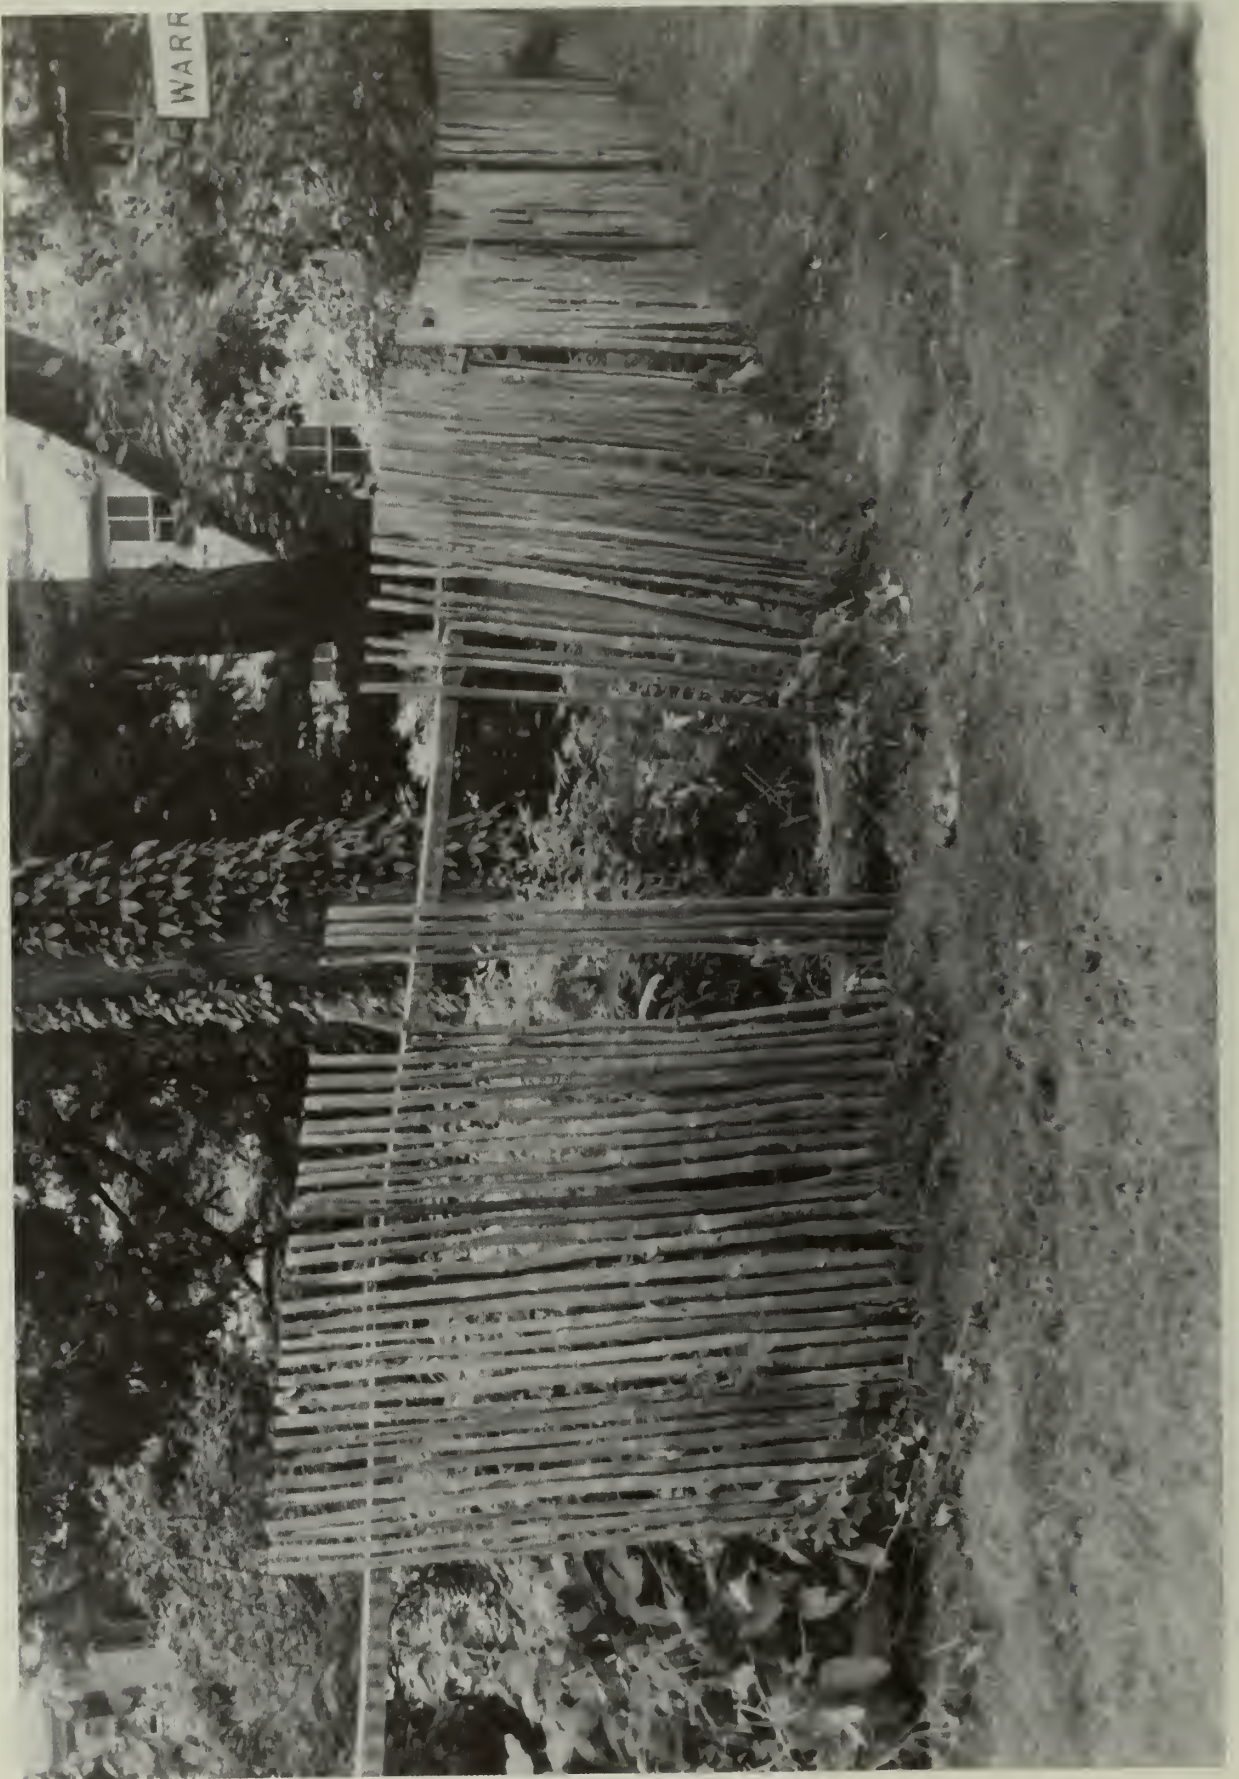
Figure 52. Spruce pole fence: dismantling of existing fence during the 1984 rebuilding.

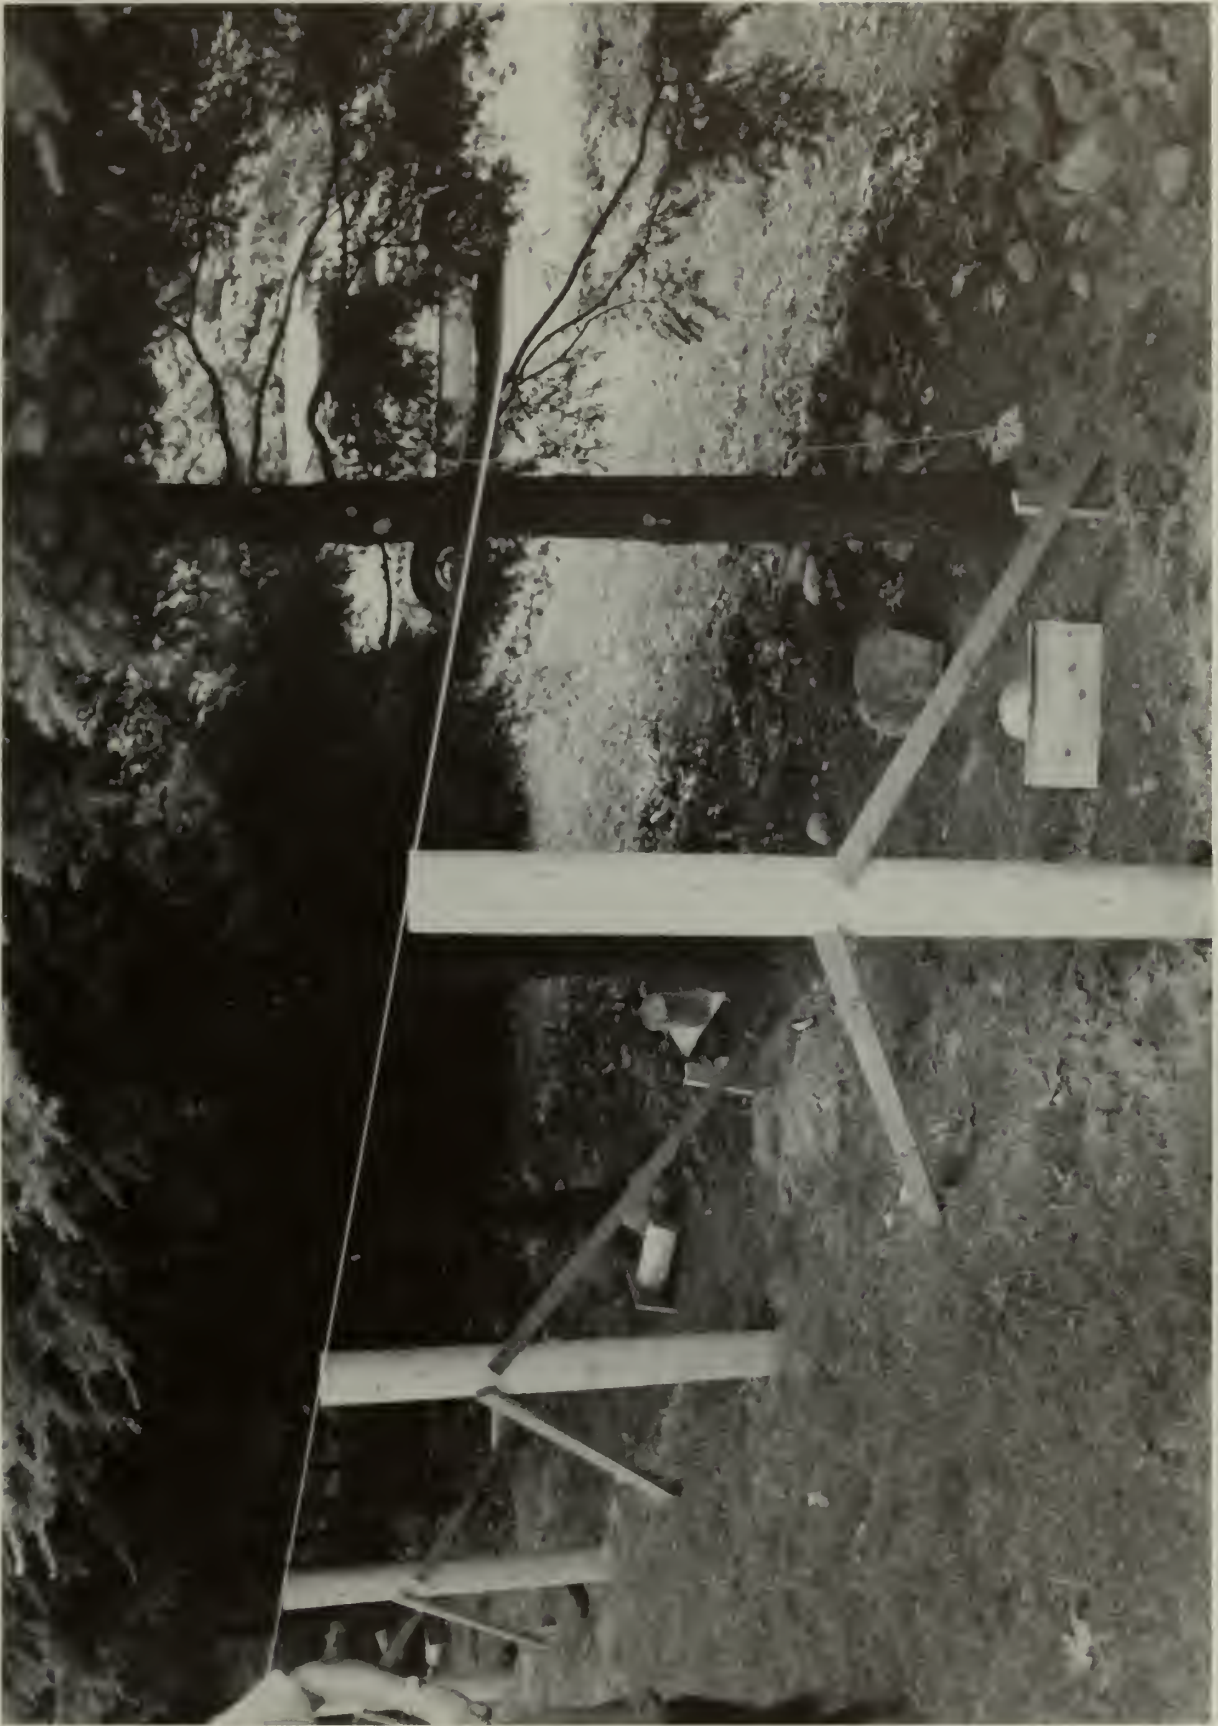
Figure 53. Spruce pole fence: setting new fence posts during the 1984 rebuilding.

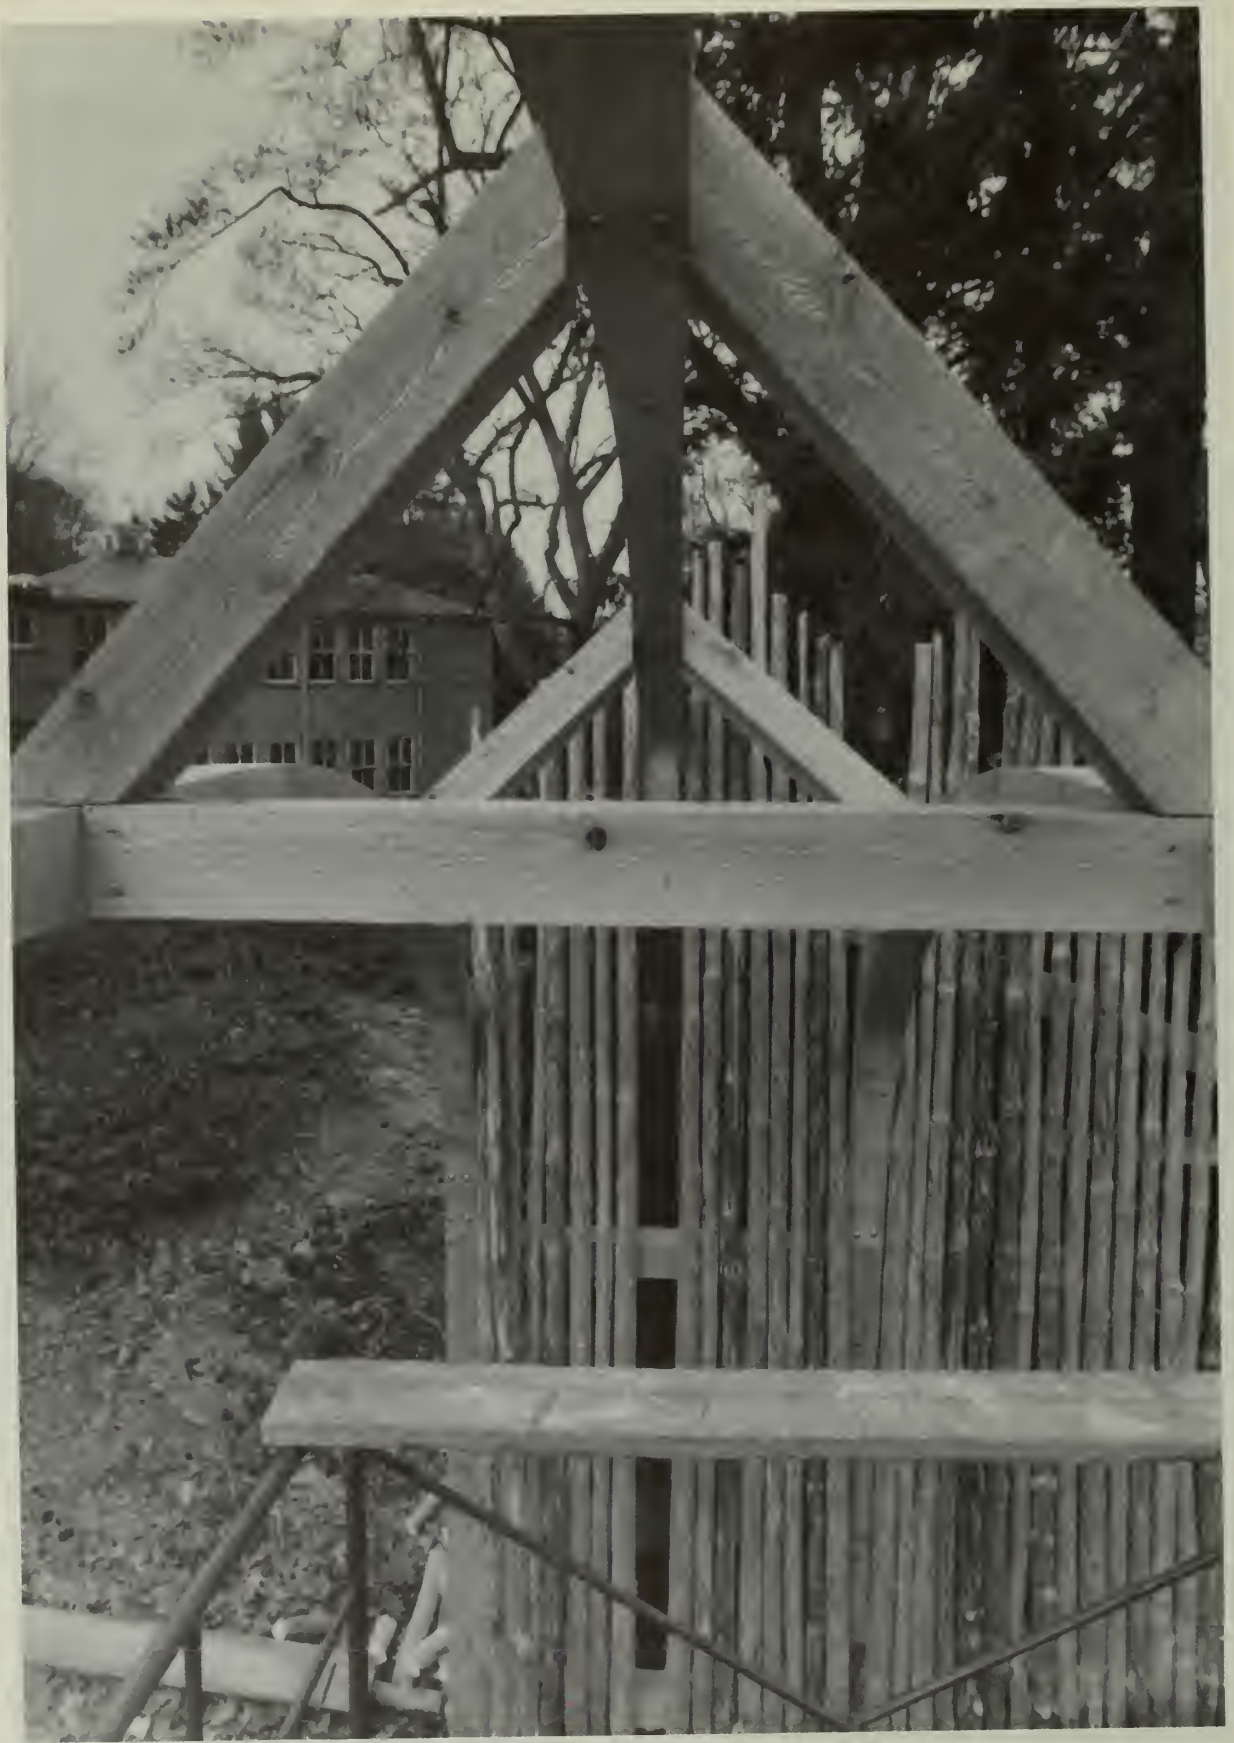
Figure 54. Spruce pole fence: reconstruction of the front driveway arch during the 1984 rebuilding.

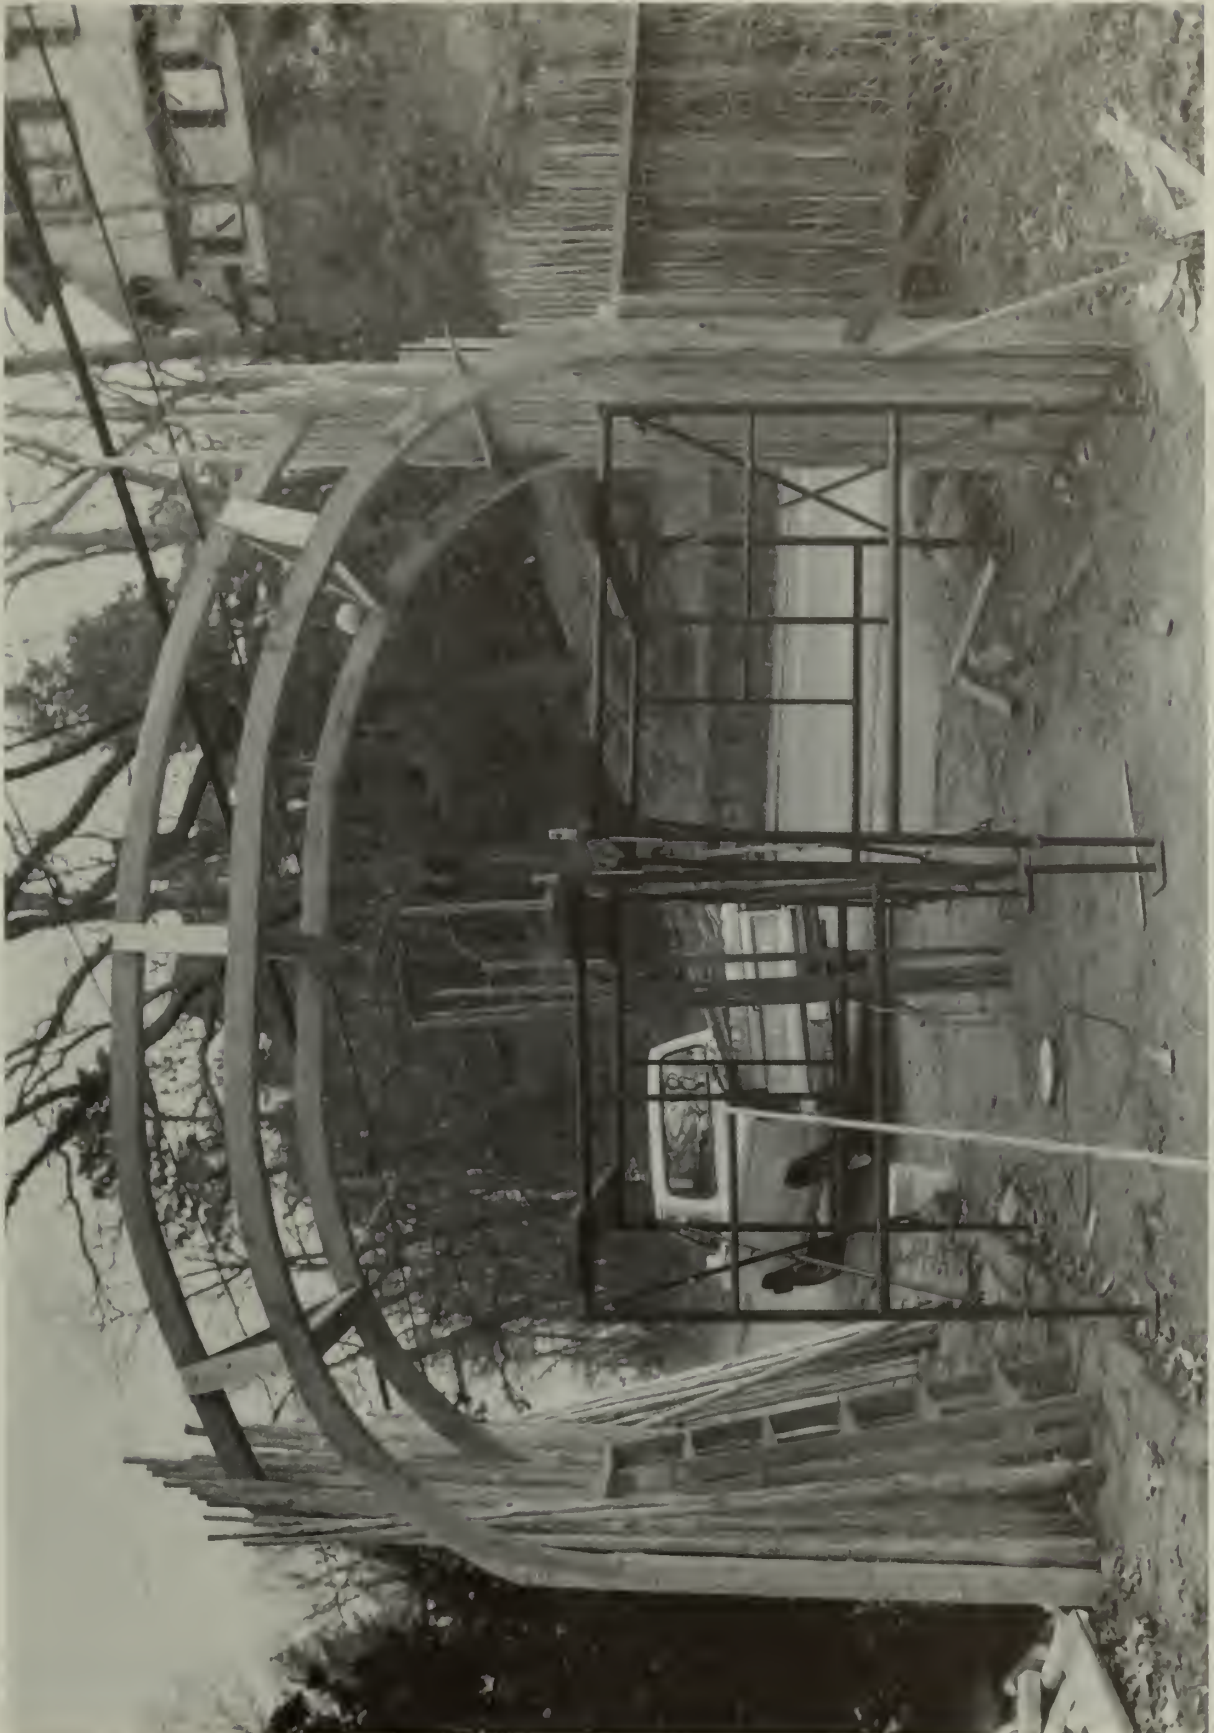
Figure 55. Spruce pole fence: reconstruction of the front driveway arch during the 1984 rebuilding.

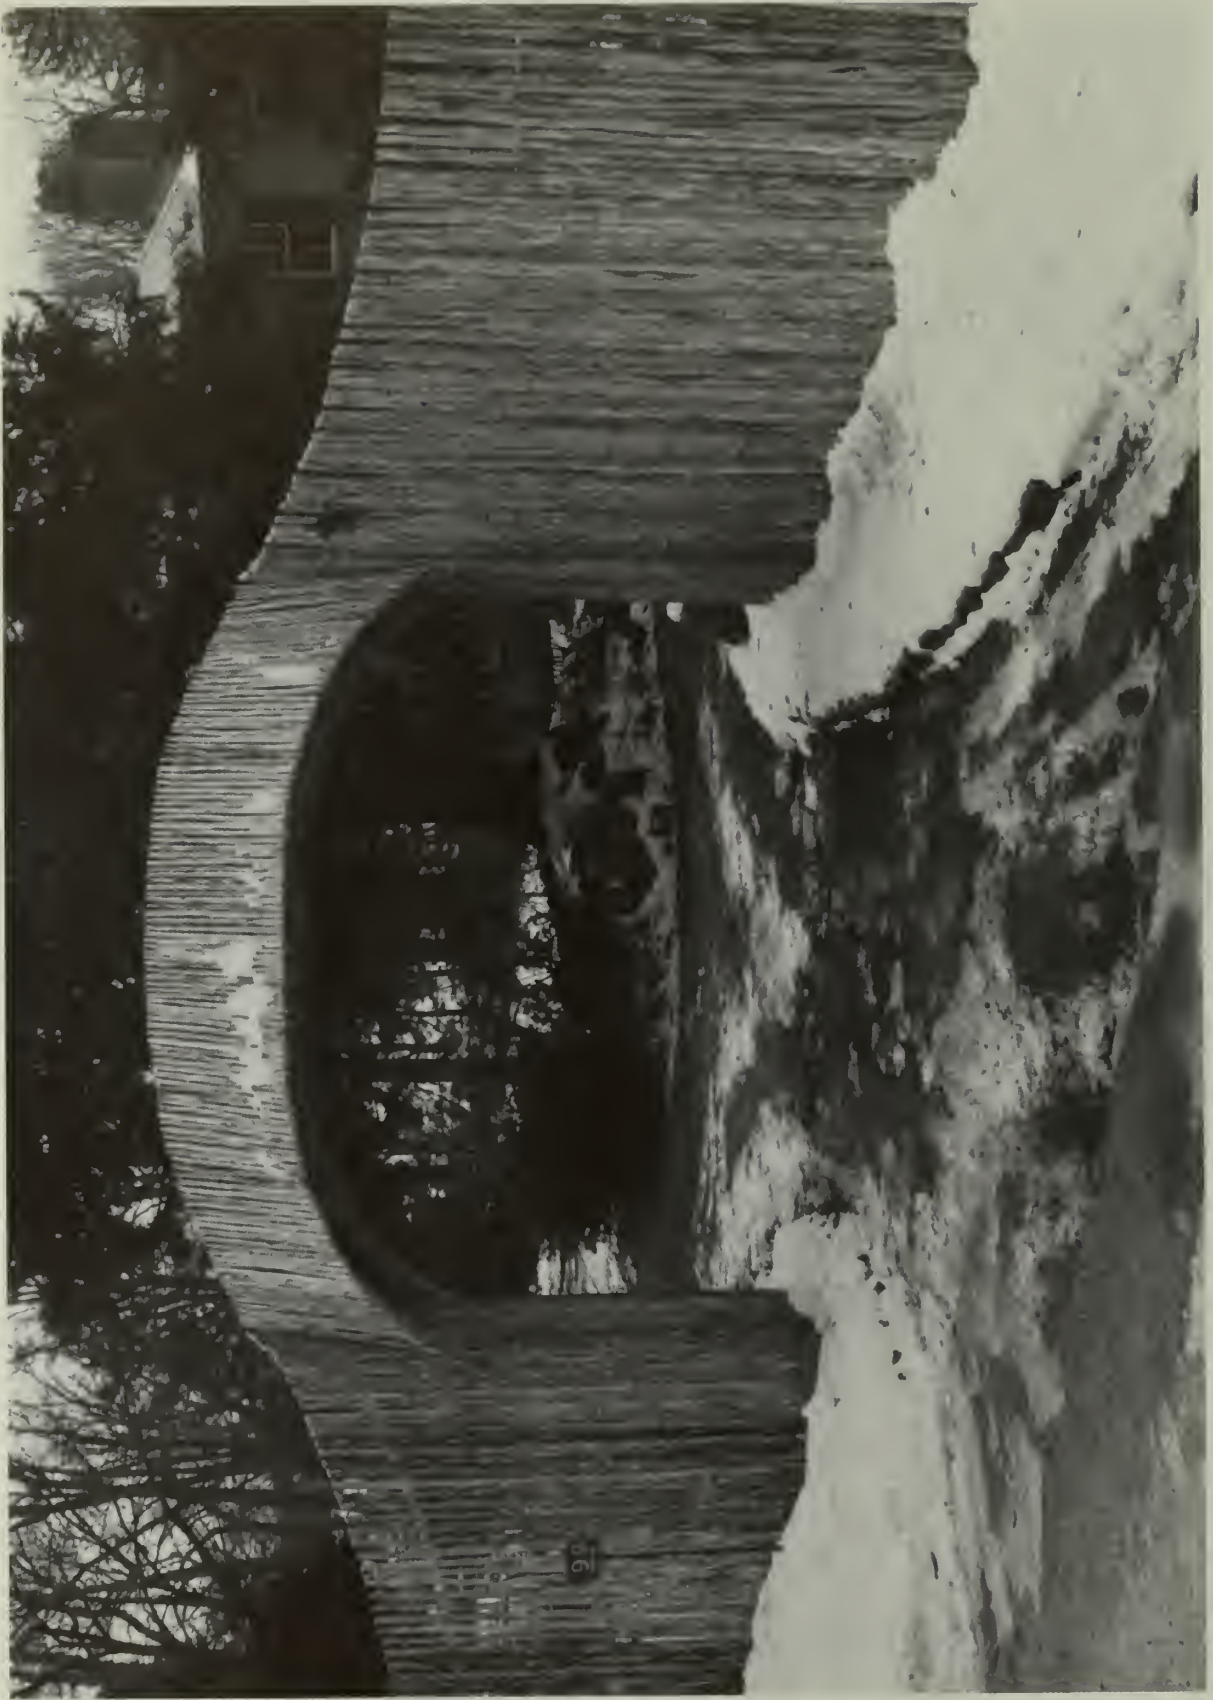
Figure 56. Spruce pole fence: front driveway arch completed during the 1984 rebuilding.
