Technical Preservation Services
Preservation Assistance Division
National Park Service
U.S. Department of the Interior
Washington, D.C.

Interpreting the Secretary of the Interior's Standards for Rehabilitation

Volume III

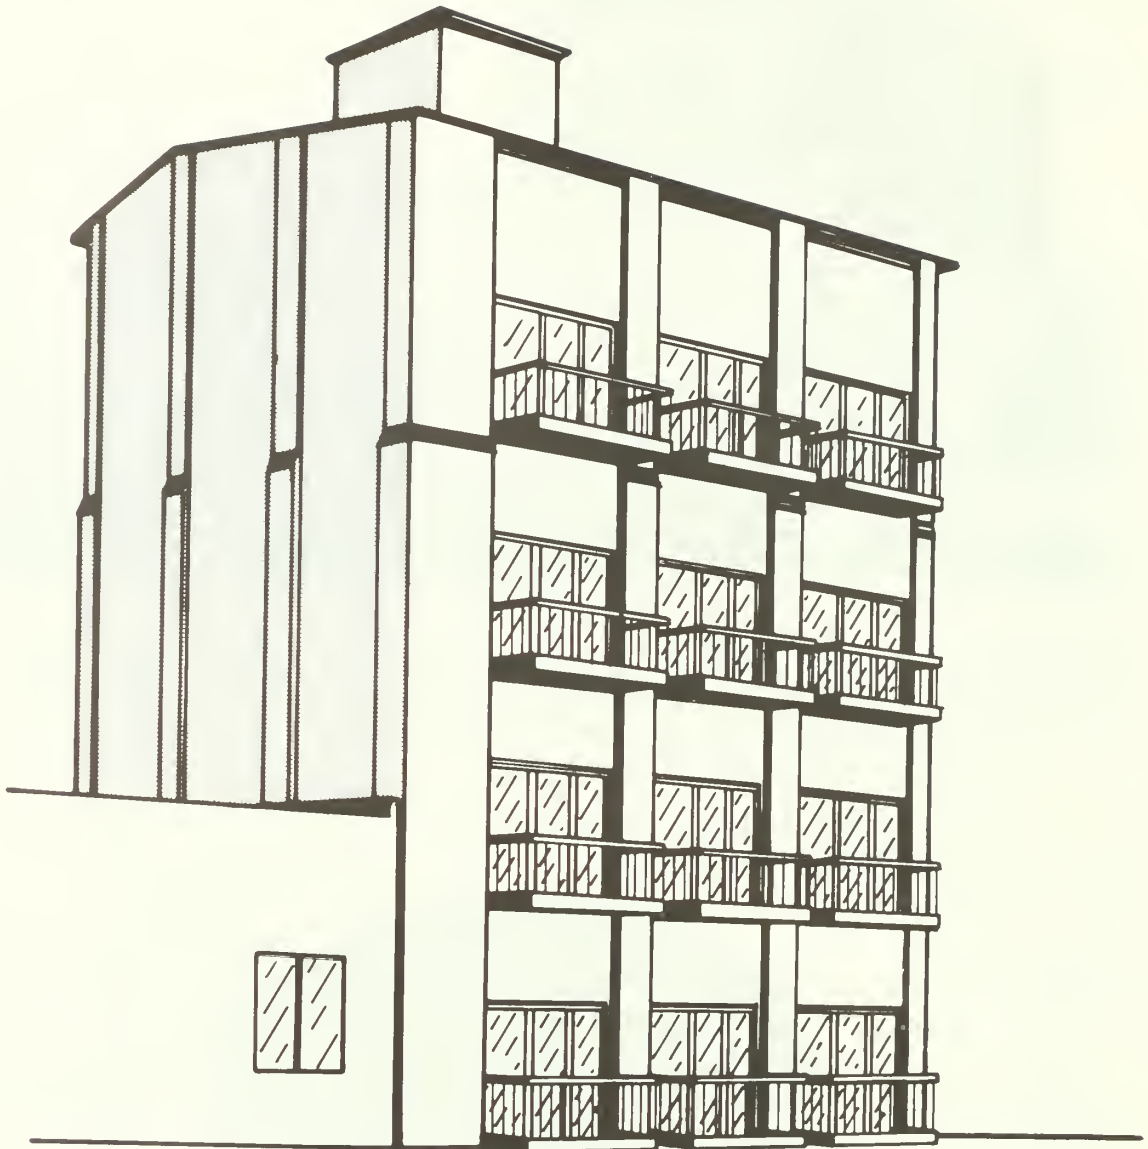
3. The rehabilitation proposal involved cutting windows on two highly visible side elevations and adding balconies. The National Park Service determined that the degree of change to accommodate this particular re-use proposal was not consistent with the historic character of the building; thus, approval was denied.

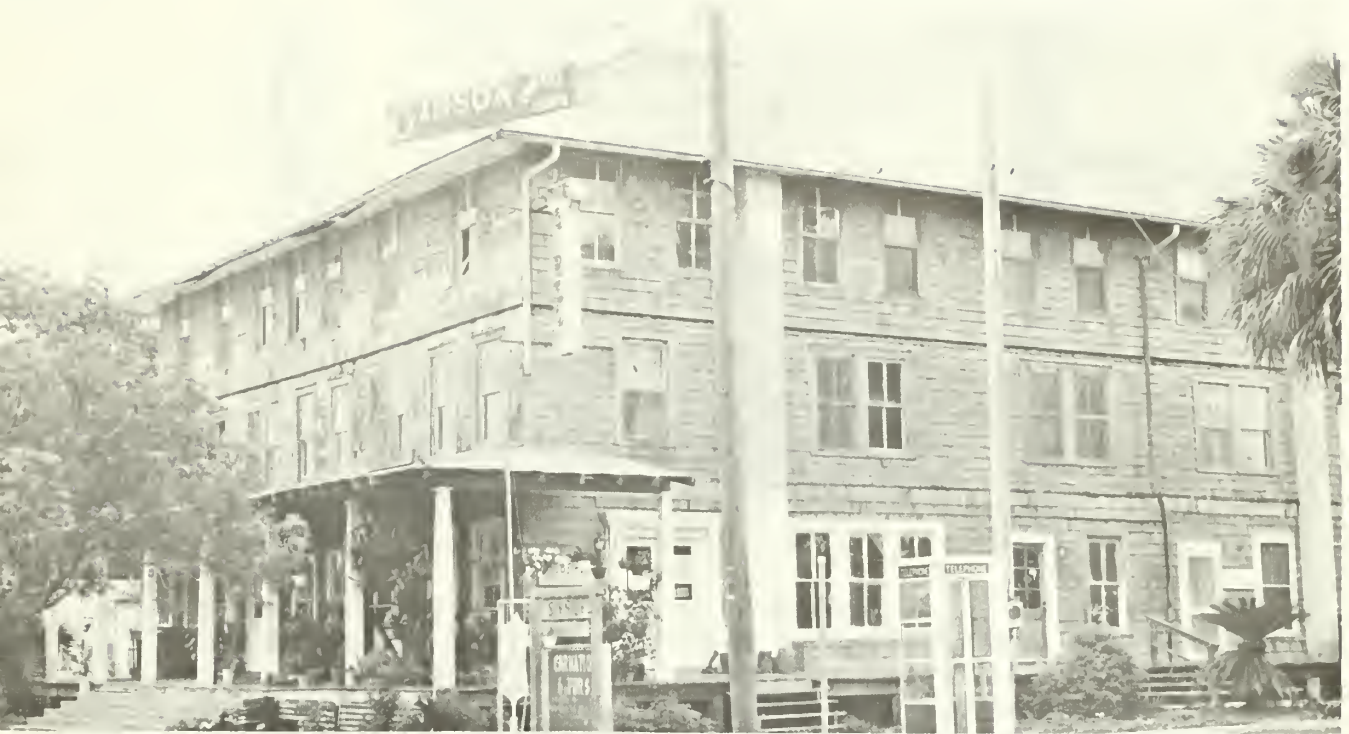
2. The hotel in 1984, prior to rehabilitation. The cupola and dormers are missing, and although a one-story front porch spans the primary elevation, it bears little resemblance to the two-story historic porch shown in the 1907 photograph. The hotel was certified as contributing to the significance of the historic district in its existing condition.

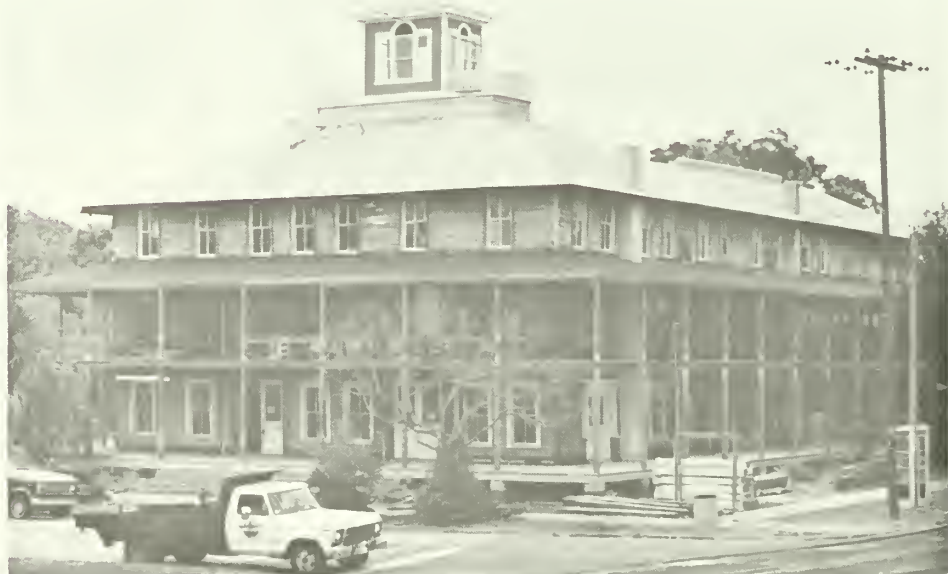
5. Hotel under rehabilitation for tax benefits. The restored cupola and two story front porch can be seen. On appeal, the Region's denial was upheld. There was neither photographic documentation nor physical evidence to support restoration of the building to the appearance shown here. The result was a "selective" restoration of architectural features that--while commercially appealing--could not be historically documented to the 1907 or the 1920 appearance.

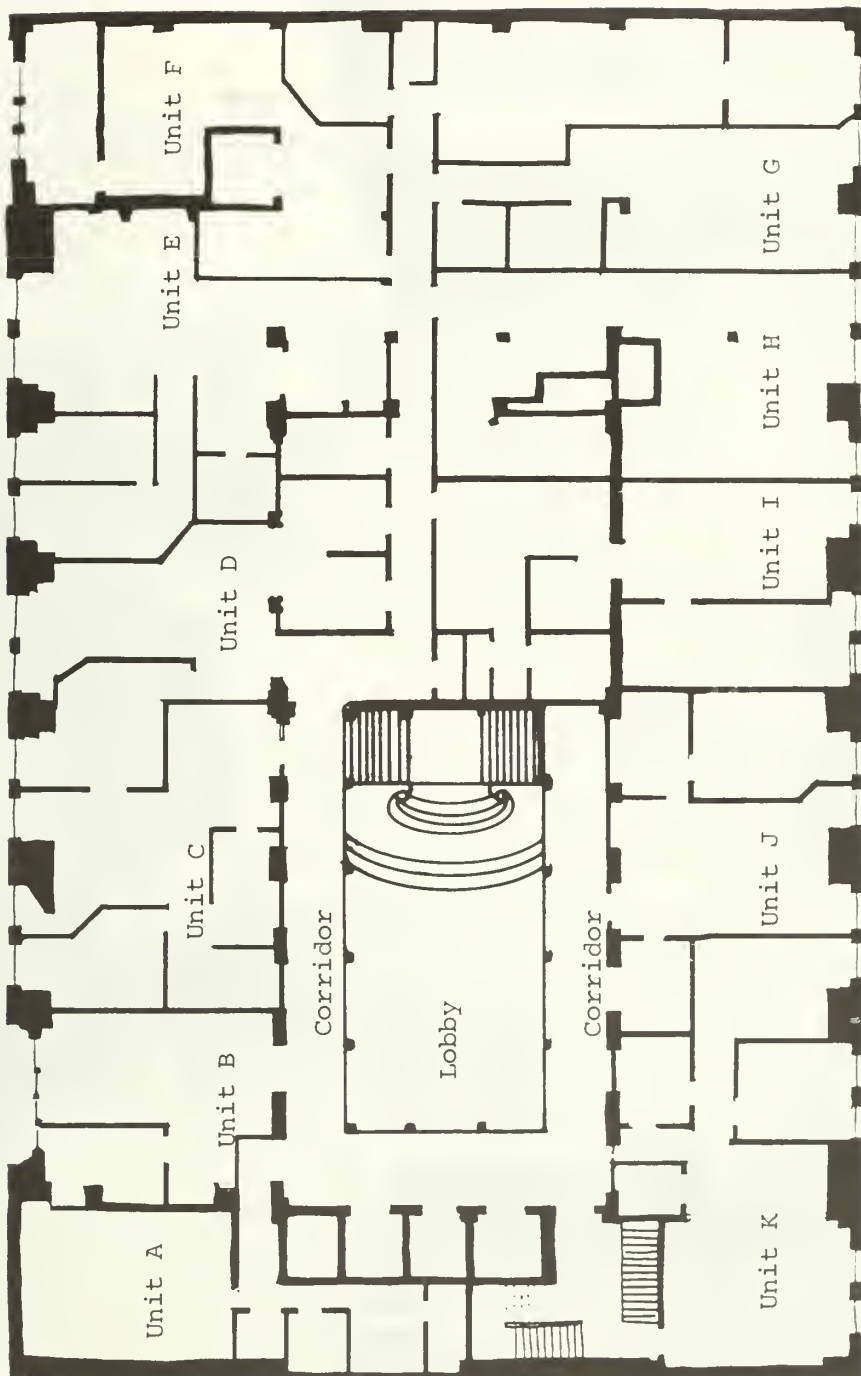
5. Lobby and adjoining spaces after rehabilitation. The palm room and dining room have been subdivided. A new partition directly behind the decorative screen has destroyed the progression of spaces that marked the original design.

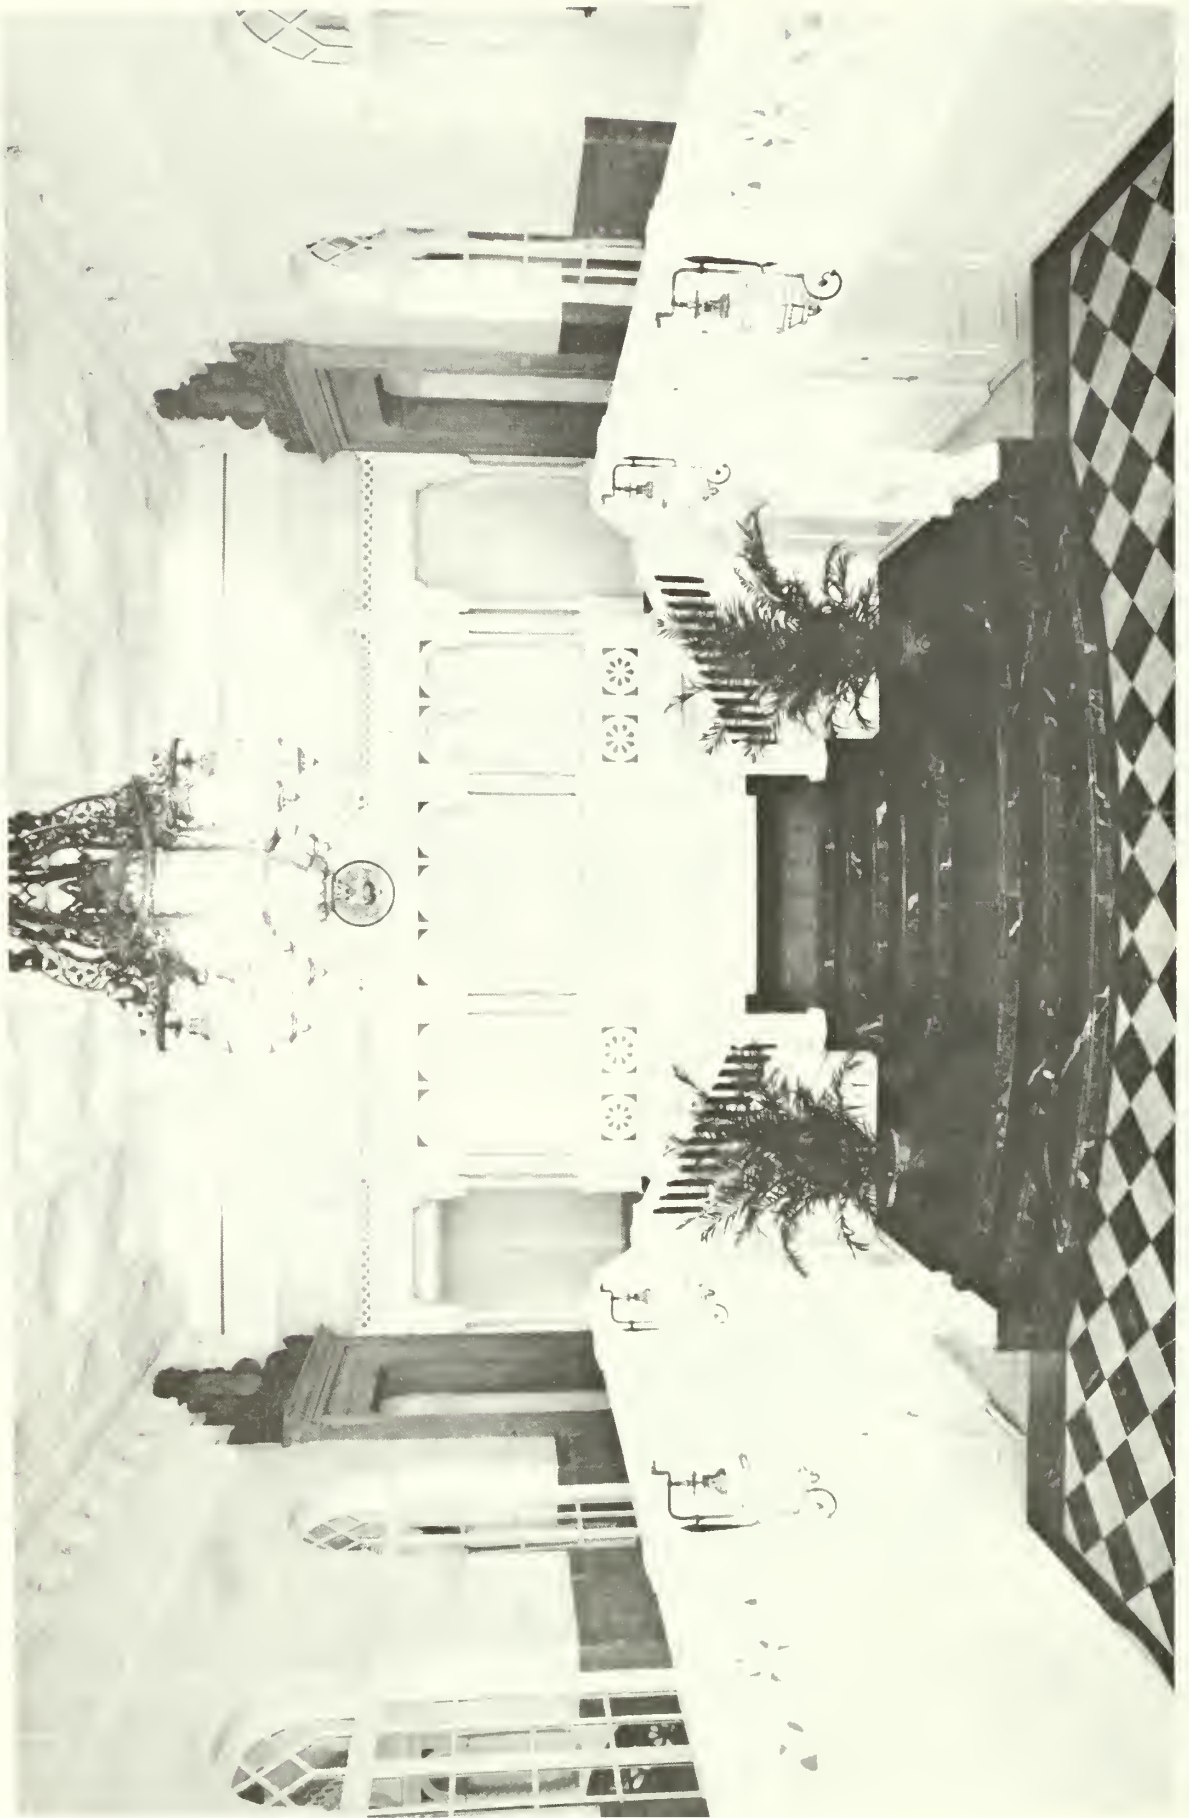
6. Lobby after rehabilitation. Partition behind screen closes off palm room and dining room from the lobby.

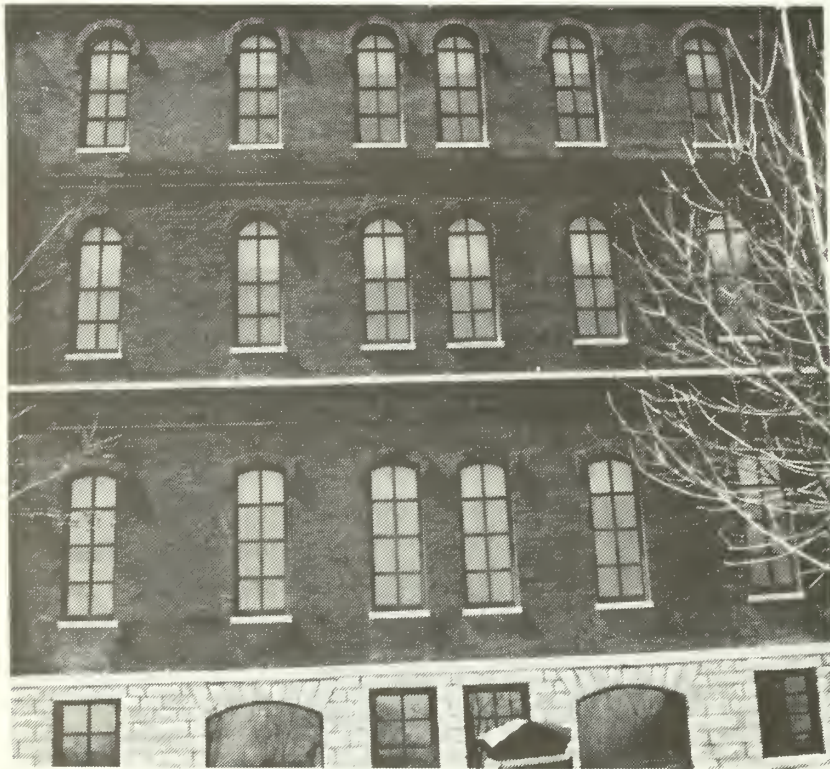
4 and 5. After rehabilitation, there is a striking change in the appearance of the entire facade due to the installation of inappropriate replacement windows. In addition to the obvious color disparity, the unit is noticeably on one plane rather than double-hung. The muntins are also much heavier and there is no meeting rail.

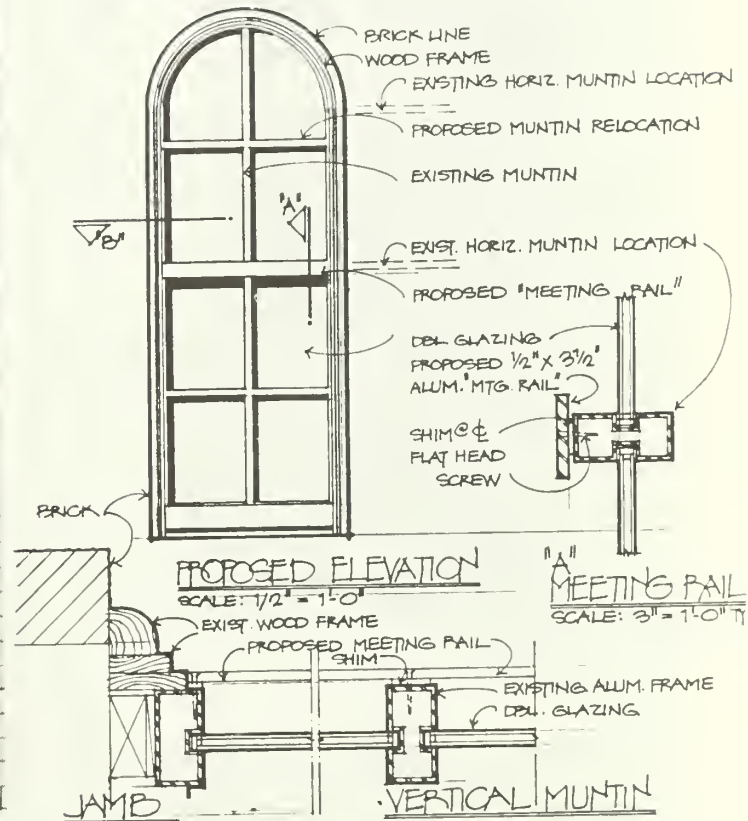
6. In an attempt to bring the inappropriate four-over-four replacement units (see 4 and 5.) into conformance with the Standards, two alternatives were proposed. In proposal A, the horizontal muntin at the top would be relocated so that all eight lights would be of equal size like the original. A 3 1/2" wide aluminum strip would be applied in an attempt to recapture some aspects of the meeting rail. Even after these adjustments, however, the upper and lower sash would read as a single, fixed unit; the muntins are also too wide and too flat.

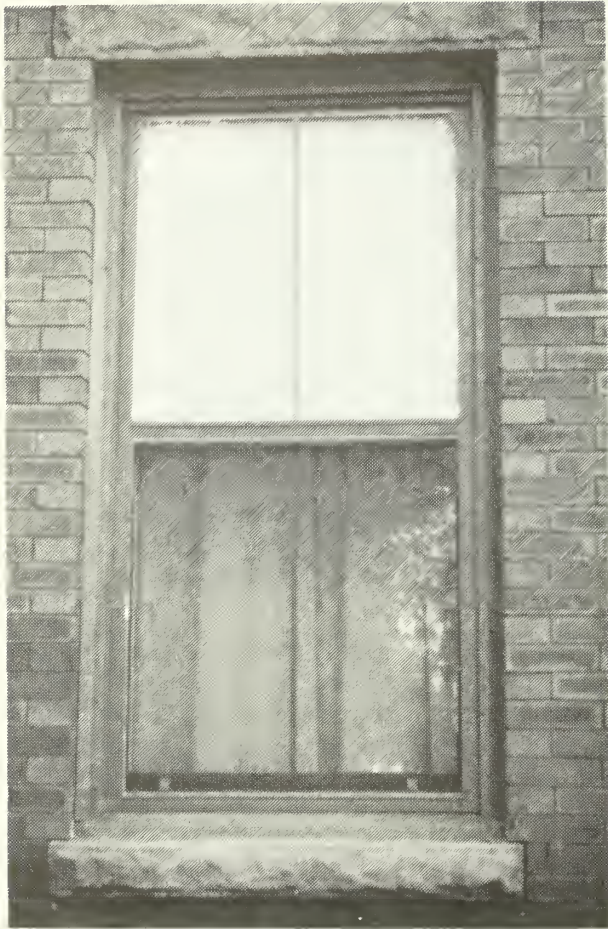
3. Post-rehabilitation photograph of aluminum replacement window. The vertical muntin was sandwiched within the insulating glass and the double-hung appearance changed since the screen panel was installed directly below the fixed upper sash.

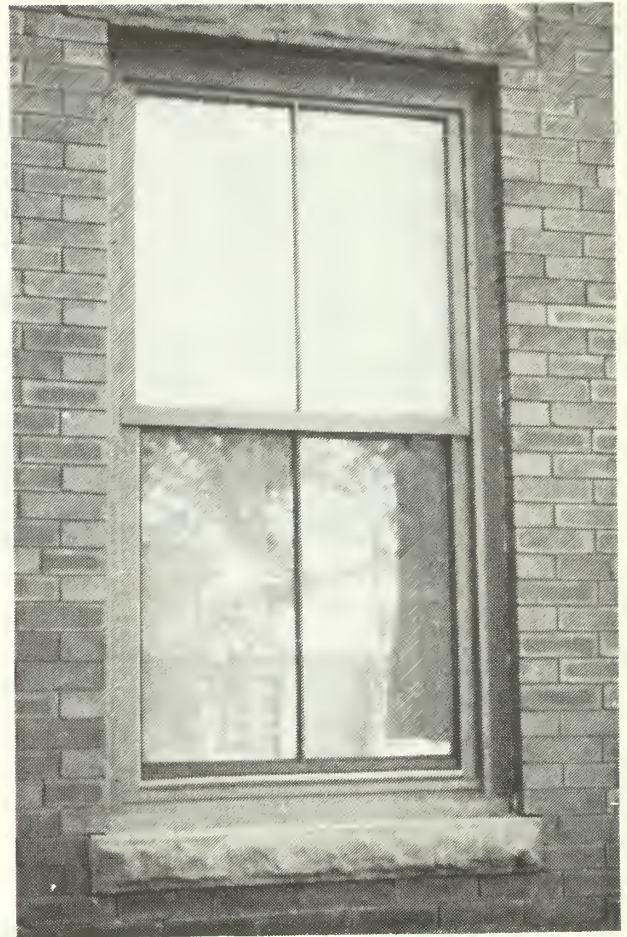
4. Aluminum replacement window with a wood mock-up of an applied unglazed sash frame and muntin placed over the upper aluminum sash. The applied frame and muntin look like temporary add-ons, rather than matching the historic sash.

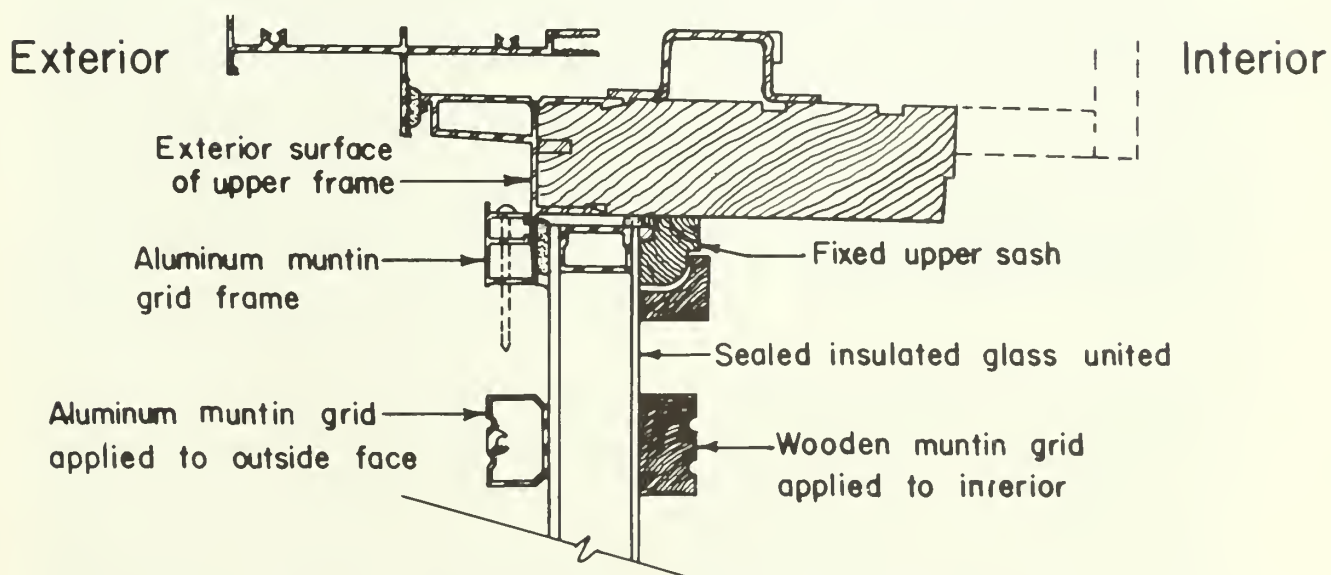
6. Shop drawing showing applied muntin grid projecting beyond the exterior surface of the sash. Also note rectangular shape and the two grooves on the interior and exterior muntin grids which produce the ribbed appearance and additional shadow lines that did not exist on the historic windows.

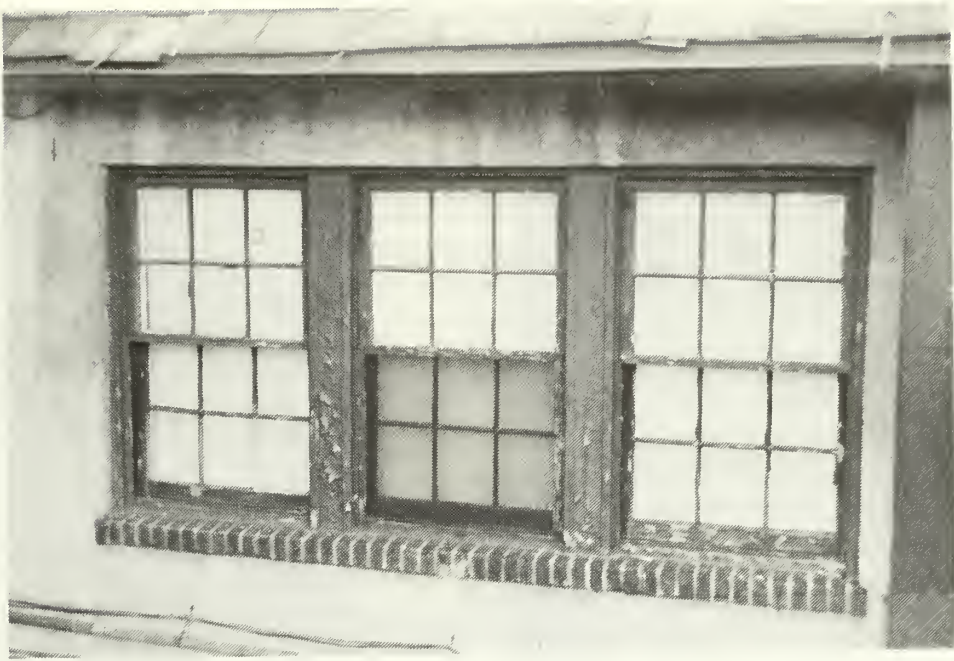
4-5. Pre-rehabilitation views of the deteriorated historic windows. Note beaded mullion above, thin muntins, meeting rails and sash on paired windows and the simple double-hung window below.

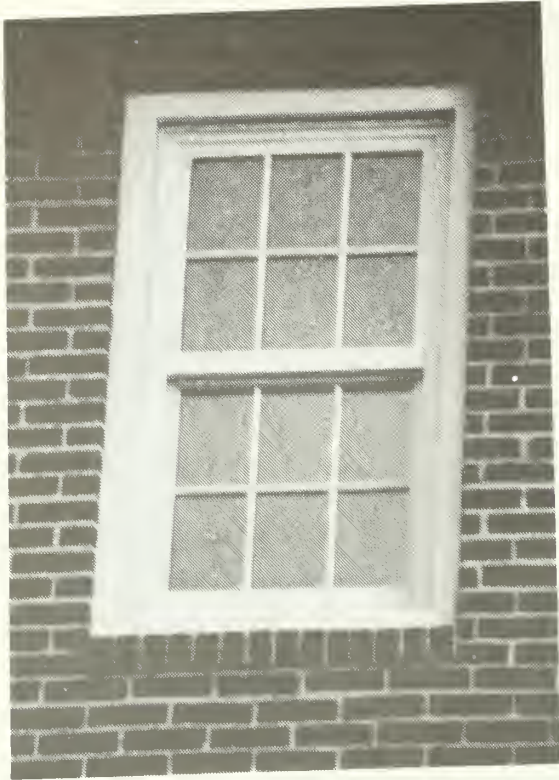
6. Proposed replacement window, exterior. Note rectangular panning, extensive subframe creating additional shadow lines. Compare the meeting rail and muntin dimensions with the historic sash in 4-5.

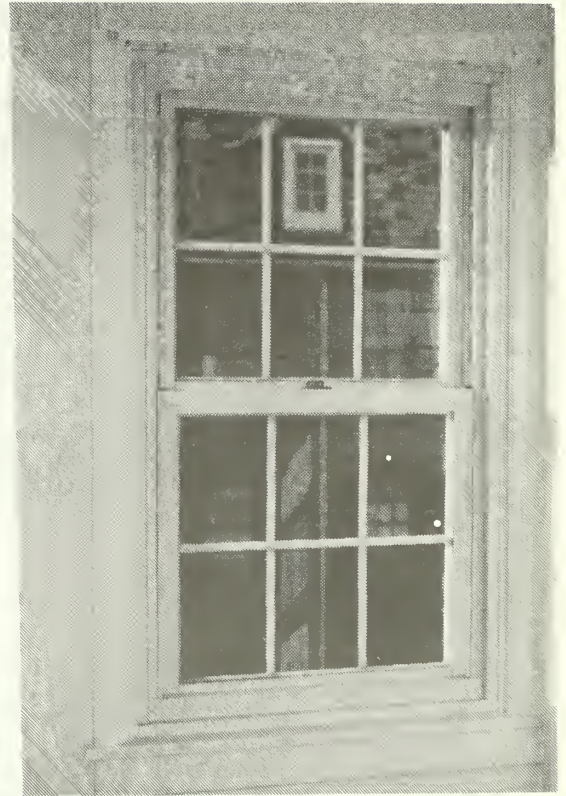
7. Proposed replacement window, interior. Note the three layers of metal comprising the subframe, and the decreased size of the sash and glazed surface within the opening.

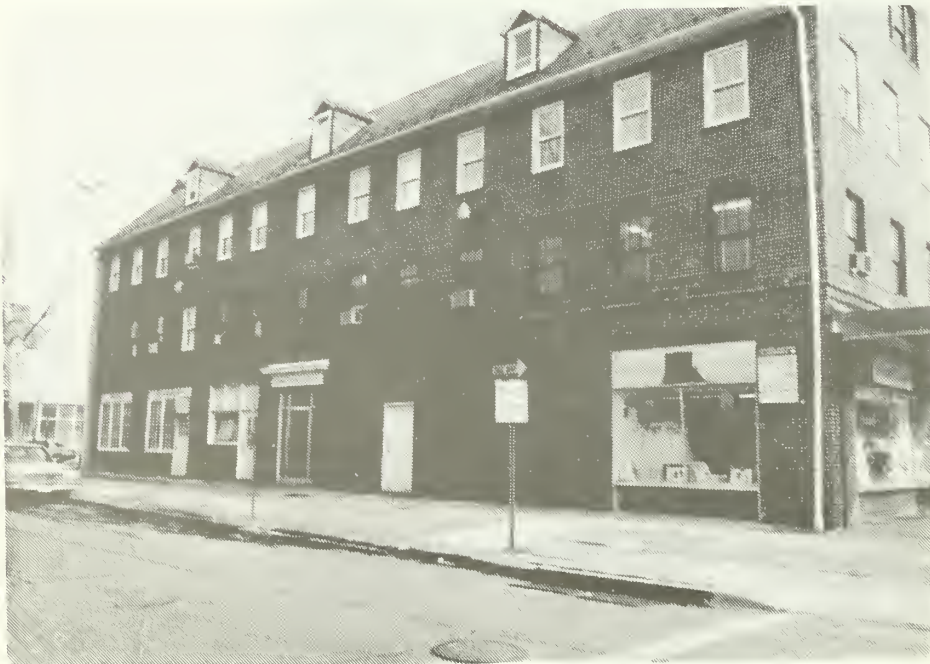
8. Proposed replacement windows on third floor and original windows below. Note how dark sash and frames are unobtrusive, light sash and frames create a striking pattern on the red brick facade.

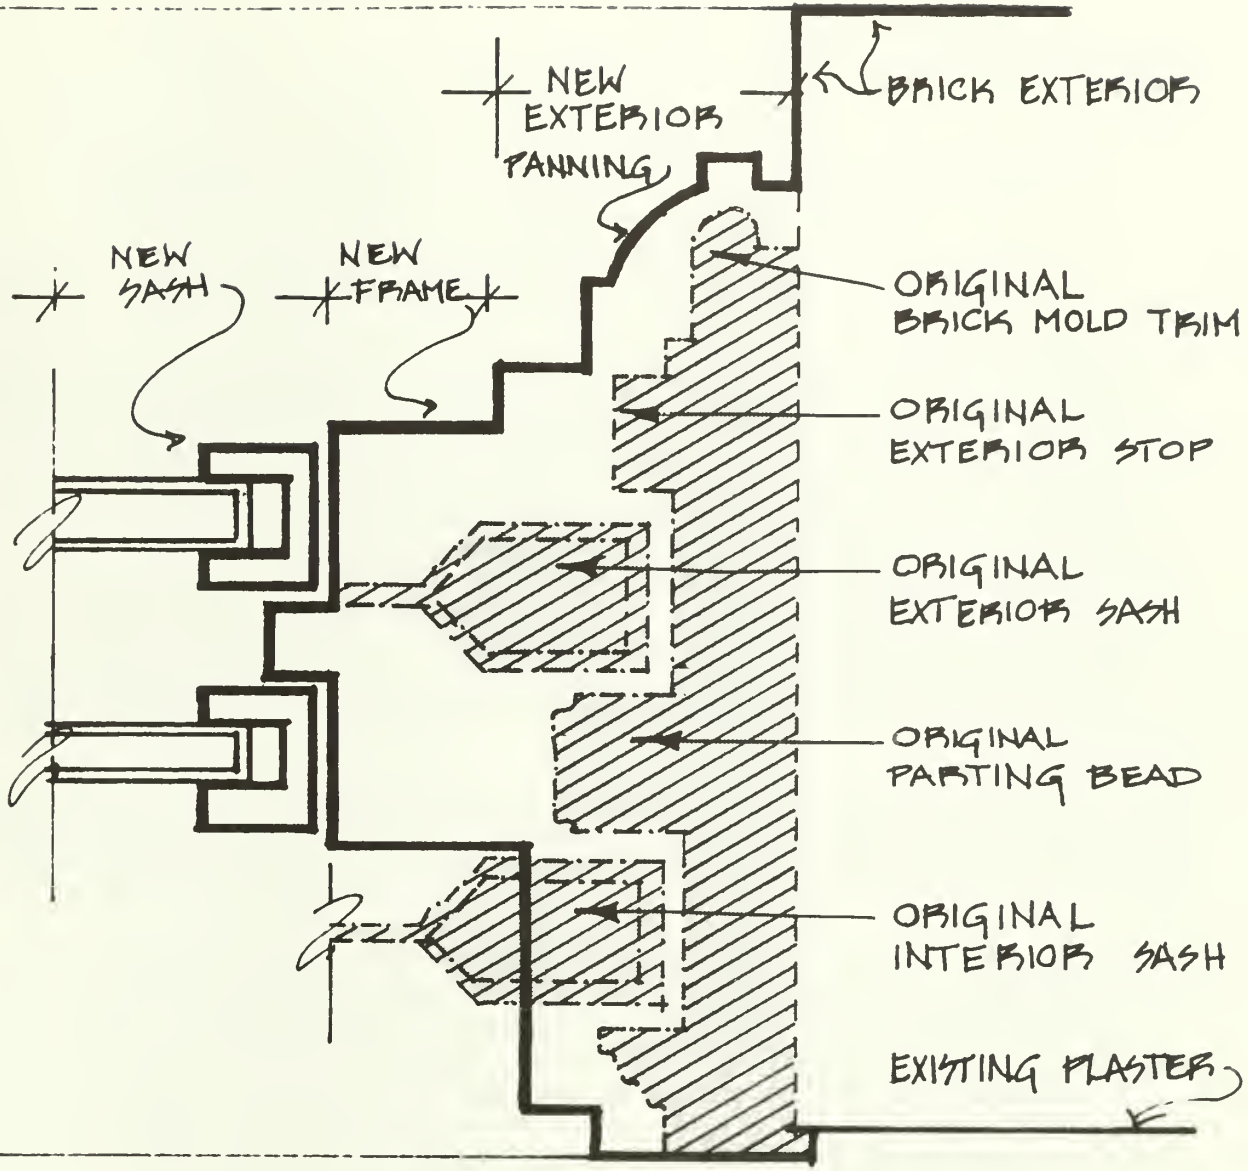
9. Drawing of proposed window and original window and frame location. Note how new sash and frame are set closer to the exterior and within the window opening. The owner's alternative panning identified above will not correct the deficiencies of the sash.

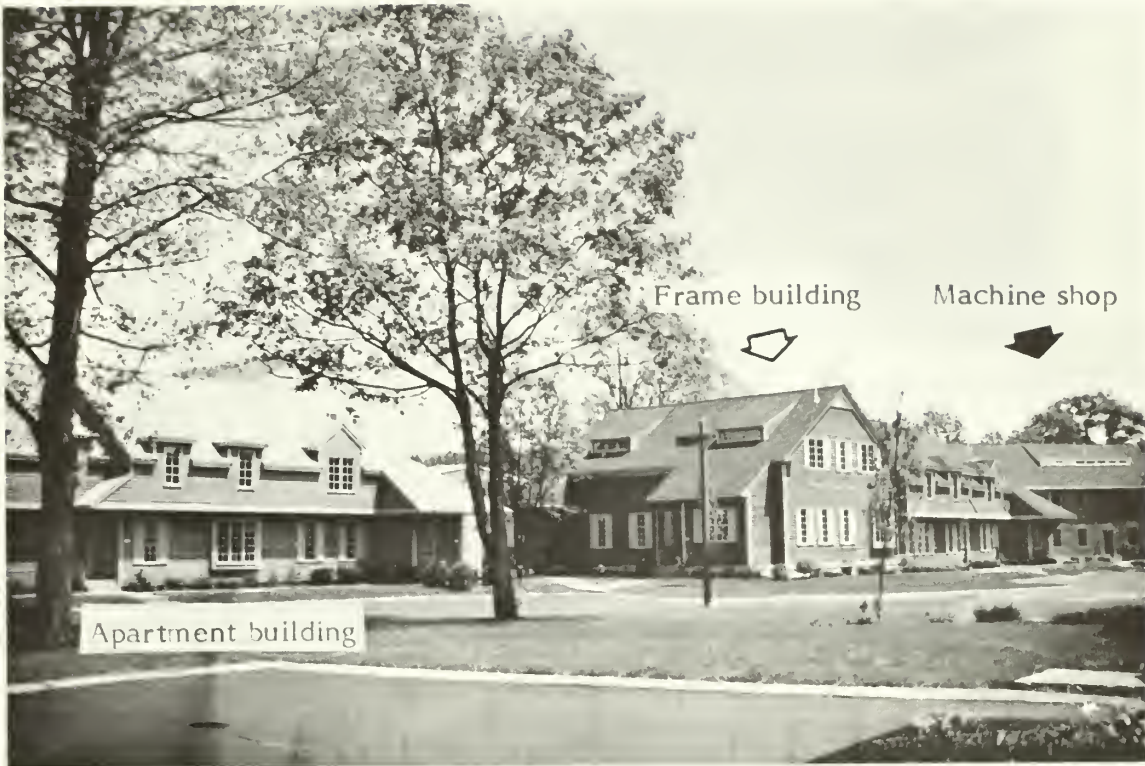
4. Post-rehabilitation view of machine shop and frame building. Note alterations to the frame building and new construction in the previous open space. The new construction introduces a variety of architectural forms and features not found on the historic buildings in the district.

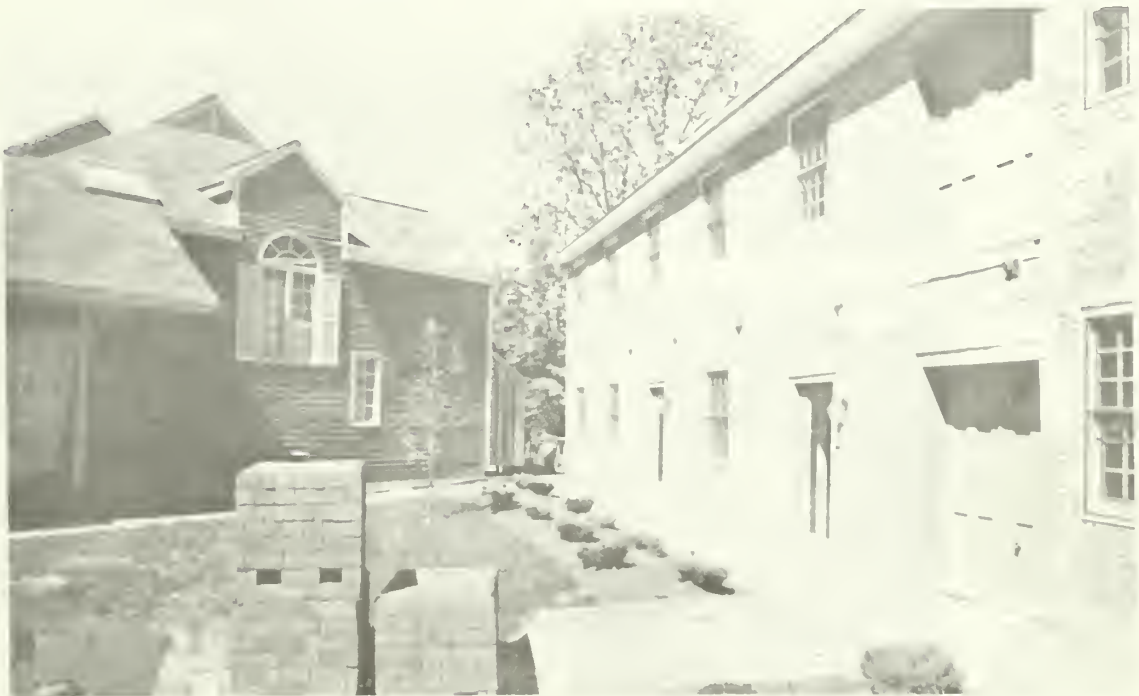
5. Note how close the frame building's new addition is located to the machine shop. A wood deck links the two structures. The new addition has created a more densely developed environment than existed prior to rehabilitation, obstructs the visibility of the machine shop, and has introduced architectural forms and features not found on historic buildings in the district. The new construction, therefore, has changed the visual qualities characteristic of the setting of this district.

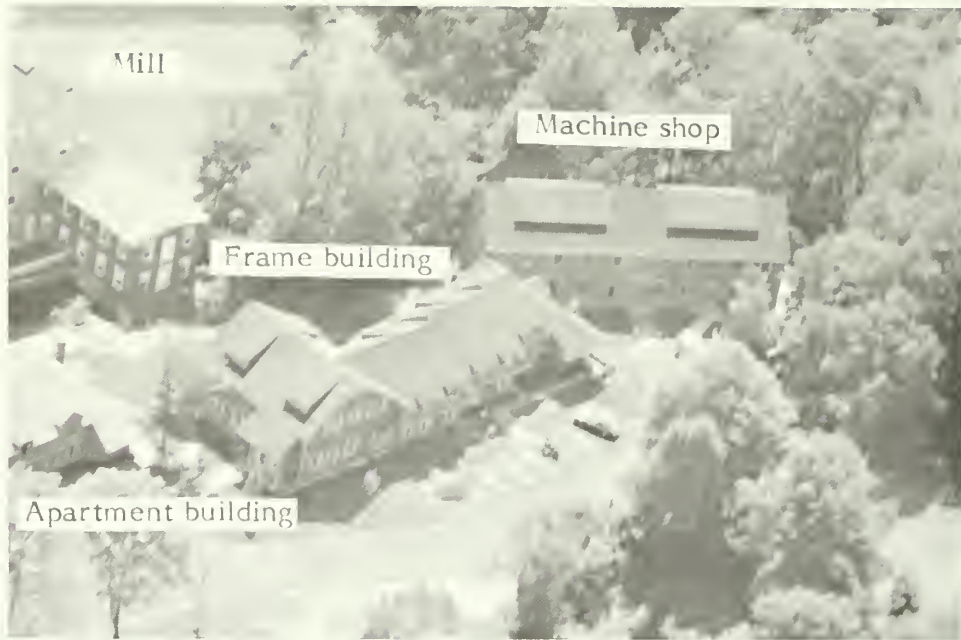
6. Aerial view of this portion of the district showing the alterations to the frame building, and a portion of the free-standing new construction on the left. The machine shop is in the center right of the picture, and the mill is located in the upper left corner. Note the more densely developed environment immediately in front of the machine shop.

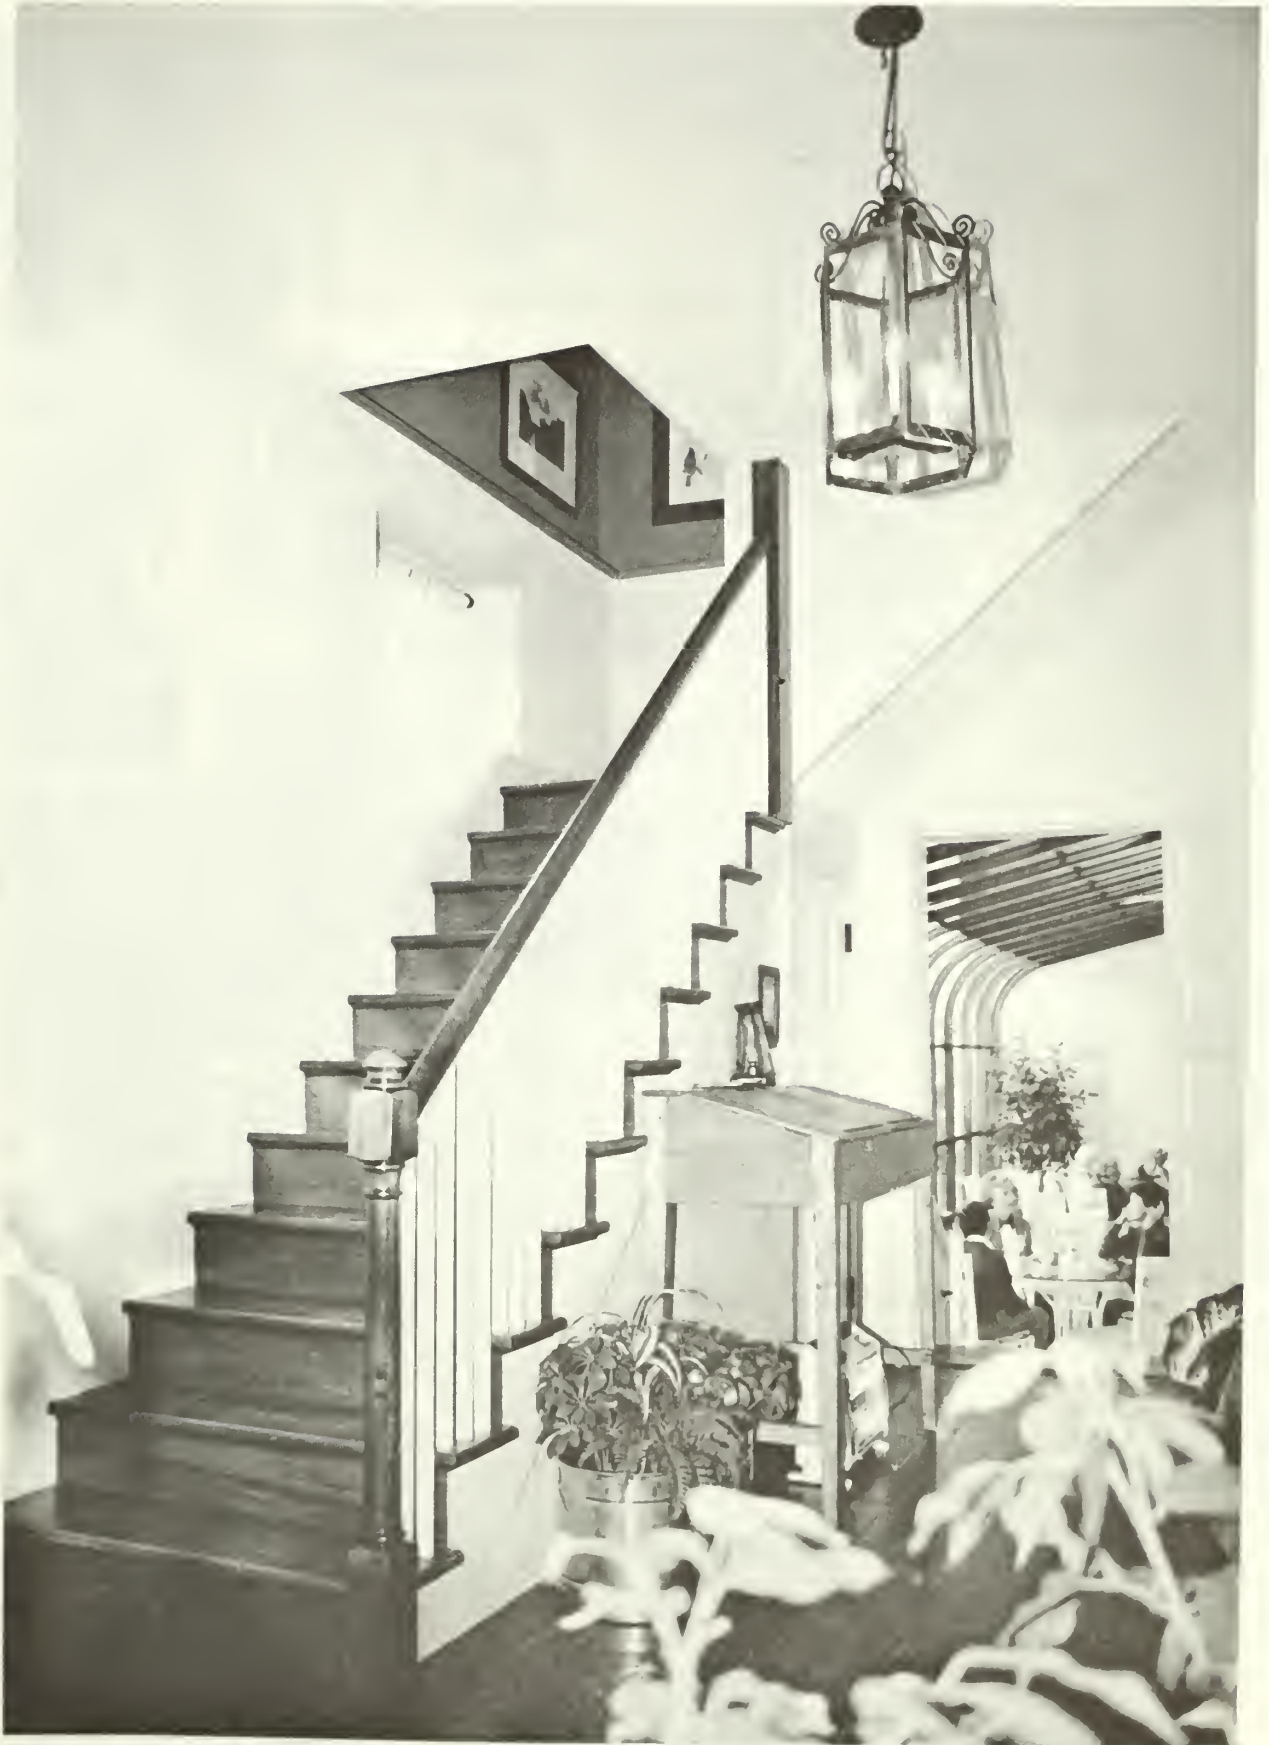
3. New stair after rehabilitation. Design of stair was not based on historic evidence.

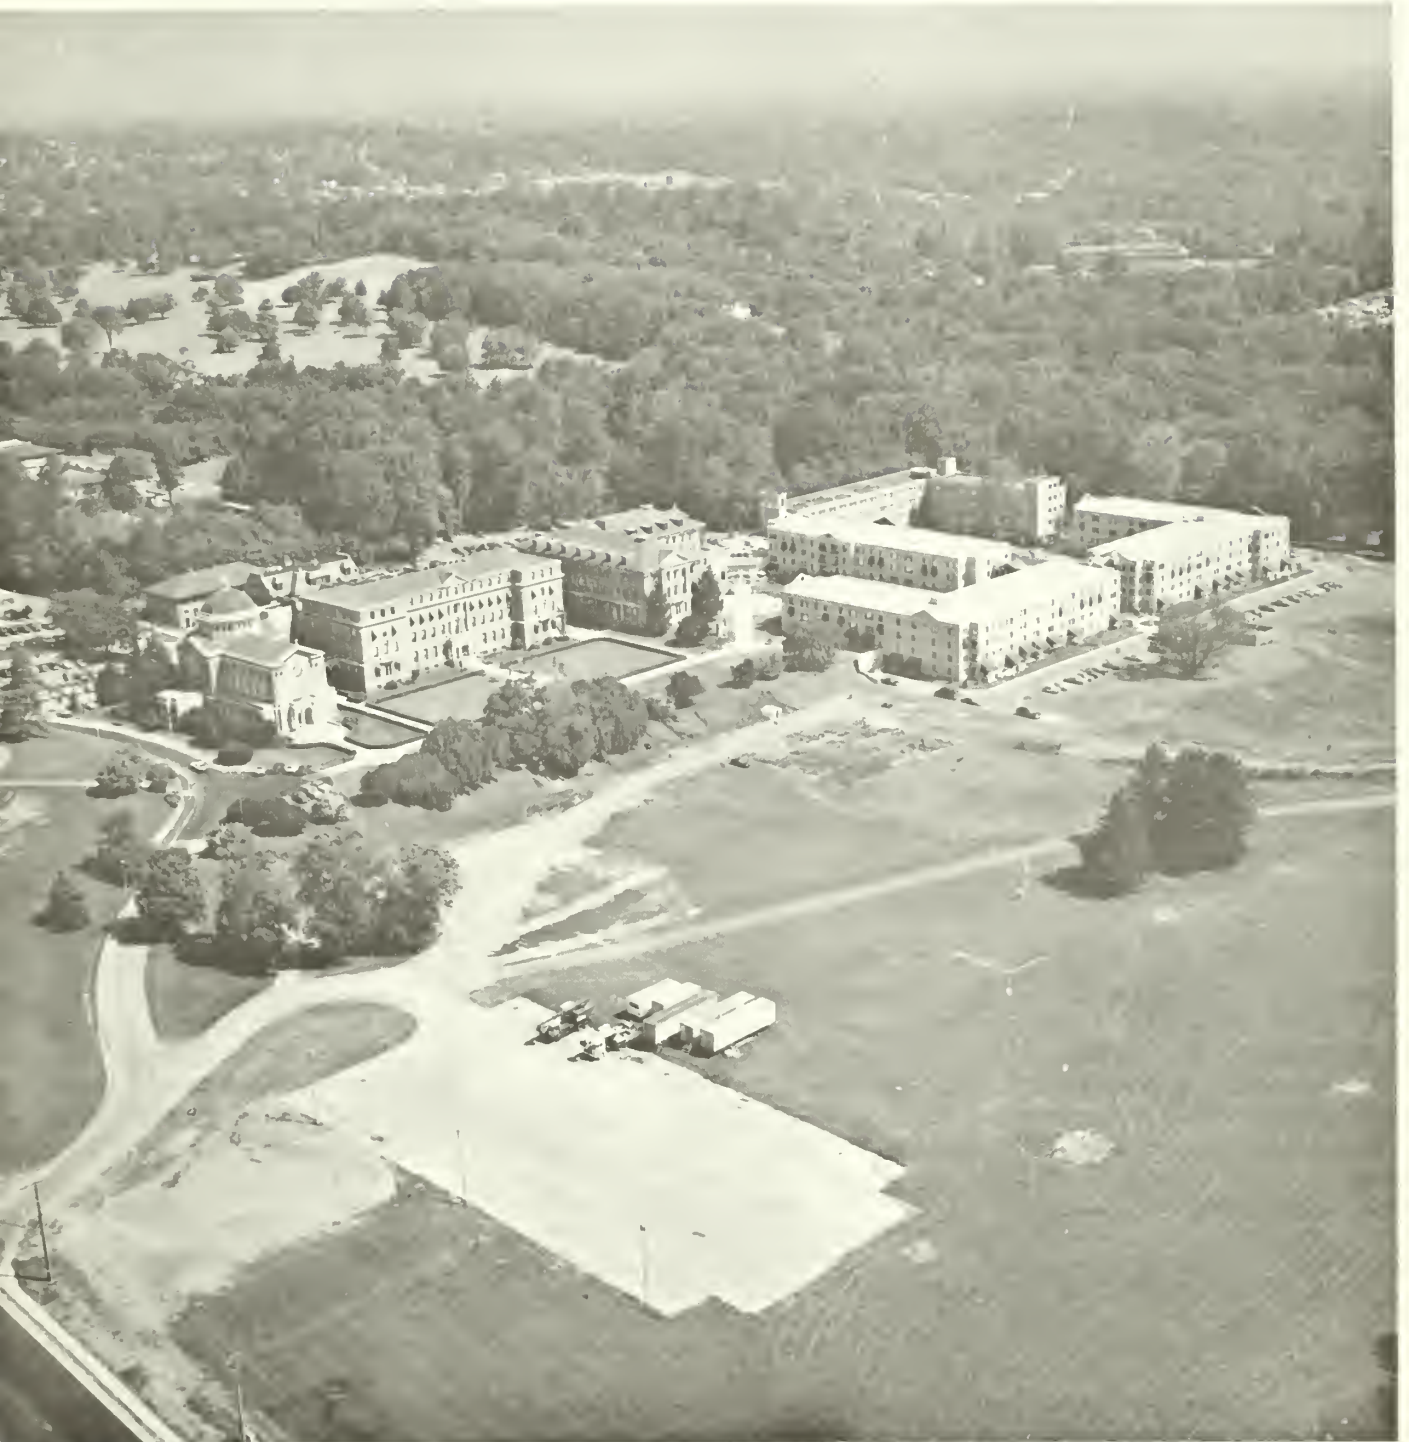
2. Aerial view of campus. The three new buildings at right visually sever the end building from the rest of the row, thereby drastically diminishing its historic character.

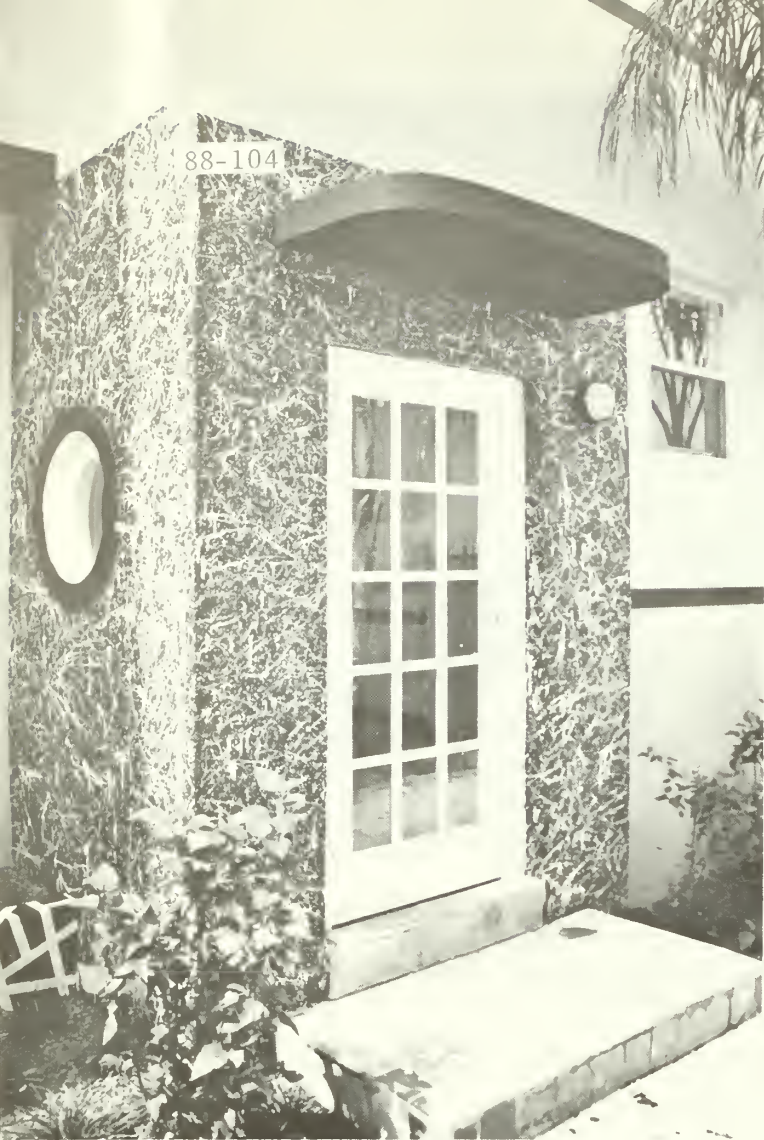
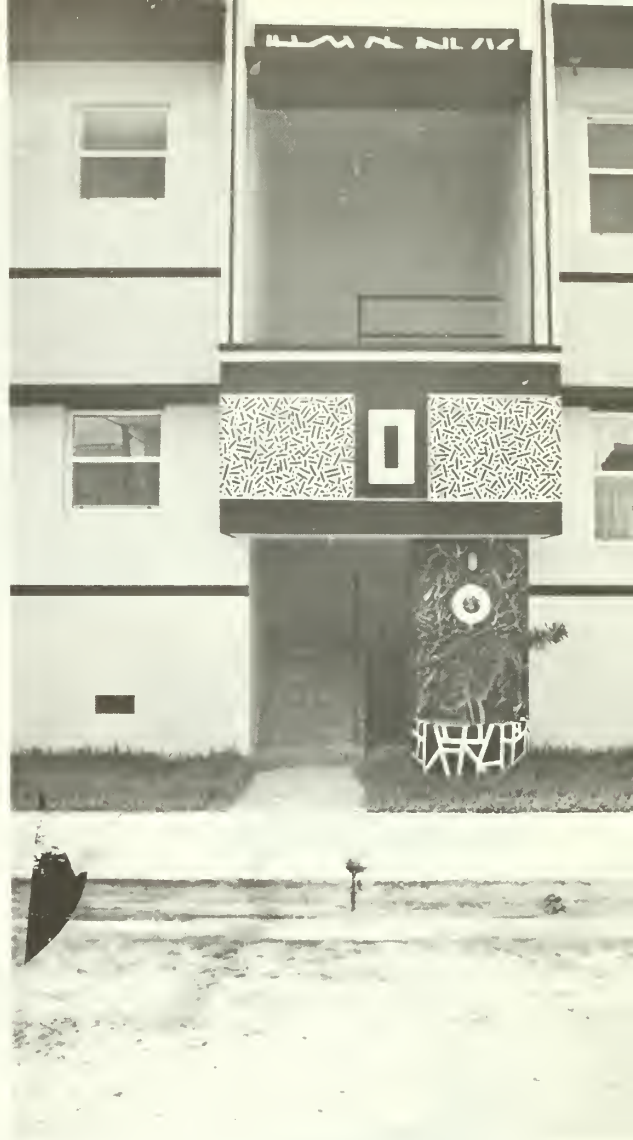
3-5. After rehabilitation the character of the building has been greatly changed by the application of a variety of decorative painted finishes, in particular the "faux" stone surfaces around doors, the contemporary patterned design used above doors and on balconies, and the "cracked tile" pattern on the planters that surround the building.
