Technical Preservation Services
Preservation Assistance Division
National Park Service
U.S. Department of the Interior
Washington, D.C.

Interpreting the Secretary of the Interior's Standards for Rehabilitation

Volume III

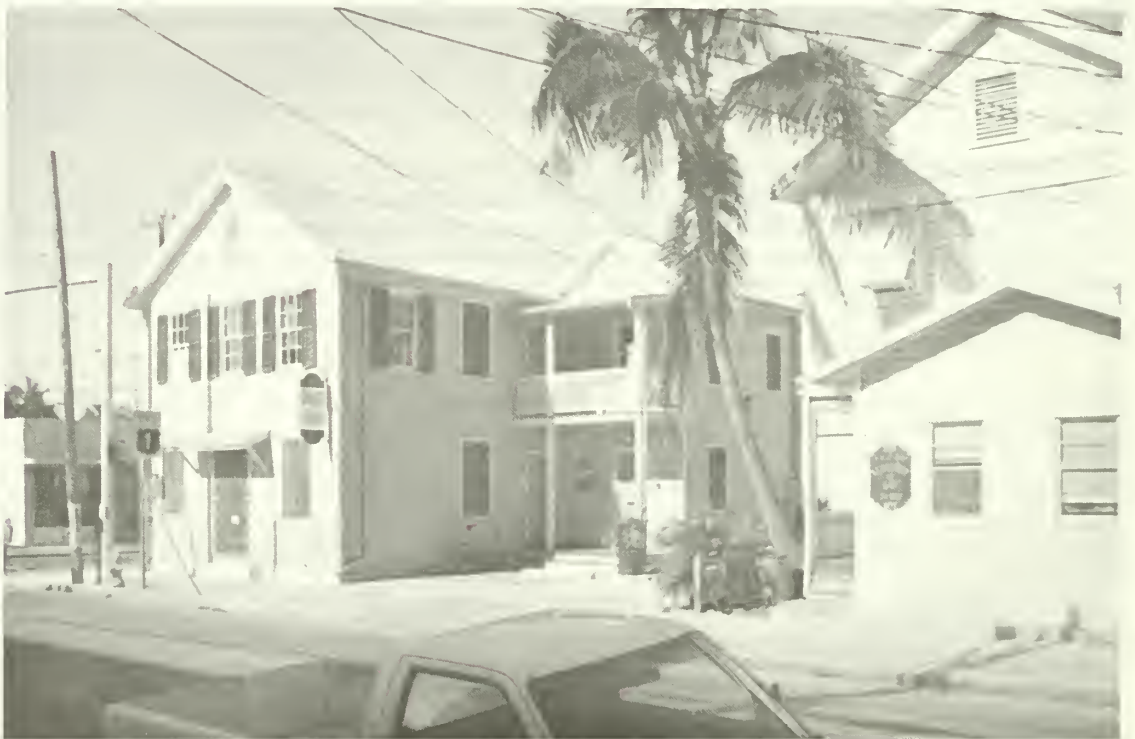
2. With the removal of the staircase there is no longer an indication of the second floor's independence from the first. The two floors of the ell addition appear to be functionally integrated.

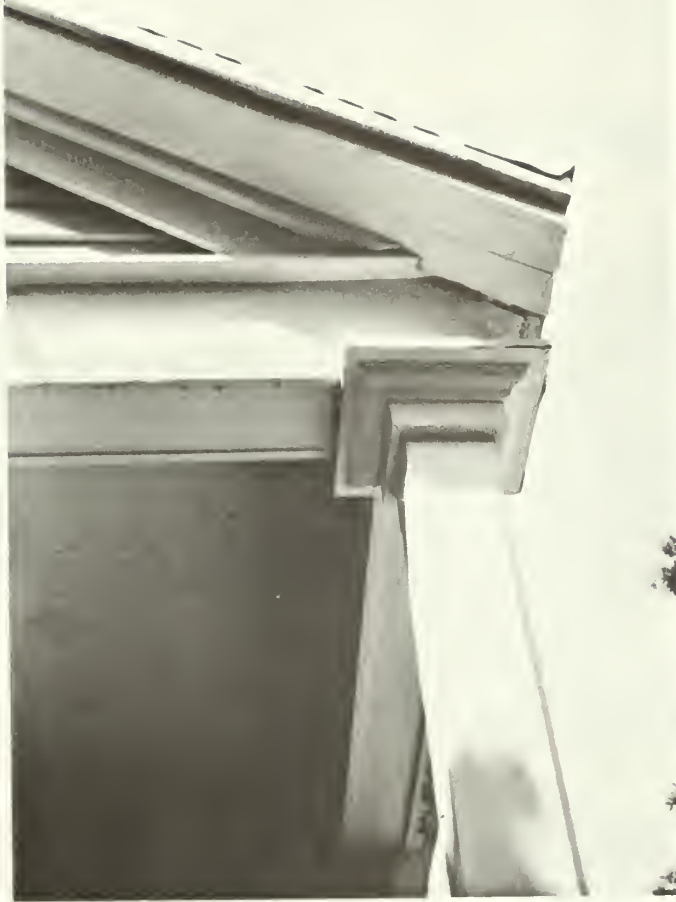
3. Not only have the added features created a non-historic appearance for the facade, but the size of the new capitals does not conform to the narrower dimensions of the overlying gable and causes an awkward overlap of the cornice. Compare with the photograph taken before rehabilitation which reveals the compatible proportions of the turned posts and the gable it supports.
