REPORT ON TWO WATER SYSTEMS  
ALPINE VISITOR CENTER  
WILD BASIN PICNIC GROUND  
ROCKY MOUNTAIN NATIONAL PARK

DENVER SERVICE CENTER  
NATIONAL PARK SERVICE

CONTRACT NO. CX-2000-3-0021

20 January, 1984

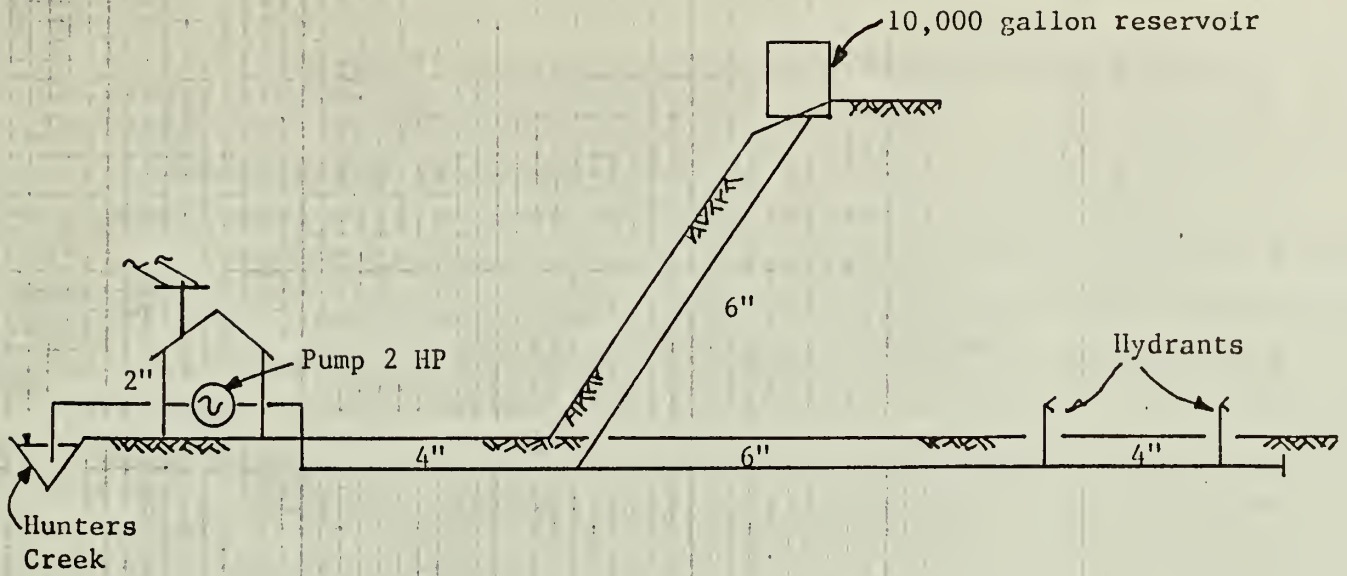
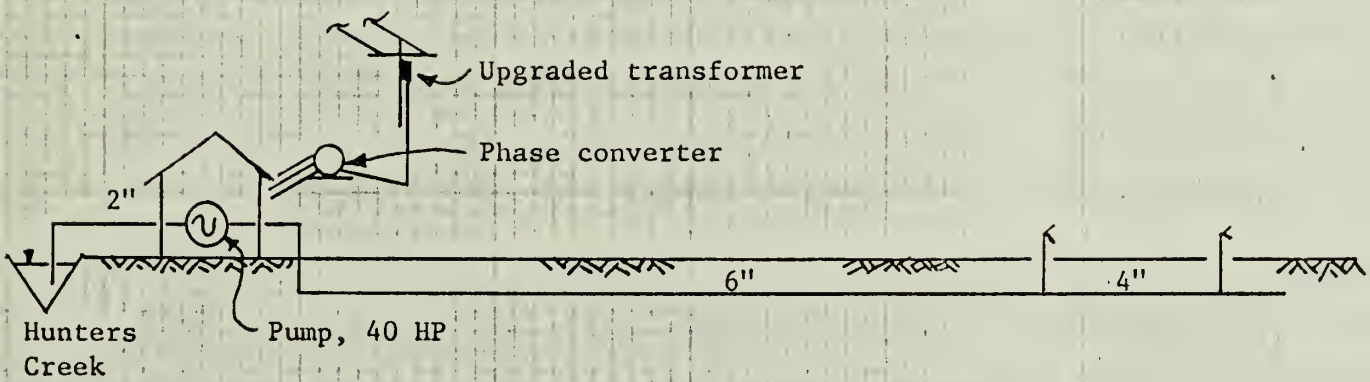
FIGURE 2.4. Wild Basin - Alternatives for on-site fire protection.

Thus, to meet NFPA standards, a storage volume of at least 2000 gallons available at a rate of 500 gallons per minute would be necessary. In practice 2000 gallons of storage would be insufficient. At least 10,000 gallons should be available. Whether these limits should be met, or alternative fire protection considered, is a matter of safety and economics. The choices can be broken down into on-site and off-site methods as follows (Figure 2.4):

The on-site systems require both high capital costs and high maintenance costs in order to ensure reliability. Further, except for the sprinkler system, trained manpower would be required to be on-site to effectively fight a fire. Such manpower is not available on-site at all times.

Fire protection from the existing water supply system is inadequate. A decision on whether or not to implement an on-site system to meet common fire protection standards needs to be made by the NPS based on safety, economics and future planned site use.

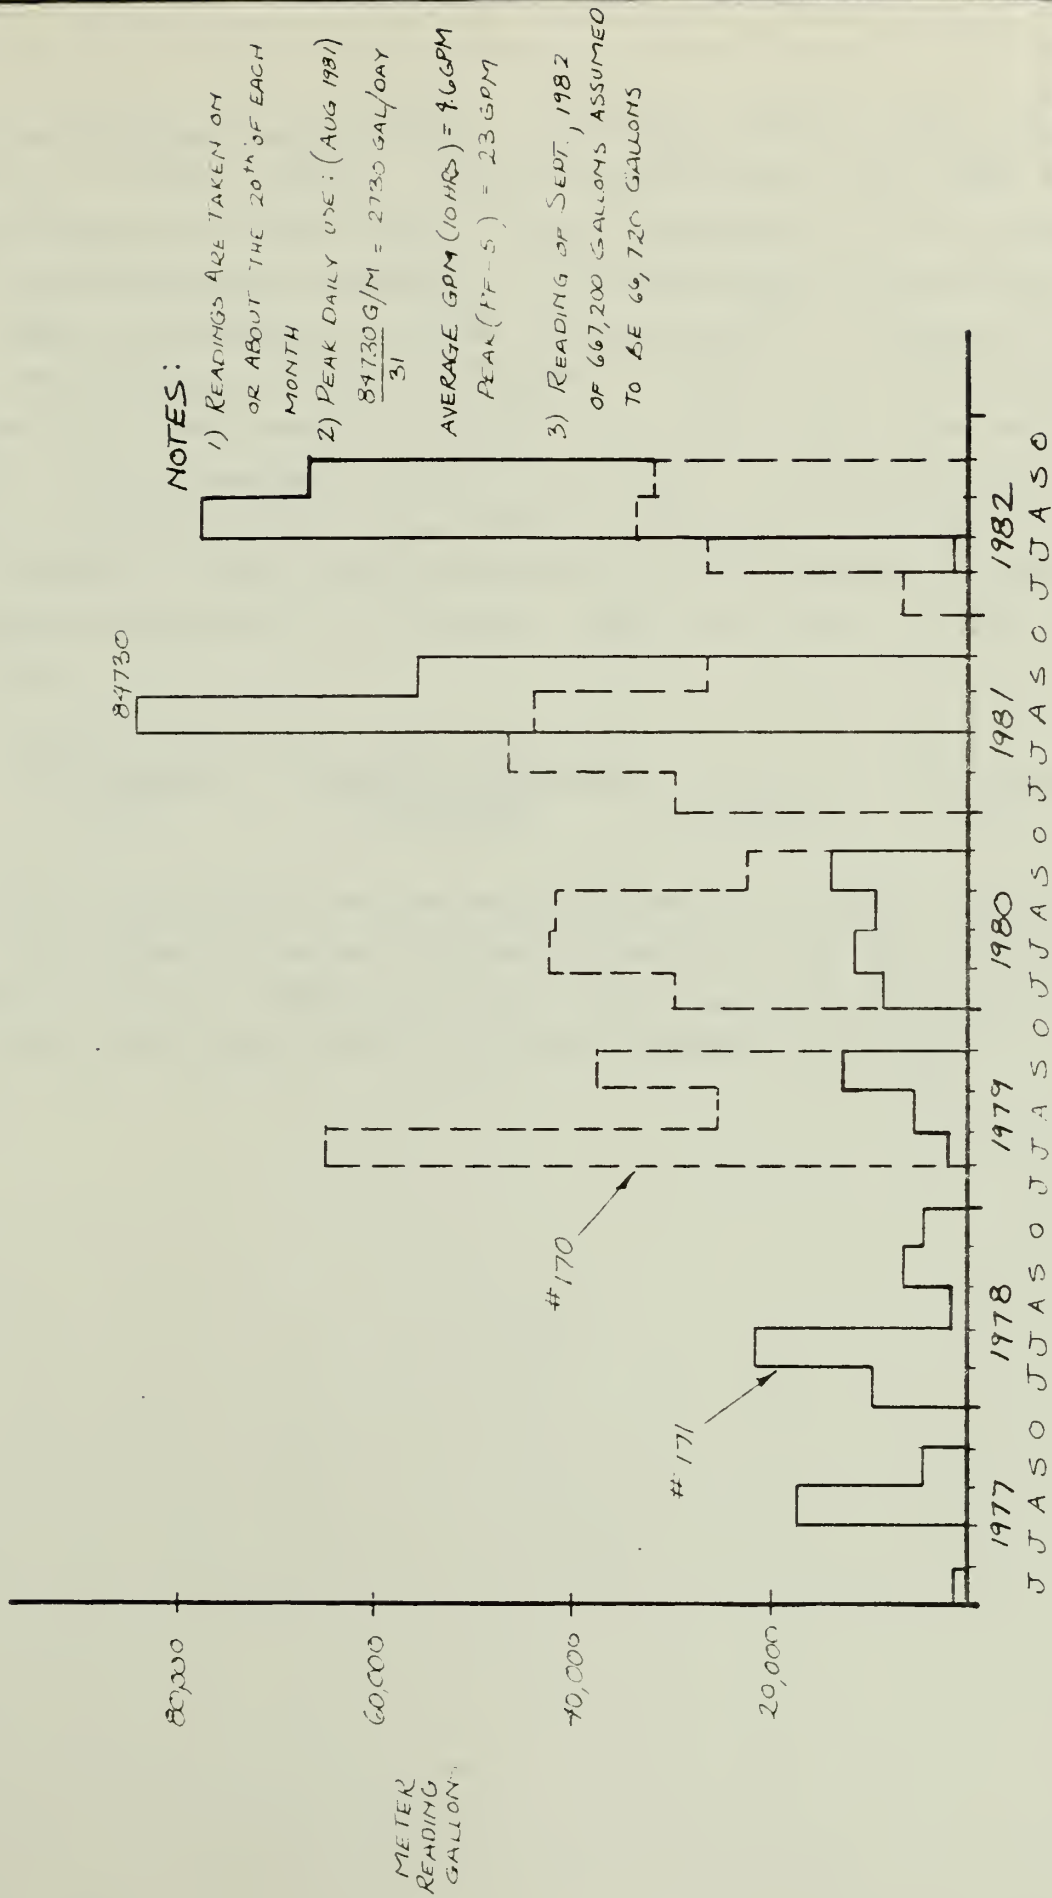
FIGURE 3.3 GRAPHICAL REPRESENTATION OF METER READINGS - AVC

course a physical impossibility. The most likely cause of these readings is faulty meters. From conversations with RMNP staff, it was learned that meter No. 171 was overhauled in the spring of 1982. Assuming that meter No. 170 was operating properly in 1982, then the readings for 1982 can be used for estimating water use. The reading reported for August of 1982 was 78,300 gallons. Assuming this represents 31 days, the daily use rate was 2525 gallons. Using standard peaking factors, the maximum daily rate could be assumed to be twice this, or 5000 gallons/day. If the peak flow was 3 times the average flow on the maximum day and the period of system use is 12 hours, then peak flows in the system would be:

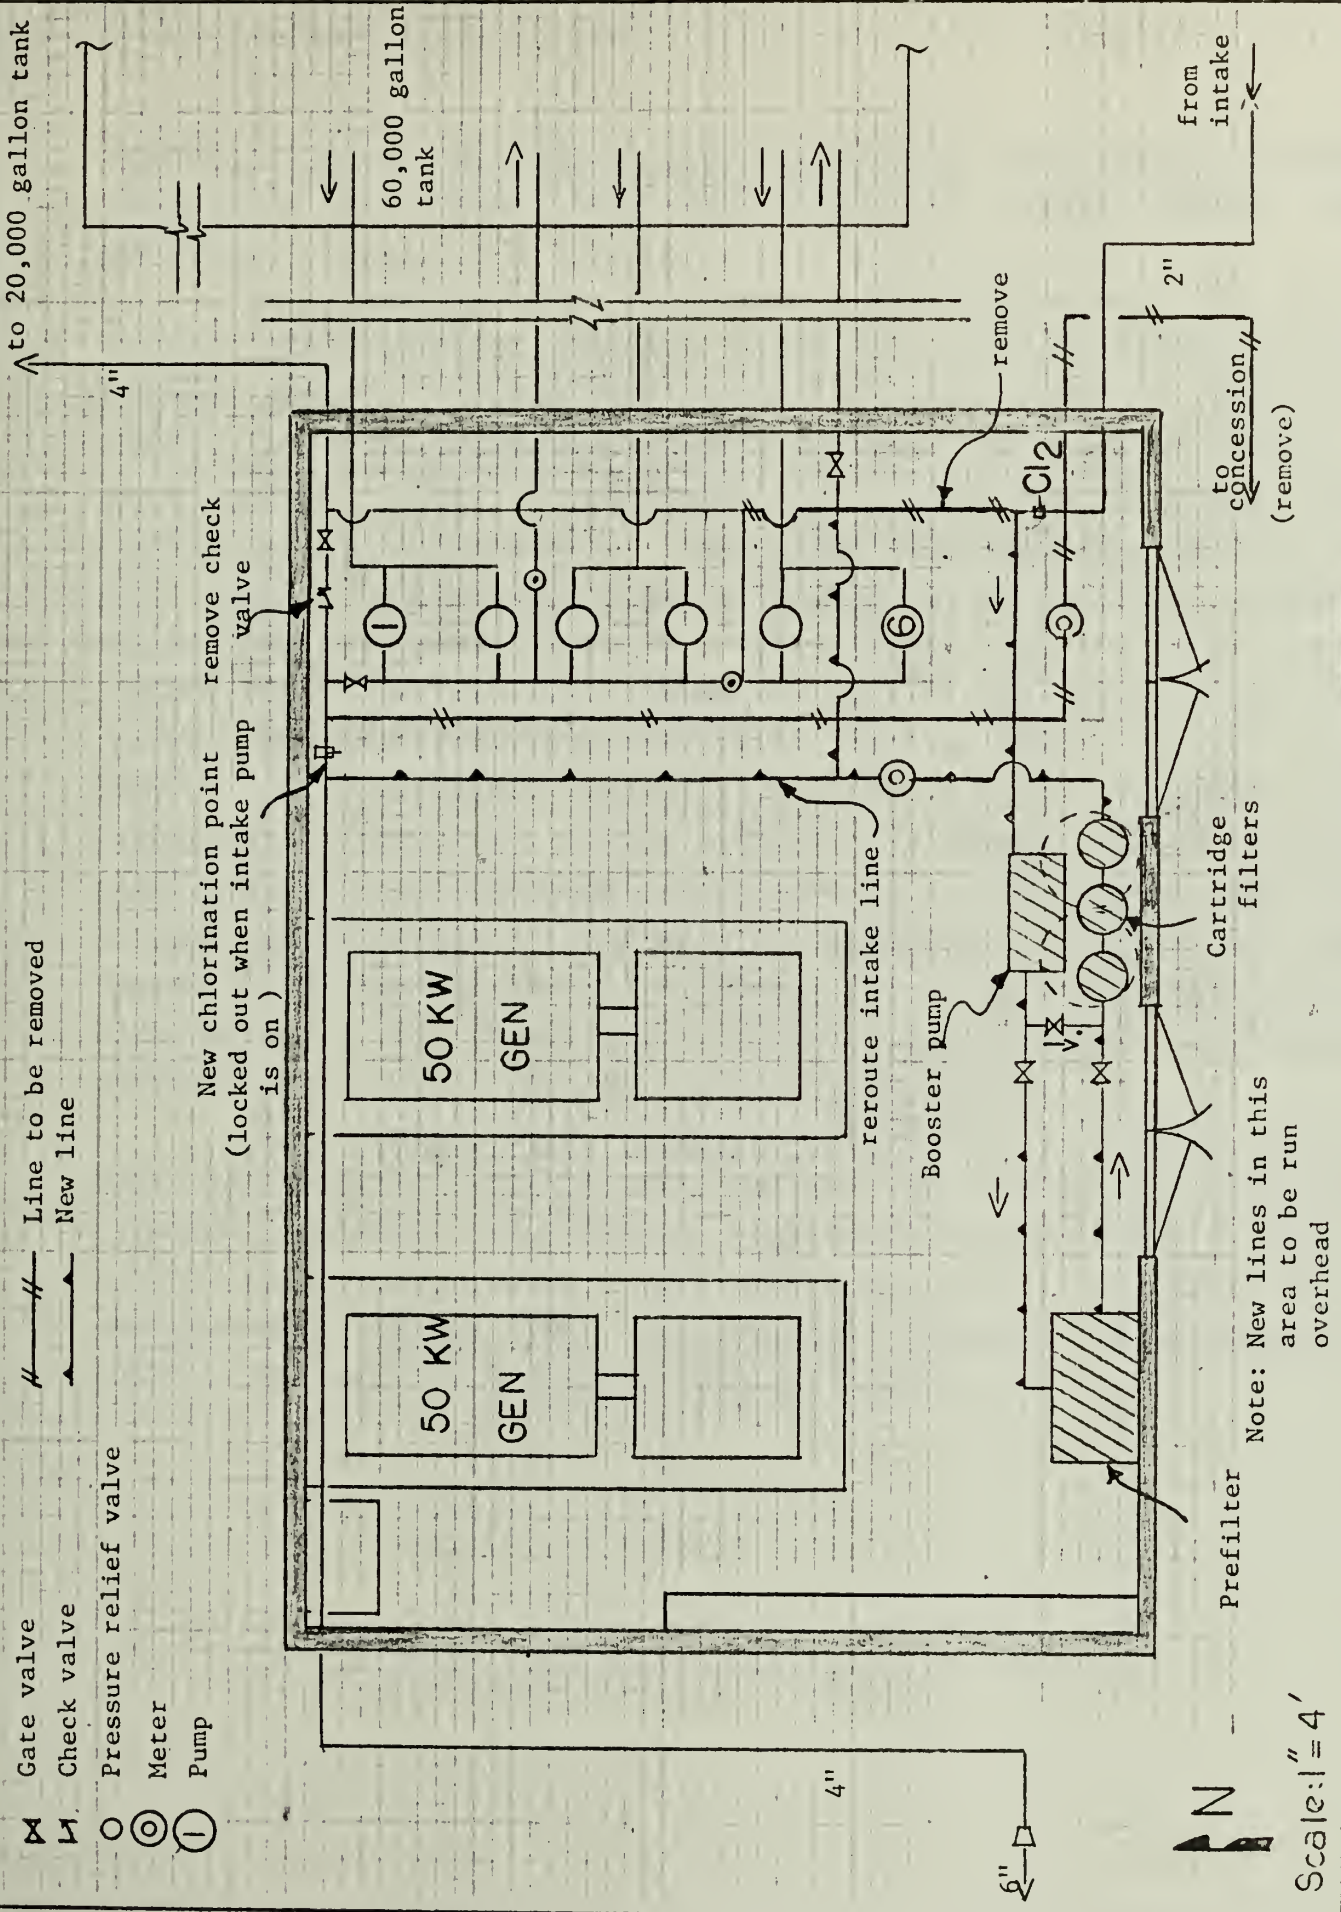
FIGURE 3.5. ALPINE VISITOR CENTER - LAYOUT OF WATER TREATMENT PROCESS IN GENERATOR BUILDING.

Figure 3.5 shows the option for preliminary layout of treatment facilities within the existing generator building. As can be seen, the availability of space within the existing generator building is limited and the addition of treatment units to this building will add to existing space problems. This will result in an inefficient piping layout and will require several additional air release valves at high points in the piping. The

layout as shown requires the location of an alternative storage space for oil drums that are presently stored within the building.

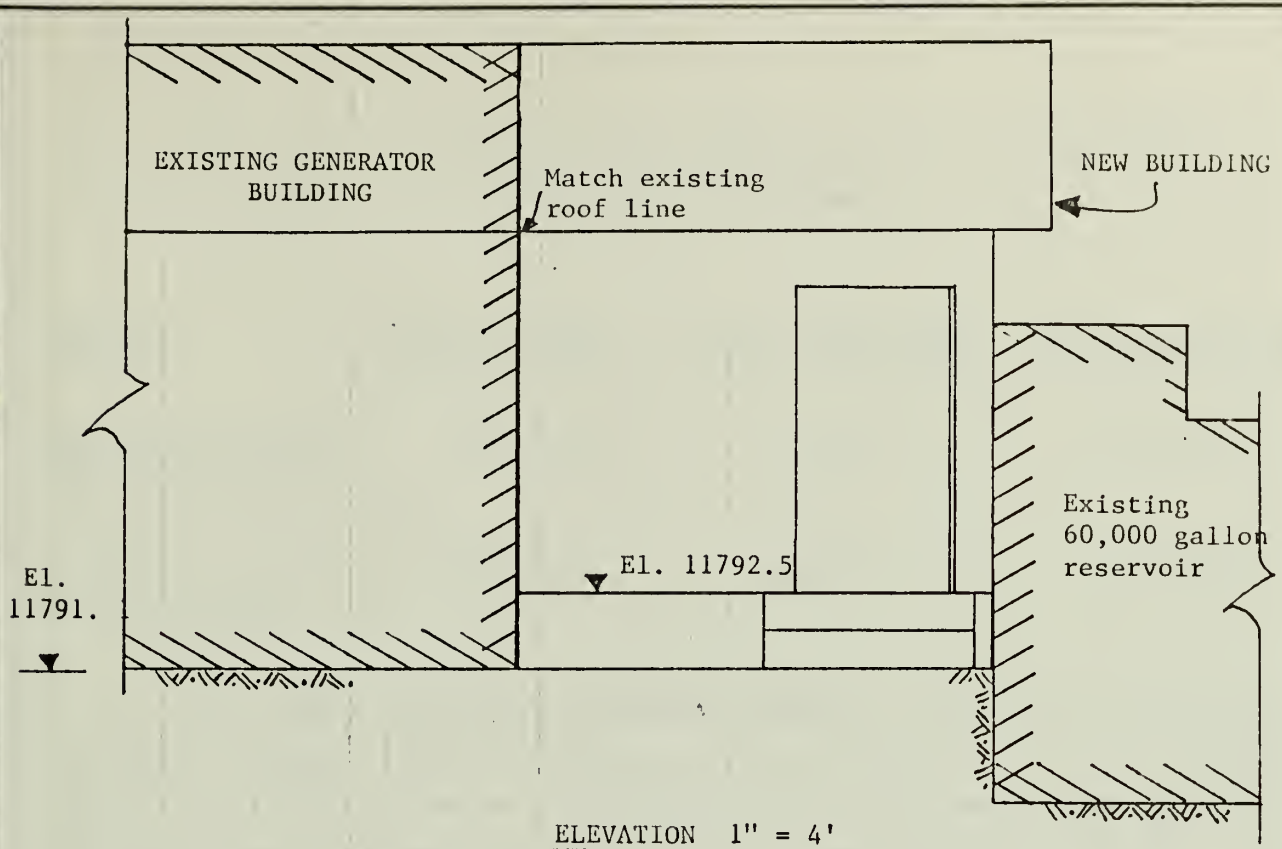
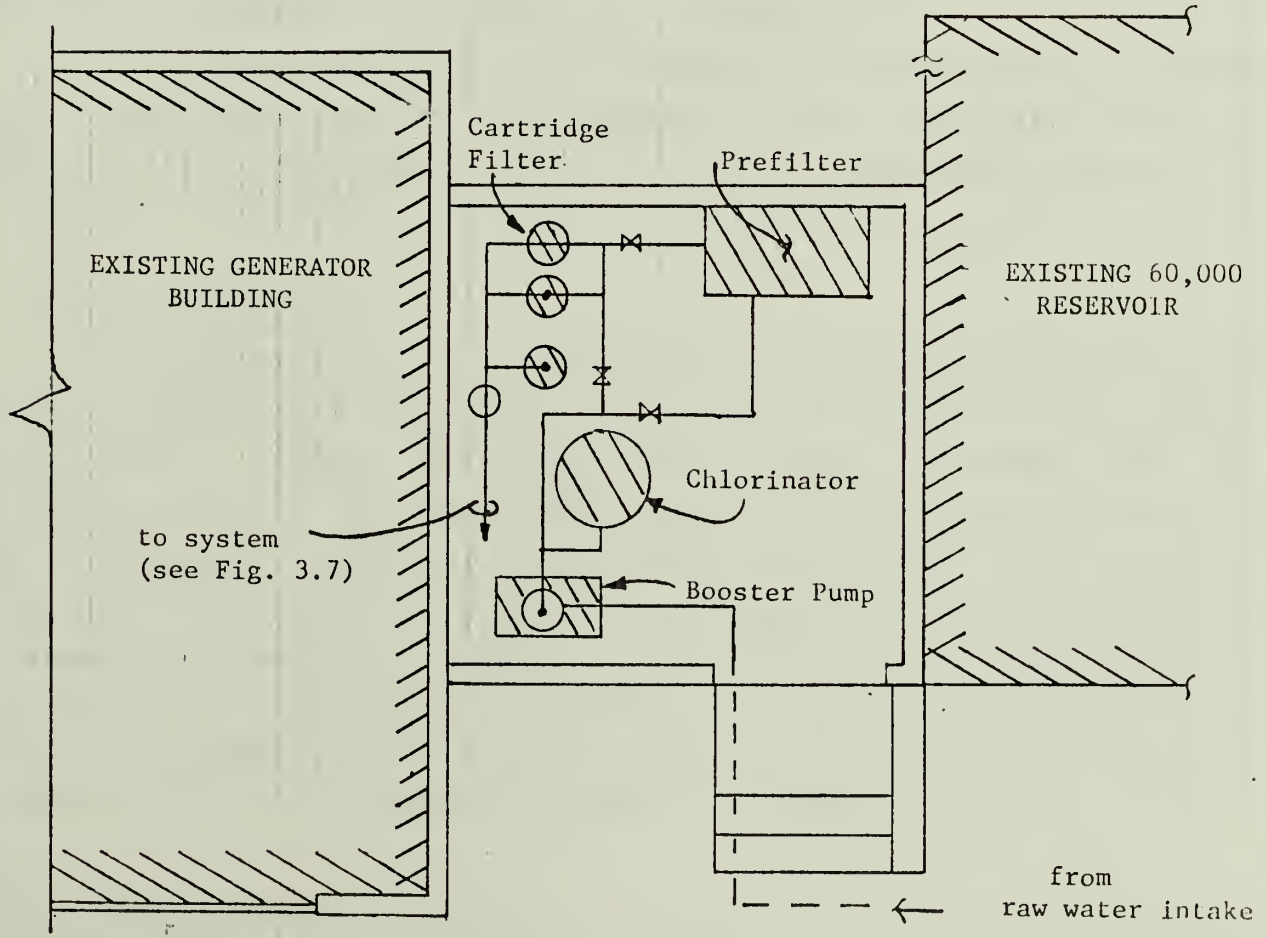
FIGURE 3.6. Alpine Visitor Center - Layout of water treatment process in new building.

An alternative is to locate a new building in the space between the existing generator building and the 60,000 gallon storage tank. A preliminary layout for this option is shown in Figure 3.6. The advantage of this approach is that it permits a more compact layout of equipment and allows better access for operation and maintenance. The major disadvantage is that it will require the construction of an additional building, thereby adding to the overall costs. There will also be some added visual impact to the area. However, this visual impact should be minimal because the overall building size is small, 10 feet x 10 feet. An additional concern is the need to provide for protection of existing piping between the 60,000 gallon storage tank and the existing generator building. This piping would be covered by the floor of the proposed building and access for any repair would become limited. Therefore, it is recommended that consideration be given to providing additional structural protection of this piping by concrete encasement.

In terms of the estimated present worth, the difference in cost between the two options is not great. A new building will result in a more efficient working condition and will achieve some savings in costs that are not reflected in the level of detail associated with this cost comparison.

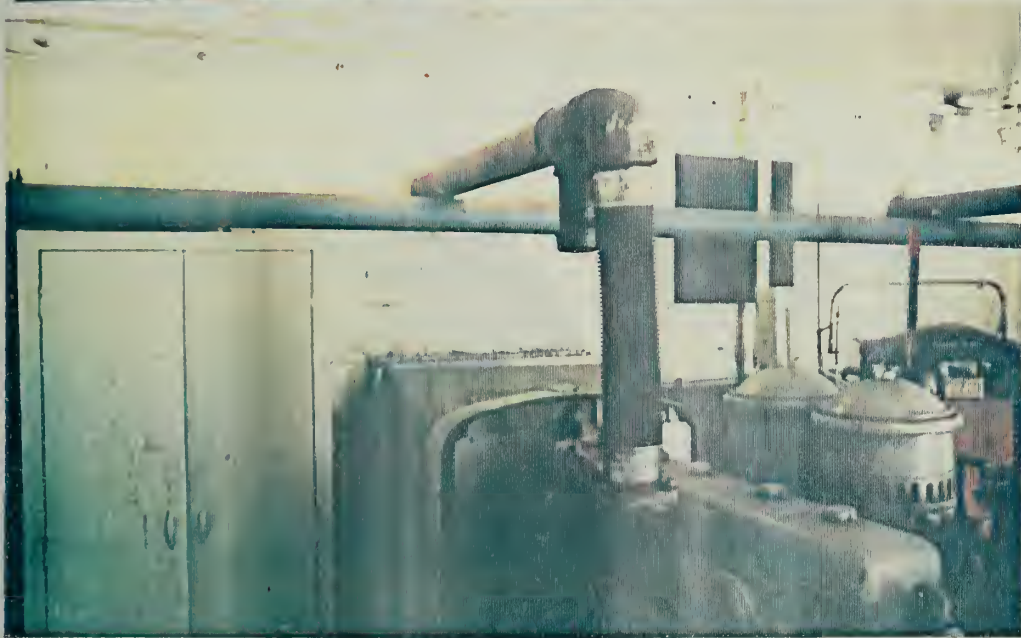
EXHAUST SYSTEM  
NOTE RIGID CONNECTION  
THRU WALL
