historic structure report
architectural data section

FORT JEFFERSON
NATIONAL MONUMENT / FLORIDA

BY: LOUIS ANDERSON
APRIL 1988

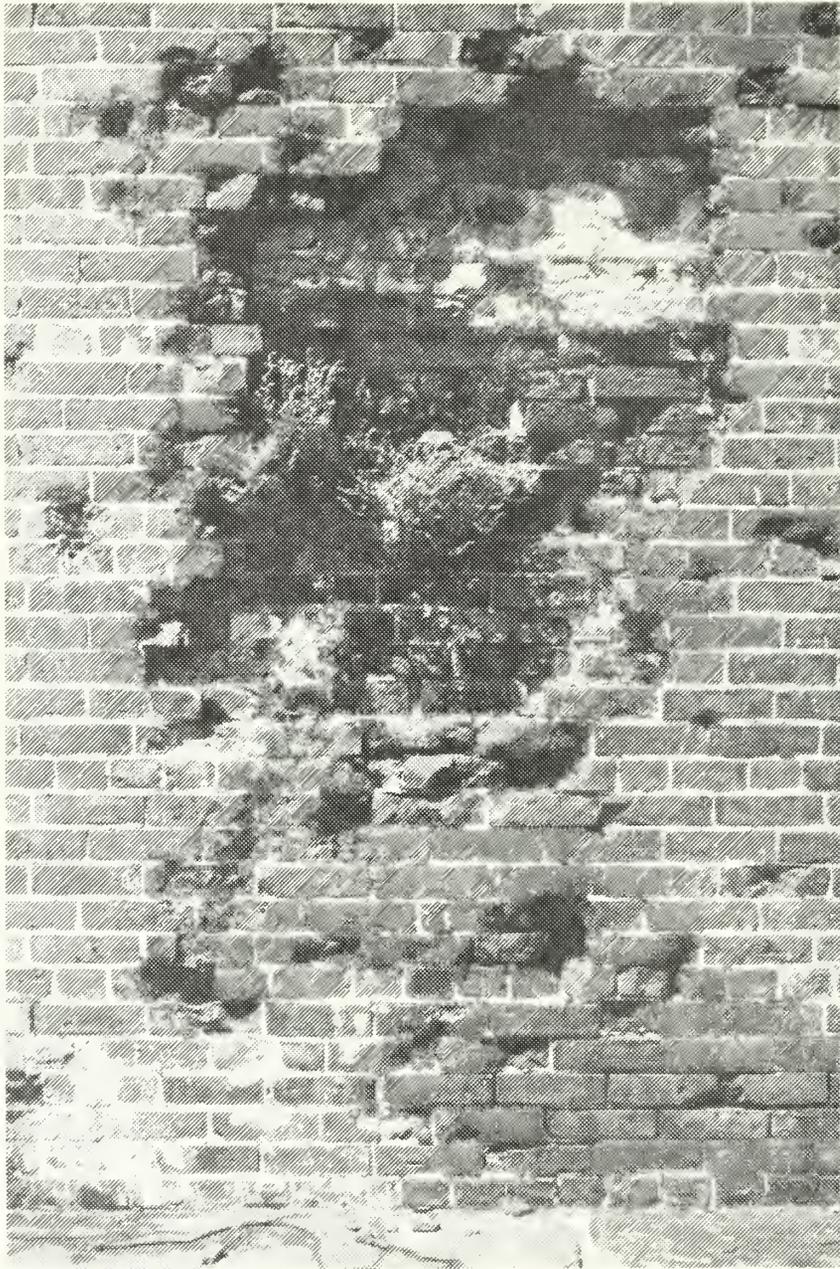
Figure 6 PRESENT CONDITION

DAMAGE TO LARGE MAGAZINE

Recommended treatment of the large magazine will be aimed at the stabilization of its present condition. Work involved would include primarily repointing but, where necessary, brick replacement and grouting of cracks as well.

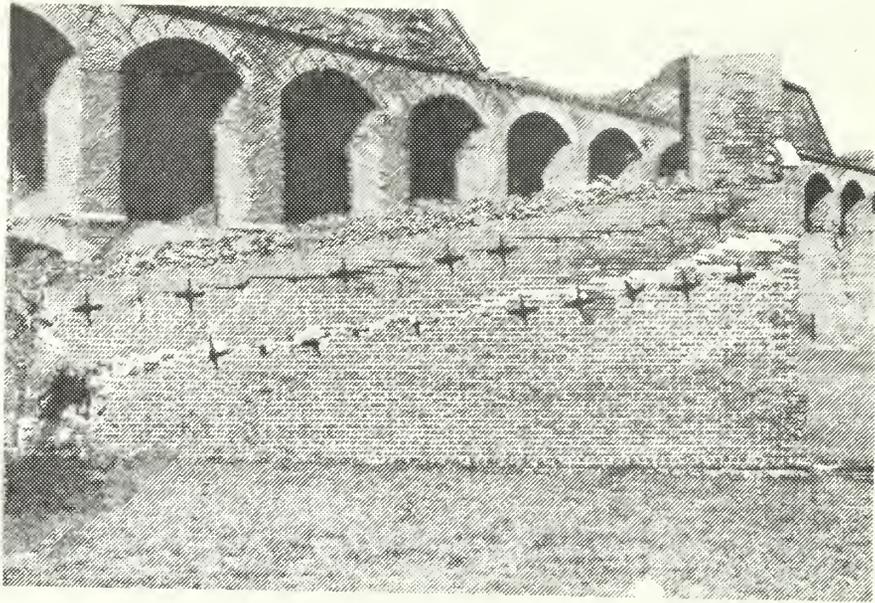
Figure 7 SHOT FURNACE CRACKING

Recommended stabilization treatment for the shot furnace will involve disassembly of brick coursing to structural cracks, preparation of measured drawings and photographs to document the disposition of the internal elements of the structure, removal of exfoliating iron tie rods and any other ironwork which may be determined to contribute to the structural failure of the furnace walls, and subsequent reassembly of the materials to historic appearance.

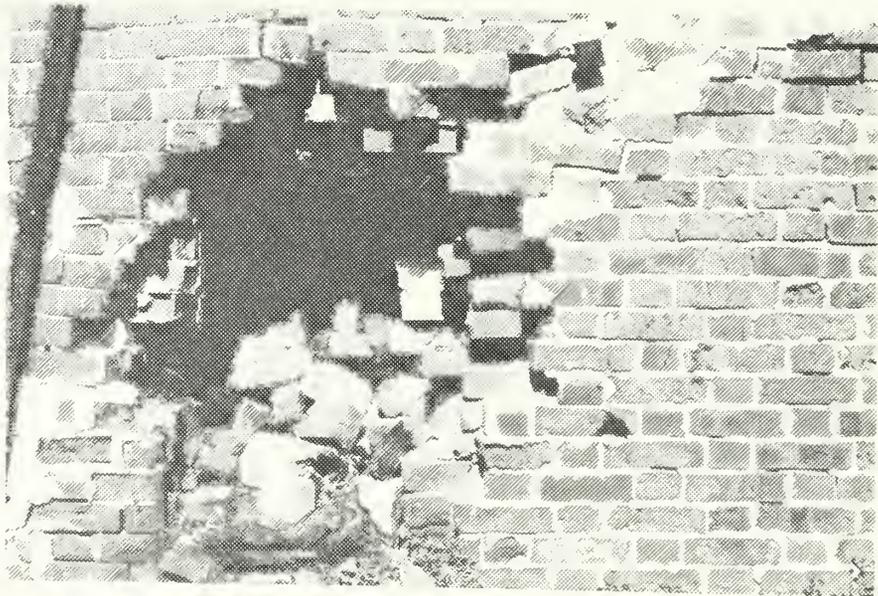
Figure 8 DAMAGE TO FIREBOX

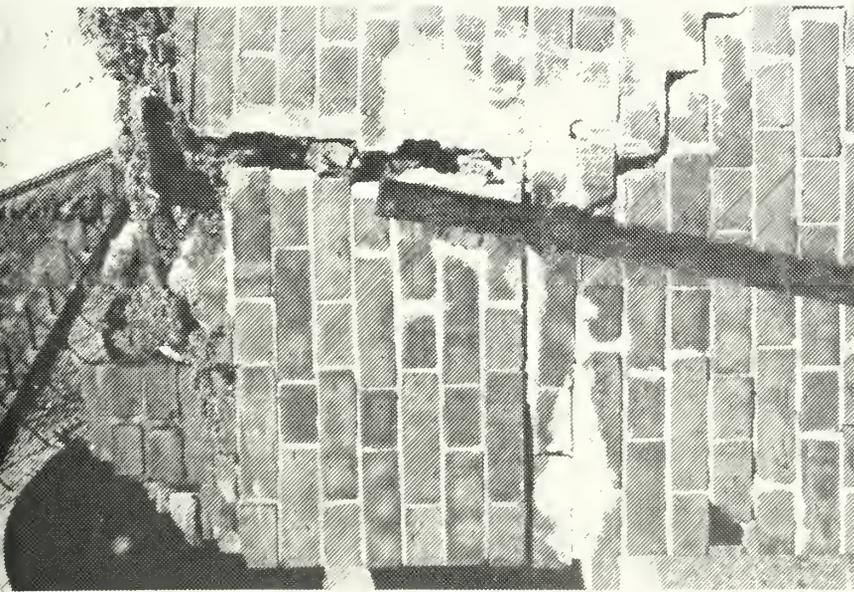
Figure 9

SHOT FURNACE
CRACKING

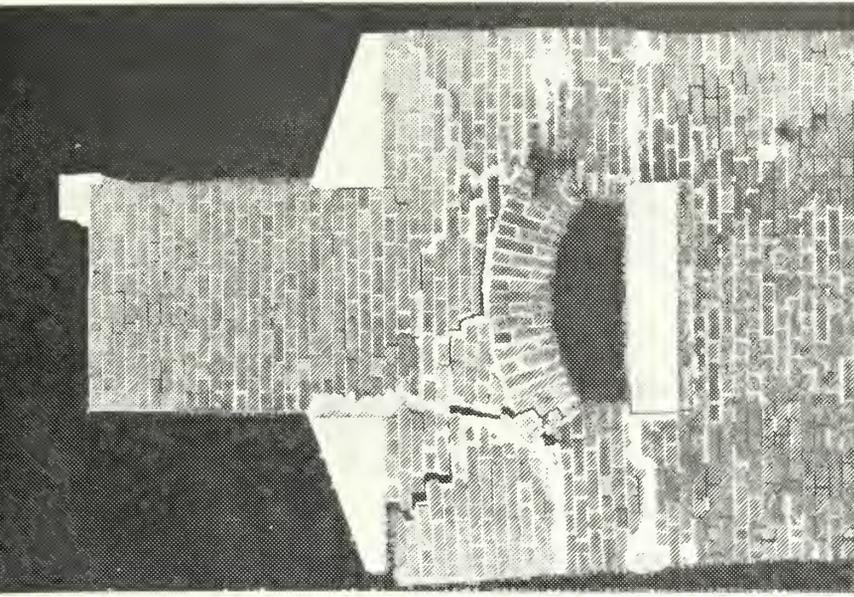
Figure 10

SHOT FURNACE
BRICK DISPLACEMENT

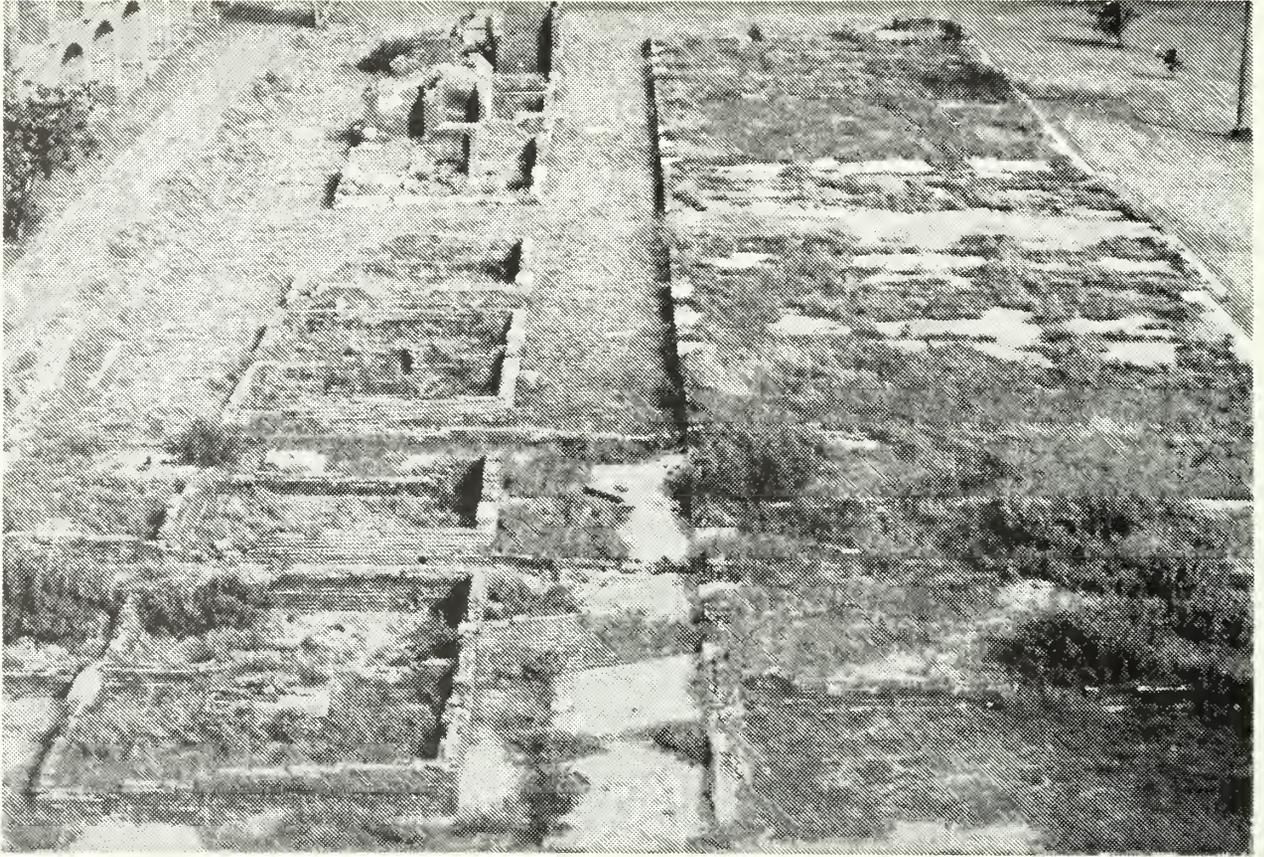
Figure 12 PRESENT CONDITION

OFFICERS' QUARTERS RUINS

The recommended treatment of the officers' quarters foundation is to preserve its present condition for use as an interpretive feature. Work involved may include spot repointing, brick replacement and selective patching of cracked or spalling concrete, as well as routine removal of encroaching vegetation.

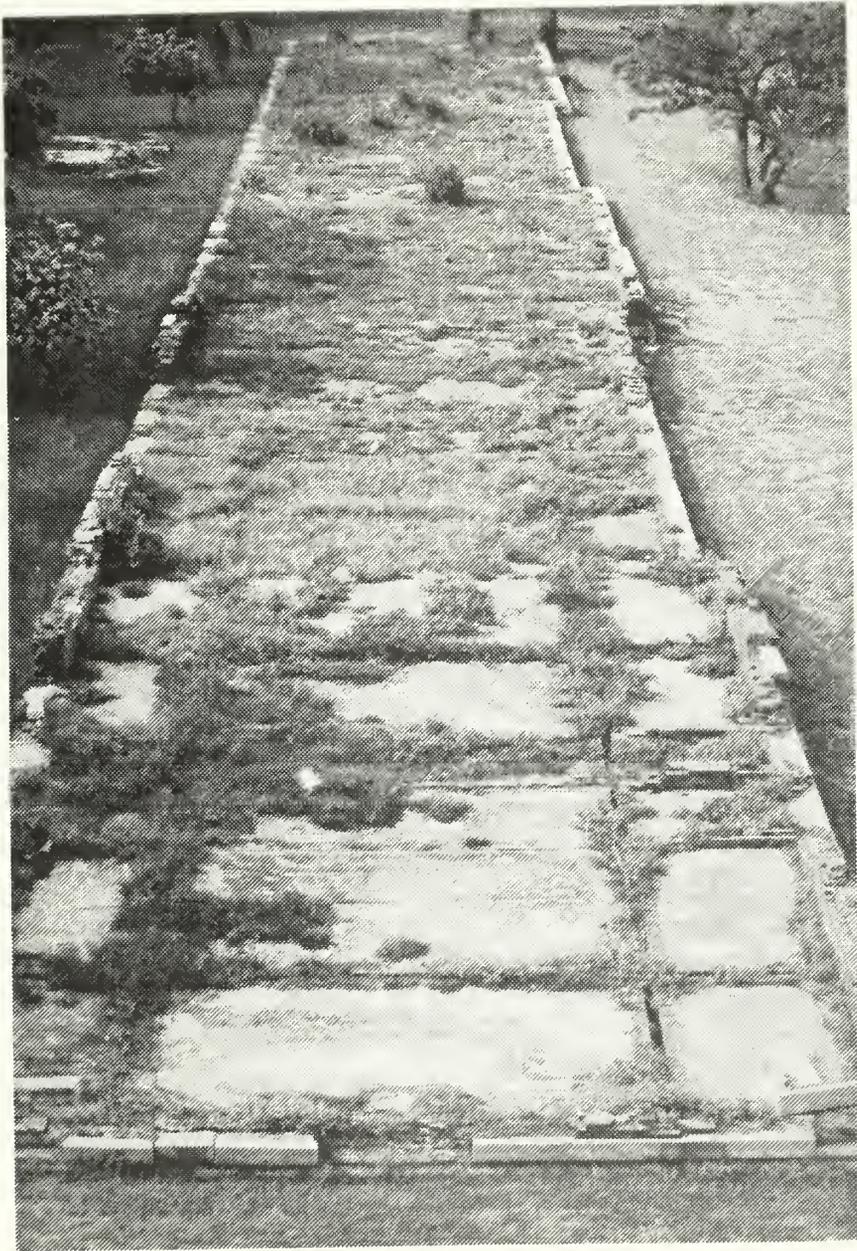
Figure 13 PRESENT CONDITION

ENLISTED MEN'S BARRACKS RUINS

The recommended treatment of the enlisted men's barracks is to preserve its present condition for use as an interpretive exhibit. Work involved may include patching of concrete where cracked or spalling, as well as routine vegetative management.

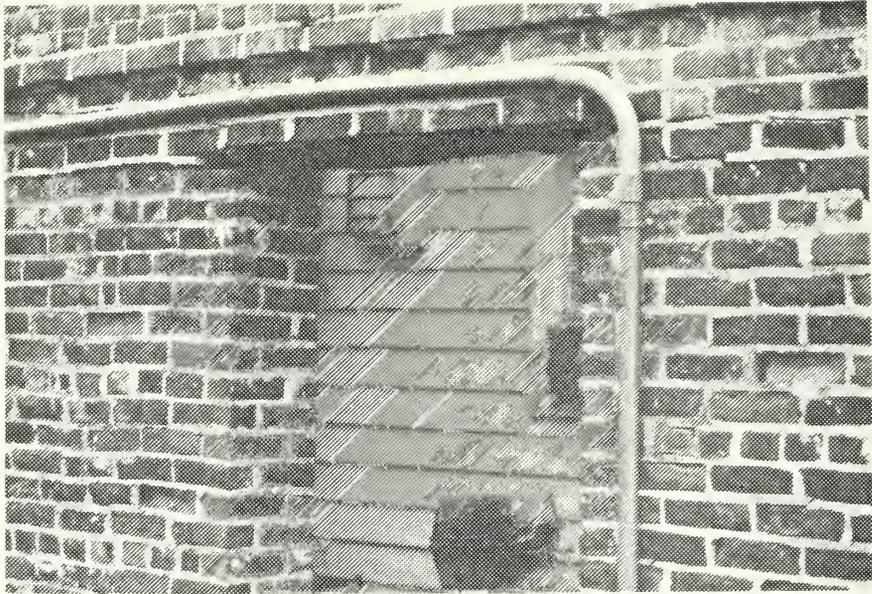
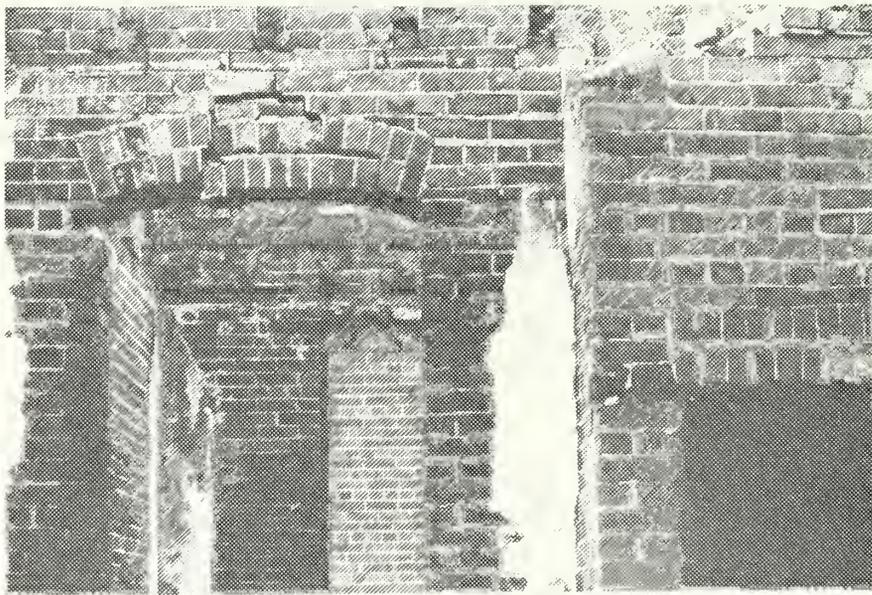
Figure 14 PRESENT CONDITION

DAMAGE TO DOORWAY LINTELS

The maintenance of the engineer officers' quarters is recommended to ensure its continued adaptive use as residence quarters for Park Service personnel. As a whole, cyclical maintenance is essential in the context of periodic monitoring and subsequent repointing of the exterior masonry walls to resist moisture transmission due to wind-driven rain. Also, masonry repairs to doorways where exfoliating iron lintels occur is suggested.

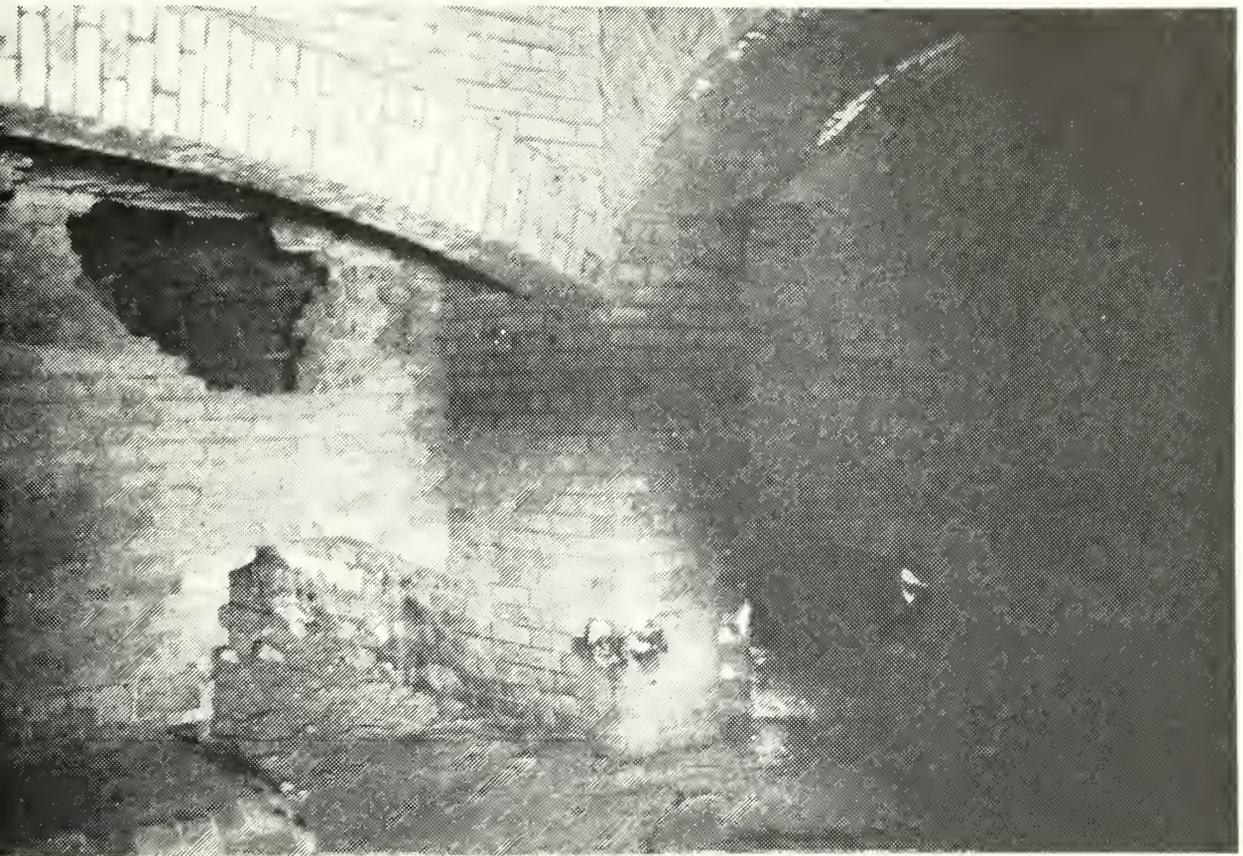
Figure 16 PRESENT CONDITION

DAMAGE TO BAKERY WALL

Stabilization involving grouting of structural cracks, treatment of oven ironwork, brick replacement and overall consolidation is recommended for the bakery in addition to auxiliary illumination.

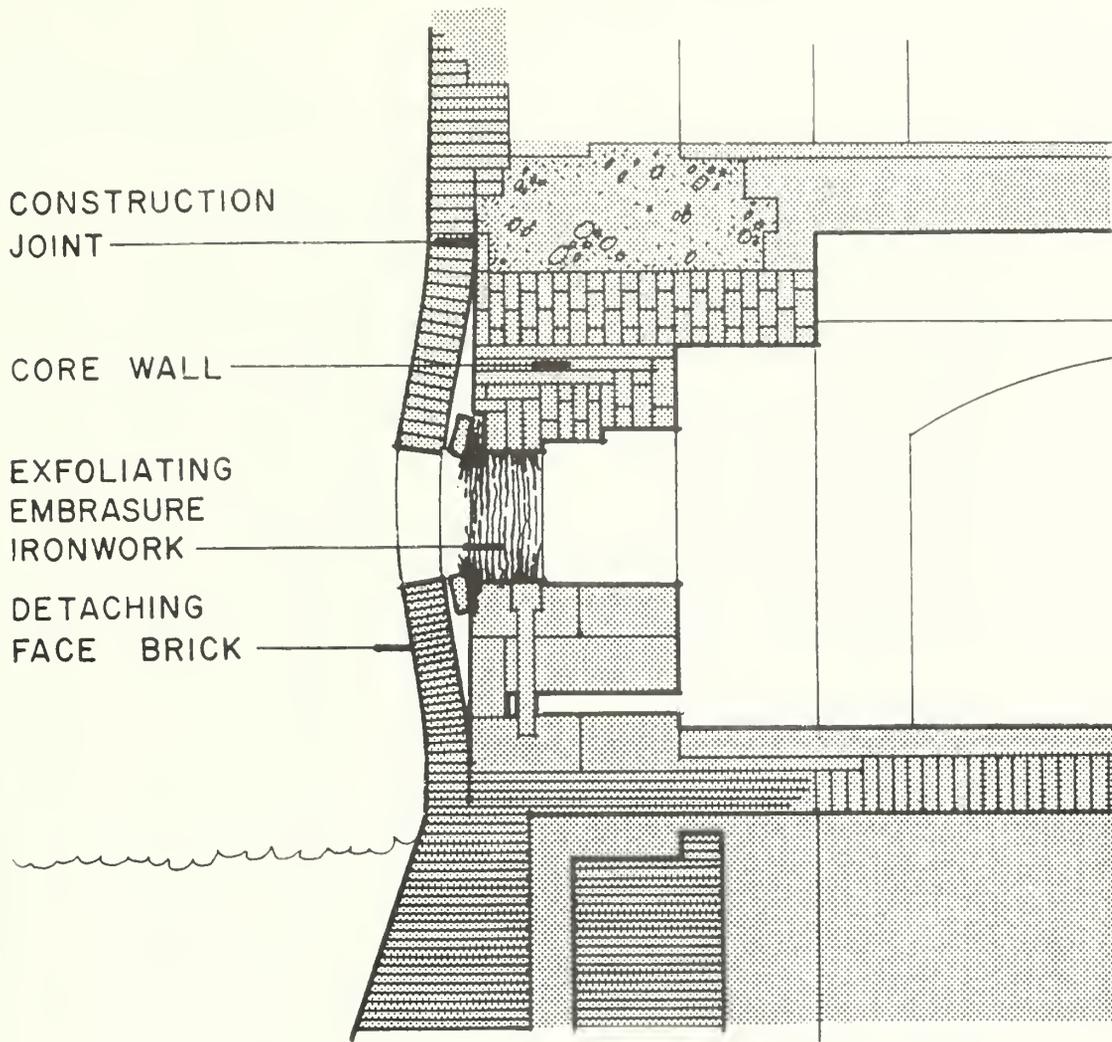
Figure 18 PRESENT CONDITION

Front 1 - Seven of 18 lower tier embrasures show bulging masonry resulting from exfoliating ironwork.

TYPICAL EMBRASURE DETERIORATION

The recommended treatment for the curtains involves the removal of exfoliating embrasure irons and rebricking of openings to historic dimensions. In addition, a major repointing effort, including the replacement of missing brick in selected areas, is strongly recommended. Cracks in the scarp should be monitored on an ongoing basis, with repairs recommended for those cracks threatening the structural integrity of the fort.

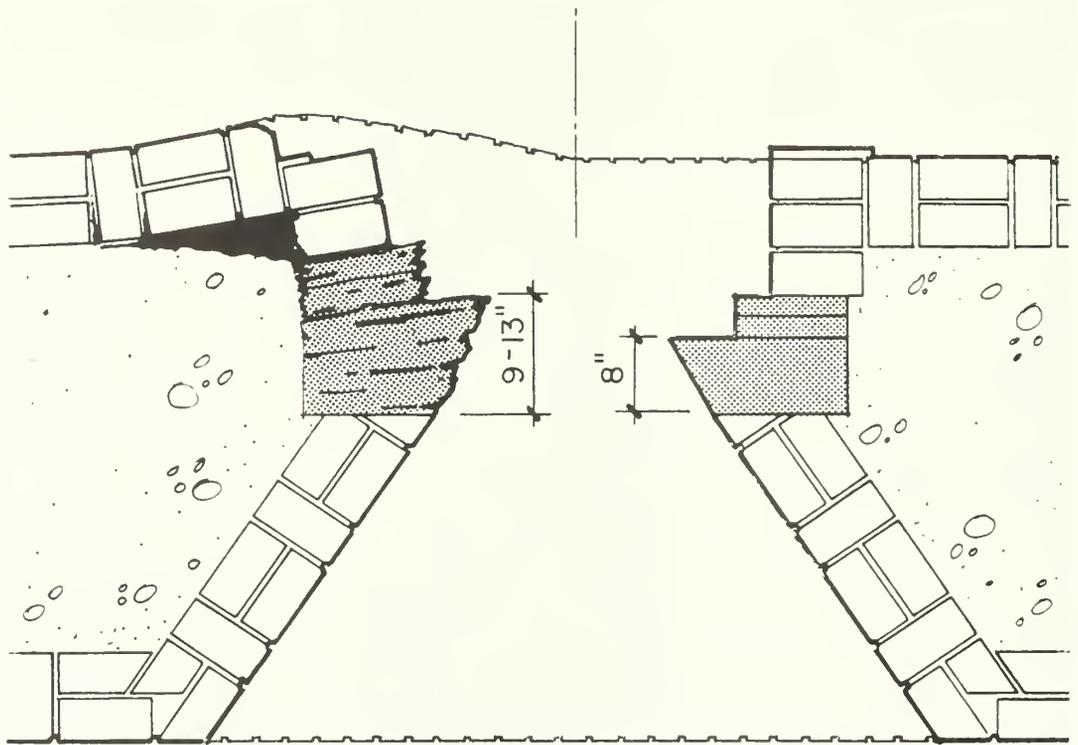
Figure 19 PRESENT CONDITION

TYPICAL EMBRASURE DETERIORATION

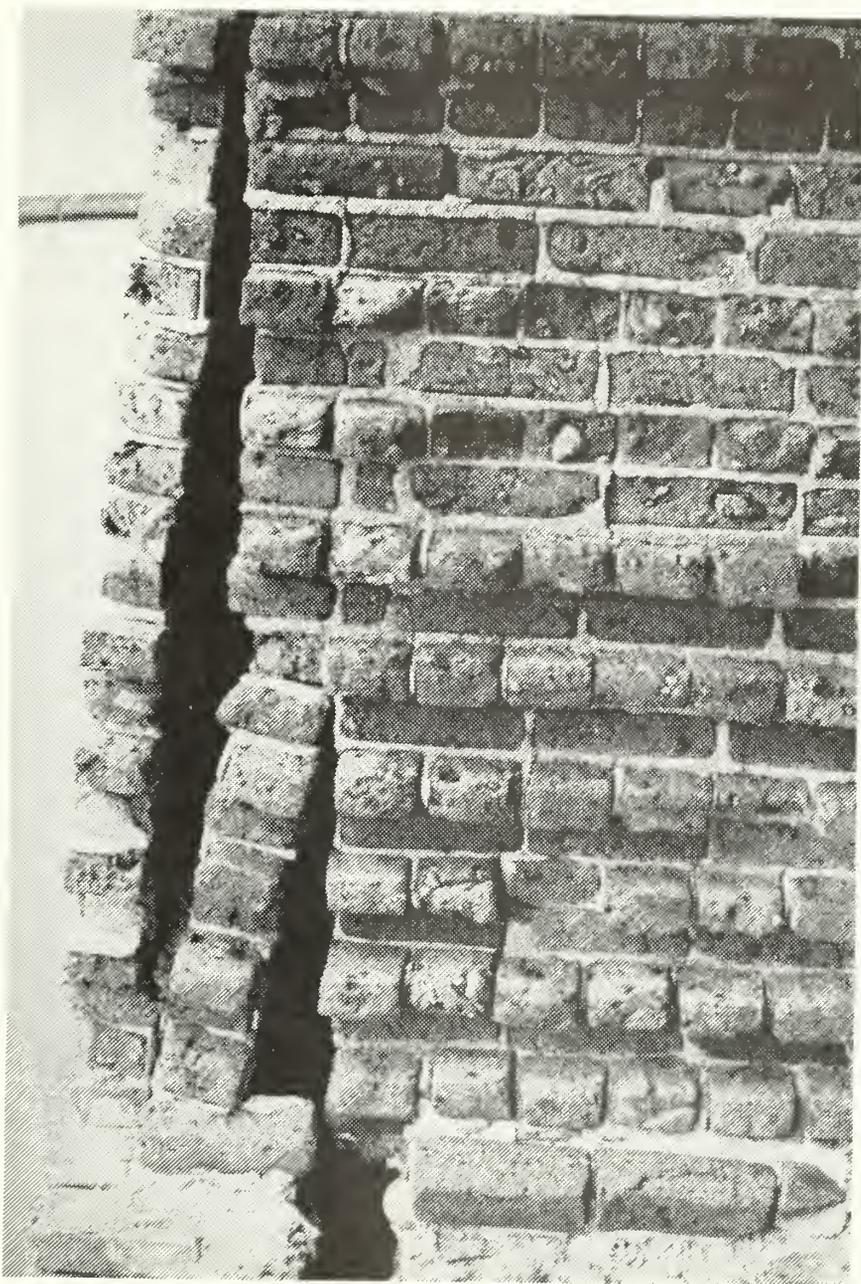
Figure 20 PRESENT CONDITION

BULGING EMBRASURE MASONRY

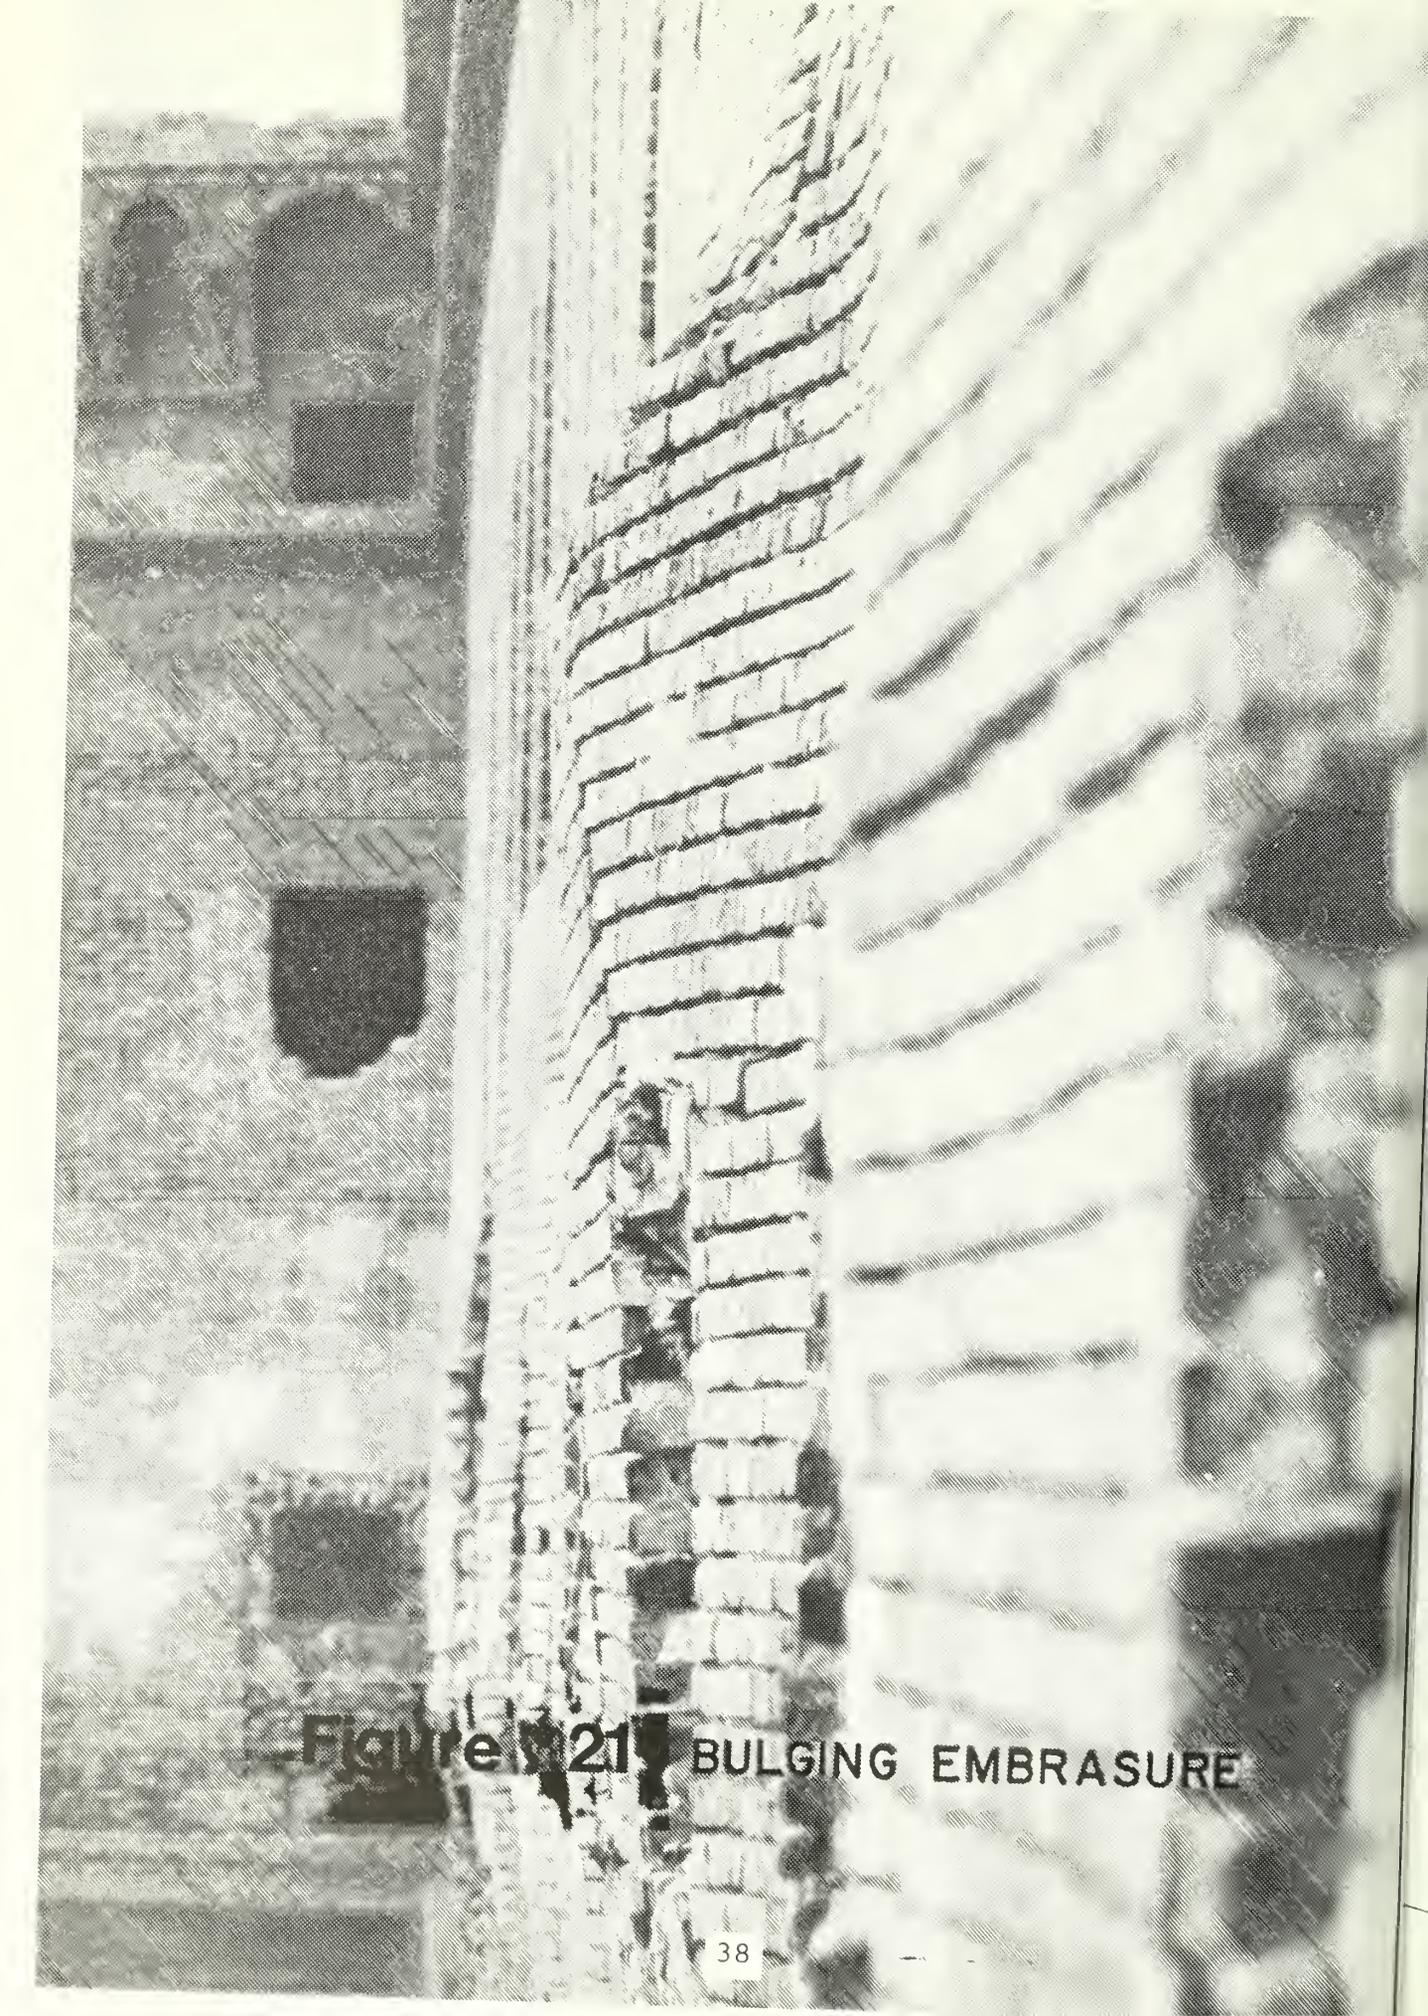
Figure 21 BULGING EMBRASURE

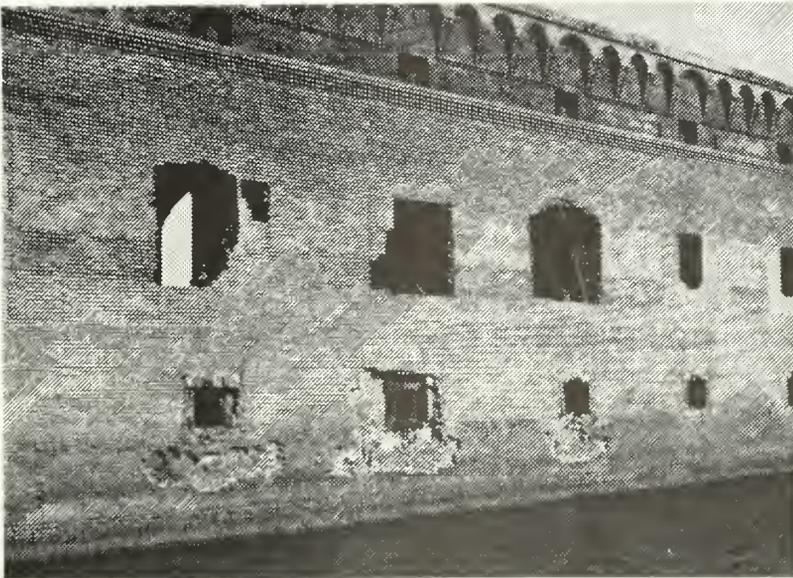
Figure 22 SCARP DETERIORATION

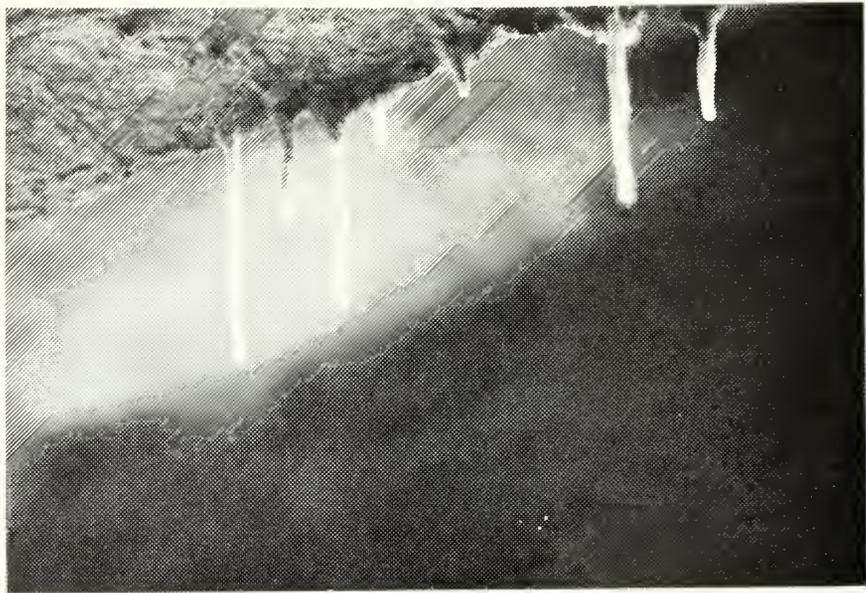
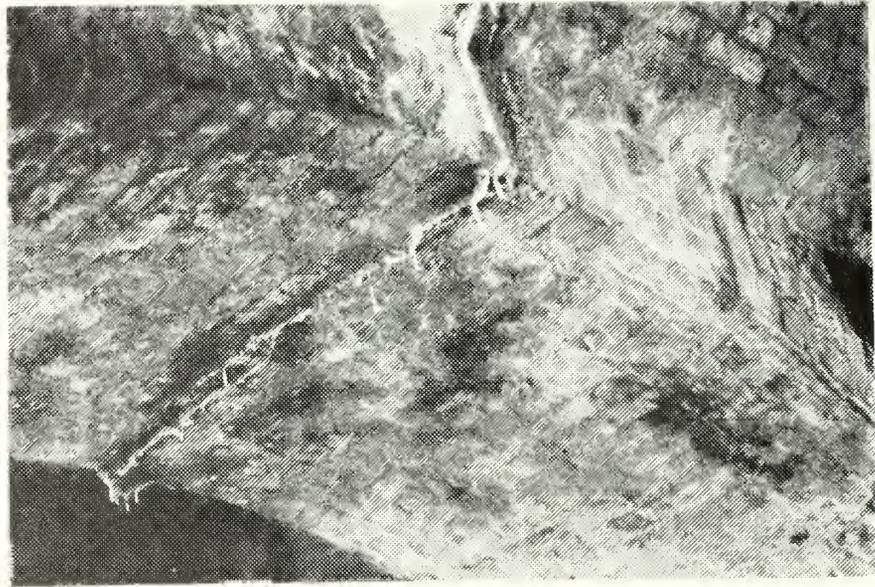
Figure 23 PRESENT CONDITION

Casemates where moisture problems seem to be concentrated are as follows: Upper Tier Casemates 12, 13, 18-20, 40, 41, 44-48, 51-54, 64, 65, 71, 72, 74, 75, 82, 83, 85-89, 91-93, 96-100, 115-117, 121-123, 138, 139, 142-144, 149-153, 155 and 156.

CASEMATE MOISTURE

The recommended treatment for the casemates is to monitor structural cracks in selected areas and repair those cracks of sufficient severity as to pose a threat to visitor safety or the stability of the fort superstructure. The recommended treatment for adaptively used casemates is the installation of some form of waterproofing membrane without permanently damaging historic fabric, and thereby upgrading these areas to suitable standards for human occupancy.

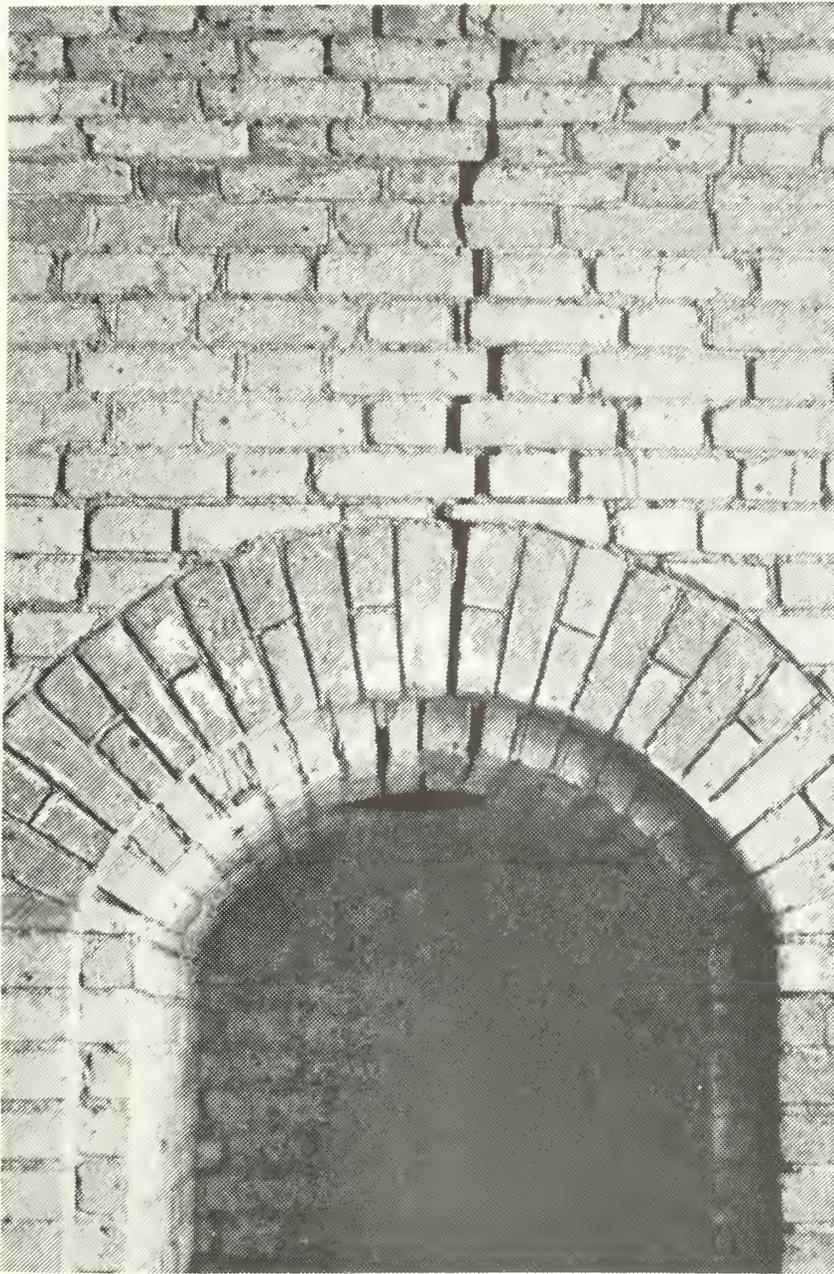
Figure 24 PRESENT CONDITION

PIER CRACKING AT CISTERN ACCESS

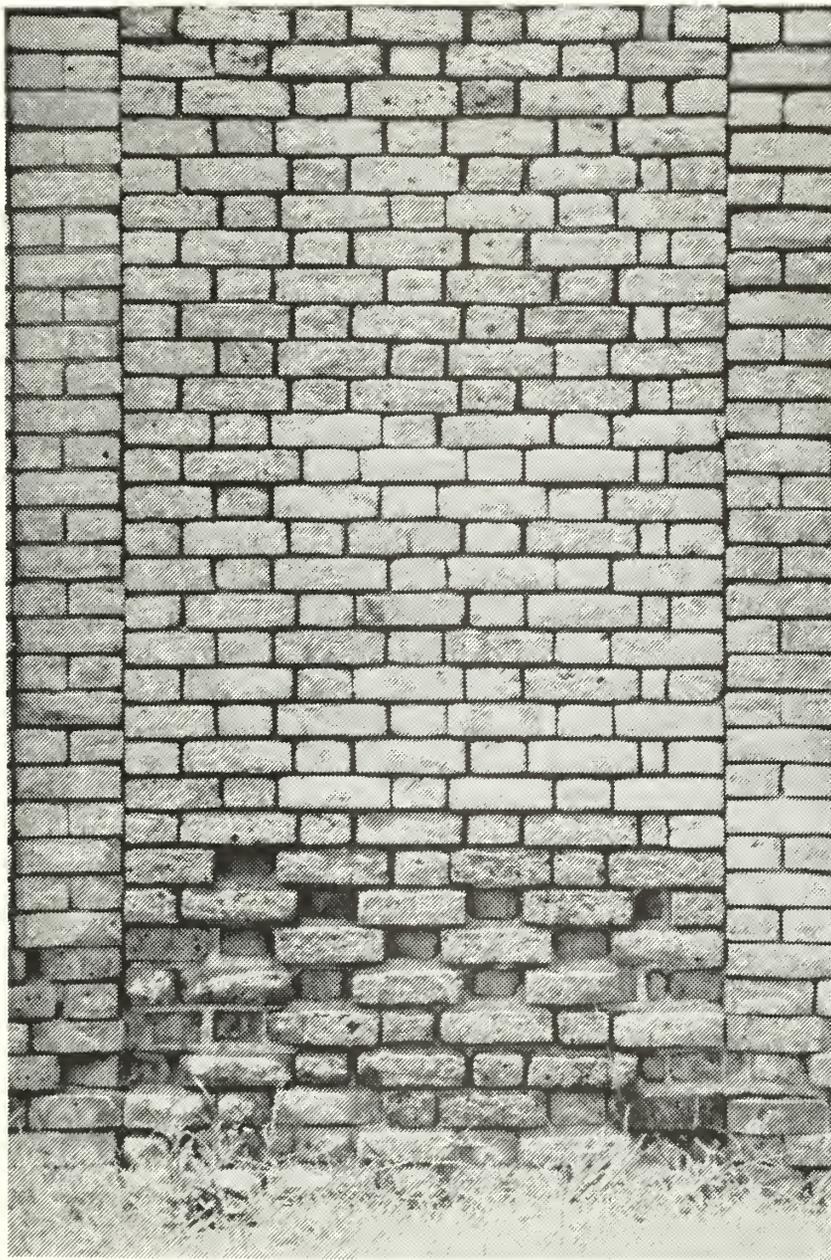
Figure 25 PRESENT CONDITION

PIER MASONRY DETERIORATION

The recommended treatment for the bastions involves the removal of exfoliating embrasure irons and rebricking of embrasures to historic dimensions with brick replacement and repointing where needed. The replacement of missing brick and selective repointing is recommended for the stabilization of the stairtowers.

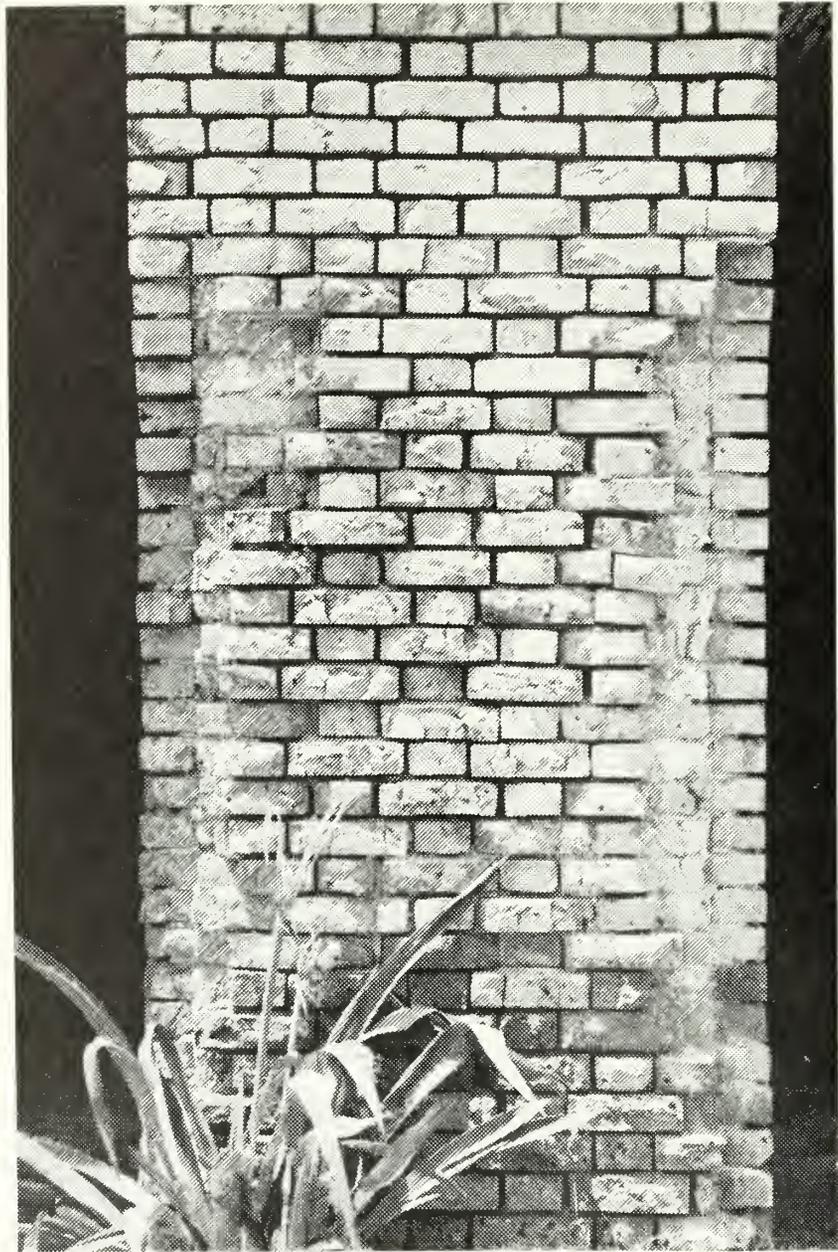
Figure 26 PRESENT CONDITION

PIER MASONRY DETERIORATION

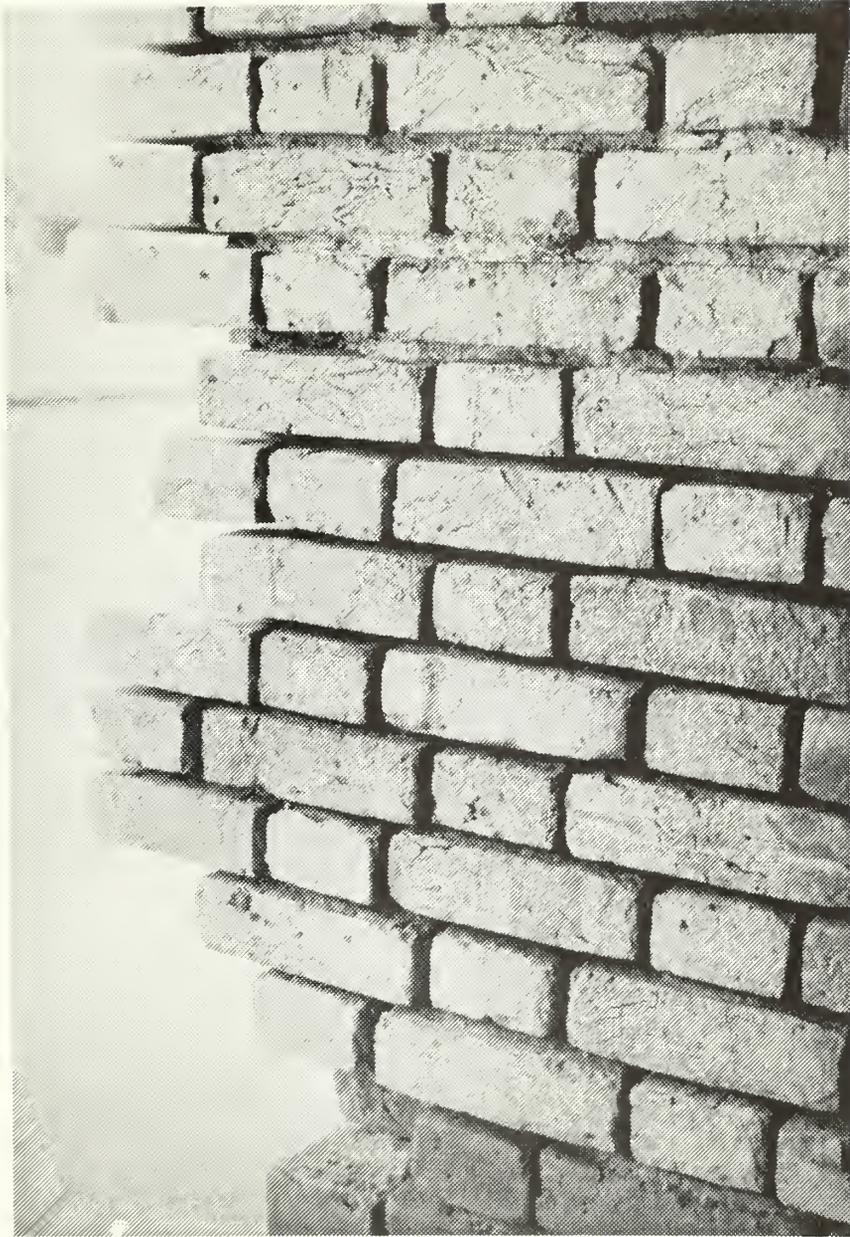
Figure 27 PRESENT CONDITION

PIER MASONRY DETERIORATION

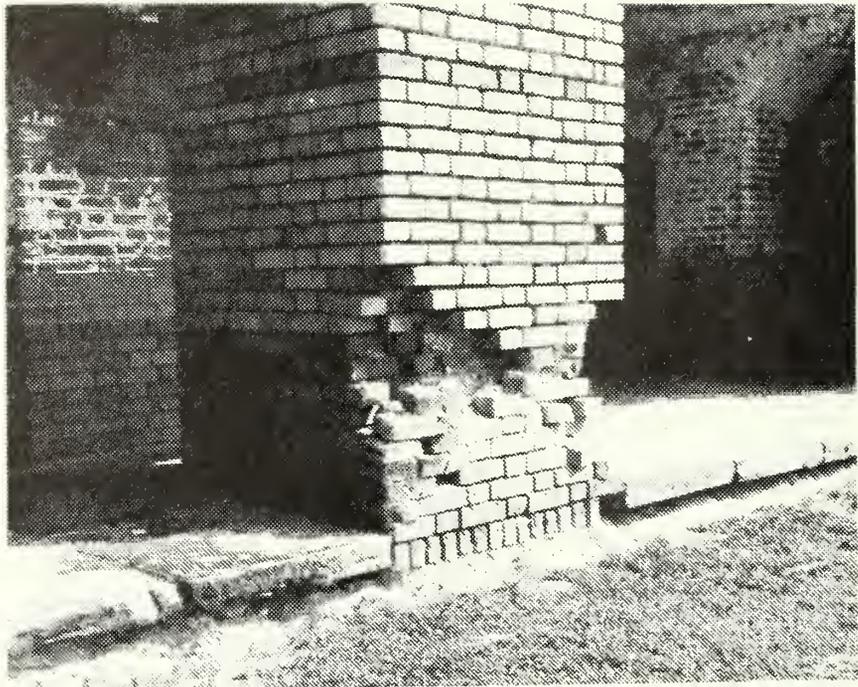
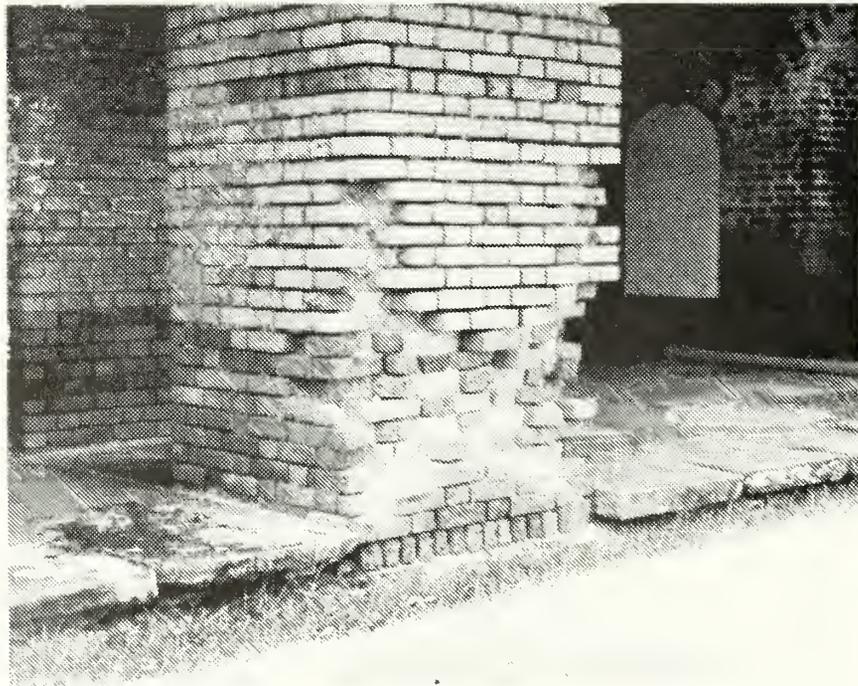
Figure 28 PIER DETERIORATION

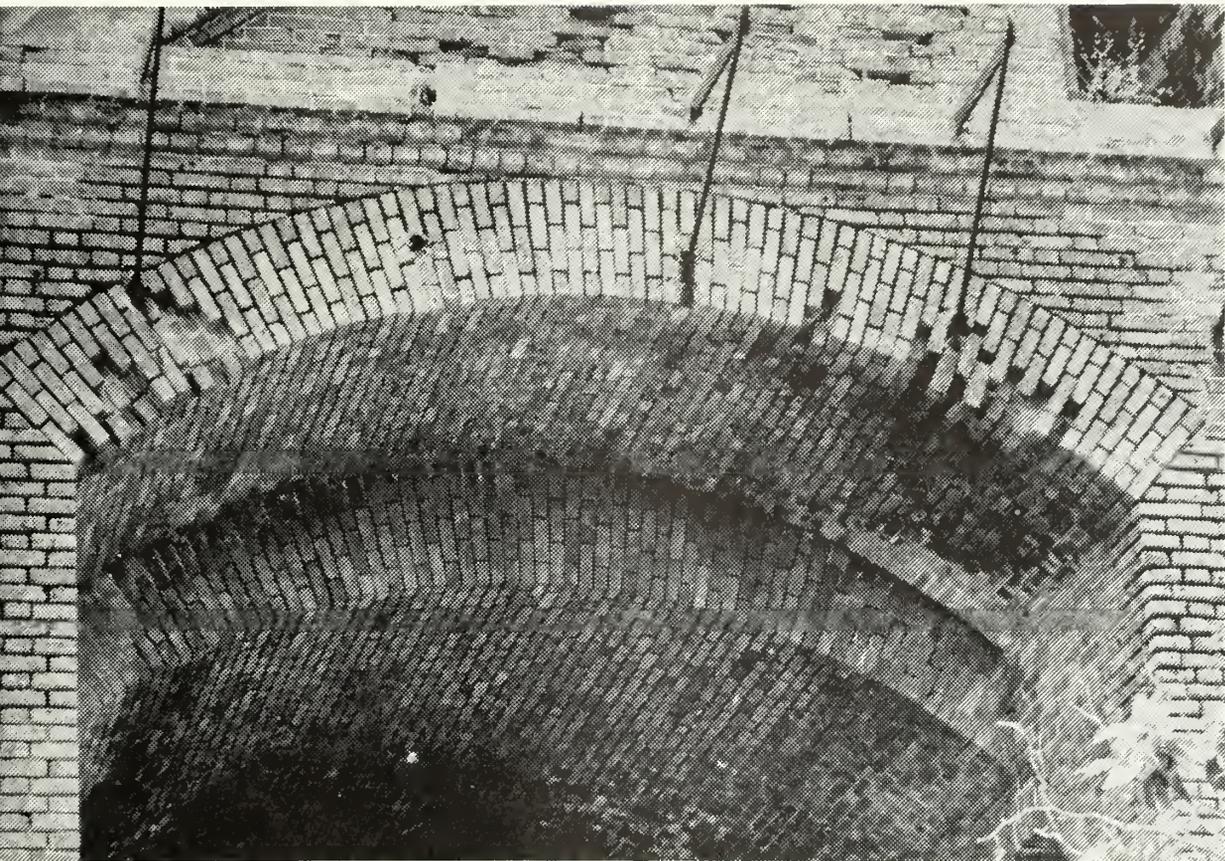
Figure 29 PRESENT CONDITION

CASEMATE ARCH DAMAGE
