historic structure report
architectural data section

FORT JEFFERSON
NATIONAL MONUMENT / FLORIDA

BY: LOUIS ANDERSON
APRIL 1988

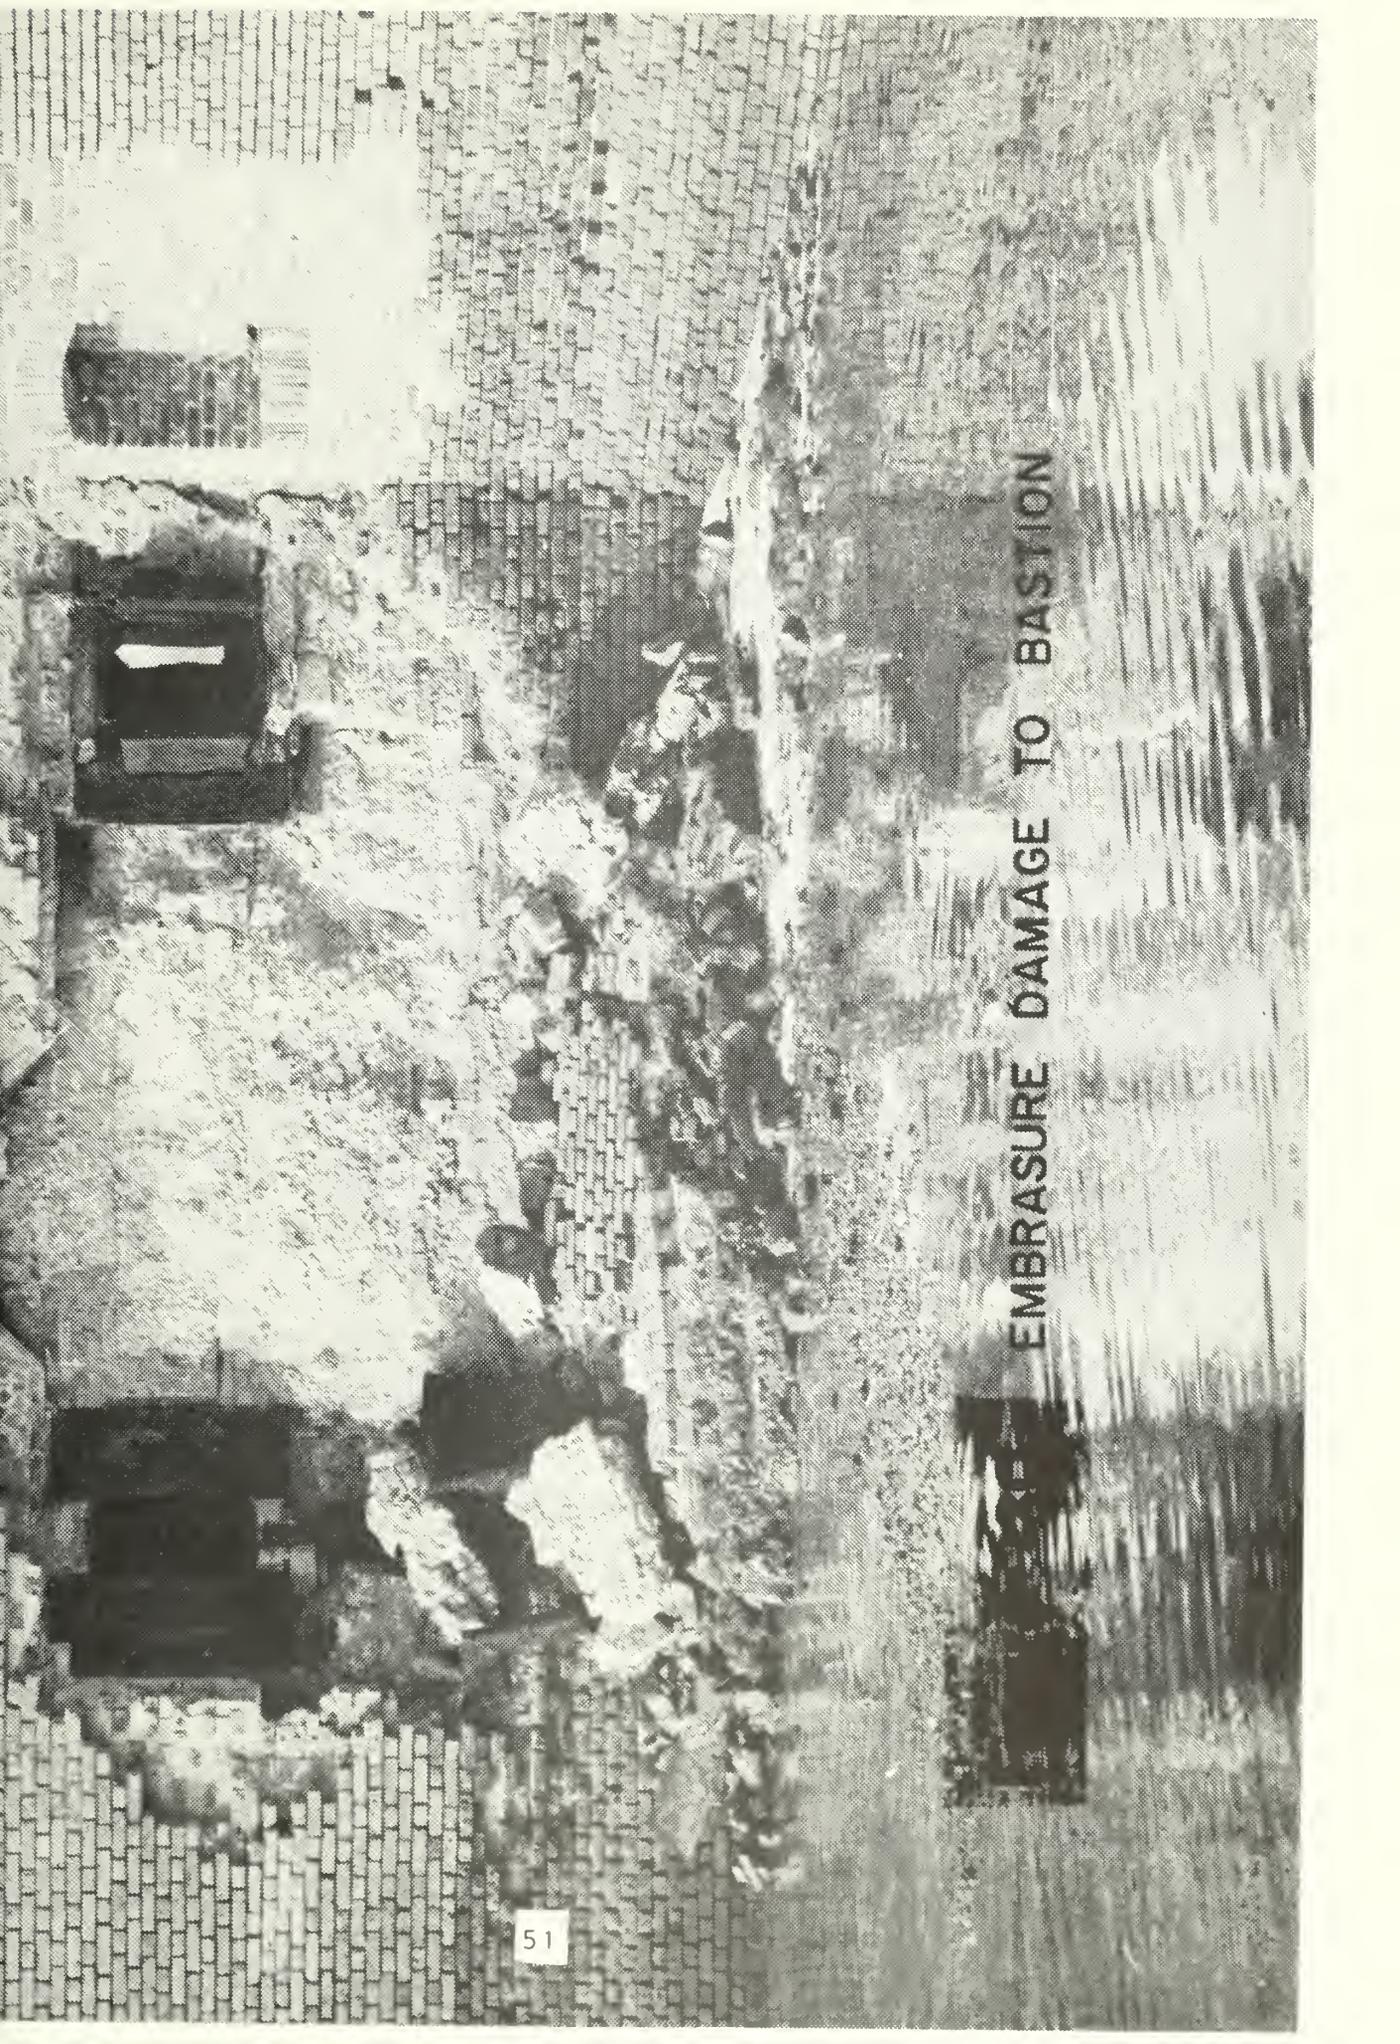
EMBRASURE DAMAGE TO BASTION

The recommended treatment for the bastions involves the removal of exfoliating embrasure irons and rebricking of embrasures to historic dimensions with brick replacement and repointing where needed. The replacement of missing brick and selective repointing is recommended for the stabilization of the stairtowers.

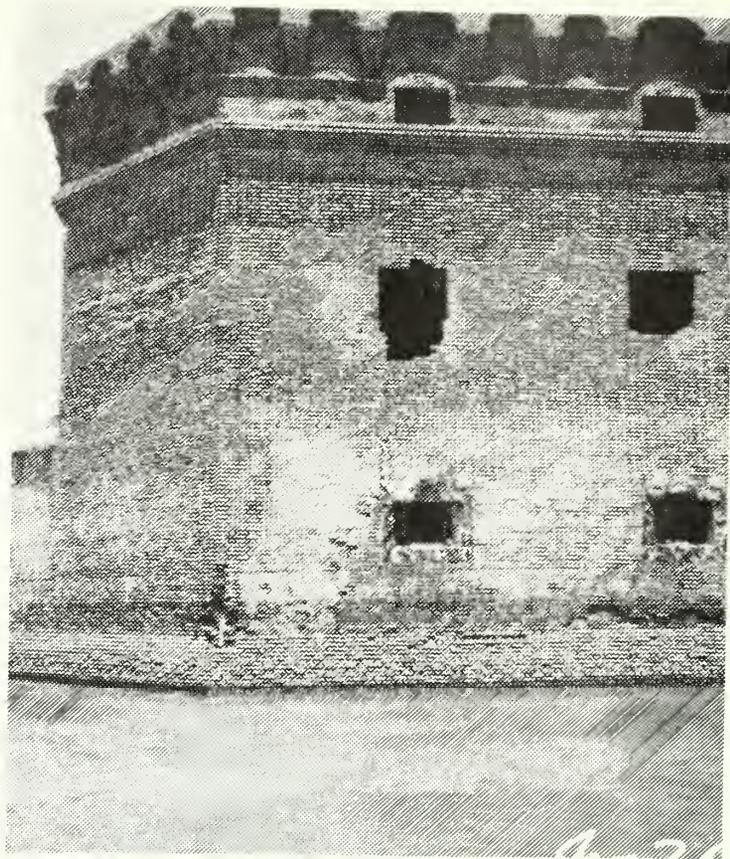
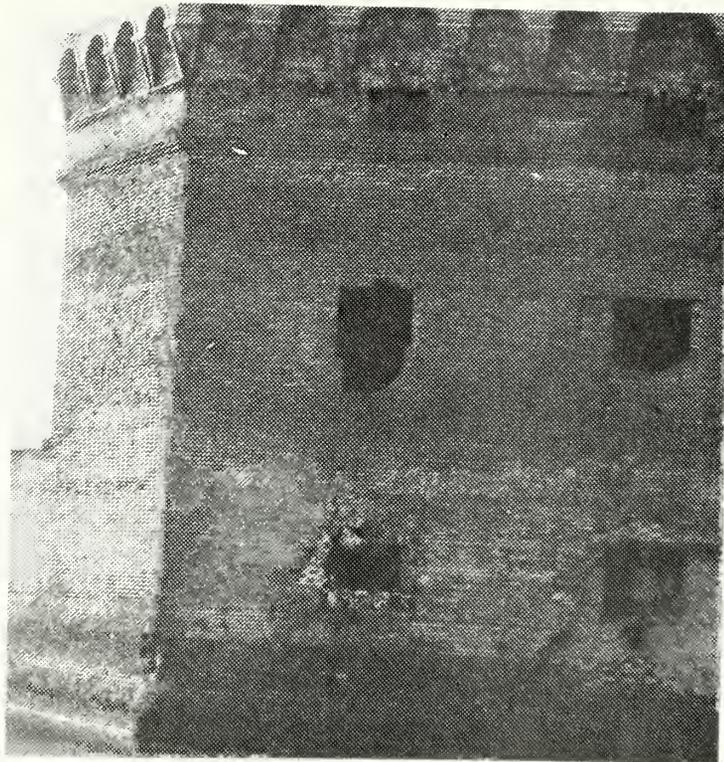
Figure 31 EMBRASURE DAMAGE

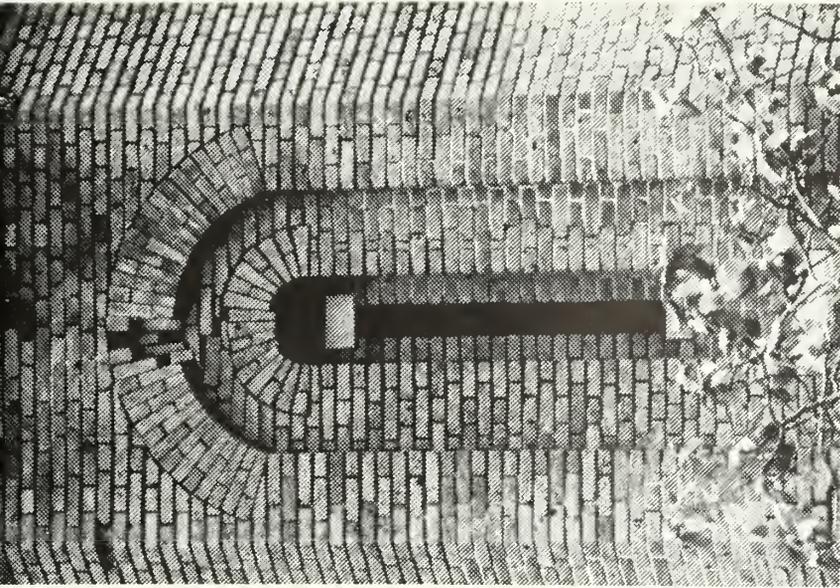
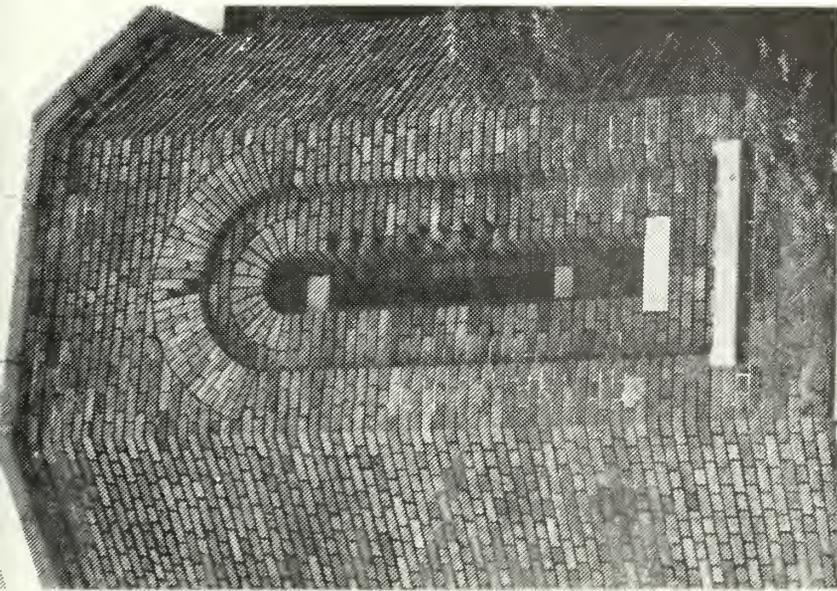
Figure 32

Stairtower 5 - The entire window arch has been repointed, although the remaining masonry surfaces are in need of a similar stabilization measure. The lower entry door jamb has lost approximately 50 brick from one side.

Stairtower 6 - The mortar of the window arches and surrounding masonry has eroded to such a depth that collapse of this area is imminent. At least two dozen brick are visibly displaced in this area and six are

STAIRTOWER DETERIORATION
