# Historic Structure Report

*Building 25  
Enlisted Men's Barracks  
Fort Hancock, New Jersey  
Sandy Hook Unit  
Gateway National Recreation Area*

**BUILDING 25  
ENLISTED MEN'S BARRACKS  
Fort Hancock**

February 2002

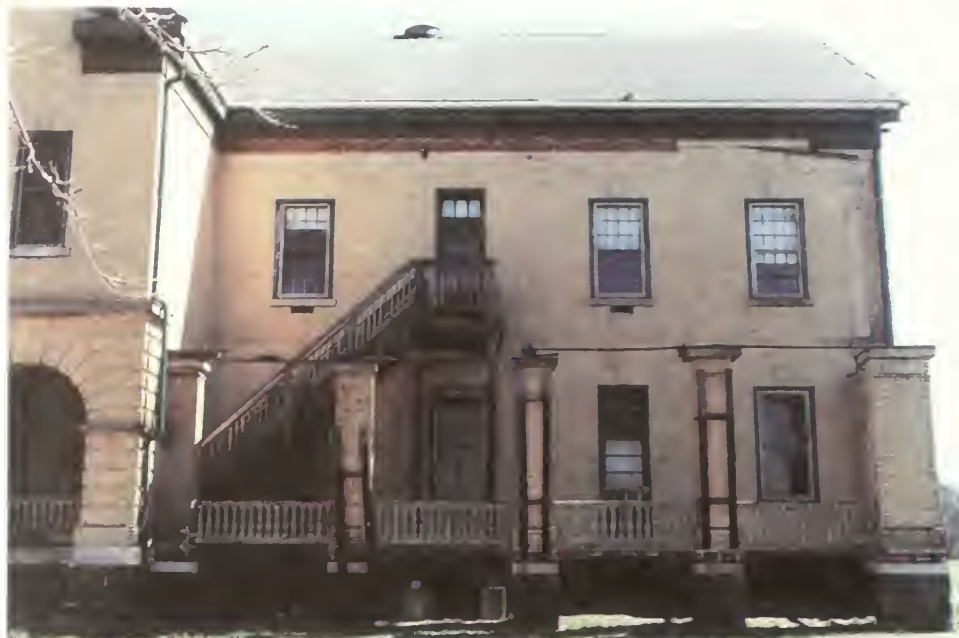
**Figure 74.** West elevation, showing replacement box cornice and fire escape.

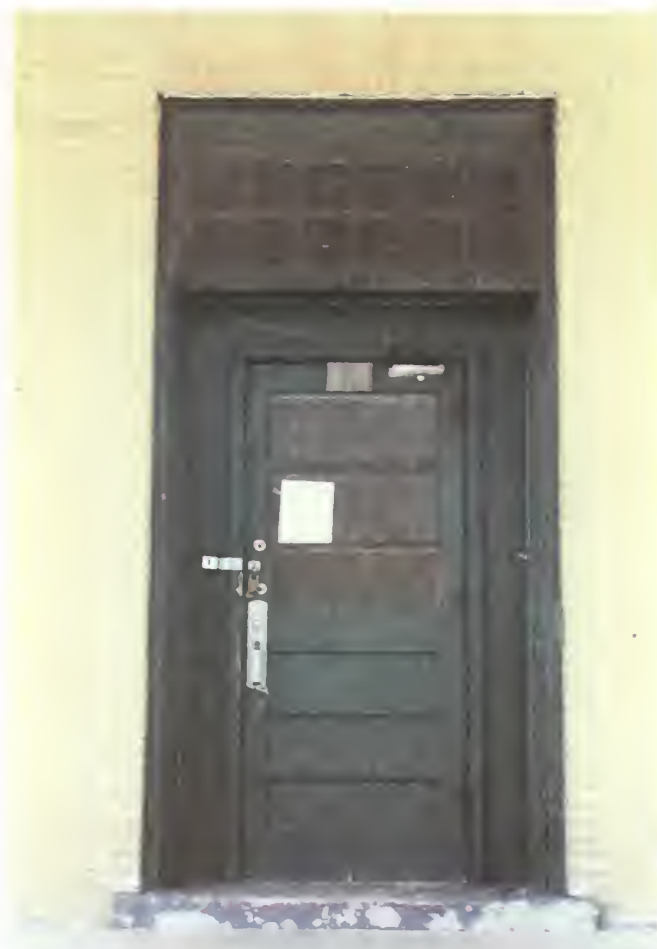
**Figure 75.** East elevation, first-story doorway, showing perimeter infill with replacement door, and original transom.

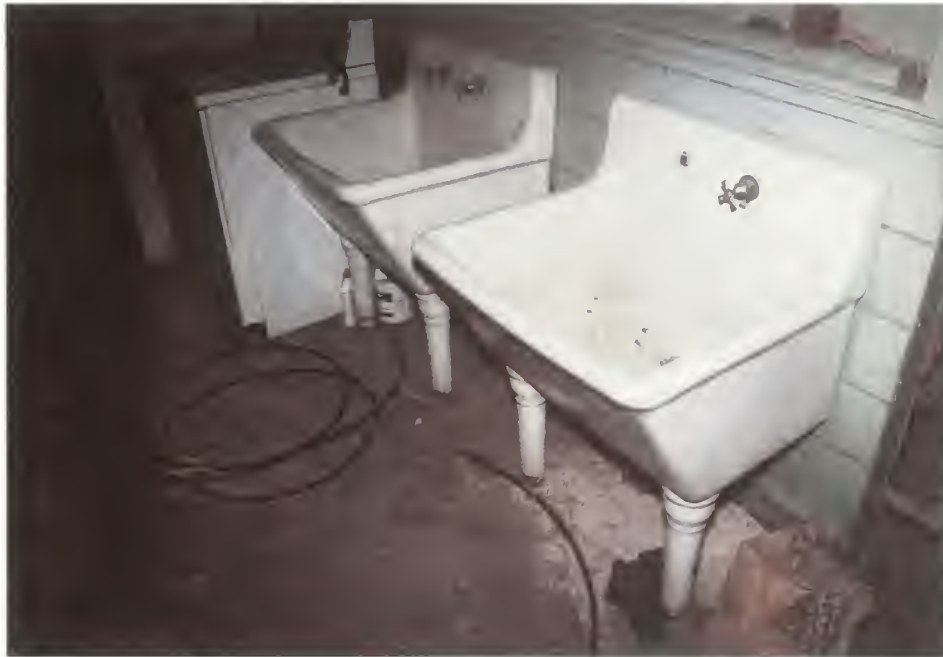
**Figure 76.** North side of basement, partition and laundry sinks in northeast corner.

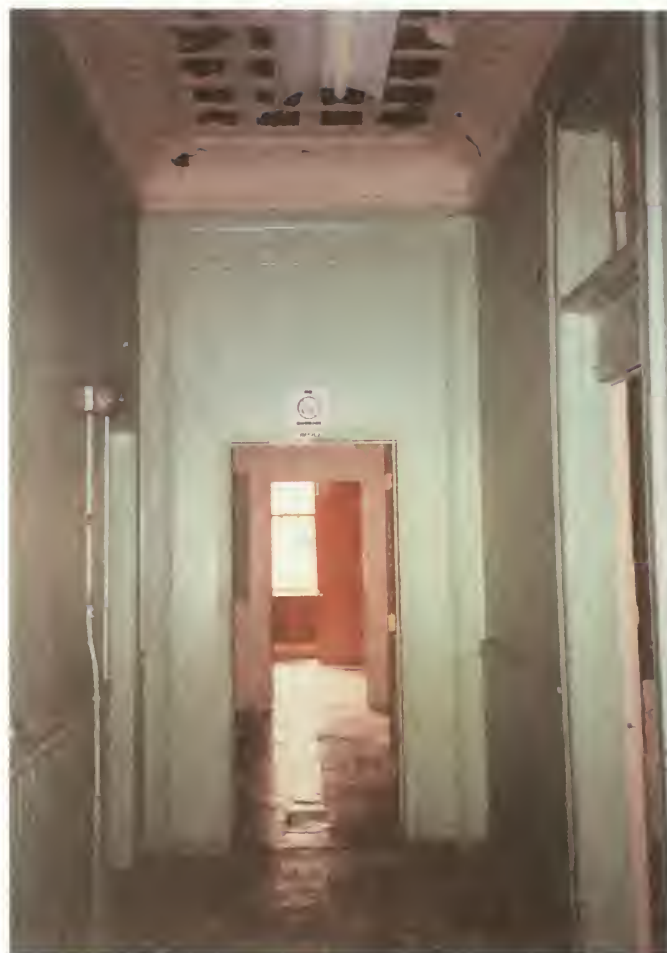
Figure 79. Doorway from side hall to mess room, showing perimeter infill for replacement door and covered transom.

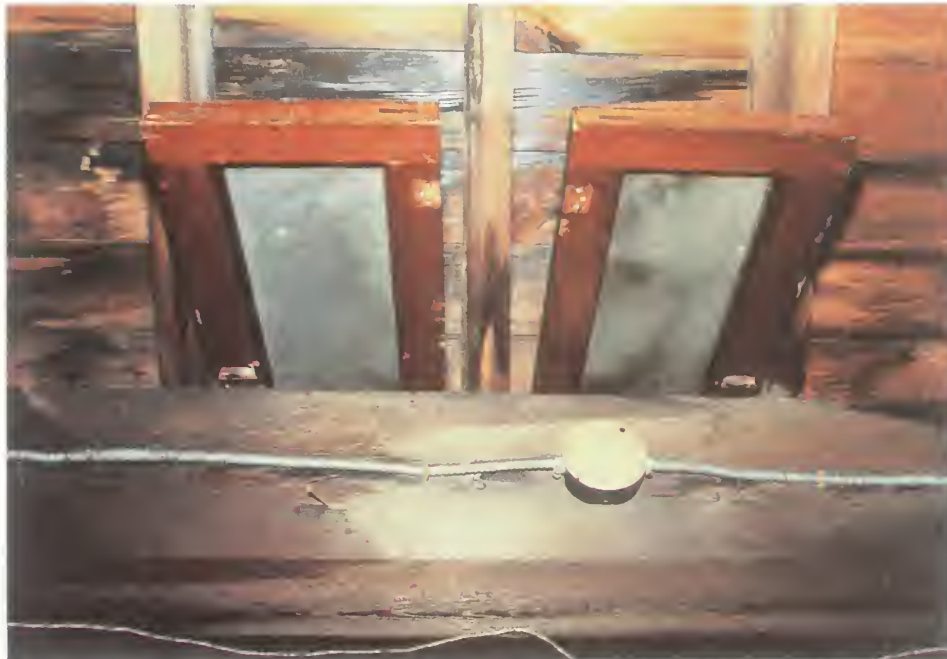
**Figure 80.** Pantry cupboard doors stored in south side of attic.

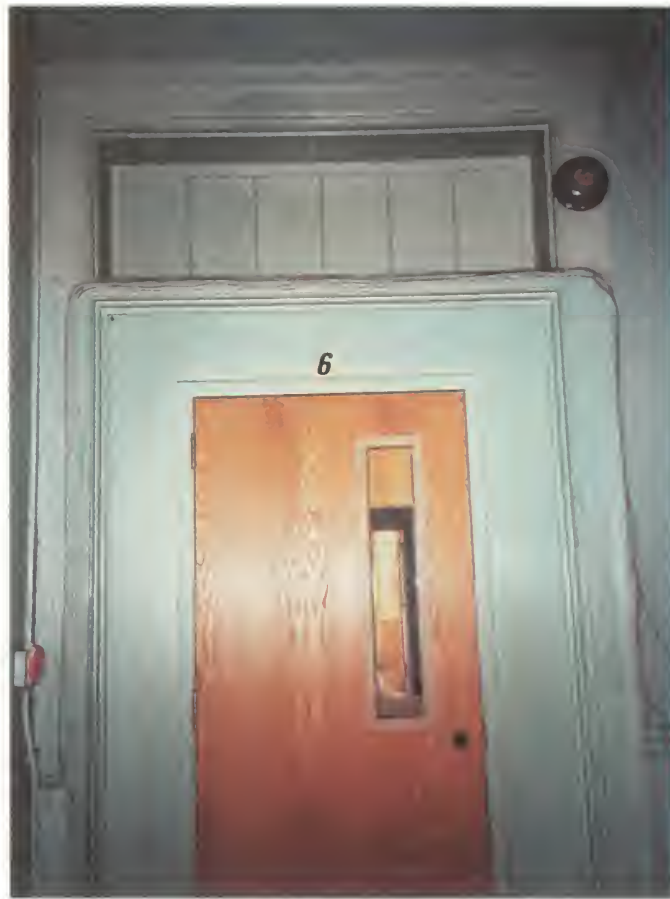
Figure 82. Doorway from center hall to south dormitory, showing perimeter infill with replacement door, and painted transom.

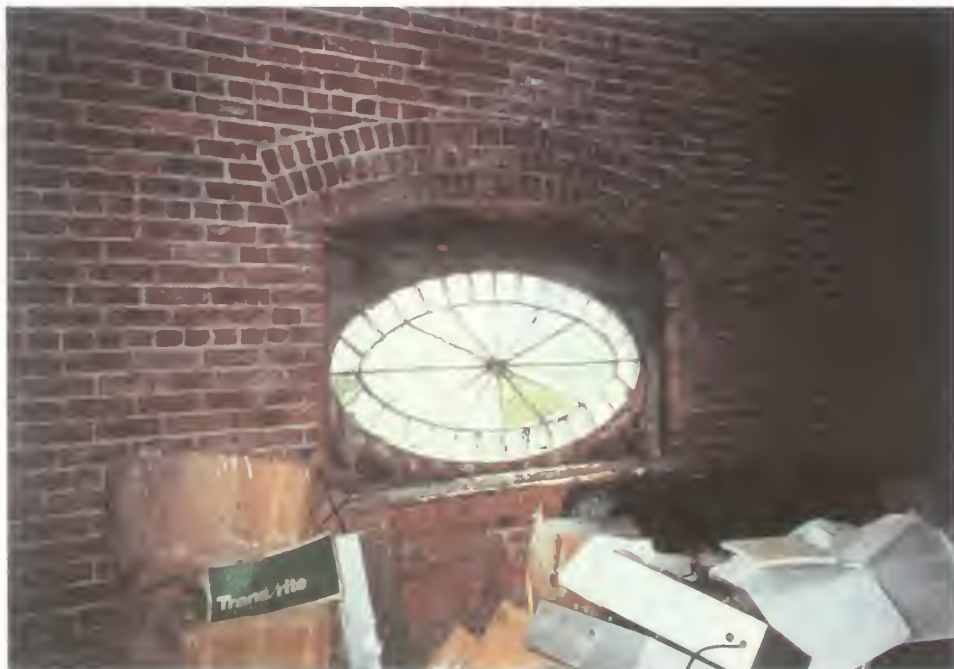
Illumination is provided by bare light bulbs screwed into sockets attached to the exposed electrical lines. These supplement the natural light obtained from the gable oculi (fig. 83).

Figure 83. South side of attic, south wall, showing interior construction of opening for oculus.
