I 29.88:G 22/2

Clemson University

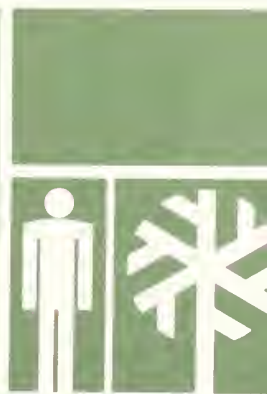
NATIONAL RECREATION AREA / NEW JERSEY - NEW YORK

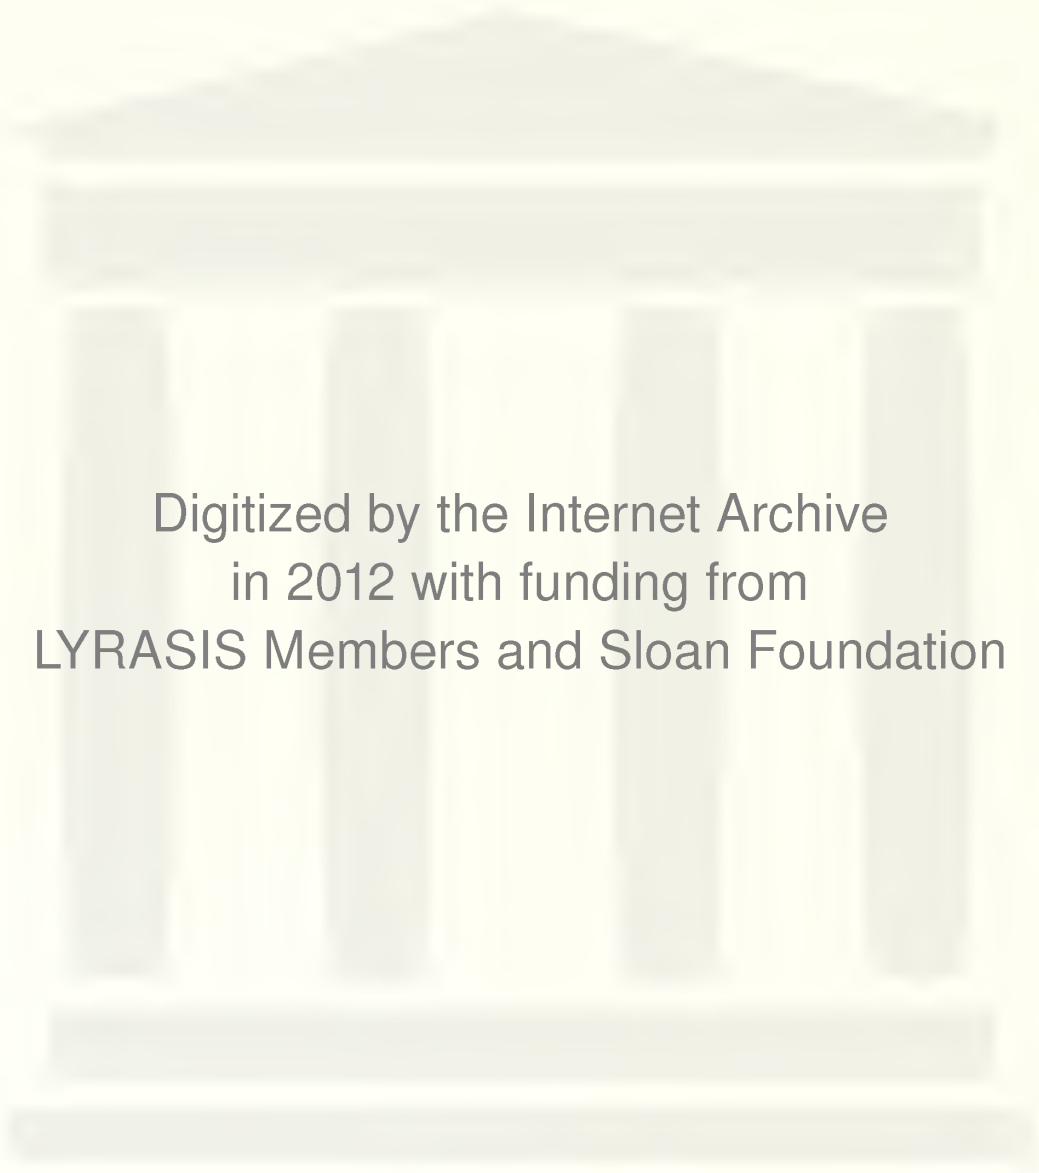
Digitized by the Internet Archive
in 2012 with funding from
LYRASIS Members and Sloan Foundation

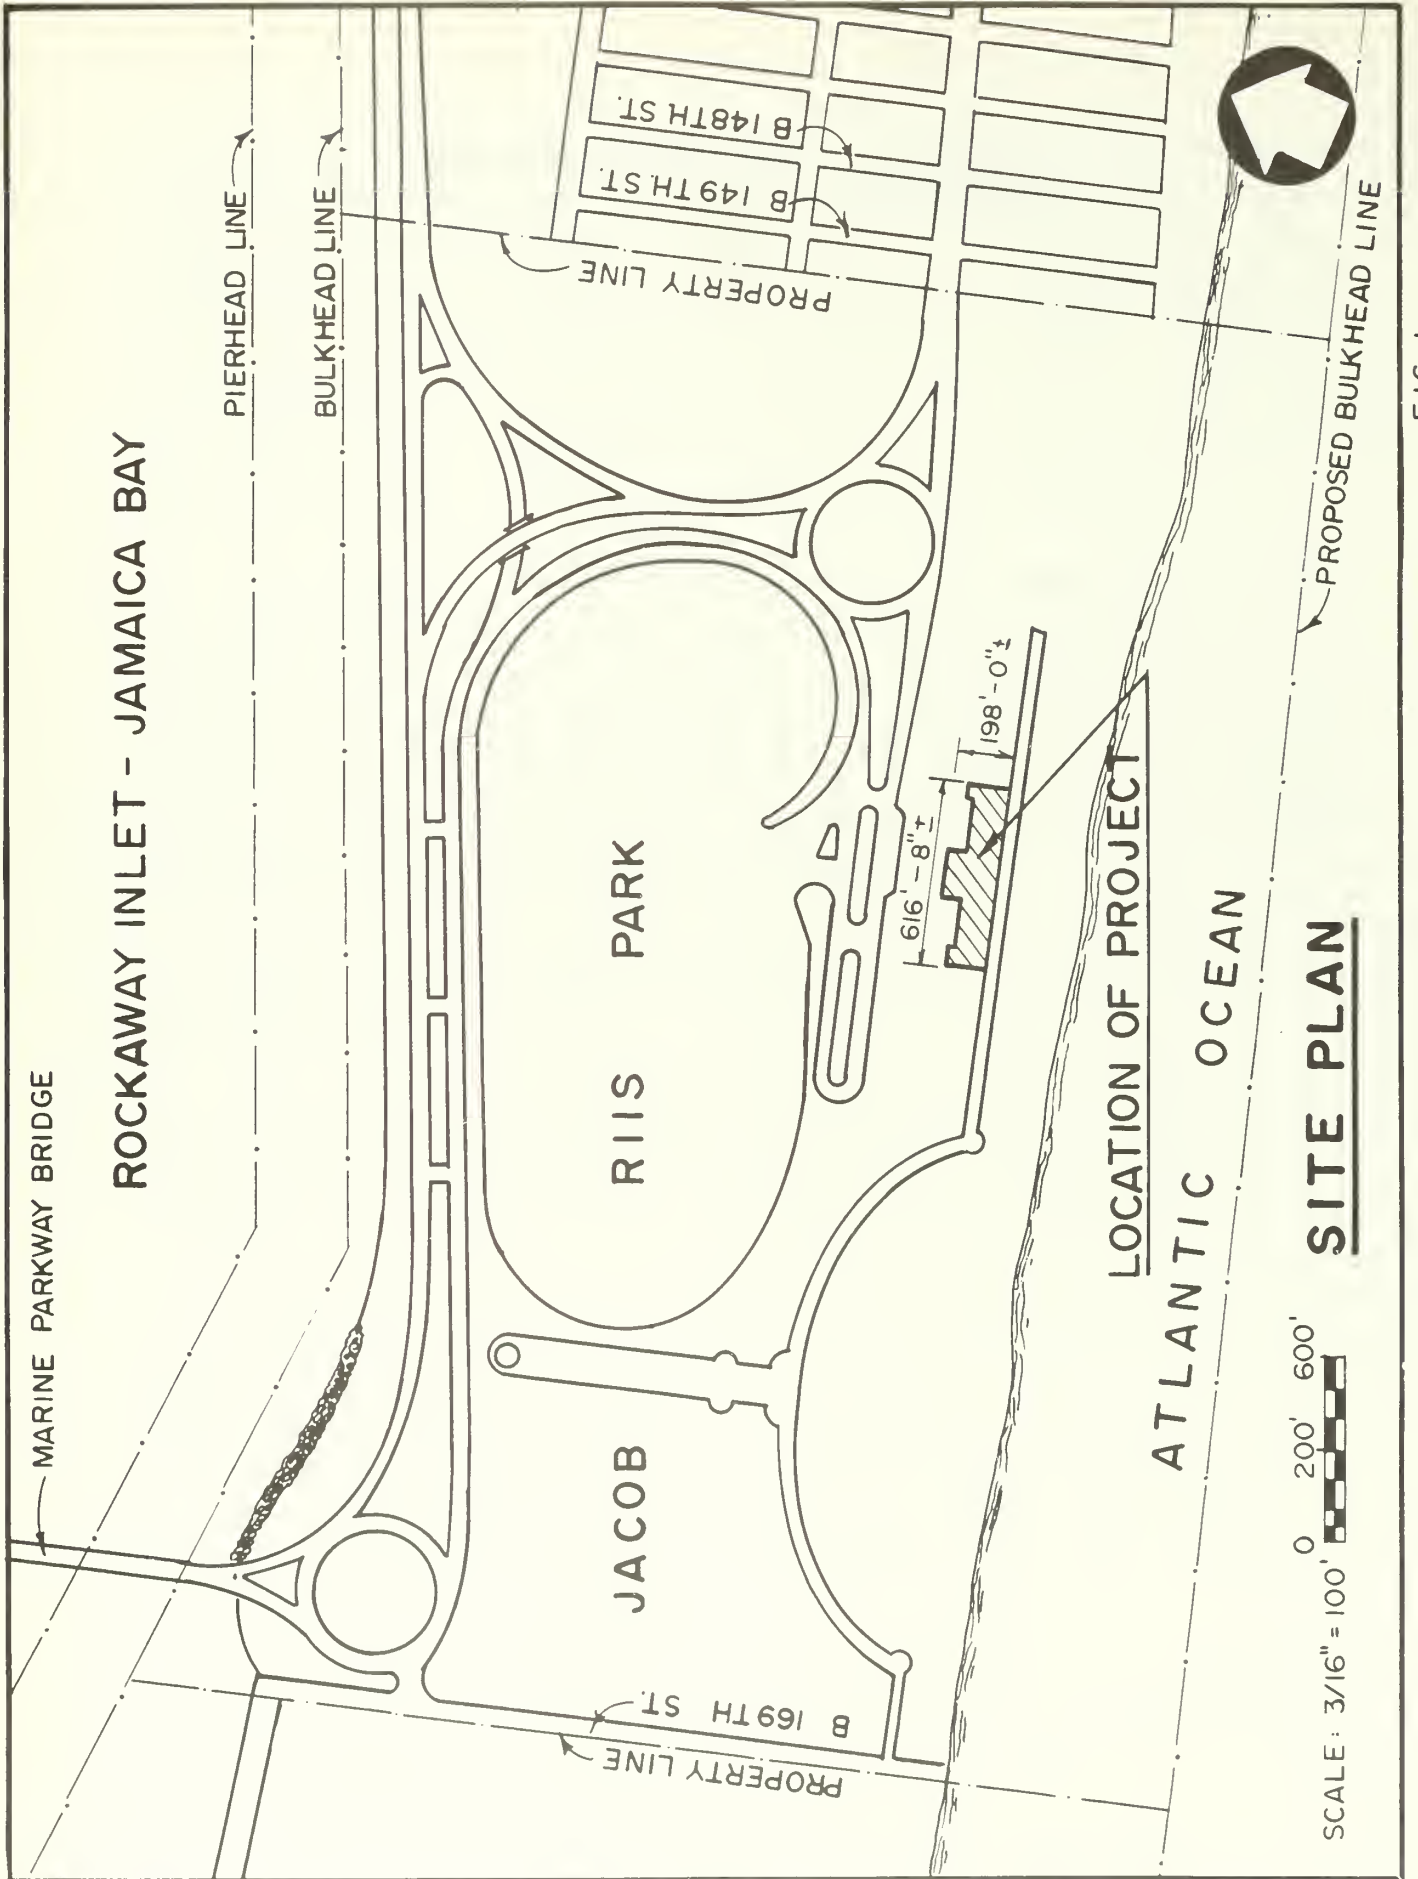
d. Evolution and Existing Conditions Drawings
and Photos

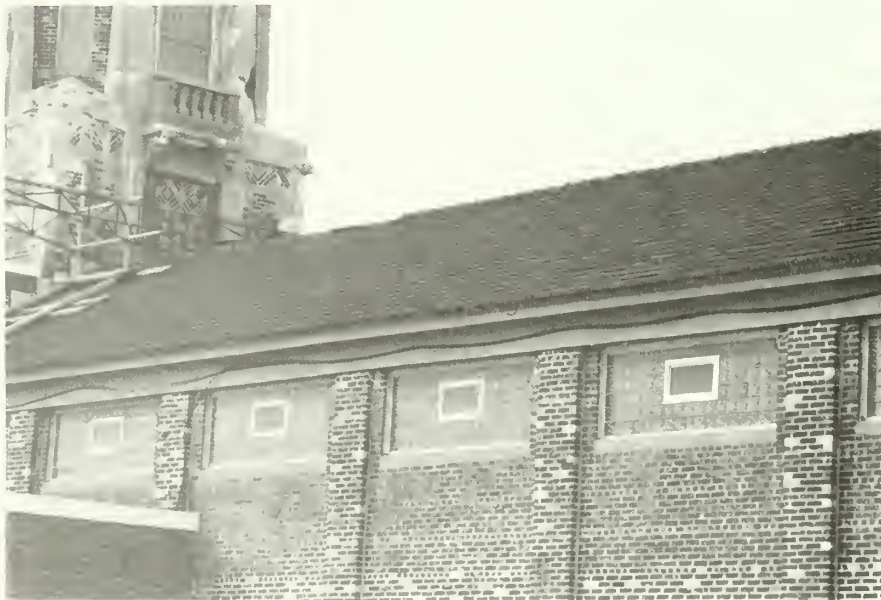
Figure 8: Ceramic veneer (terra-cotta) the roof finish at Beach Pavilion. Note missing ridge coping to left. Broken tiles lay under scaffolding.
NPS photo, October 1985.

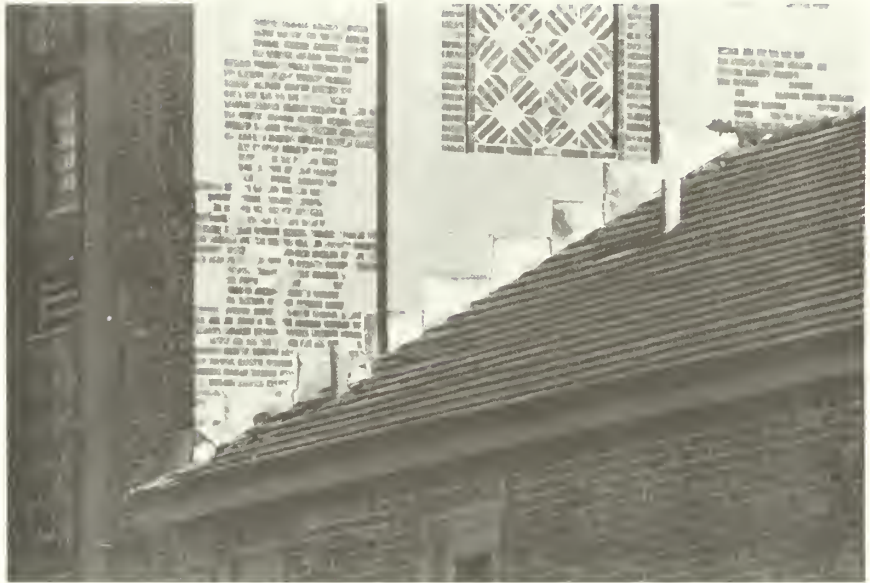
Figure 9: Faulty counterflashing at base of West Tower. Flashing pulling out from joints in wall. Joints needs repointing. NPS photo, October 1985.

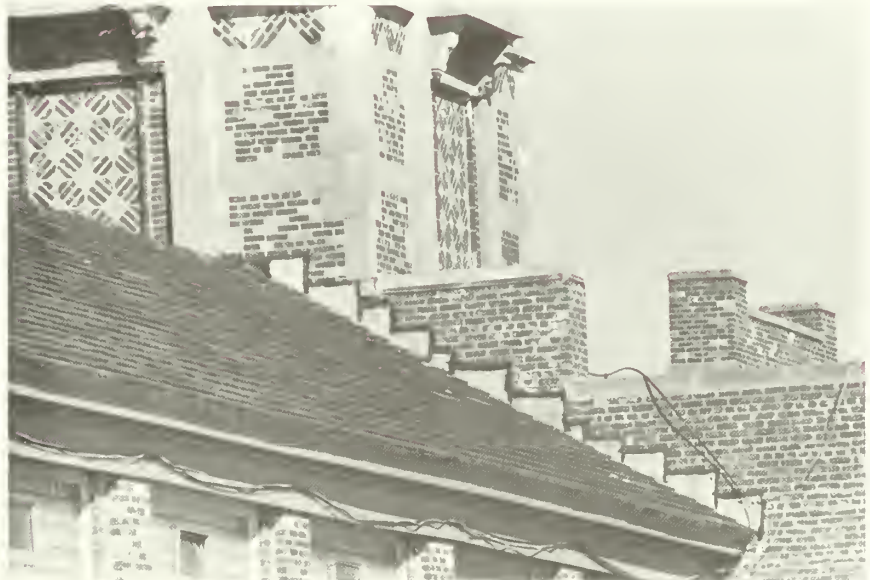
Figure 10: Rusting drip flashing at roof edges, West Tower. Note cornice and eaves below, and faulty counterflashing at base of tower. Tar at joints of flashing is deteriorating. NPS photo, October 1985.

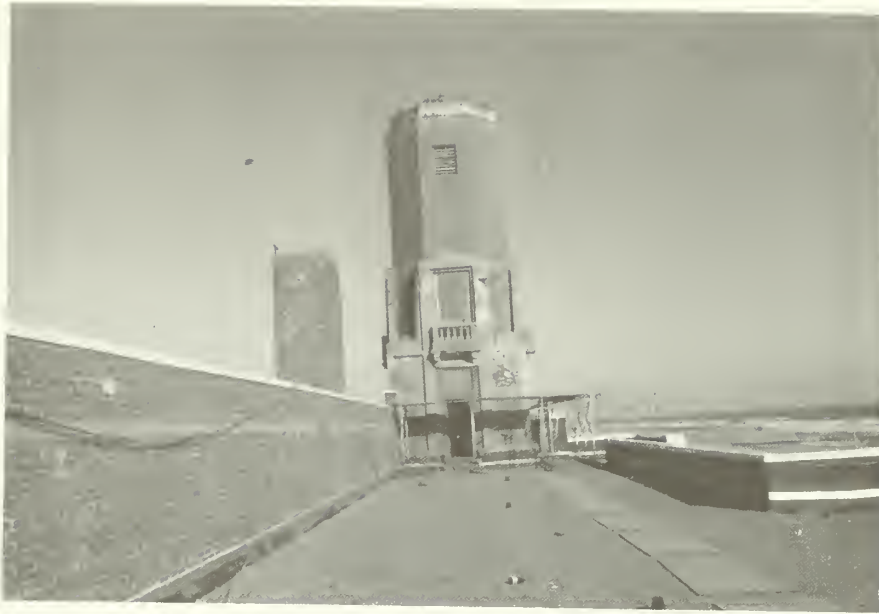
Figure 11: Built-up roof of Part 2 looking east. Worn areas of roof found to have water below surface of felt. East Tower in background. NPS photo, October 1985.

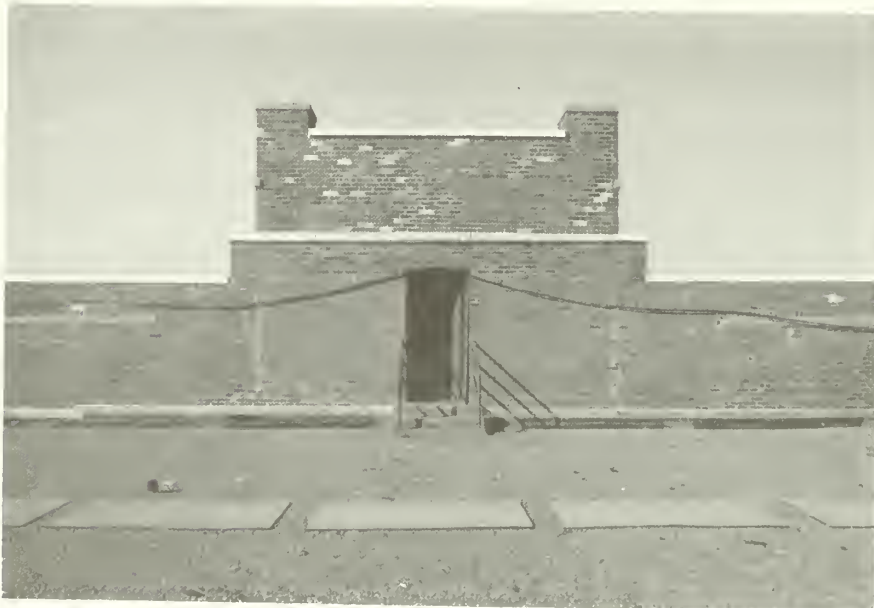
Figure 12: Built-up roof in front of Utility Penthouse. NPS photo, October 1985.

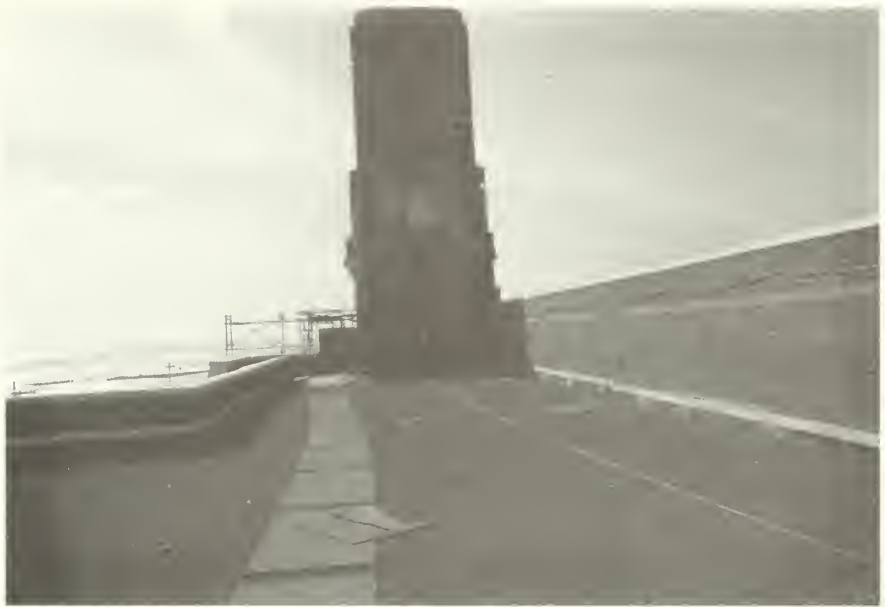
Figure 13: Built-up roof looking west. Worn areas indicate presence of water as on east side. West Tower in background.
NPS photo, October 1985.

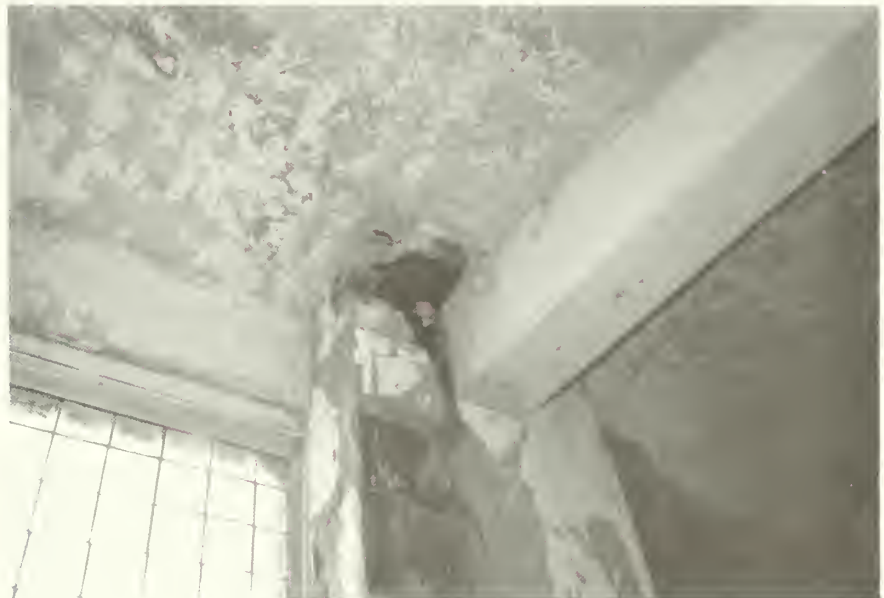
Figure 14: Water damaged plaster and clay tile chase in kitchen area. Problem caused by damaged roof leader. Other moisture around this area is attributed to poor ventilation and lack of temperature controls in the unconditioned space.
NPS photo, October 1985.

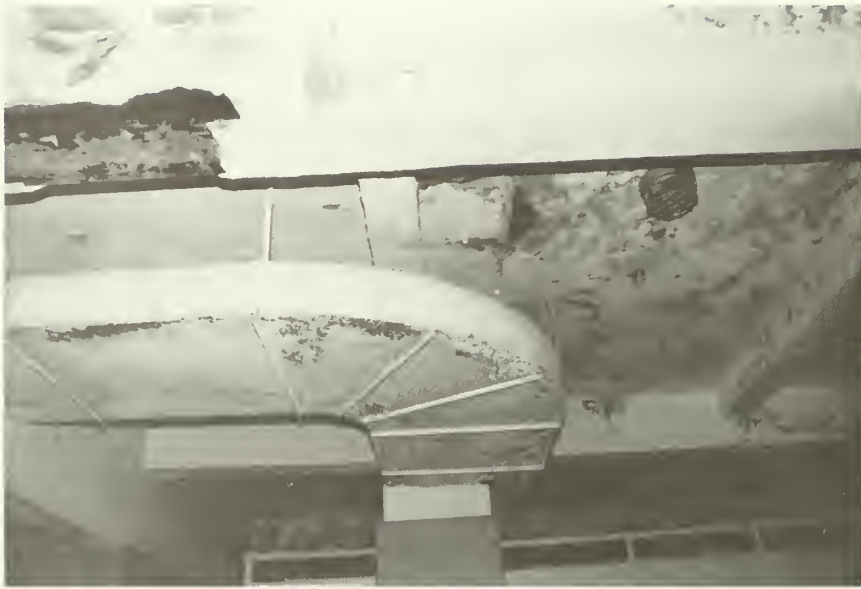
Figure 15: Other moisture problems in second floor area. Plaster and concrete coatings are spalling at beams and ceilings. Paint also blistering and peeling.
NPS photo, October 1985.

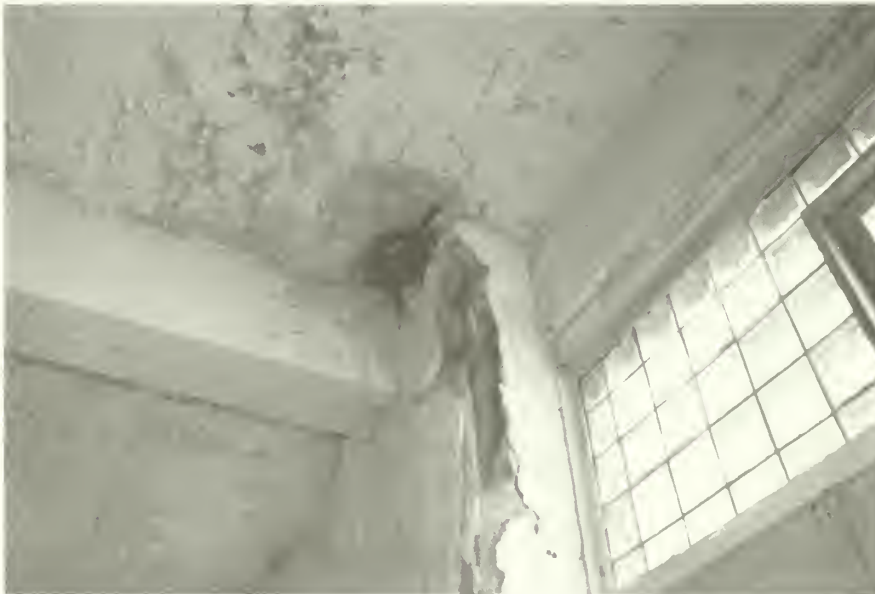
Figure 16: Moisture problems in kitchen area at beams, ceilings, and clay tile chase areas.
NPS photo, October 1985.

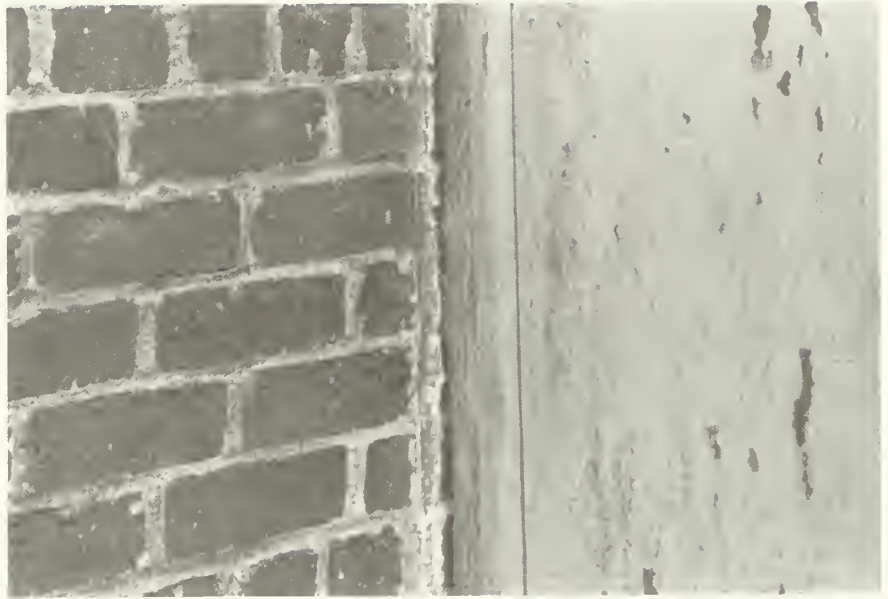
Figure 17: Sandblasted wall outside of "Shed A" (see Existing Conditions drawings). Shed walls to right.
NPS photo, October 1985

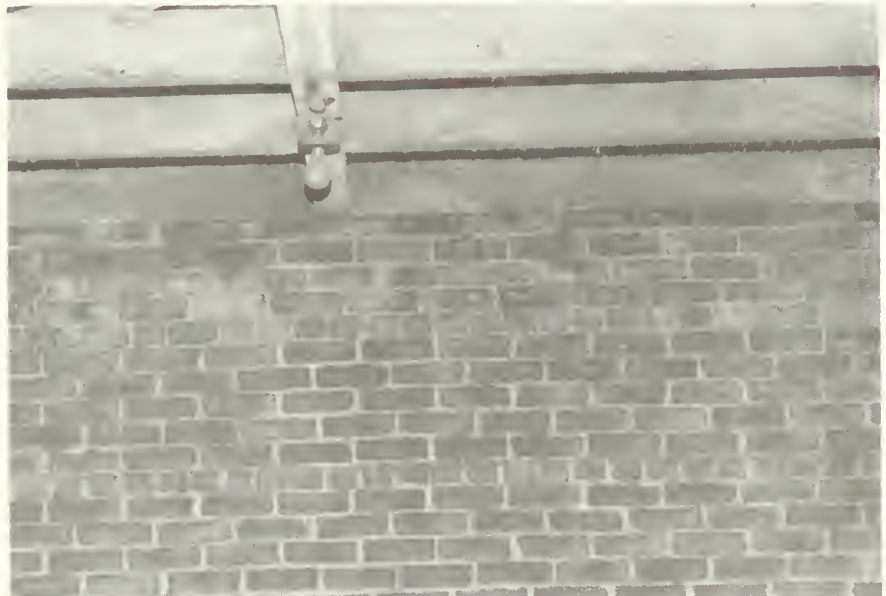
Figure 18: Unabraded brickwork at interior of "Shed A." No sandblasting occurred here and remnants of older paint remain.
NPS photo, October 1985.

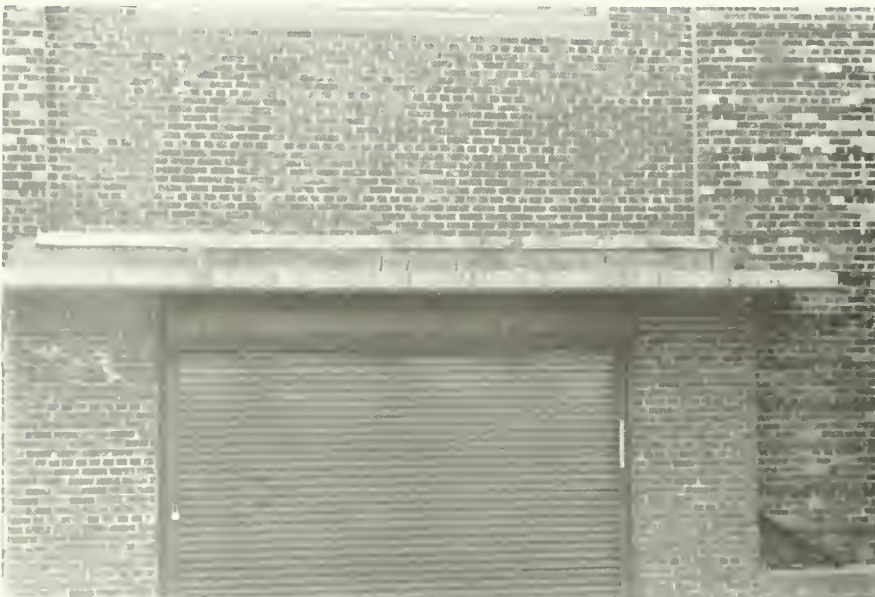
Figure 20: Typical oxide jacking at concrete canopies. Rust and steel bars visible. Typical rollup doors below canopy. NPS photo, October 1985.

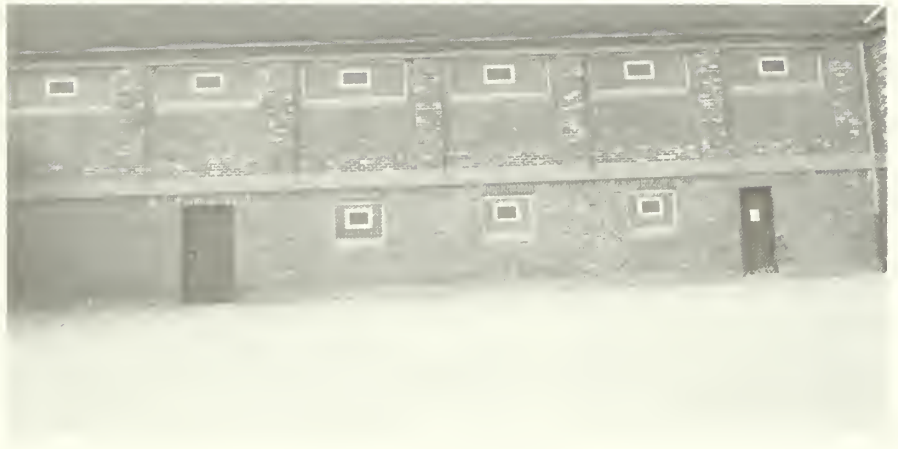
Figure 21: South Elevation--Part 3. Lintels between windows rusting and damaging walls between them. Conditions prevail at first floor of this facade.
NPS photo, October 1985.

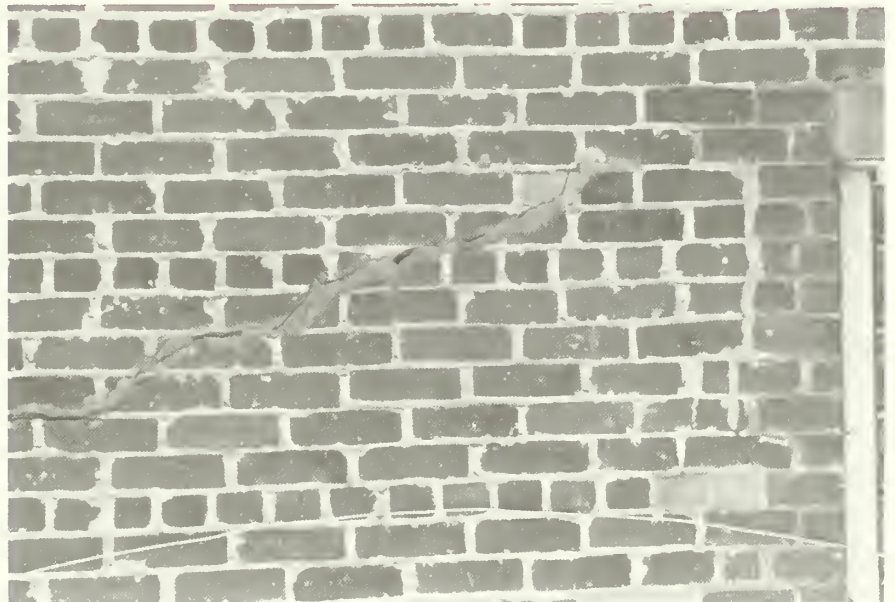
Figure 22: Typical condition of repaired cracks. Cracks are reopening.
NPS photo, October 1985.

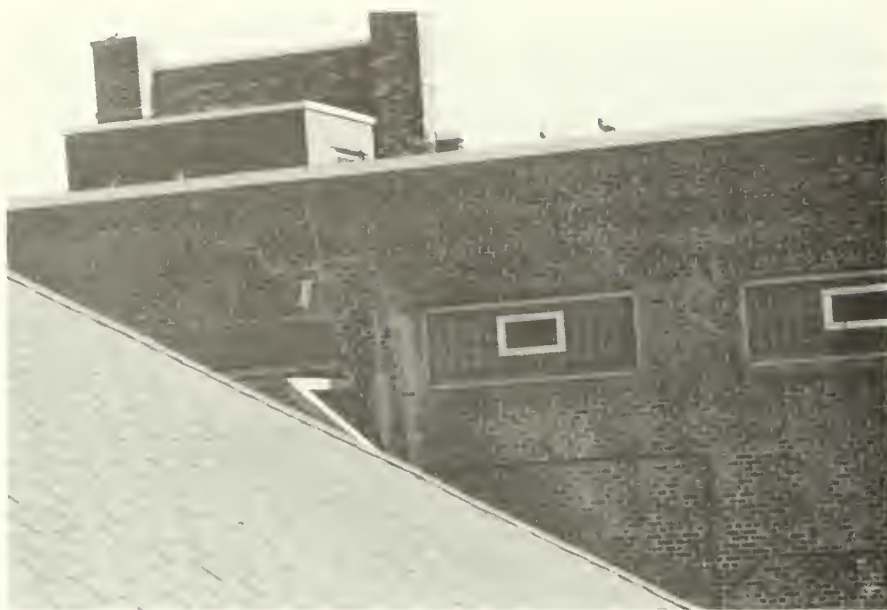
Figure 23: North elevation--part 2. Cracks typical at corners and in line of windows due to oxide jacking of steel lintels. NPS photo, October 1985.

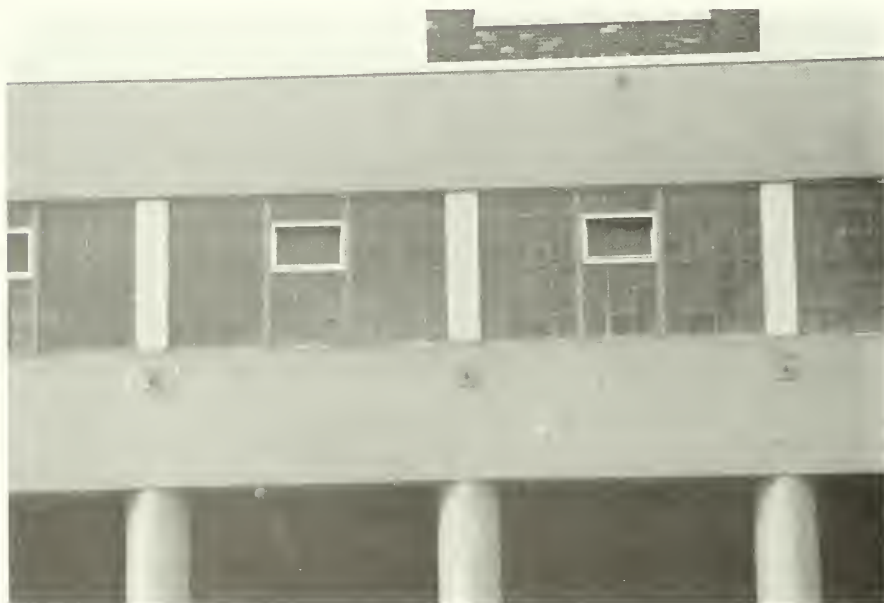
Figure 24: Elevation of loggia (North Elevation--Part 2). Note typical glass block windows with vents used throughout the Beach Pavilion. Problems of concrete in beams, columns and ceiling typical. NPS photo, 1985.

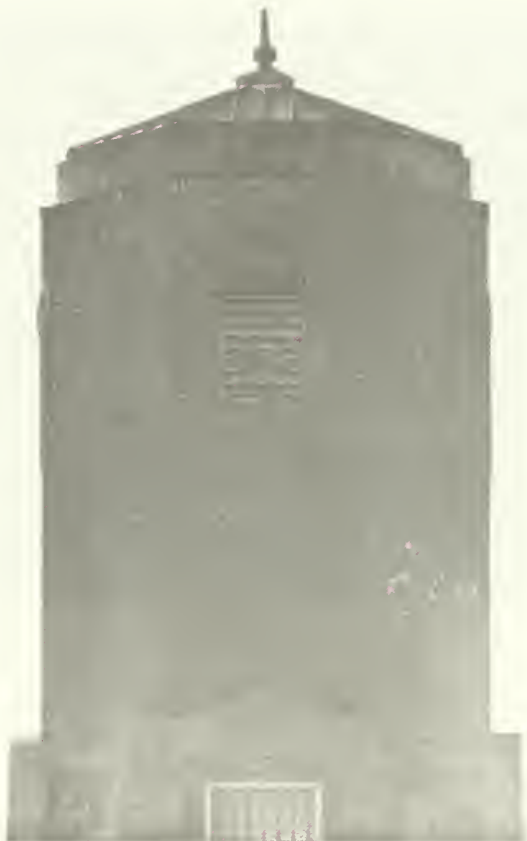
Figure 26: Tower roof--typical at East and West towers. Roofs leak between top of wall and roof finish, and at hatchway.
NPS photo, October 1985.

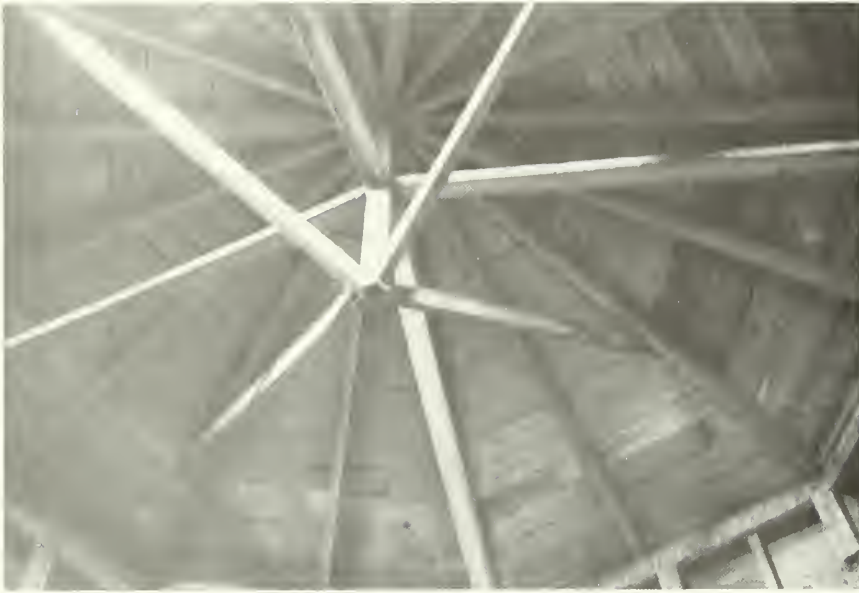
Figure 27: Tower roof framing--typical.
NPS photo, October 1985.

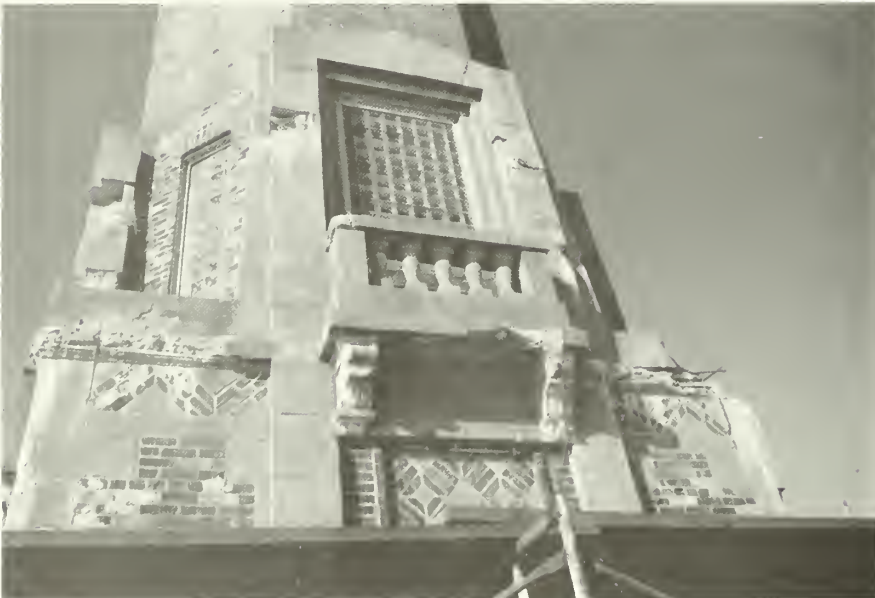
Figure 28: Deteriorating walls and decorative features at towers. Note also solid glass block windows.
NPS photo, October 1985.

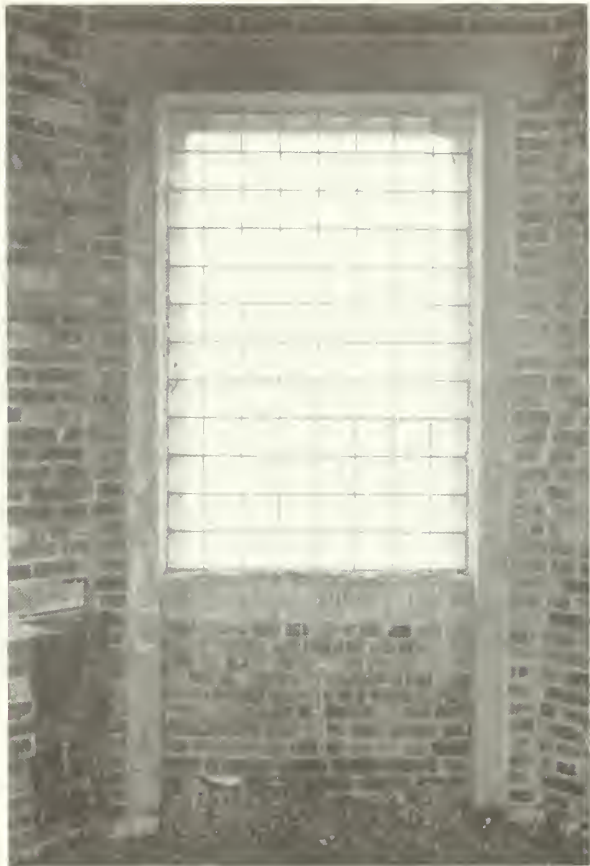
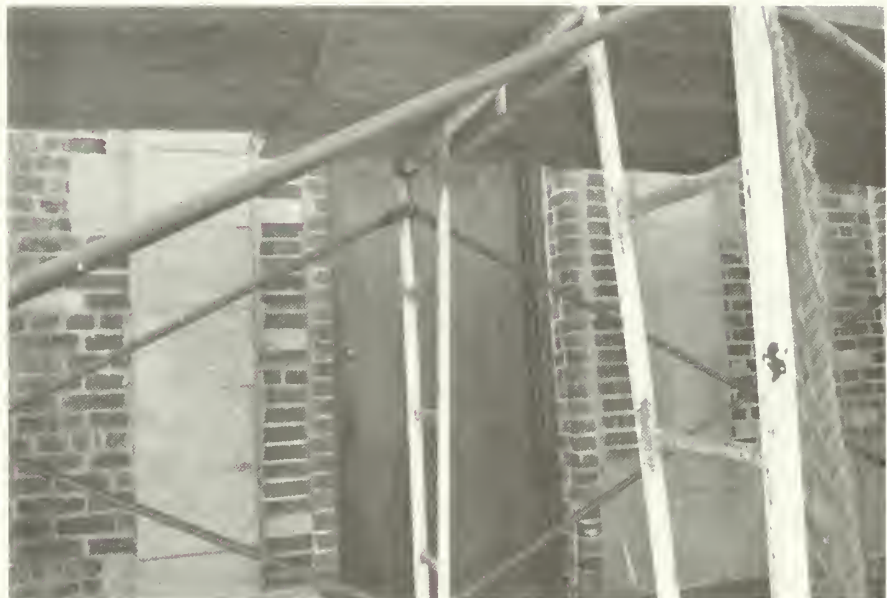
Figure 30: Flush doors at towers and penthouse. Doors typical throughout Beach Pavilion. NPS photo, October 1985.

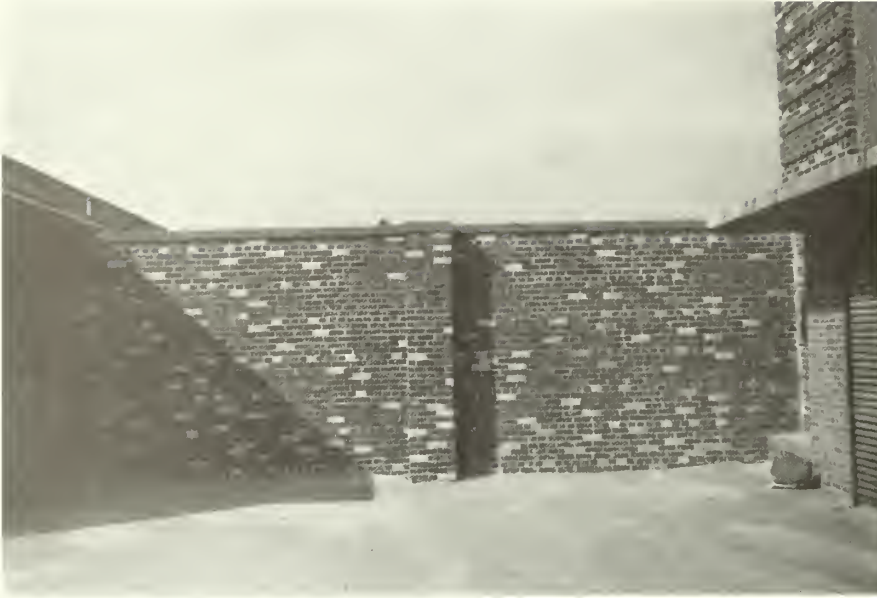
Figure 31: West Screen Wall: Masonry conditions typical to those of building walls (Pavilion).
NPS photo, October 1985.

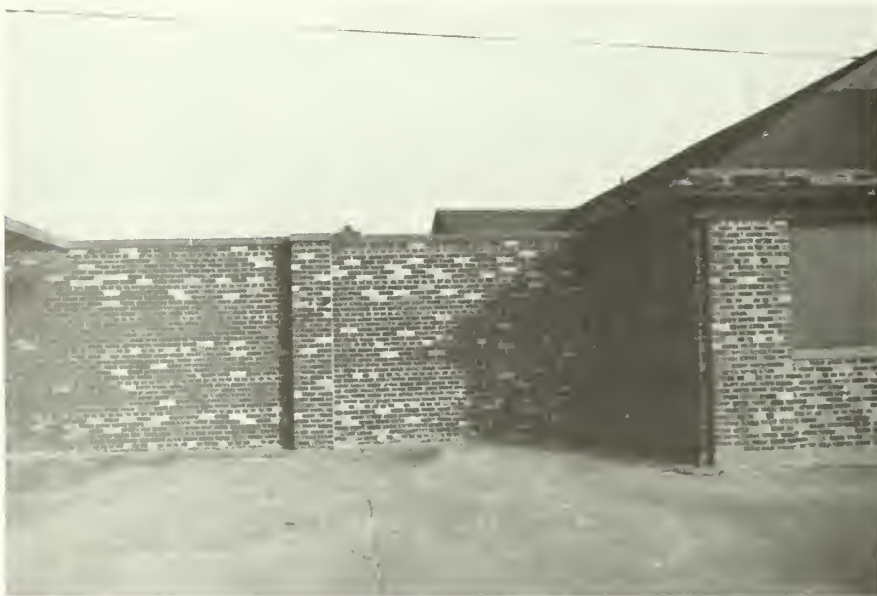
Figure 32: East Screen Wall: Walls conditions similar to those of West Screen Wall.
NPS photo, October 1985.

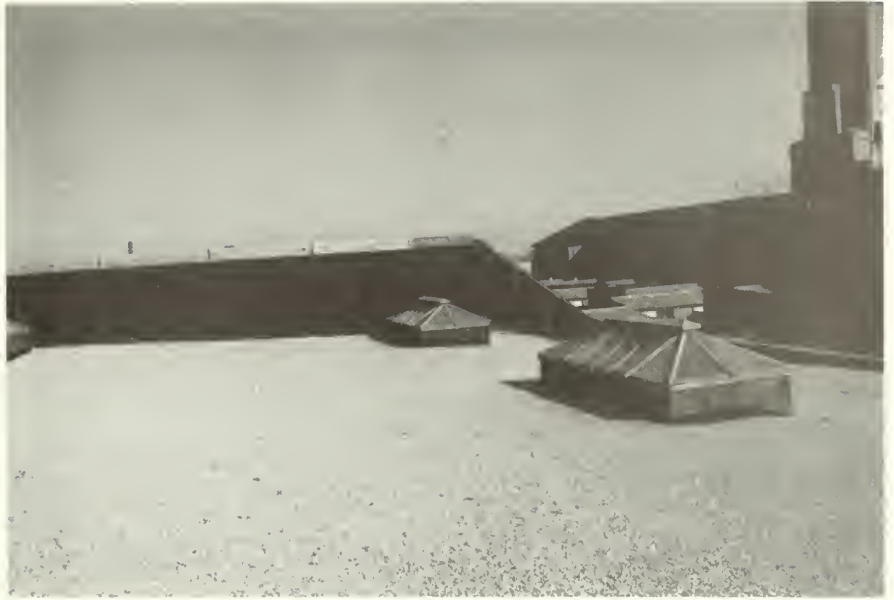
Figure 33: Central built-up roof at Entrance Pavilion, looking southeast.
NPS photo, 1985.

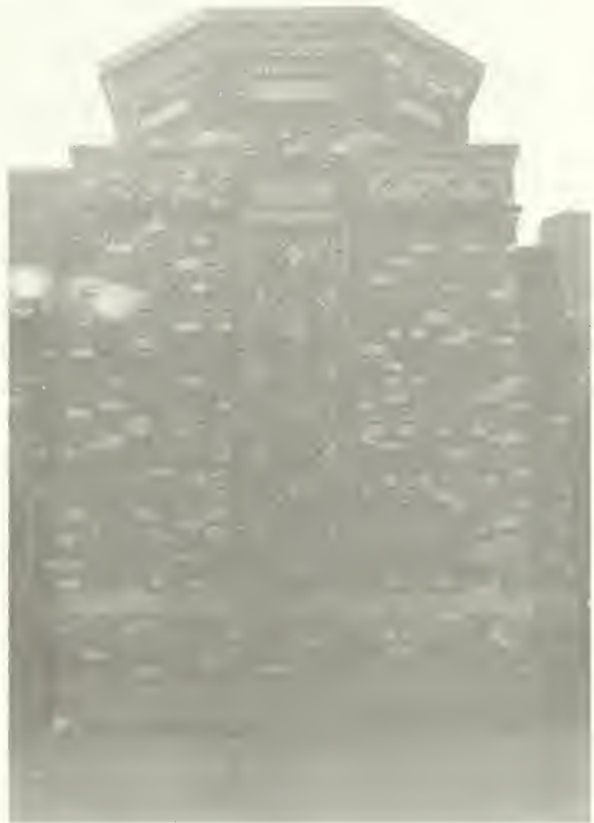
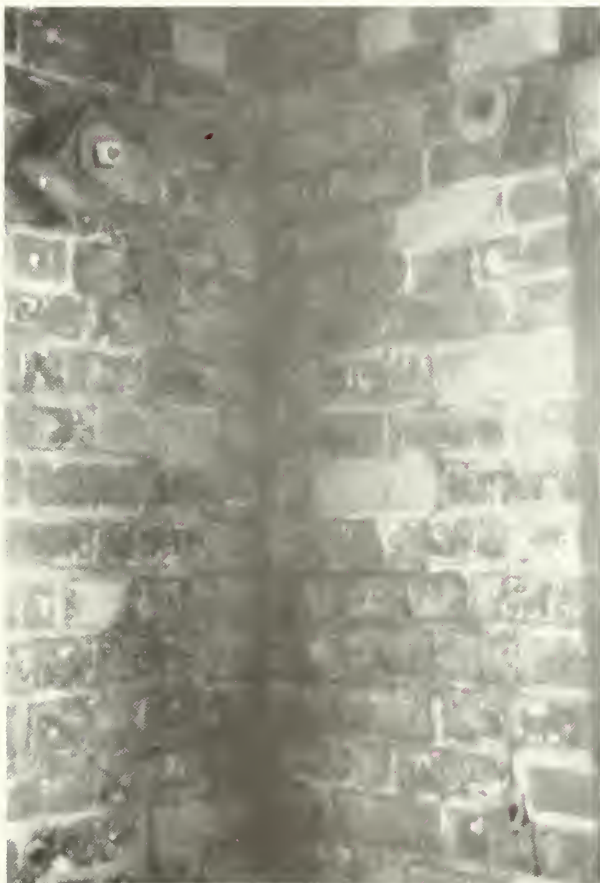
Figure 38: Typical wall conditions, with bolts at interior of Entrance Pavilion arcade. NPS photograph, 1985.

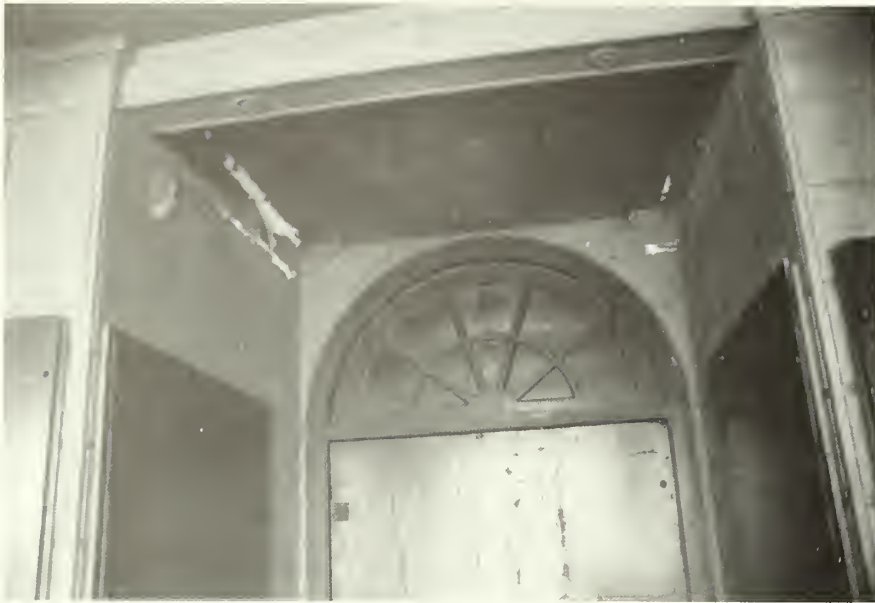
Figure 39: Plaster molding damage at door 410, Entrance Pavilion.
NPS photo, 1985.

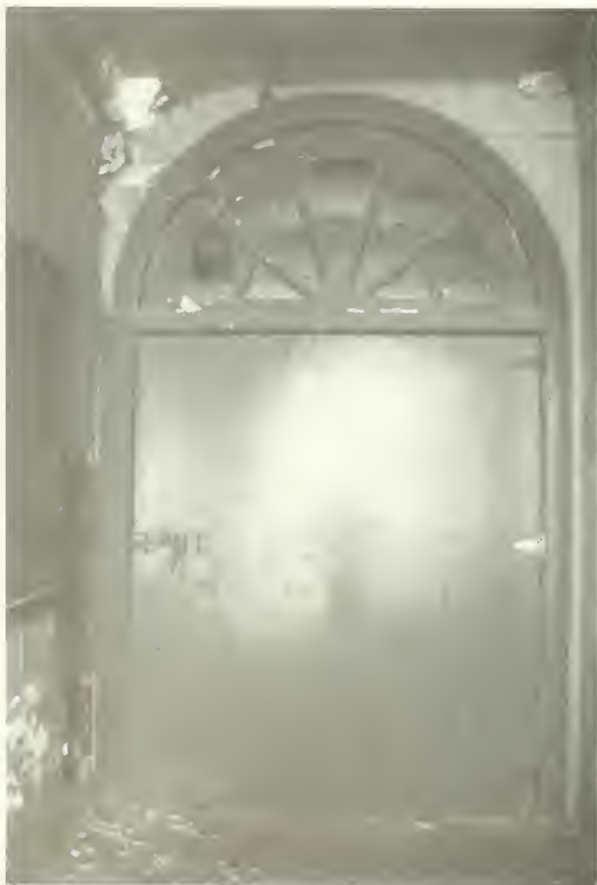
Figure 40: Plaster wall deterioration at door 409, Entrance Pavilion.
NPS photo, 1985.

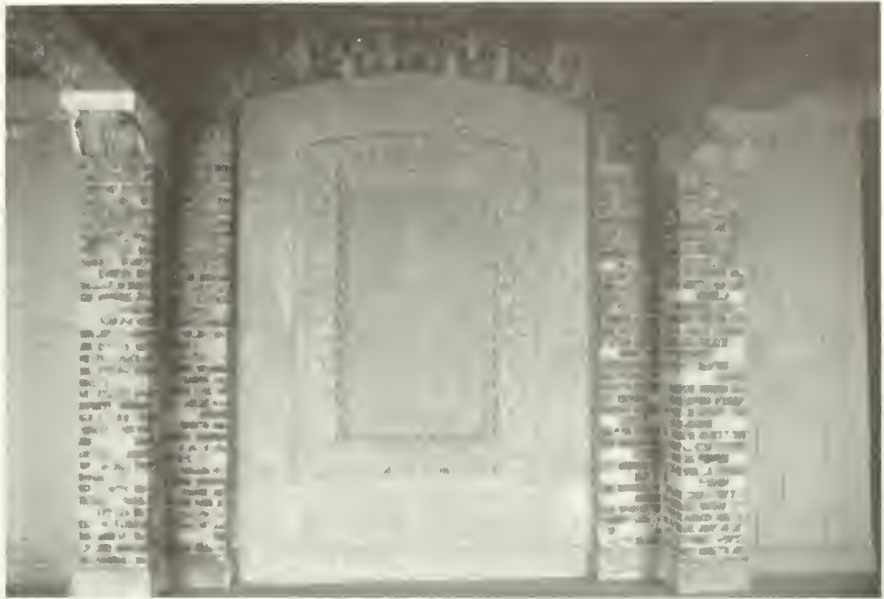
Figure 41: Cast stone wall panel at Entrance Pavilion.
NPS photo, 1985.

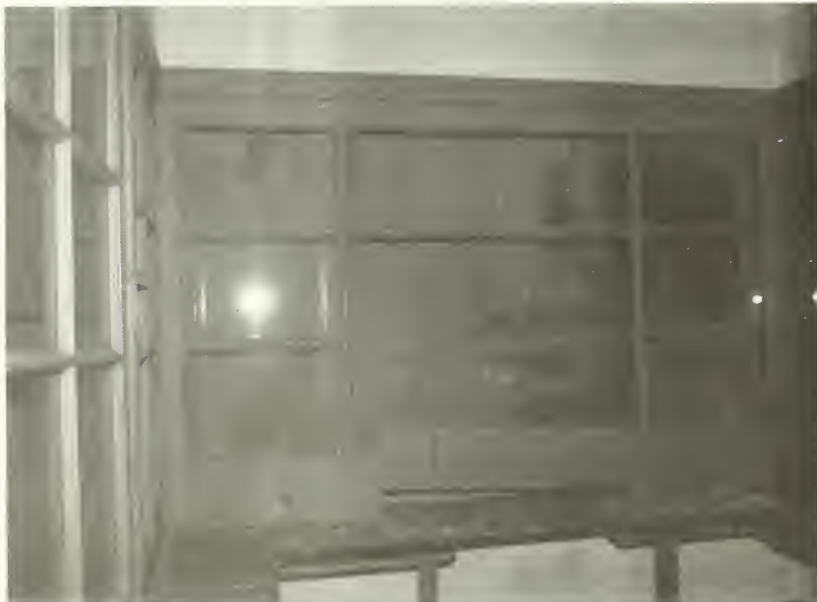
Figure 52: Typical ticket booth windows.
NPS photo, 1985.

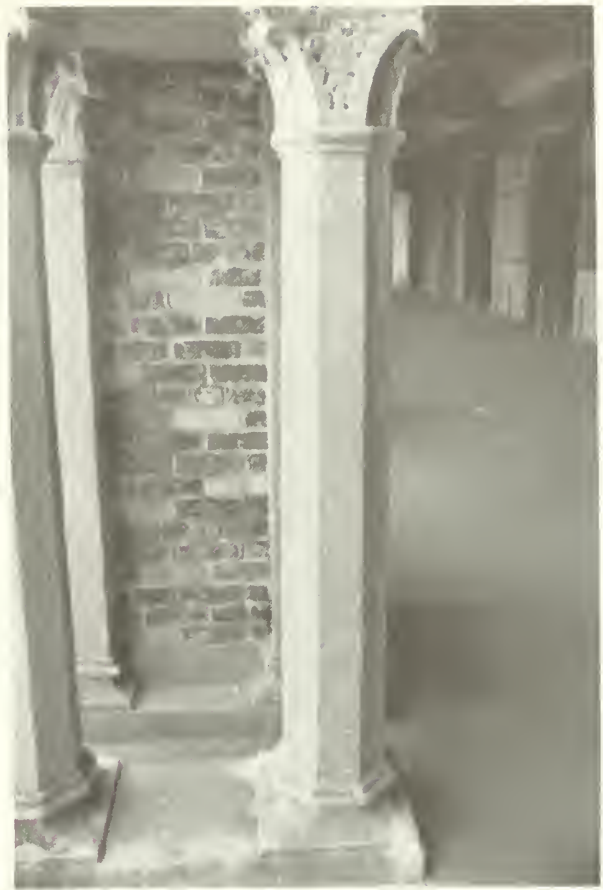
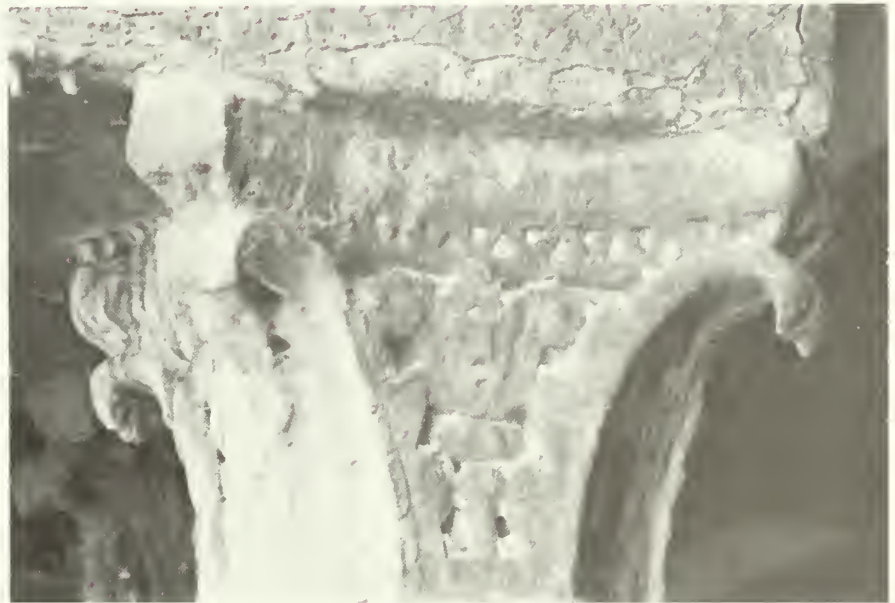
Figure 54: Typical column capital with efflorescence. NPS photo, 1985.

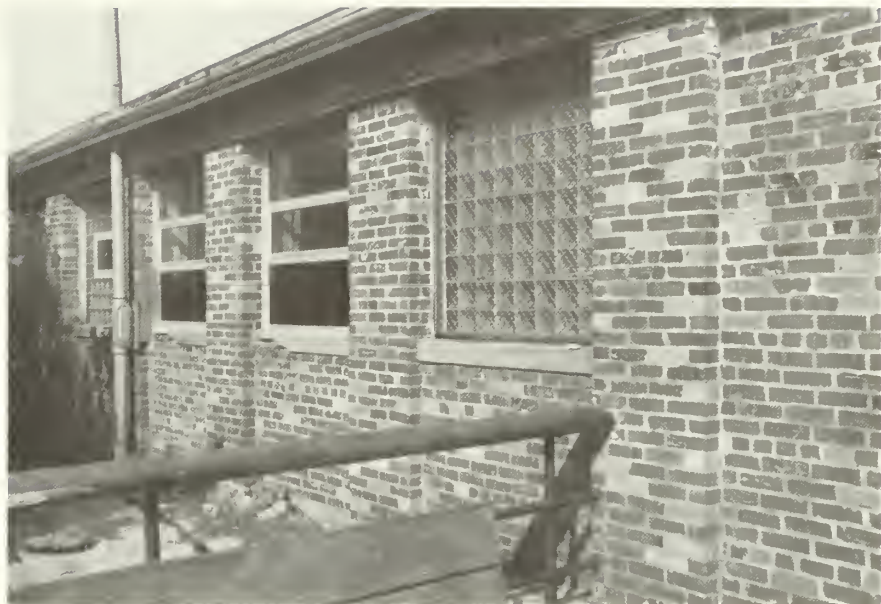
Figure 65: West Wing, West Elevation, showing spalling sills at windows 509, 510, and 511. NPS photo, 1985.

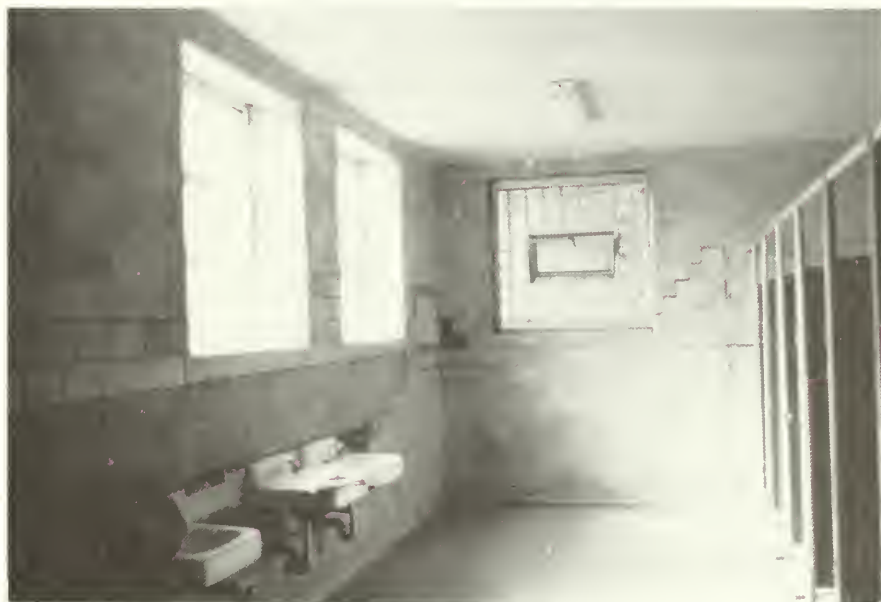
Figure 66: Interior of women's toilet room, West Wing, looking north. NPS photo, 1985.
