I 29.88:G 22/2

Clemson University

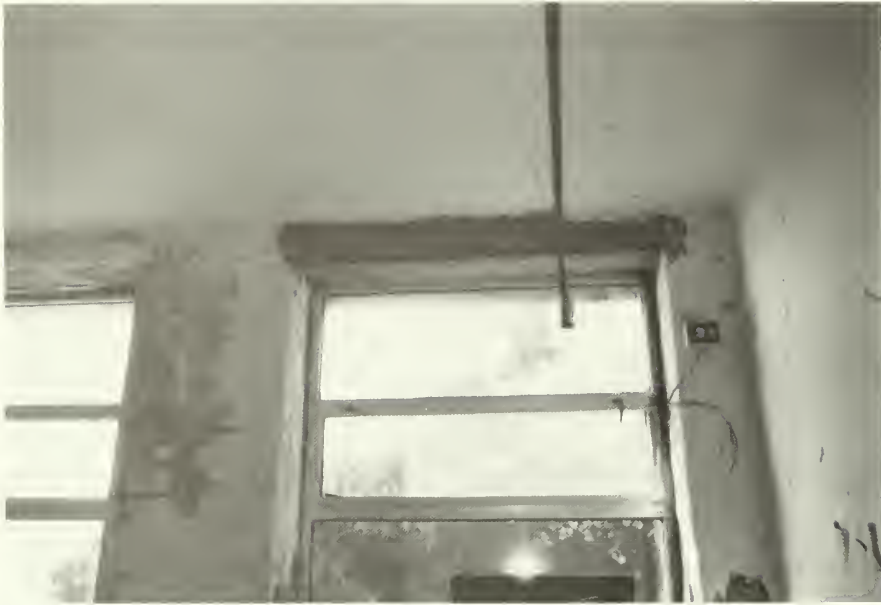
Figure 67: Water damage at Windows 510 and 511, West Wing. NPS photo, 1985.

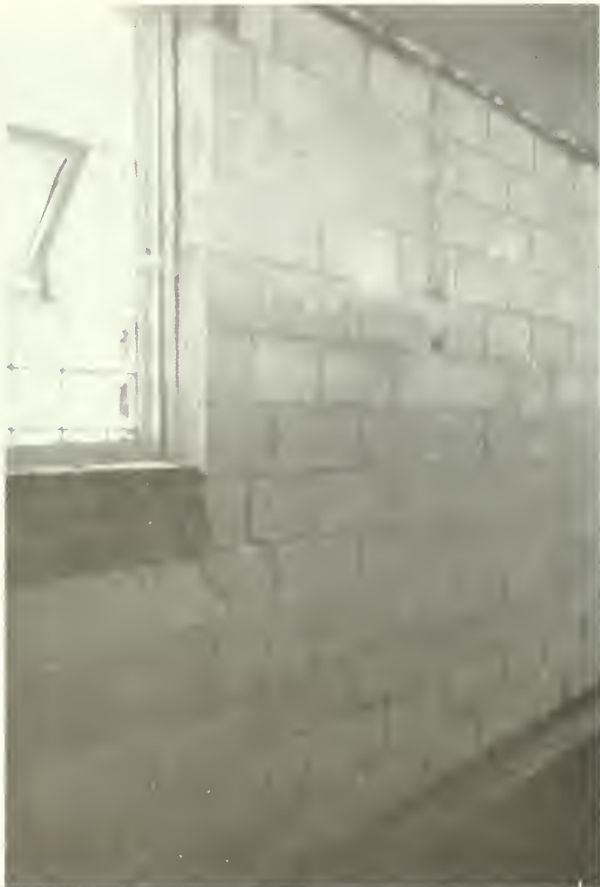
Figure 68: Rebuilt east wall, women's toilet room, West Wing. NPS photo, 1985.

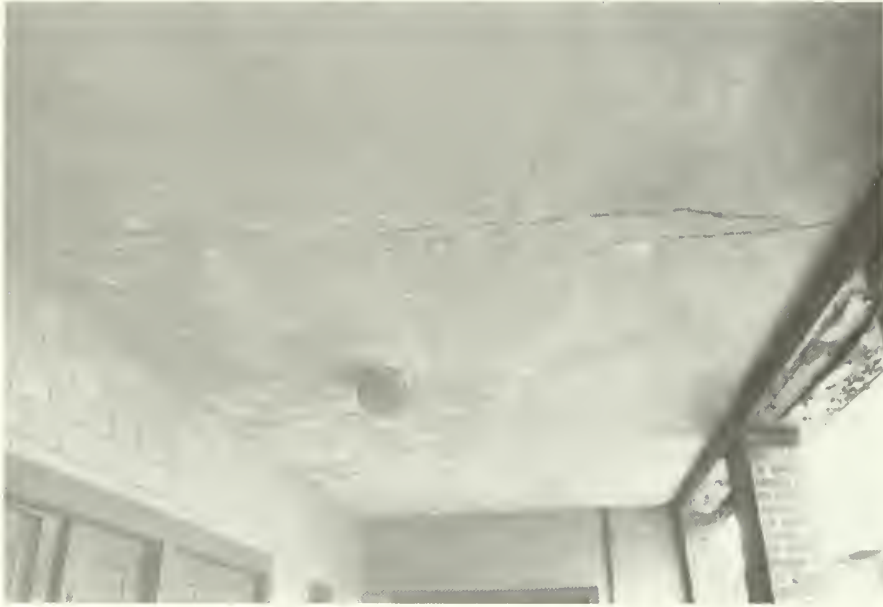
Figure 71: West Wing loggia, cracks in ceiling.
NPS photo, 1985.

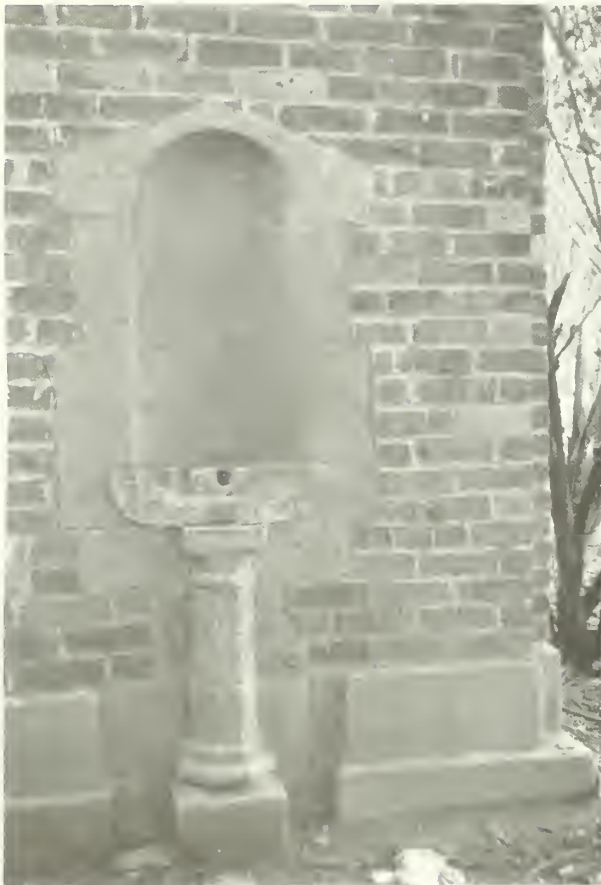
Figure 72: Drinking fountain at West Wing.
NPS photo, 1985.

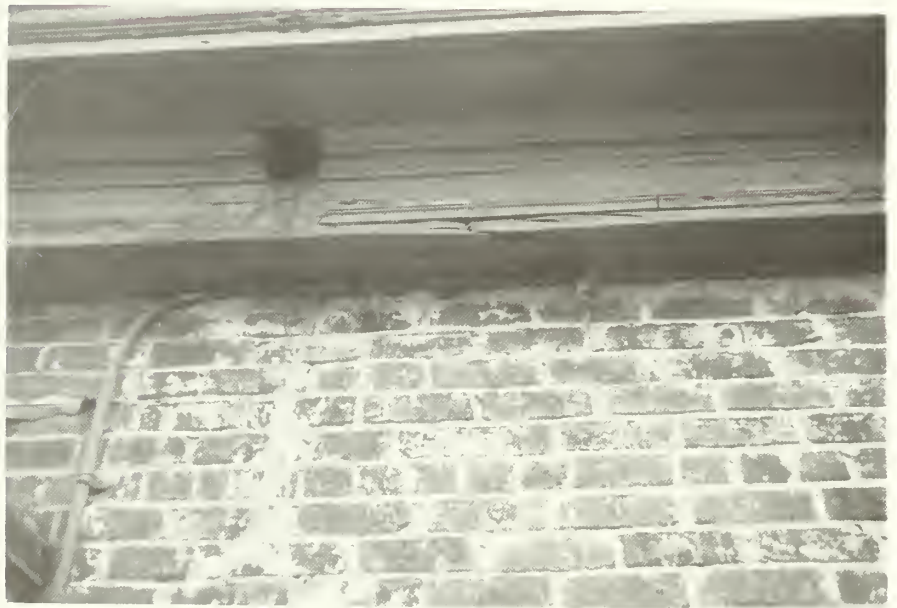
Figure 74: Typical eave conditions. East Wing.
NPS photo, 1985.

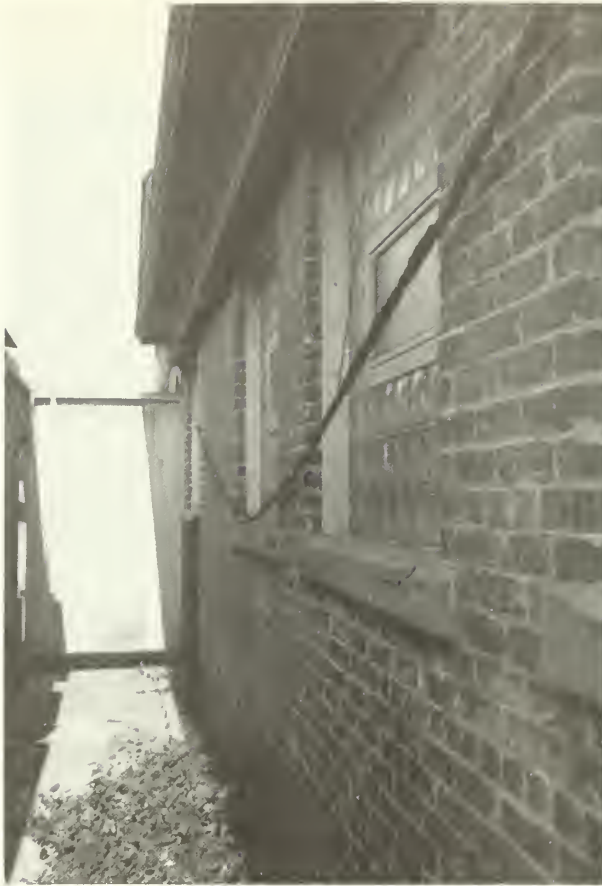
Figure 75: West wall of East Wing, showing typical eave and sill conditions.
NPS photo, 1985.

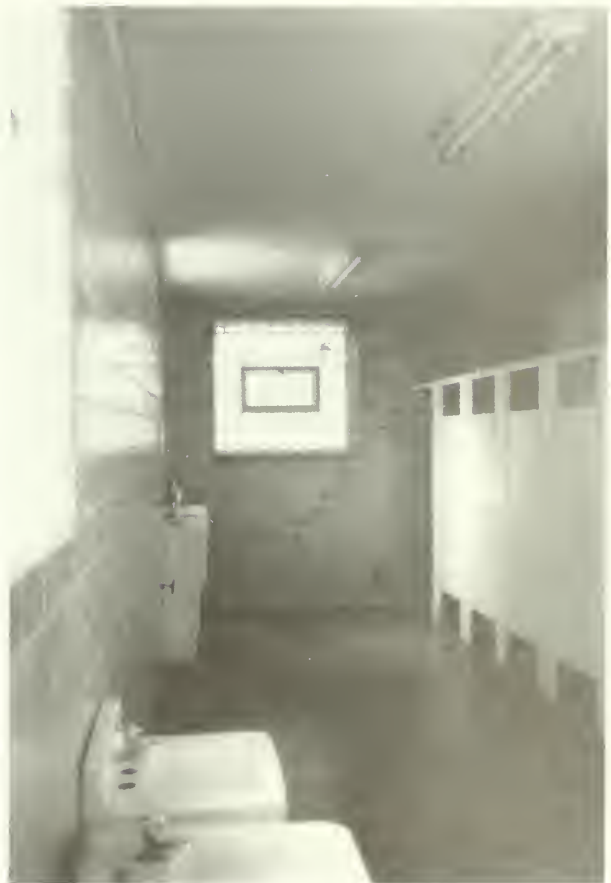
Figure 77: Wall bulging out under Window 631, East Wing.
NPS photo, 1985.

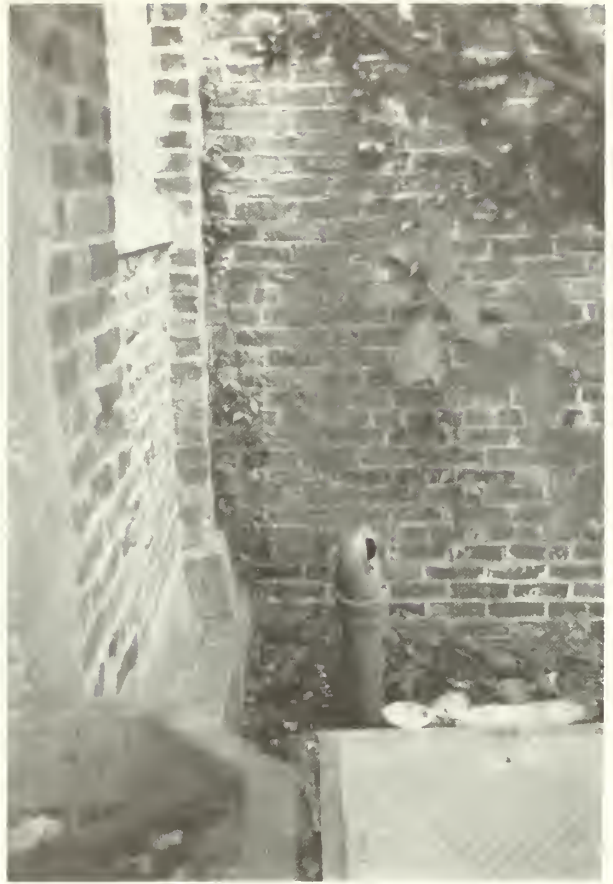
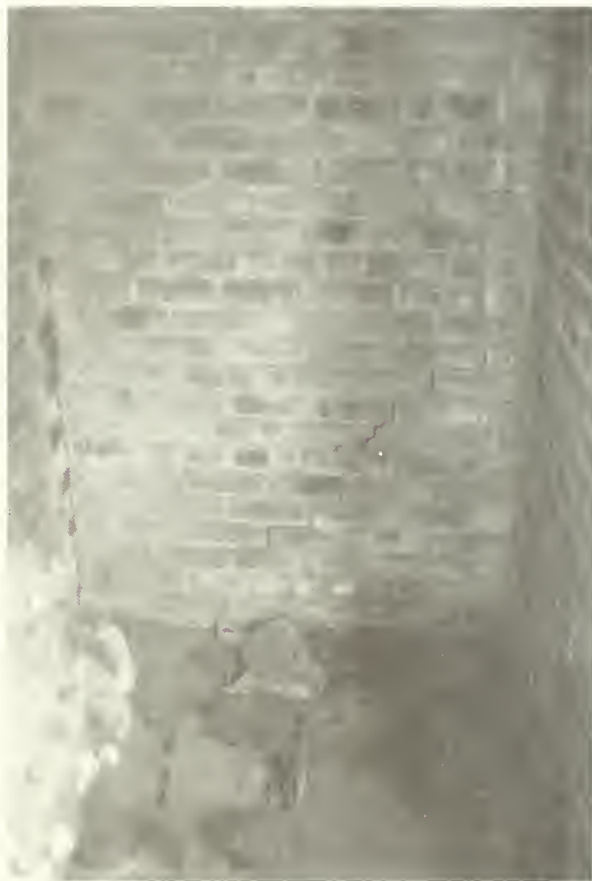
Figure 78: Interior of East Meter Room showing crack in west wall of East Wing.
NPS photo, 1985.

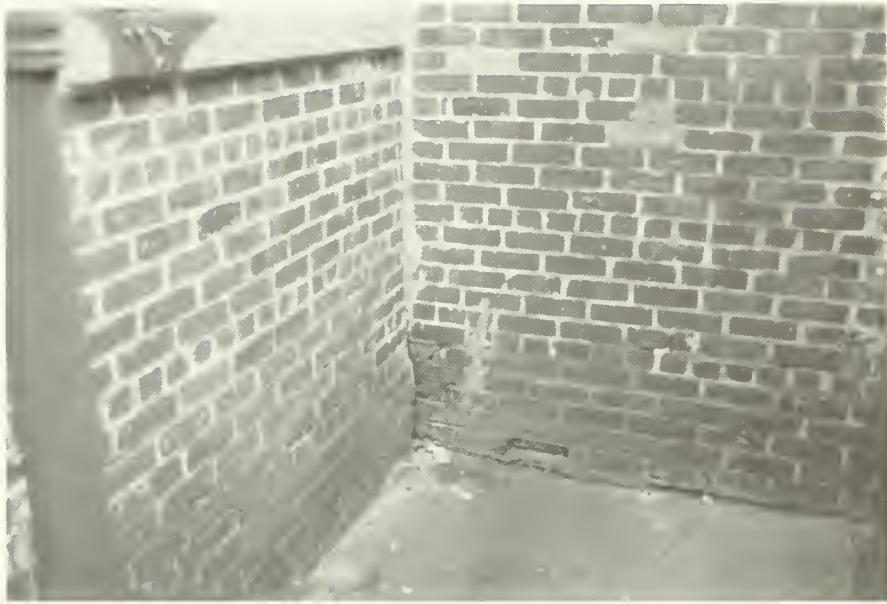
Figure 79: Wall bowing out under Window 618, East Wing.
NPS photo, 1985.

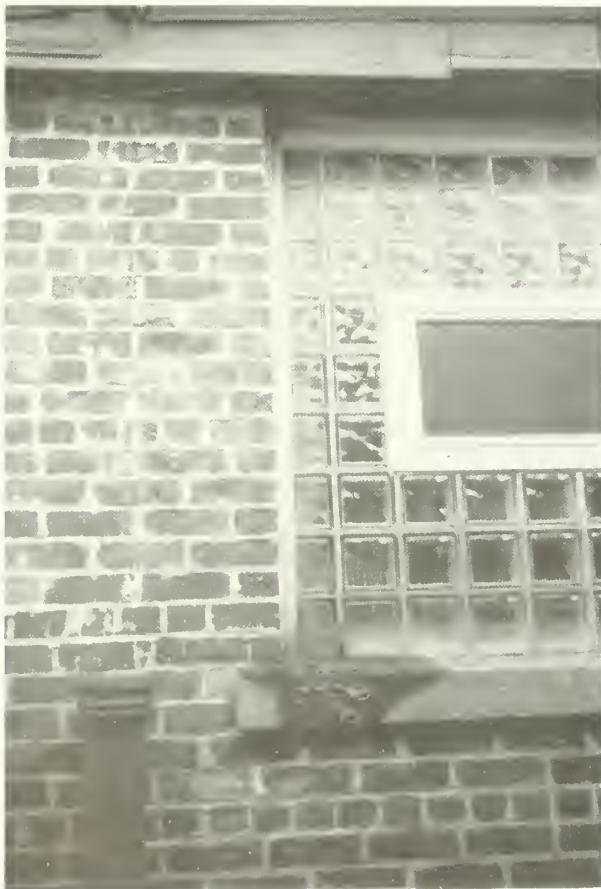
Figure 80: Dark stain and waxy efflorescence at Window 618, East Wing.
NPS photo, 1985.

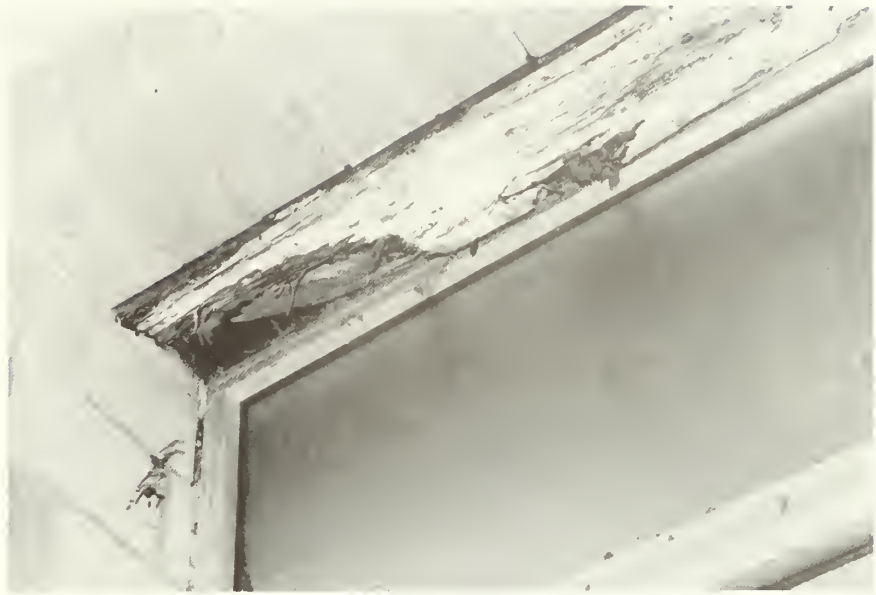
Figure 81: Rotten lintel at Window 629, East Wing.
NPS photo, 1985.

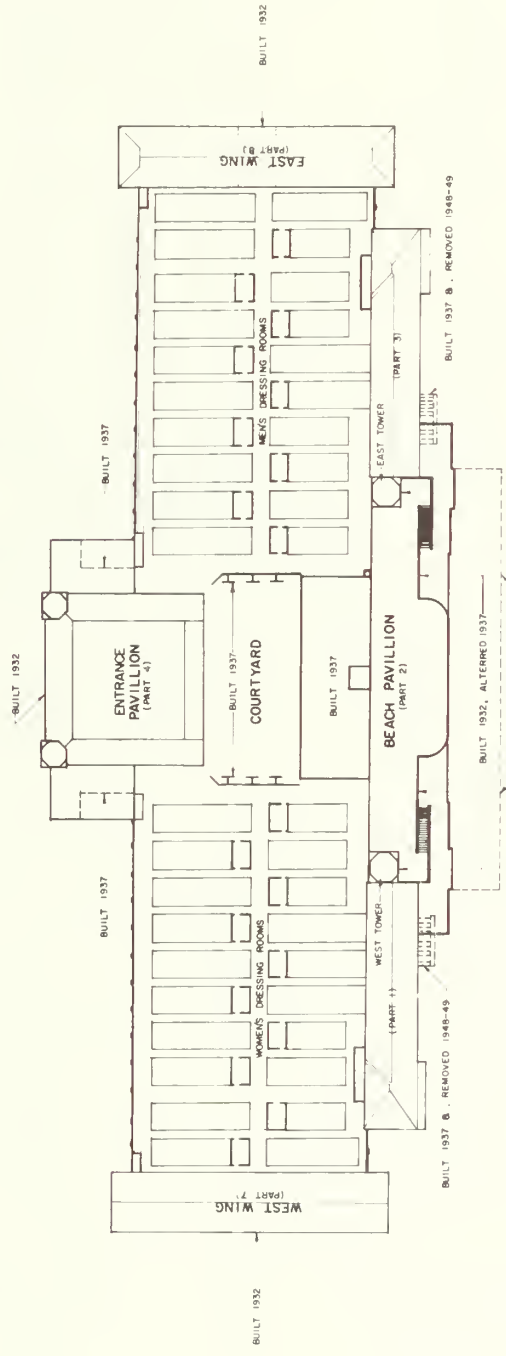
PLAN BATHHOUSE COMPLEX
 SCALE 1/32" = 1'-0" 0 1 2 3 4 5 6 7 8 9 10 FT

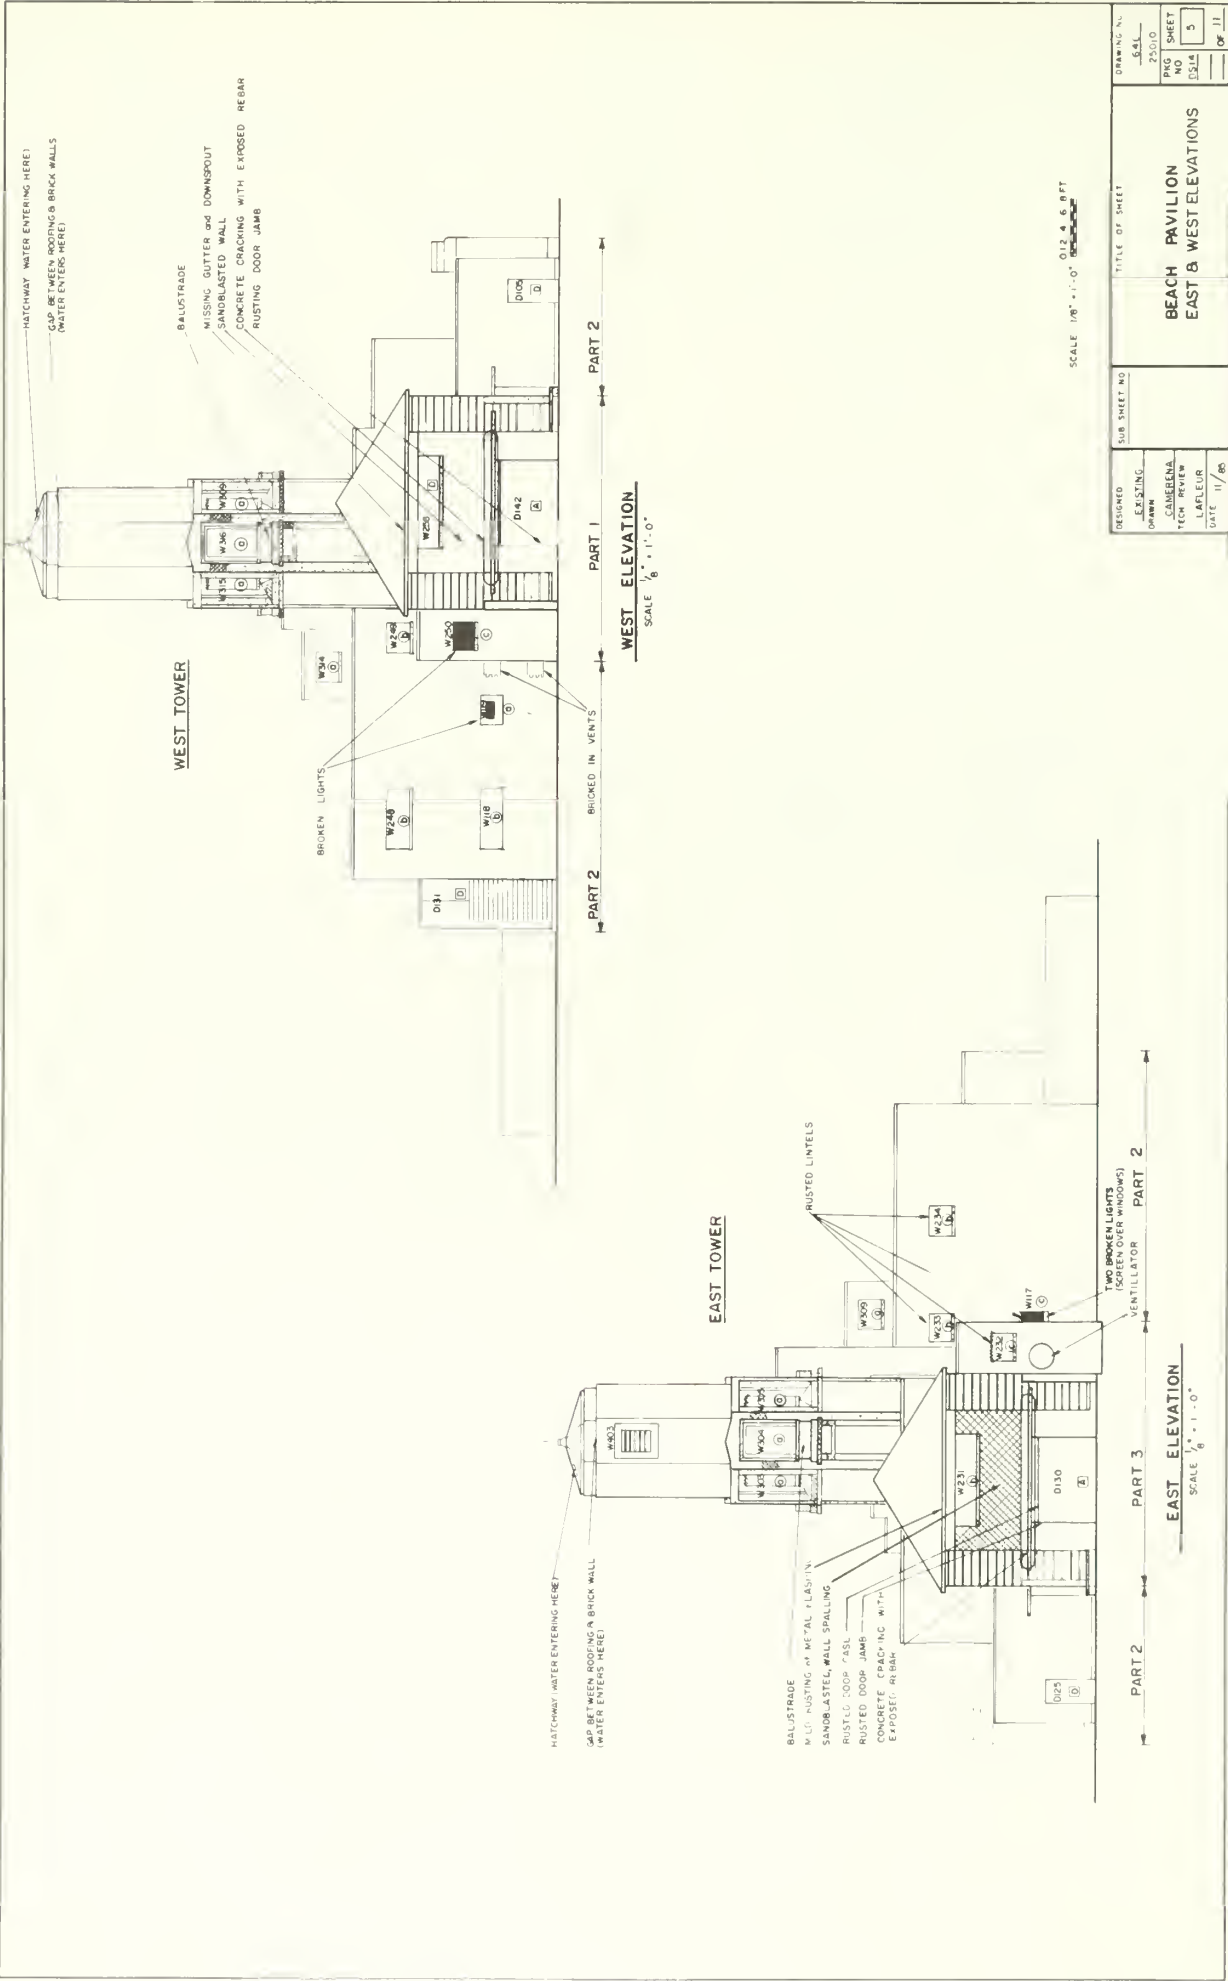
DESIGNED EXISTING	DRAWN CAMERENA	TECH. REVIEW LALFLEUR	DATE 11/85	DESIGNED EXISTING	DRAWN CAMERENA	TECH. REVIEW LALFLEUR	DATE 11/85	DESIGNED EXISTING	DRAWN CAMERENA	TECH. REVIEW LALFLEUR	DATE 11/85
SUB SHEET NO.				TITLE OF SHEET				DRAWING NO.			
				EVOLUTION / EXISTING CONDITION PLAN				546			
								25010			
								PAGE SHEET			
								NO. 2			
								25010			
								OF 11

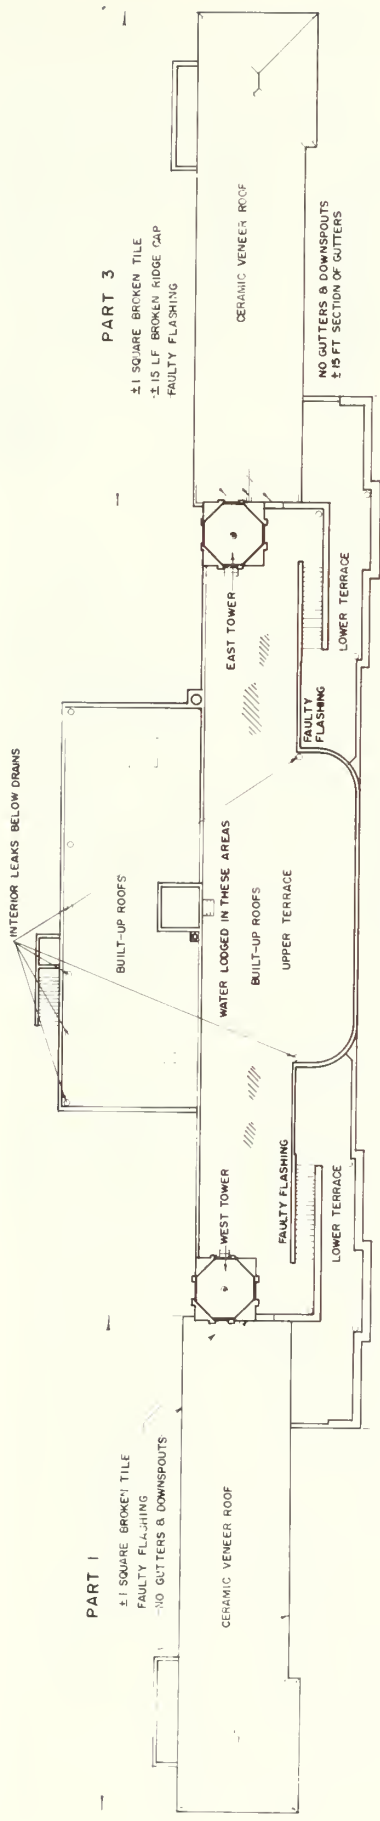
DESIGNED	EXISTING	DRAWN	CAMERENA	TECH REVIEW	LAFLEUR	DATE	11/05
SUB SHEET NO.		TITLE OF SHEET		DRAWING NO.			
		BEACH PAVILION		E-61			
		EAST & WEST ELEVATIONS		NO.		2500	
				PAGE		5	
				SCALE		OF 11

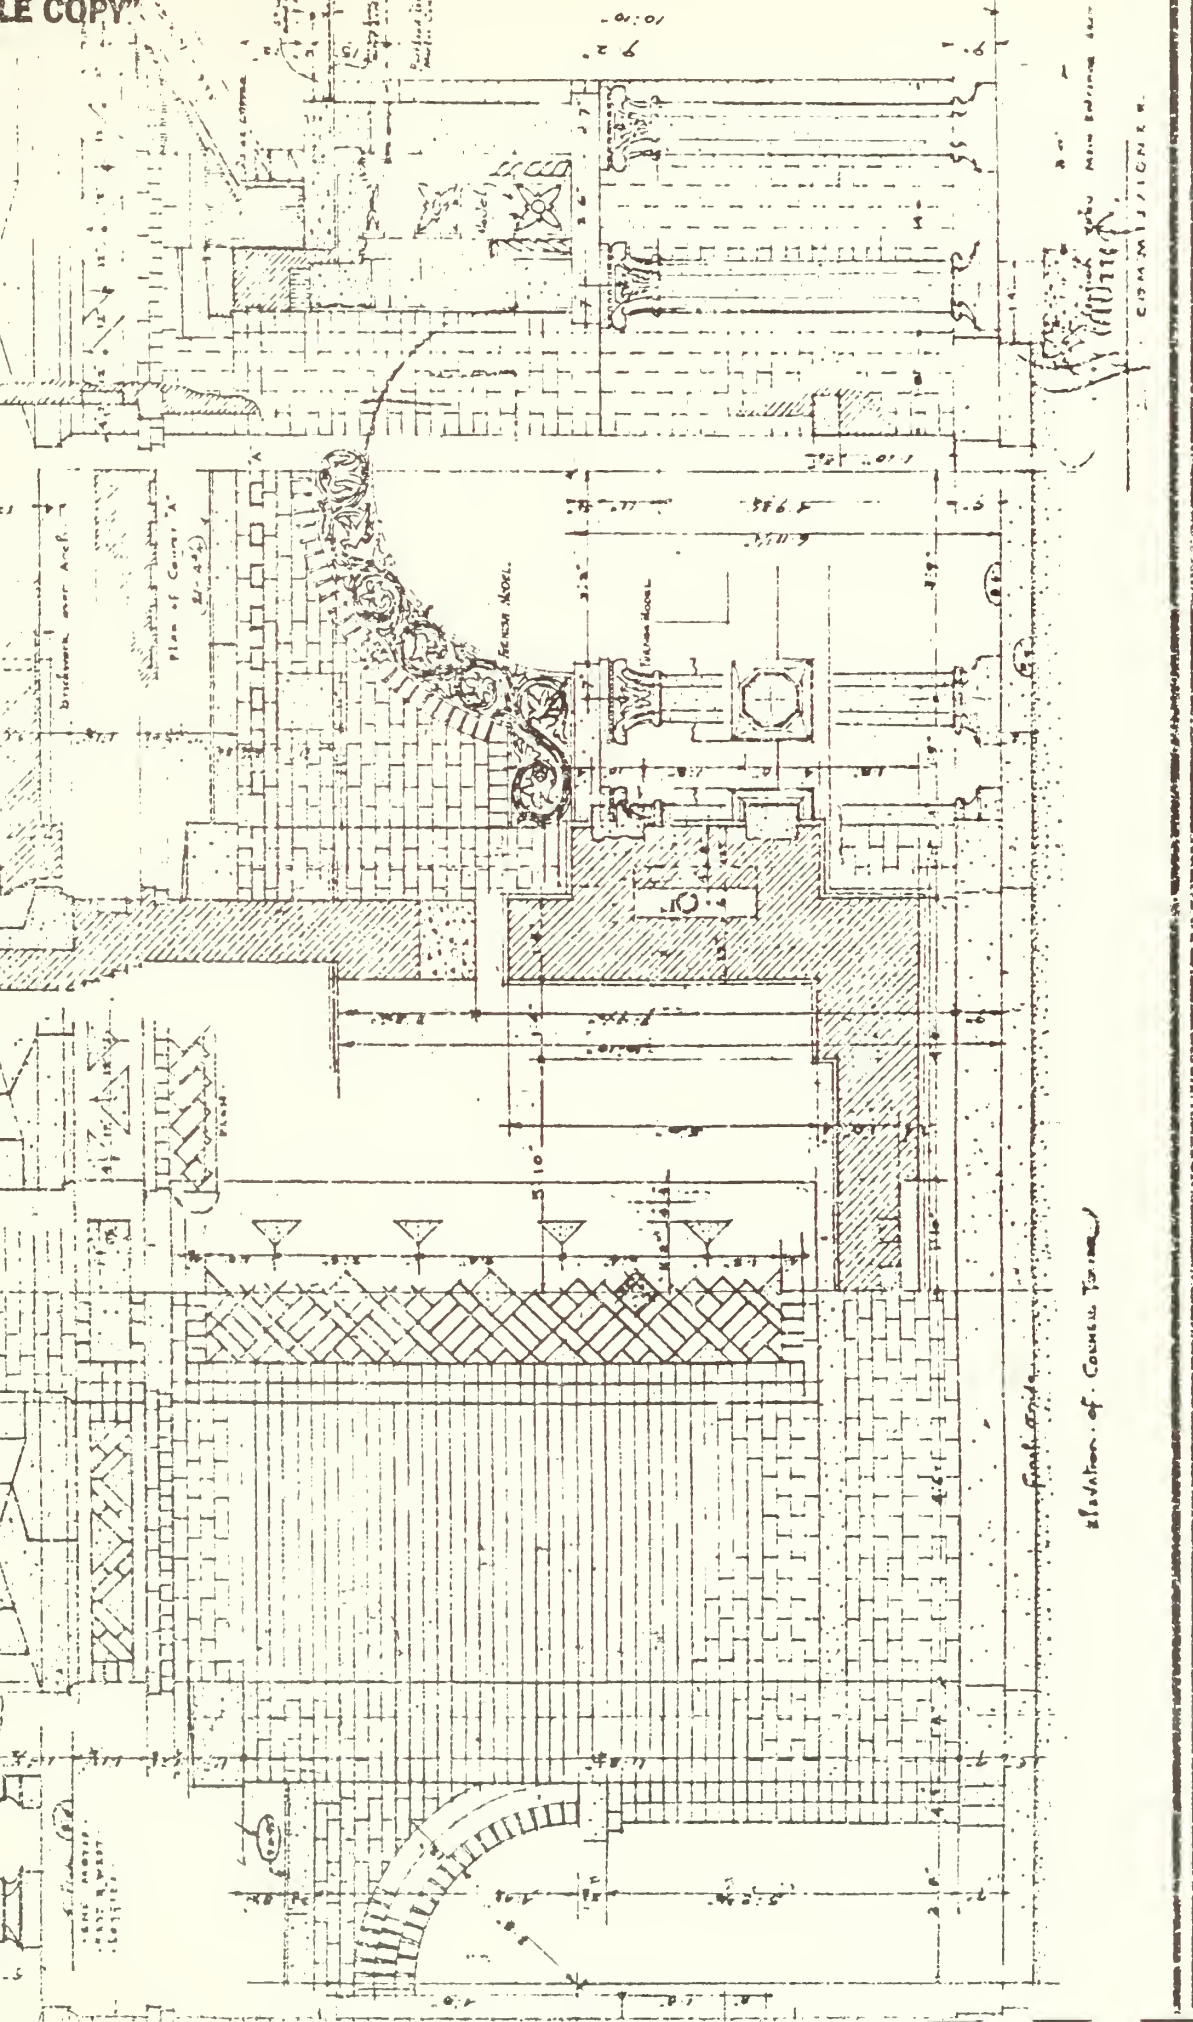
Existing Conditions Report

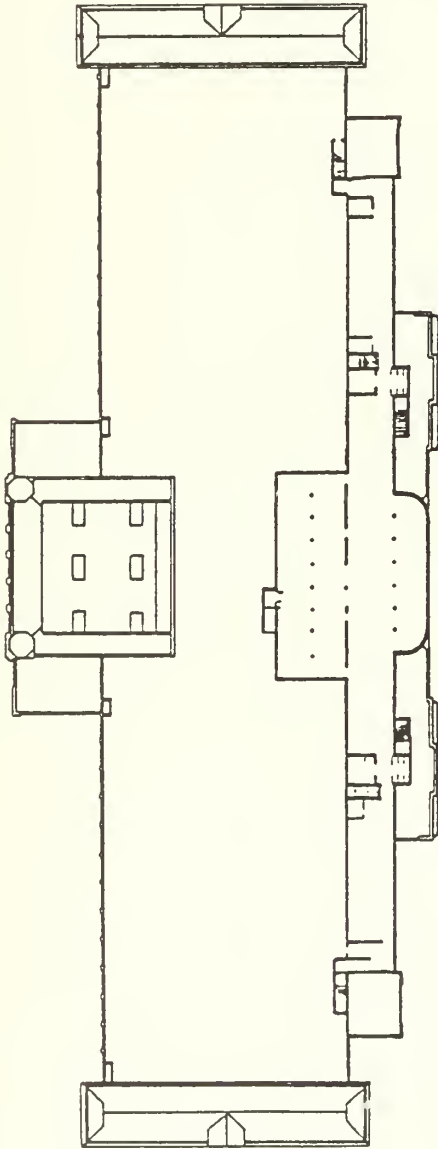
- 1) A general description of the project
- 2) A record of all structural problems
- 3) A record of various materials conservation issues including water drainage, roof condition, cast stone and masonry failures and other problems relating to building materials.

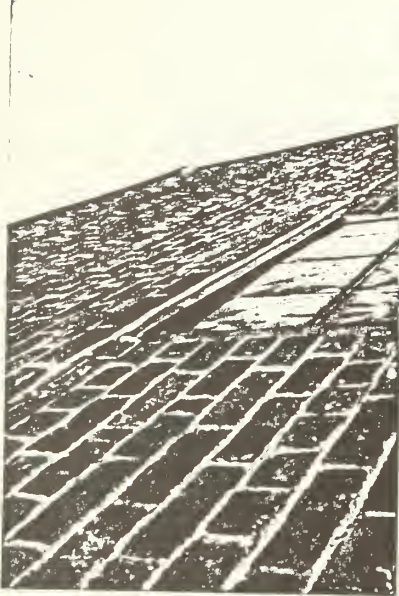
1. Typical 'jacking' effect of deteriorating steel lintel at Beach Pavilion.

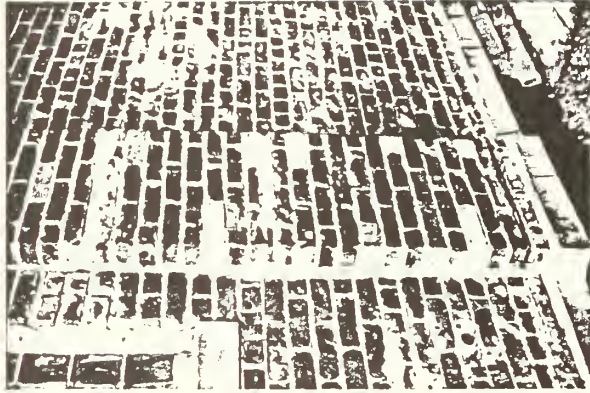
2. Rusted reinforcing in masonry pier, typical at Beach Pavilion.

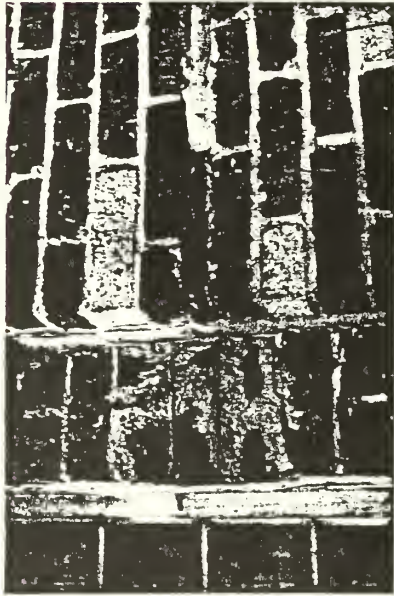
3. Detail of steel reinforcing at masonry pier, Beach Pavilion.

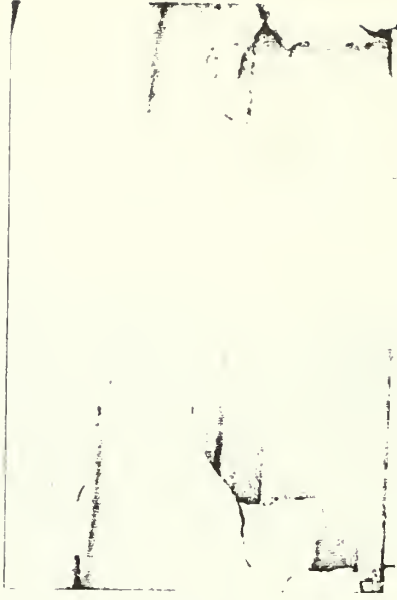
4. Interior view of deteriorated steel lintel, Beach Pavilion.

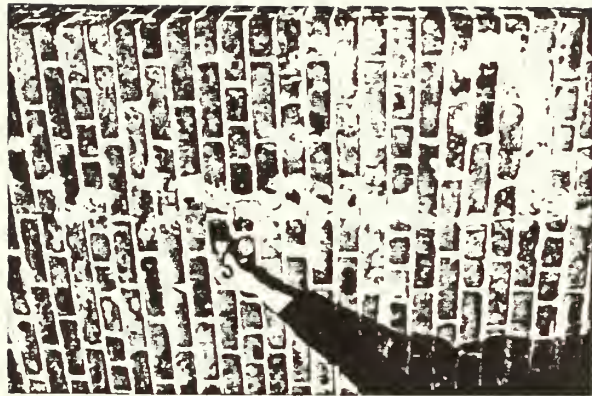
5. Typical cracked and spalled brick at Beach Pavilion.

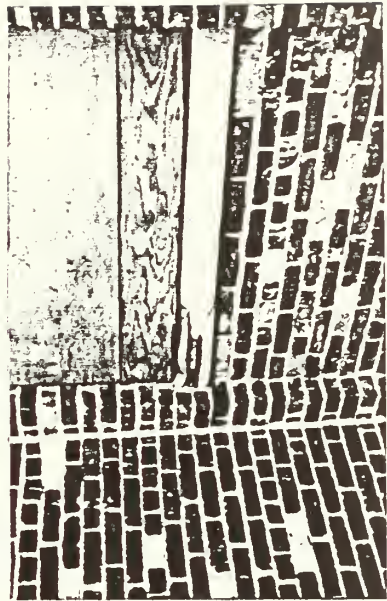
6. Typical cast stone deterioration at Beach Pavilion.

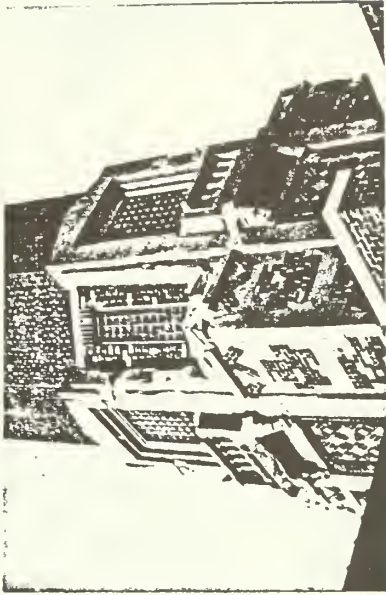
7. East tower - Cast Stone and Brick Deterioration.

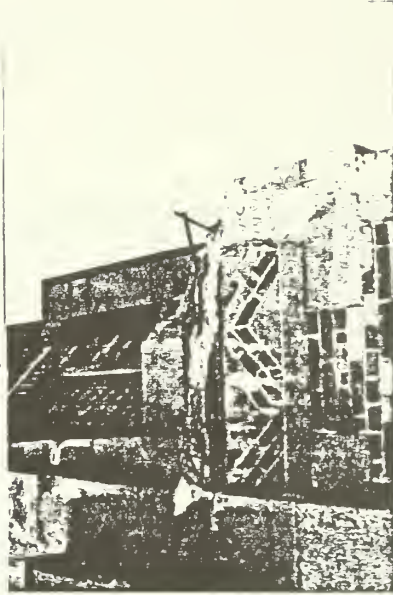
8. East tower - detail of exposed reinforcing.

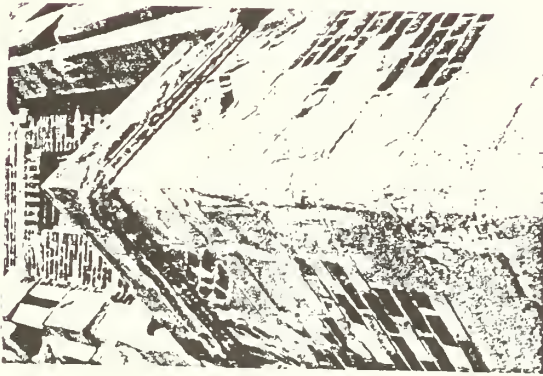
9. Detail of spalled cast stone quoins at west tower.

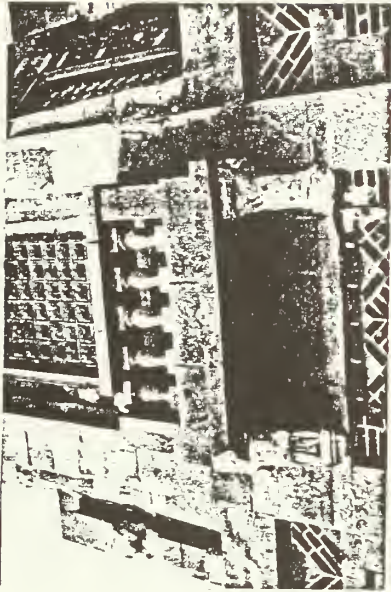
10. West tower cast stone deterioration at balcony.

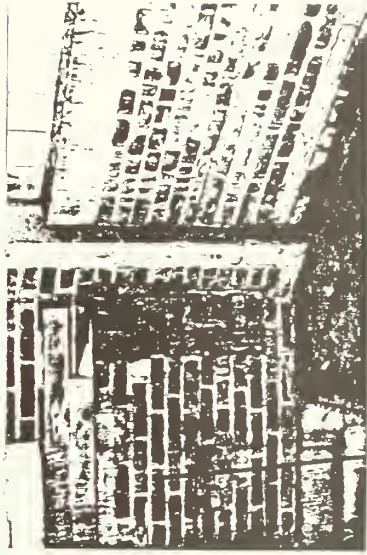
11. View of interior water damage at west tower.

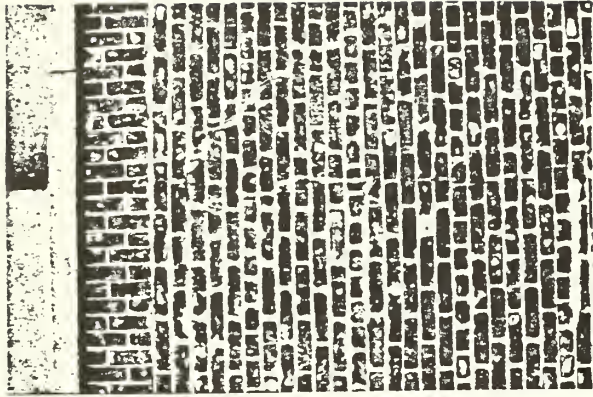
12. Typical crack in brick masonry wall at Beach Pavilion.

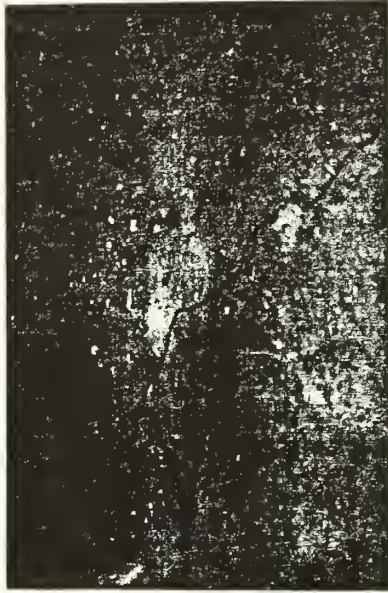
13. Crack at second floor between original structure and 1937 addition.

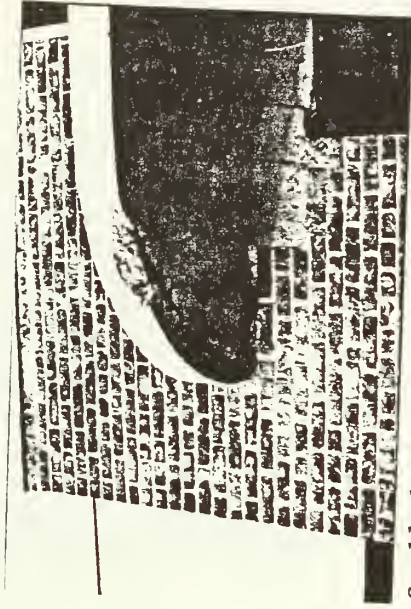
14. Spalled concrete canopy at Beach Pavilion.

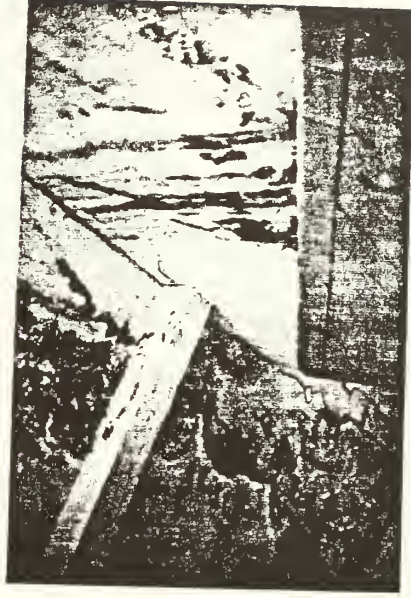
15. Peeling paint, spalling plaster, spalling concrete, and minor rusting of reinforcing.

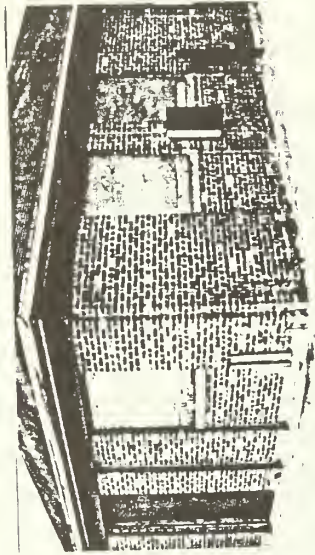
16. East wing showing typical spalling and cracking of brick walls.

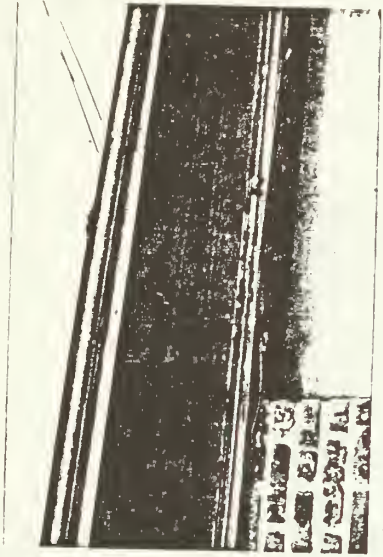
18. View of typical wooden eave condition at Wings.

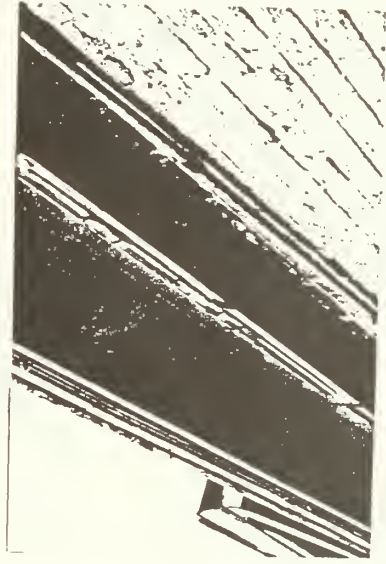
19. Court-side eave condition at West Wing.

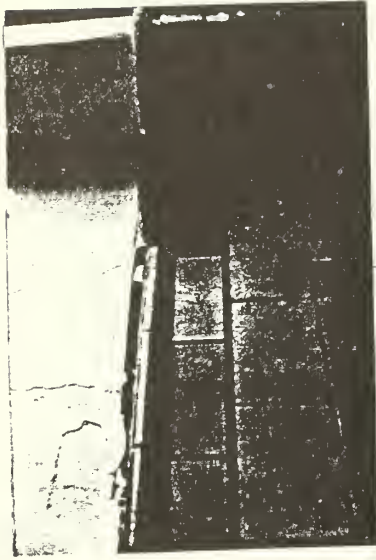
20. Settlement of partition wall at east exterior wall of West Wing.

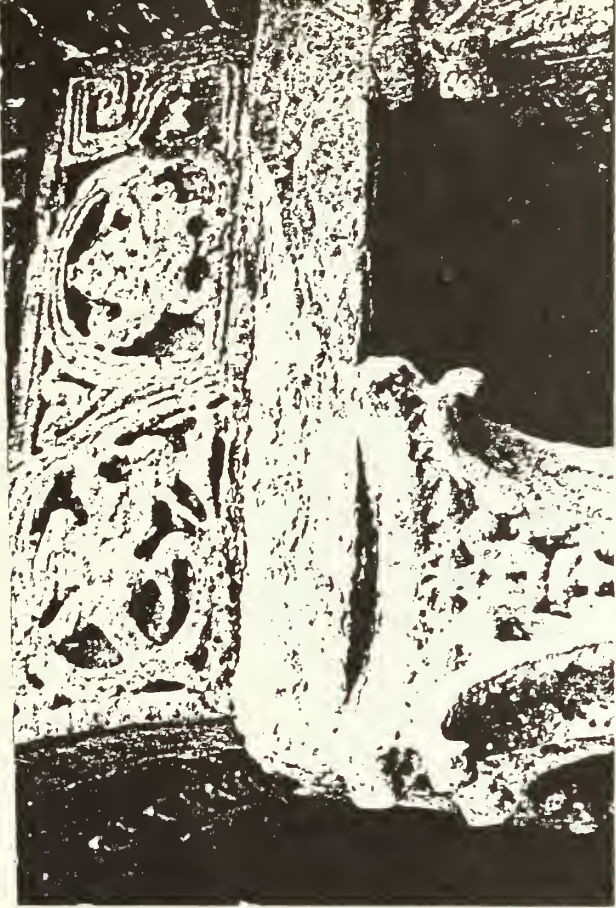
22. Detail of spalled cast stone at Entry Pavilion.

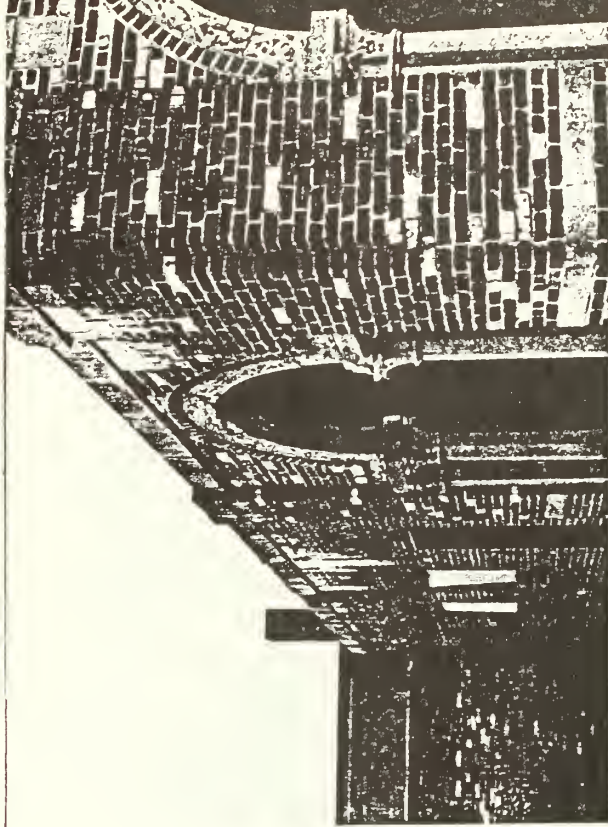
23. View of east parapet of Entry Pavilion. Note efflorescence and slight bowing of parapet wall.

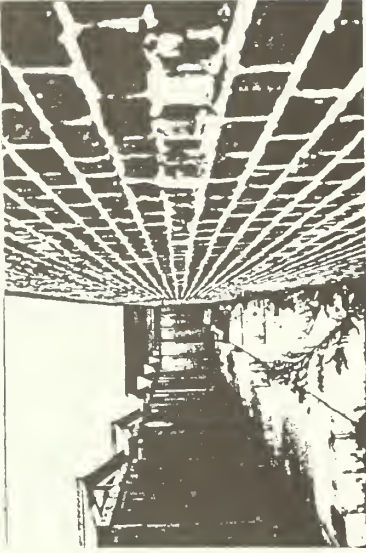
24. View of West Court enclosure wall.
Note slight bow inward.

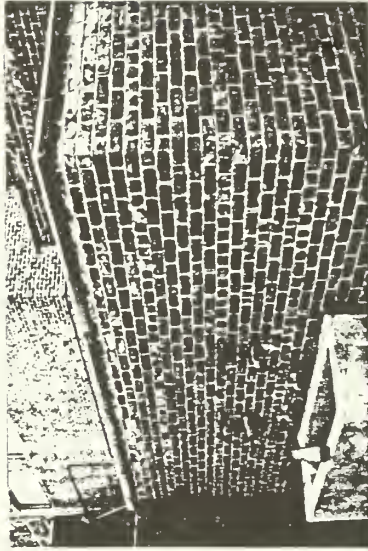
25. Typical free standing masonry wall at courtyard.

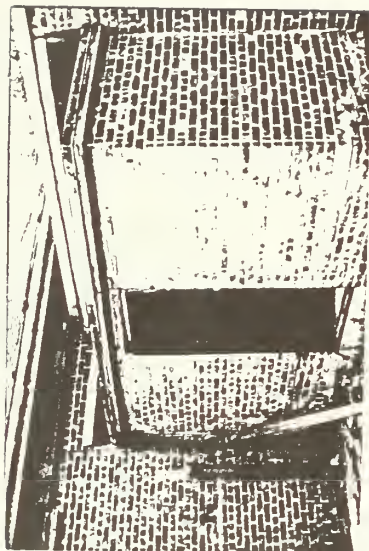
26. Northwest pump house. Note severely cracked brick walls.
