HISTORIC STRUCTURE REPORT

TUMACACORI NATIONAL MONUMENT  
Arizona

by  
Anthony Crosby

September 1985

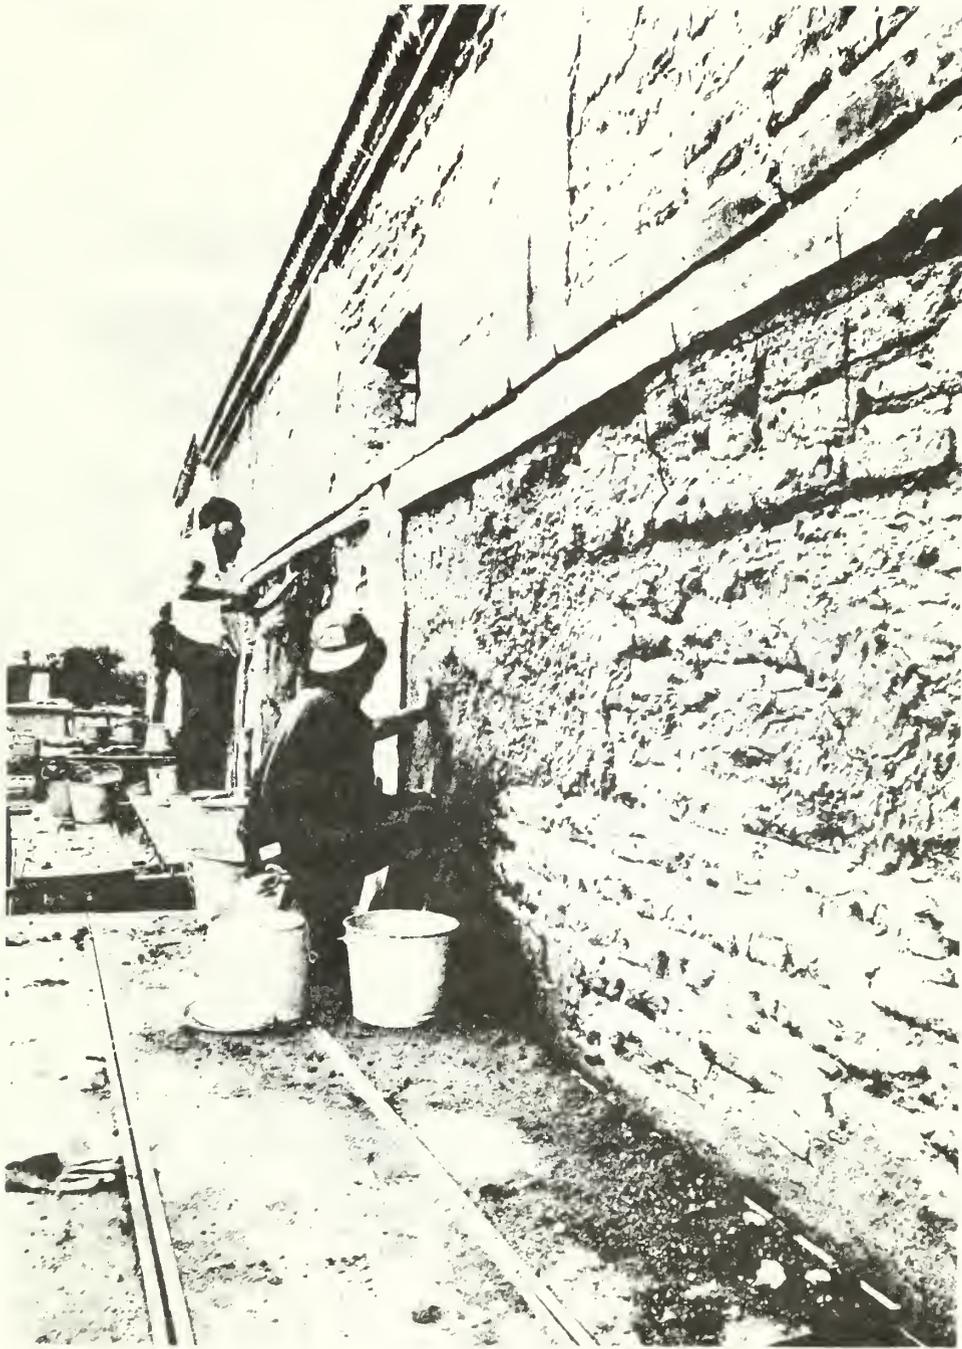
1. West church wall during the filling of voids.

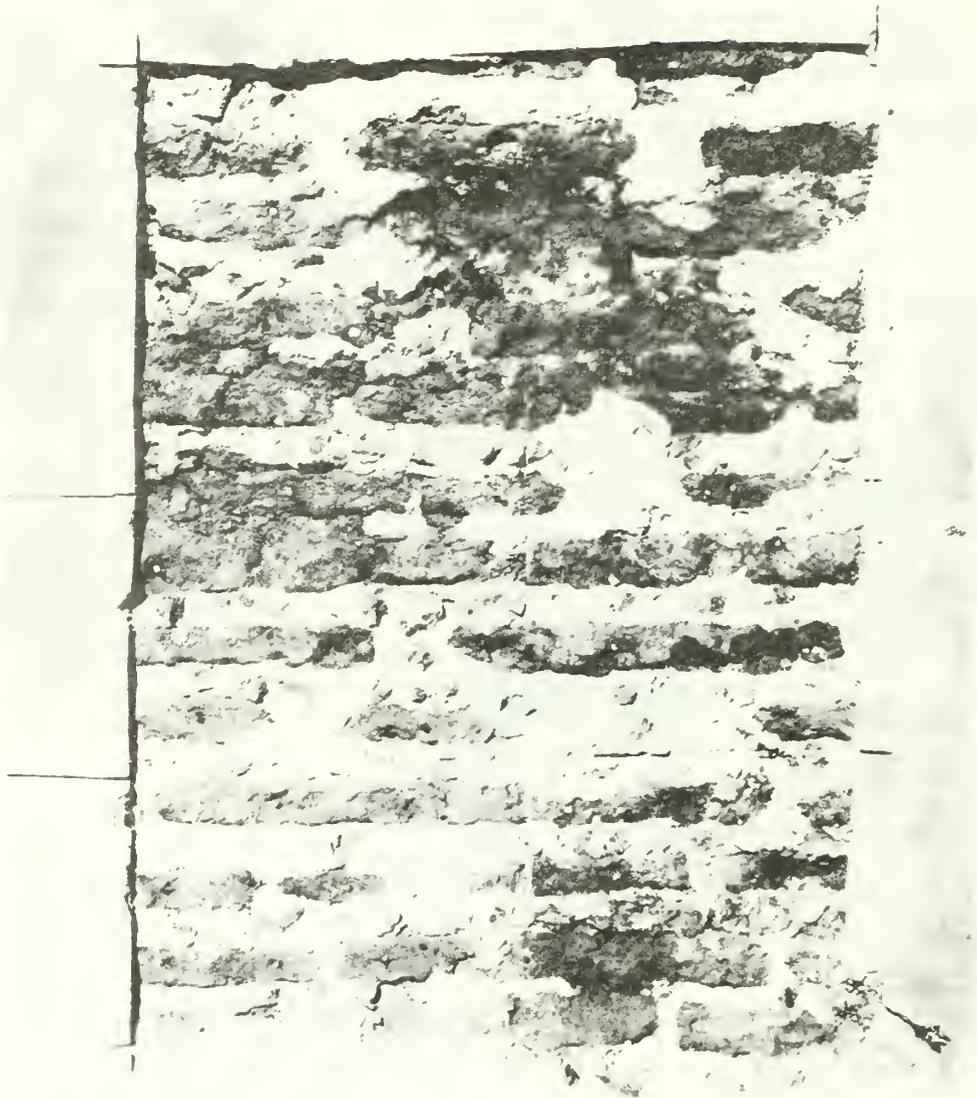
2. A view of the west exterior sanctuary wall during the removal of cement stucco.

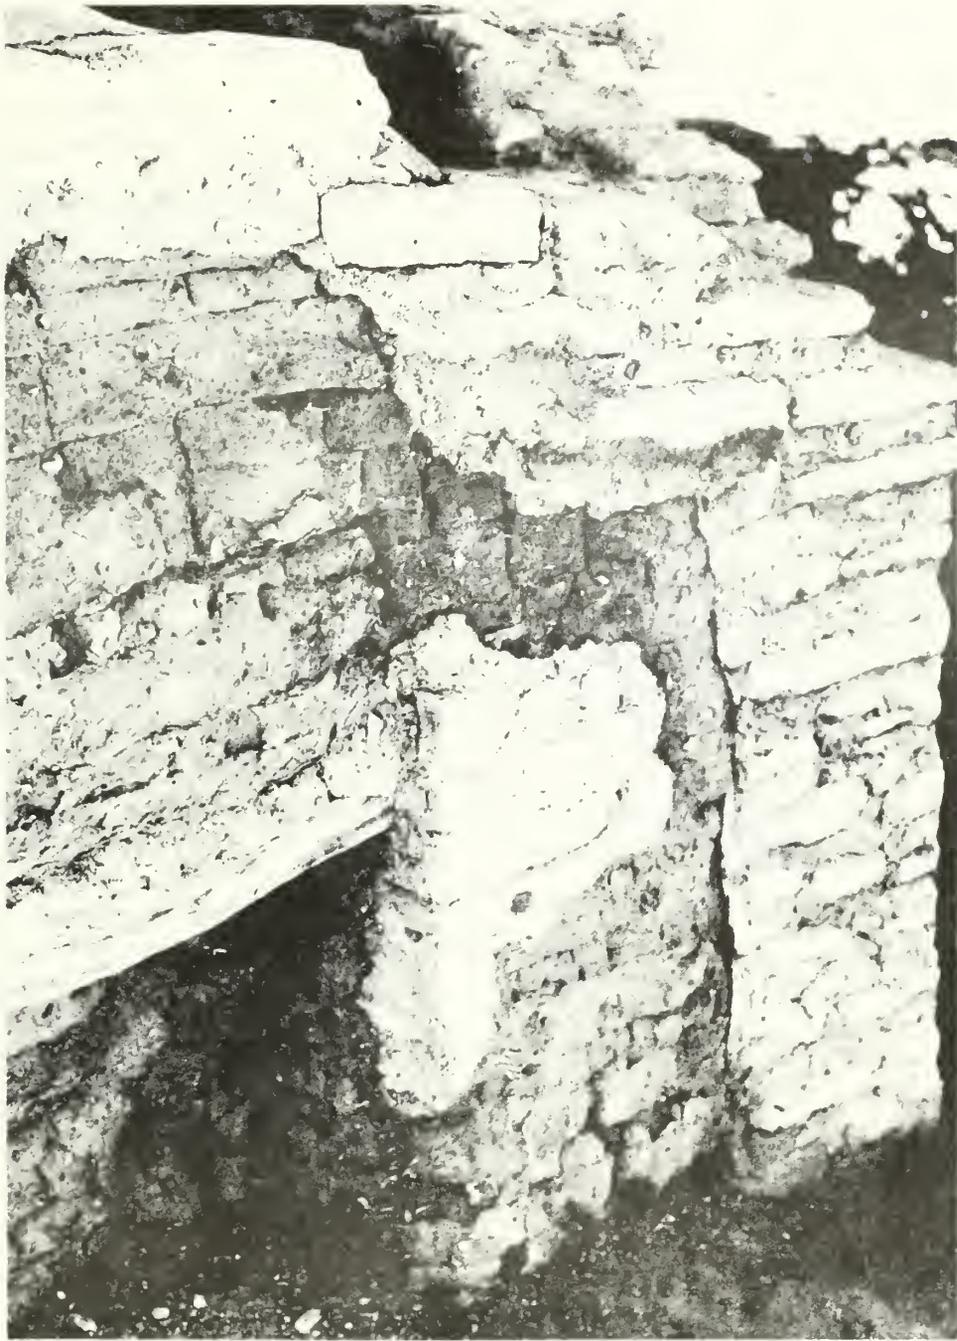
5. Northeast corner of granary showing effects of dissimilar materials.

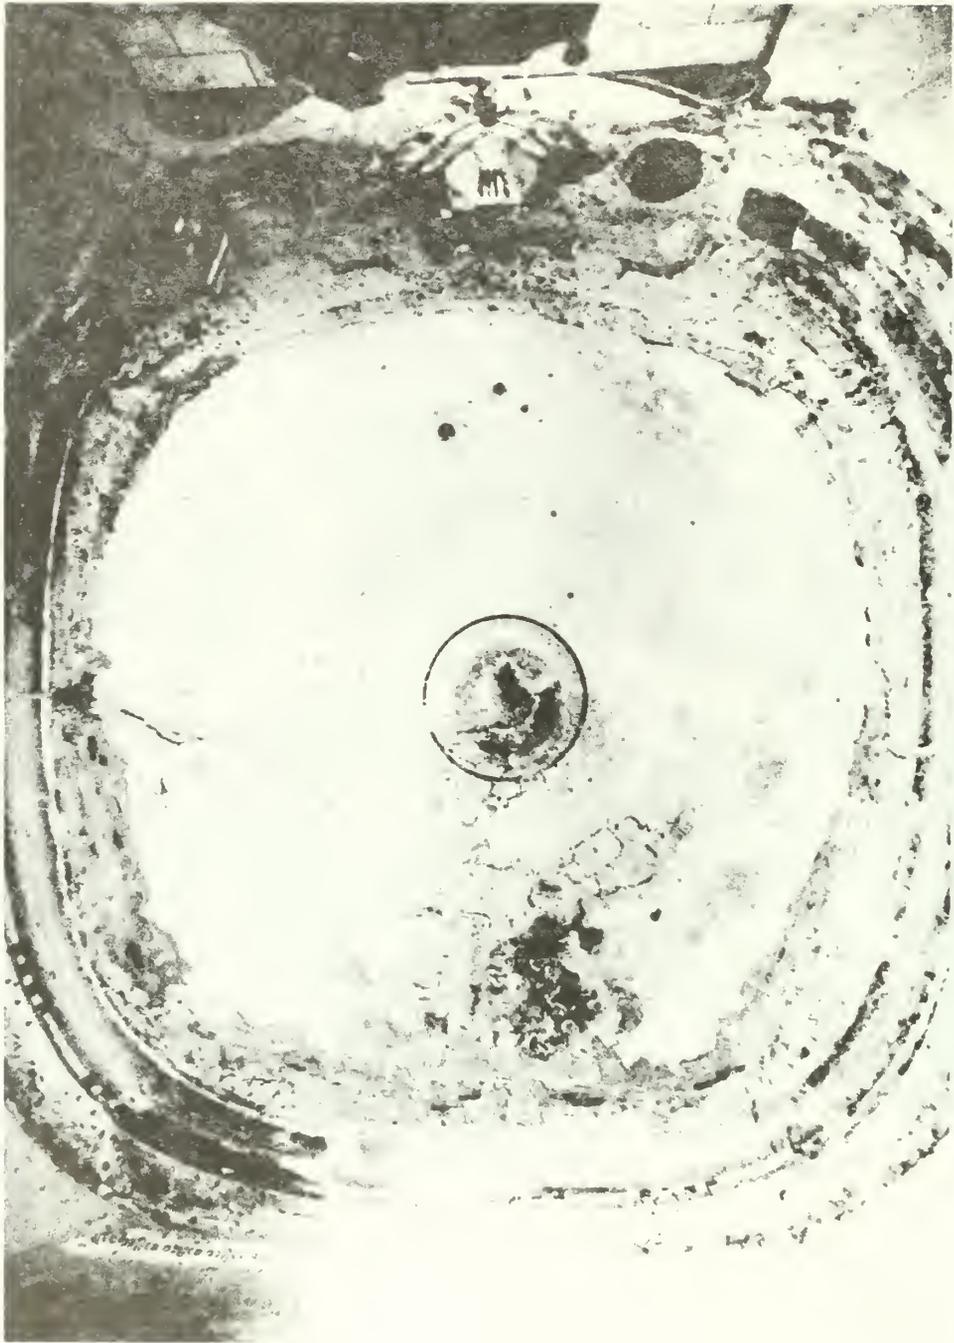
20. Interior of the dome before treatment, 1979.

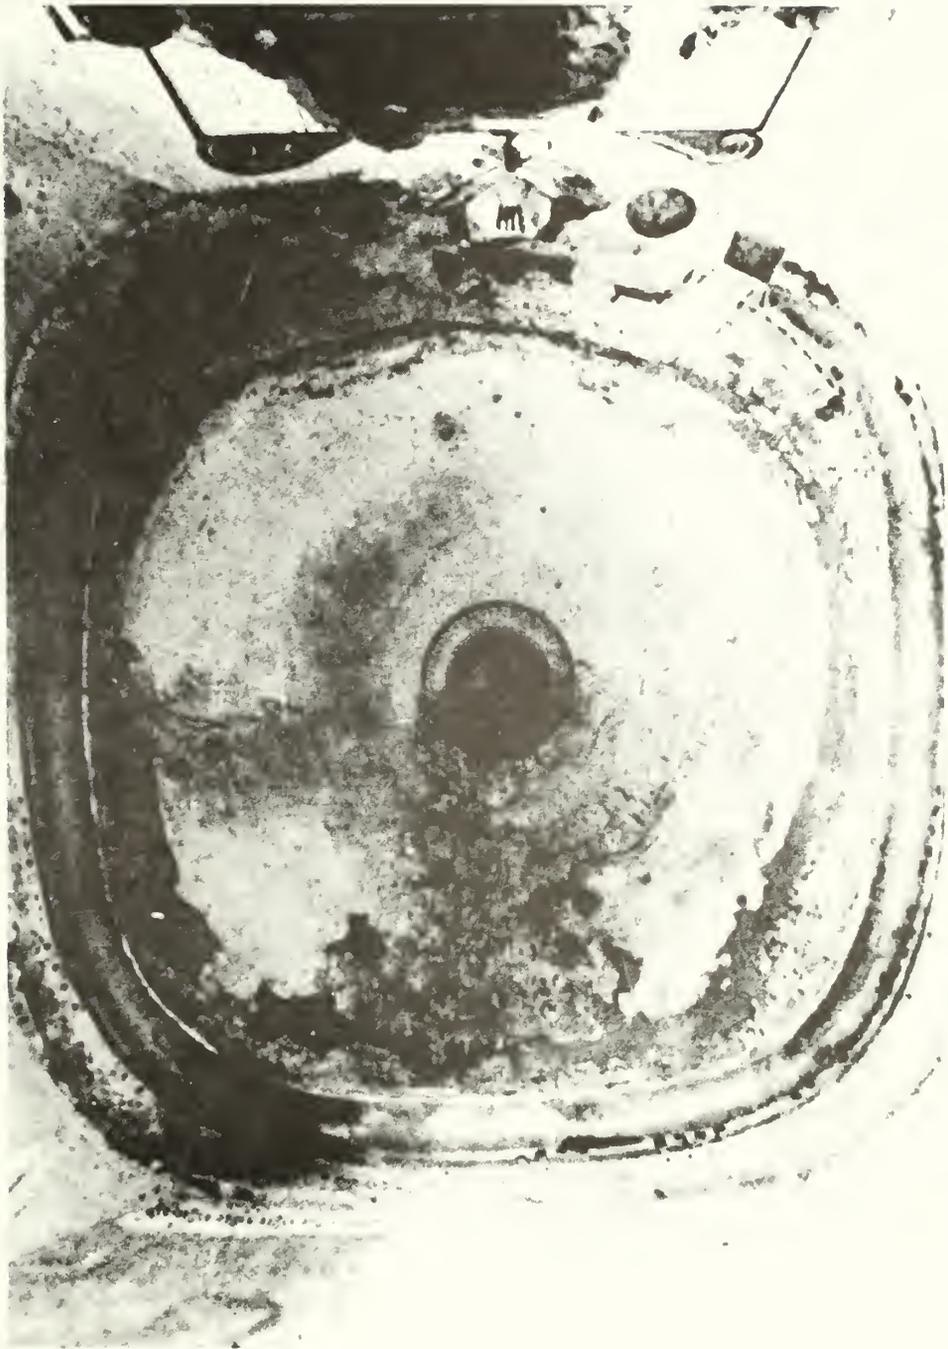
21. Interior of the dome after treatment, August 1982.

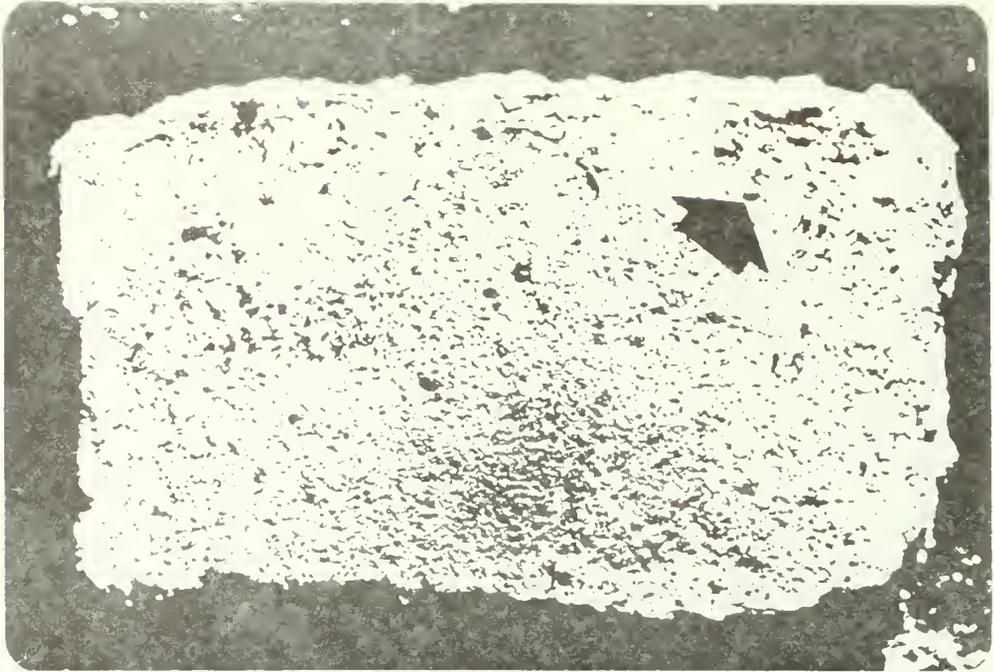
Figure 4a: Surface deterioration of plaster Sample B.  
Scale: actual size.

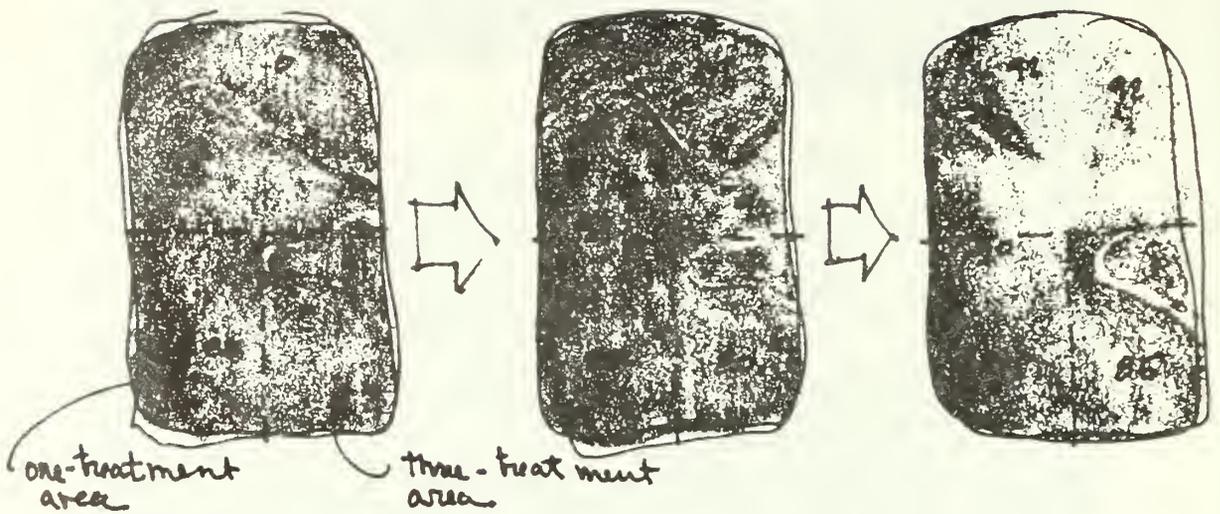
Figure 7: Back side of plaster Sample B showing visible capillary rise and relative surface moisture readings after 1 1/2, 2 1/2, and 4 hours, respectively. The blue areas are those which appear to be wet.

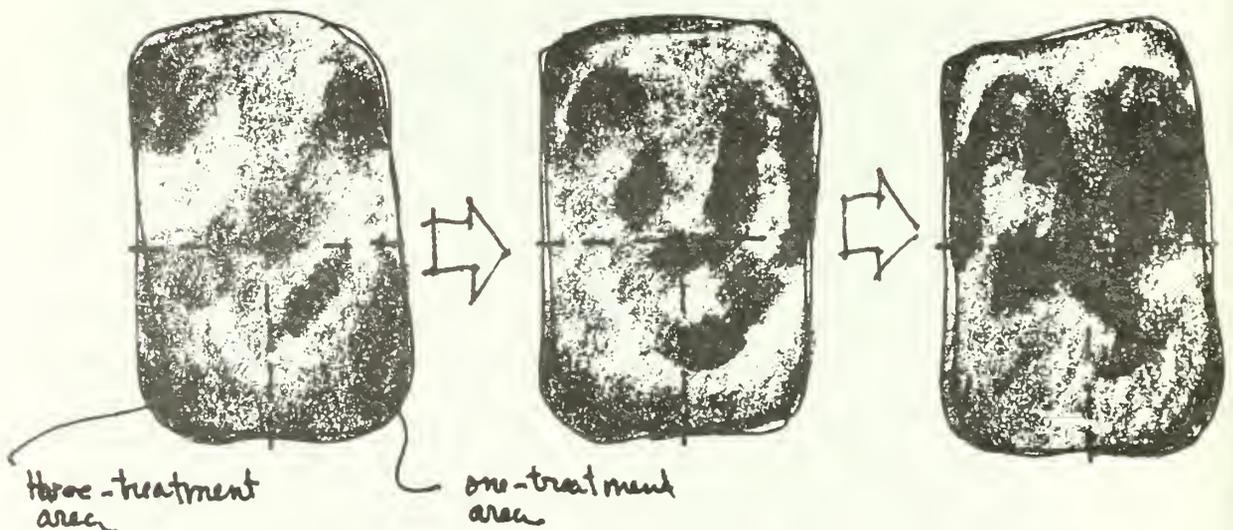
Figure 8: Front side, or finished surface of plaster Sample B showing the formation of efflorescence after 2, 3, and 18 hours respectively. The intensity of the gray areas represents the amount of efflorescence.
