historic structure report  
units 2, 3, and 4  
volume 4  
part 3

ELLIS ISLAND  
STATUE OF LIBERTY

**HISTORIC STRUCTURES REPORT  
UNITS 2, 3 AND 4**

**Volume 4  
Part Three**

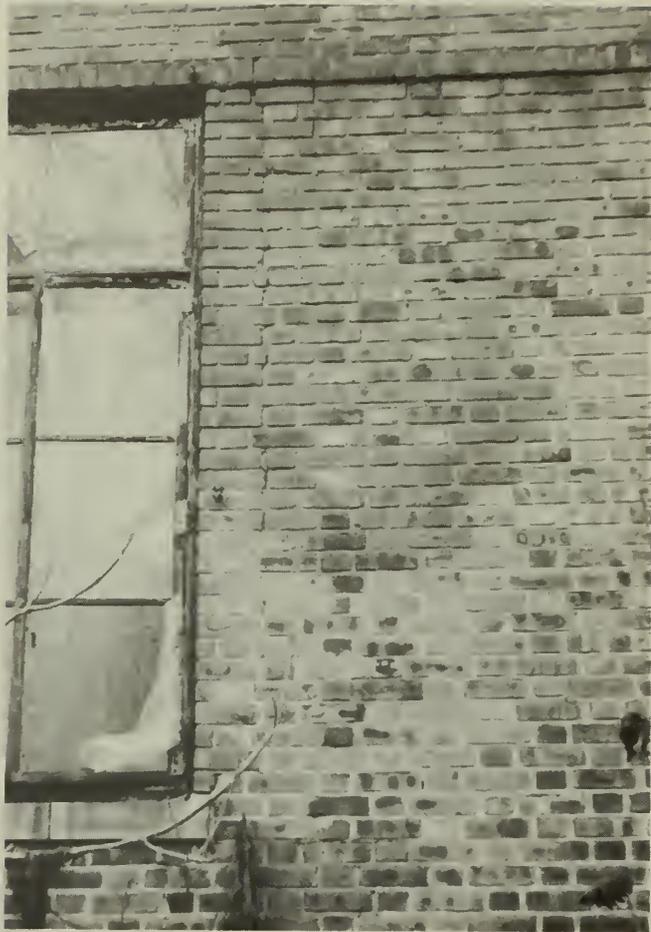
Only one crack was found in the exterior walls. This was vertical and located in the east wall of the north portion of the central block (photo 33).

All structural cracks seem to have been caused by thermal movement. The roof leaks were probably the result of cracks in the roof structure now concealed by the hung ceiling. In general, such cracks are structurally not a problem. However, when upgrading of the building is undertaken, further investigation in the leakage areas should be made. Since the corrosion of the reinforcing bar occurred in a joist completely supported on the bearing wall, no emergency repair appears necessary.

33. Vertical crack, east wall.

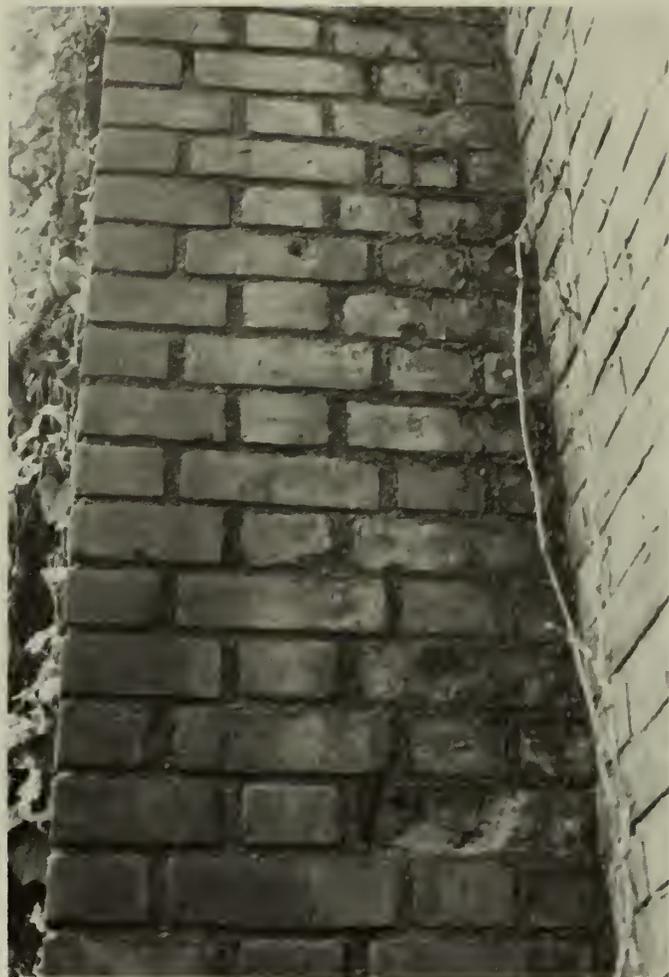
25. Efflorescence, east facade.

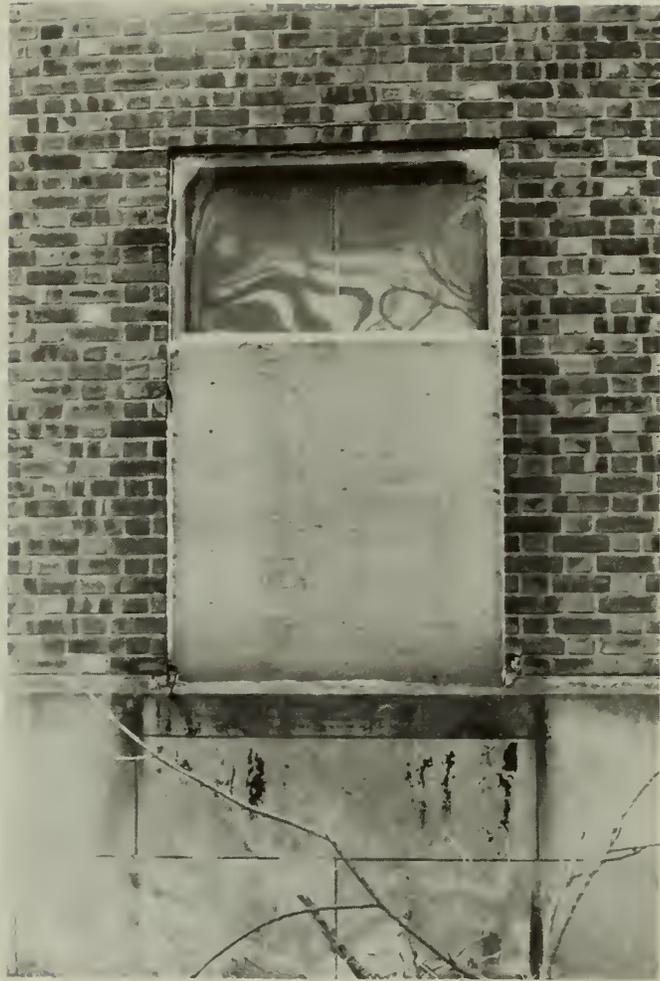
27. Chipping, terra cotta sill, west facade.

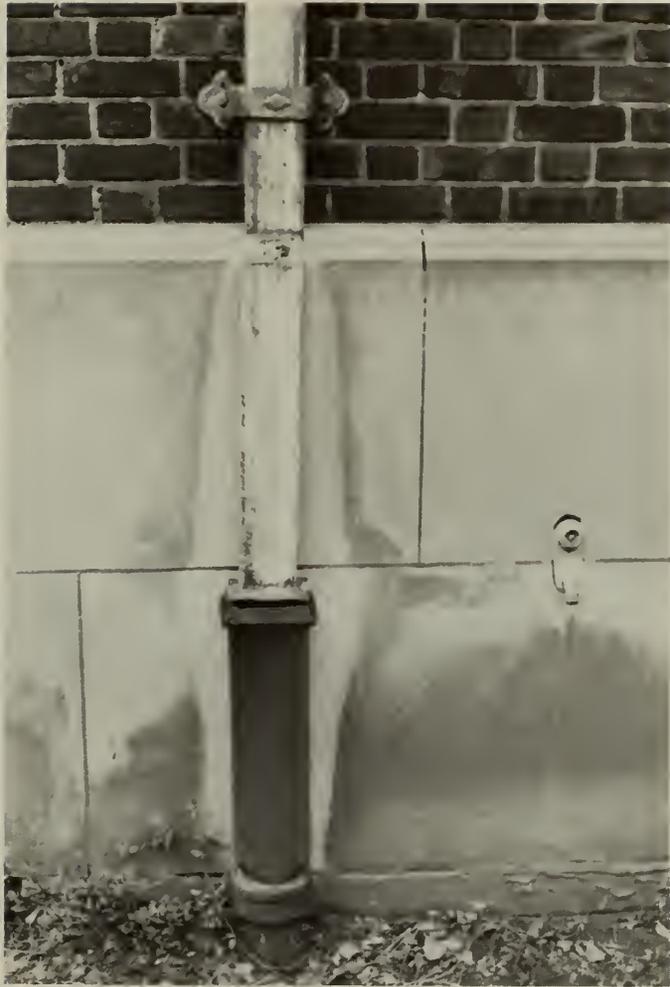
28. Iron staining, north facade.

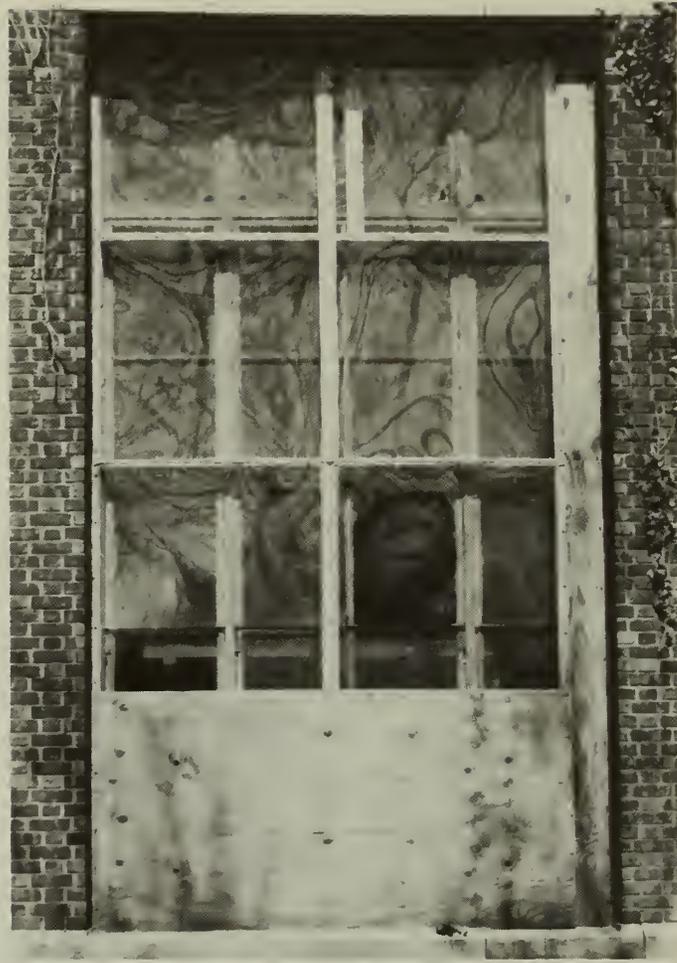
29. Copper staining, east elevation.

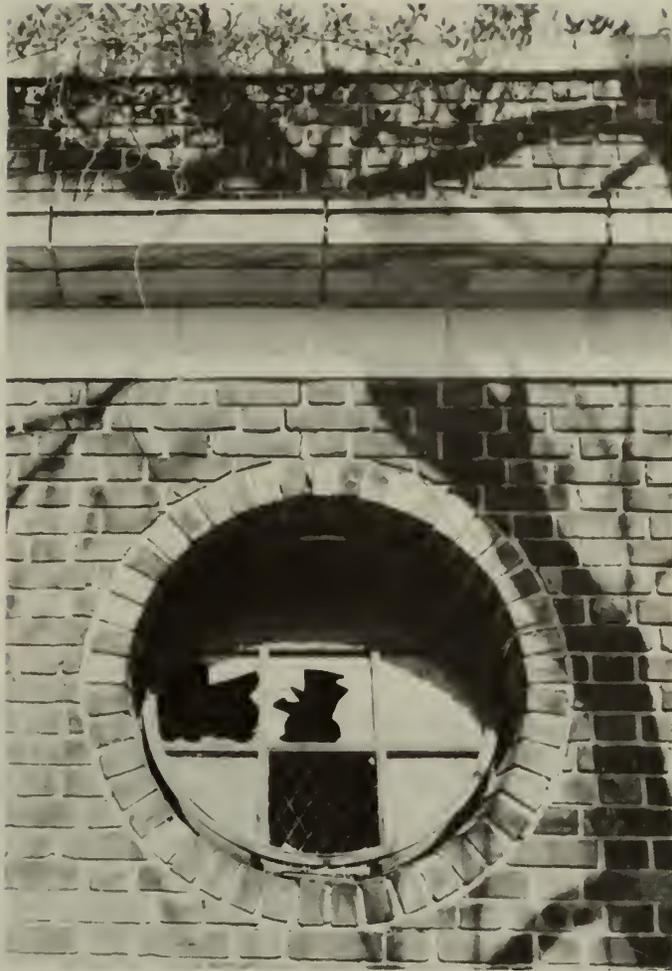
Terra cotta exhibits general surface weathering, disintegration of mortar, and chipping and spalling (photo 35). Carbon soot staining generally coats terra cotta cornice and roof coping surfaces.

35. Broken terra cotta, shelter.

The only repair necessary to the shelter structure is the cosmetic patching of the terra cotta trim. No other remedial action is required.

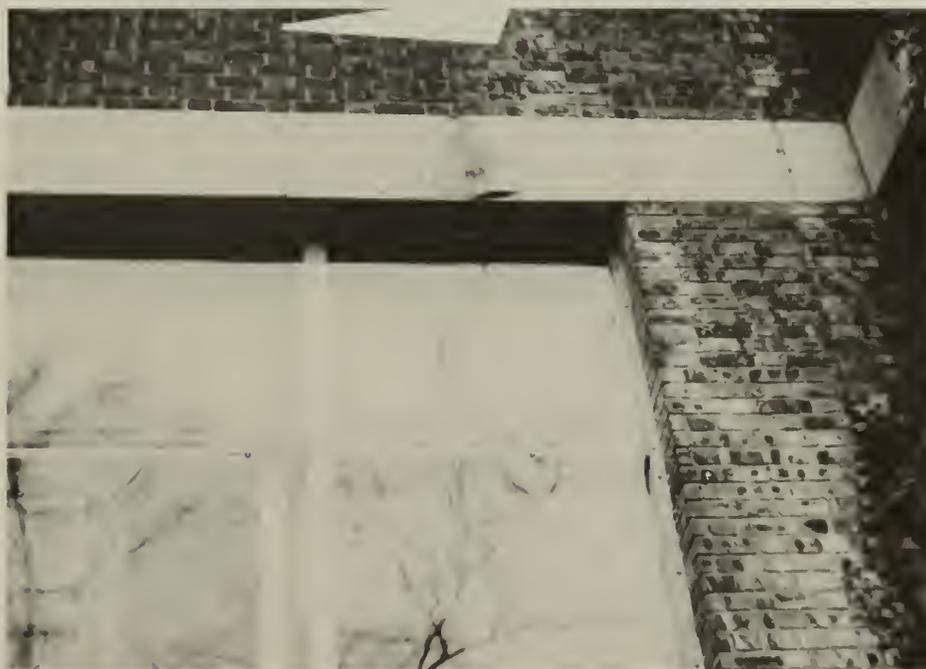
61. Horizontal cracks above lintel, north facade, west link.

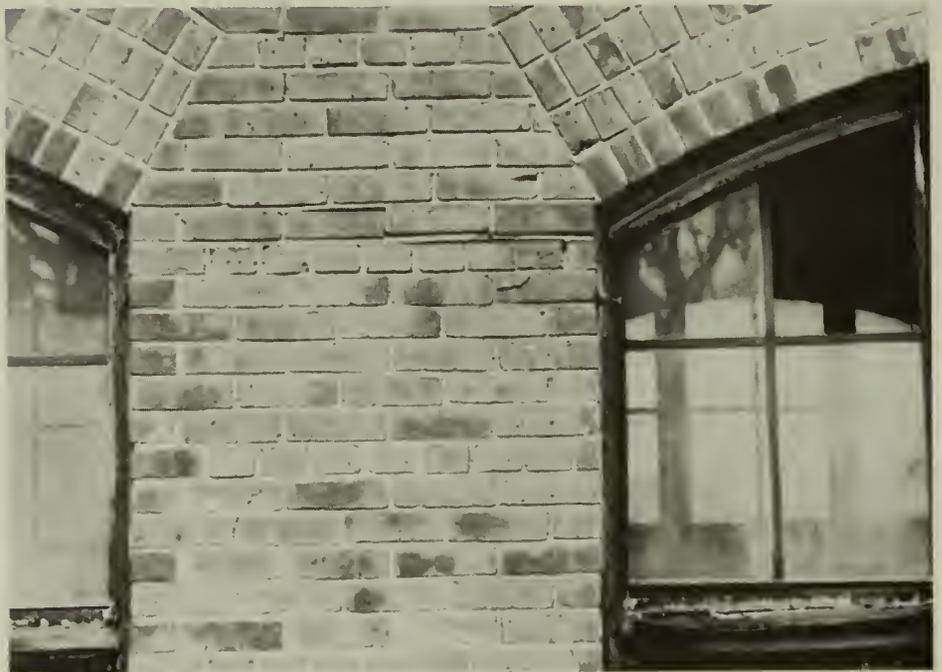
25. Cracking at brick joints, C-7B.

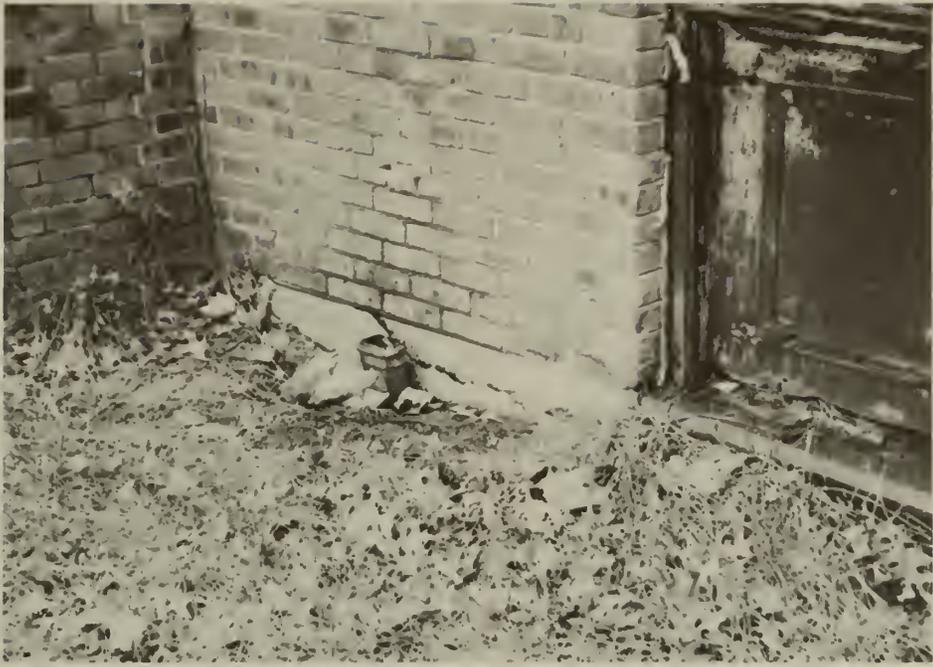
26. Cracking at brick joints, C-7B.

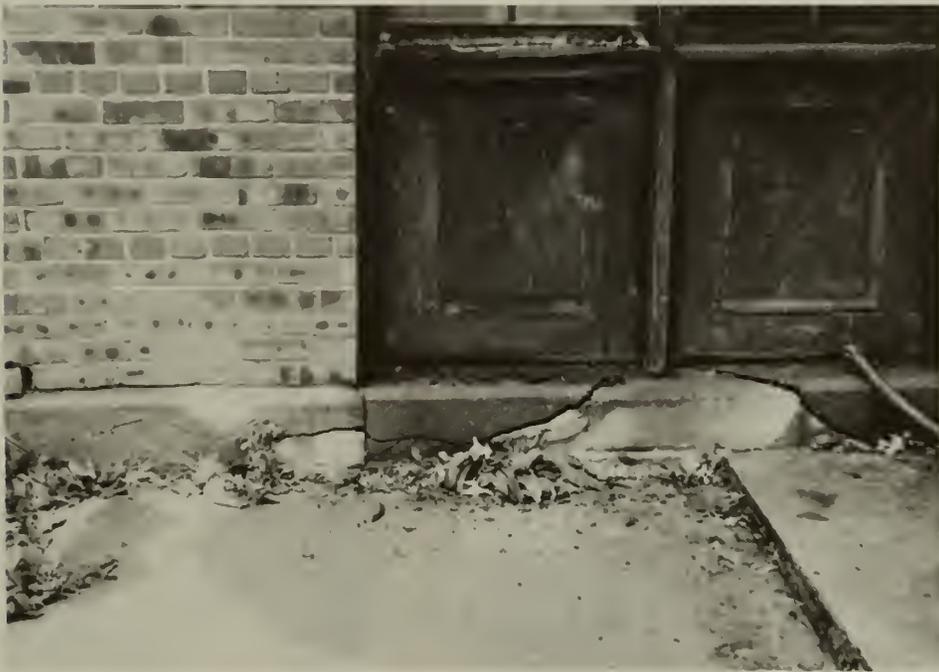
27. Cracking of concrete base, C-7B.

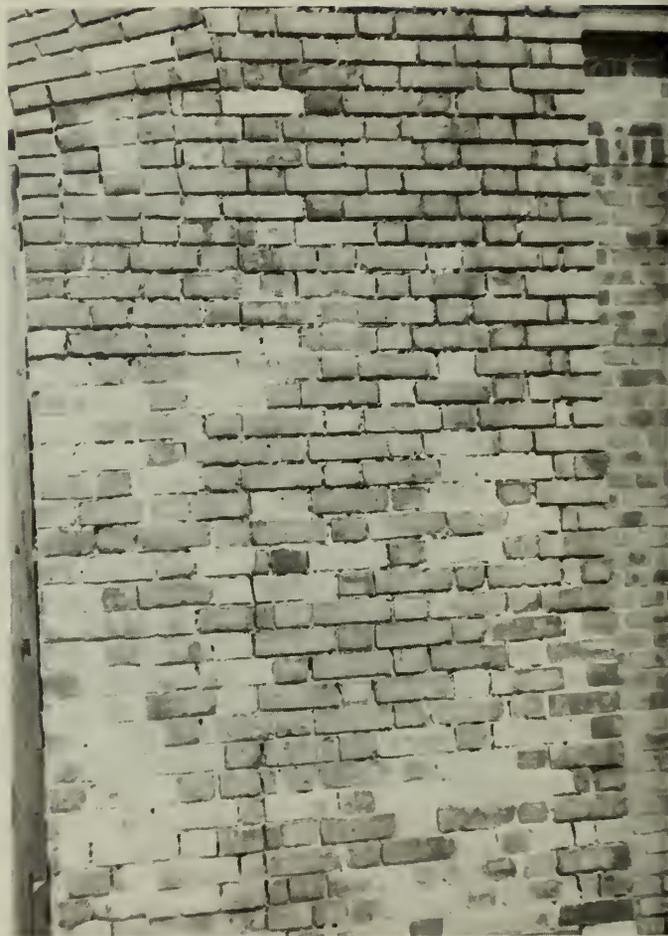
29. Deteriorated brick joints,  
east wall of south pavilion,  
C-7A.

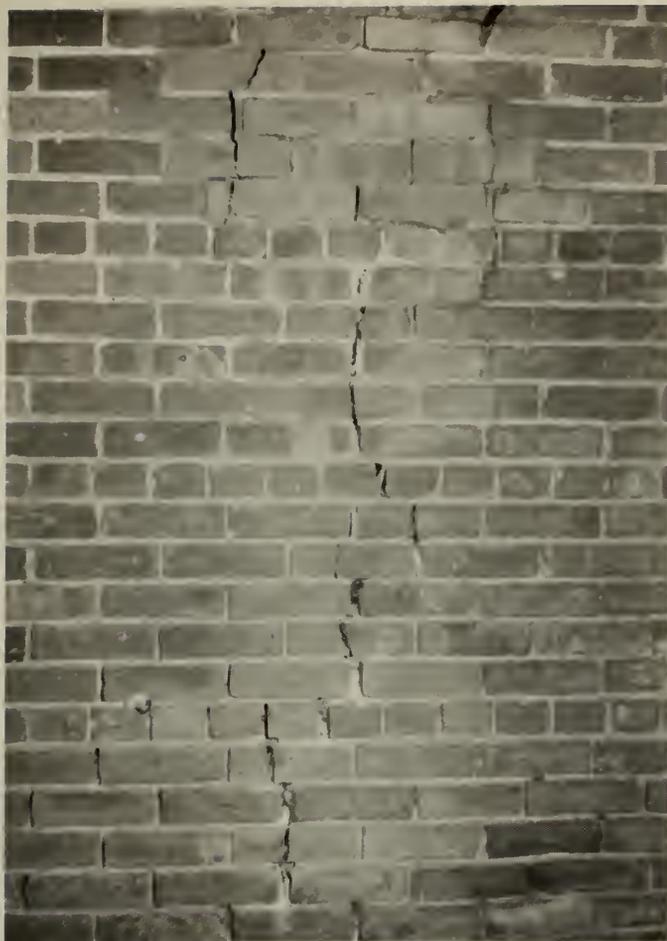
30. Deteriorated brick joints,  
north wall of south pavilion,  
C-7A.

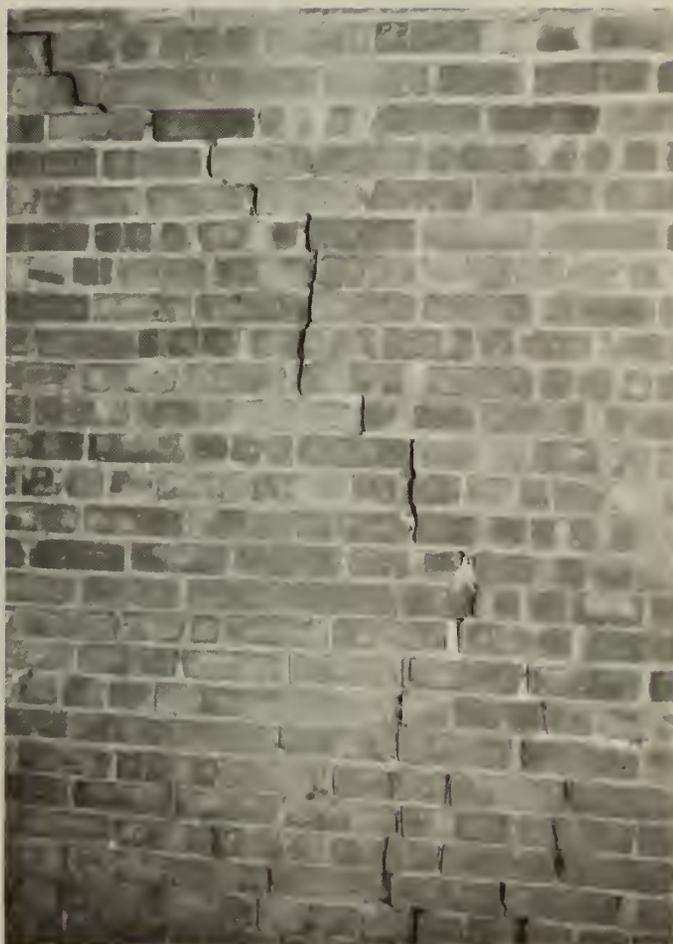
31. Cracks on interior wall of south pavilion, C-7A.

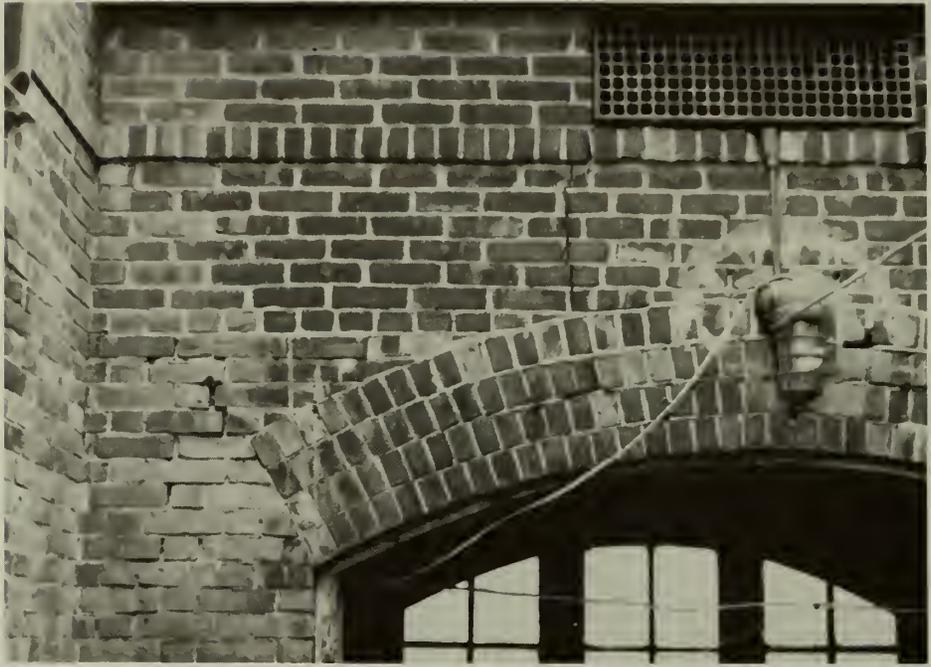
32. Cracks on interior wall of south pavilion, C-7A.

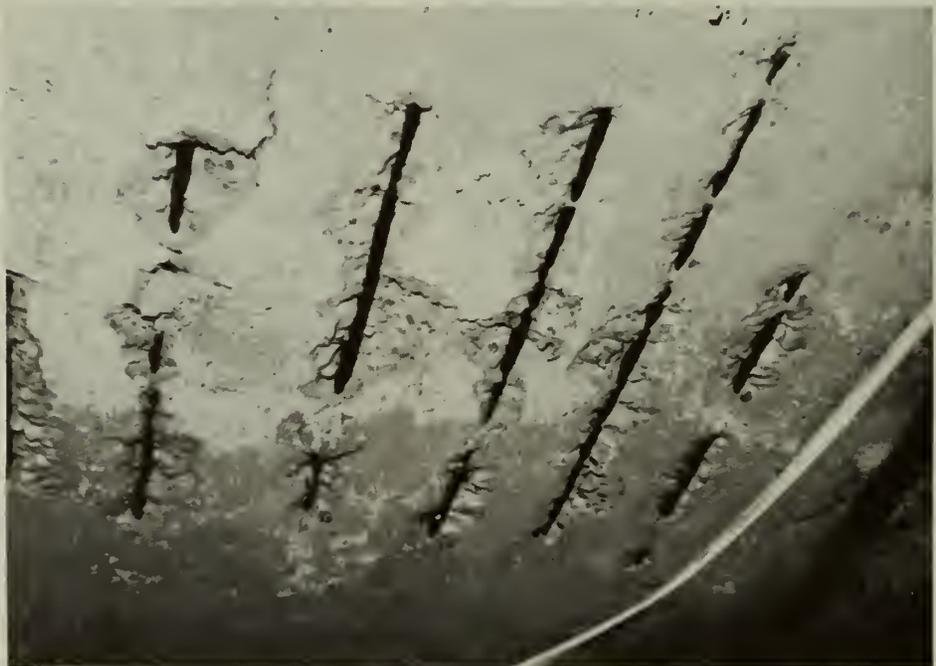
33. Cracks, west elevation of south pavilion, C-7A.

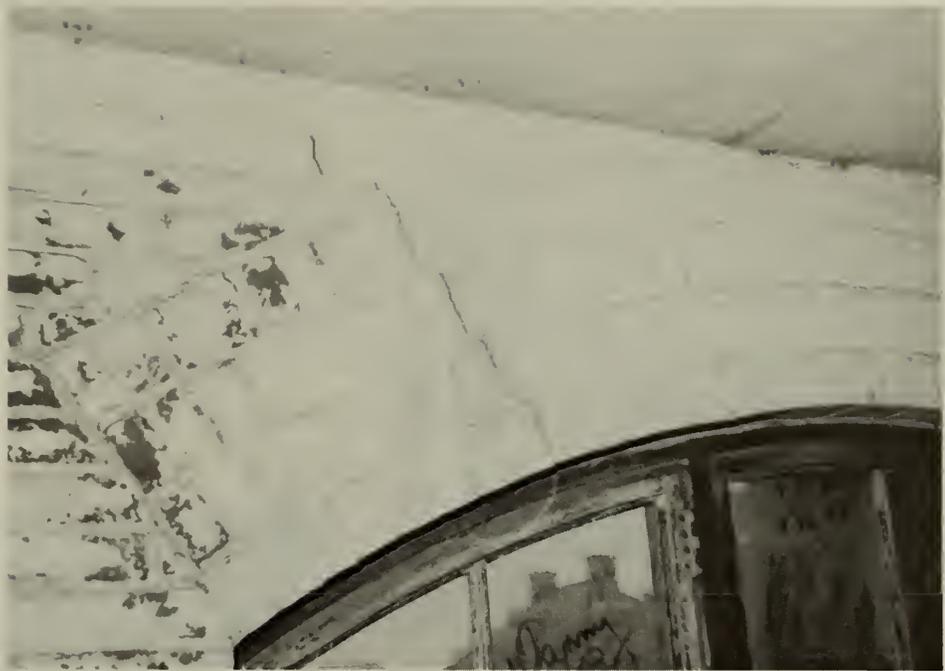
34. Exposed and rusting steel in ceiling slab of north pavilion, C-7A.

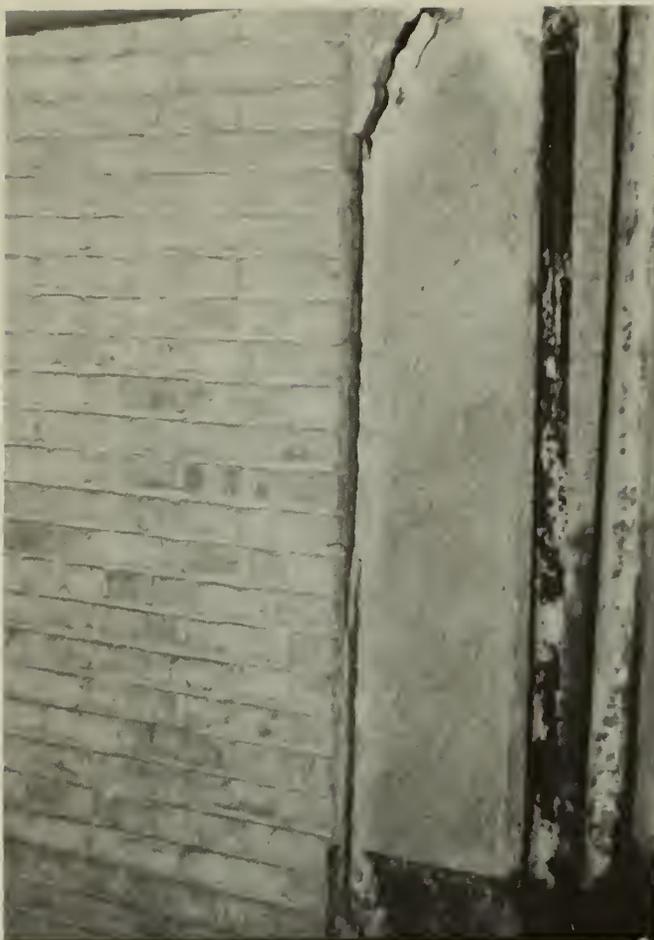
35. Diagonal cracks, north wall of north pavilion, C-7A.

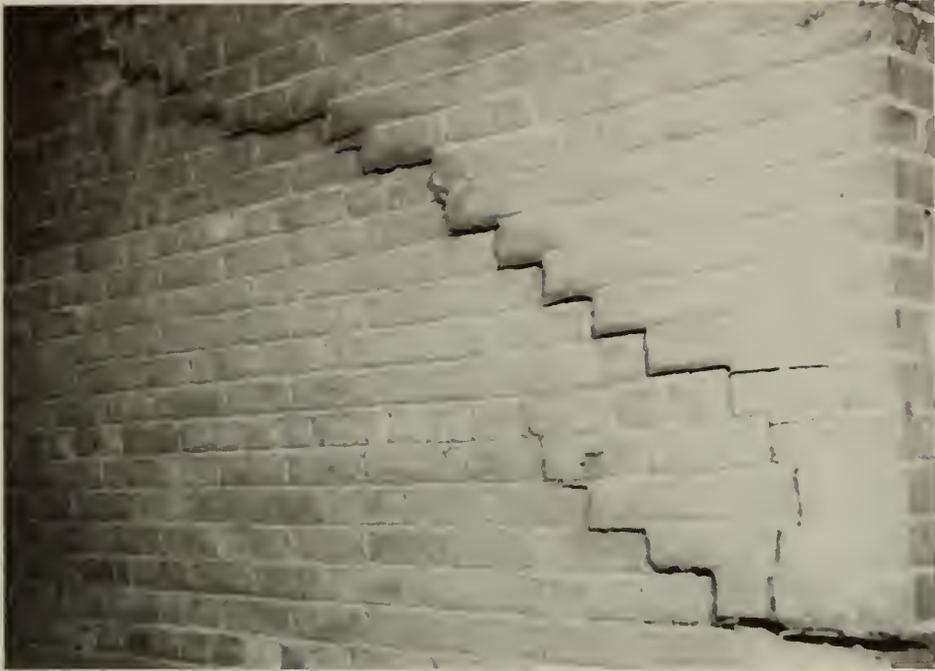
37. Gap at junction between walls of C-8C and C-9A.

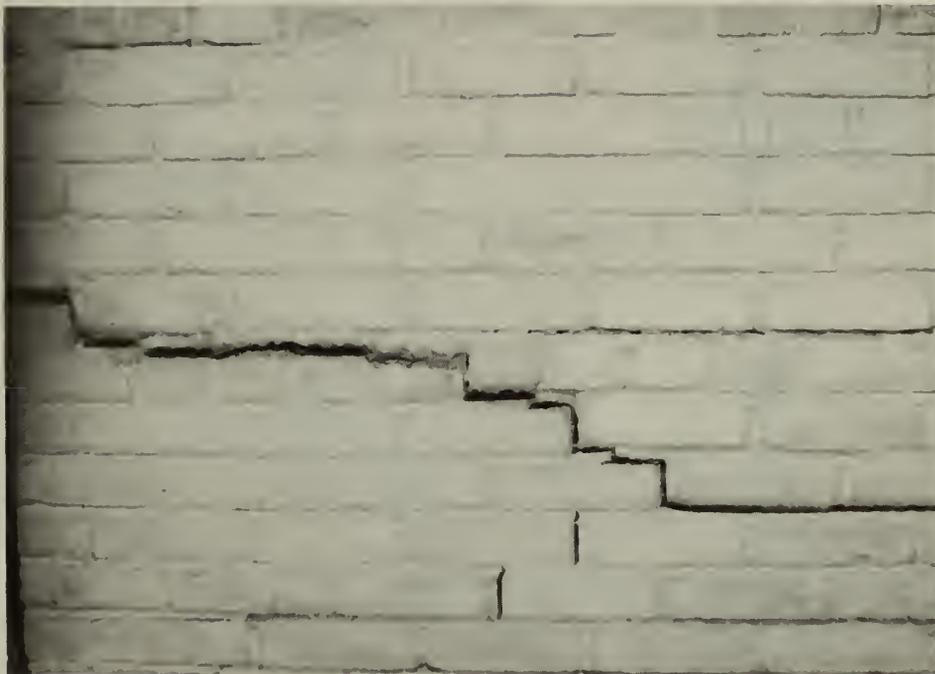
38. Diagonal cracks, east wall, C-8C.

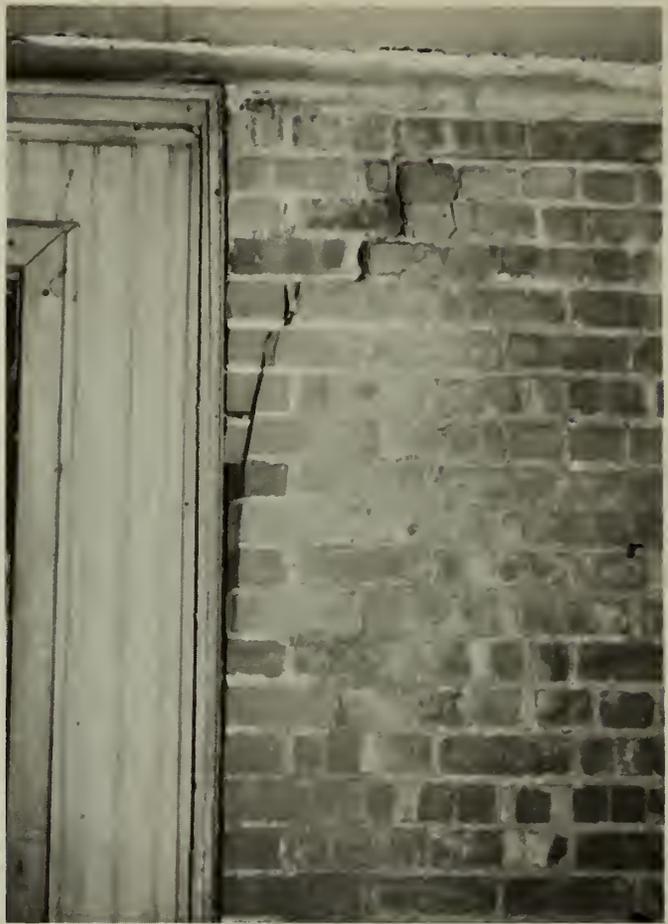
39. Diagonal cracks, north wall, C-8C.

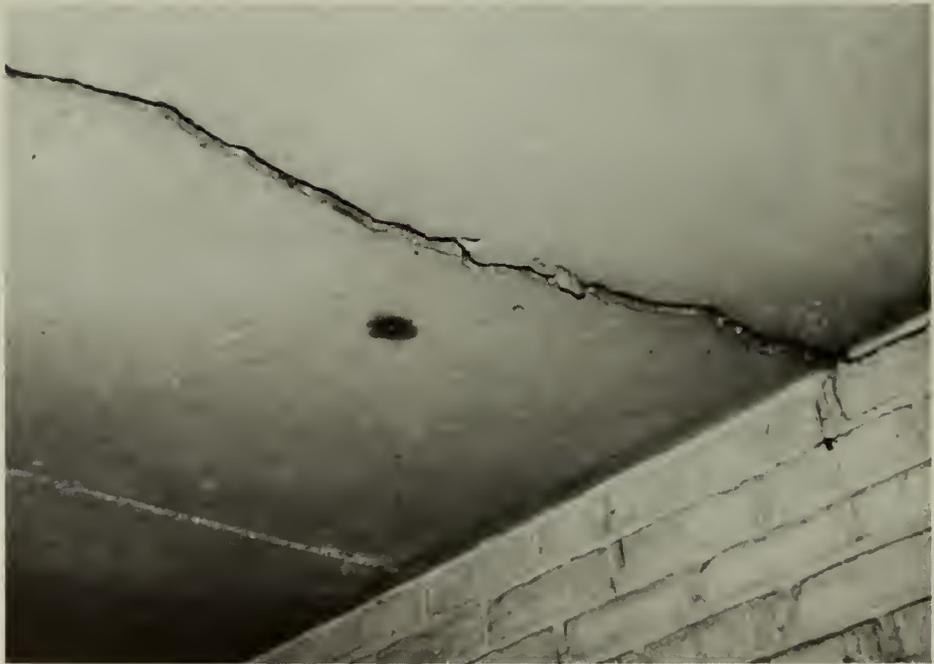
40. Crack, east wall near window, C-8C.

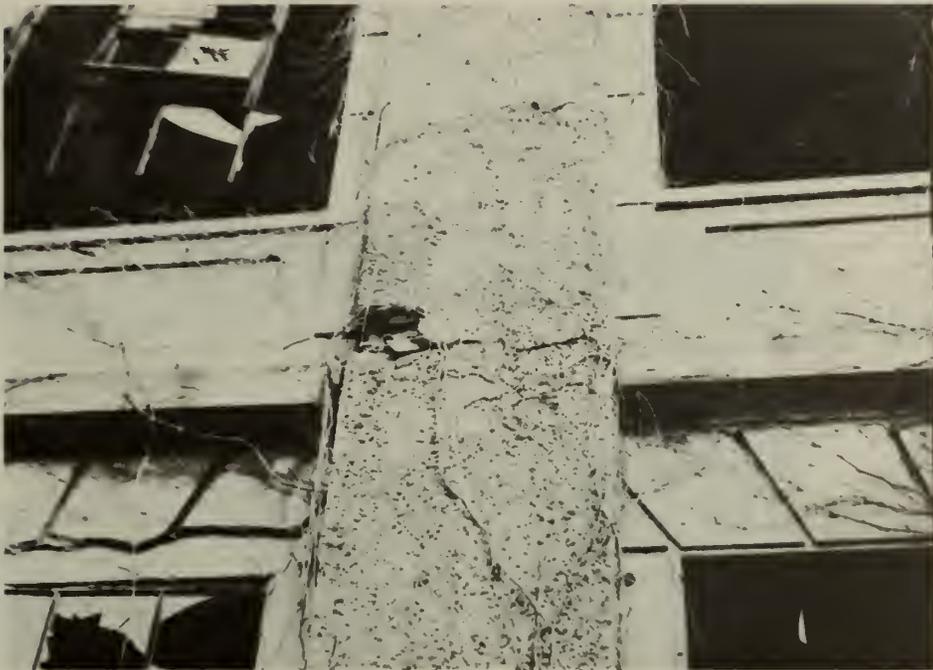
42. Diagonal cracks, south wall, C-8C.

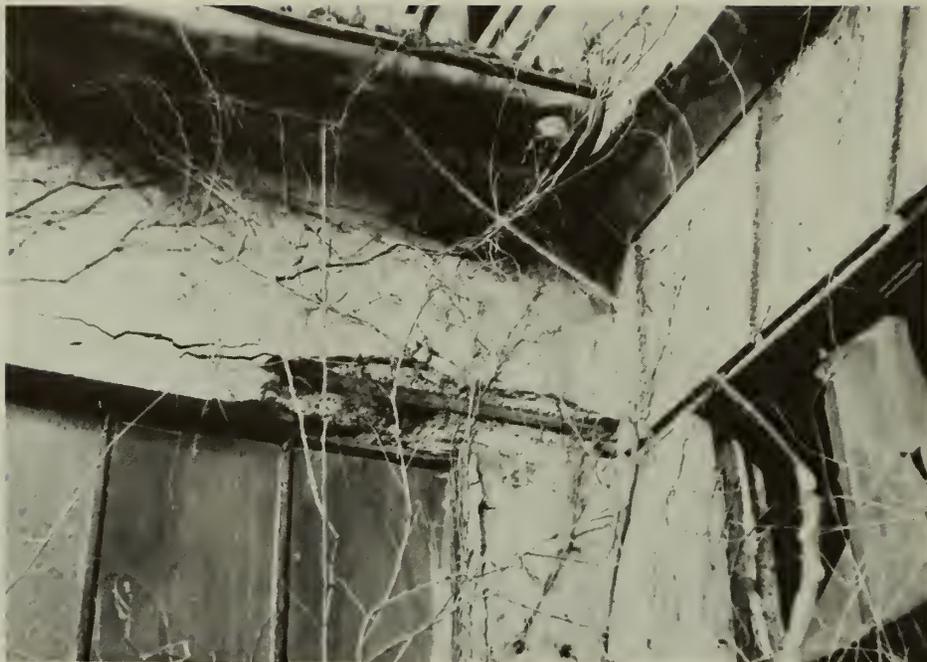
43. Cracking and buckling of pier, south elevation, C-9C.
