# historic structure report

## restore historic commissary building to 1897

# FORT SMITH

NATIONAL HISTORIC SITE / ARKANSAS

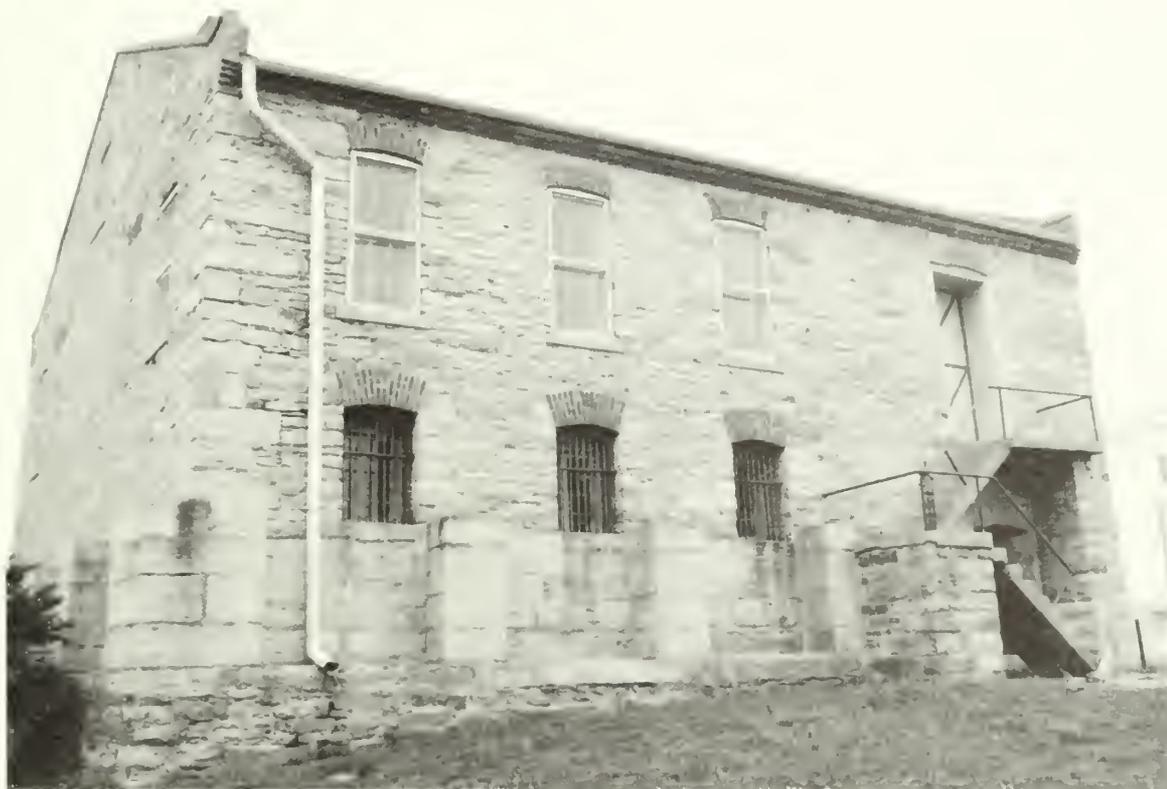
Figure 57. Southwest Exterior View (5/18/82): This view shows the painted metal downspout that was replaced in 1983 and the condition of stone masonry mortar joints that were thoroughly repointed in 1984.

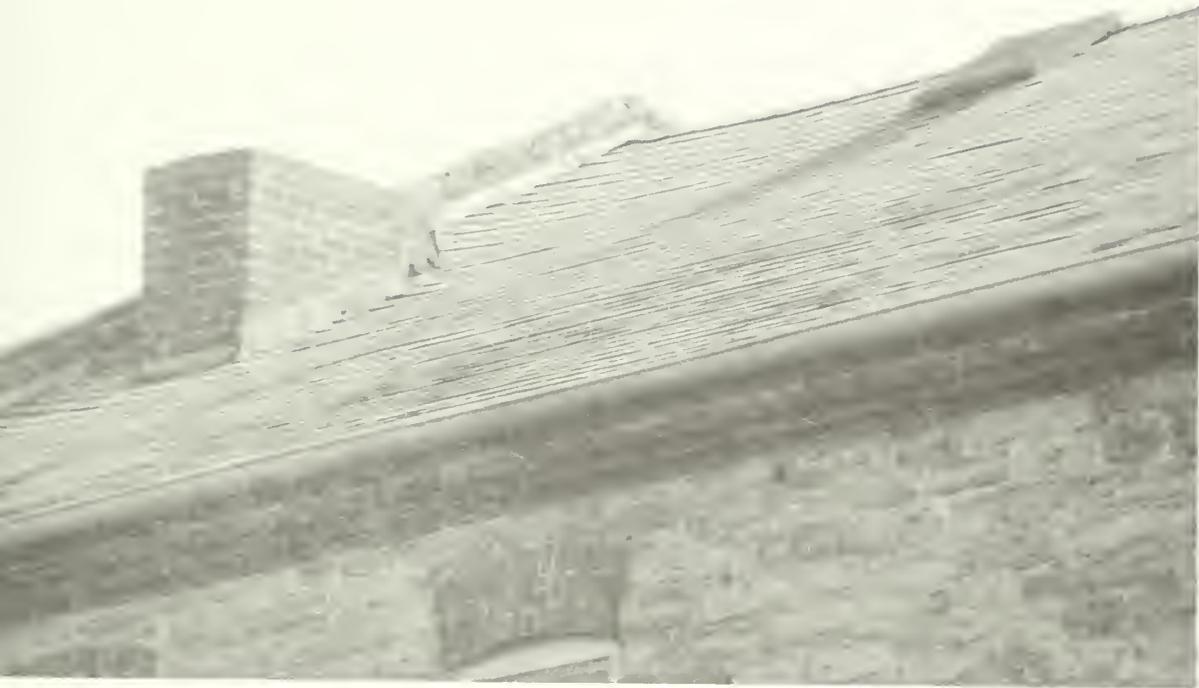
Figure 59. Roof Features (5/20/82): This detail documents the condition of asbestos shingles, galvanized steel flashing, and the roof scuttle cover that was removed in the fall of 1983. Note, too, the west chimney as it looked before 1983 when it was restored to its ca. 1897 height. The restoration was based on the number of brick courses and design detailing in figures 31 and 33.

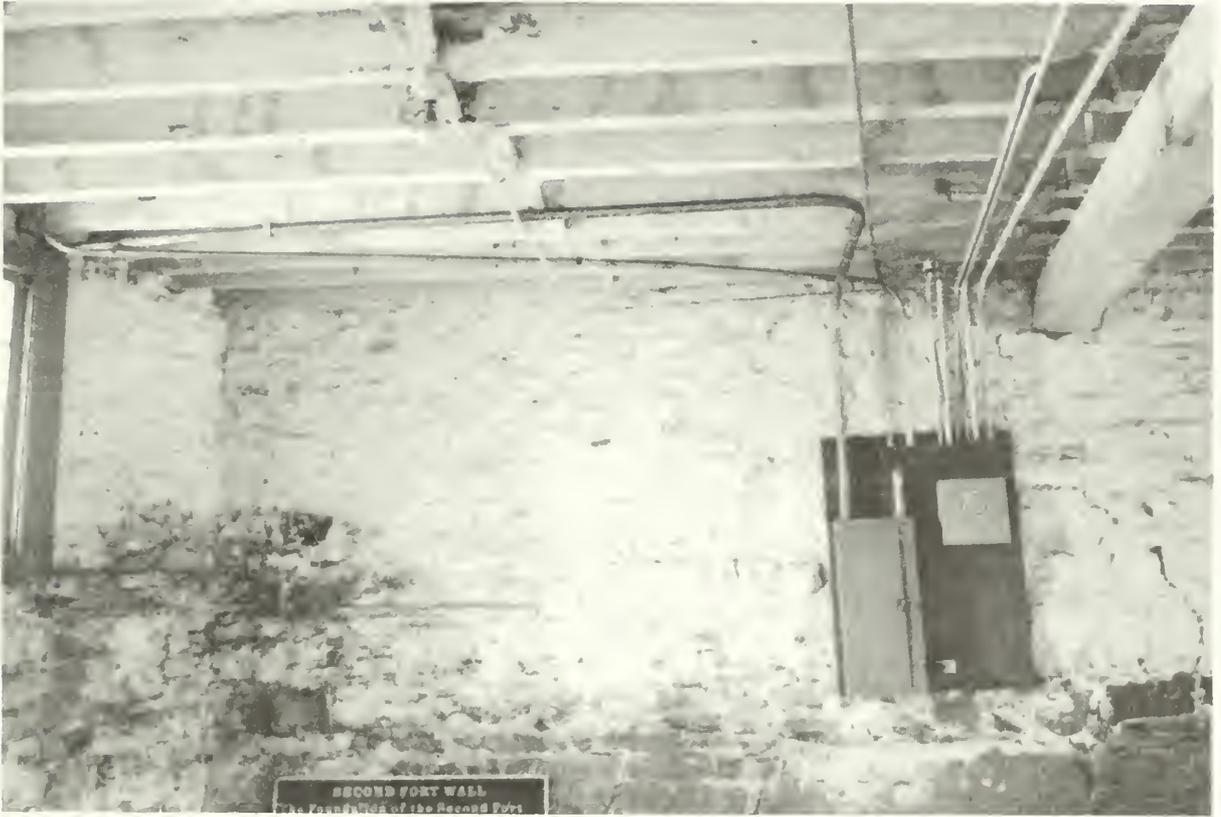
Figure 63. First Floor (6/26/83): General view of first-floor condition before restoration. Note light fixtures, gas stove heaters, and concrete slab floor that were removed, and deteriorated support posts and whitewash that were restored.

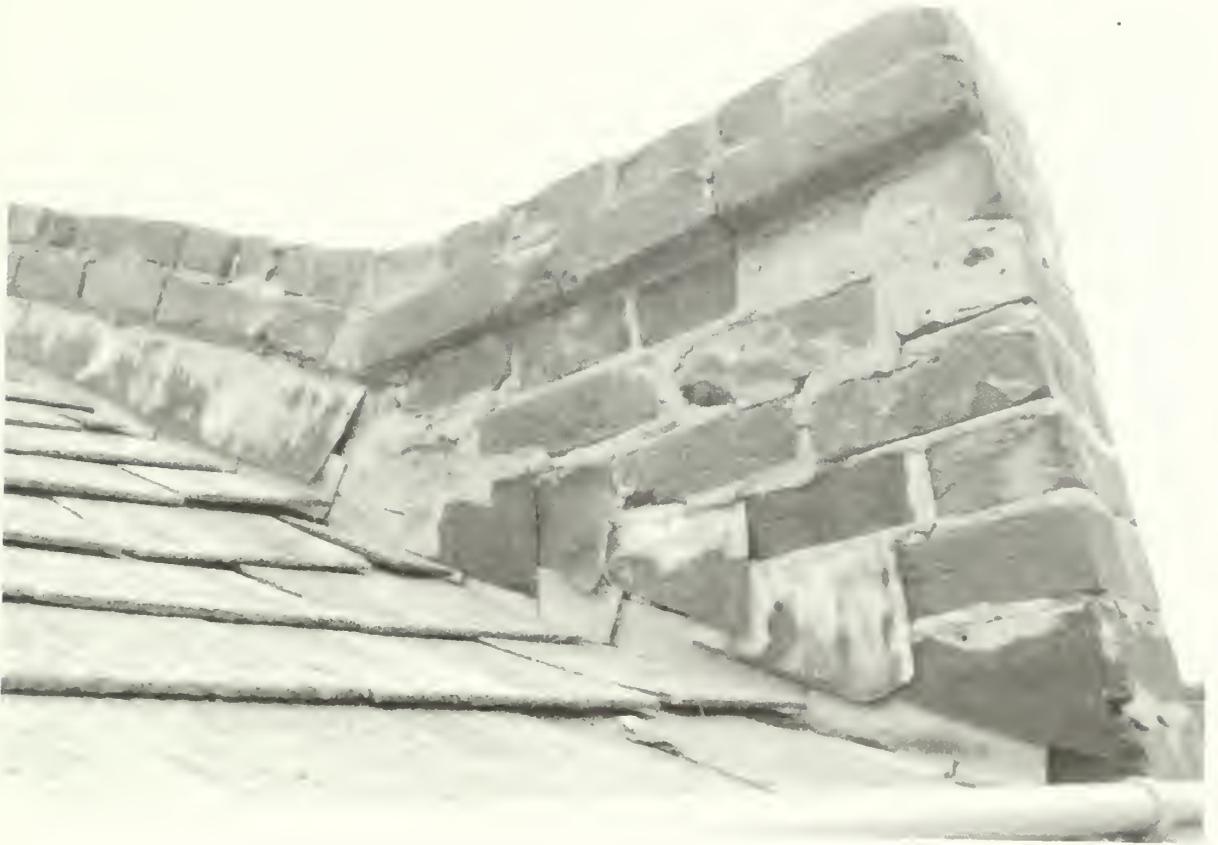
Figure 67. South Brick Cornice (6/25/83): It was recognized that the brick cornice had suffered deformation because of wall and door arch settlement, and cracks and some repointing was anticipated. The extent of the condition, however, was revealed only after the gutters and roof eave were removed (see figure 68).

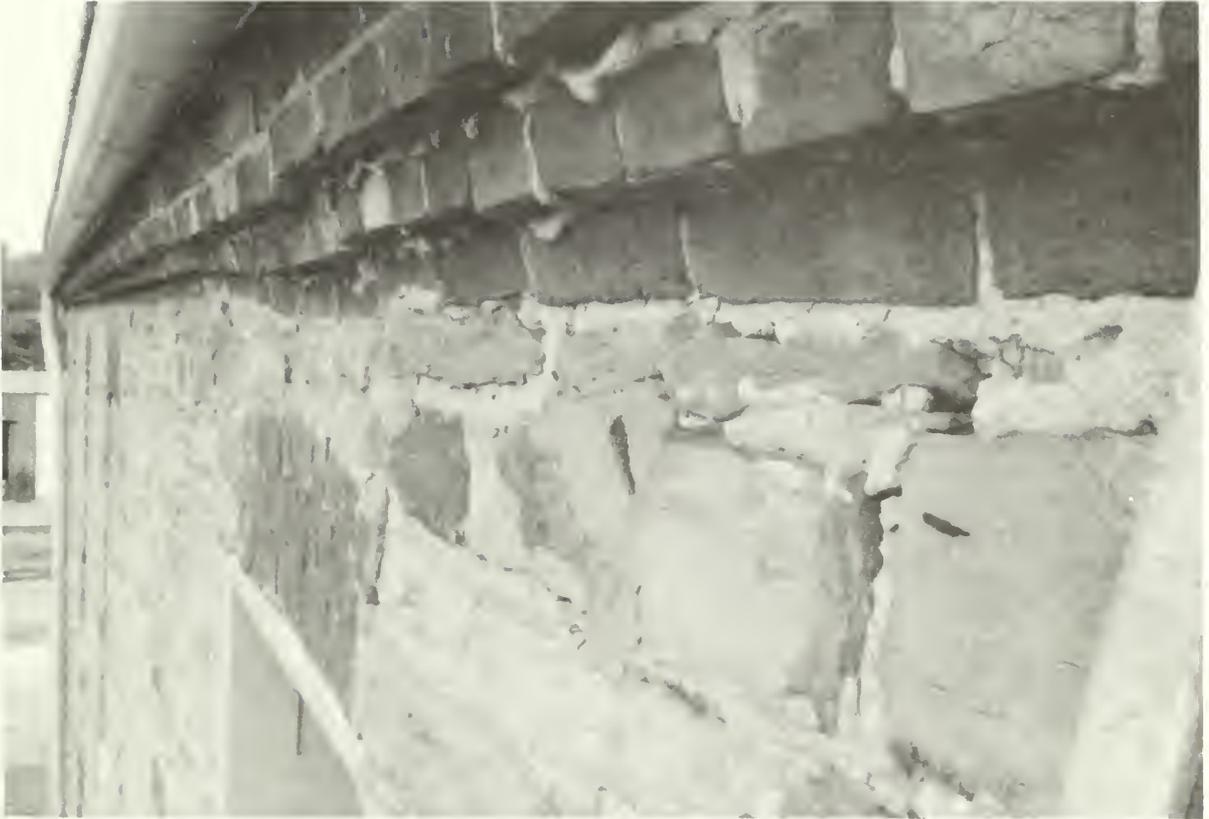
Figure 68. South Brick Cornice (10/7/83): After the gutter and roofing was removed, it was clear that the cornice at the south eave was separating and the danger of its falling off was apparent. The separation was nearly two inches. It was decided to dismantle the brickwork to a sound level and rebuild the cornice, duplicating the original profile, and using metal brick ties to secure it to the brick nogging between the attic joists.

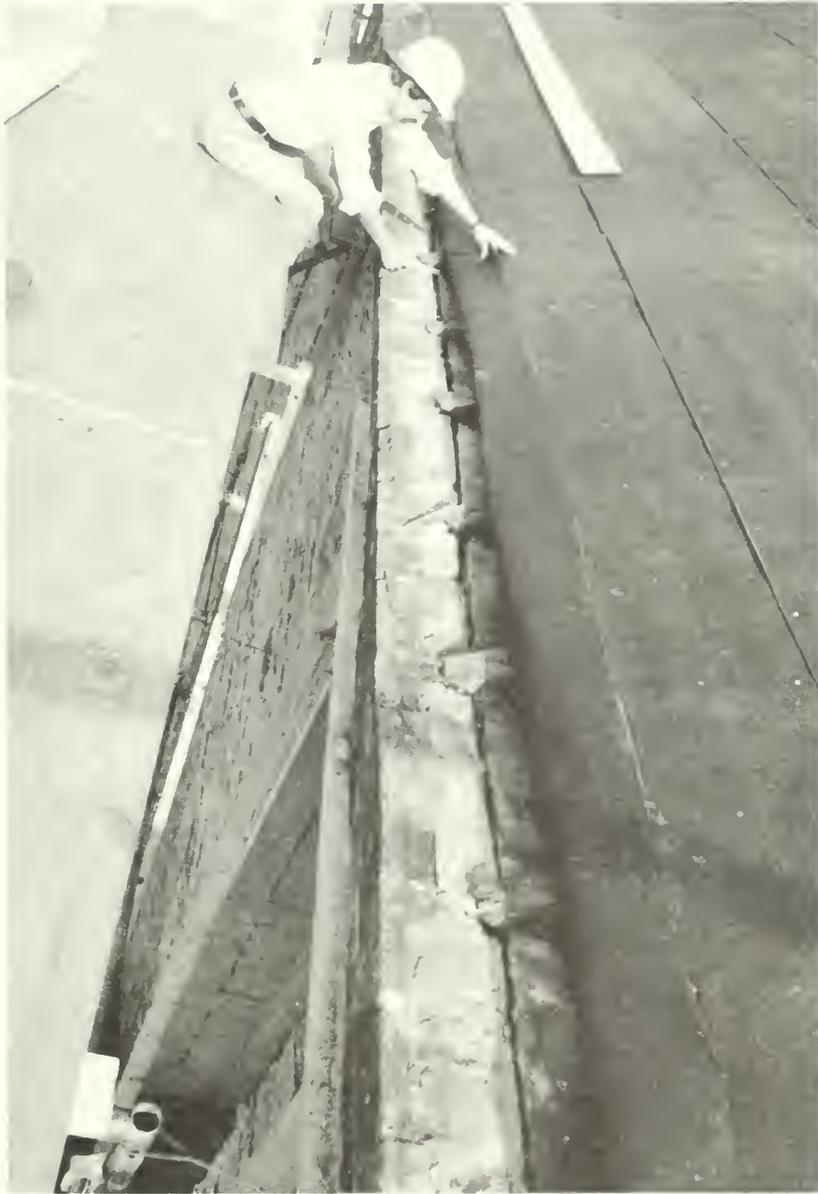
Figure 69. South Brick Cornice (10/8/83): The brick dismantled effortlessly because the lime mortar had become quite useless. Rafter tails too, were exposed to inspection, and although somewhat weathered, their condition was generally very good for their 140-year age. In some cases, sister rafters were nailed to the existing to reinforce them as had been done traditionally - note left rafter in lower photo.

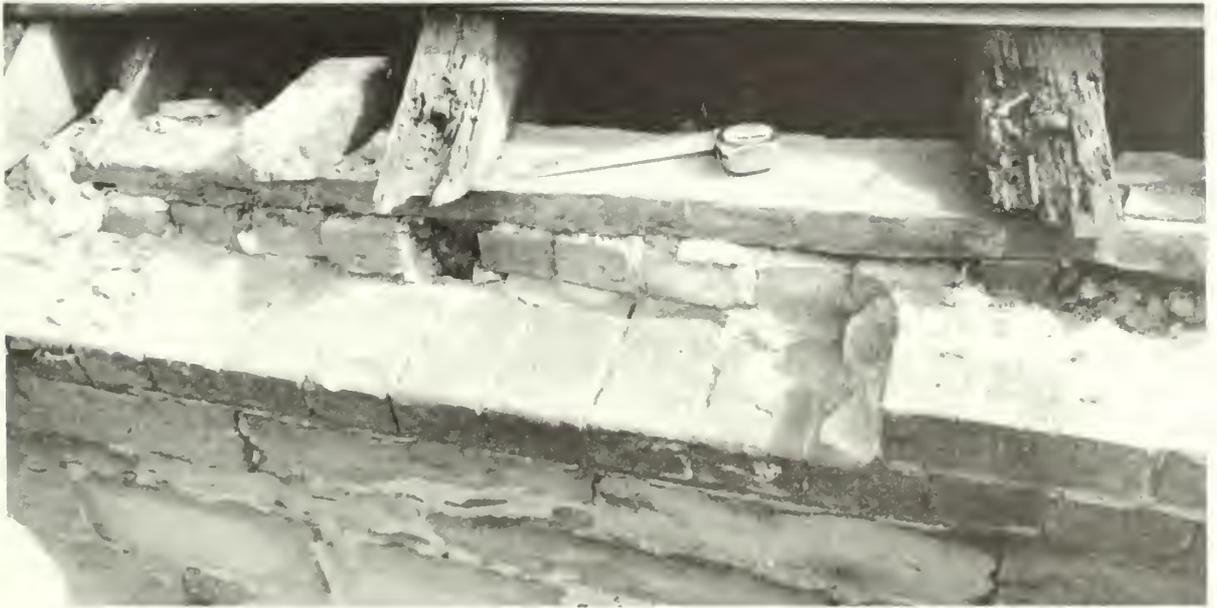
Figure 70. North Eave (10/7/85): At the north, brick cornice separation and deterioration was much less than the south: no wall or arch cracking was present. Subsequently, very little brick repair was undertaken on the north.

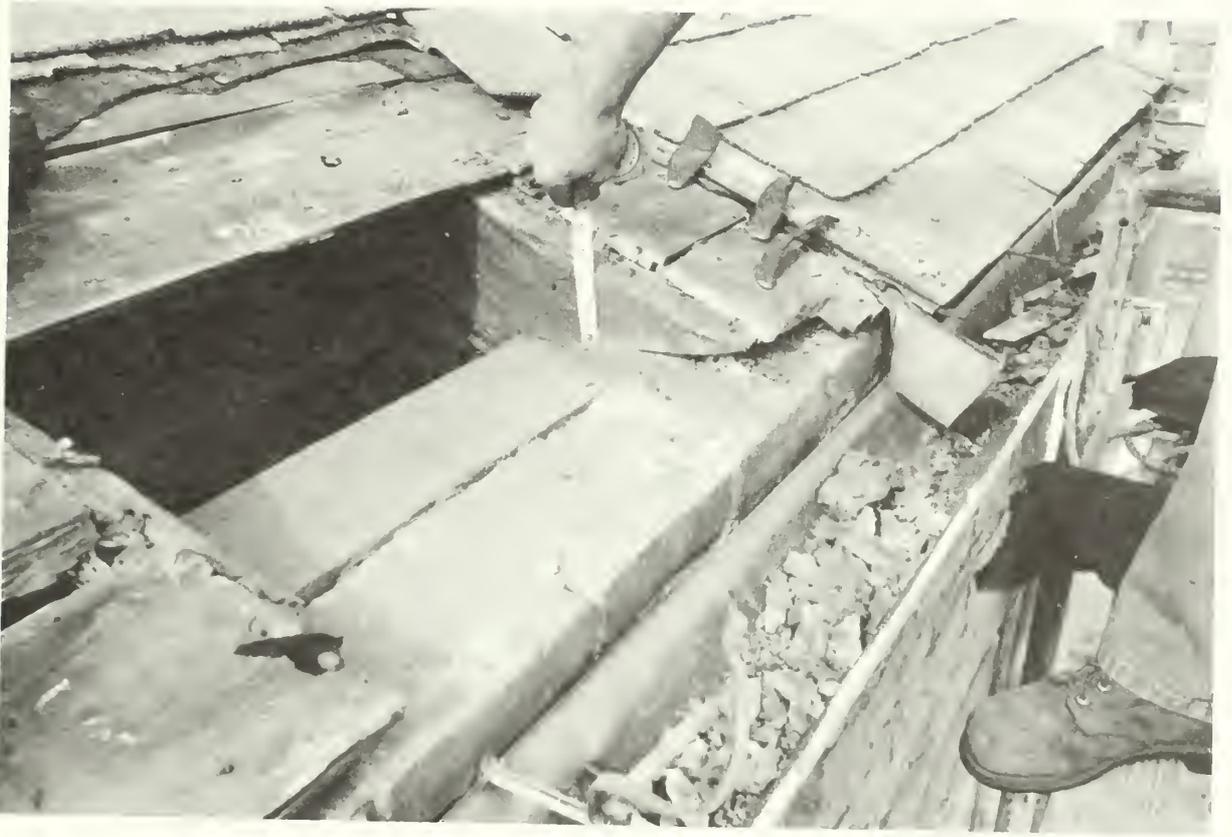
Figure 71. North Chimney (12/14/83): In this view the new slate shingle roof with copper flashing and counterflashing is in place, and the chimneys have been restored to their ca. 1897 appearance. Notice that the chimneys are fitted with slate caps and that bricks have been left out just below the cap corbel to facilitate ventilation of the entire building. By 1894 the north chimney had fallen down to the lower height shown here, compared to the south chimney which, although damaged, was fairly intact.

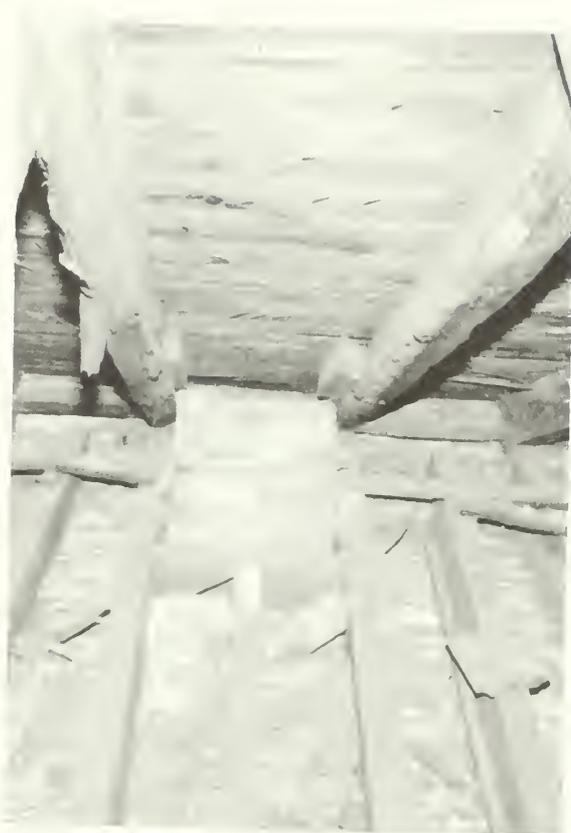
Figure 76. Attic (6/25/83): Four points are illustrated in these photographs. At the left, the large east wall shear crack is clearly visible, but more importantly, it is an old and dormant crack whitewashed historically. In the right view, the attic floor joists appear with a whitewash coating showing that the second floor had a semiopen ceiling between 1845-1866 and was whitewashed before being plastered in 1866. The variety of modern rafter bracing is shown and the need to replace it with a uniform and reliable system is apparent. The network of dead vines suggested that the growth of vines (see historical photos) was very extensive and probably caused damage to the roof system.

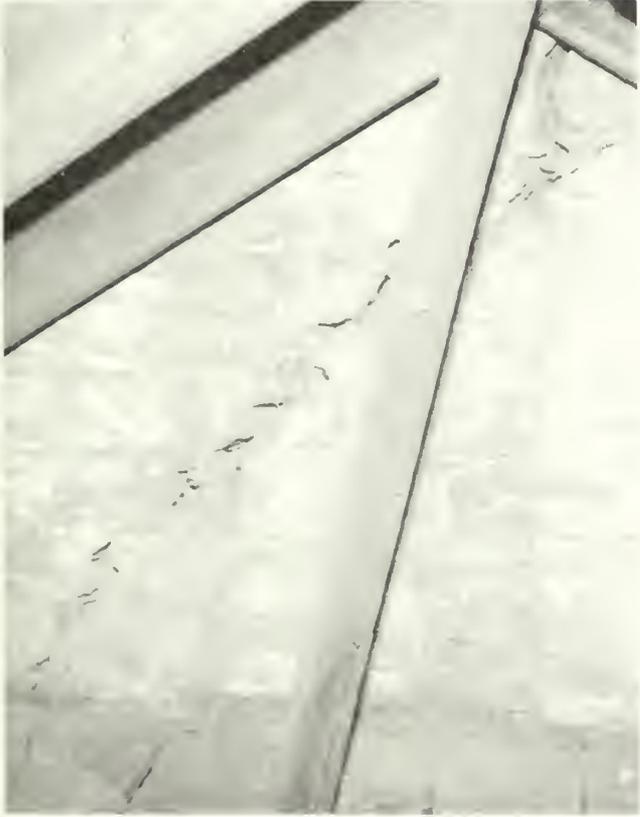
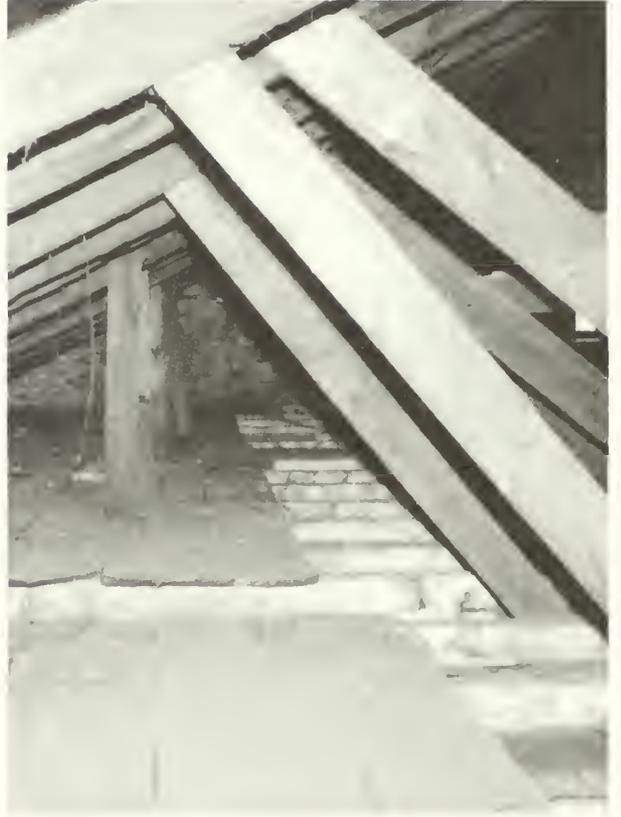
Figure 77. Attic (5/20/82): General view showing condition before phase I work. The planking was taken up, the entire attic floor insulated, and then the planking reinstalled.

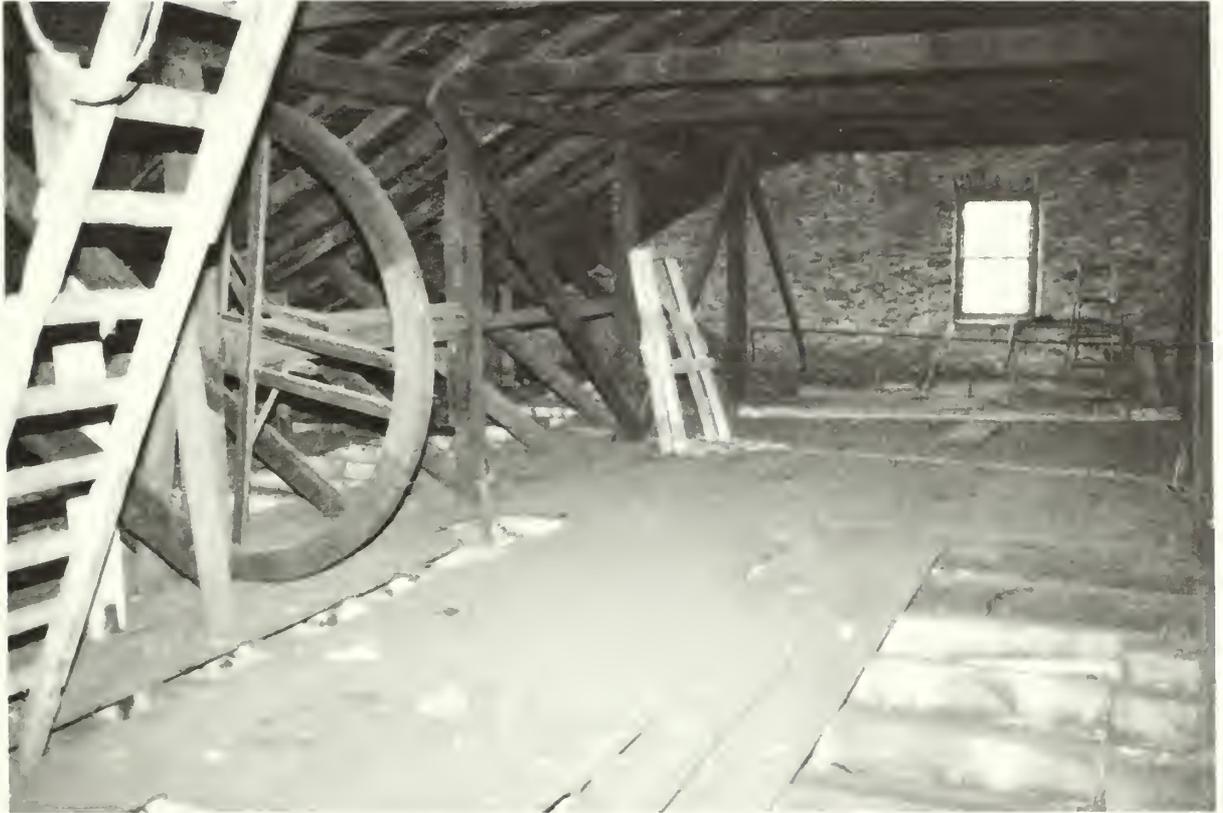
Figure 78. Attic (5/20/82): There were several features of the attic that required treating in the phase I work: the chimneys were stained and discolored because of roof leakage, and the brick mortar joints were eroded - daylight was visible through many joints; the hybrid system of rafter bracing was, by engineering standards, unreliable; and the hoist was dried out and needed wood preservation. Note, also, scatter of slate shingles on floor and missing floorboards.

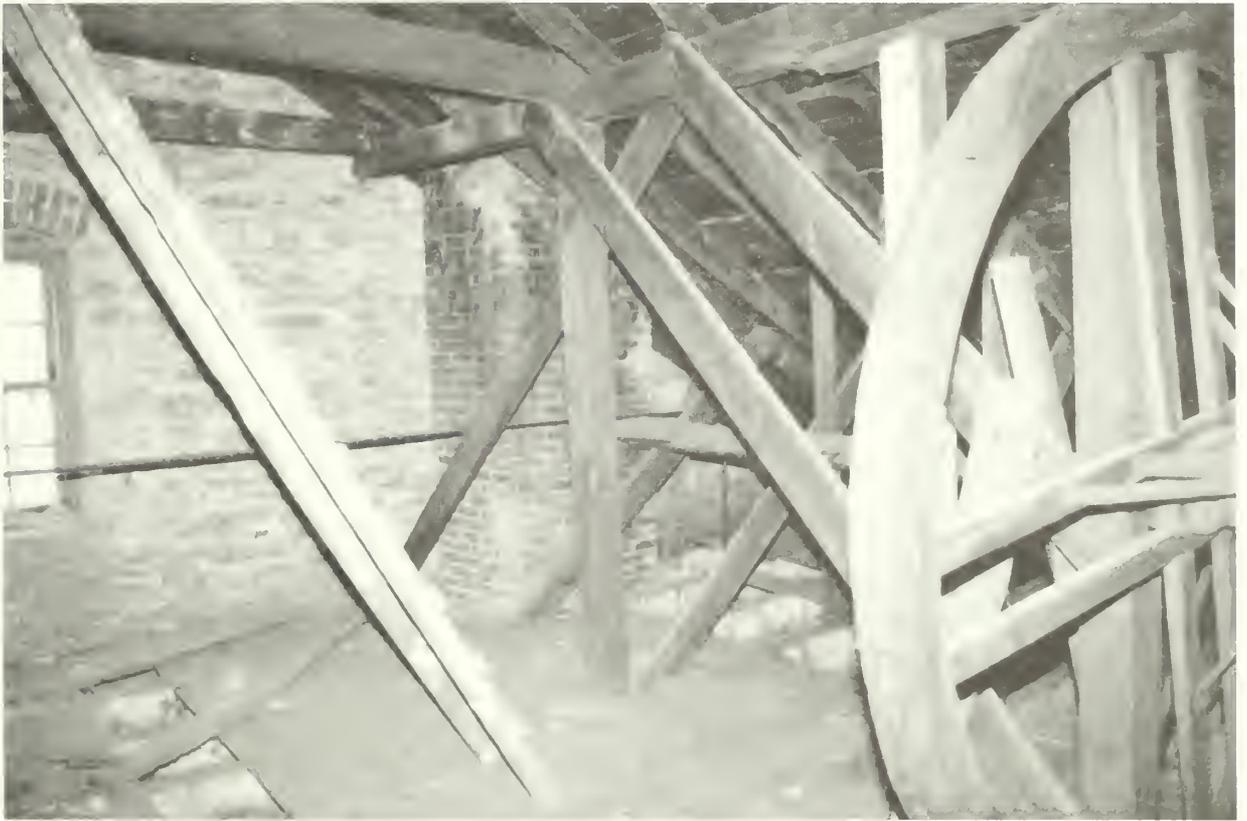
Figure 79. Attic at Southwest Chimney (6/25/83): The discoloration on the chimney brick, as well as the complexity of bracing and repairs, provided evidence of recurring problems in this area. Not only was rafter bracing replaced, but post-to-post cross-bracing and purlins also had to be replaced as part of the chimney stabilization. The chimney, itself, was dismantled down to floor level and rebuilt with the same and duplicate brick with lime-cement mortar in 1983.

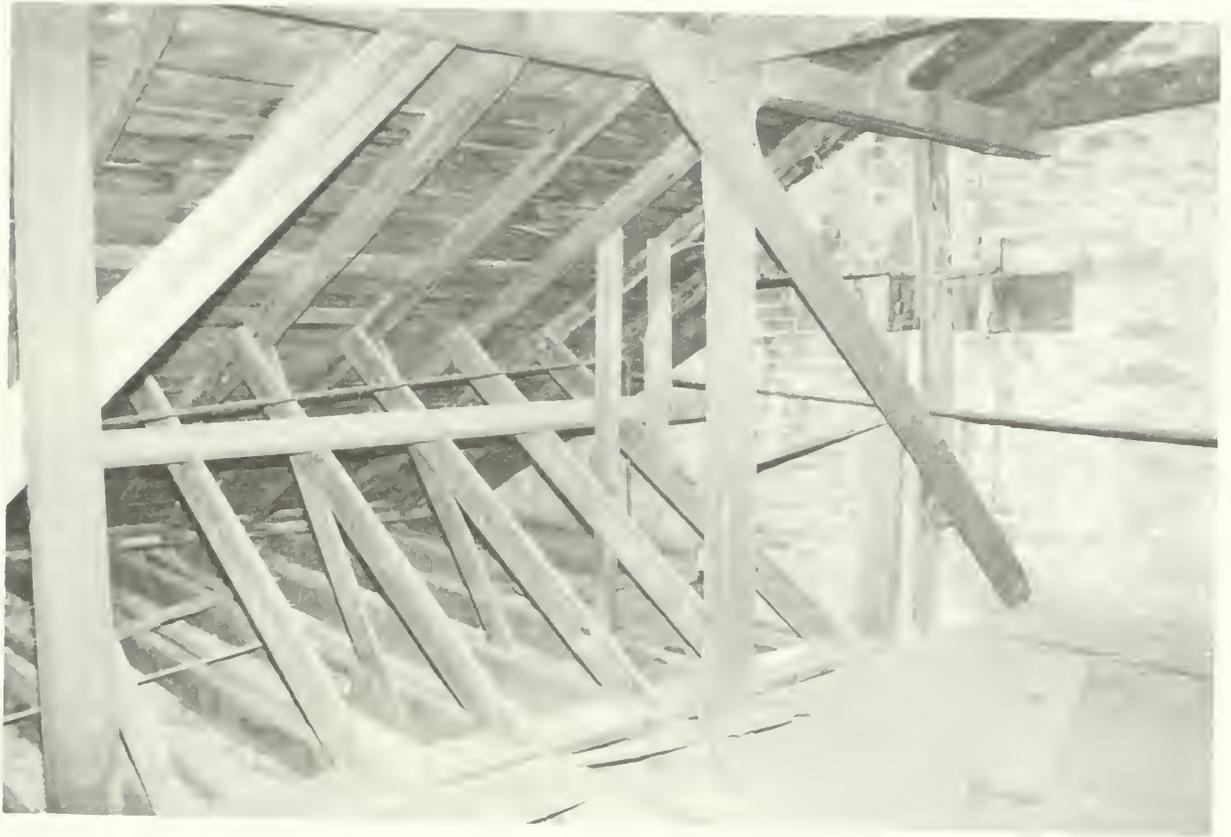
Figure 80. Attic (12/14/83): This photograph shows the completed attic treatments looking towards the north chimney and hoist wheel. The steel double-channel beams at floor level carry most of the roof load by way of the diagonal struts as well as the intermediate attic support posts. They are in a three-bay spanning pattern, transferring loads to the masonry bearing walls and to the major support posts below.

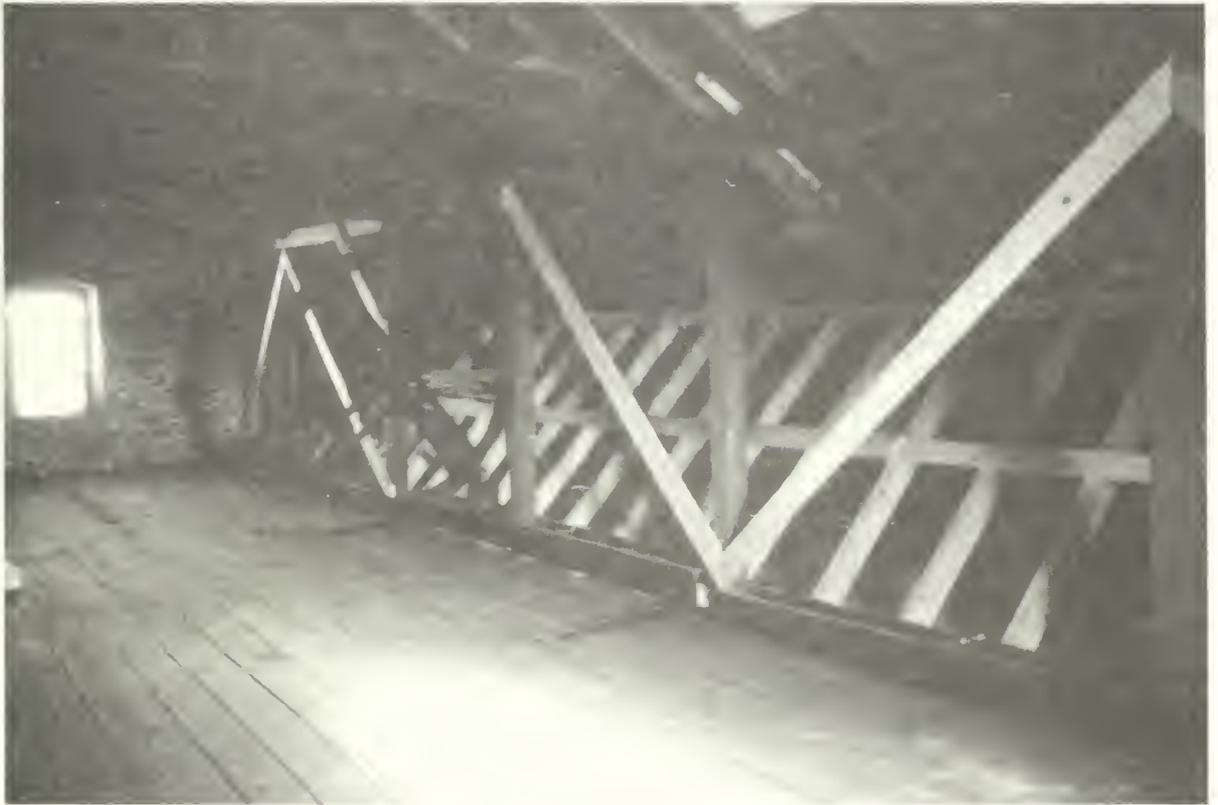
Figure 81. Attic (12/14/83): Looking towards the south corner, in this view, attic structural systems--steel beams at floor level and wooden diagonal struts and braces--have been installed. The historic flooring has been reinstalled. Note hoist cable chase (small square box) at left. Also, light-colored roof sheathing is 1983 replacement material.

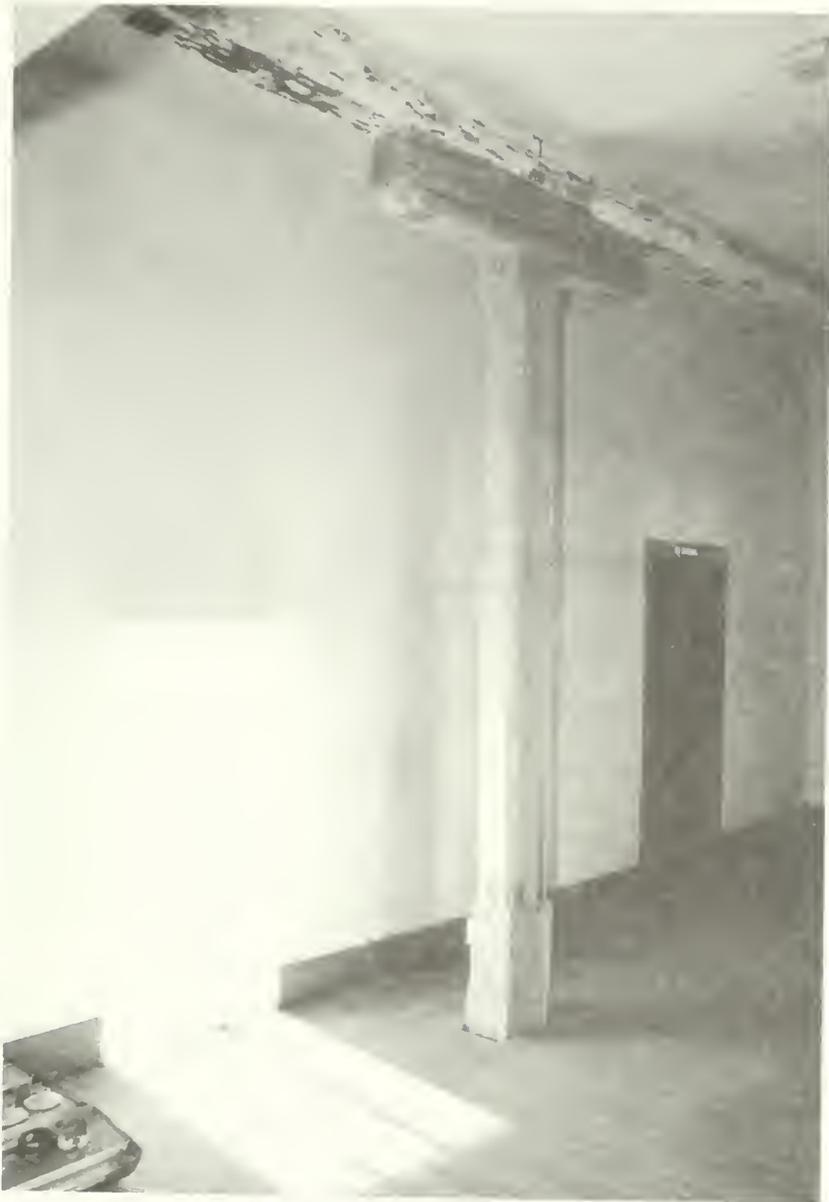
Figure 84. Reconstructed Support Post (12/14/83): The original support post at this location was removed, maybe as early as 1866; but, at least by the time the present partitions were installed. The 3" by 8" pilaster to the right was installed to replace the post function, an inadequate structural solution. The new post here duplicates size and design of posts in the north room and is hewn red oak.

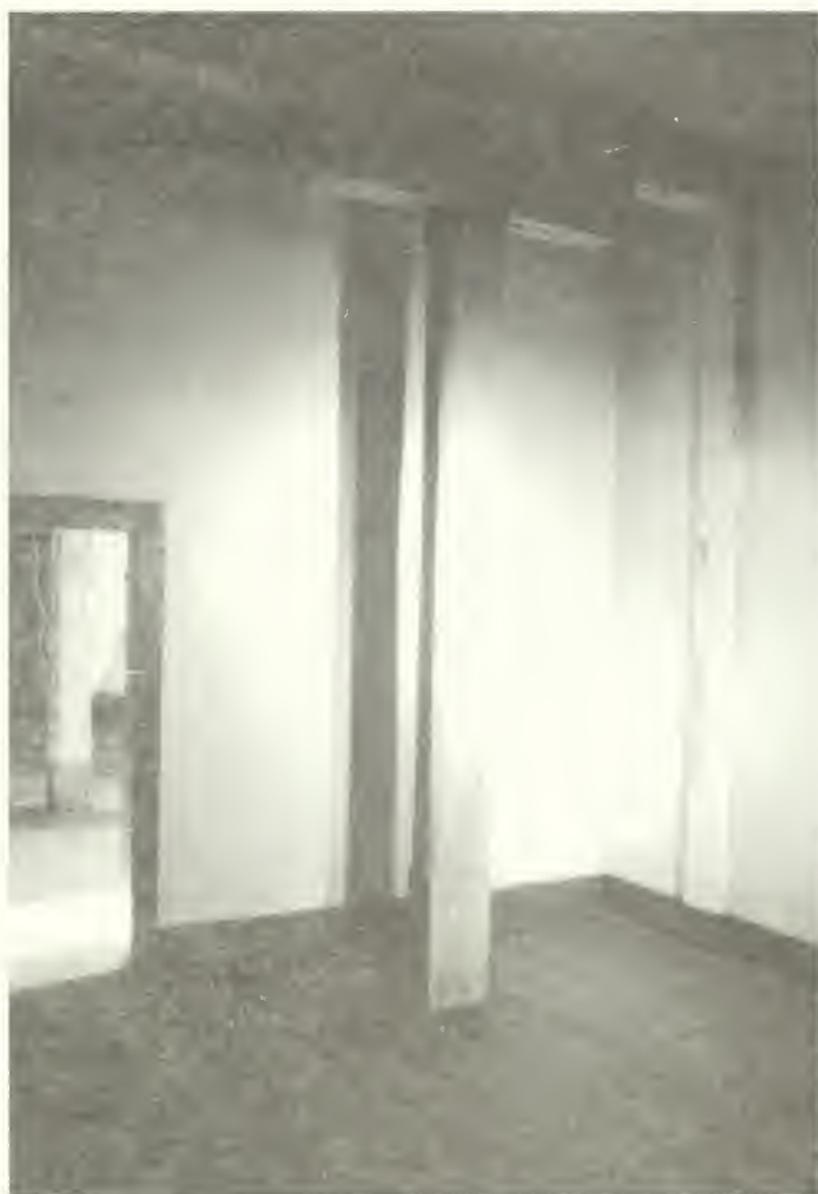
Figure 85. First Floor (1/31/84): Detail of east corner after most of the concrete slab had been removed. Notice shadowy pattern on walls, possibly locating historic furnishing elements. Because of these ghosts, the decision was made not to restore the whitewash on walls, but rather to preserve these shadowy patterns for visitors to observe.

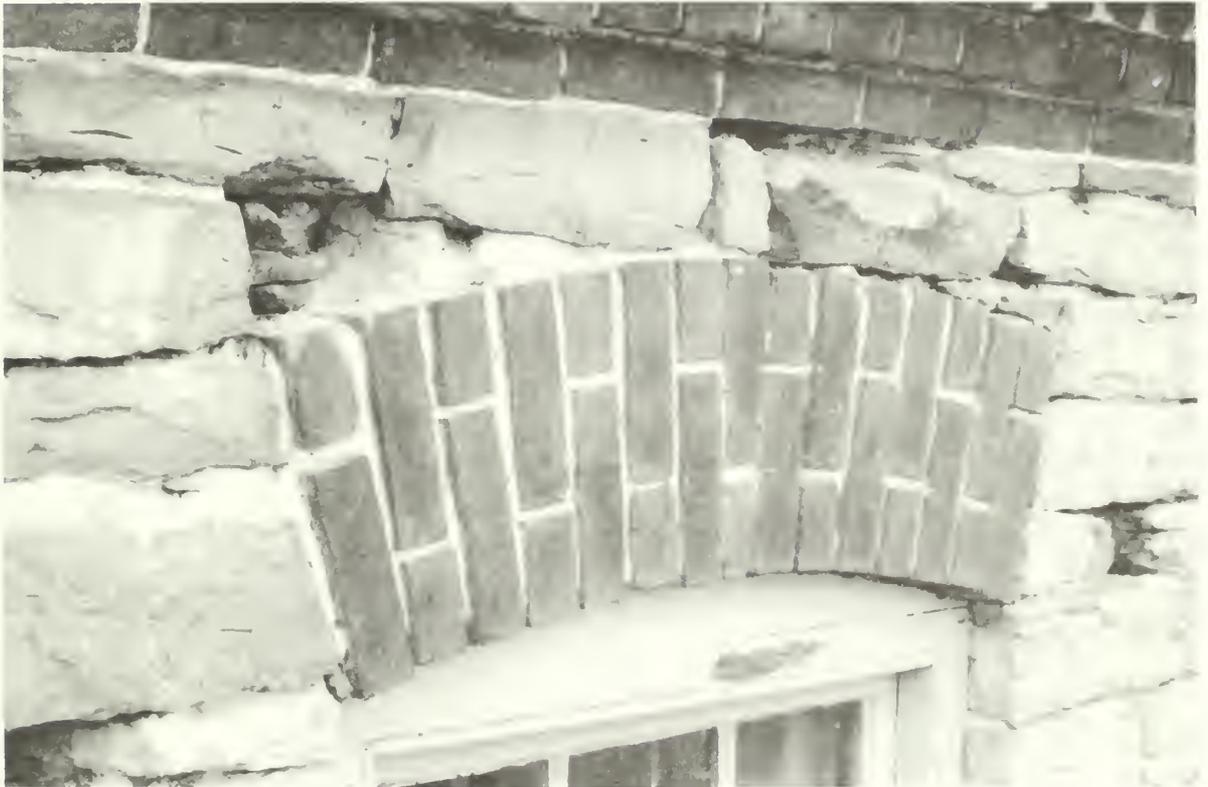
Figure 90. East Wall-Shear Crack (8/84): These photographs were taken after the removal of modern cement and loose mortar. Clearly exposed is the major shear crack that resulted from differential settlement of the south corner of the commissary.

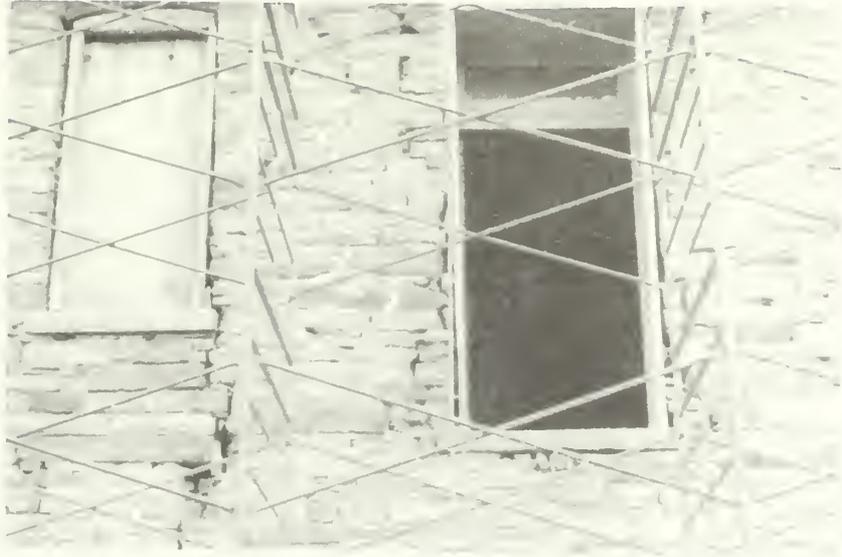
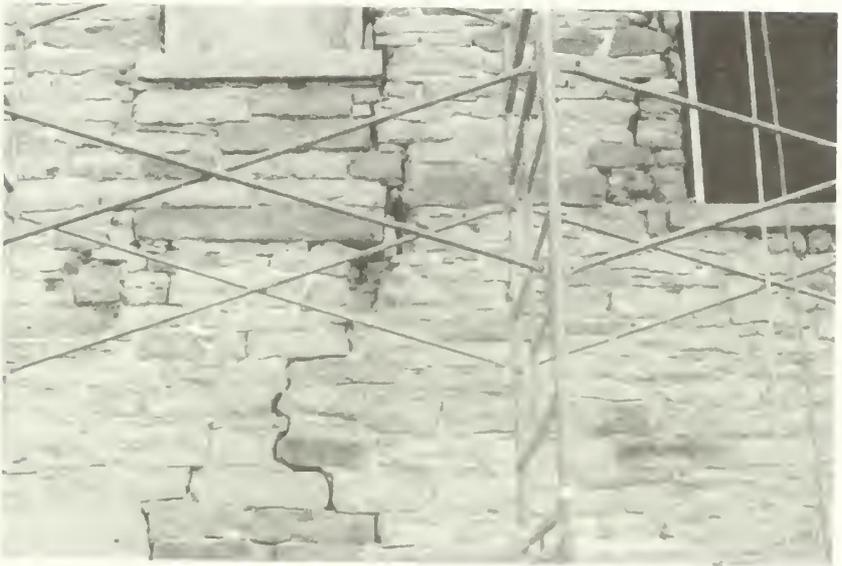
Figure 91. Wall Treatment Detail (1/3/85): In the center of the photo is a typical beam pocket after rehabilitation. Also shown are historic mortar joints and 1984 repointing that blend indistinguishably and the feather and wedge tool marks on some of the stones showing the historic stone quarrying technique employed.

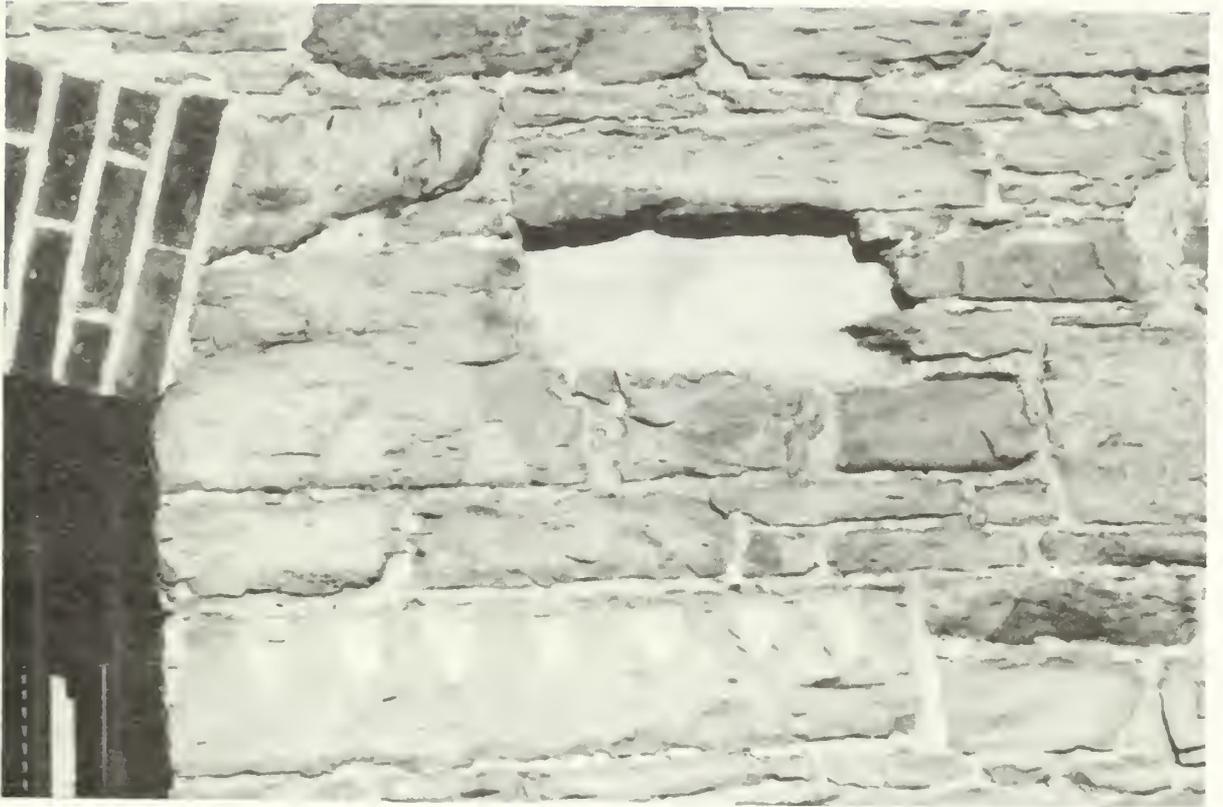
Figure 92. Fort Curtain Wall (ca. 9/8/84): Two views of extant segments of the second fort curtain wall foundation east of the commissary. The segments of wall were reconstructed on top of these footings. Where footings were absent, concrete footings were installed (see "Archeological Data" section).
