THE STANTON HOUSE

Women's Rights National Historical Park

Historic Structure Report

THE STANTON HOUSE
HISTORIC STRUCTURE REPORT

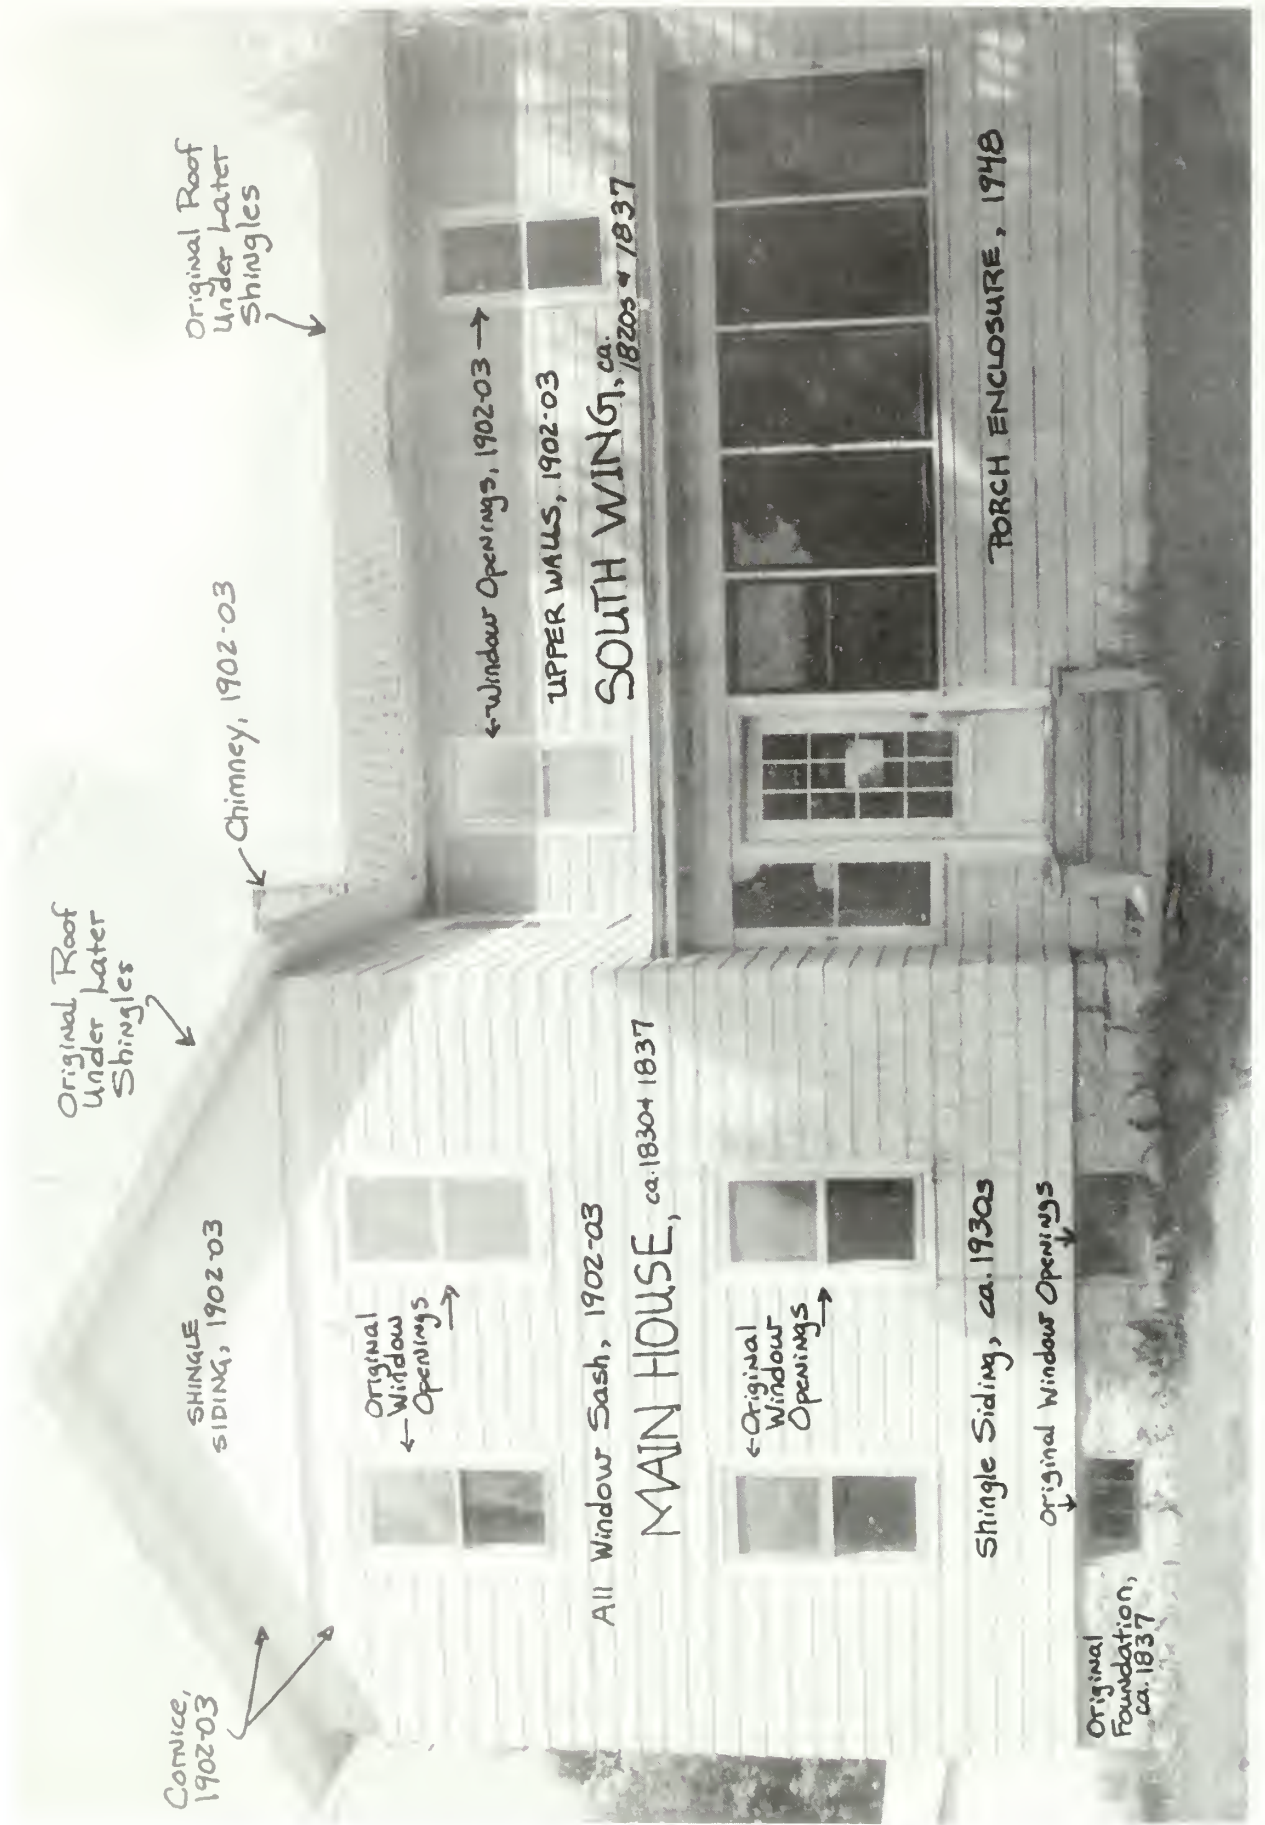
Figure 26. Stanton House: west elevation, June 1982.

Comice,
1902-03

SHINGLE
SIDING, 1902-03

PORCH ENCLOSURE, 1948

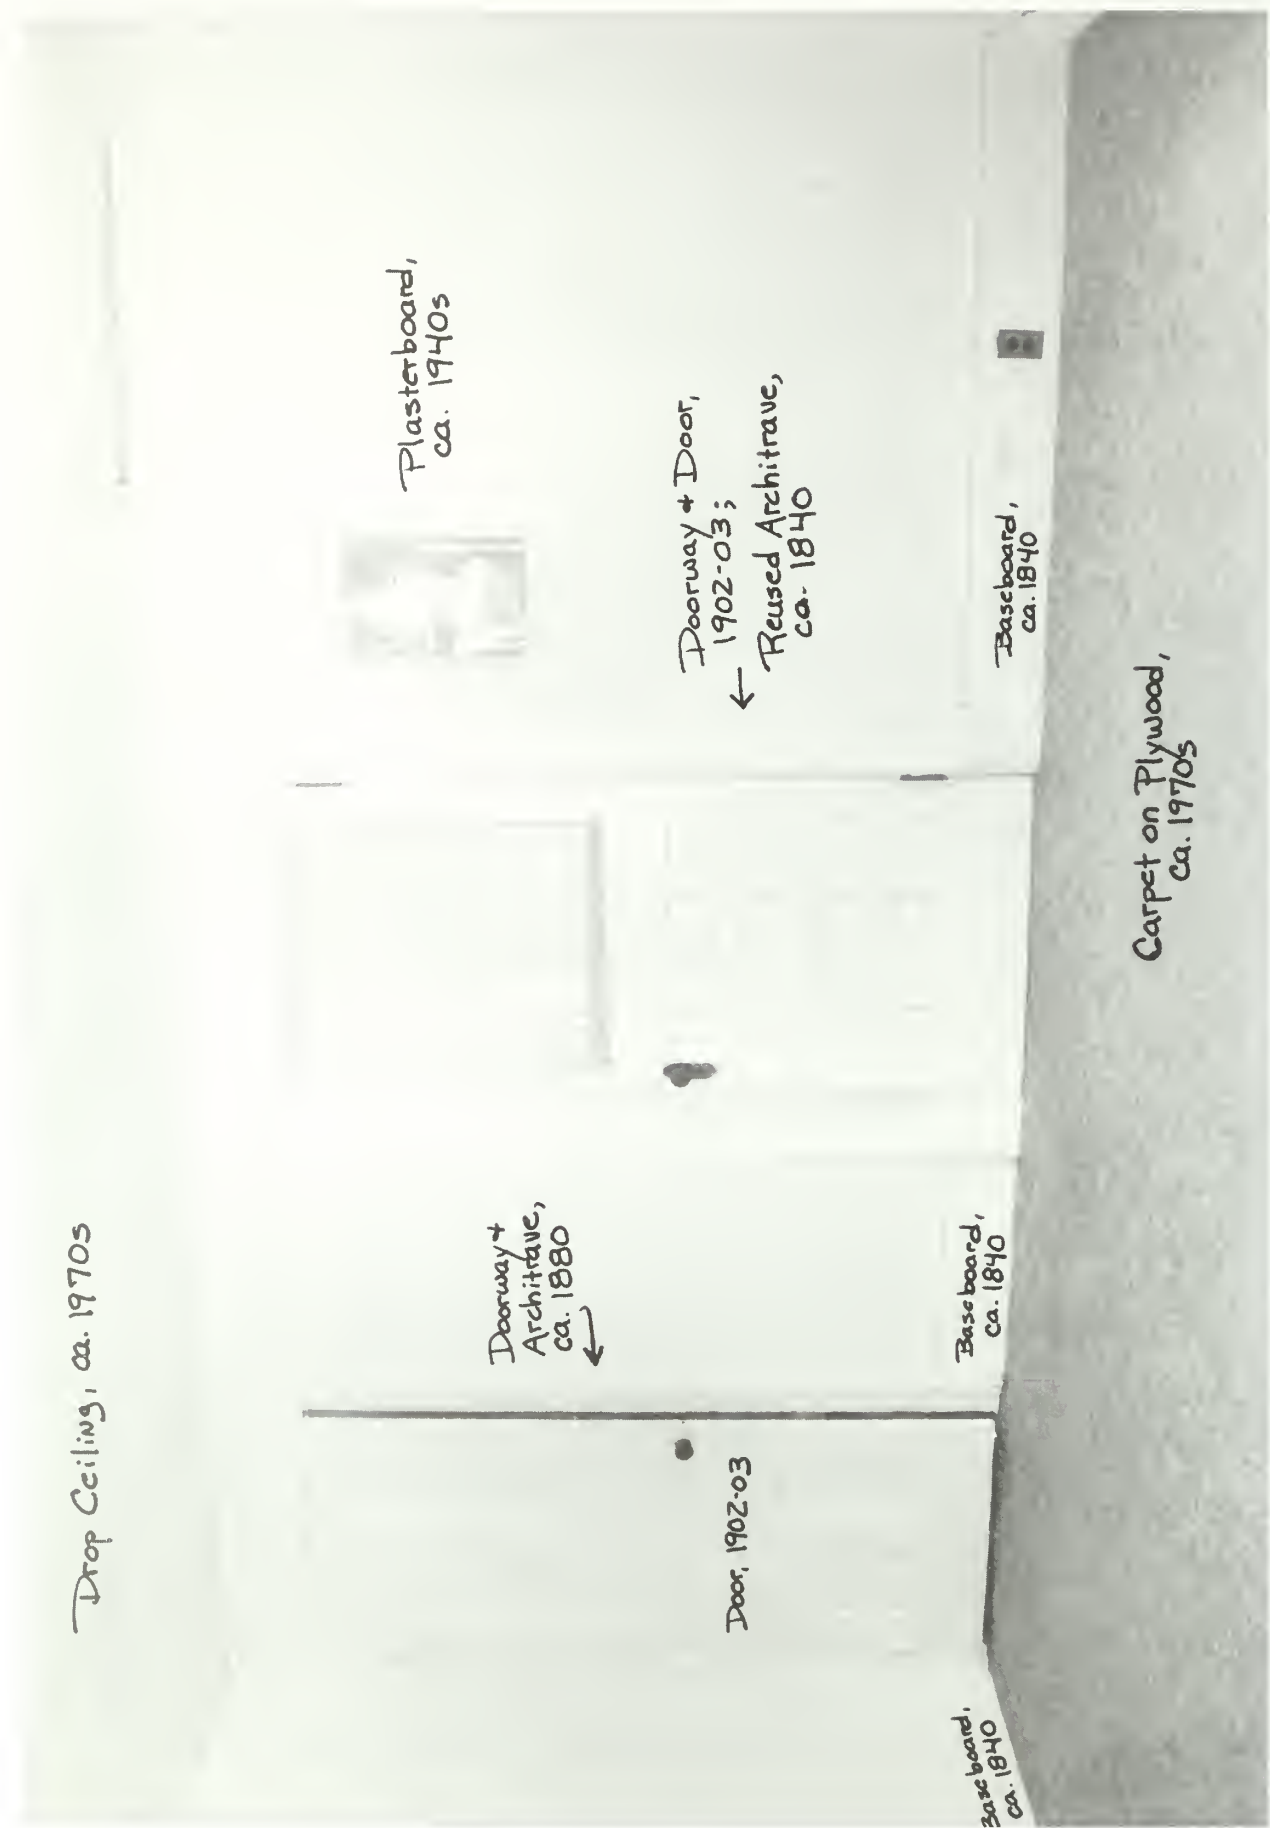
Figure 39. Stanton House: Room 101, looking east, June 1982.

Drop Ceiling, ca. 1970s

Doorway +
Architrave,
ca. 1880
↘

Baseboard, ca. 1840

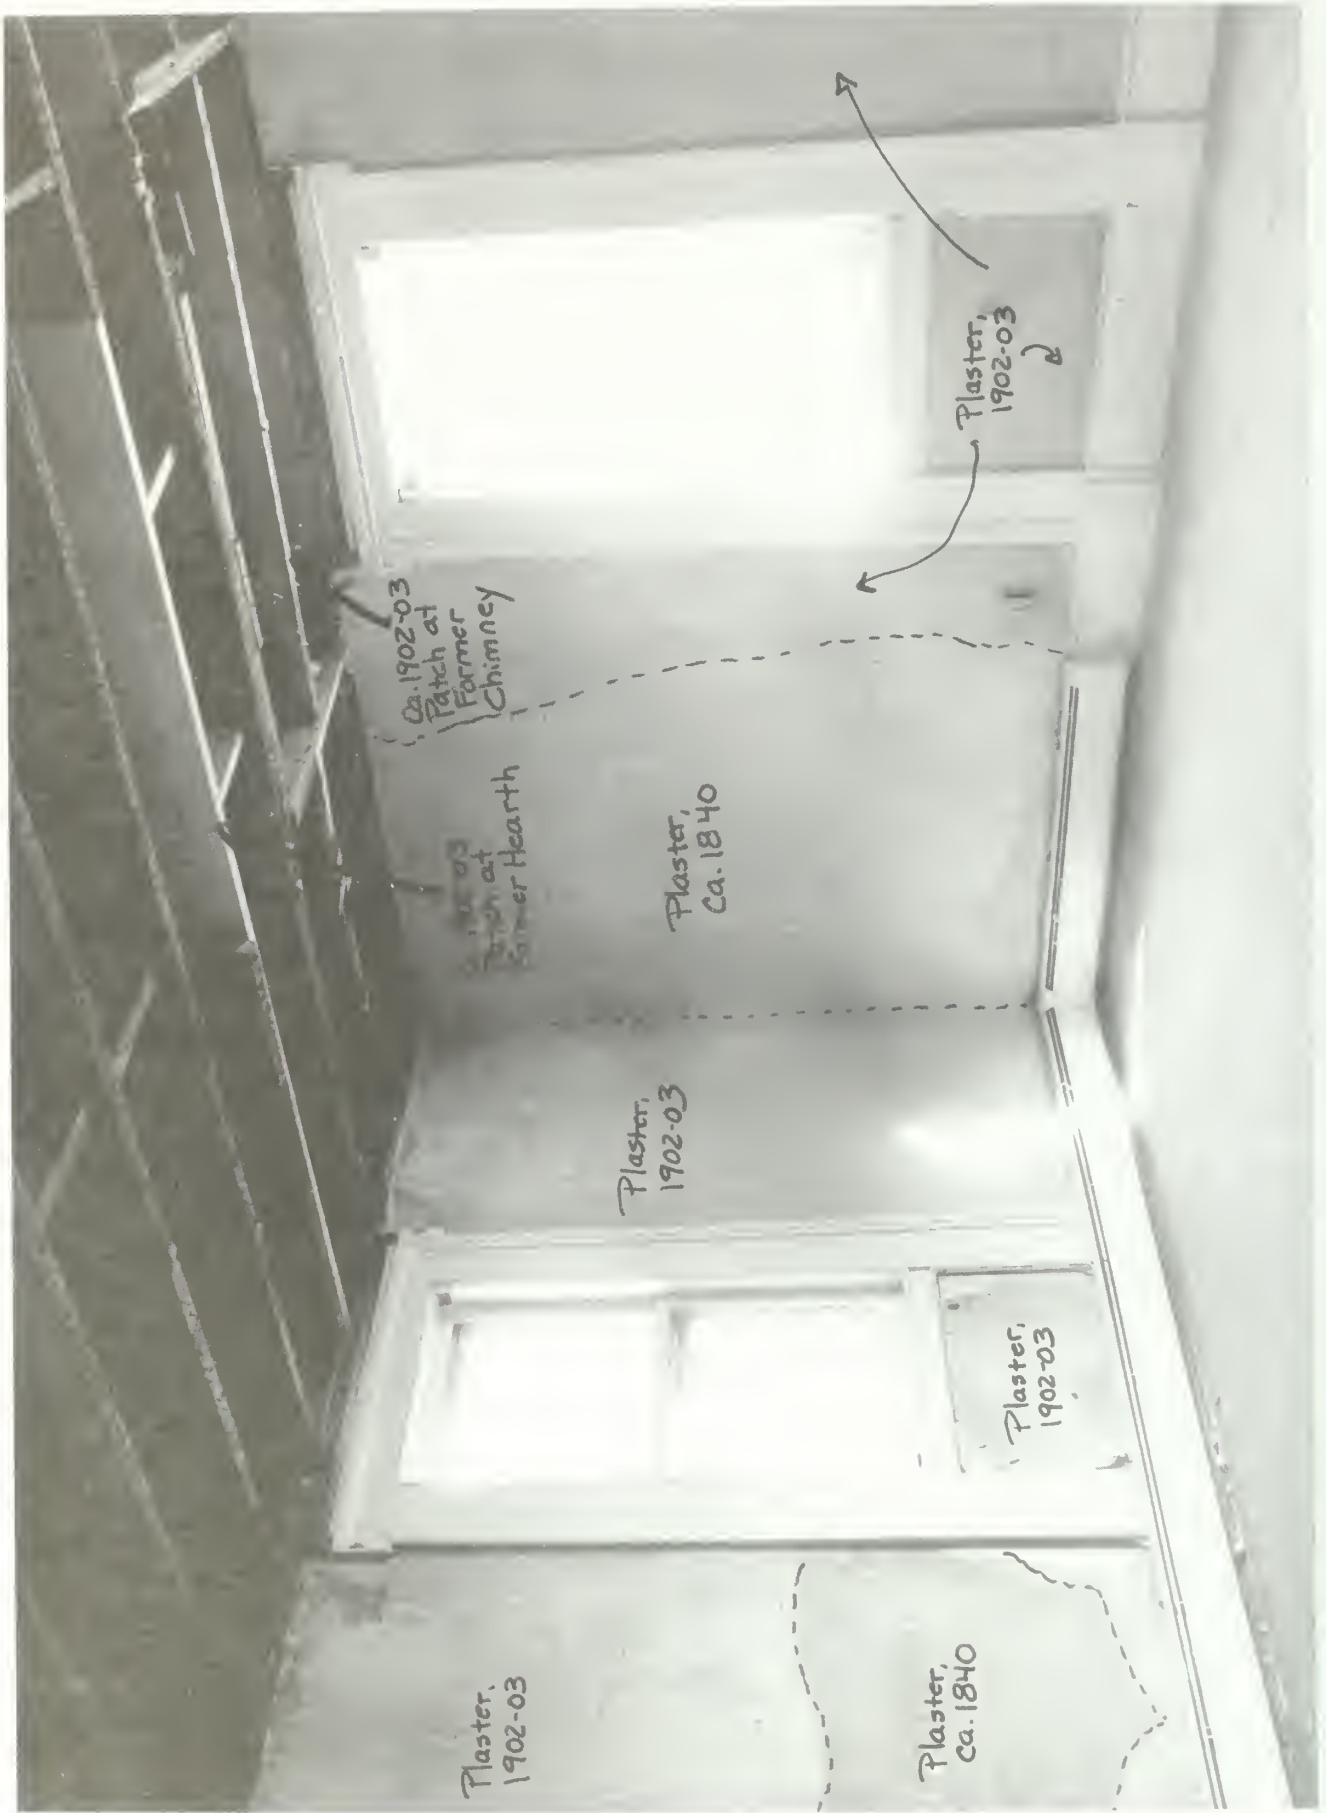
Figure 42. Stanton House: Room 101, looking northwest, July 1982.

Paneling, ca. 1970s

Baseboard
Heating Unit, ca. 1960s

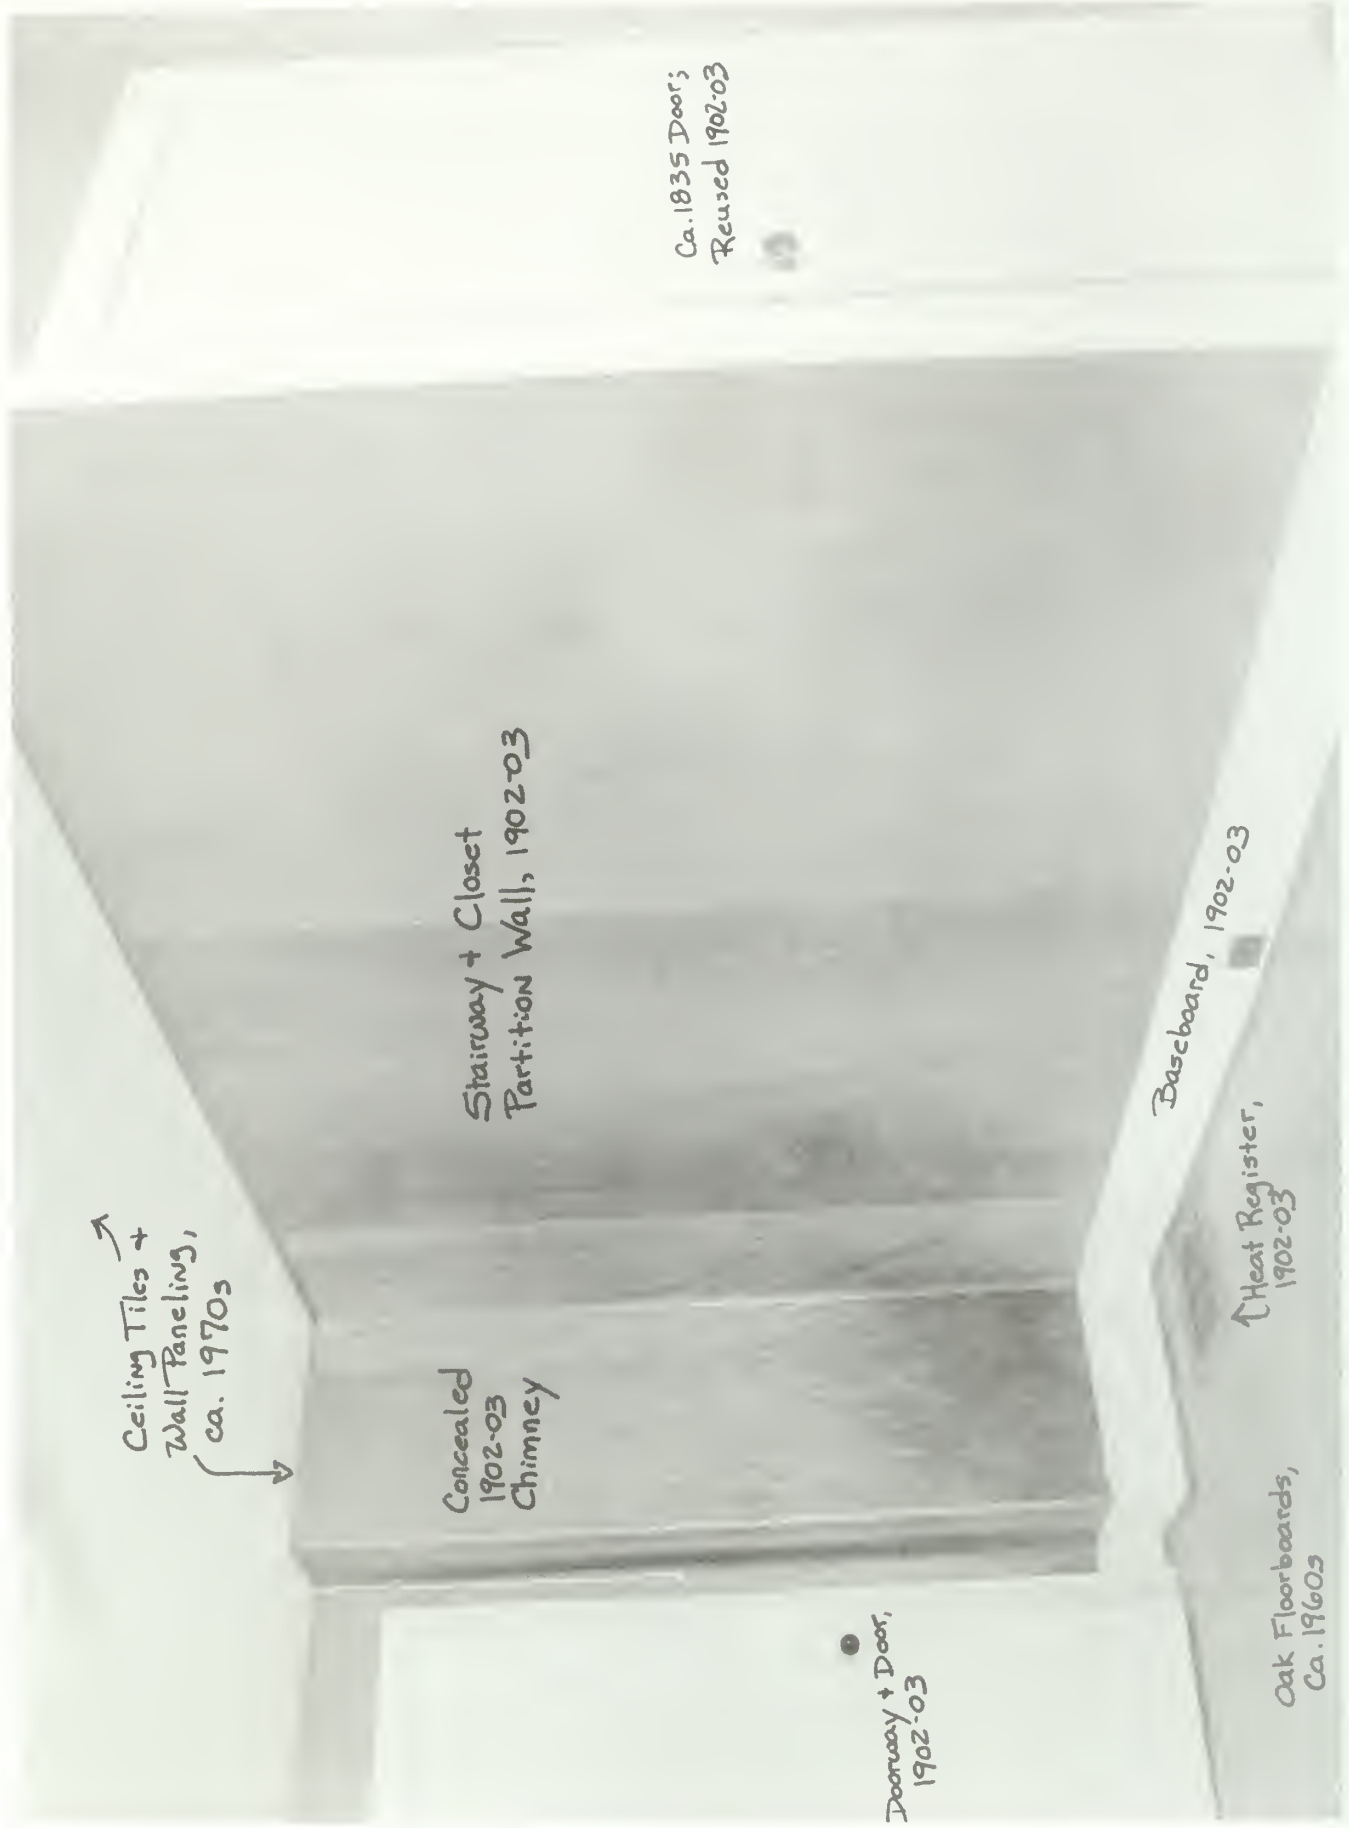
Figure 43. Stanton House: Room 102, looking east, June 1982.

Ceiling Tiles +
Wall Paneling,
ca. 1970s

Concealed
1902-03
Chimney

Later Partition Wall, 1902-03

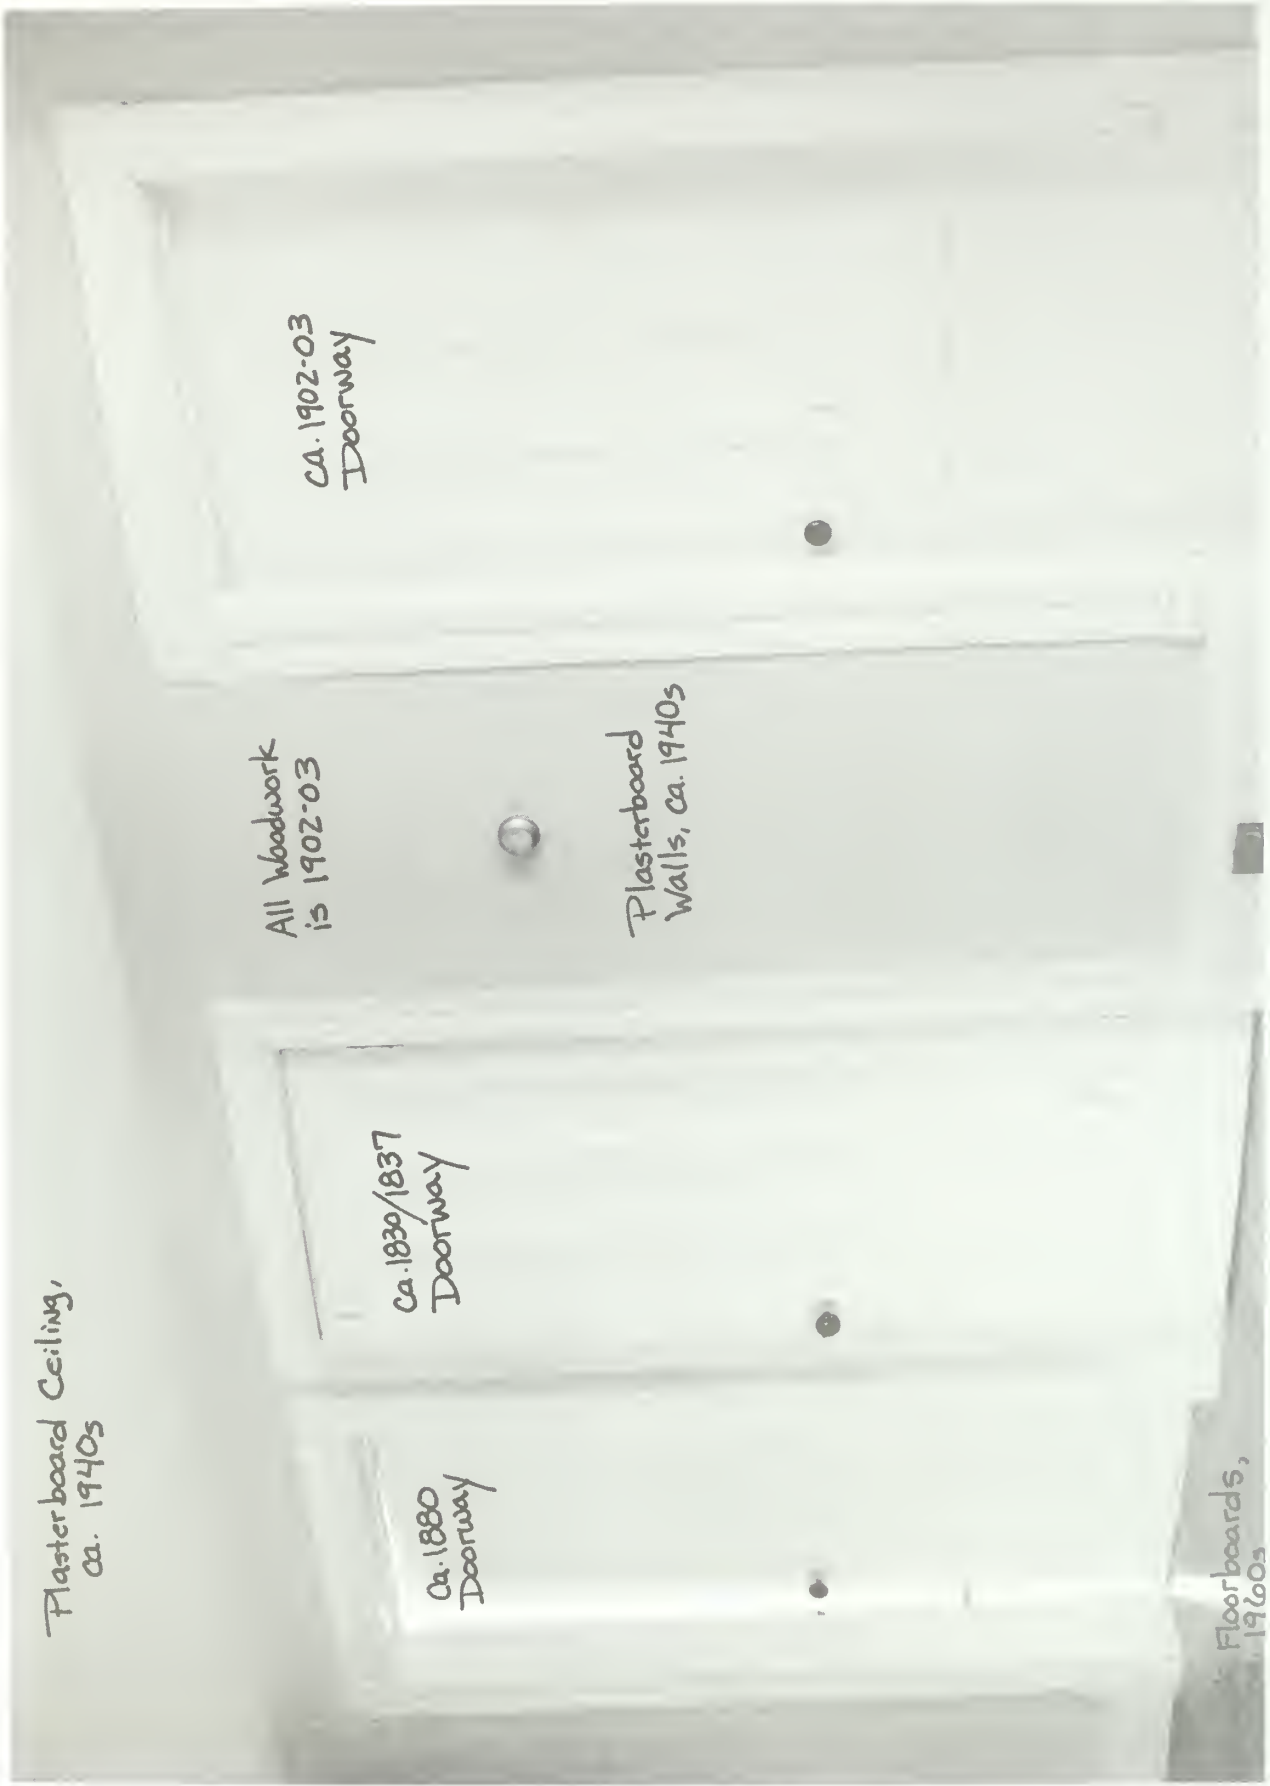
Figure 45. Stanton House: Room 103, looking west, June 1982.

Plaster board Ceiling,
ca. 1940s

All Woodwork
is 1902-03

Oak Floorboards,
ca. 1960s

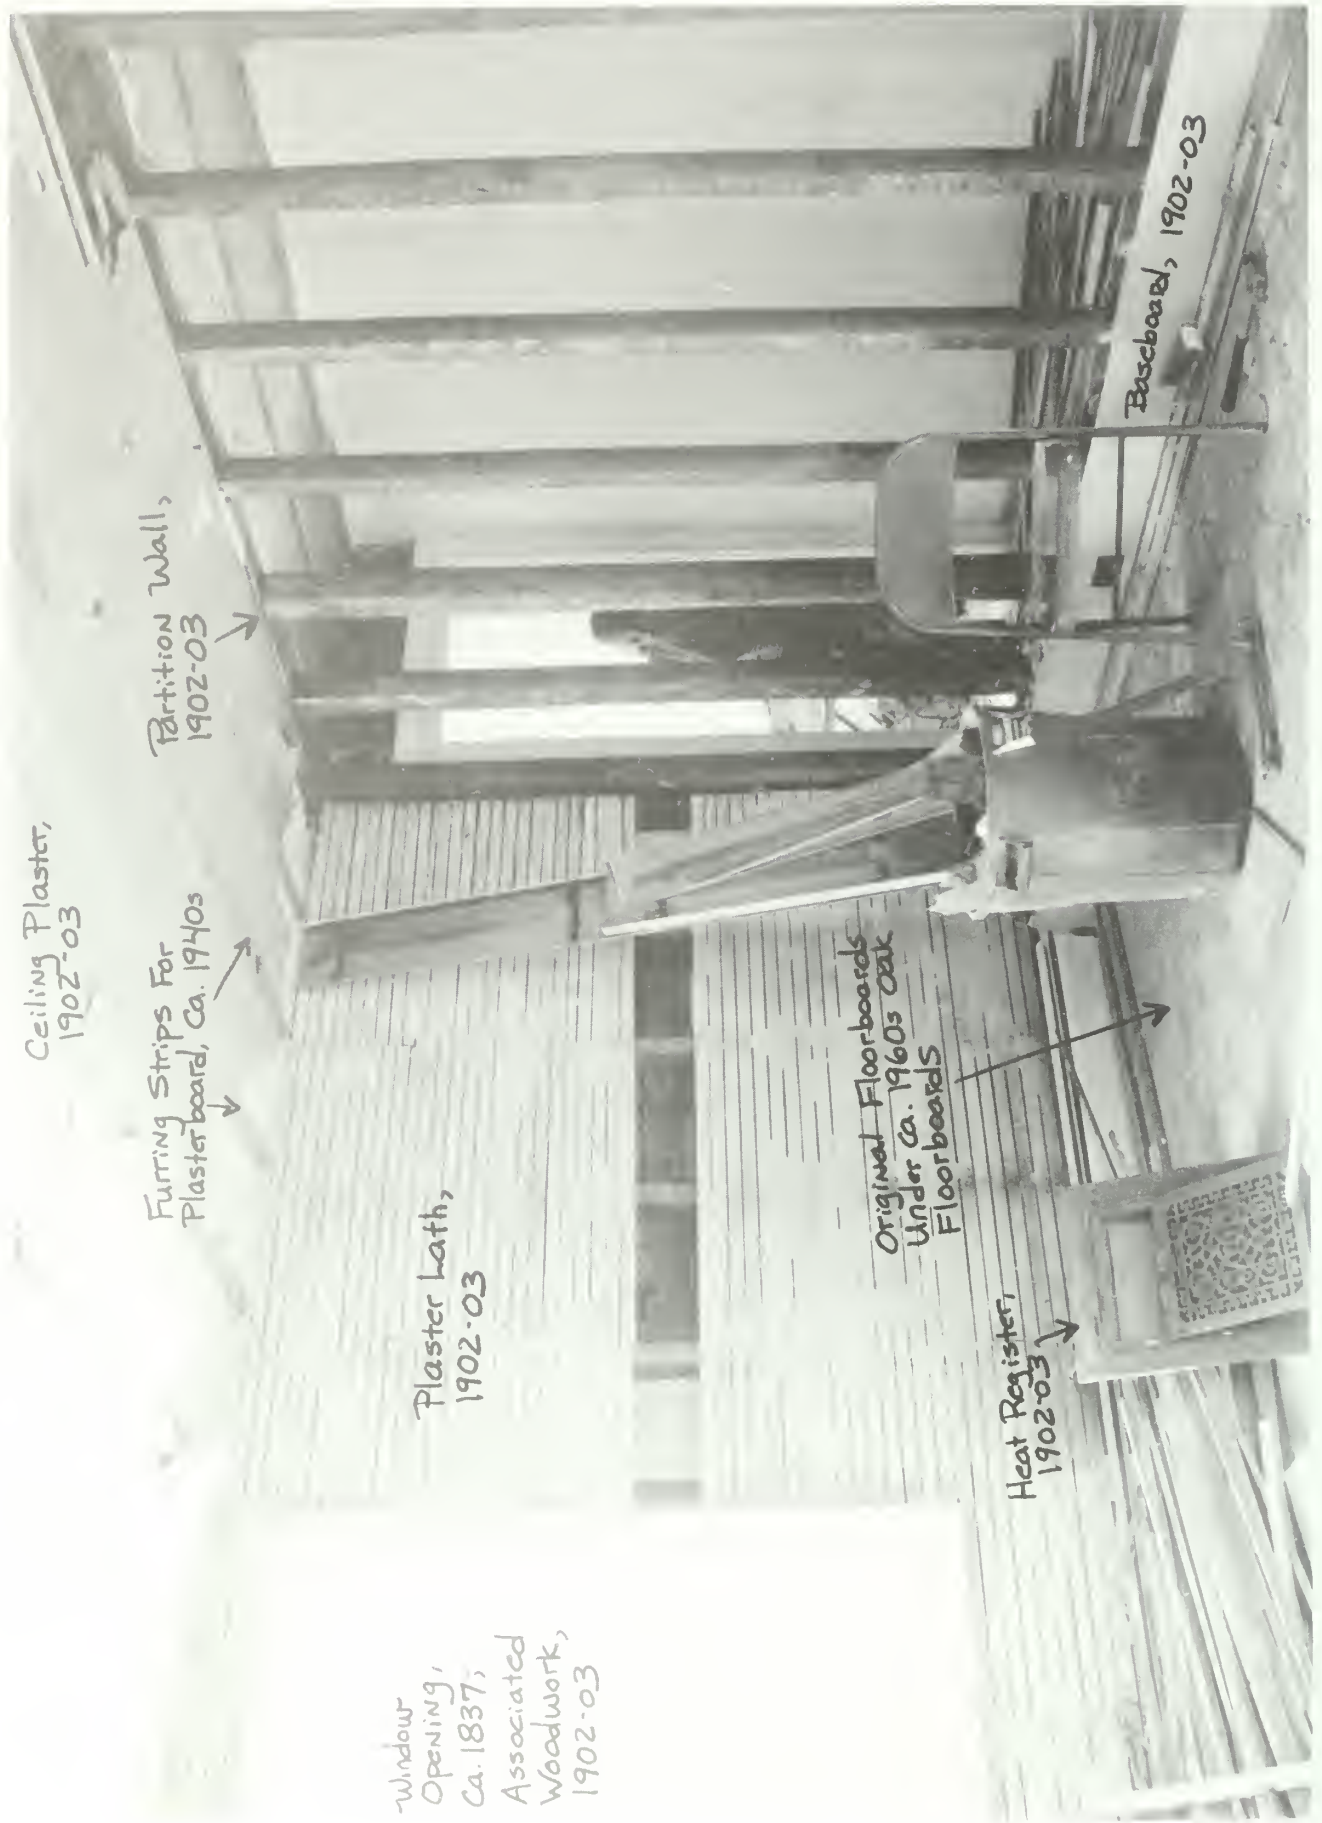
Figure 47. Stanton House: Room 103, looking southwest, June 1982.

Window
Opening,
Ca. 1837,
Associated
Woodwork,
1902-03

Plaster Lath,
1902-03

Reused Historic
← Woodwork

Baseboard, 1902-03

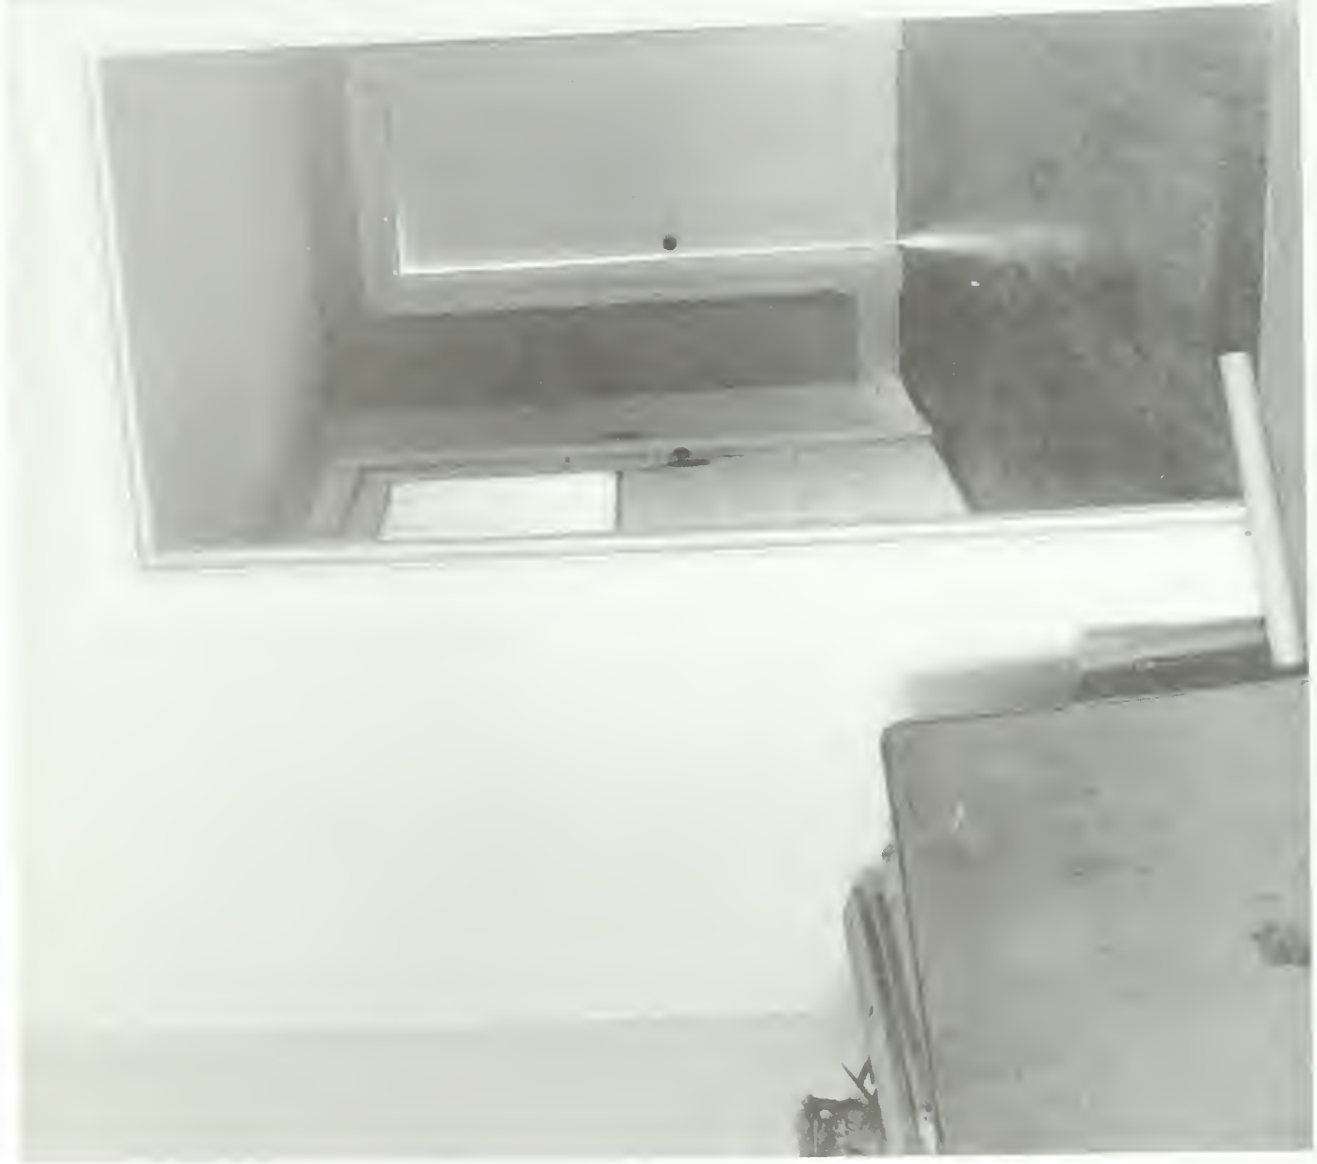
Figure 50. Stanton House: Room 104, looking north, June 1982.

Plasterboard
ca. 1910s

Linoleum Tile

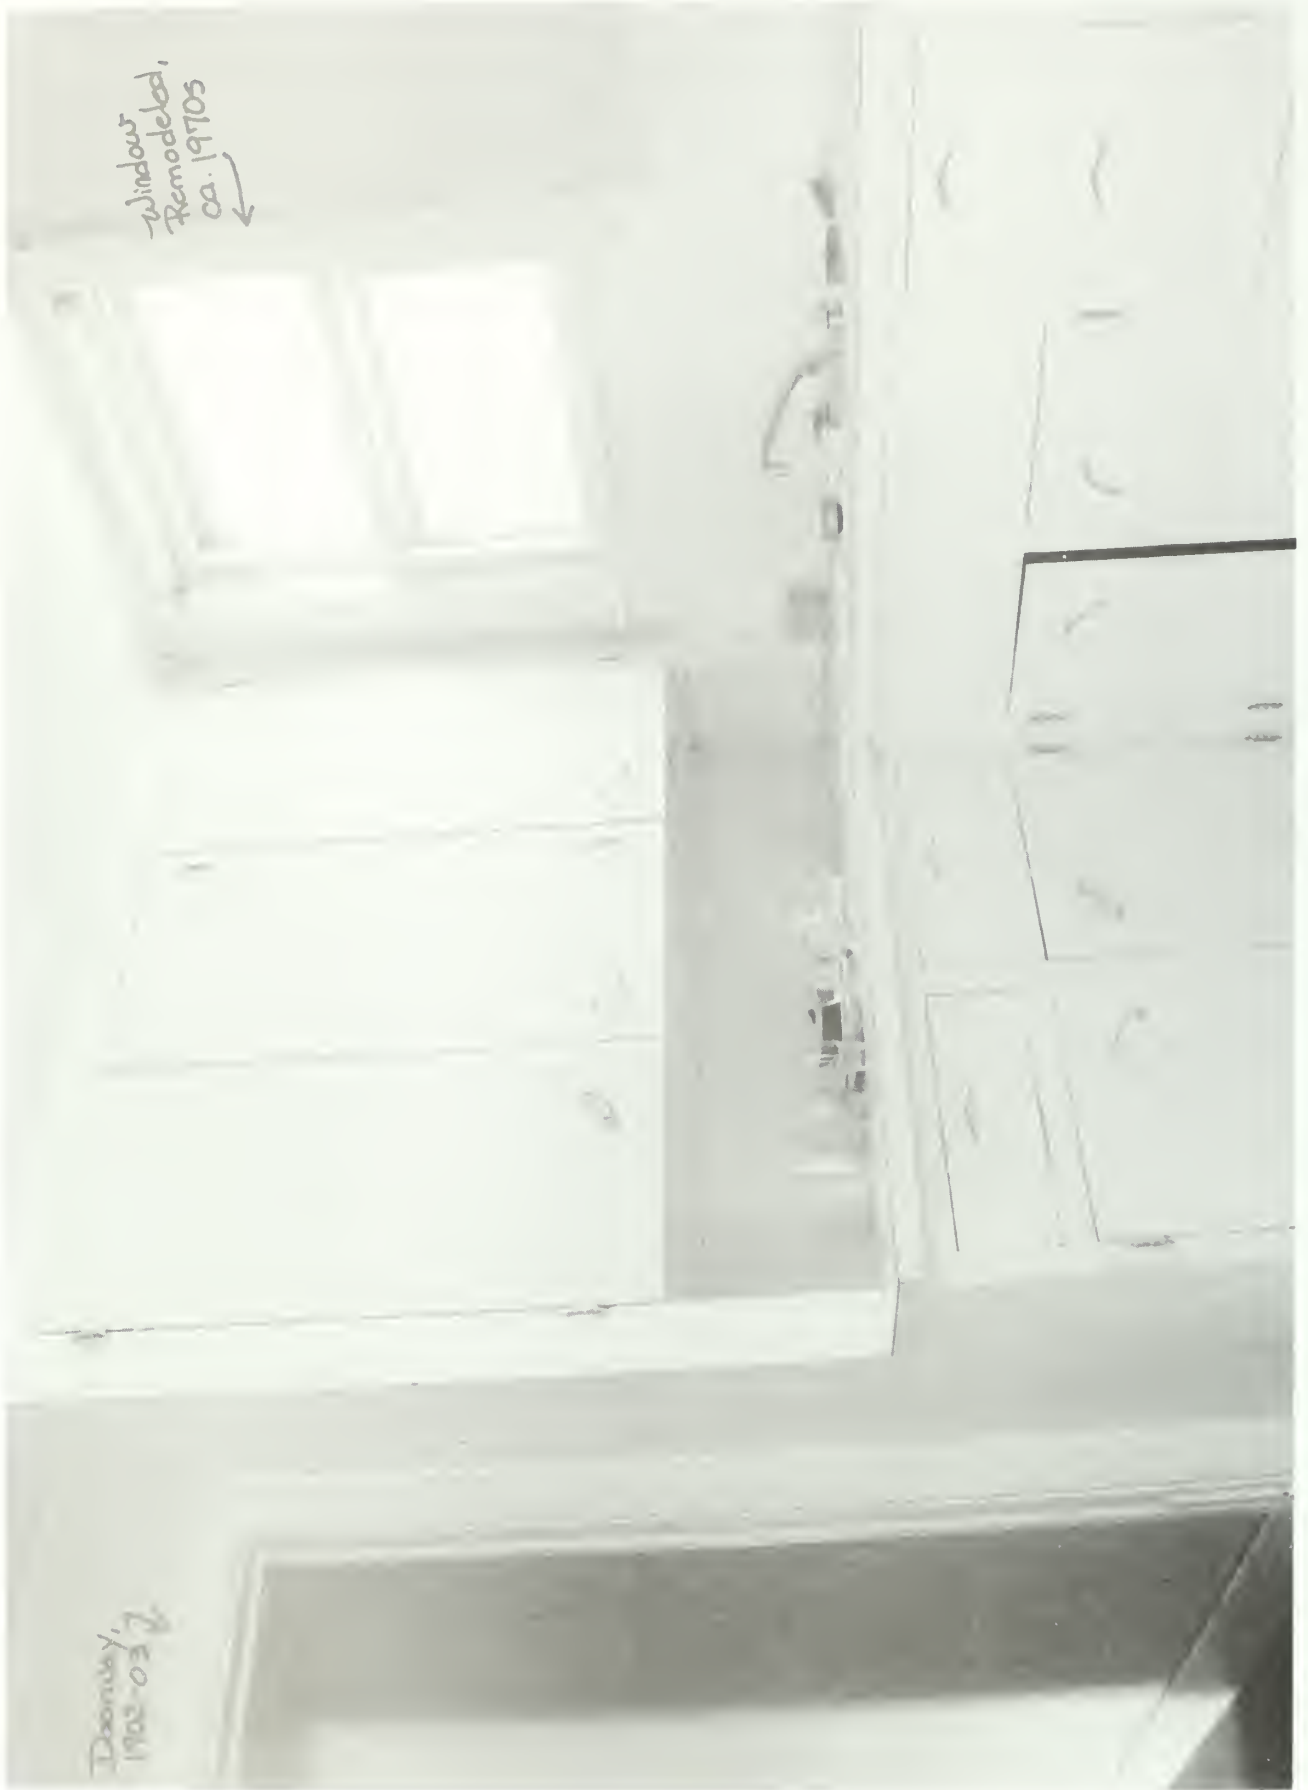
Figure 52. Stanton House: Room 105, looking northwest, June 1982.

Plasterboard Walls,
ca. 1940s

Baseboard Heating Unit, ca. 1960s

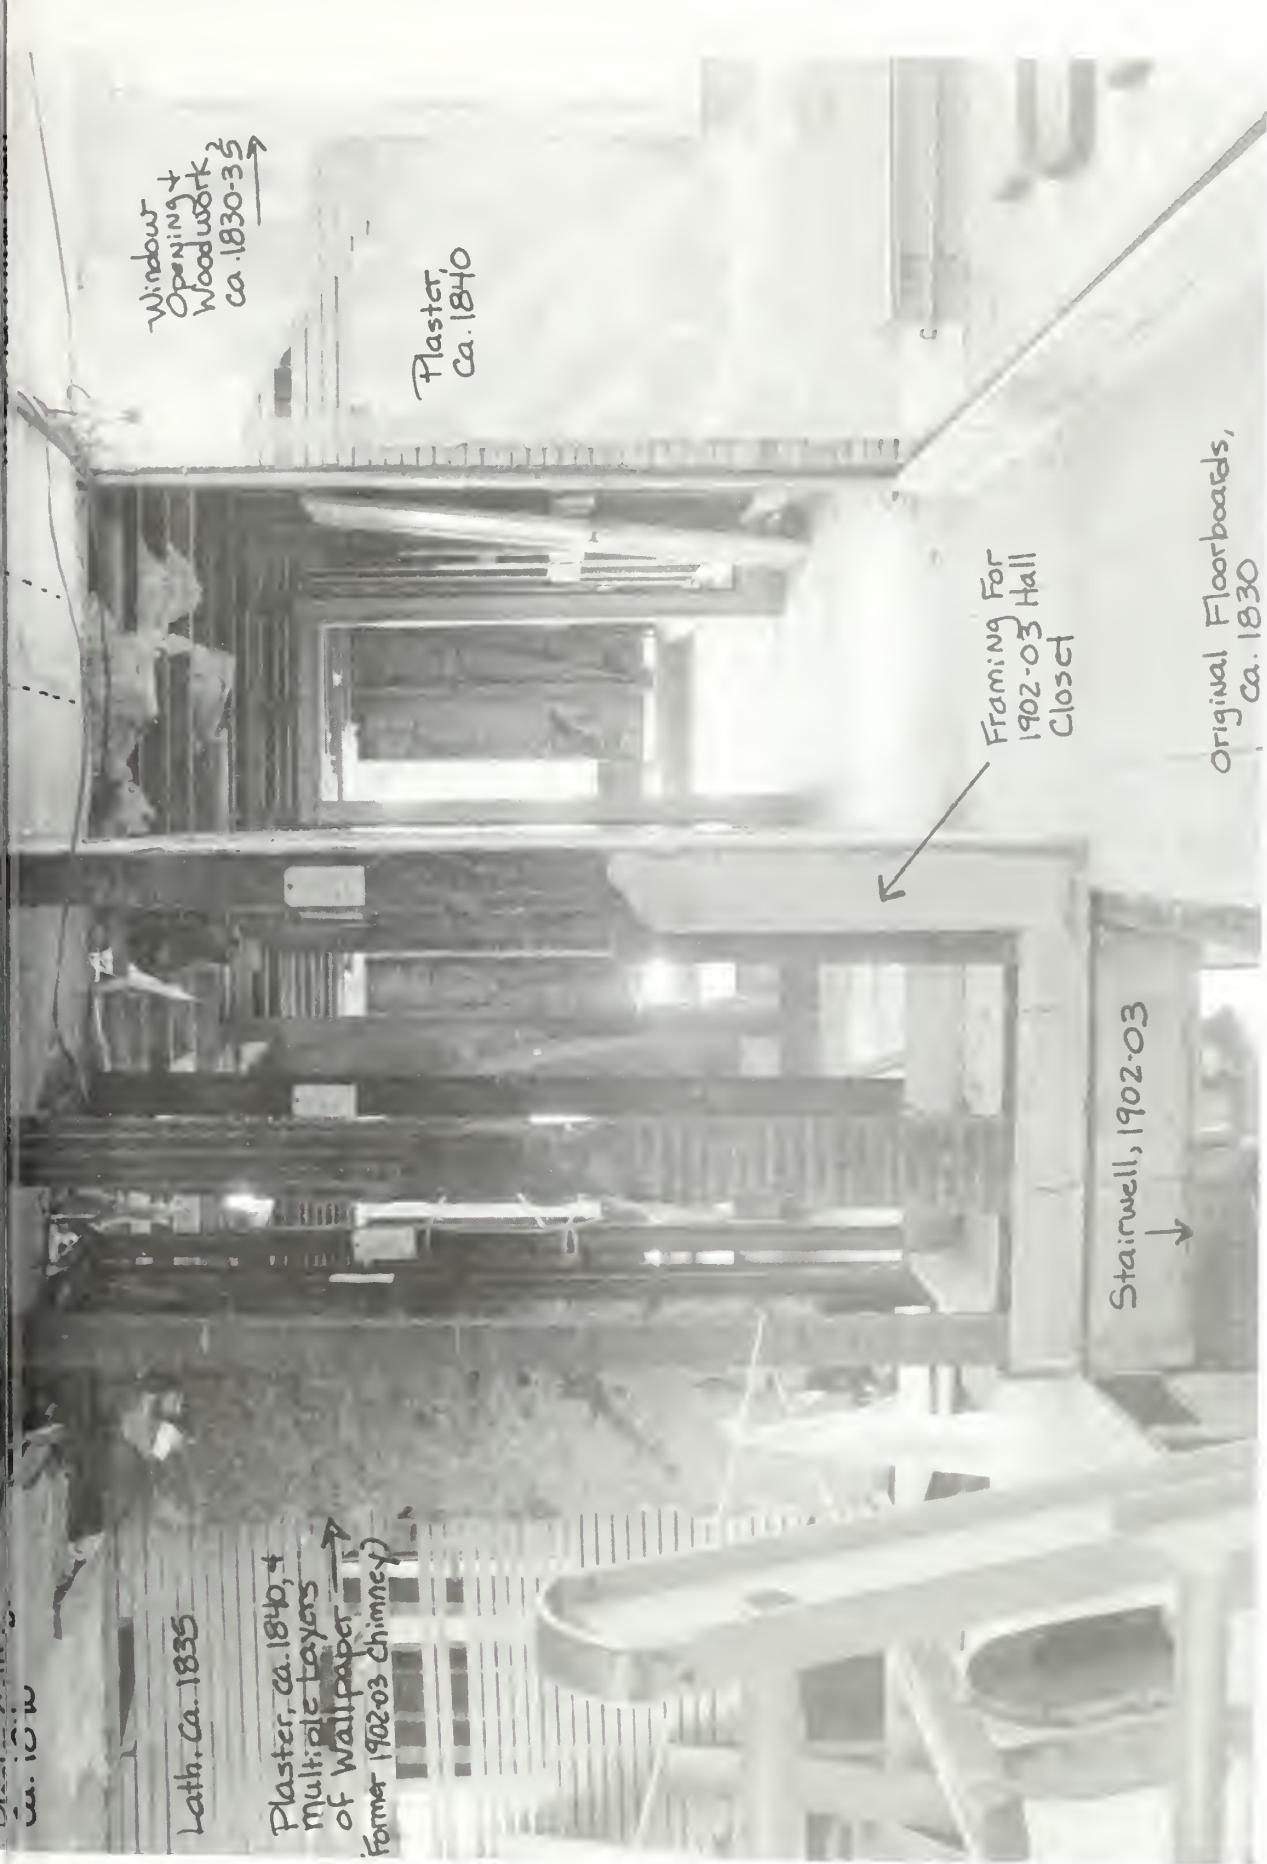
Figure 59. Stanton House: second-story hall, looking south, October 1982.

Textured Skim Coat, ca. 1970s,
On ca. 1840 Plaster Ceiling

Newspapers Dated
"July & August 1934"

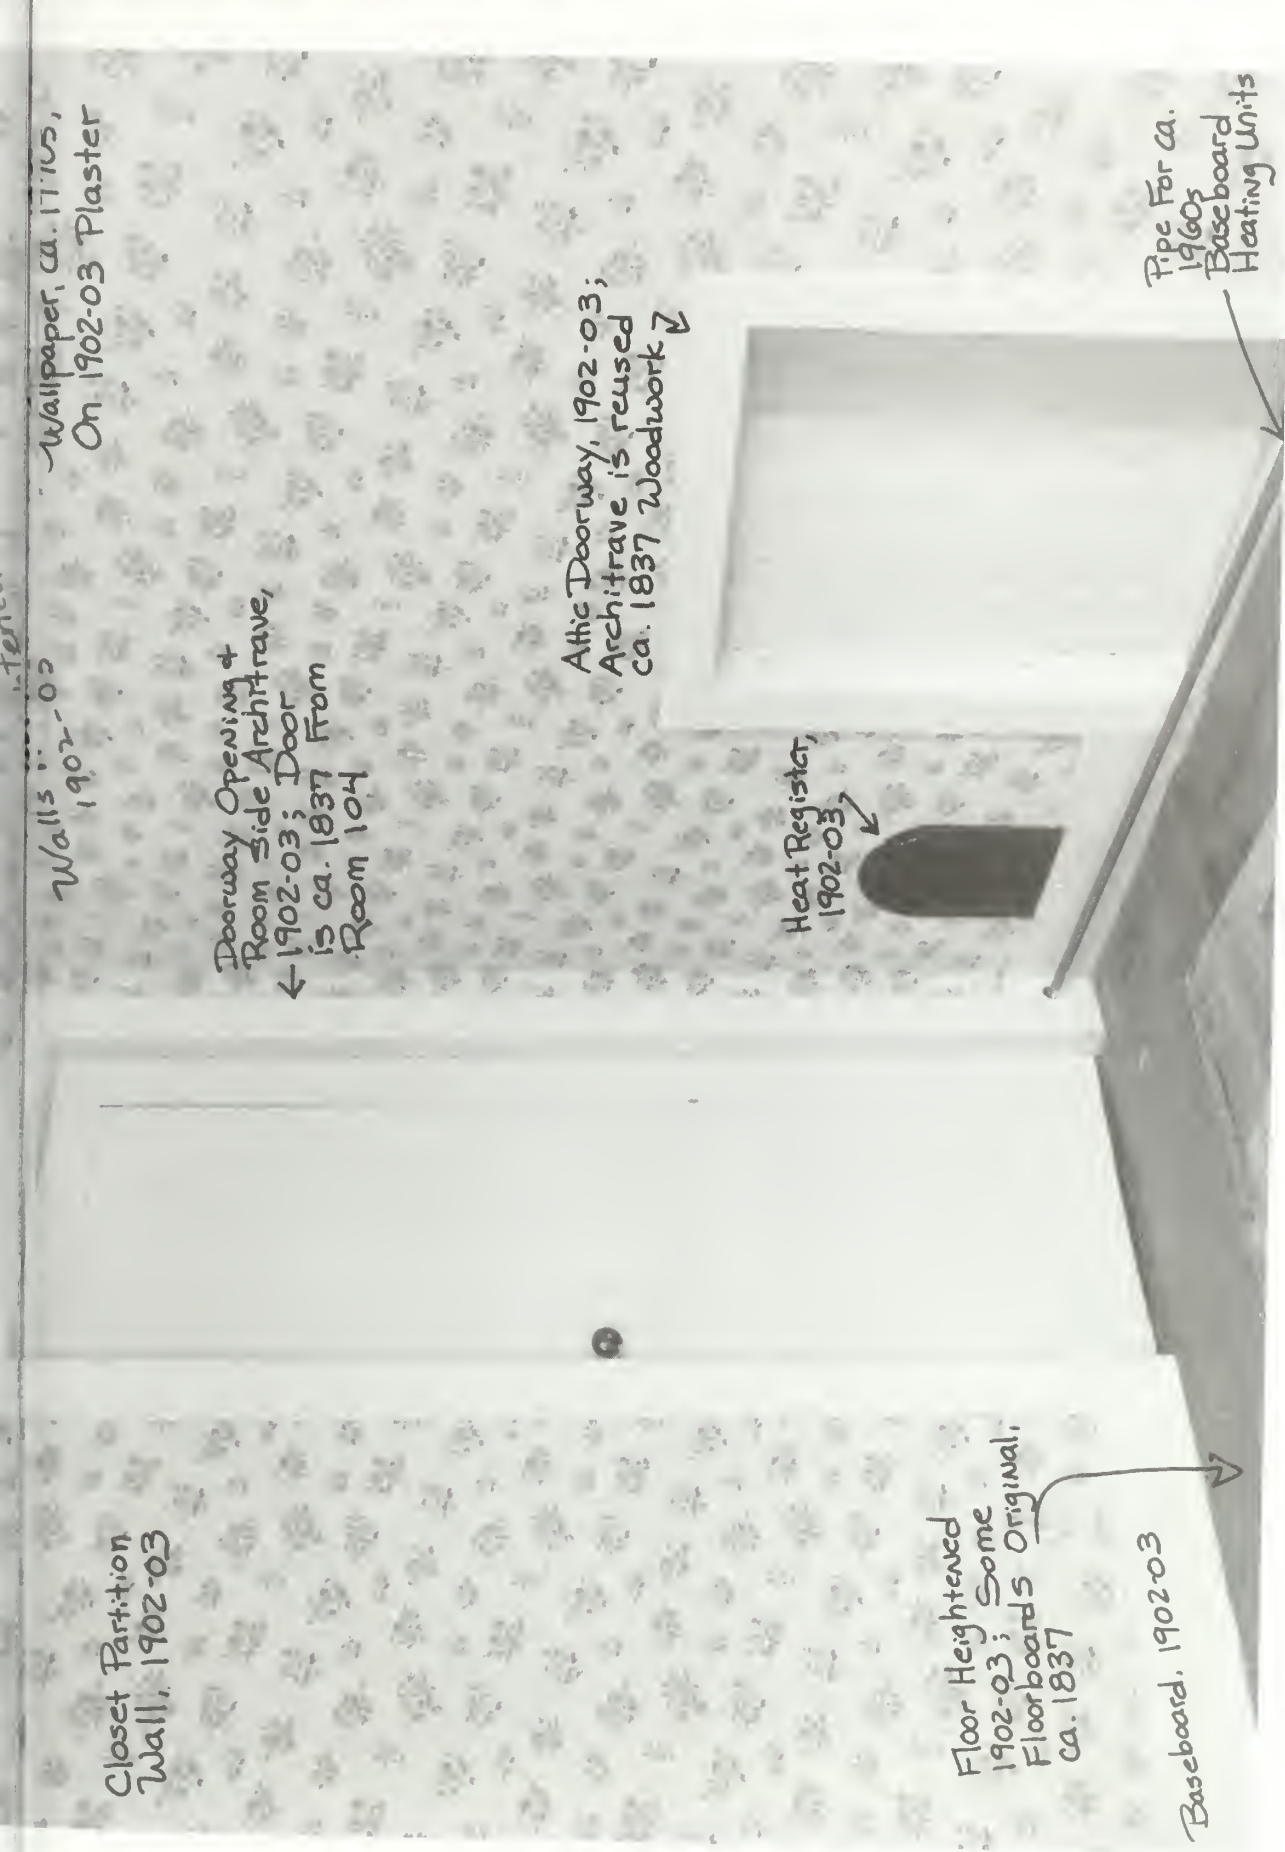
Figure 66. Stanton House: Room 204, looking southwest, June 1982.

Walls, 1902-03
On 1902-03 Plaster

Closet Partition
Wall, 1902-03
