THE STANTON HOUSE

Women's Rights National Historical Park

Historic Structure Report

THE STANTON HOUSE
HISTORIC STRUCTURE REPORT

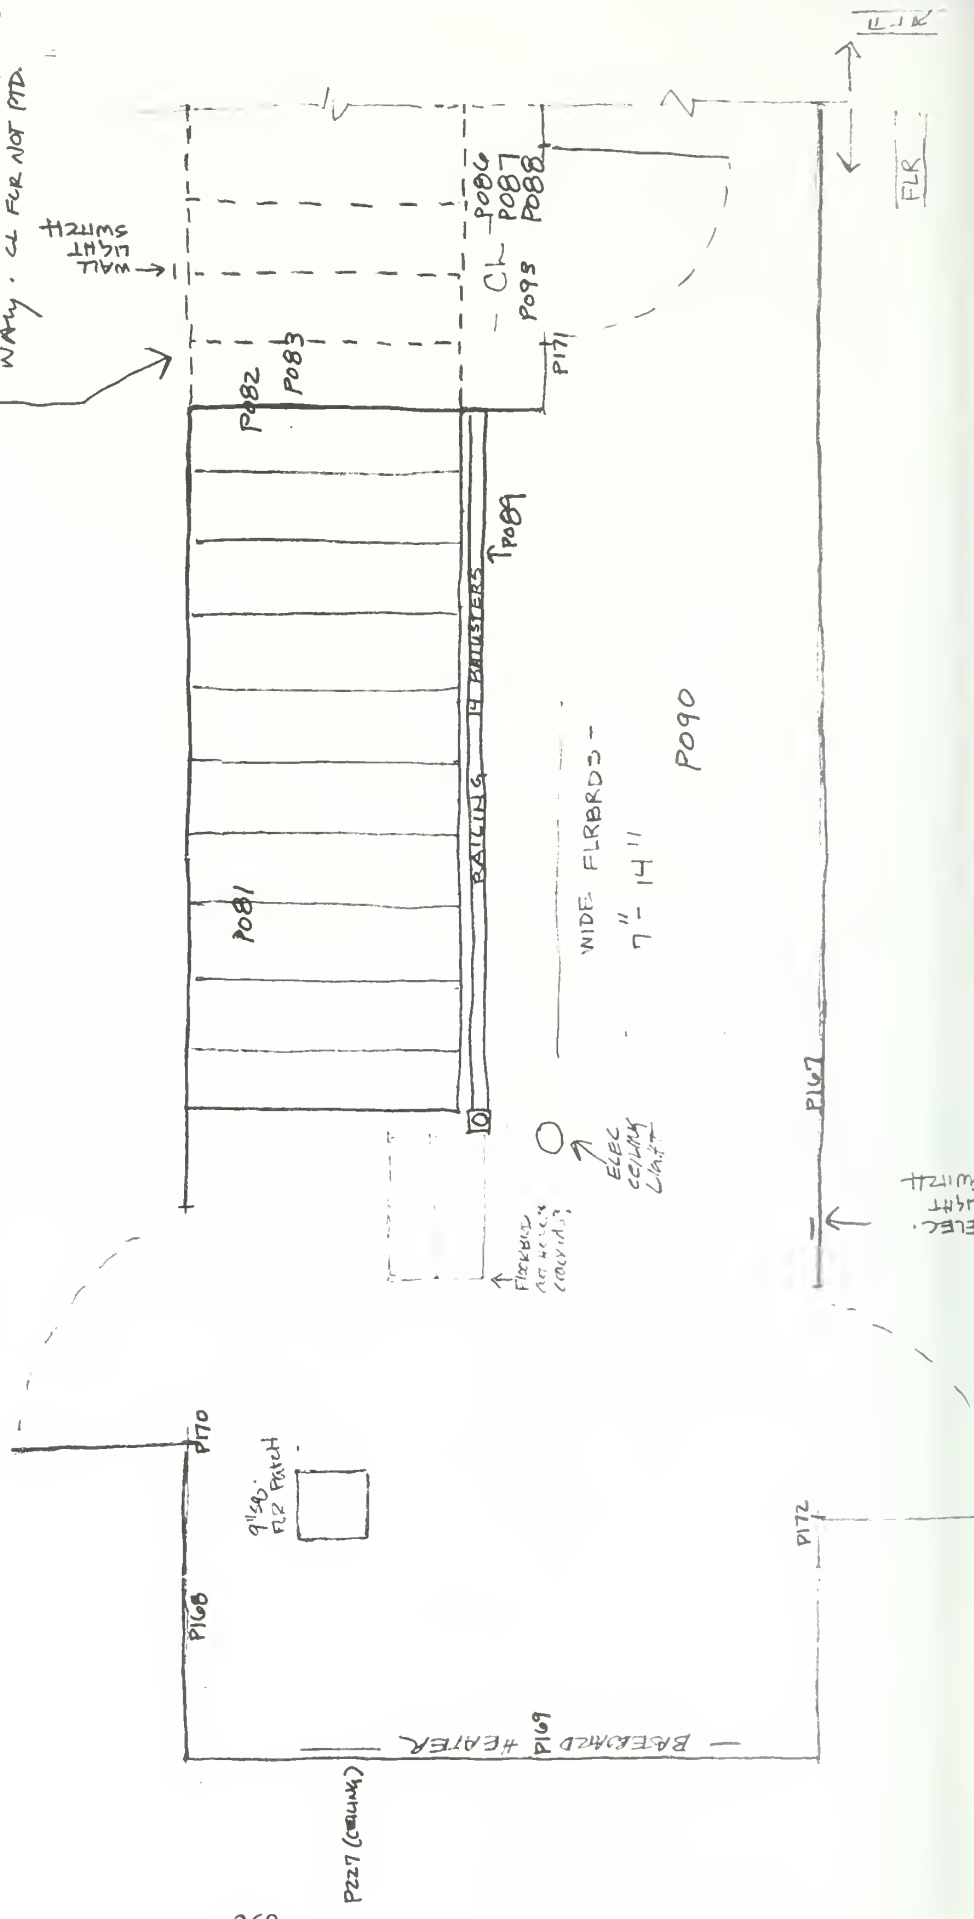
CEILING = ACOUSTICAL TILE
 FLOOR = WIDE PLANK
 WALLS = MODERN PANELING
 ALL DOORS = MODERN

ELEC LIGHT IN CL. CEILING
 CLOSET INT. PLASTERED. H2O
 DAMAGE SE CORNER. EVIDENCE
 FROM INT. OF EARLY DOOR FRAME -
 3 HINGED DOOR. SWUNG SAME
 WAY. CL FLR NOT PTD.
