KIRK STREET AGENTS' HOUSE

Lowell National Historical Park

KIRK STREET AGENTS' HOUSE
HISTORIC STRUCTURE REPORT

Lowell National Historical Park
Lowell, Massachusetts

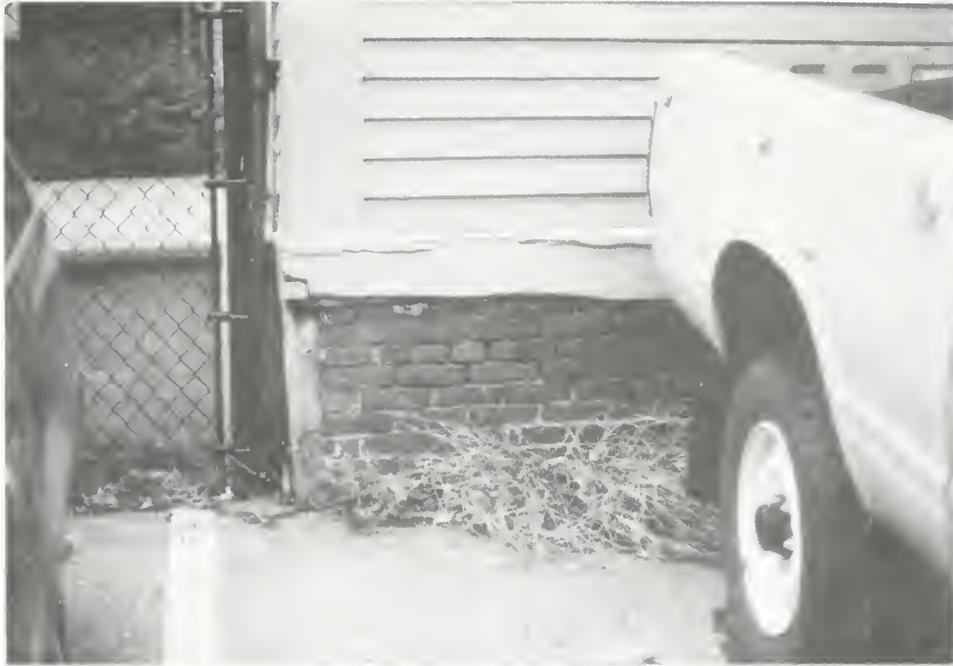
Figure 71. Ell, East Elevation: Foundation and Water Table at South End.

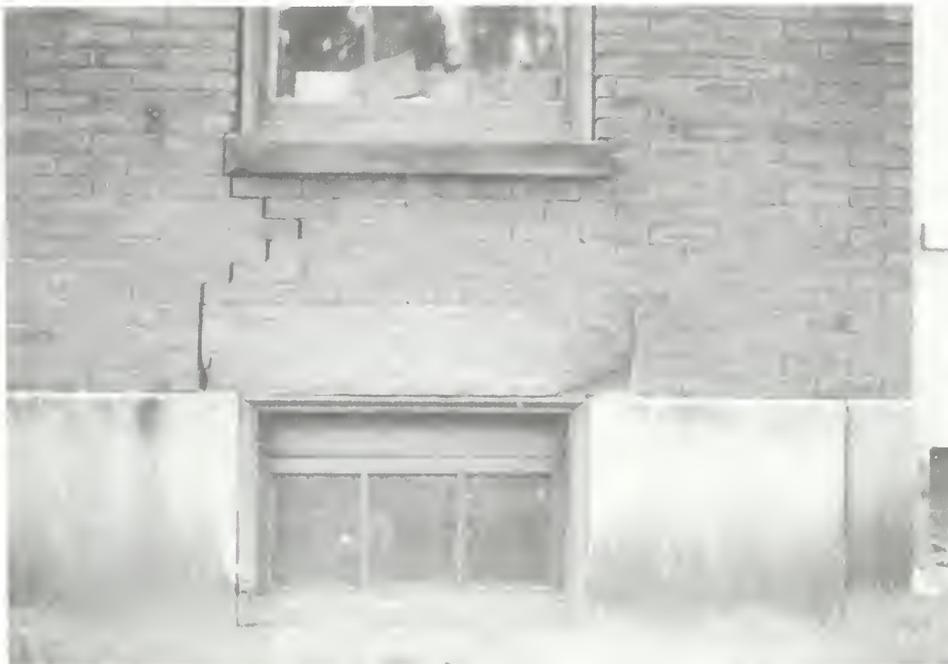
Figure 72. Main Block, South Elevation: Brownstone and Mortar Deterioration between Windows W002 and W111.

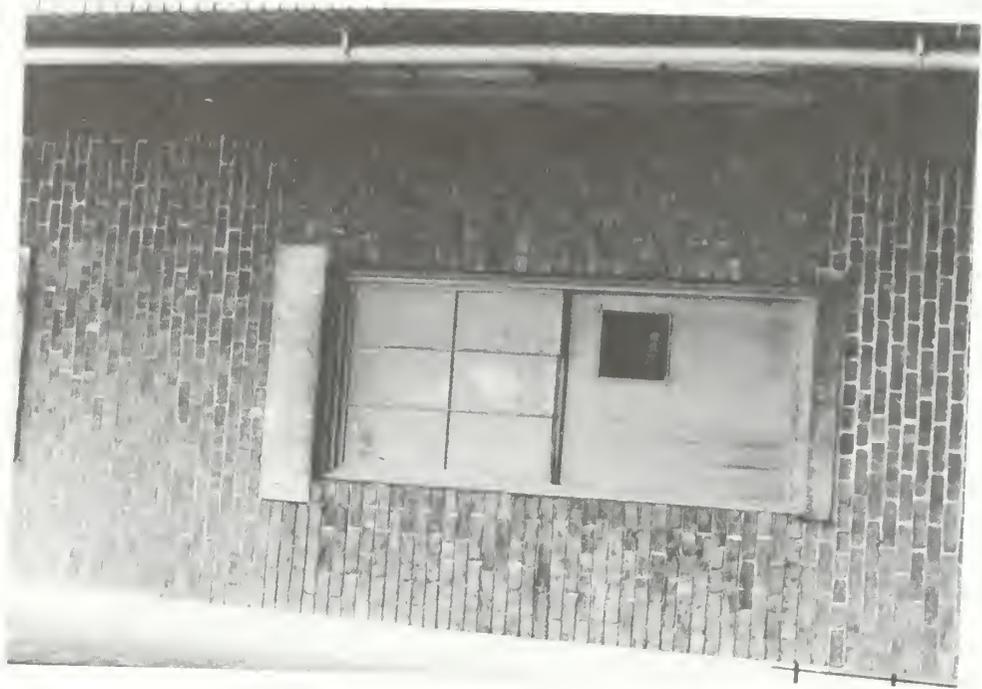
Figure 74. North-Unit Stair Tower, North Elevation: Window W124.

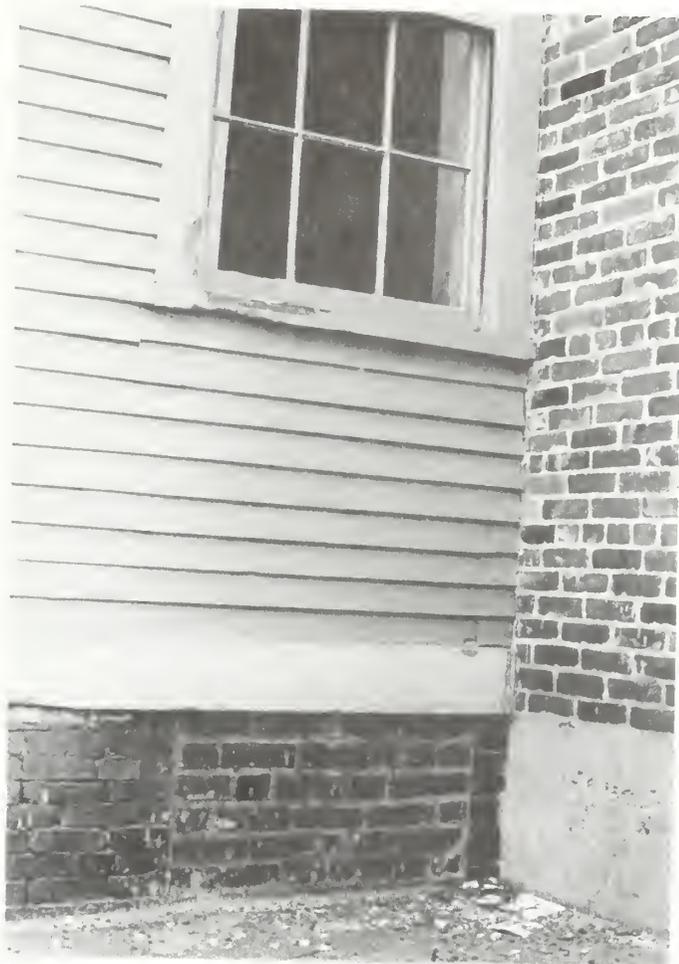
Figure 75. Ell, North (Rear-Yard Elevation): Foundation and Water Table.

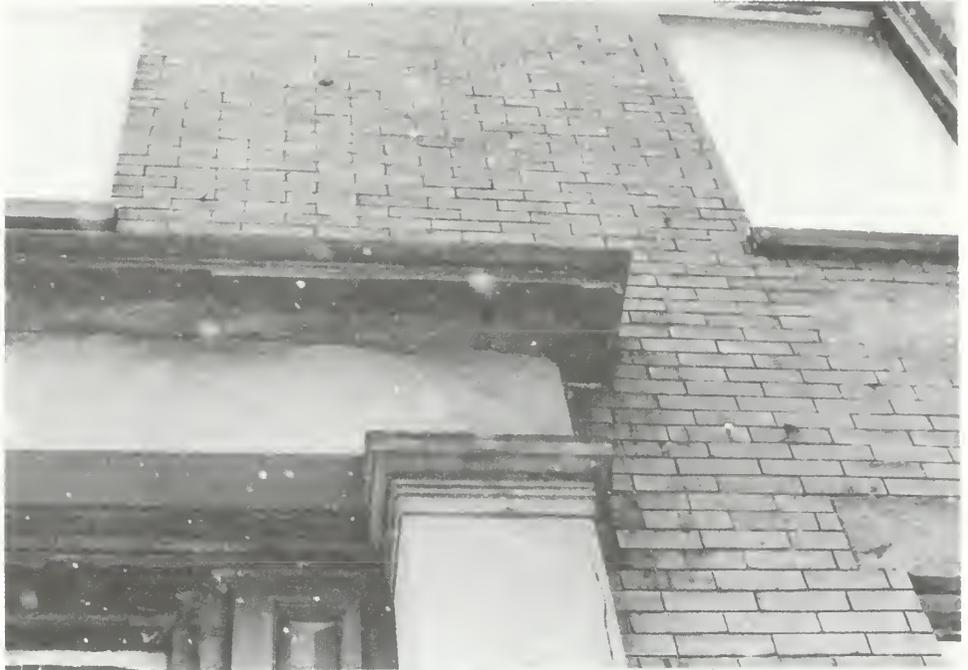
Figure 77. Main Block, West Elevation: Deteriorated Brownstone Surround of South-Unit Entrance.

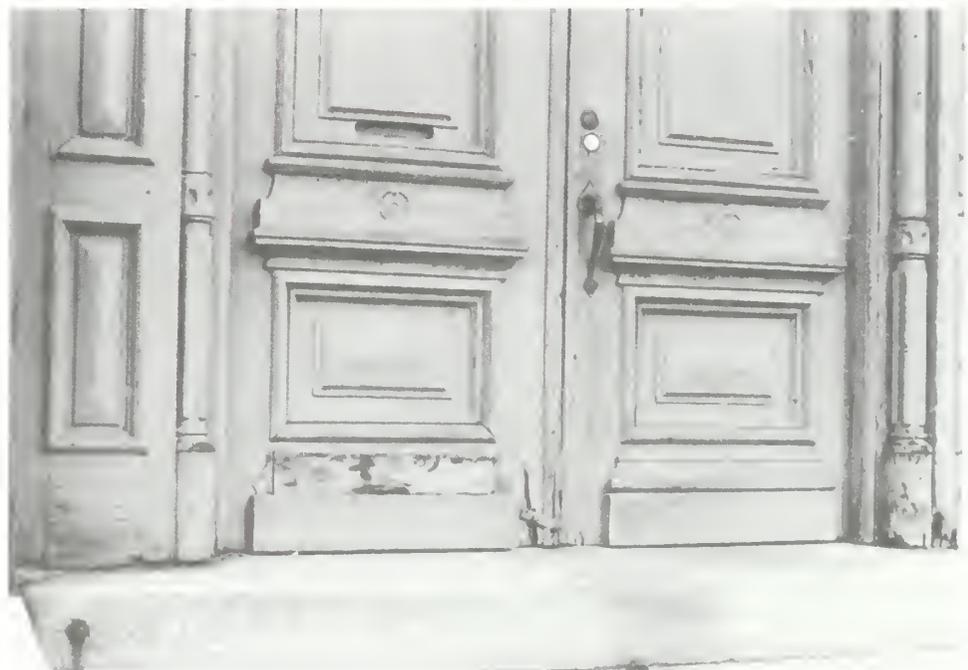
Figure 78. Main Block, West Elevation: Detail of Deteriorated South-Unit Entrance Door.

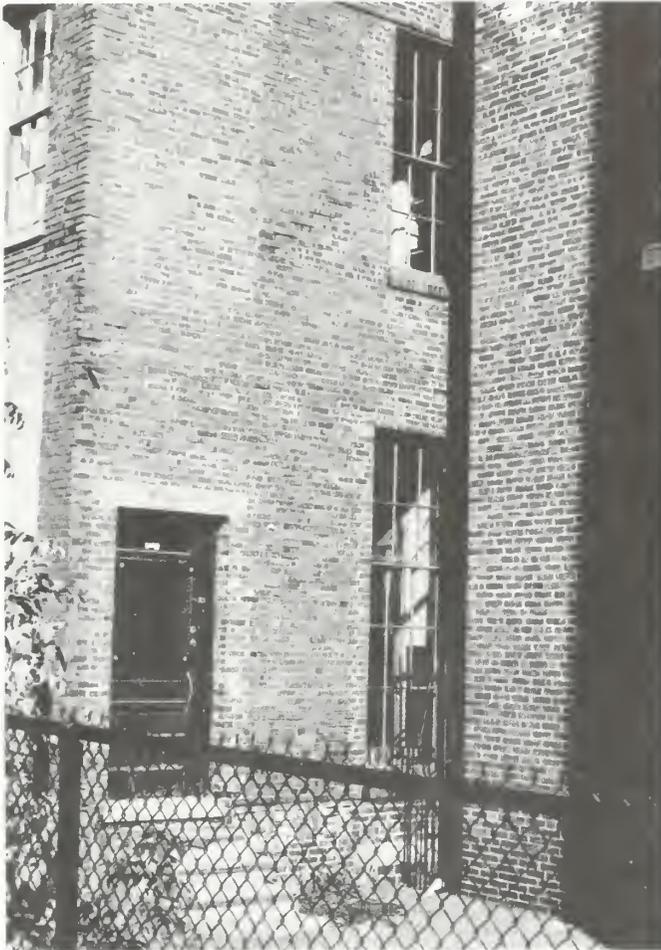
Figure 79. North Stair Tower: East Elevation.

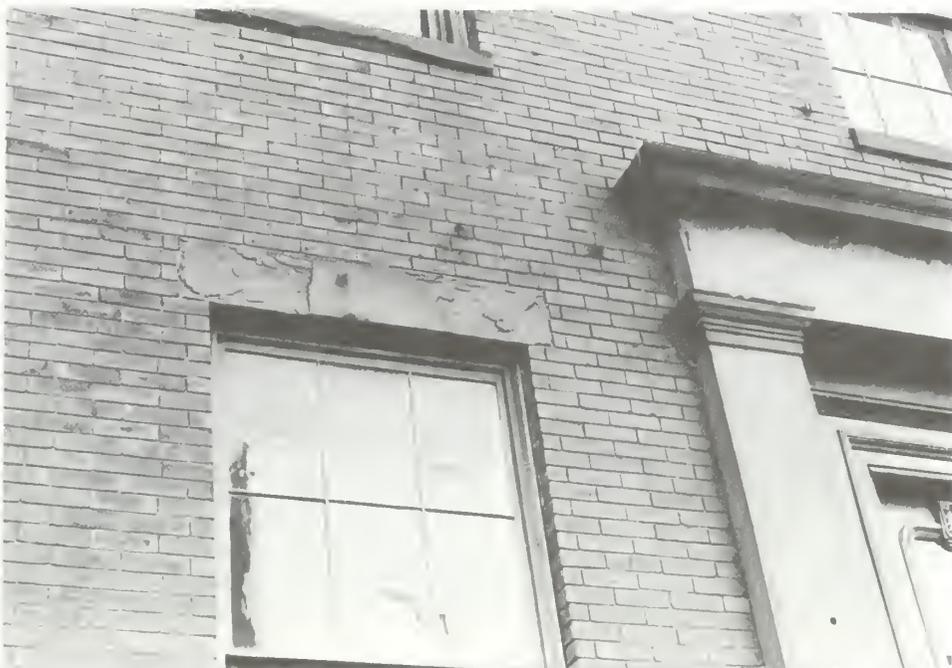
Figure 80. Main Block, West Elevation: Deteriorated Lintel over Window W106.

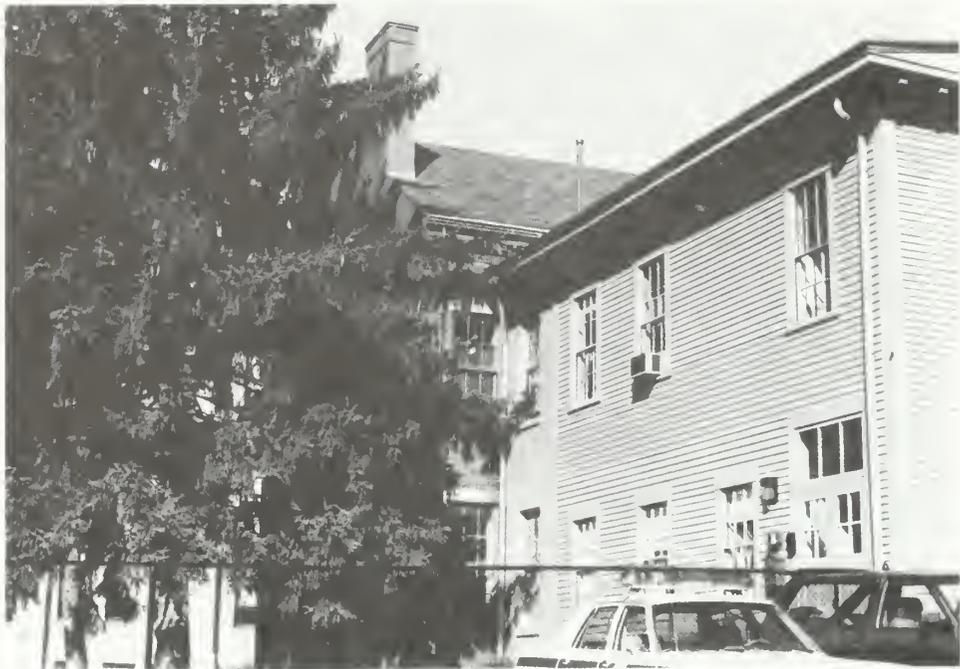
Figure 81. Ell: South Elevation, Looking Southeast.

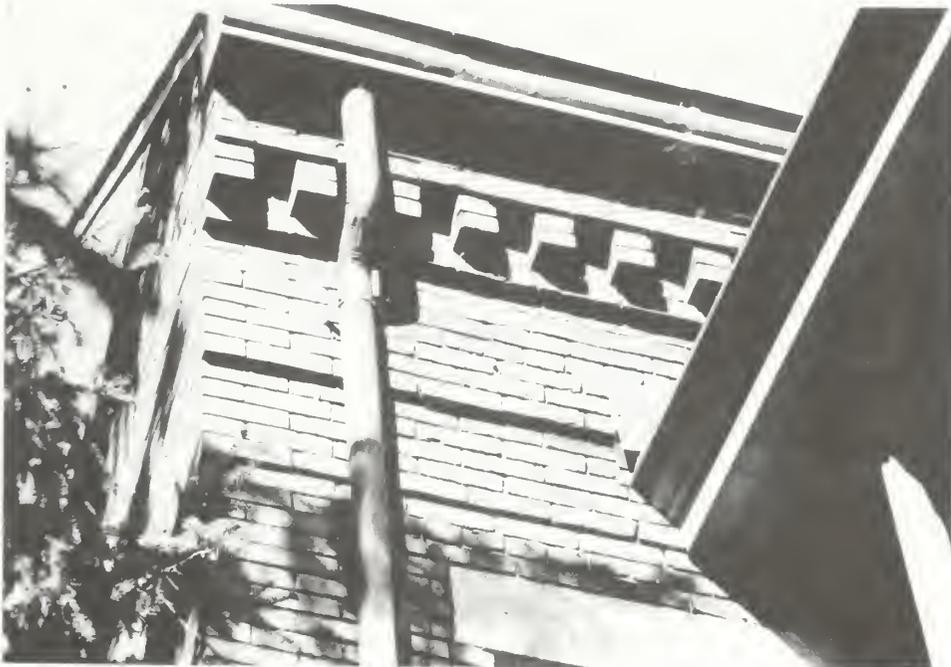
Figure 83. Main Block, East Elevation: South End, Cornice and Eaves at Junction of South-Unit Stair Tower.
