ELLIS ISLAND STATUE OF LIBERTY NATIONAL MONUMENT

HISTORIC STRUCTURES REPORT UNIT ONE BUILDINGS

Volume 2 Part One

Beyer Blinder Belle/ Anderson Notter Finegold

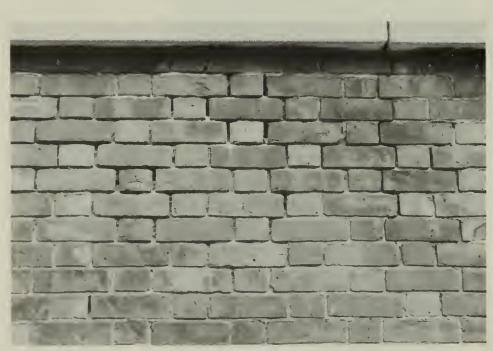
45. Mortar loss and surface spalling, south elevation.

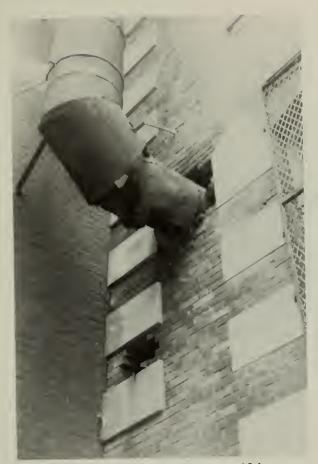
46. Hole in brick, east pavilion, north elevation.

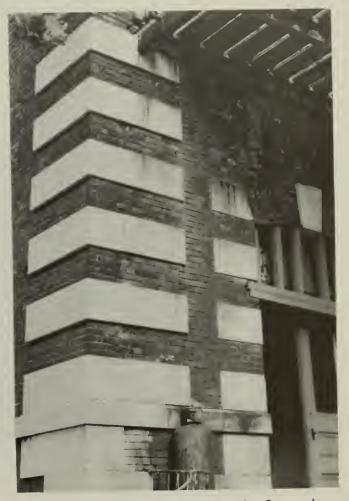
47. Iron staining, west end of porch.

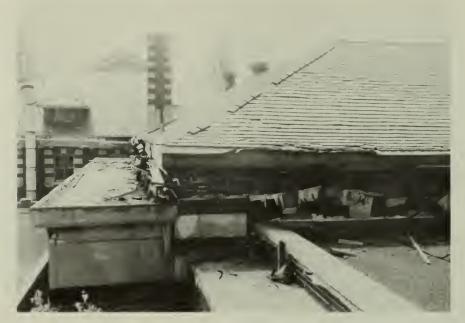
A considerable number of the flat terra-cotta roof tiles are cracked or spalling (photos 12-16 and 48). Valley flashing is torn, copper gutter joints are open and sections of gutter are missing on all elevations. The majority of downspouts are missing, while others have been replaced with PVC piping. The copper cornice has experienced serious

48. Missing, cracked, and spalling roof tile; deformed gutter falling off, west pavilion, northwest corner, view east.

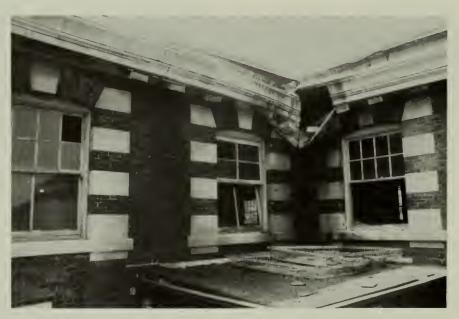
deterioration; large sections are missing, deformed, or falling off the building at all elevations (photos 7, 8, 13, 15, 17, 27-29, 48-50).

49. Deformed gutter falling off, juncture of east pavilion and north elevation, view southeast.

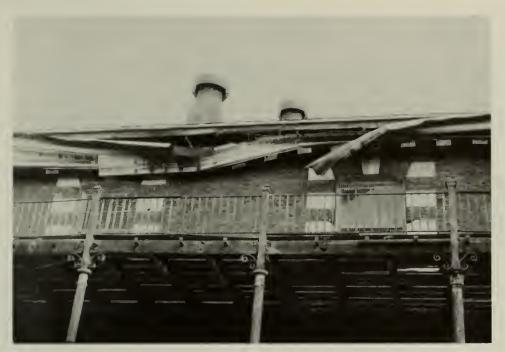
The porch is in dangerously poor condition. Plate beam ends at floor and roof (second floor) levels are corroded to the point of being structurally unsound (see "Structural"). At present the floor is temporarily shored with wood posts. The concrete floor is spalling at the edges. The exposed wood roof is rotting. The iron stair risers are also corroded and the slate treads are unstable. Sections of railing at the first floor of the porch are missing. In addition only two of the original cast-iron post capitals are extant and one of the brackets is missing (photos 19, 20, 21, 50-53).

50. Collapsing gutter; missing bracket and extant cast-iron capital, porch; south elevation, view north.

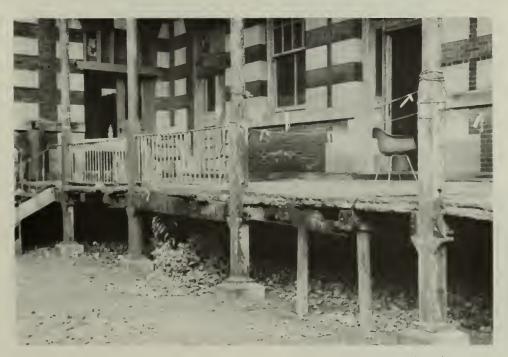
51. Corroded beams, missing railing, temporary shoring. Porch, view northwest.

The south porch represents an unsafe condition and therefore should be completely dismantled and rebuilt with as many new members as required. Sound members should be stored until rebuilding of the porch is undertaken.

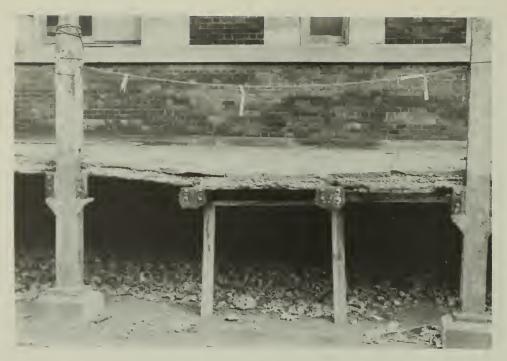
52. Corroded beams, temporary shoring, spalling concrete Porch, view north.

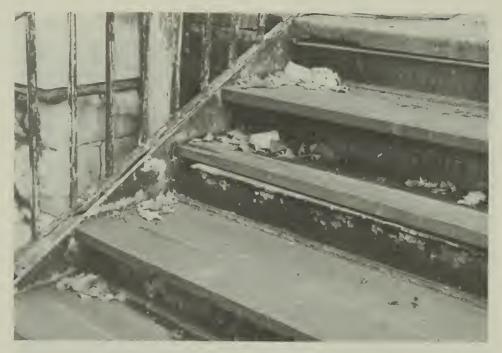
53. Corroded risers, unstable slate treads, porch stairs.

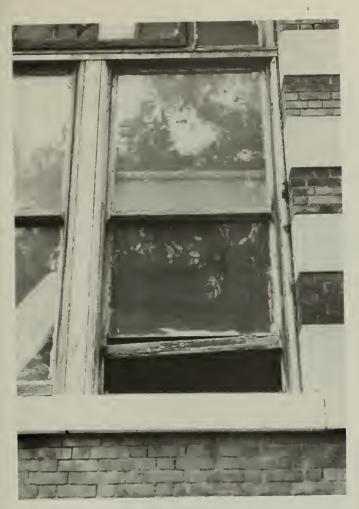
The majority of windows have rotted frames, split or rotted sash, and broken or missing glass (photo 54). Doors are split and warped.

54. Window, south elevation.

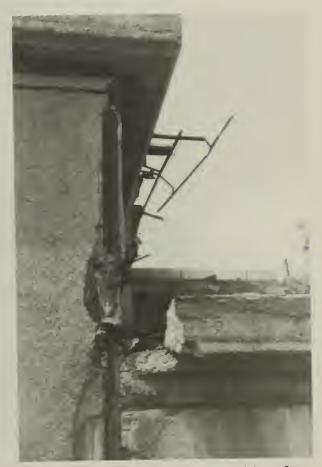
The "ice plant" (room 119) is in a highly deteriorated condition. The concrete base course, window sills, lintels, and coping are cracking and spalling (photos 55 and 56). The brickwork has experienced some spalling and loss of material, particularly at the inset panels of the parapet (photo 57). Wood window frames are rotted, warped

55. Spalling concrete, corridor from the kitchen and laundry to the bakery and carpentry (hall 201).

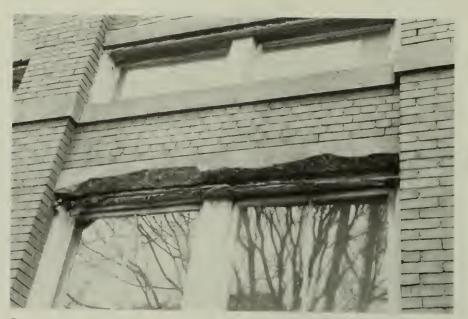
56. Spalling at window lintel, "Ice Plant", north elevation.

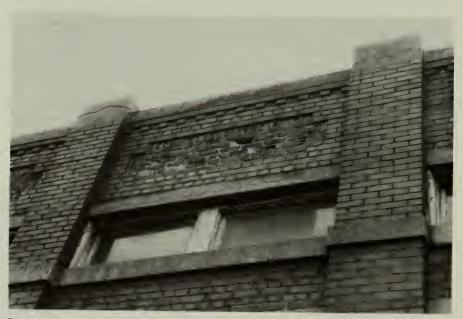
57. Spalling and loss of masonry units. "Ice Plant", north elevation.

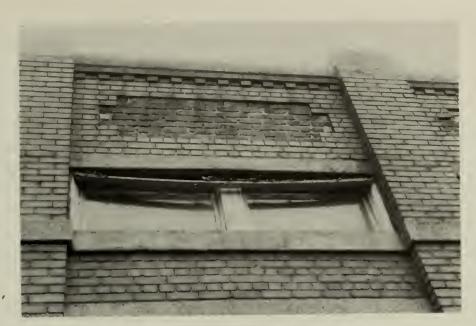
and are separating in places (photo 58). Part of the frame is missing on one window and rusted counterweights are exposed (photo 59).

58. Warped and separating window frame, "Ice Plant", north elevation.

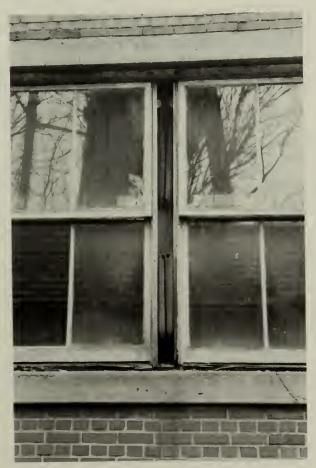
59. Exposed rusted counterweights, "Ice Plant", north elevation.

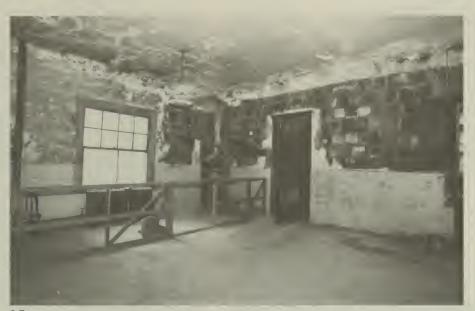
35. Room 201- deteriorating plaster and exposed terracotta block in northeast corner.

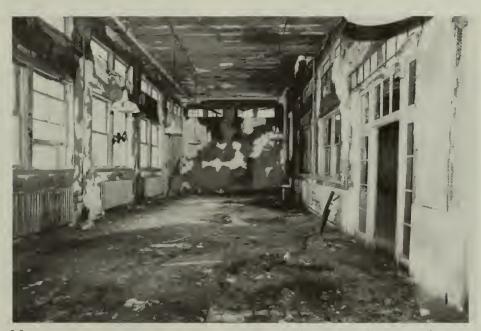
36. Room 119- destroyed plaster finishes and extensive moisture penetration.

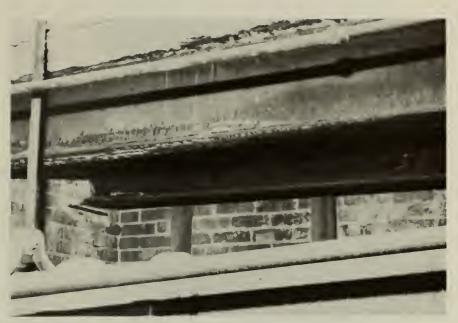
7. Delaminating corrosion of flange of steel beam added under first floor construction.

The corroded first floor beams found in the basement should be uncovered and cleaned of scaling rust. The beams can then be measured and further action determined through analysis. If reinforcing is required, one solution is the welding of a plate to the bottom flange. Corrosion of the beam in the southeast corner is quite advanced and should not be neglected.

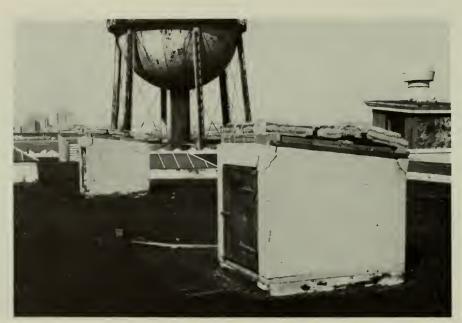
The tar paper roofs are cracked and bubbling. Concrete and brick fan houses are severely cracked and spalled and have torn or missing flashing (photo 33). Downspouts and gutters are clogged with debris. Large sections of the copper cheneaux are missing on the east and north elevations (photo 50).

33. Fan houses on roof, cracking and spalling, view west.

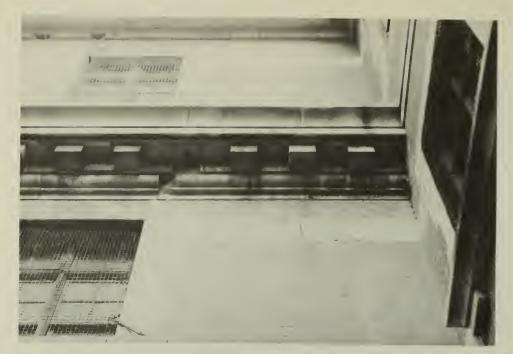
41. Spalling and loss of material at cornice, south elevation, west side.

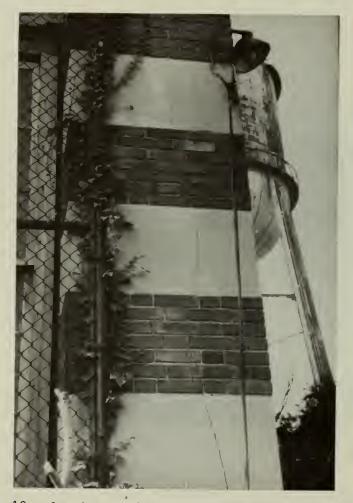
42. Crack, northwest corner, view southwest.

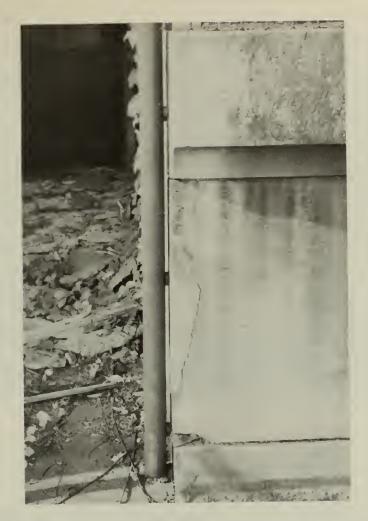
43. Crack at central entrance, north elevation.

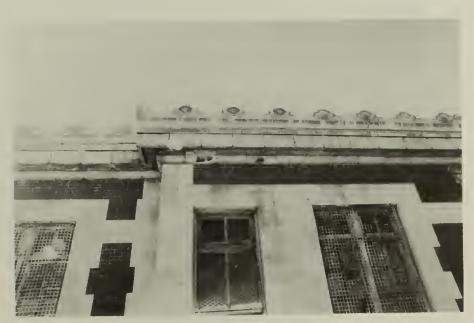
44. Holes in terra-cotta cornice, north elevation.

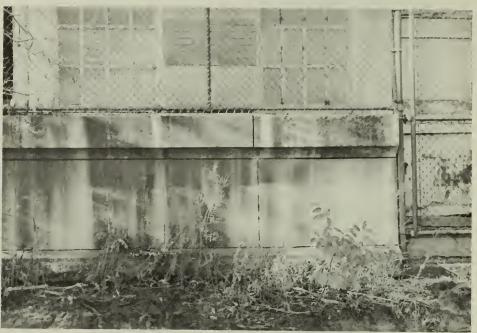
45. Severe iron staining at base, north elevation.

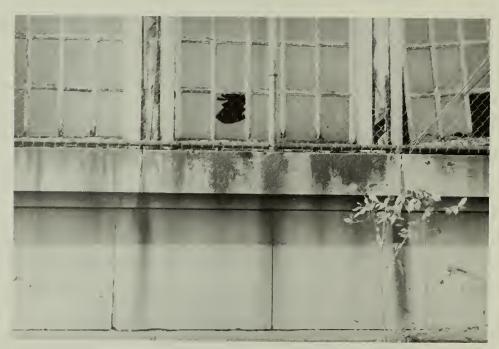
46. Severe iron staining at base, north elevation.

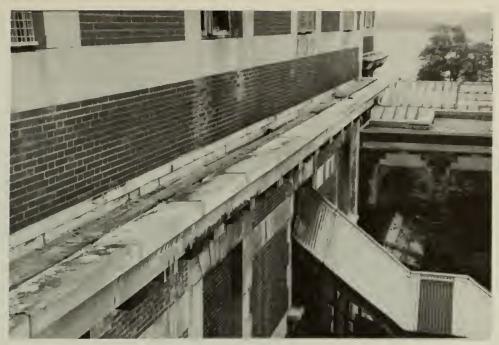
47. Efflorescence, south elevation.

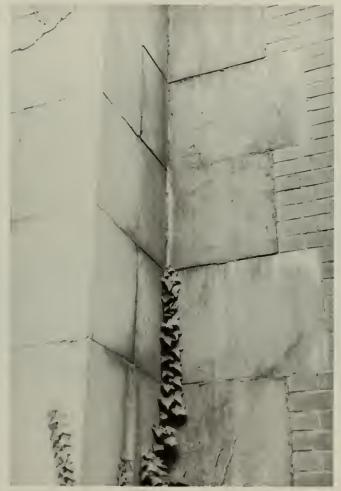
48. Biological staining, southwest corner.

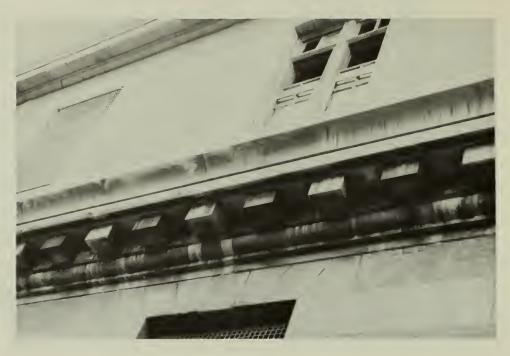
49. Black crust on second story cornice.

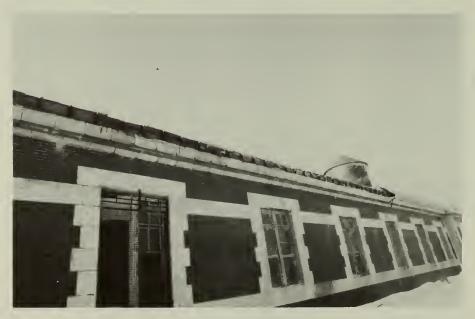
50. Large section of missing copper cheneaux, north elevation.

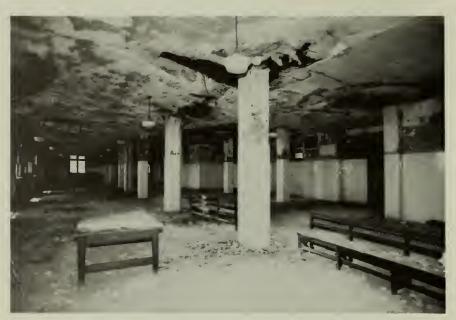
14. Room 212- view southwest- tile wainscot on walls and columns, tile floor, deteriorating plaster on walls and ceiling.

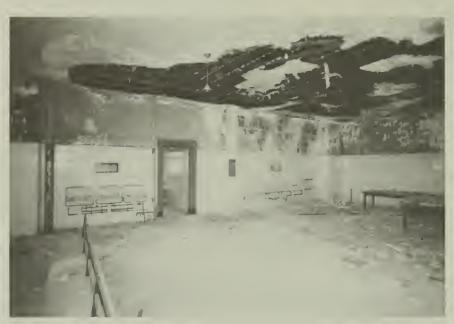
21. Room 212- southwest corner, deteriorated ceiling and wall plaster.

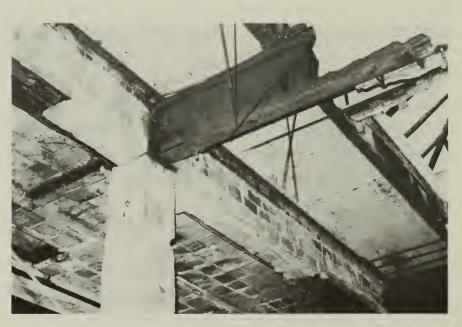
Room 112, corroded beams around skylight, south side.

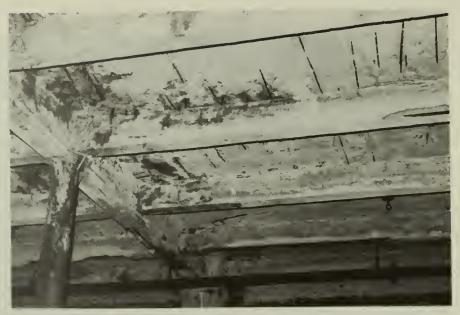
5. Room 209- reinforcing rusting through slab soffit. Spalling of ceiling parging.
