ATWOOD-HIGGINS HISTORIC DISTRICT CULTURAL LANDSCAPE REPORT AND OUTBUILDINGS HISTORIC STRUCTURES REPORT

CAPE COD NATIONAL SEASHORE

CULTURAL LANDSCAPE REPORT AND OUTBUILDINGS HISTORIC STRUCTURES REPORT

WELLFLEET, MASSACHUSETTS

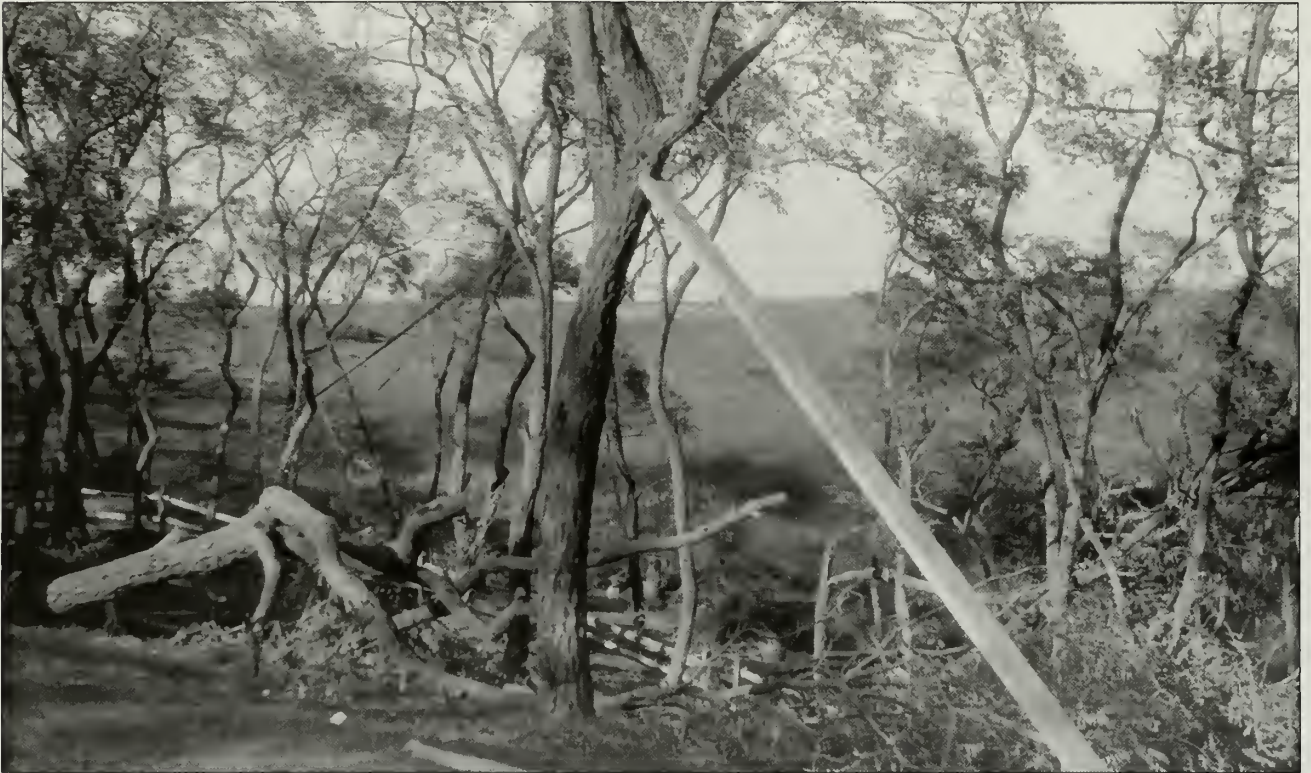
Figure 17. Damage done by the August "tornado" of 1924, possibly looking northeast from the house lawn, showing the area where Higgins went on to plant two maples. Note the number of fallen trees and the fence at the bottom of the hill. (Cape Cod NS archives.)

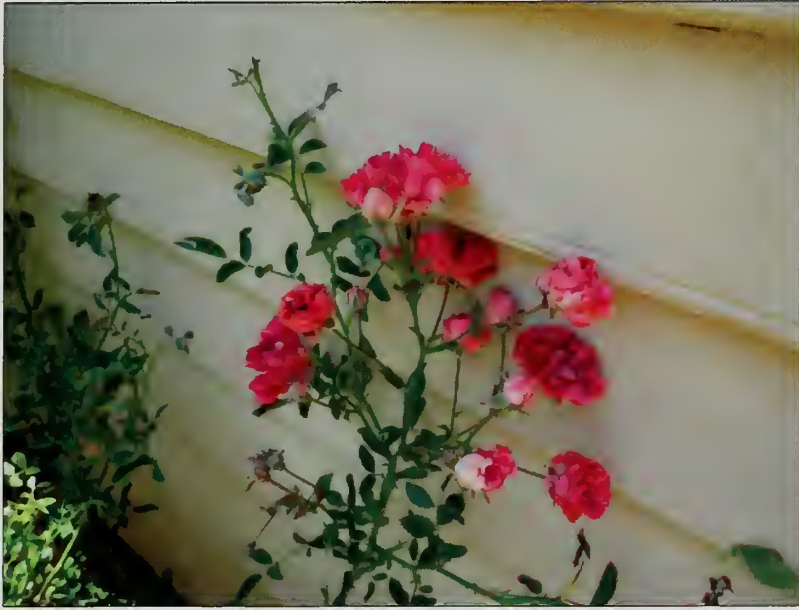
Figure 69. House lawn just south of the house. Plants growing by the foundation including a pink cultivated rose, multiflora rose and non-native, self-seeded garlic mustard. (OCLP, June 2010.)

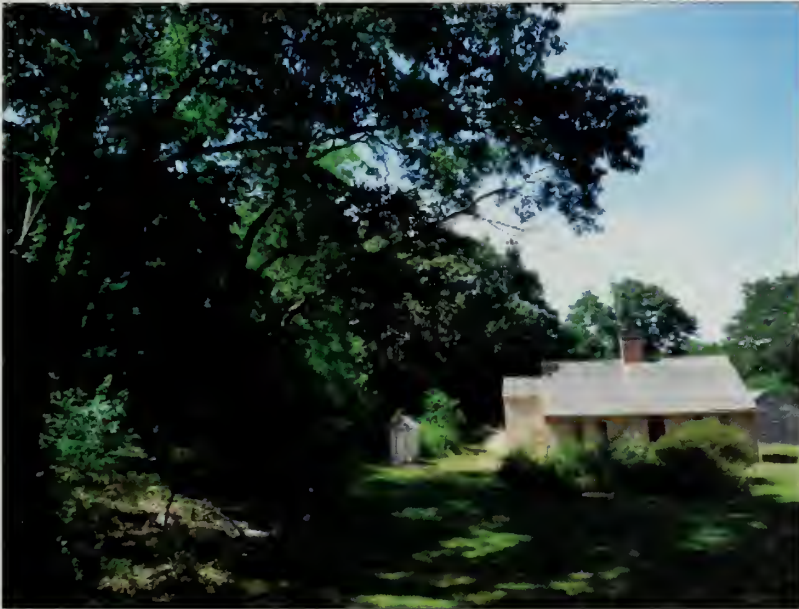
Figure 70. View north at the edge of the house lawn. Note the two deer-browsed Globe arborvitae growing along the west side of the grass at lower left. (OCLP, June 2010.)

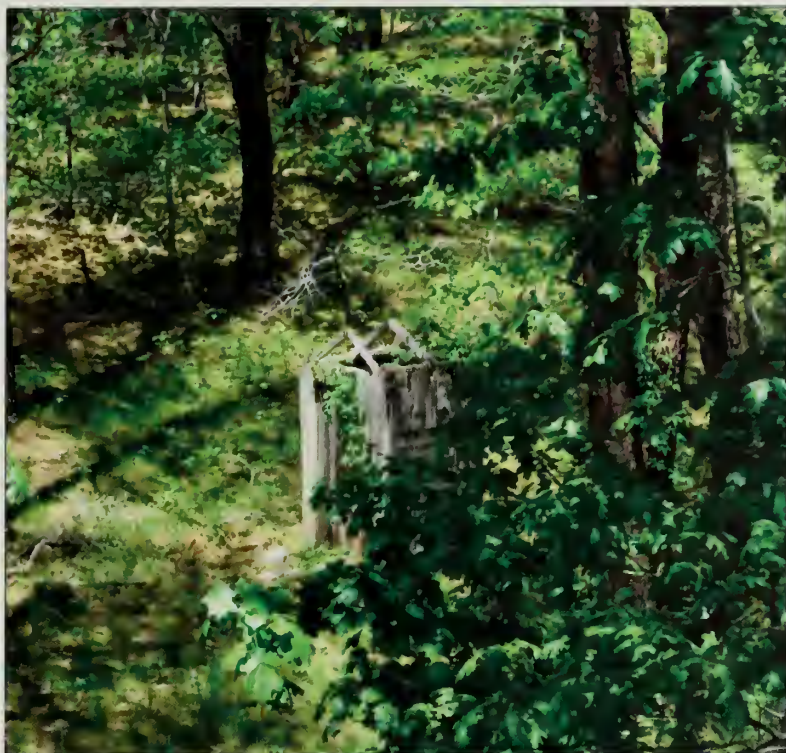
Figure 87. Privy in poor condition, without a roof, set off in the woods northwest of the Country Store. (OCLP, May 2010.)

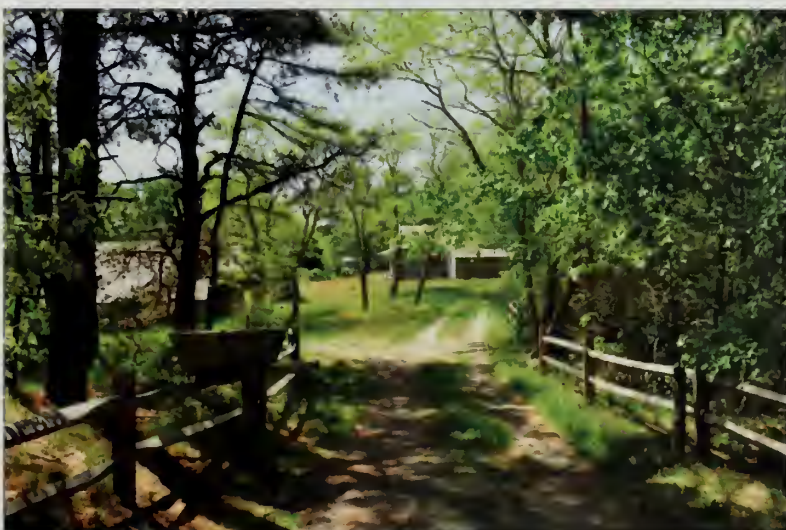
Figure 89. Entrance fence to the building complex, replaced in June 2007 and extending only part way around the corner toward the barn. (OCLP, June 2010.)

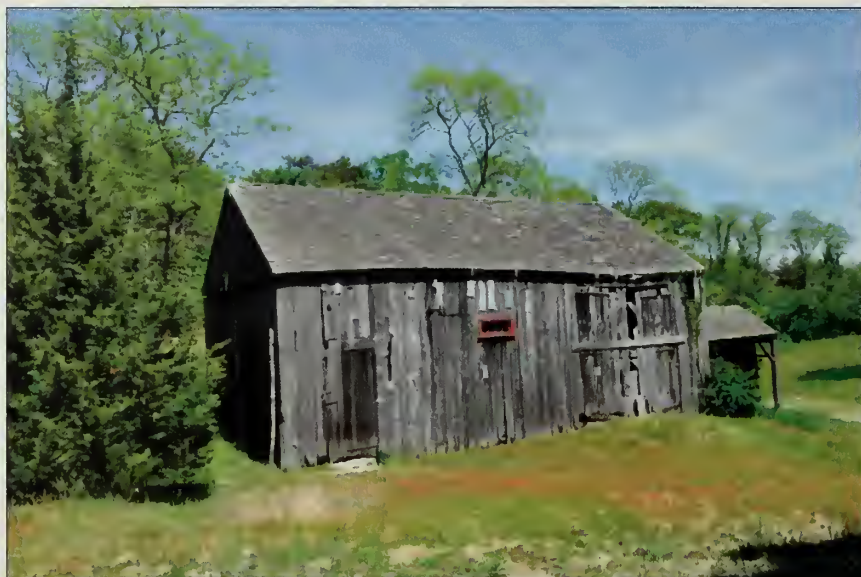
Figure 90. South and west sides of the Barn. Note the Eastern red cedar on the building's southwest corner, Virginia creeper growing along the eaves and the barberry in the southeast corner. (OCLP, June 2010.)

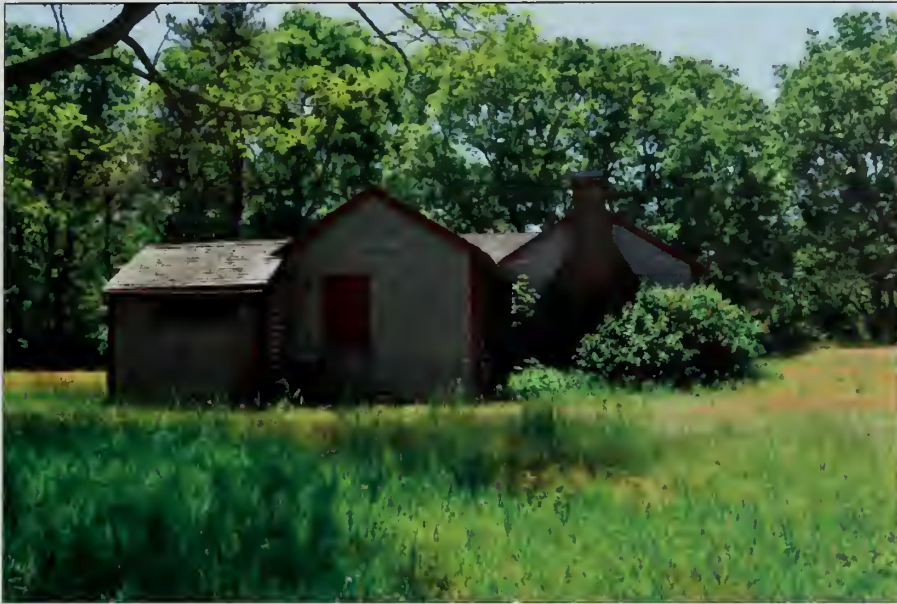
Figure 93. North side of the Guest House. Note the Norway maple, lilac, and day lilies growing along the foundation. (OCLP, June 2010.)

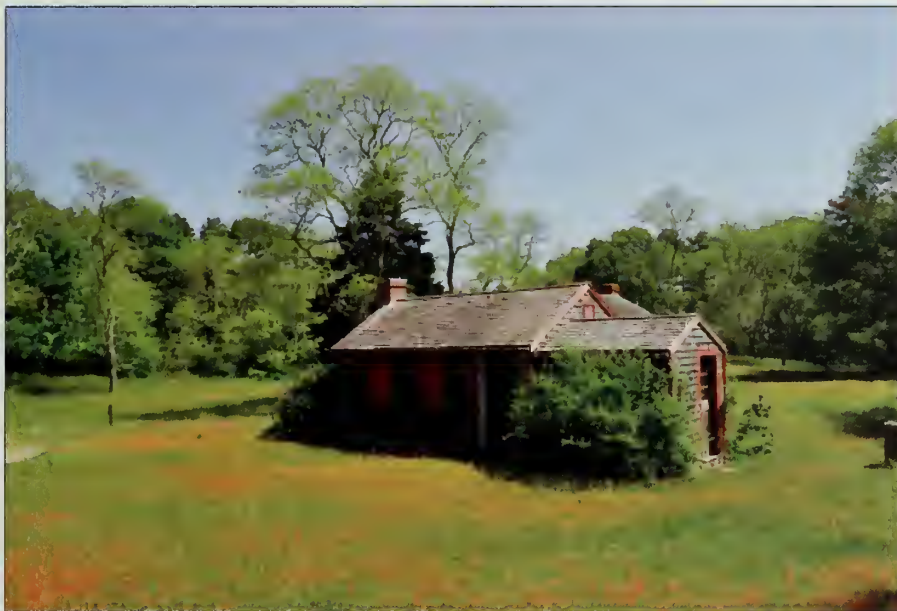
Figure 94. South and west sides of the Guest House with a large honeysuckle at the corner of the building. The granite base for the sun dial is visible at far right. (OCLP, June 2010.)

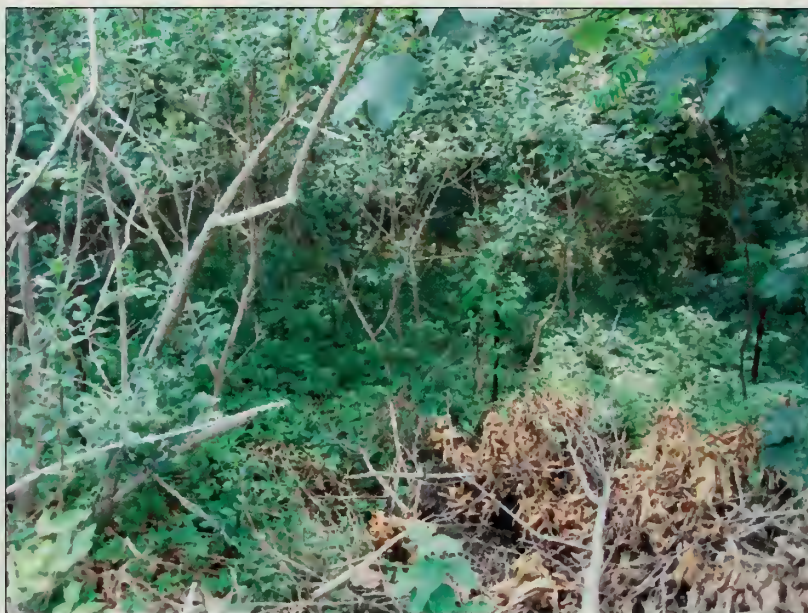
Figure 96. Site of an old garden in the woods south of the guest house. Note the rusted metal garden fence stakes. (OCLP, July 2007.)

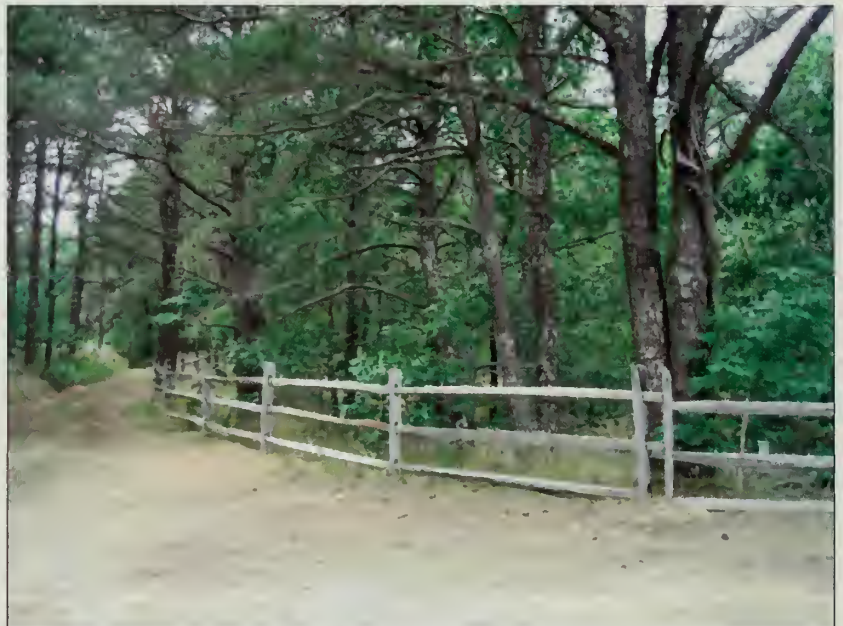
Figure 103. Old Town Road leading away from the building complex, west of the Country Store, to the Garage concealed behind the slope at left. Note the original fence with three rails, which was repaired in June 2007, and the small green pipe at right. (OCLP, July 2007.)

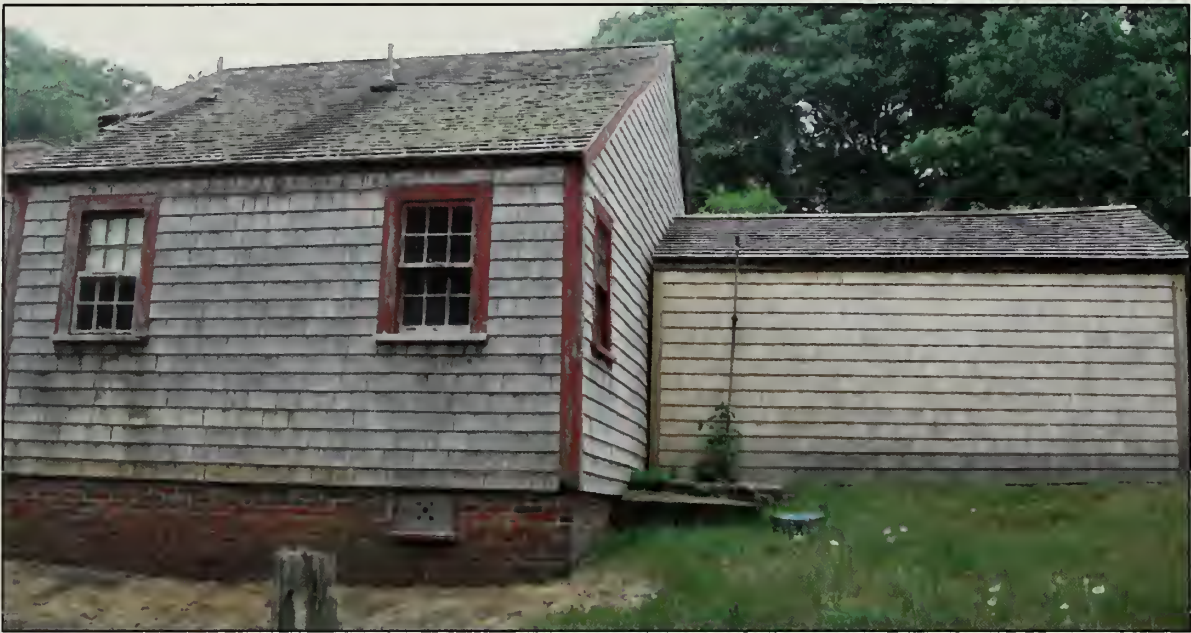
Figure 233. East elevation, Woodshed, showing brick foundation on Laundry/Bath addition (2007).

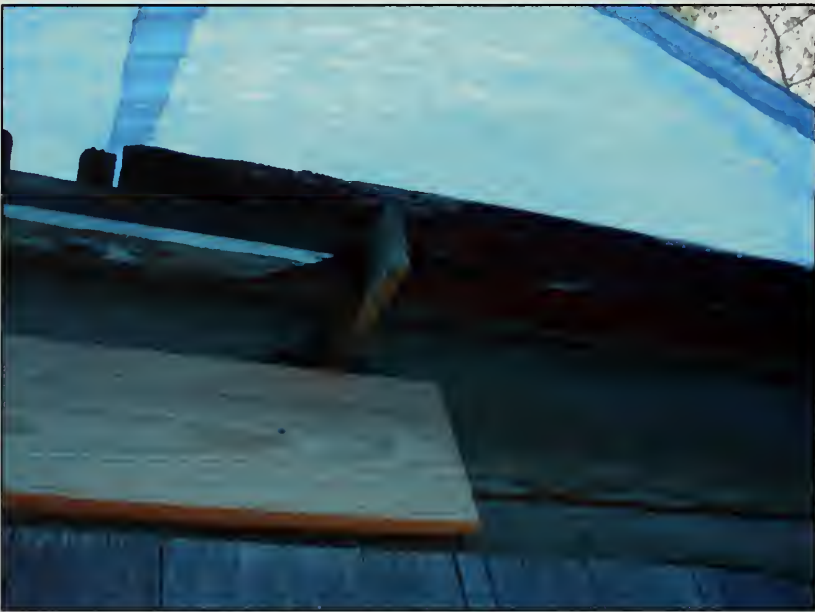
Figure 266. Gutter system on northeast elevation, Garage. Repair in progress in 2007 above and 2010 below (2007 and OCLP, 2010).

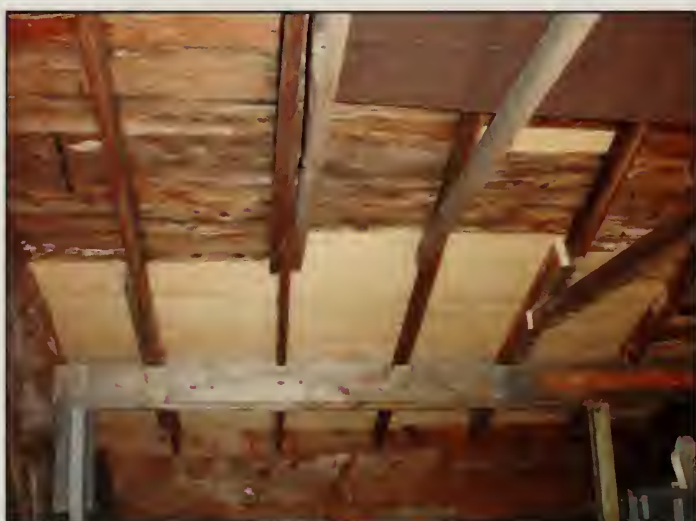
Figure 273. Ceiling of Room 101, Garage. Note sheathing repairs, placement of beam to support rafters, and sistering of collar ties between rafters (2007).

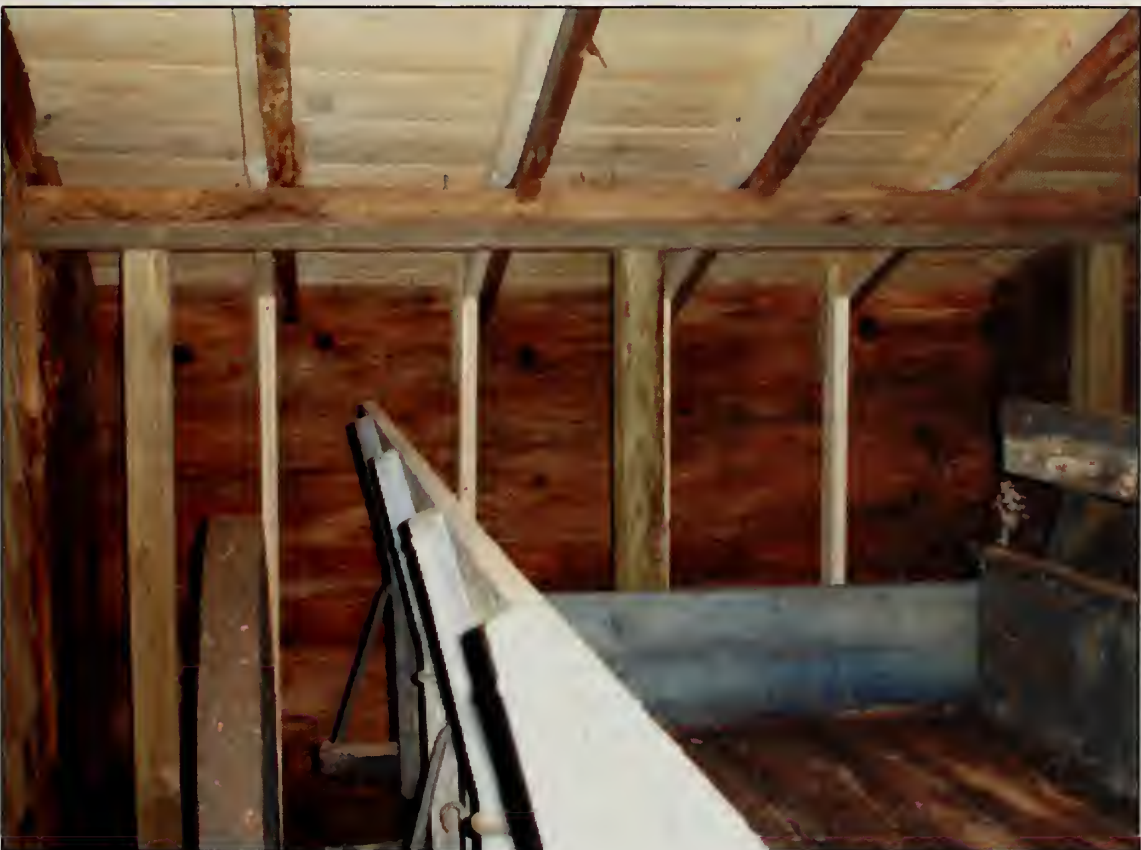
Figure 280. Ceiling and wall, southwest elevation, of Room 102, Garage. Note replaced sheathing boards, sistered rafters, sistered rafter support beam, and support posts (2007).

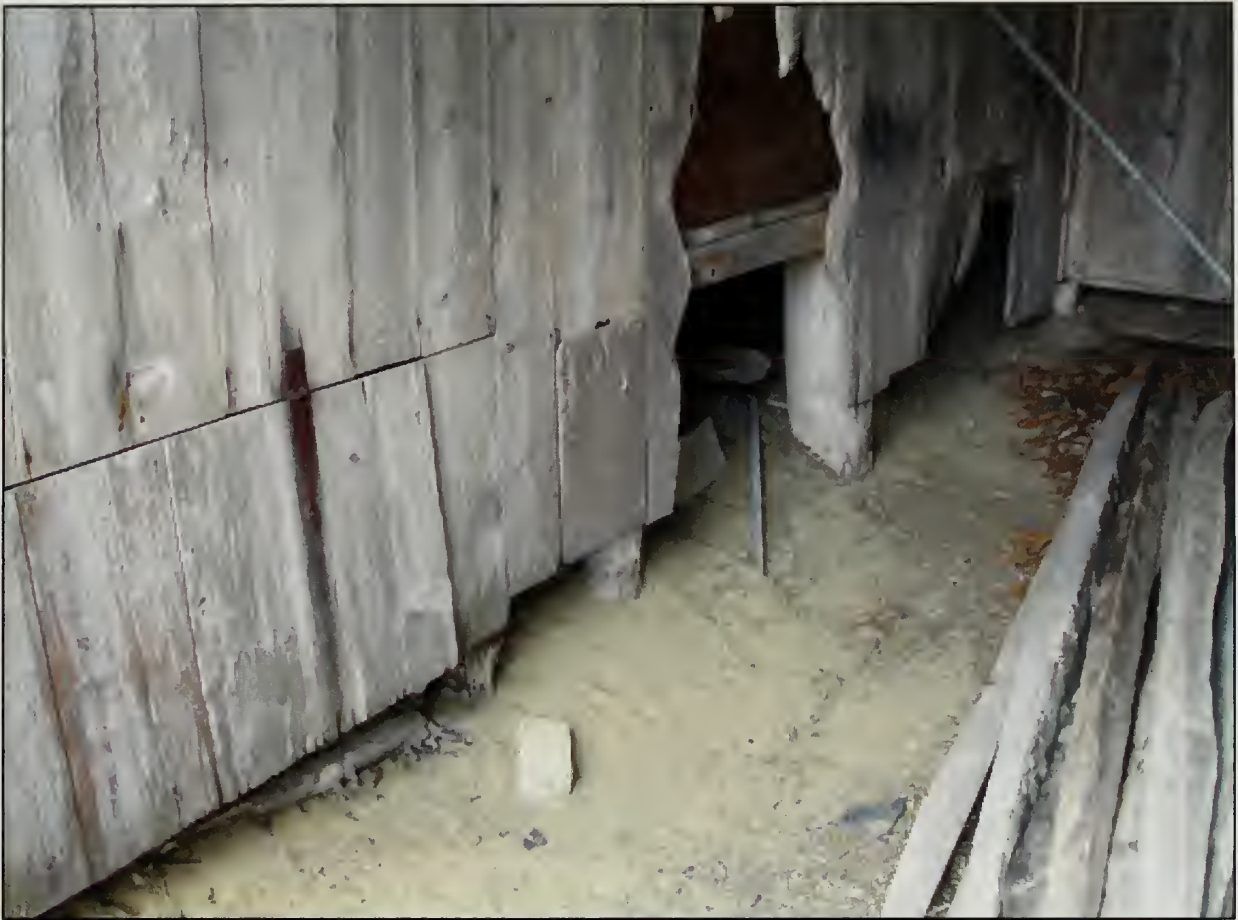
Figure 286. Wooden post foundation, Barn. (Photograph taken in the Open Shed looking at the south wall on the north side of the Barn where wall siding is missing) (2007).
