## THE LAND TITLE BUILDING Philadelphia, Pennsylvania

# Tech Notes

## MASONRY

## Stabilization and Repair of a Historic Terra Cotta Cornice

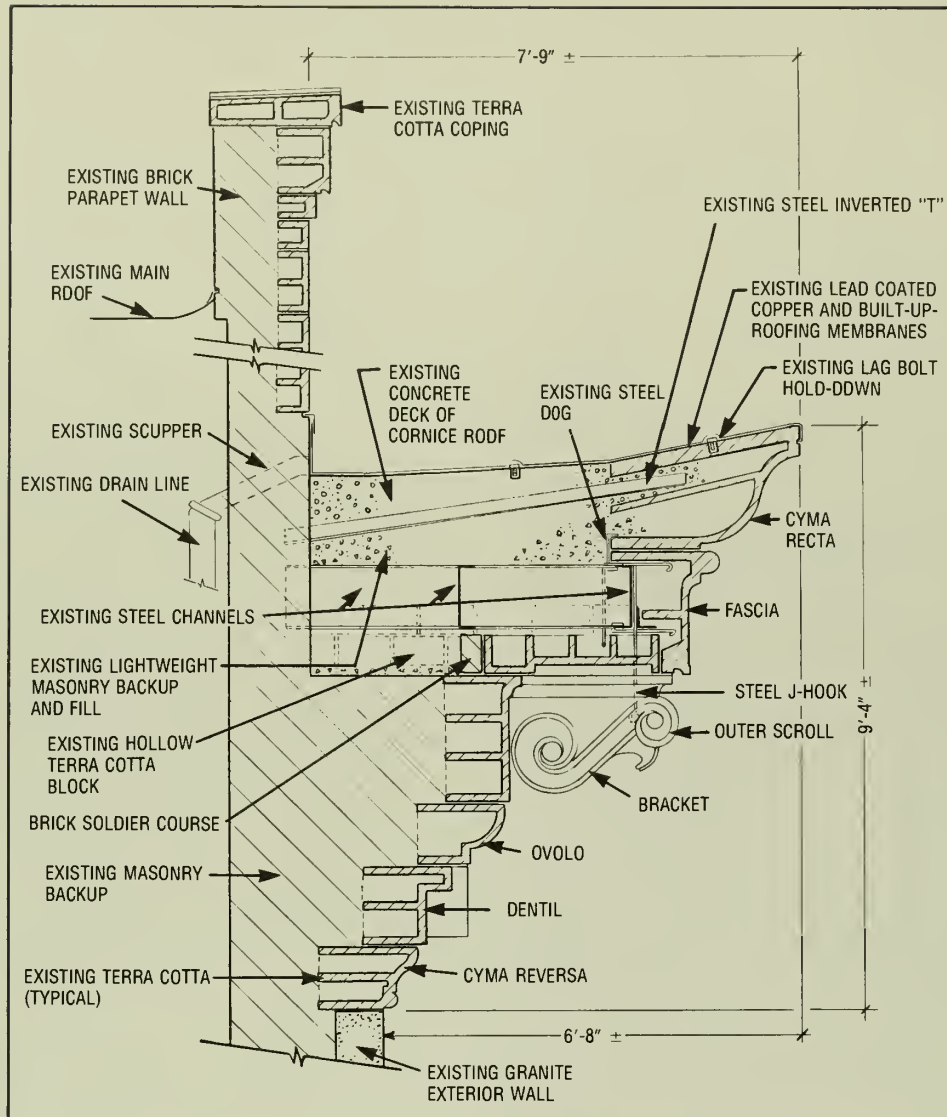
Figure 1. Section through the cornice and the parapet showing the structure's construction and attachment to the building. The inverted T's are embedded in concrete and act in friction to help support the cyma recta unit from rotating outward. The test openings did not penetrate below the soffit level of the cornice. Drawing by Jeffrey S. Levine.

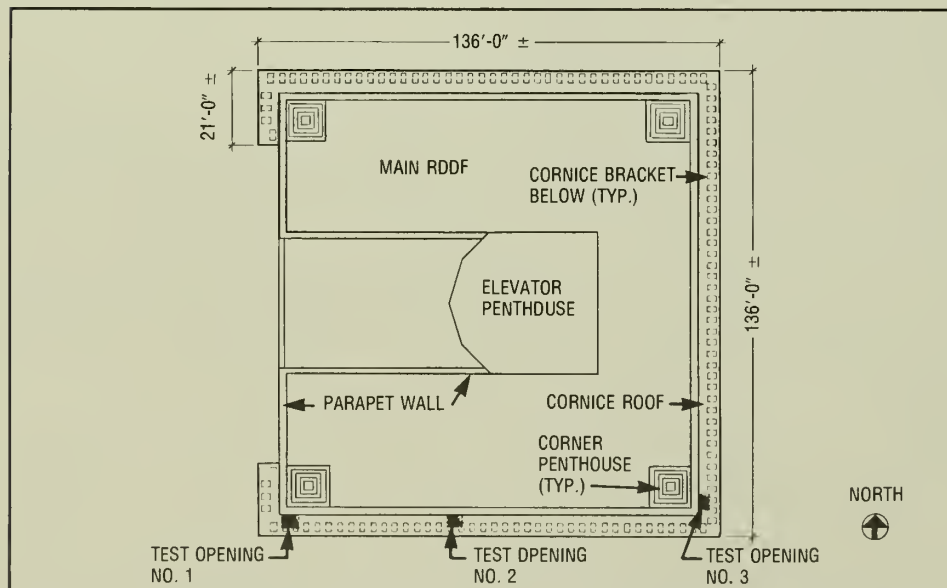
Figure 2. Roof plan of the 1902 tower showing the location of test openings in the cornice roof. Each bracket was later numbered consecutively so that easy reference could be made to a particular area of the cornice. Drawing by Jeffrey S. Levine.

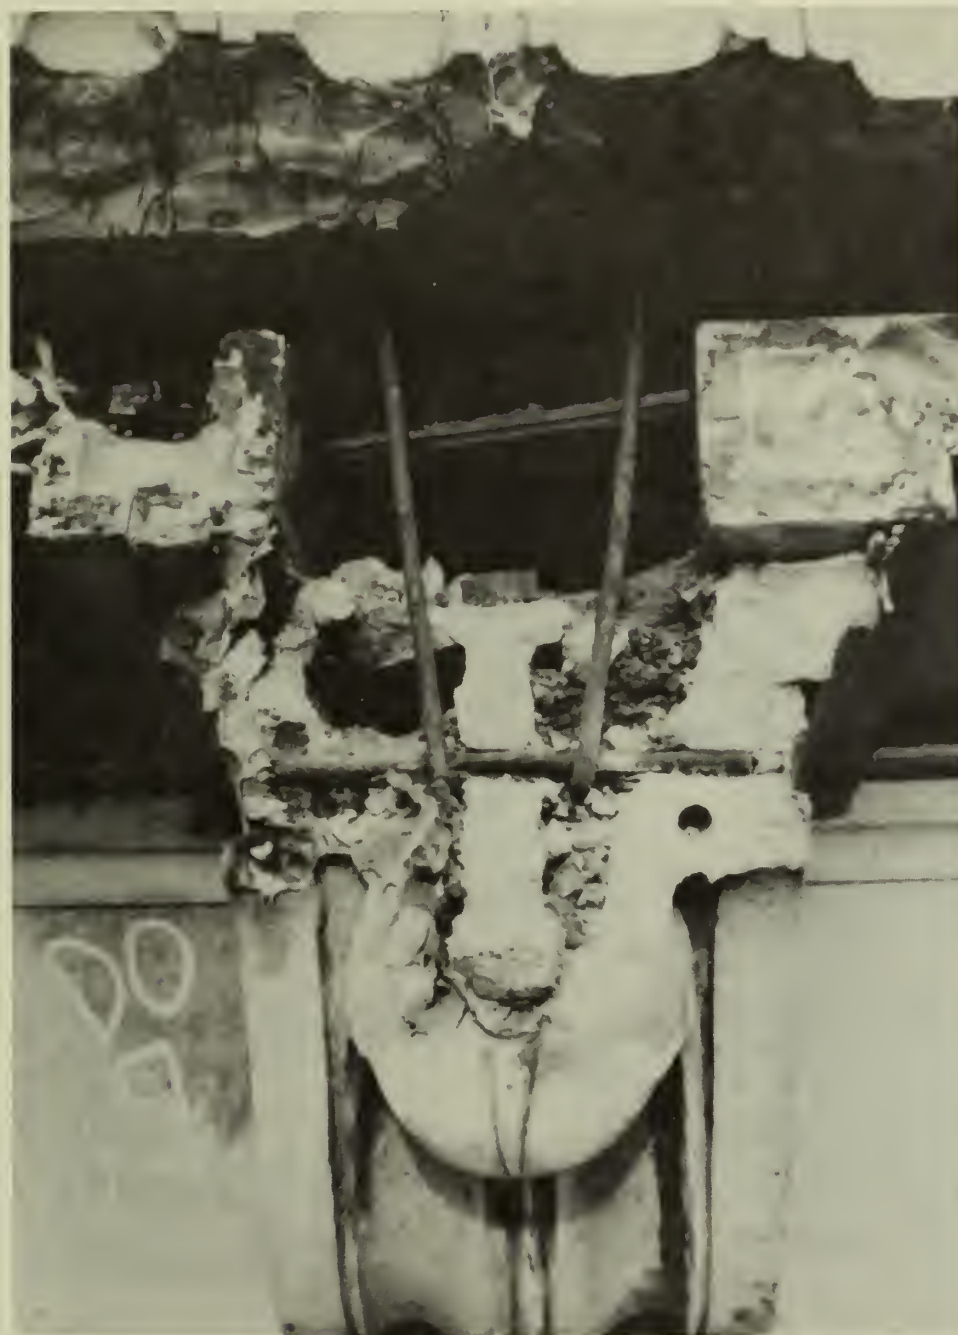
Visual inspection of the terra cotta revealed four common types of deterioration: spalls, glaze crazing, cracking, and open mortar joints. In addition, sounding the terra cotta units with a wooden mallet indicated that roughly 10% of the terra cotta units had cracked internal webs. Deterioration resulting in loss of material appeared with less frequency and was found principally at the outer scroll of the brackets (see figure 3) and at the scalloped fascia (see figure 4).

Figure 3. Numerous brackets were found to be missing their outer scrolls due to oxide jacking of the steel J-hooks, steel pencil rods, and temporary support wires located within the units that were used for installation. Cracking in the brackets whose outer scrolls had not yet broken off indicated potential for further loss of material if stabilization measures were not undertaken.

During the original construction of the cornice, the brackets were hoisted into place and temporarily supported by the wires cast into the nose of the bracket units. J-hooks were then dropped down from the outermost steel channel above into the upper and outermost cells formed by the unit's internal webbing. A steel rod was then inserted horizontally through holes cast into the exterior sides and internal webs of the unit such that, with minor adjustment in the length of the J-hooks, the rod sat in the trough of the J-hooks; the weight of the bracket were thereby transferred to the J-hooks (see also figures 1 and 5). Photo by Jeffrey S. Levine.

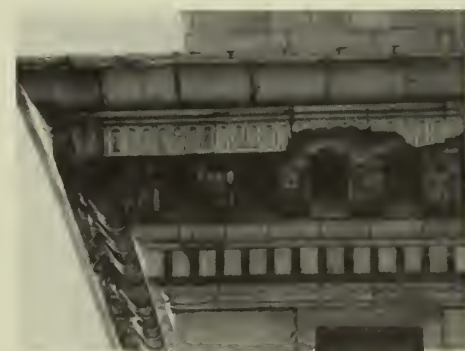
Figure 4. Extreme loss of material was noted in the scalloped fascia above the brackets at the south end of the east elevation of the cornice. This deterioration and corresponding cracking in other fascia units was due to rusting of the structural steel angle iron which supports the fascia units at their center webs (see figure 1). A likely point of water entry was a large open joint located immediately above the fascia, at the bed joint of the cyma recta units. Photo by Jeffrey S. Levine.

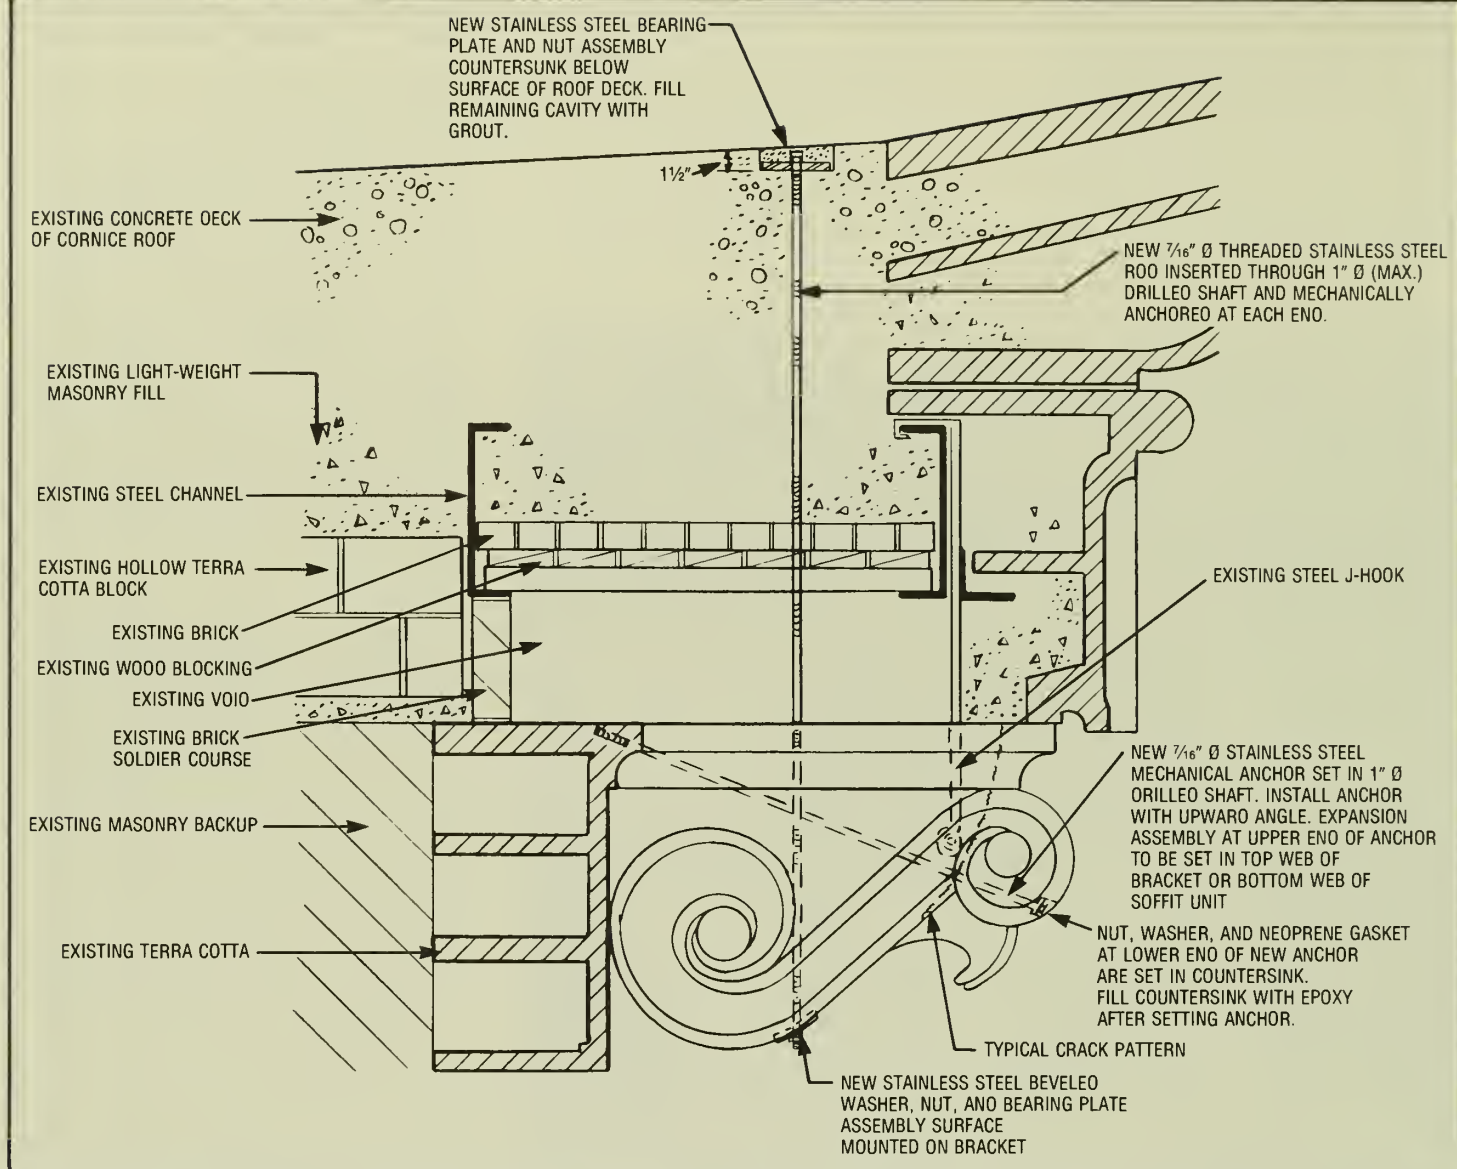
Figure 5. Detail section through the cornice showing the manner in which the vertical and angled outer scroll anchors were installed in the bracket units. The vertical hash-marks represent a typical crack pattern found in brackets which had not yet lost their outer scrolls. All 128 brackets received angled outer scroll anchors and about 80 received vertical anchors. Drawing by Jeffrey S. Levine.

to be suitable when set in brick backup or in structural steel. Pull-out values of from 500 to 1,800 psi were obtained in these materials, without any slippage or failure. These values were sufficiently high to provide a working safety factor of four times the weight of the terra cotta unit being supported. After making the decision to use mechanical anchors, drilling tests were conducted to determine anchor depths and backup materials at typical anchor locations on the cornice. Because the depth of penetration of the bracket units into the backup masonry could not be verified by non-invasive means, it was decided to anchor all brackets which had lost their outer scrolls or which had cracked internal webs. Given the condition of the light weight fill, this could only be achieved by extending vertical anchors through the roof (see figure 5).
