# OFFICERS CLUB Building No. 114

Sandy Hook Unit  
Gateway National Recreation Area  
Fort Hancock, New Jersey

Historic Structure Report

June 2006

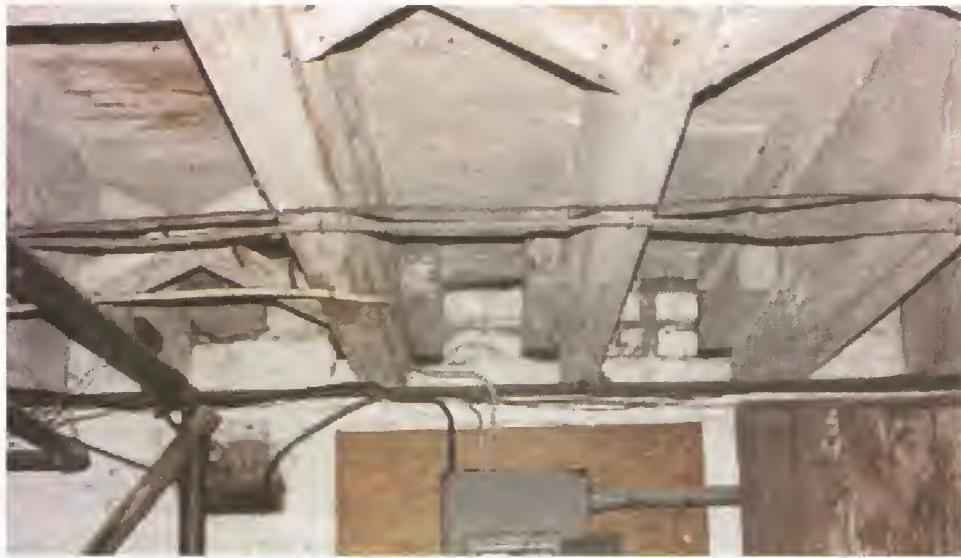
Figure 30. Officers Club, basement of rear ell, south wall, showing extant framing and brick infill that is evidence of earlier opening, 2005.

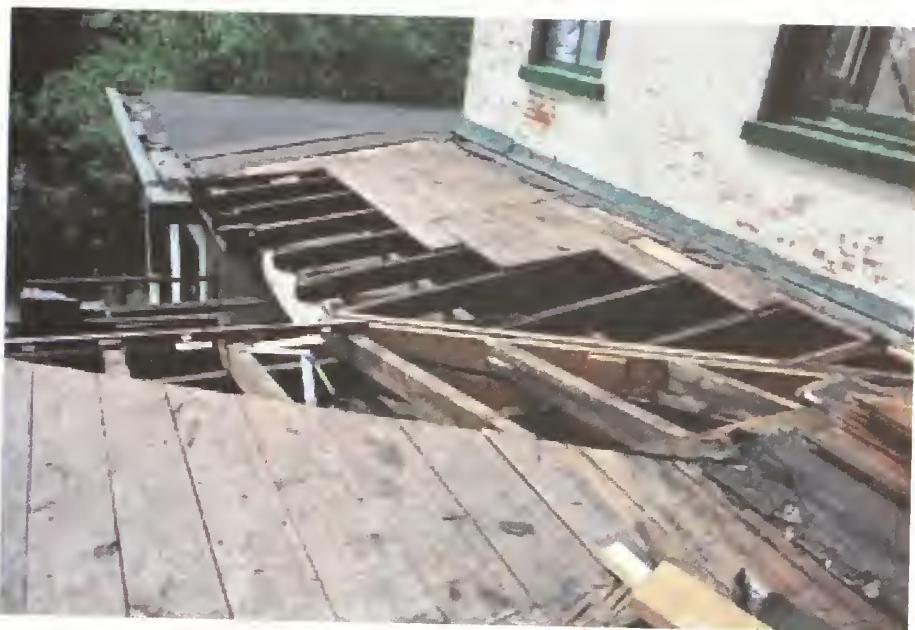
Figure 34. Officers Club, east façade, piazza roof, showing original framing and repairs, 1991.

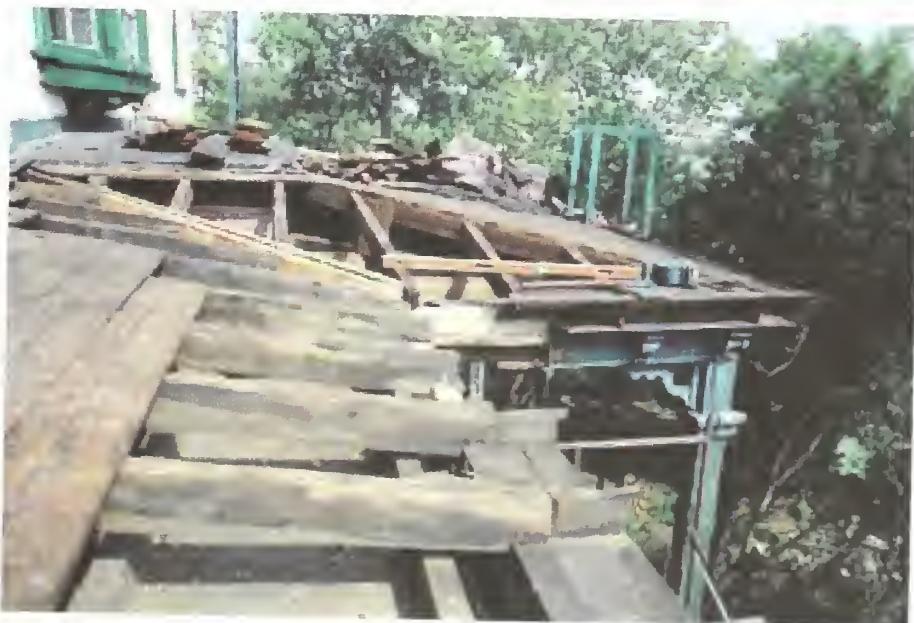
Figure 35. Officers Club, east facade, piazza roof, showing original framing with extended rafters for integral gutters.

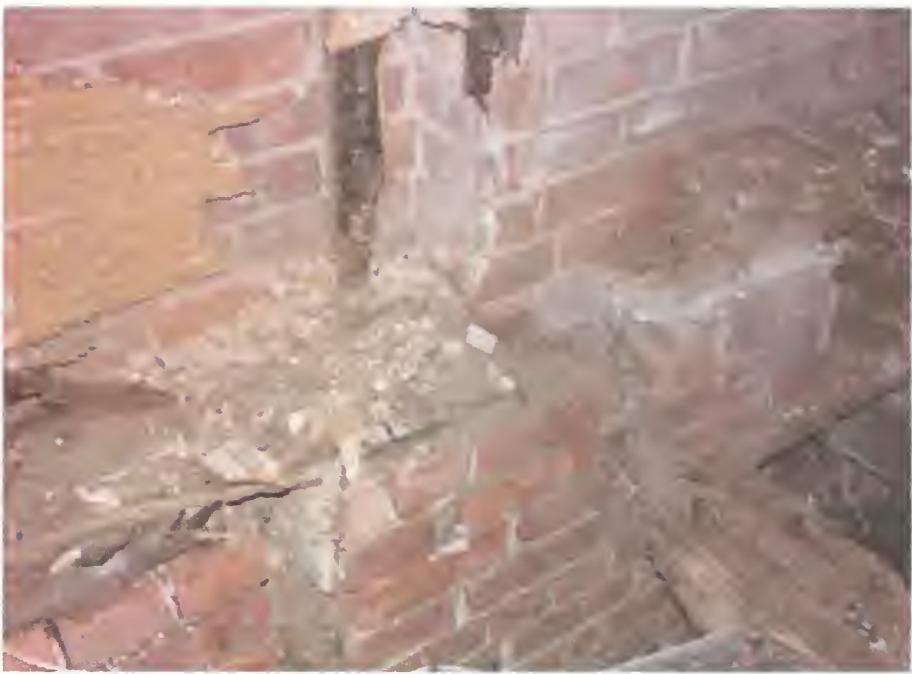
**Figure 38.** Officers Club, showing exterior bearing- wall construction at transition from first story to second story; also shows pockets in masonry for framing, 2005.
