BALCONY HOUSE: A HISTORY OF A CLIFF DWELLING, MESA VERDE NATIONAL PARK, COLORADO

by
Kathleen Fiero

with
Report of the 1910 Excavation and Repair of Balcony House
by
Jesse L. Nusbaum

Mesa Verde Museum Association, Inc.
Mesa Verde National Park, Colorado
1998

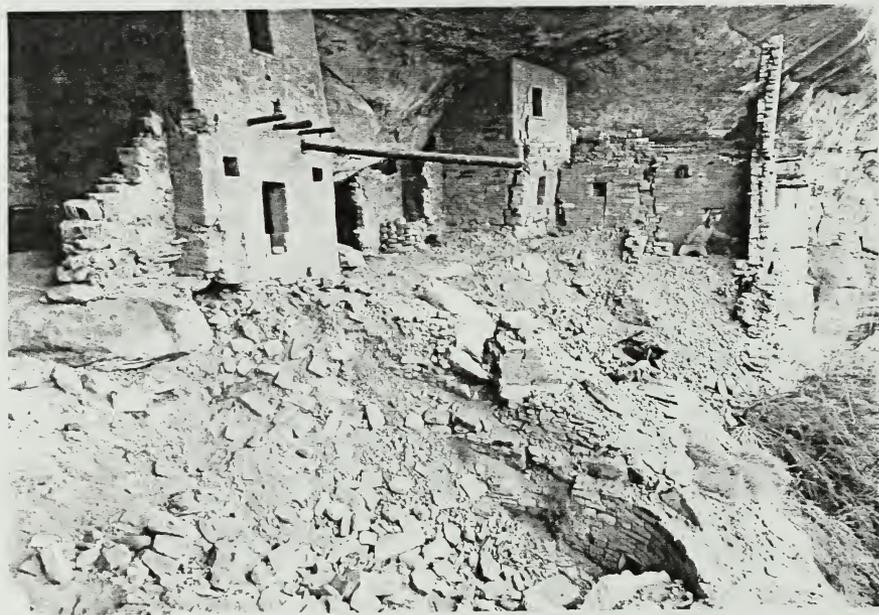
Figure 2.14. Balcony House before repair in 1910 view from south side, south of Kiva Plaza to the dividing wall, showing the extent of damage and destruction of the two kivas bordering the house wall and retaining front wall caused by massive rock fall from the alcove roof. Also note the curved stone kiva wall with niche in the foreground. E.M. Nusbaum is excavating at the dividing wall at right. Photo by Jesse L. Nusbaum, Courtesy Museum of New Mexico, Neg. No. 2151.35, 6320.

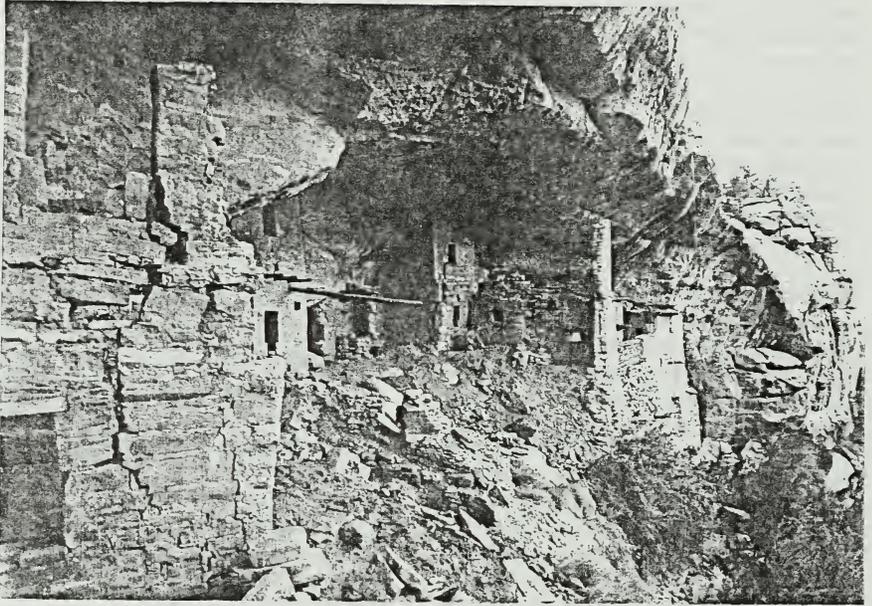
Figure 2.26. Balcony House before excavation in 1910. Notice the retaining wall at north end of dwelling, right of photo, the point where construction on the boulder had resulted in movement of the wall. Also notice the hose coming down from the mesa top in the north end of the site. Photo by Jesse L. Nusbaum, Courtesy Museum of New Mexico, Neg. No.2151.22, 60501.

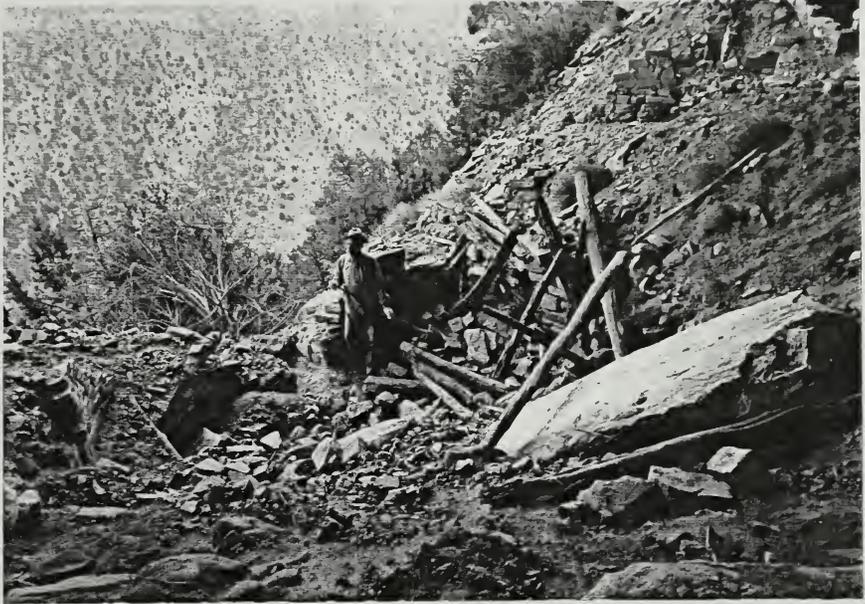
Figure 2.28. “Massive rockfall from roof of Balcony House alcove in the South or Kiva Plaza, following abandonment. Largely destroyed the two deep, cribbed roof kivas, cracked, or felled bordering house walls including the high retaining wall fronting the Plaza, and catapulted over the vertical cliff wall to talus slope below, most of resultant debris. The man, my father, standing on the sandstone formation floor of the kiva has exposed front walls, including air draft entrance (ventilator shaft) that survived.” Jesse Nusbaum caption, Photo by Jesse L. Nusbaum, Courtesy Museum of New Mexico, Neg. No. 2151.24, 60511.

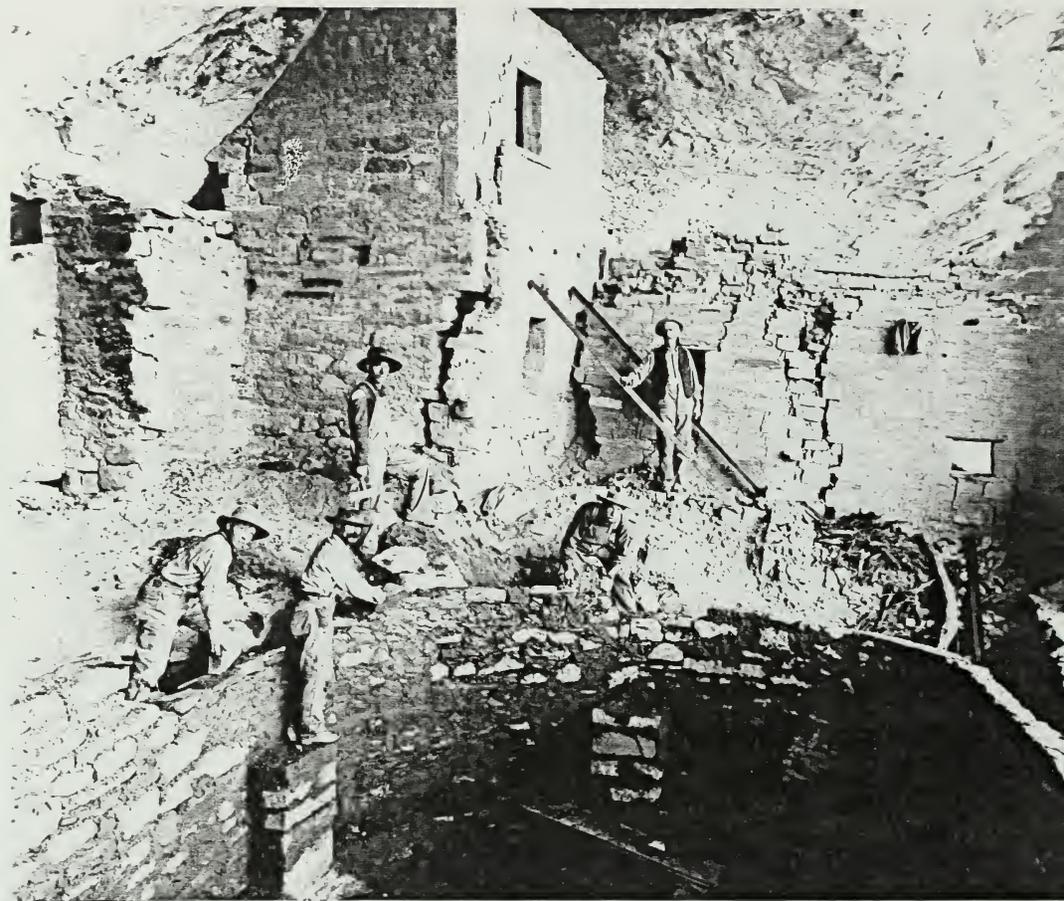
Figure 2.30. Repairing North Kiva, Kiva A, of Balcony House, Mesa Verde 1910. This is the wall that collapsed burying one of the workers. At far back E.M. Nusbaum with vest and hand on angle iron bracing wall of Room 18. Other workers are not identified but may be Scharf, Tommy, and Percy "Jack" Adams (at north edge of kiva). Photo by Jesse L. Nusbaum, Courtesy Museum of New Mexico, Neg. No. 2152.23, 60513. Mesa Verde National Park 740-08, Neg. No. 20354.

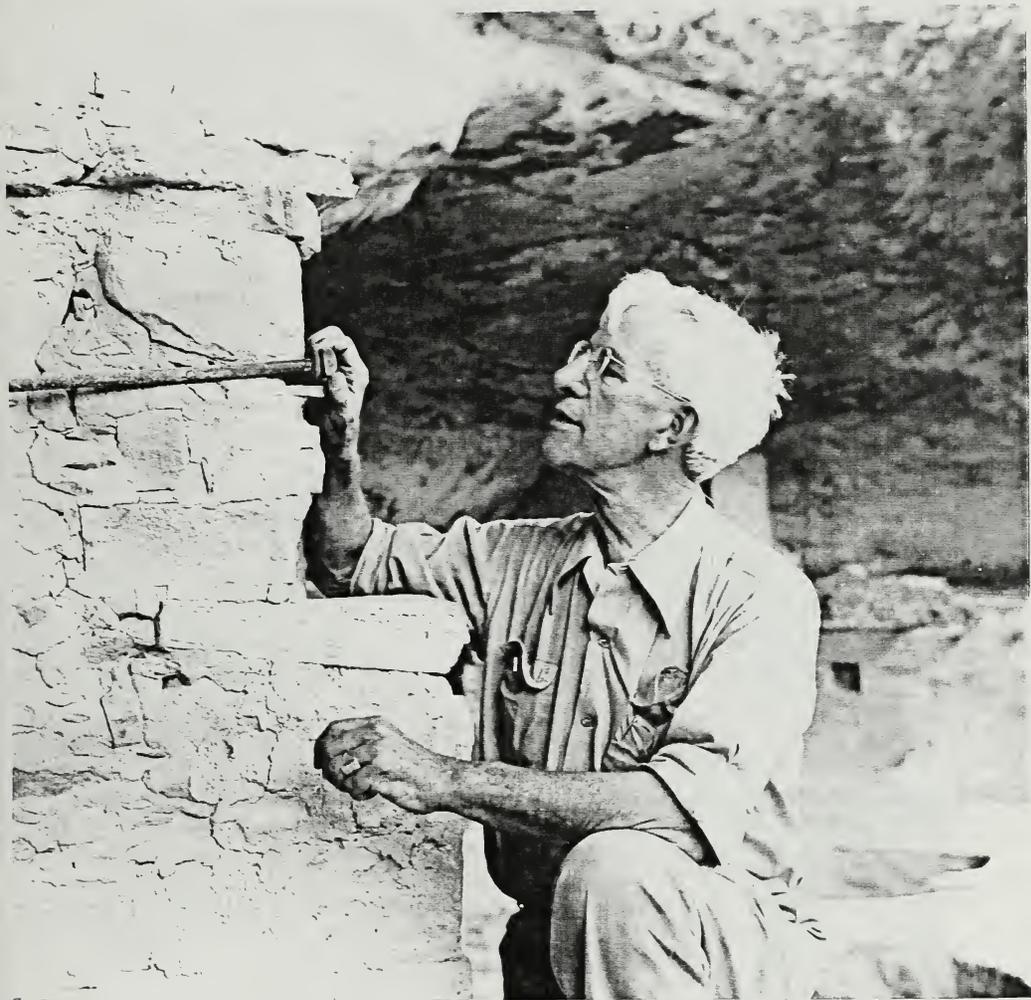
Figure 3.3. Jesse Nusbaum in 1965 inspecting the turnbuckle he installed in Room 26 at Balcony House in 1910. Photo by Elmer Weaver, Nusbaum (Talley) Papers Mesa Verde National Park # 1328.

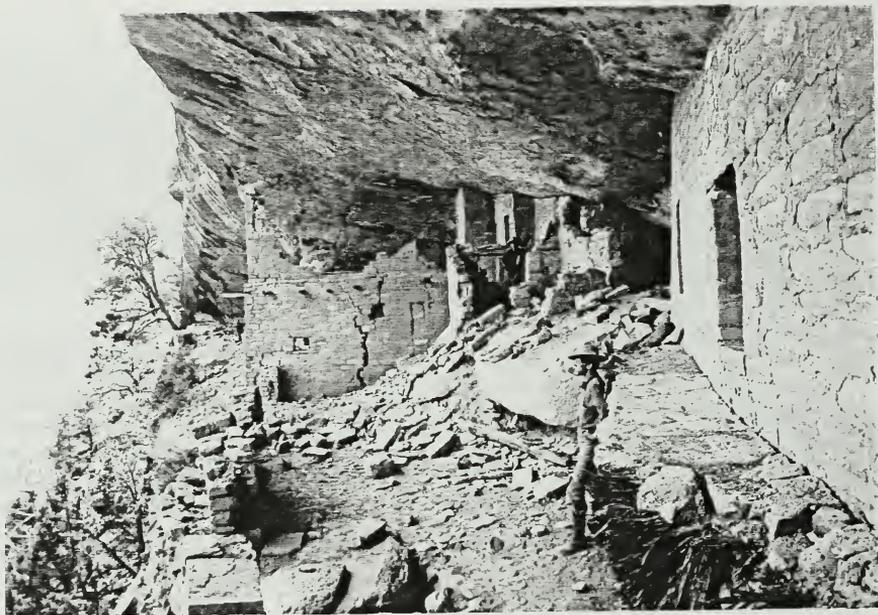
Figure 5.4. Balcony House, North Plaza, before stabilization 1907, looking south. The balcony construction with overlapping split cedar (juniper) slabs, bundles of bark, mud, clay, and flat slabs of sandstone is visible across Rooms 5 and 6. Unidentified man stands in front of the balcony in the North Plaza. Dr. A.J. Fynn (identified by Jack Smith) stands in background in Room 12. Photo by Jesse L. Nusbaum, Courtesy Museum of New Mexico, Neg. No. 2151.6, 6318.

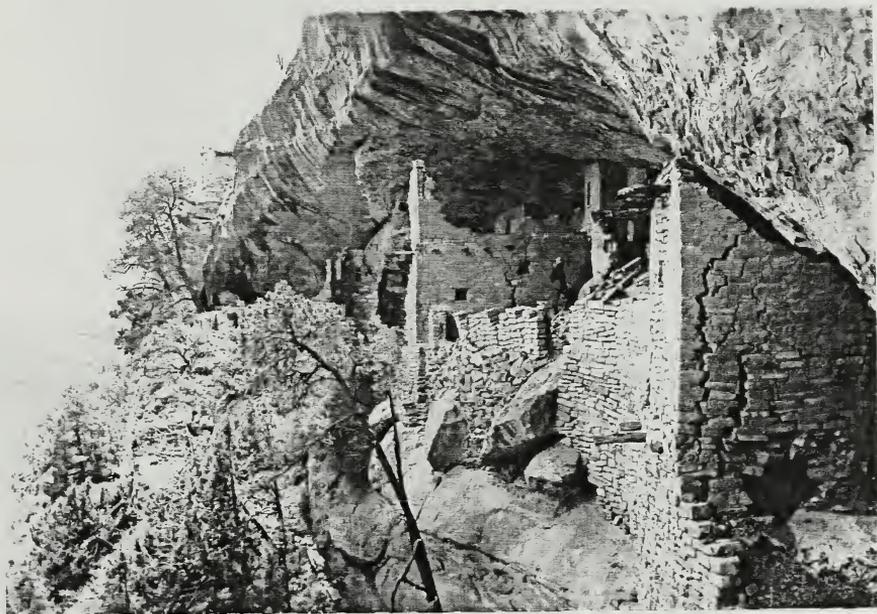
Figure 5.5. Balcony House, looking south into alcove, before restoration in 1907. Notice large cracks in walls of Rooms 4/5, at right of photo, where walls settled and had poor bonding. A.J. Fynn, a visitor, stands in the North Plaza near deteriorated retaining wall. Photo by Jesse L. Nusbaum, Courtesy Museum of New Mexico, Neg. No. 2151.15, 6314

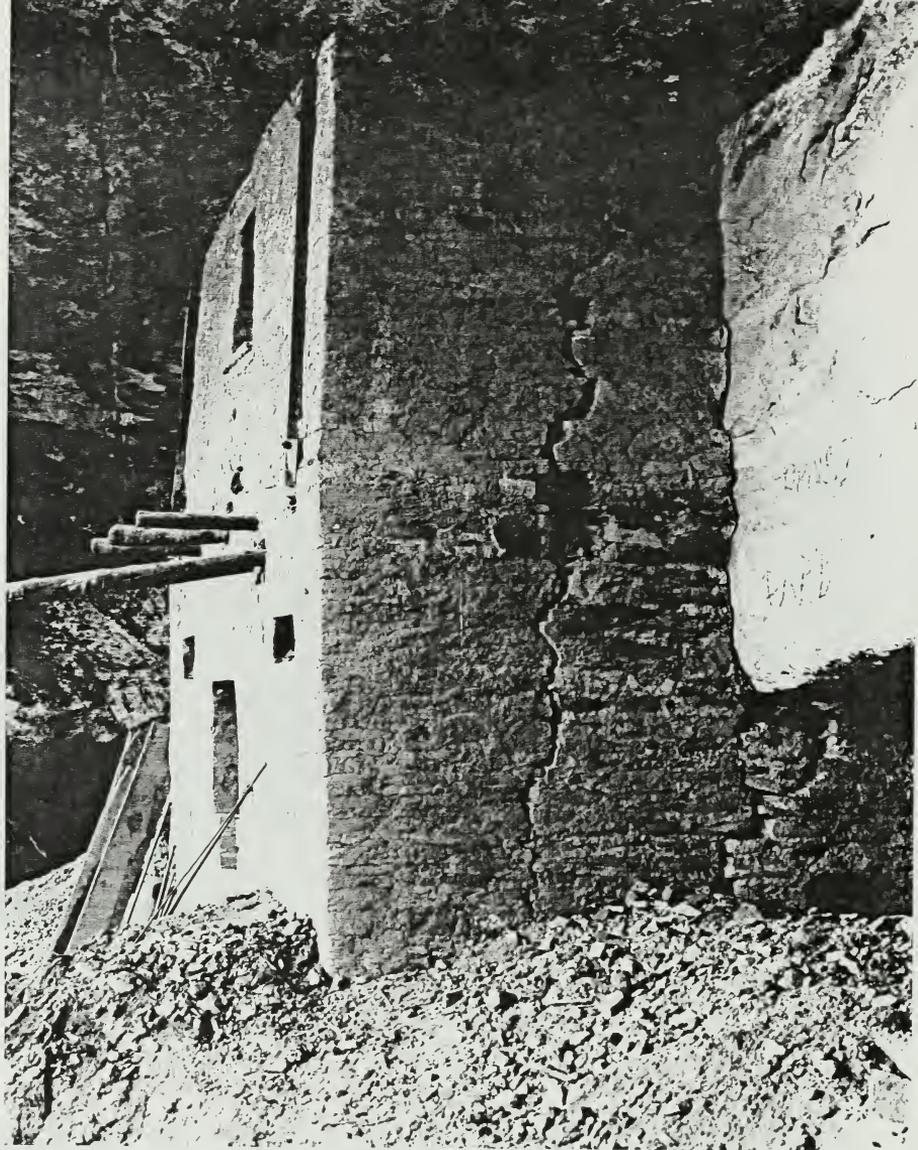
Figure 5.6. Cracks in wall of main "tower" South Plaza during stabilization 1910. Note graffiti on plastered wall at right. Metal braces have been installed on Room 21b. Milled boards and metal rods are waiting for use at the base of the "tower." Photo by Jesse L. Nusbaum, Courtesy Museum of New Mexico, Neg. No. 2151.12, 60526.

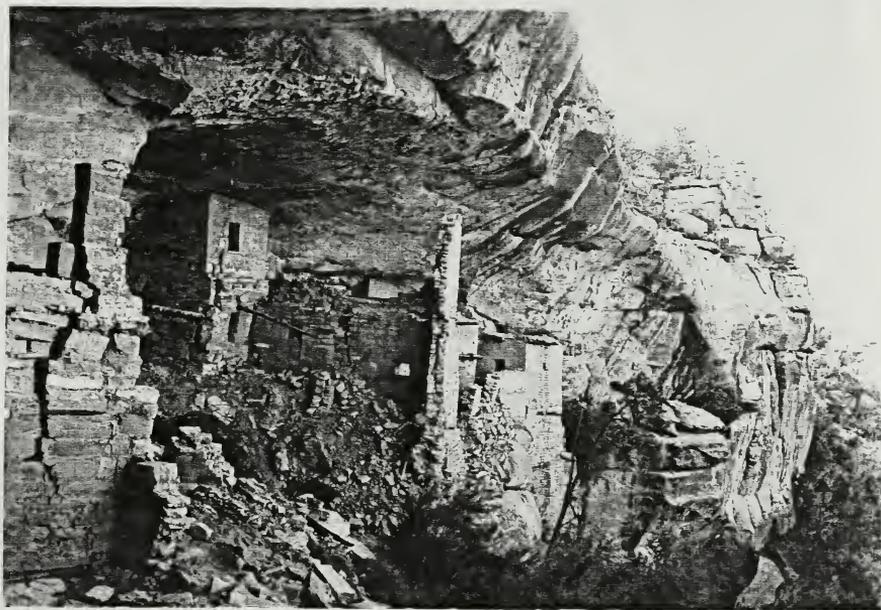
Figure 5.15. Balcony House looking from the south in 1907 before stabilization “That Balcony House needed attention to save it from early destruction was obvious,” wrote Jesse Nusbaum. Photo by Jesse L. Nusbaum, Courtesy Museum of New Mexico, Neg. No. 2151.22, 60502.
