# Arlington House, The Robert E. Lee Memorial

## North Dependency Historic Structure Report

2010-0053-P

Report prepared by Charles Fisher, Chad Randl and Kaaren Staveteig

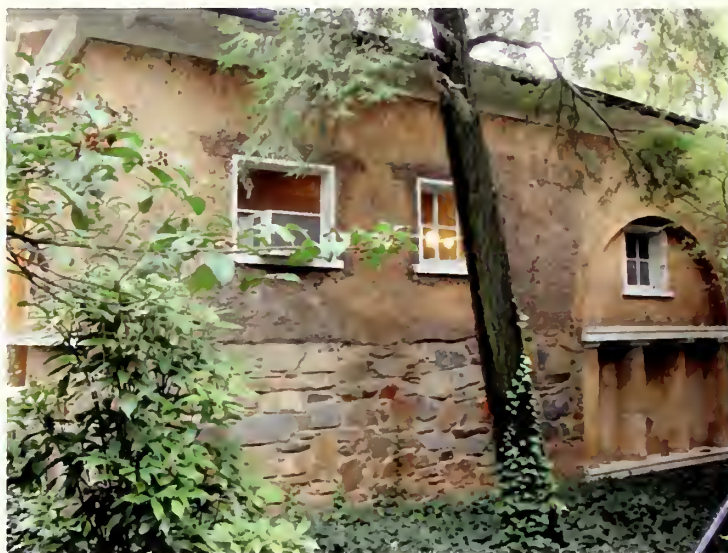
Figure 3. North elevation, 2003. Grade changes and window infill help conceal the historic two-story appearance of the facade.

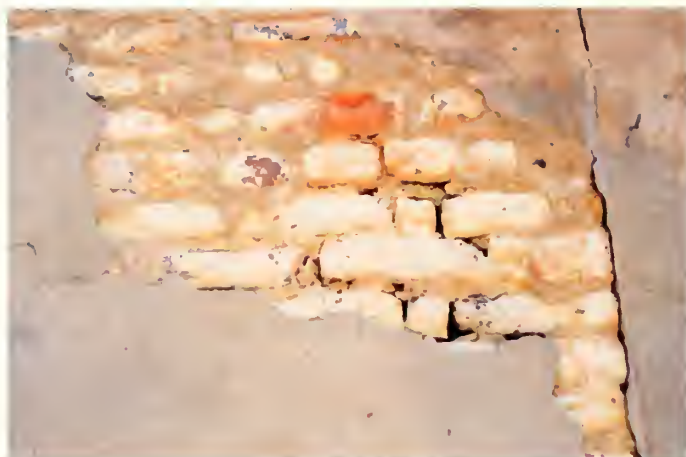
Figure 4. North elevation, 2003, showing painted brick beneath later smooth stucco finish in the recessed arch.

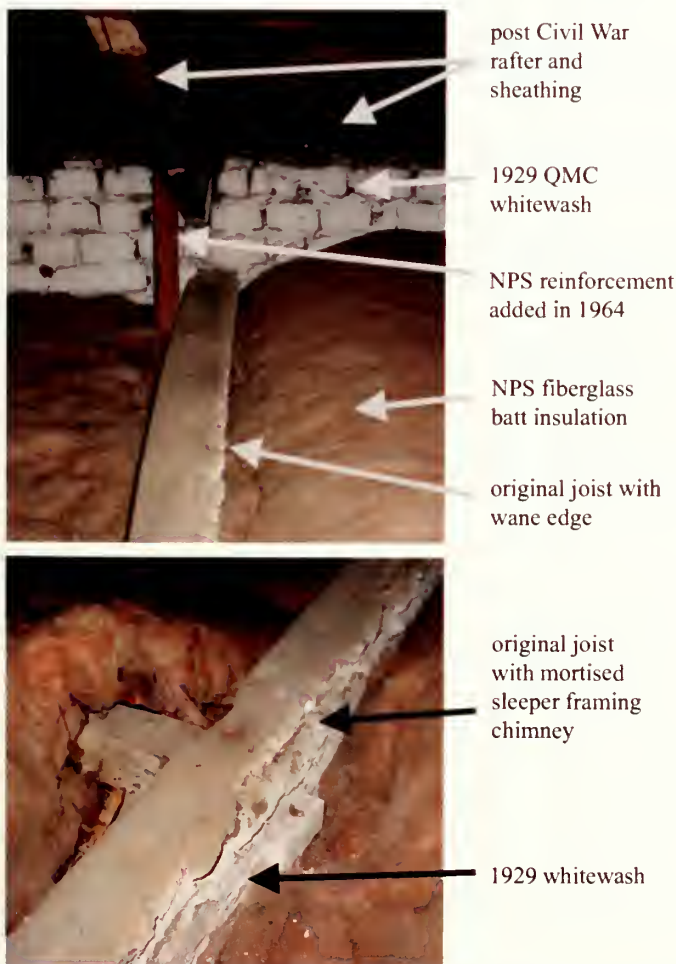
Figures 5 (top) and 6. Above east room, 2003. A surviving original joist with a wane edge, roughly finished and unpainted (until the 1929 QMC restoration). Original joists passed through or sat atop the north and south exterior walls to function as outriggers beneath the eaves.

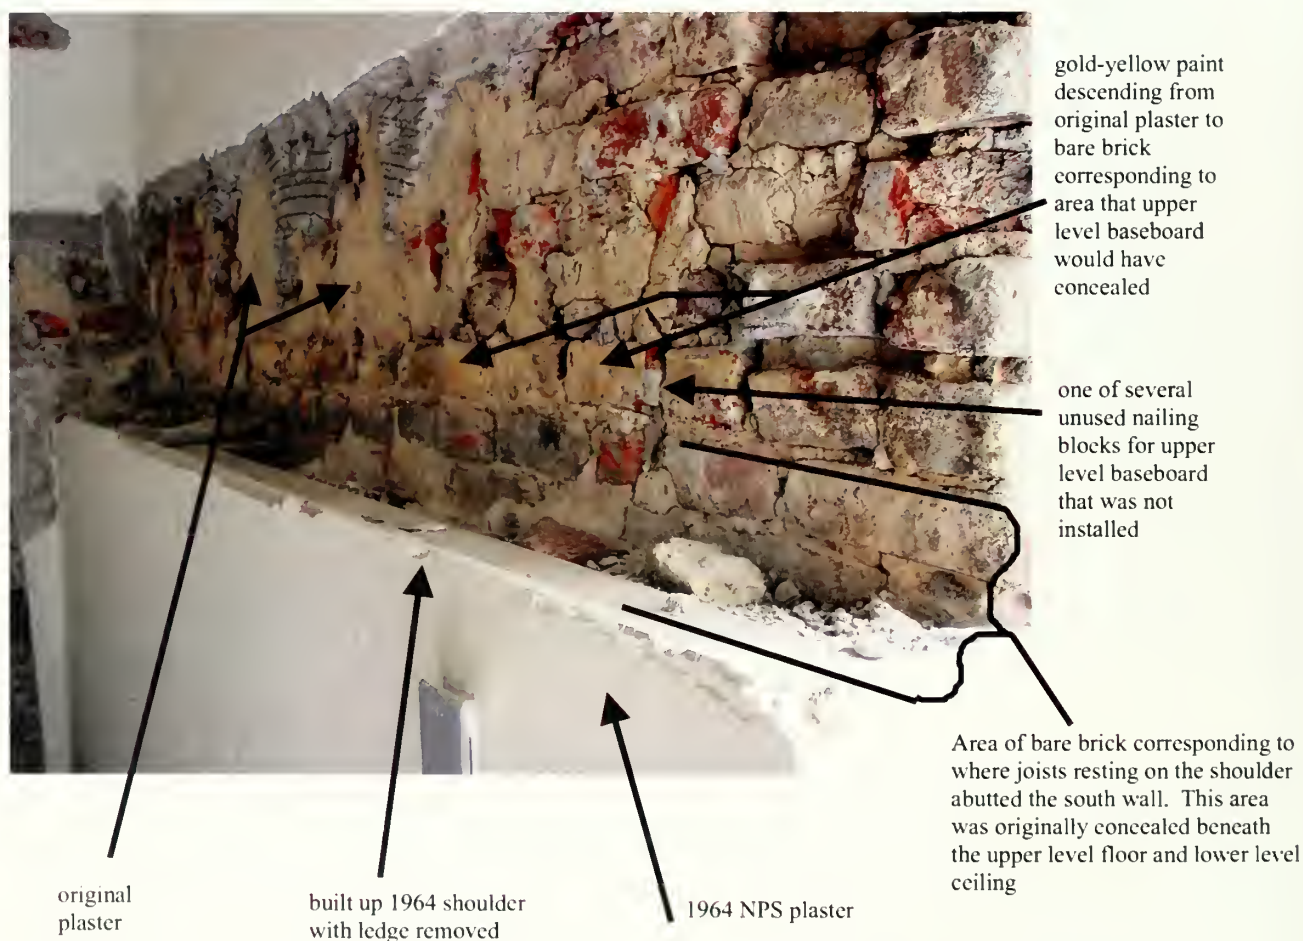
Figure 12. East room, south wall, 2003. Showing area where the upper-level floor joists rested on the shoulder and against the east side of the south wall. Originally this area was concealed behind the upper-level floor and the lower-level ceiling. A gold-yellow distemper paint is found on the original plaster above continuing down to where the plaster thins to bare brick. This area where the plaster stops was originally to have been covered with a baseboard. But unused nailing blocks suggest that the baseboard was never installed and the lower edge of the upper-level wall was simply painted over.

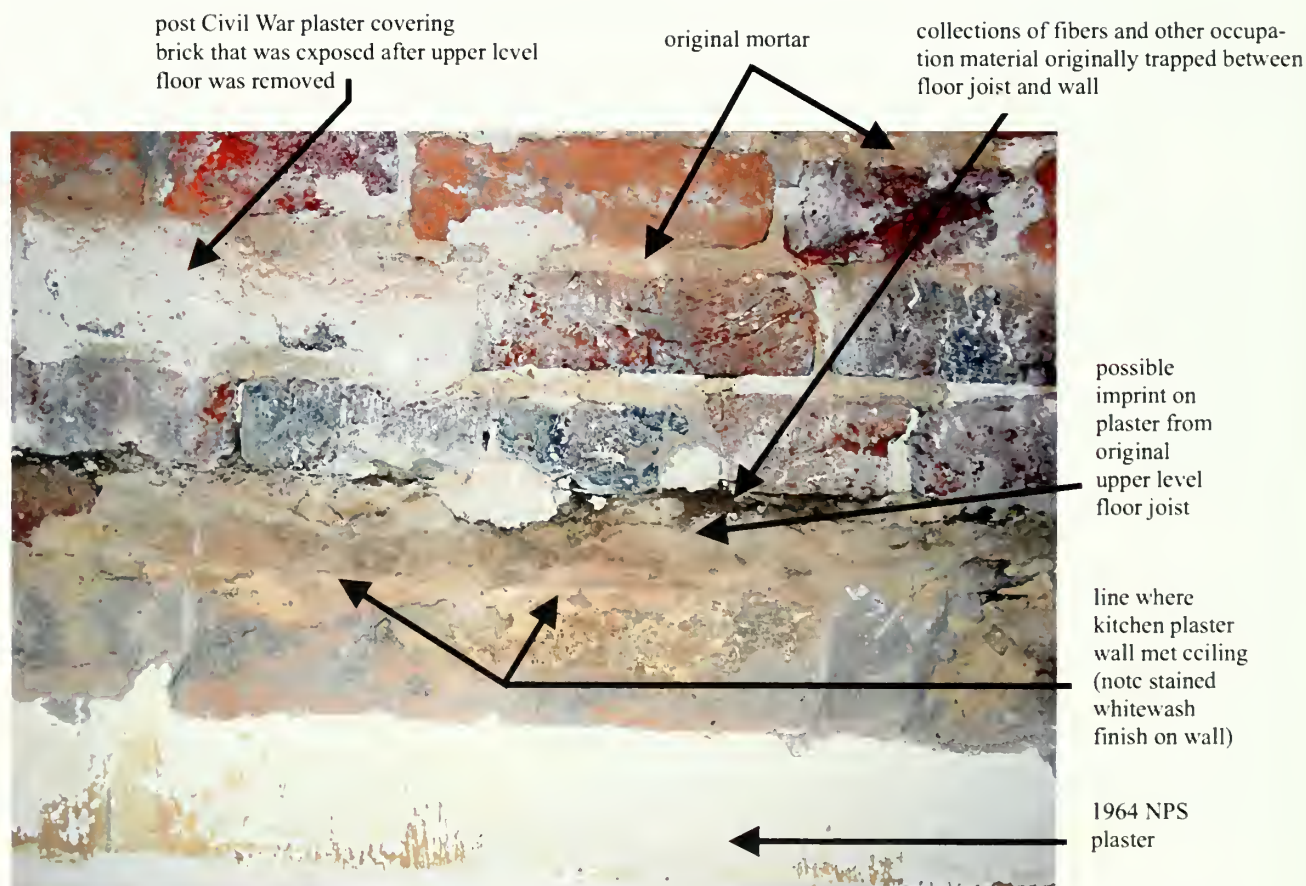
Figure 14. East room, west wall, 2003. Showing evidence of original floor level between upper living space and lower-level summer kitchen.

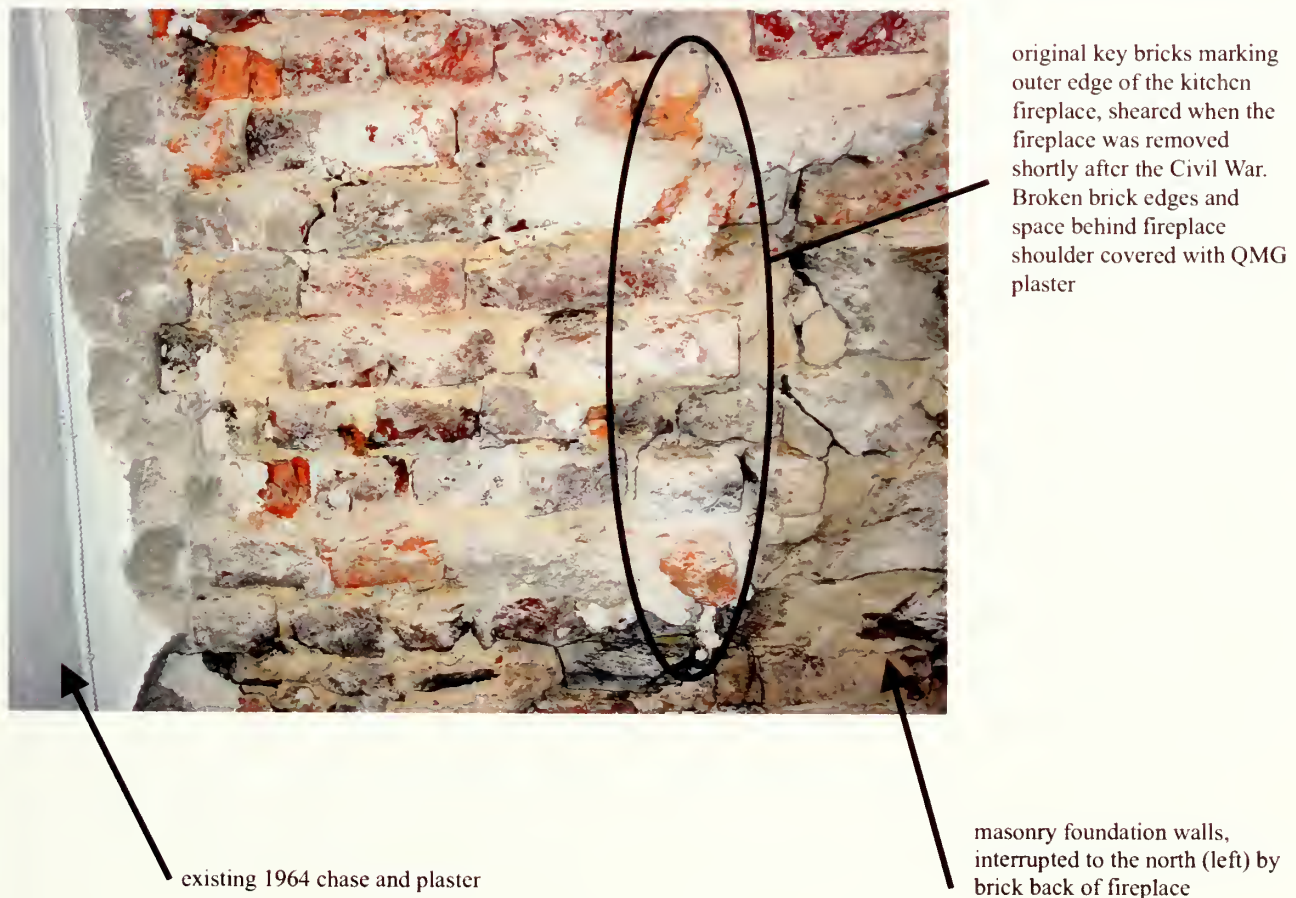
Figure 15. East room, south half of east wall, 2003. Showing the area behind the south half of original fireplace. Key bricks that once provided the connection between the wall and the fireplace were sheared to make the wall flush, when the fireplace and upper-level were removed. Plaster over top the broken bricks is the same as the post-Civil War era QMC plaster along the original upper-level floor line (see Figures 13 and 14).

Investigation revealed rows of spaced key bricks still embedded in the wall approximately 6'-6" apart (Figure 15). These bricks tied the original fireplace to the east wall and provided the outer dimensions (width) of the historic fireplace. Along the north side of the 1964 chase, just above the current grade, remnants of the original plaster flue lining with accumulations of soot are clearly visible (Figure 16). Other isolated patches of original plaster with soot are also visible further up on the wall corresponding to what was the original flue. A pattern to the plaster that might suggest the presence of a fireplace on the upper-level in addition to the lower-level summer kitchen fireplace was

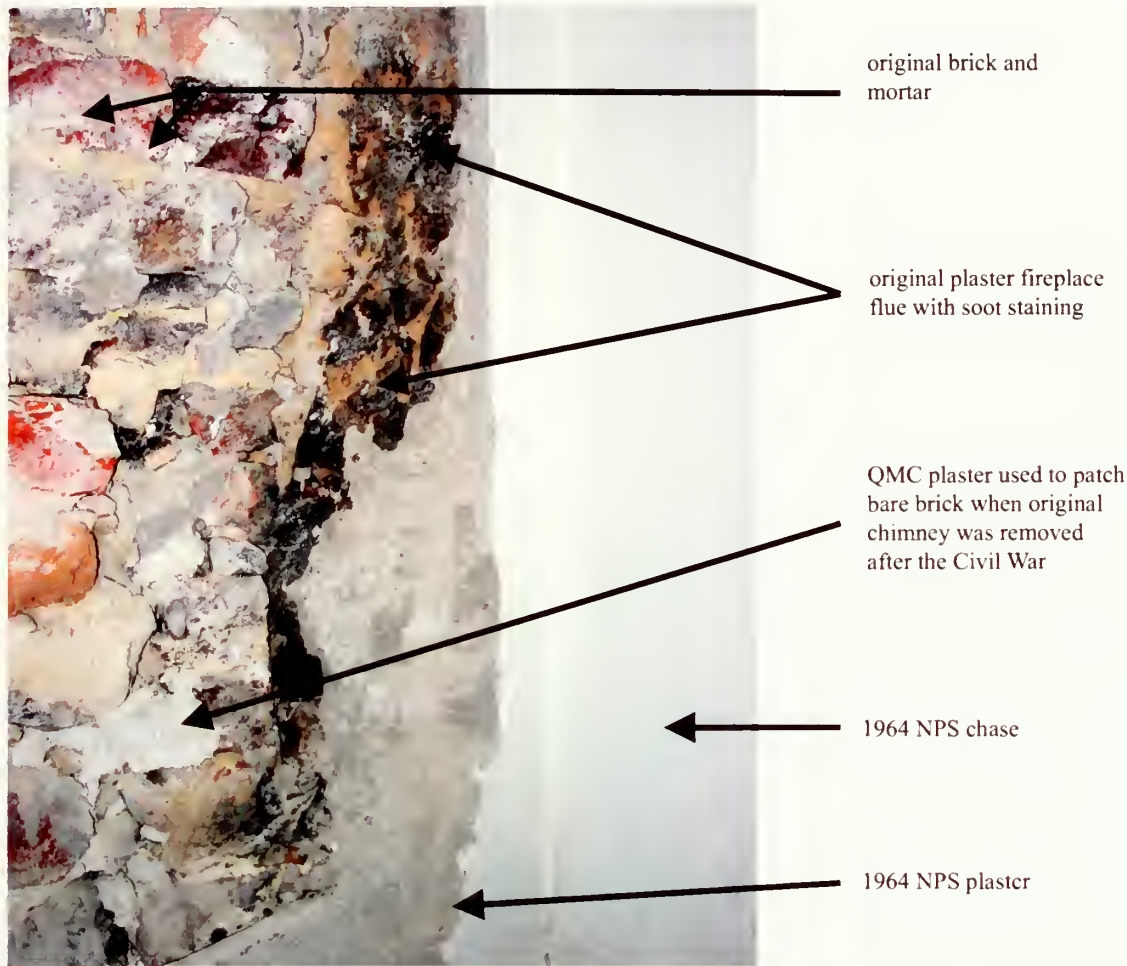
Figure 16. East room, north area of east wall, 2003. Showing area to the north of the 1964 NPS chase. The soot-stained flue of the original fireplace is visible beneath the NPS plaster.

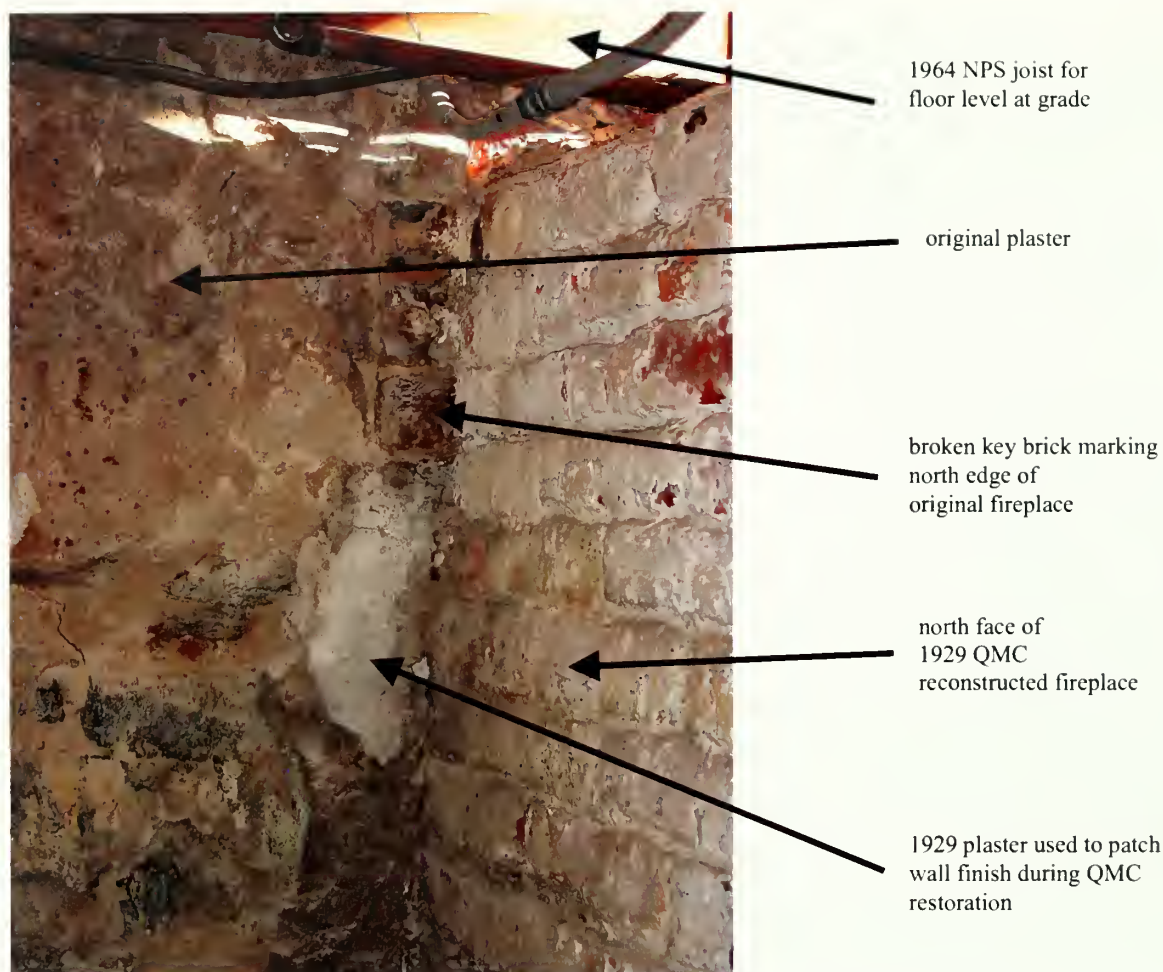
Figure 17. East room, north portion of east wall, 2003. Showing area of wall beneath current grade with evidence of original kitchen fireplace edge, original plaster and alterations made in 1929 when the QMC restored the summer kitchen and reconstructed a fireplace.

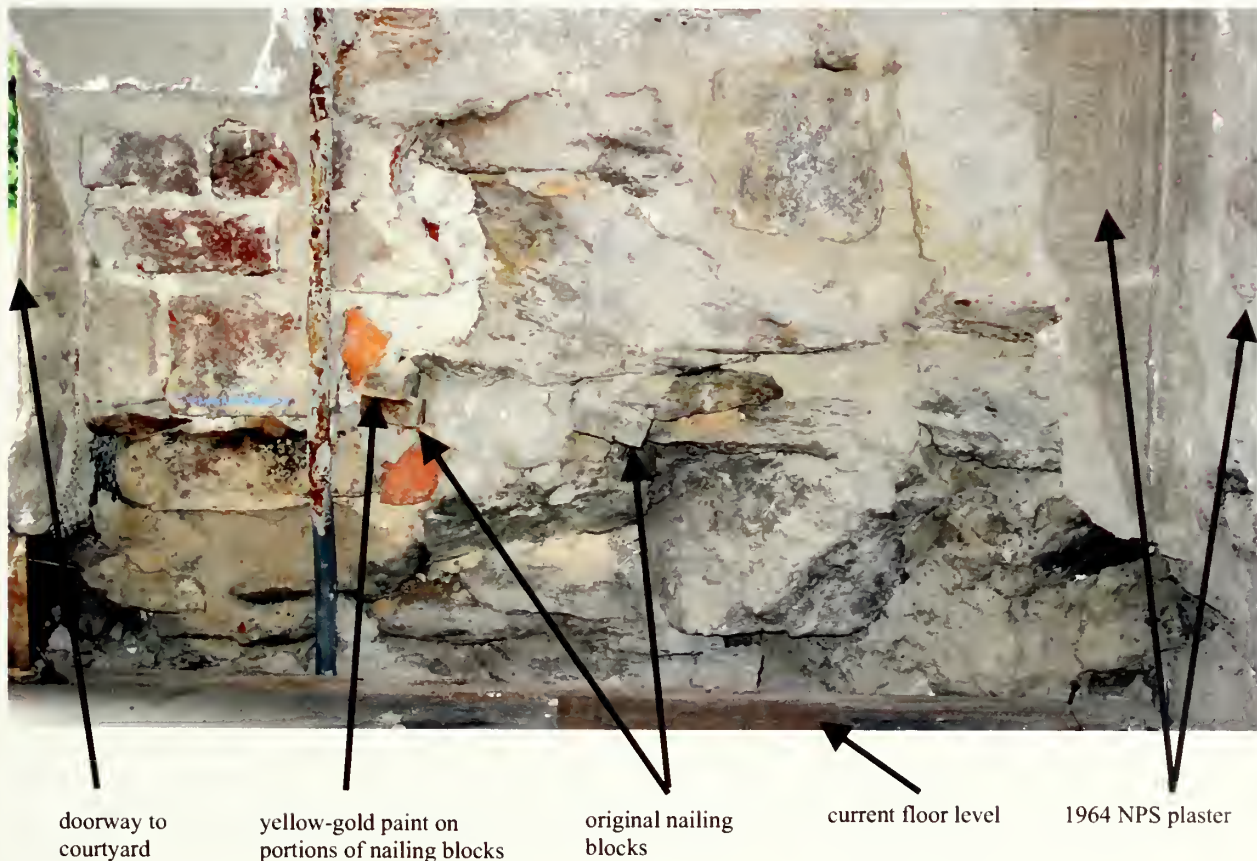
Figure 20. Center room, close up of west side of south wall, 2003. Showing nailers embedded in original plaster.

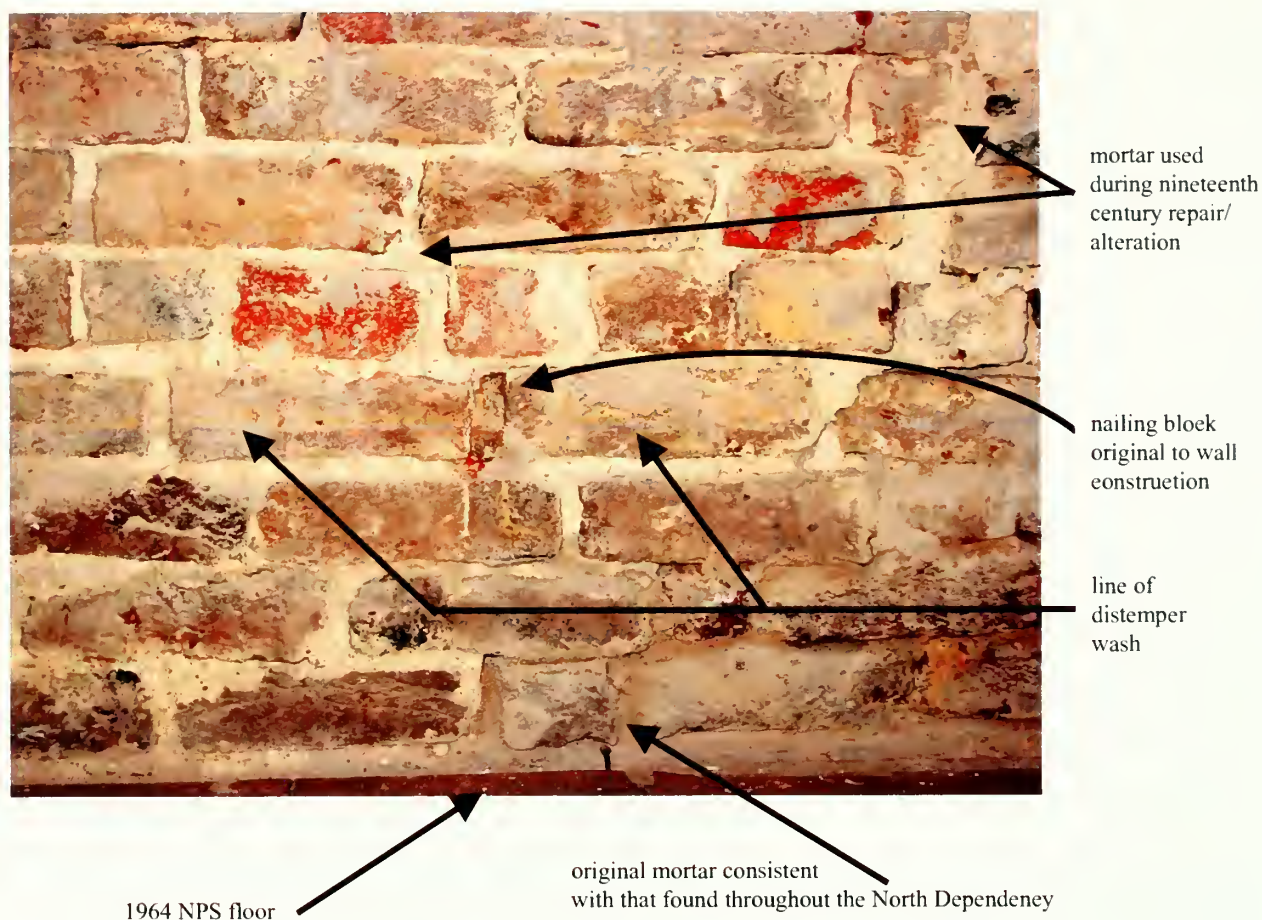
Figure 21. Center room, close up of north wall, 2003, Showing nailers and line of bright yellow distemper wash. It appears that the nailers provided a means of anchoring a baseboard to the wall above the floor. The distemper probably marks a line corresponding to the upper edge of the baseboard. Brick above the line would have been covered with plaster; brick below the line would have been concealed beneath the baseboard. Evidence of distemper on brick is similar to that found on the south wall of the east room, North Dependency (see Figure 12).

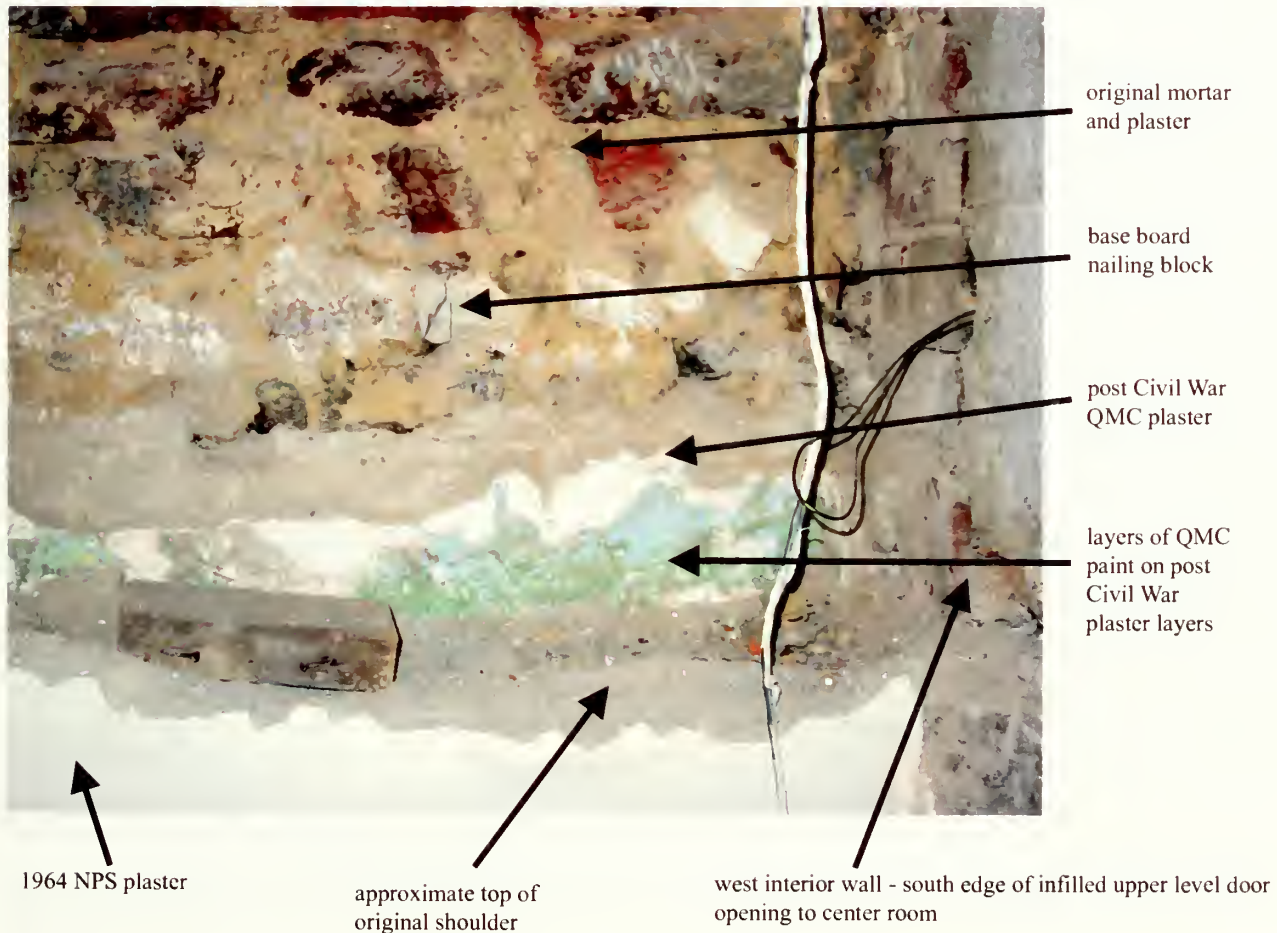
Figure 22. East room, west corner of south wall. After the Civil War, the QMC converted the east and west rooms to single level spaces by removing the upper-level floor and installing a new floor at-grade. This alteration revealed several courses of bare brick that the QMC then plastered over. Remnants of this plaster are visible on all four interior walls. Layers of paint finish survived on the north and south walls behind several courses of brick that the QMC had laid atop the original shoulder to raise the shoulder height during the 1930 restoration. The photo shows the shoulder with these later bricks removed to reveal the post Civil War plaster beneath.

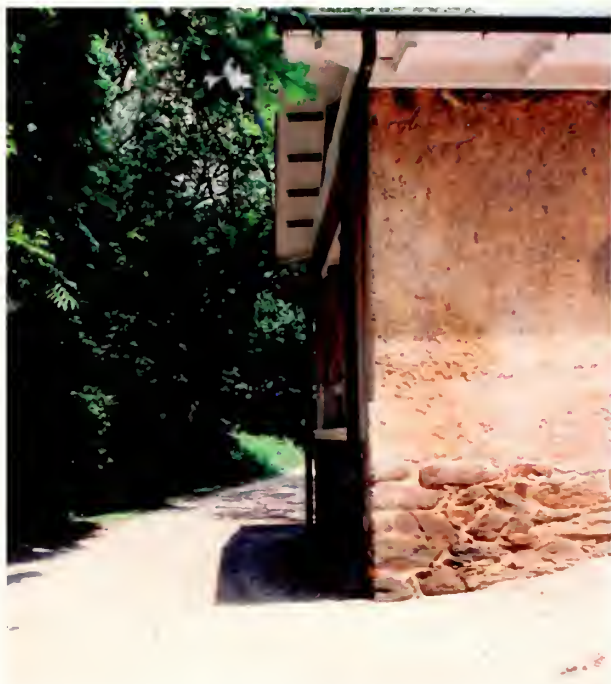
Figure 2. Road along west elevation where vehicular traffic splashes water onto the masonry wall and damages historic masonry and finishes.

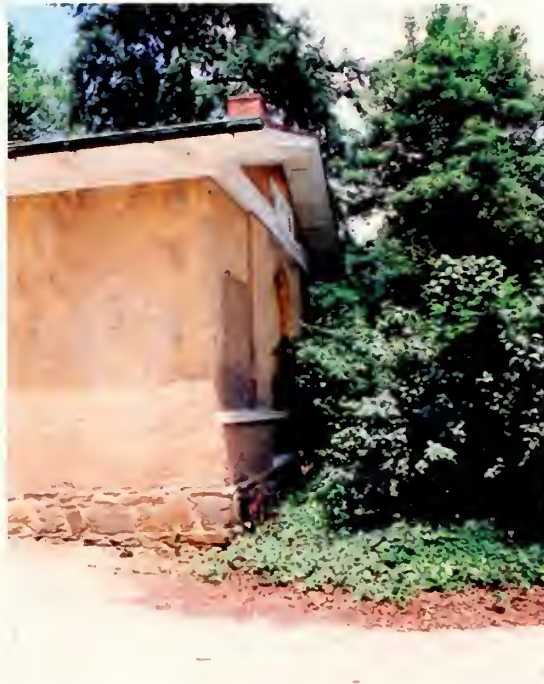
Figure 3. Vegetation on east elevation contributing to the buildings moisture problem.

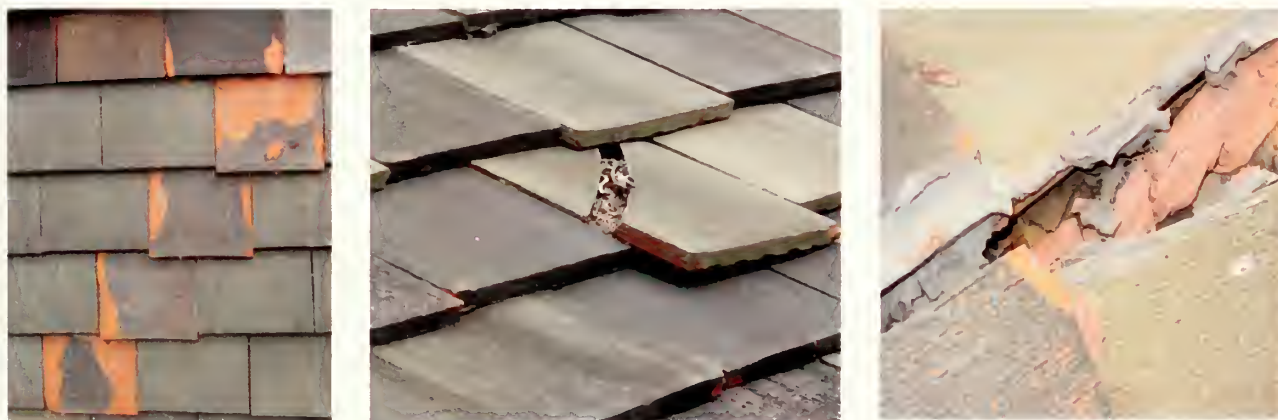
Figure 7: Delamination, chipping, crazing, and structural failure of tile shingles

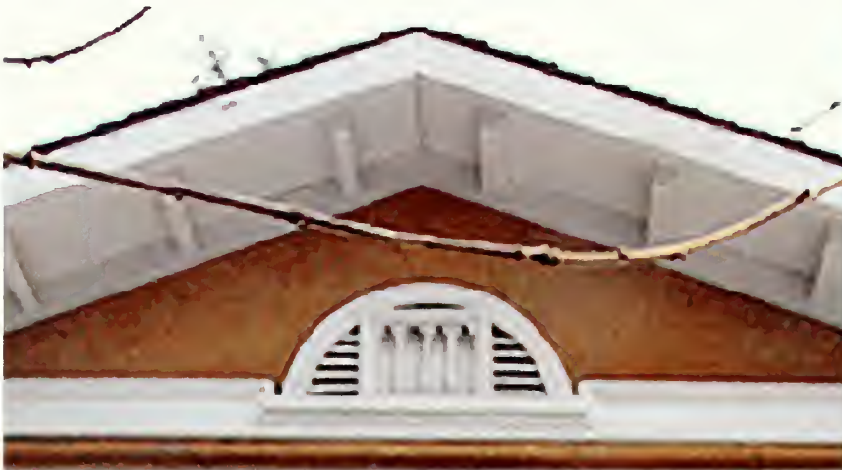
Figure 19. West elevation, fascia board is deteriorated.

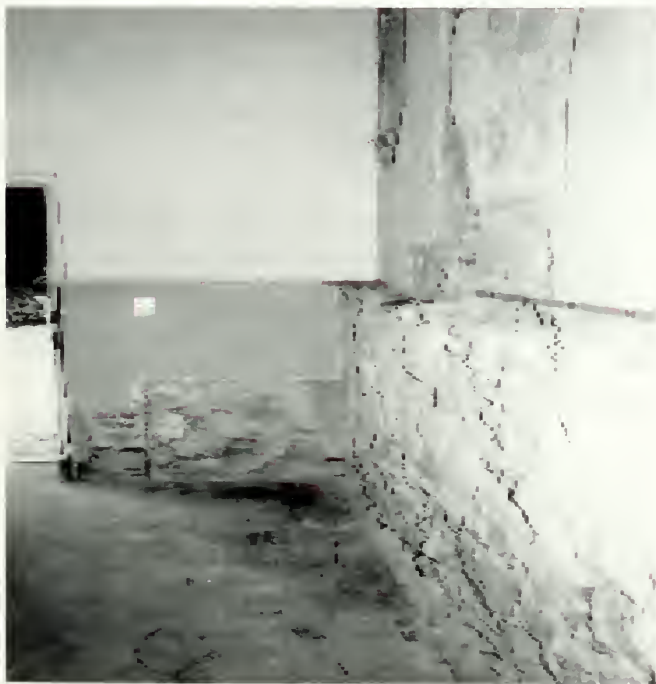
Figure 30. North wall, west end of the center room showing exposed masonry and window hung with the Army's L strap hinges.

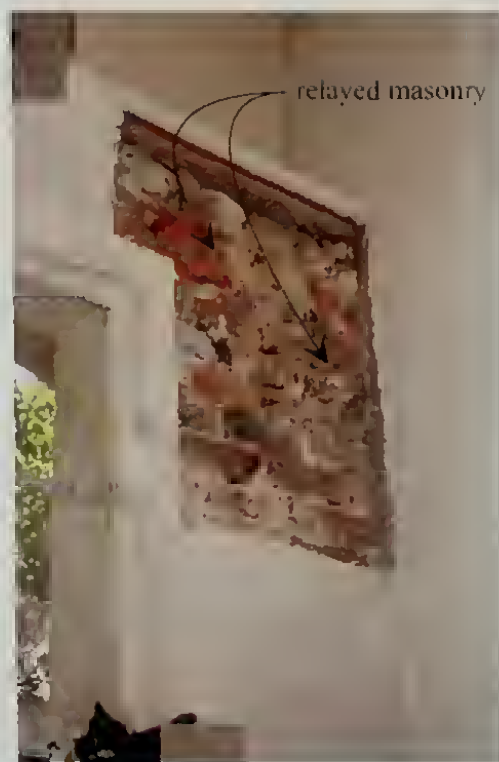
North Dependency, Center Room: The north elevation contains evidence of a large repair or possibly the addition of the exterior arch and window. Distemper finishes found in the undisturbed lower area of the wall suggest that this room had a similar paint history as the upper east room. The general location of the floor level is indicated by a gradual reduction in the plaster thickness. The floor line is not as distinguished as that documented in the east room, but this is due to the quality of the surviving evidence.
