ANALYSIS OF THE HYDROLOGIC,
HYDRAULIC AND GEOMORPHIC ATTRIBUTES
OF THE YOSEMITE VALLEY FLOOD:
JANUARY 1-3, 1997

William L. Jackson
Gary M. Smillie
and
Michael W. Martin

**NATIONAL PARK SERVICE
WATER RESOURCES DIVISION
FORT COLLINS, COLORADO**

FEBRUARY 21, 1997

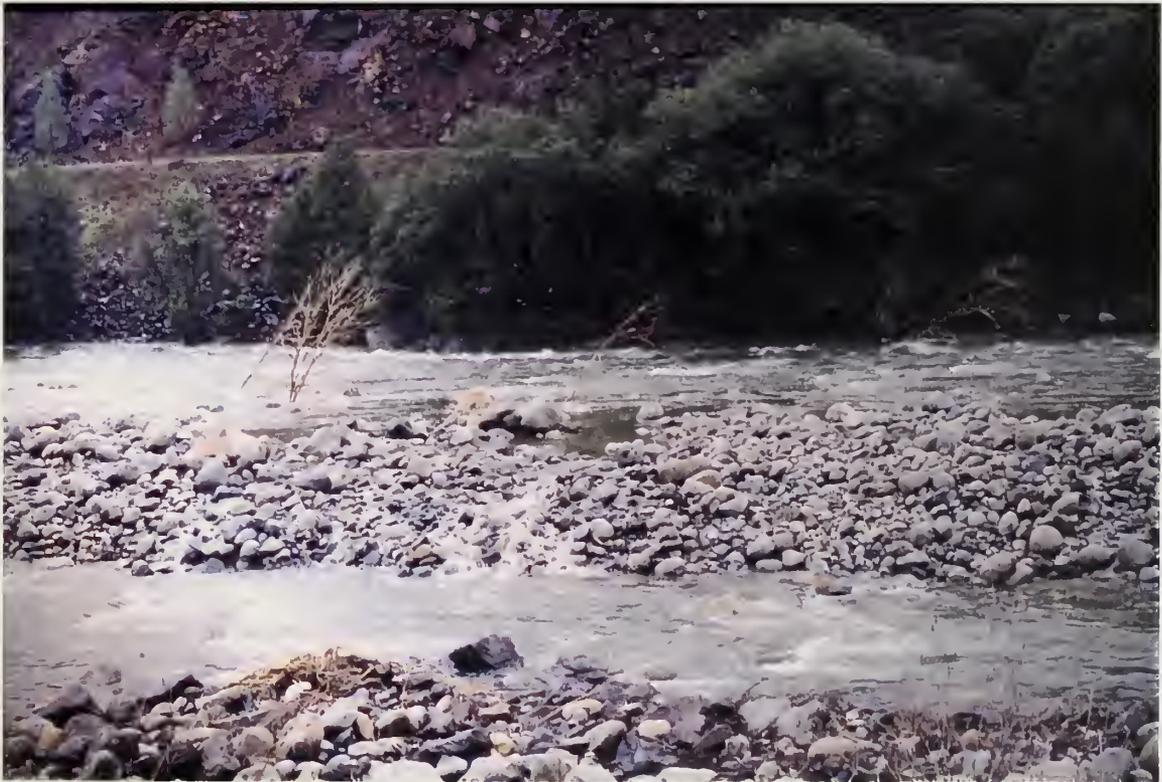
The flood in this reach was deep (15-30 feet) and generally confined by valley walls or by the road prism. Velocities were extremely high and flows were supercritical. Stream power and sediment transport energies were enormous. At some locations enough valley width existed for the pre-flood river to have established some slight sinuosity and side-channel bar deposits. During the flood, the river went straight down-valley, typically cutting off bar deposits and scouring any vegetation established on them (Figure 5). Interestingly, very little disturbance to hillslope (non-riparian) natural resources was observed in undeveloped reaches downstream from the diversion dam.

The primary flood effects in this reach involved impacts to the road and utility corridor. This was a deep, high-energy flood. In places the flood mobilized the rock riprap placed to protect fill material used to construct the road prism. This resulted in erosion of the road prism and undermining of the road surface. In other places high-energy flows over-topped the road and flowed down the road, eroding fill material under the road surface and eventually undermining the road surface and causing it to fail and/or wash away.

Figure 5. Photo of post-flood Merced River channel in Reach 1 near El Portal.

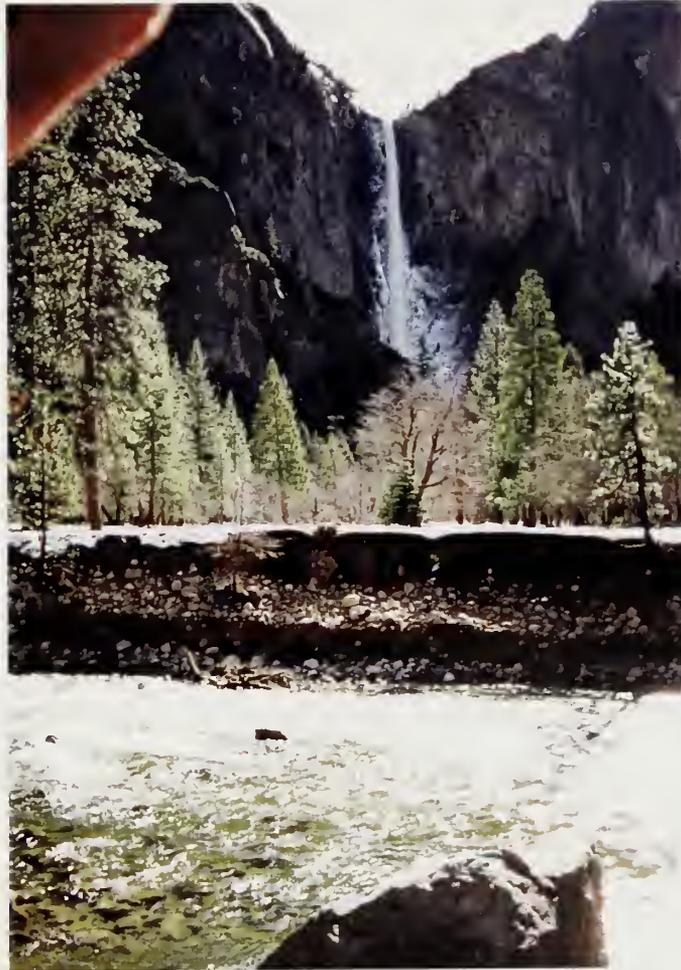
Infrastructure in this portion of the valley is limited to roads on both sides of the river, Pohono Bridge, and utility lines. During the flood, depths of flow were moderate (8 - 10 feet) in this area and velocities were high enough to move large bed material and erode banks. As in other areas upstream, overbank flow likely did not follow the channel alignment but rather travelled directly down valley in many locations. Significant scour and/or deposition occurred along both banks of the river as it passed over the old Bridalveil Moraine material causing instability (Figure 6). Except for some damage to Pohono Bridge and its' approaches, there was only minor impact to infrastructure in this reach.

Figure 6. Photo of post-flood Merced River channel in Reach 2 where it passes over Bridalveil Moraine. Some streambank erosion is evident in this photo.

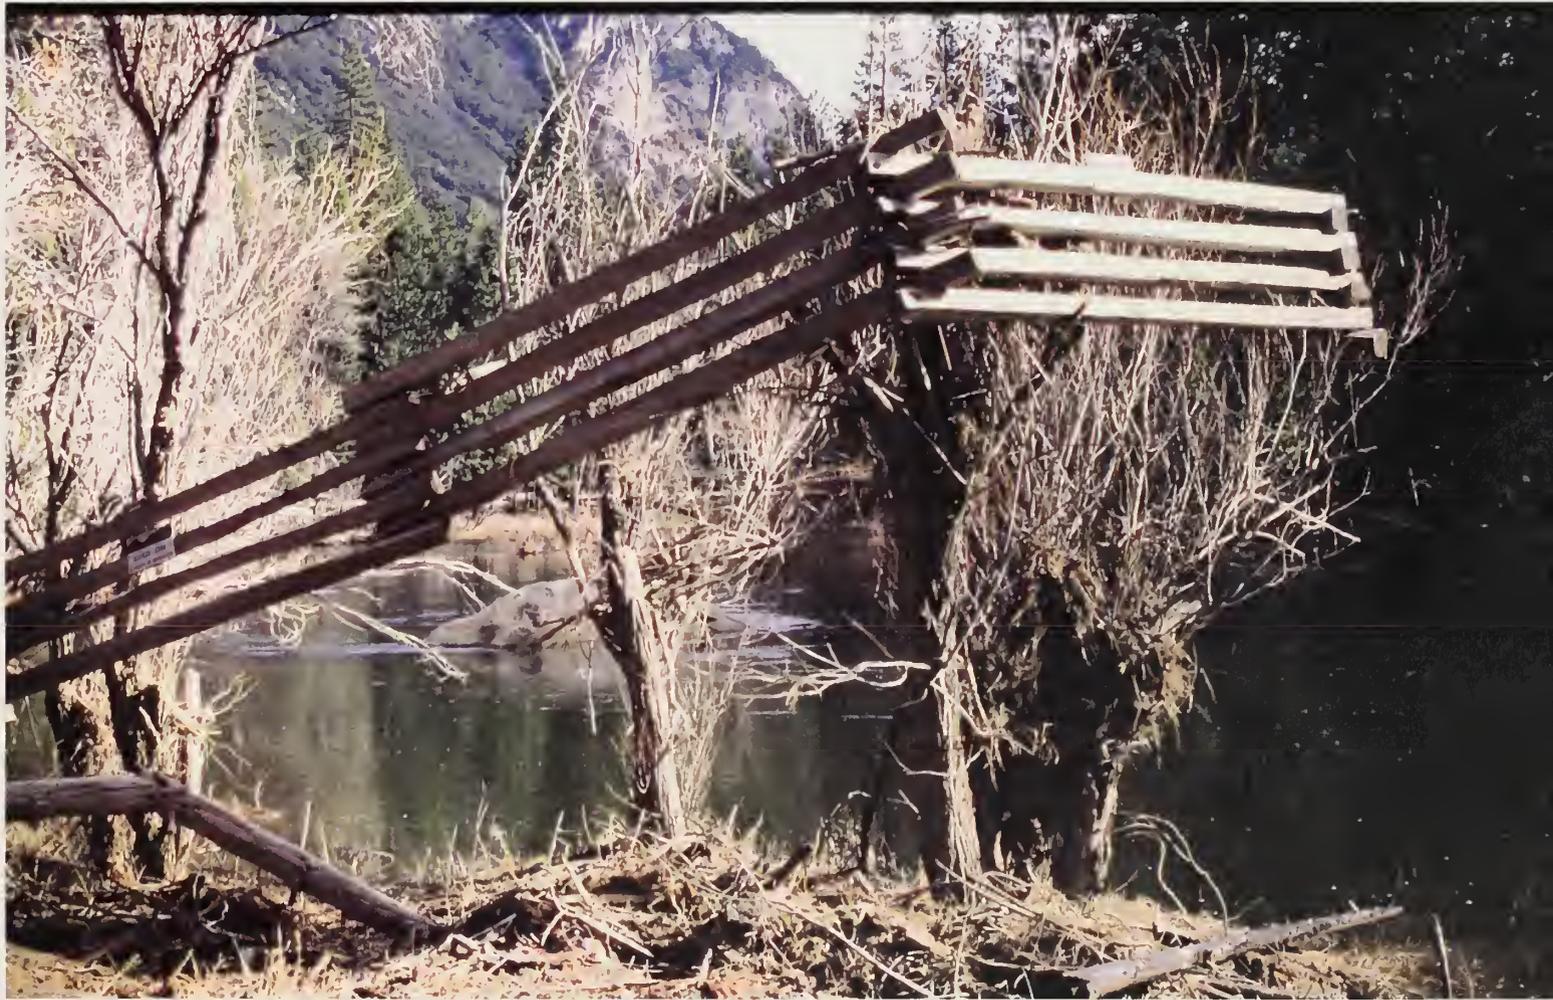
there is very little consequence stemming from inundation in absence of significant velocity. It is also interesting to note that even floating trees and other large woody debris caused no significant damage to bridges because flow velocities were so low. In general and for the same reason, buildings also realized little structural damage from flowing water or debris.

Figure 7. Photo of wooden fence in Reach 3 upstream from El Capitan Bridge, which was floated by impounded water but not significantly damaged.

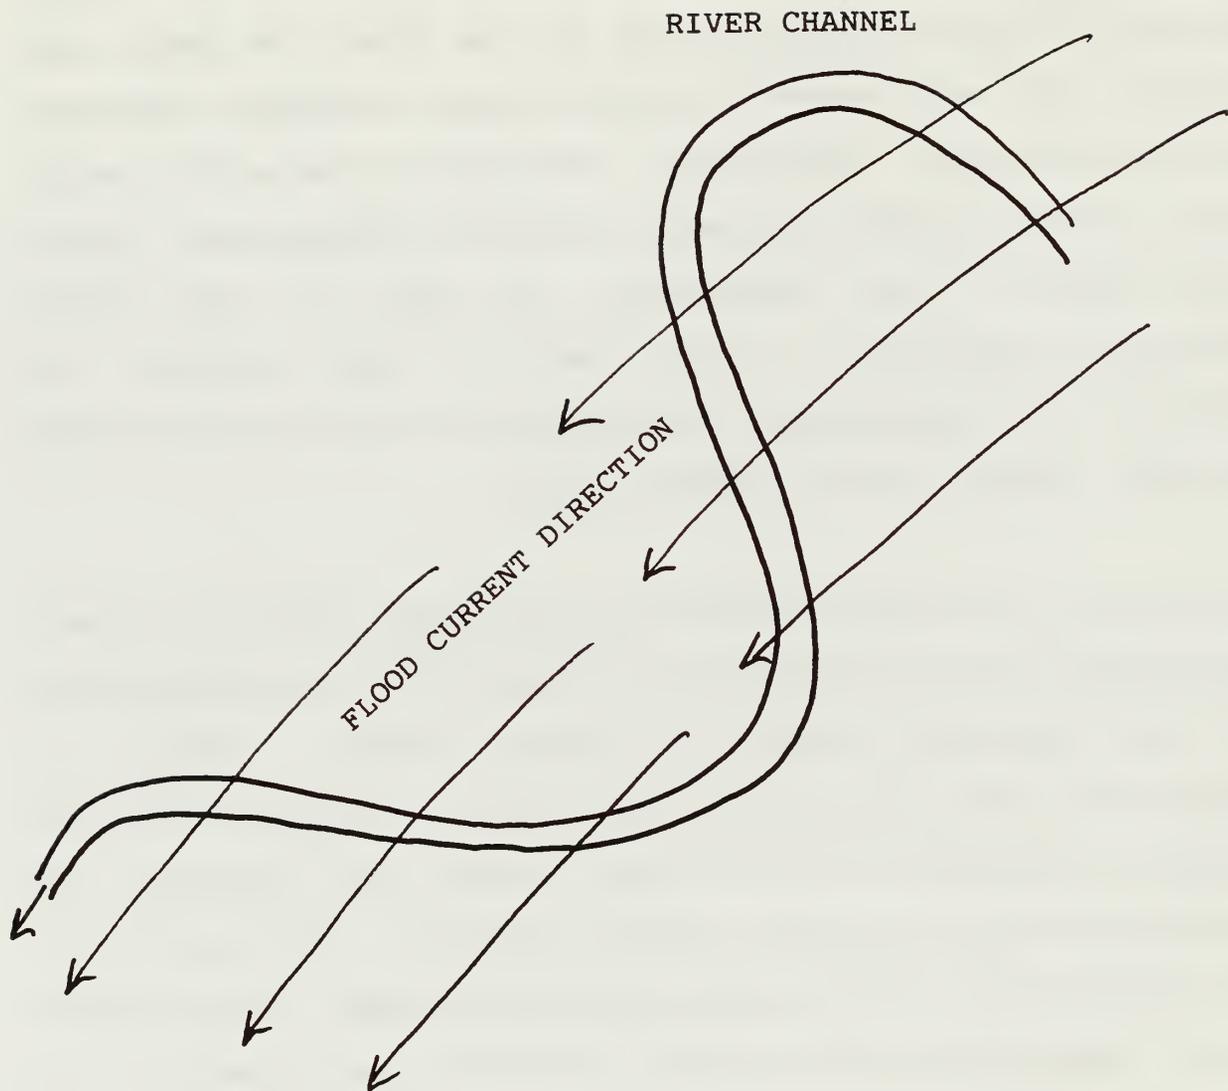
Figure 8. Sketch depicting the direction of flood flows across meanders.

water flowing across the meander necks resulted in adjustments to the river channel and floodplain. Flood channels cut across meanders, and there were areas of localized sediment deposition - both on floodplains and in channels. Also, there were areas of bank erosion, usually at the outside bends of meanders. Much of the resource adjustment which occurred was probably exaggerated by the poor condition of vegetation cover on floodplains and banks. Also, bridges, such as Sugarpine Bridge, had inadequate capacity to convey the full flood discharge and functioned to cause additional flow to cut across meanders.

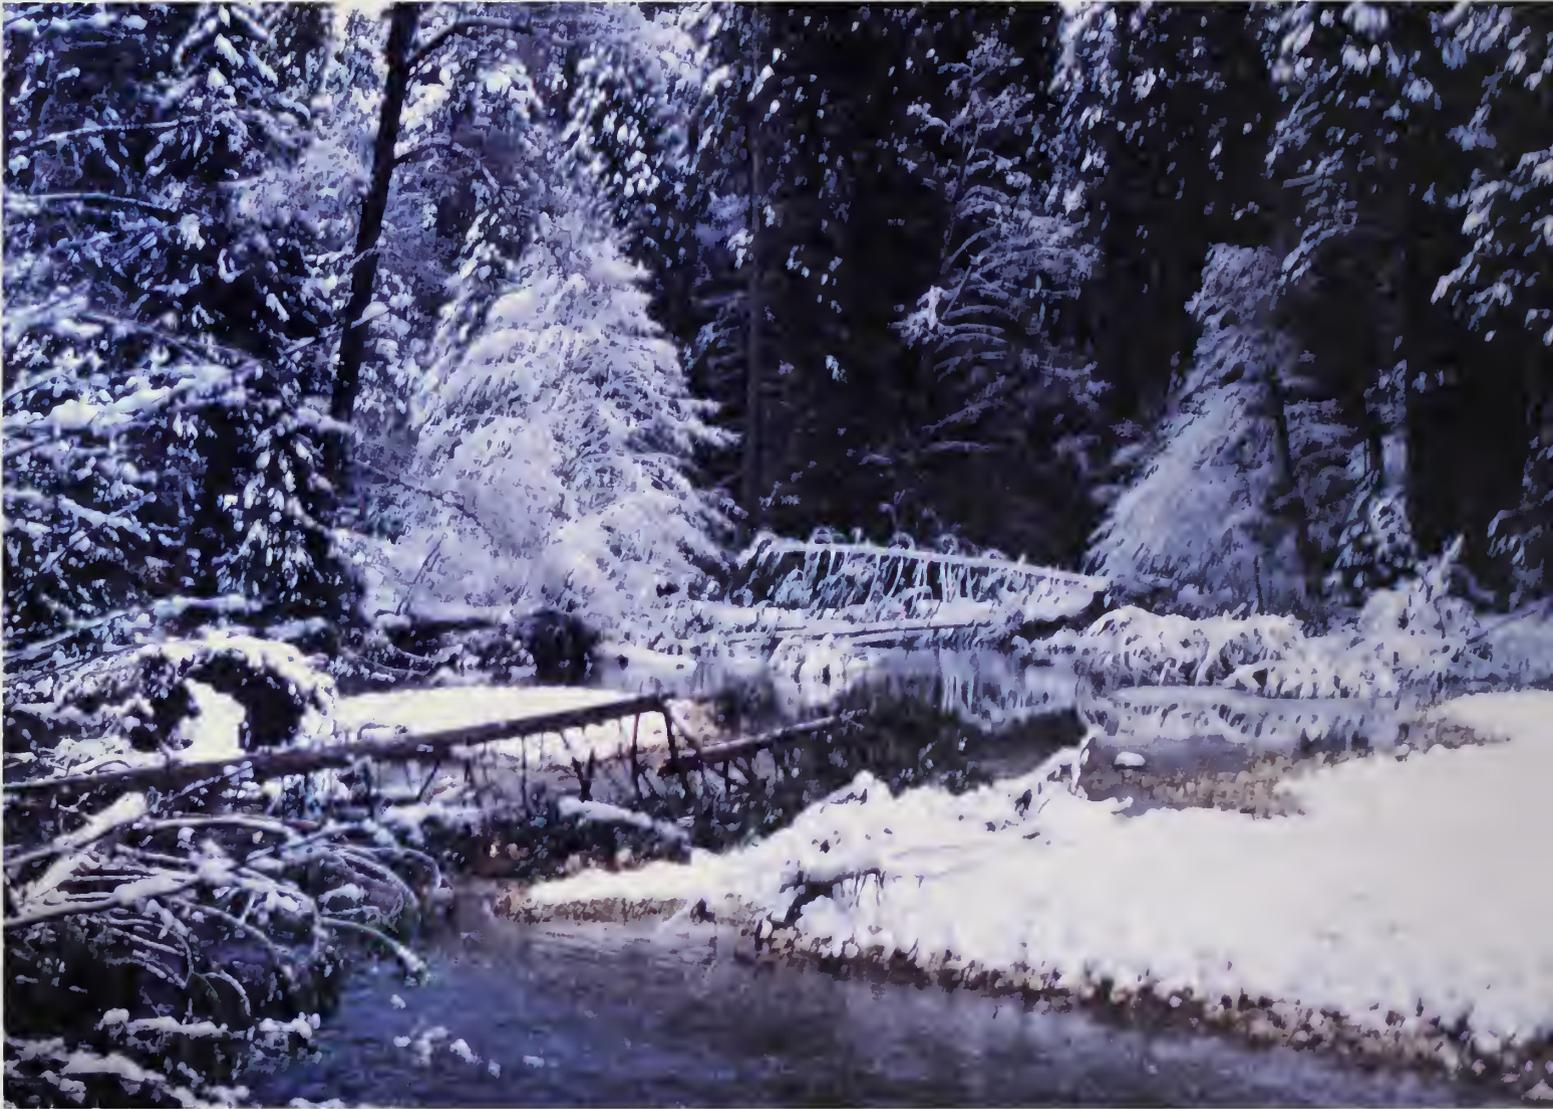
By far the most dramatic effect of the flood along the lower Tenaya Creek and the Merced River upstream from Tenaya Creek confluence, involved the downing of trees and the enormous amounts of transported woody debris (Figure 9). The energies of this flood were sufficient to undermine mature trees on the river banks, causing them to fall into the river. Once in the river, trees interacted with flows to cause local areas of bed material deposition and bank erosion (and additional tree fall). Upon recession of the flood, enormous amounts of woody debris remained in the river channel and overbank areas.

Figure 9. Post-flood photo of the Tenaya Creek channel upstream from the Group Campground.

The principal effects of the flood in this area were eroded banks with associated loss of riparian vegetation and accumulation of massive quantities of woody debris on the floodplain. The bank erosion probably was caused by a combination of natural channel migration pushing the stream in that direction and, possibly, compromised bank integrity caused by human use. The woody debris accumulated simply as a result of abundant supply of material in the river and the opportunity to lodge in the sparse timber, brush, and fixed objects in the campground.

If the notion of the channel migrating slowly to the right floodplain on what is essentially an alluvial fan is correct, the long-term use of the campground location will be problematic. Repeated destruction of facilities can be anticipated in the future by woody debris and inundation as aggradation causes lesser floods to access the overbank areas. Additionally, bank erosion will likely continue causing a loss of developed area or bank stabilization. Bank stabilization is never a desirable activity in a national park but in an aggradational environment such as this, it would not only be harmful to resource conditions but would also likely require channel manipulations such as dredging in the future. Our recommendation for this site is to invest minimally, if at all, in repairing the existing facility and consider moving the campground to a more stable location. The left overbank area of Tenaya Creek in the same reach may be a more stable location, as would be an abandoned terrace level upstream on the right bank.

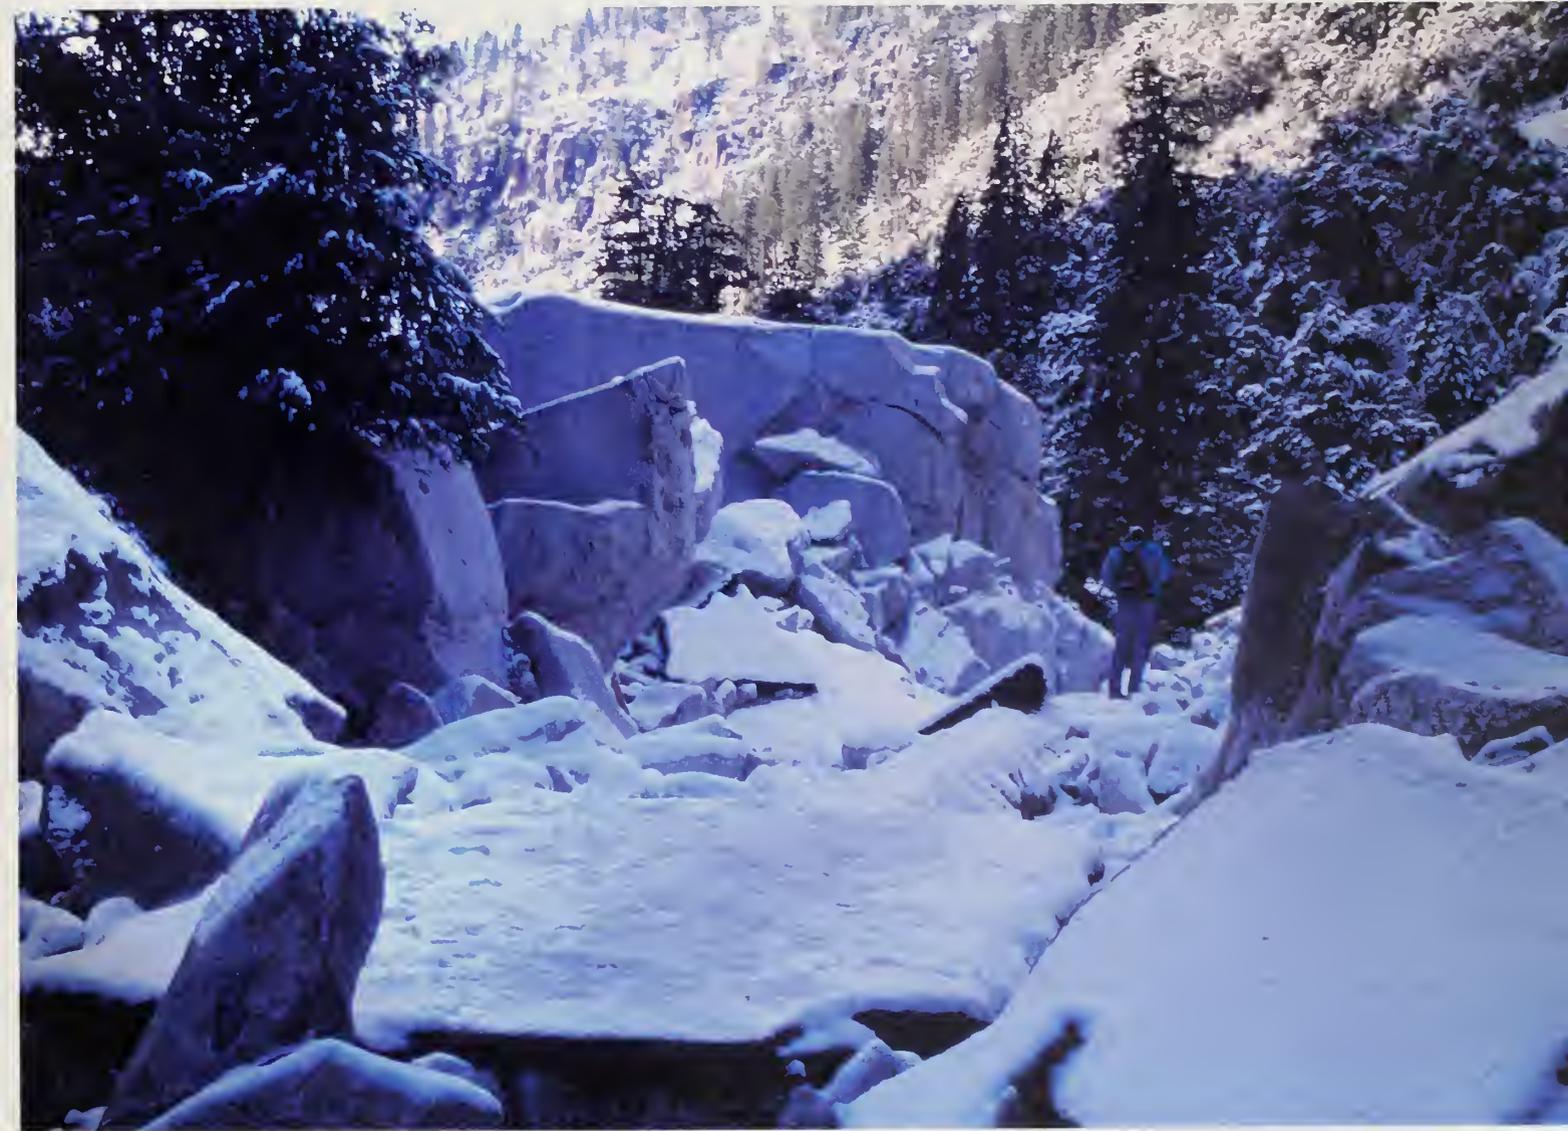
corridor) there was less opportunity for impacts to park facilities. In several locations, the road embankment was eroded causing partial failure of the road surface. Also prevalent were zones with insufficient local drainage. Where culverts became blocked or were insufficient in number and/or size, flow in ditches parallel to the road caused widespread damage.

By far the most notable damage in this area and, for that matter, anywhere within the park proper, is the obliteration of a 300-400 foot section of El Portal Road (Figure 10). The park sewer line located under the road also was completely severed in this area. This damage was caused by the flood level exceeding the elevation of the road (by upwards of 4 feet) just upstream from a confined length of roadway. The confinement is caused by a talus slope with very large boulders bordering the road on both sides. When river flow entered the road, it travelled down the steep grade at a high velocity tearing asphalt and road base apart and washing this material nearly completely away. This segment of road has repeatedly been damaged by high flows but nothing of this magnitude had been experienced in the past. One reason the devastation was unprecedented, besides the extremely high discharge, is that a landslide occurred in 1982 that left additional boulders along the road that lengthened the confined area and extended the amount of road length impacted by high-energy water flowing over the surface.

Figure 10. Photo of Cookie Slide area on Highway 120 between Yosemite Valley and El Portal.

Several steps can be taken to improve performance of this segment of road during flood events. Two ideas proposed by Federal Highway Administration engineers include raising the road at the break-out point and blasting some of the recent landslide material to allow the flow to return more quickly to the channel. We think these are good ideas that would reduce future repair costs substantially. The amount the road is elevated can be dictated by practical considerations related to the road grade. Any additional elevation at the break-out point will not only provide a higher level of protection but reduce the amount of flow down the road when overtopping occurs. Beyond these suggestions we think that placement of more culverts and use of grouted riprap where embankment protection is deemed essential should be considered. Finally, in some cases it may be cost-effective to tolerate some level of damage from low-probability floods in some difficult locations rather than attempting to design the road to withstand extremely rare floods.

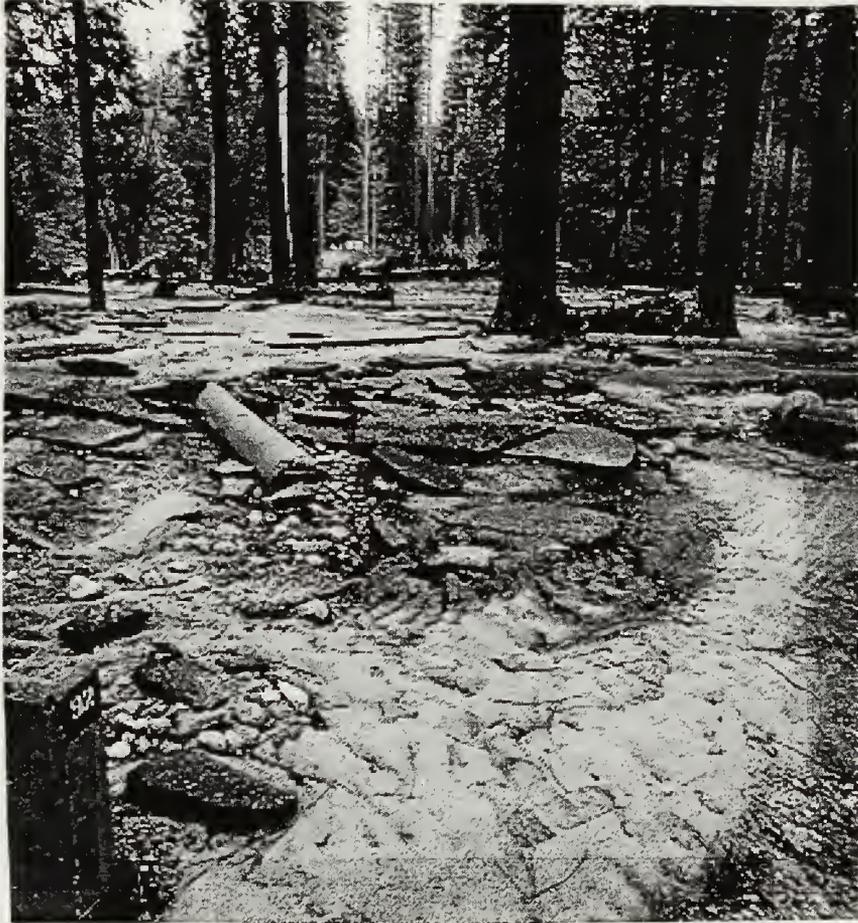
flood, none of the other sites we visited were affected as much as Lower Pines Campground (Figure 11). Flowing water rearranged everything that was not fixed in-place. In much of the campground, asphalt pavement on roads and parking spaces was peeled by the flow, broken up, and transported. The cutoff channel associated with Sugarpine Bridge and the bike path enlarged greatly during the flood and appears to have become the primary path for flood waters through this reach. Other smaller channels were eroded further upstream in the campground above the effect of the bridge. This material was transported down valley and some of it was redeposited on the left bank of the river downstream from Ahwahnee Bridge where overland flow velocity was reduced by high depths in the river.

At a point approximately 2/3 of the distance upstream on the meander bend, there is a rise in elevation on the meander neck. Campground units on this higher floodplain level experienced little or no flooding. All other Lower Pines Campground campsites are located low on the floodplain and will experience frequent flooding in the future.

Figure 11. Post-flood photo of Lower Pines Campground

The following discussion presents several factors to consider in planning for repair or rehabilitation of this area. First it should be recognized that much of Lower Pines Campground is in an area susceptible to damaging hydraulic conditions during floods. Conditions experienced during the January flood will be experienced periodically in the future and, therefore, investments made to

rebuild camping facilities or other infrastructure in this location will continue to be subject to flood risk. Certain areas in the camp, furthest upstream, were located favorably from a flood standpoint and can be considered to be at very low-risk. Also, portions of other nearby campgrounds experienced little damage during the flood and represent the best available areas to use as camps in this part of Yosemite Valley. Much can be gained by identifying these locations and incorporation this knowledge into the decision making process.

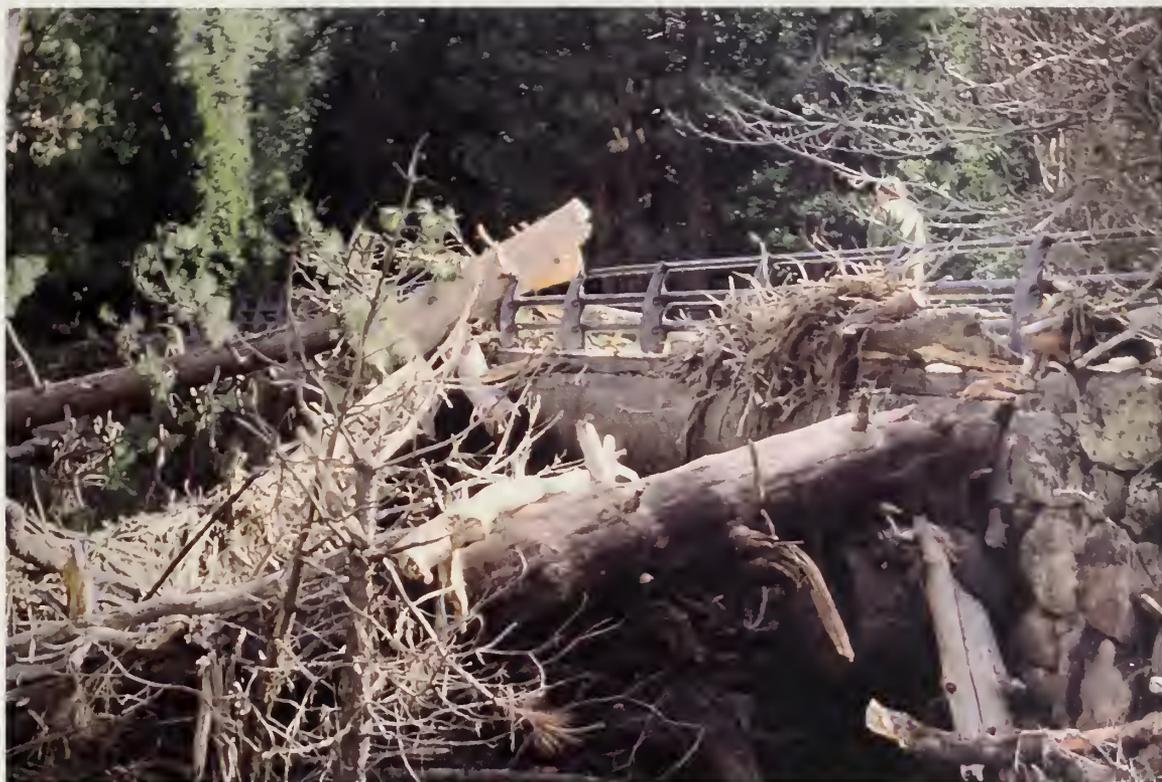
Photo of large woody debris piled up against El Capitan Bridge. This debris was floated by the deeply impounded water behind El Capitan Moraine. However, because velocities were low, very little damage was done to the bridge.
