Hawaiian Volcanoes During 1951

GEOLOGICAL SURVEY BULLETIN 996-D

By GORDON A. MACDONALD and CHESTER K. WENTWORTH

*A report of the Hawaiian
Volcano Observatory*

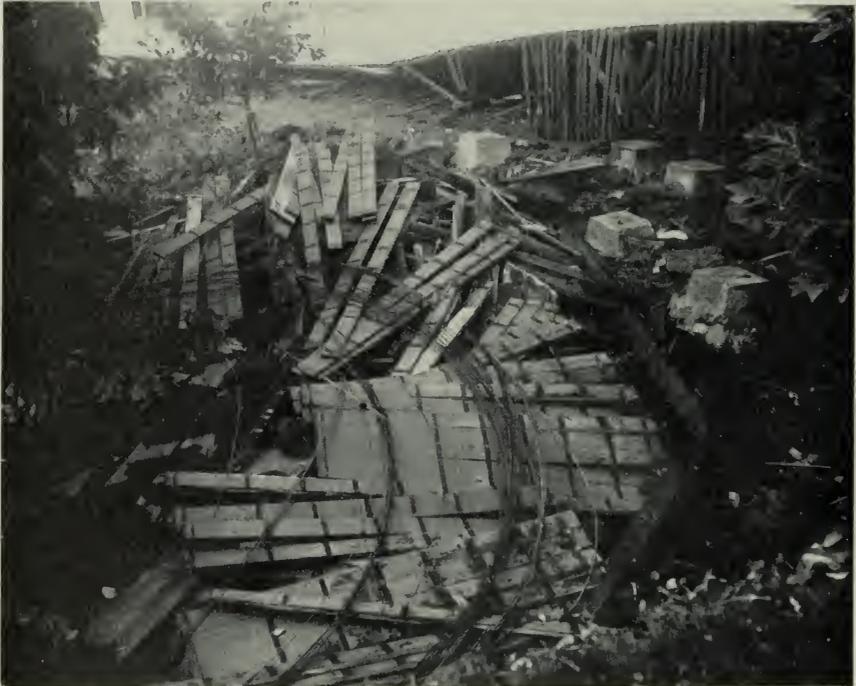
the length of the building were entirely adequate, but there was comparatively little bracing parallel to the width of the building, and some of this bracing was fastened, not to joists, but to floorboards. As a result, the underpinning was deficient in stiffness parallel to the ground slope. The direction of shaking during the earthquake was nearly parallel to this weakness in the structure, and the swaying caused the underpinning to fail in part and allow the building to slump downhill onto the ground (fig. 44). The building is a total loss.

FIGURE 44.—Honaunau School building from the southwest. All but the south end of this building was dropped and moved westward owing to inadequate bracing of the underpinning in an east-west trending direction transverse to the longer dimension. The wood-stave water tank collapsed and was thrown westward from its concrete-block footings.

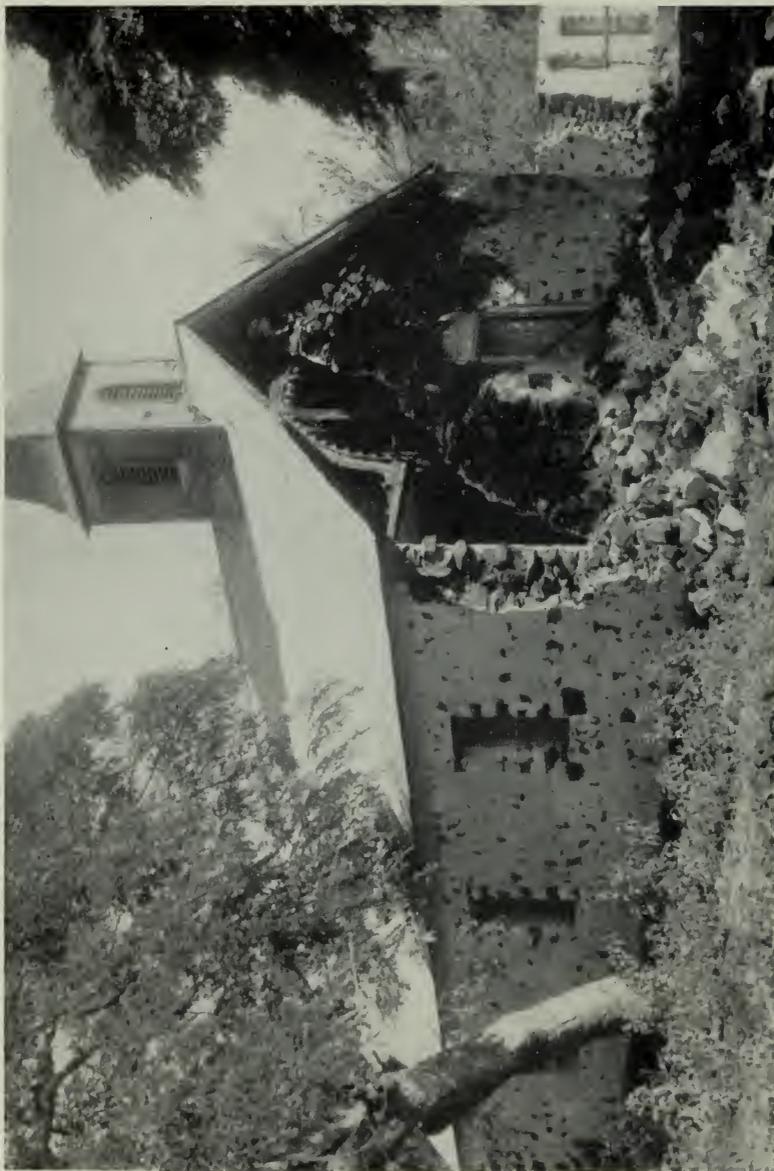
FIGURE 45.—Church at Puua, 0.6 mile north of Hookena, viewed from the northwest. The western and eastern walls of the building were damaged. The severe damage at the northwest corner of the church building and of the old unroofed building beyond it, suggest displacement of the walls toward the northwest in the direction of the epicenter.

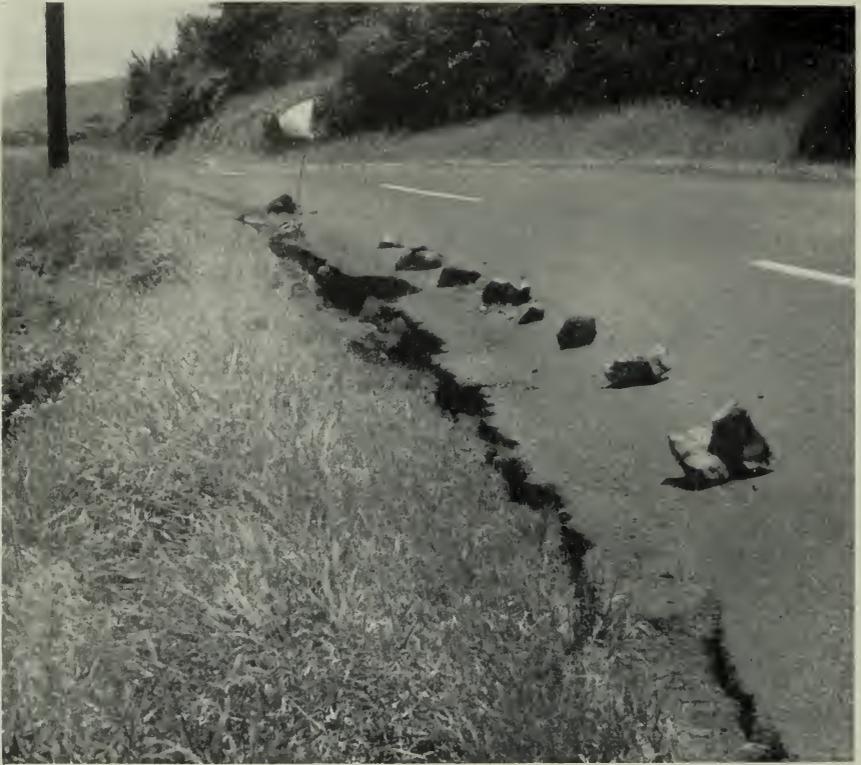
A common occurrence was the formation of a crack parallel to the edge of the pavement on its downslope side, either within the pavement a few inches from its edge, or between it and the shoulder (fig. 46). Some of these cracks were as much as 75 feet long and 8 inches wide. This apparently resulted from a downslope lurching of the shoulder that moved as a separate unit from the portion of the fill

FIGURE 46.—Crack along the edge of the highway pavement 2 miles south from Kaimalino, apparently resulting from a downslope lurching of the shoulder, which moved as a separate unit from the part of the fill beneath the pavement.

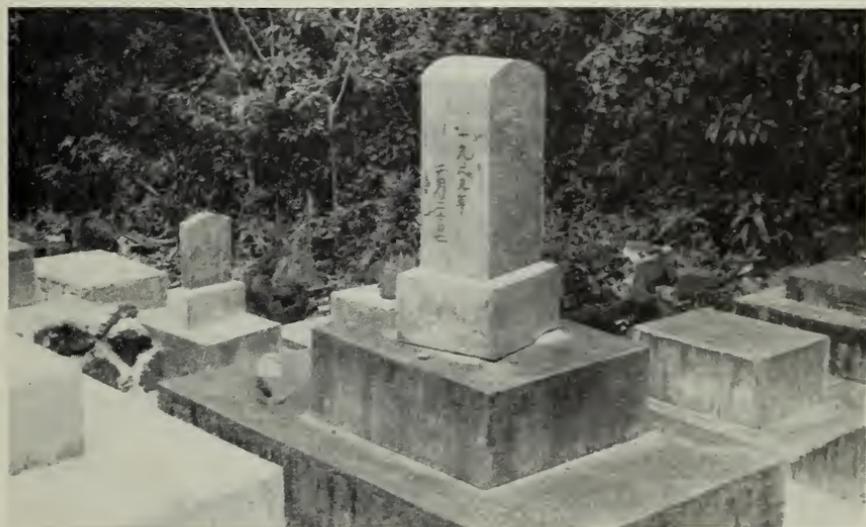
Derangement of headstones included overturning of stones (fig. 47), and shifting of stones on their bases with or without rotation. Many grave caps were broken, some by falling or disturbance of headstones, and some by lurching or slumping of the adjacent subsoil.

FIGURE 47.—Gravestone rotated counterclockwise, in the Daifukuji cemetery at Honalo. Other stones have been thrown from the vacant bases visible in the photograph and are out of sight behind the bases.
