FLOOD HAZARD EVALUATION
FOR DIVIDE AND WILD CREEKS
GLACIER NATIONAL PARK

Technical Report NPS/NRWRD/NRTR-91/02

August 1991

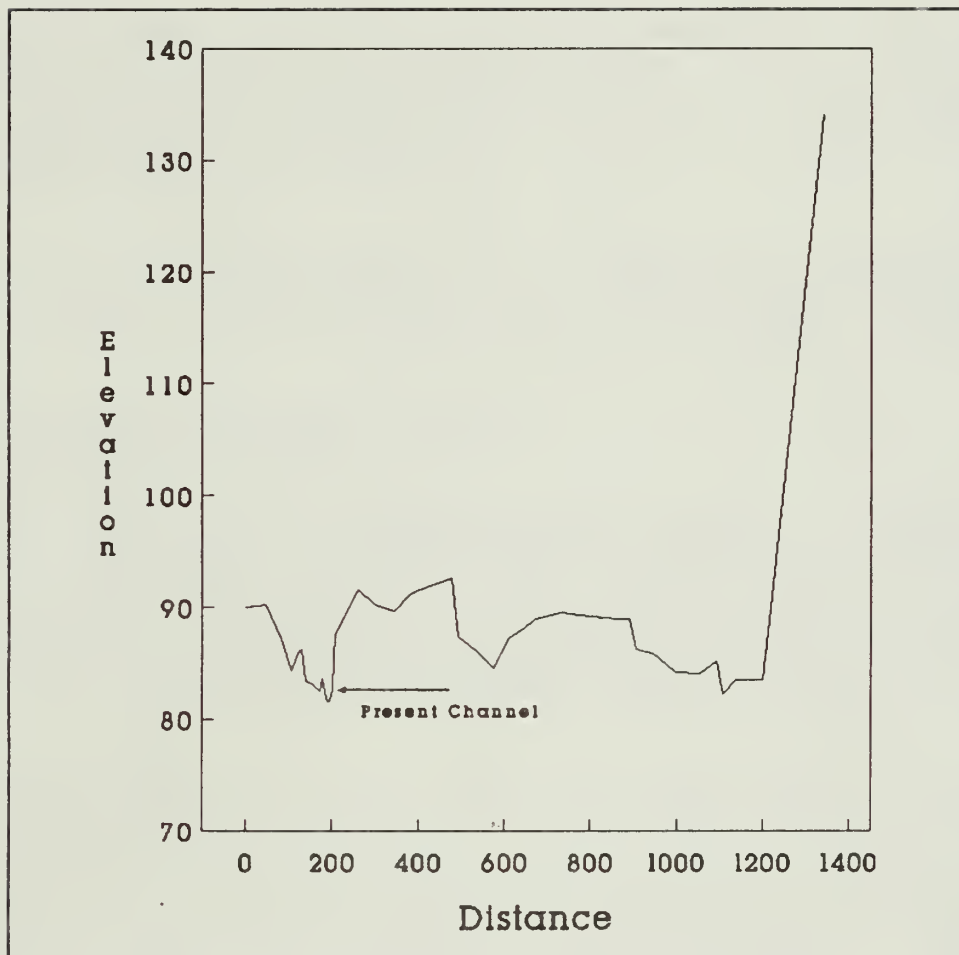
sediment. The stream in the area of the fan is less steep and unconfined by canyon walls. As the stream flows across the alluvial fan, velocity is reduced and much of the sediment load is deposited. As shown on Figure 2, the stream bed of Divide Creek in the vicinity of the developed area is at nearly the same elevation as its adjoining floodplain and, as a result, any deposition of material onto the bed encourages the stream to change course and find a lower portion of the floodplain. For this reason, the stream channel is very unstable and historically has shifted over a large area extending from near the town of St. Mary (present location) to a location near the historic St. Mary Ranger Station. Review of topographic maps suggests that the Divide Creek fan extends well into St. Mary Valley and may be responsible for splitting a large prehistoric lake into the two lakes present today, Upper and Lower St. Mary Lakes.

Figure 2. Profile of Divide Creek and floodplain in residential/maintenance area. Profile is perpendicular to channel, approximately 100 feet downstream of access road bridge.

Stream hydraulics were modeled using HEC-2, a water surface profile computer model developed by the Hydraulic Engineering Center, COE (US COE 1982). Flows required to reach the base and top of the floodwall assuming the present topography are estimated to be 6,000 and 16,000 cfs, respectively. Assuming 3 feet of additional deposition in the channel, the flow required to reach the base of the wall is approximately 1,500 cfs and to reach the top of the wall is about 9,000 cfs. The elevation of the floodwall is, therefore, adequate to provide a large degree of protection even with a few feet of deposition in the channel. However, the ability of the floodwall to structurally withstand the hydraulic forces exerted by high flows is questionable. Additionally, potential exists for undermining of the structure and circumvention of flow upstream. Thus, it appears that the major concerns in this area are the stability of the metal wall and preventing flow from circumventing the wall upstream at the nick point.

The presence of the floodwall increases flooding potential in the town of St. Mary by preventing Divide Creek from using a large portion of its floodplain. Structural protection is advisable on the east bank of Divide Creek to avoid transferring flooding and channel erosion problems to neighboring land owners.

Structural improvement of the existing metal flood wall is recommended. The floodwall should be extended further upstream to the nick point and tied into the higher local topography. The floodwall, including its foundation should be evaluated for its ability to withstand the hydraulic forces of a design flood, such as the 100-year flood, and improved if necessary. Private property, east of the channel, should also be protected by an appropriately designed structure. The highway bridge should be enlarged or replaced by a bridge with larger flow capacity.

Maintaining channel capacities on a regular basis by removing accumulated sediment is the most important factor in reducing the flood hazard at Divide Creek. Since Divide Creek is an aggrading system, it continuously loses capacity to convey flow. It can be expected that the developments at Divide Creek will become increasingly more susceptible to flooding at ever lower flow levels if the channel is allowed to aggrade. A plan needs to be implemented with appropriate environmental permitting to maintain a channel that will have the ability to hold at least moderate flow events such as the 10- to 25-year flows. Minimum channel elevations and cross-sectional areas can be designed according to such criteria. These elevations and areas will then have to be maintained on an annual basis. This work could be completed each fall in anticipation of the next years high flows. All work should be thoroughly coordinated with the state of Montana to insure adequate permitting is obtained and any adverse environmental impacts minimized.

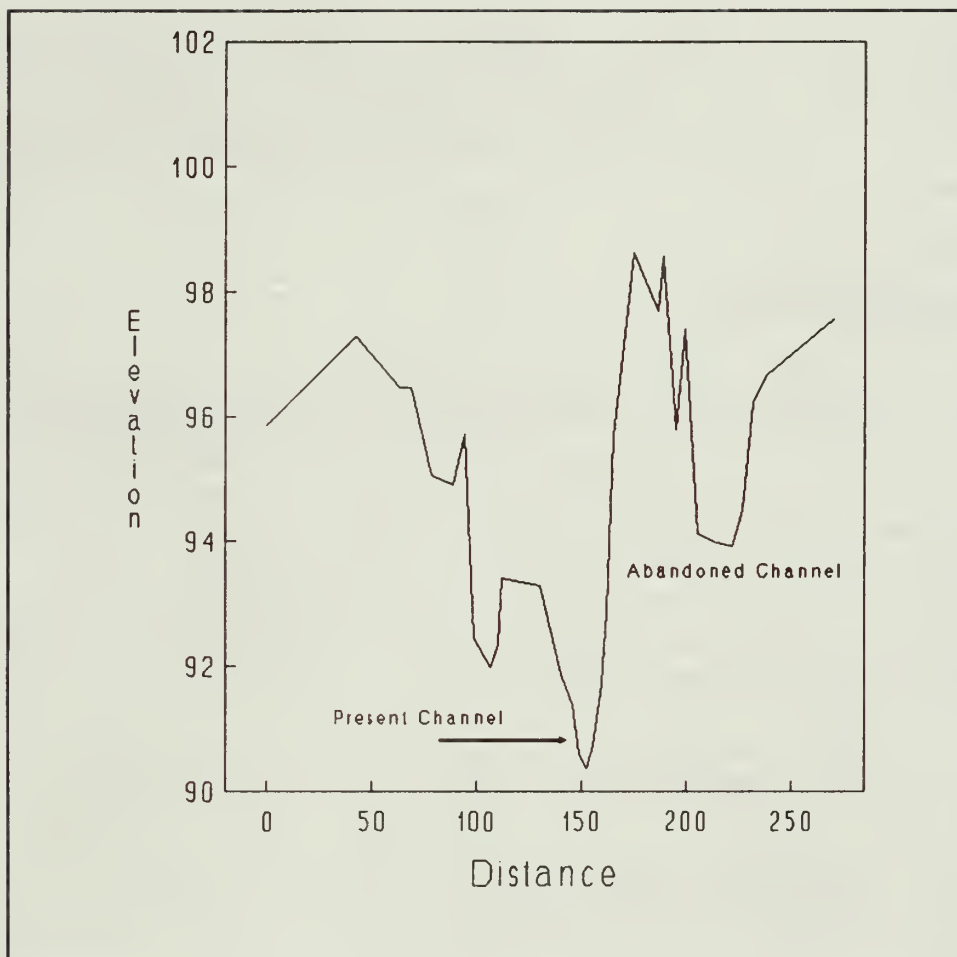
The nick point is located upstream of the maintenance yard, and is an area where the stream is presently attempting to change course. Abandoned channels are present at elevations lower than some areas of the current channel (Figure 3). A dike has been built of channel material and debris to prevent the channel from changing course and utilizing the adjacent abandoned channel. This abandoned channel runs through the developed area and would cause flooding if it were reclaimed by the stream. The nick point is upstream of the floodwall so any flows

Figure 3. Profile of Divide Creek at the "Nick Point".

entering the development from the nick point would be trapped behind the floodwall and kept within the developed area.

A flow of about 3,000 cfs is predicted to reach the base of the nick point dike and would begin to cause instability due to the erosive, non-cohesive nature of the dike material. Hydraulic modeling with an assumed 3 feet of channel bed aggradation indicates a flow of about 3,000 cfs would reach the top of the dike. Due to the unconsolidated nature of the dike material, the dike could be expected to fail at flows much less than 3,000 cfs. Therefore, the combination of aggradation and high flows makes the dike a likely candidate for catastrophic failure. This type of failure would cause rapid flooding of the developed area with little or no warning and could result in loss of life and property.

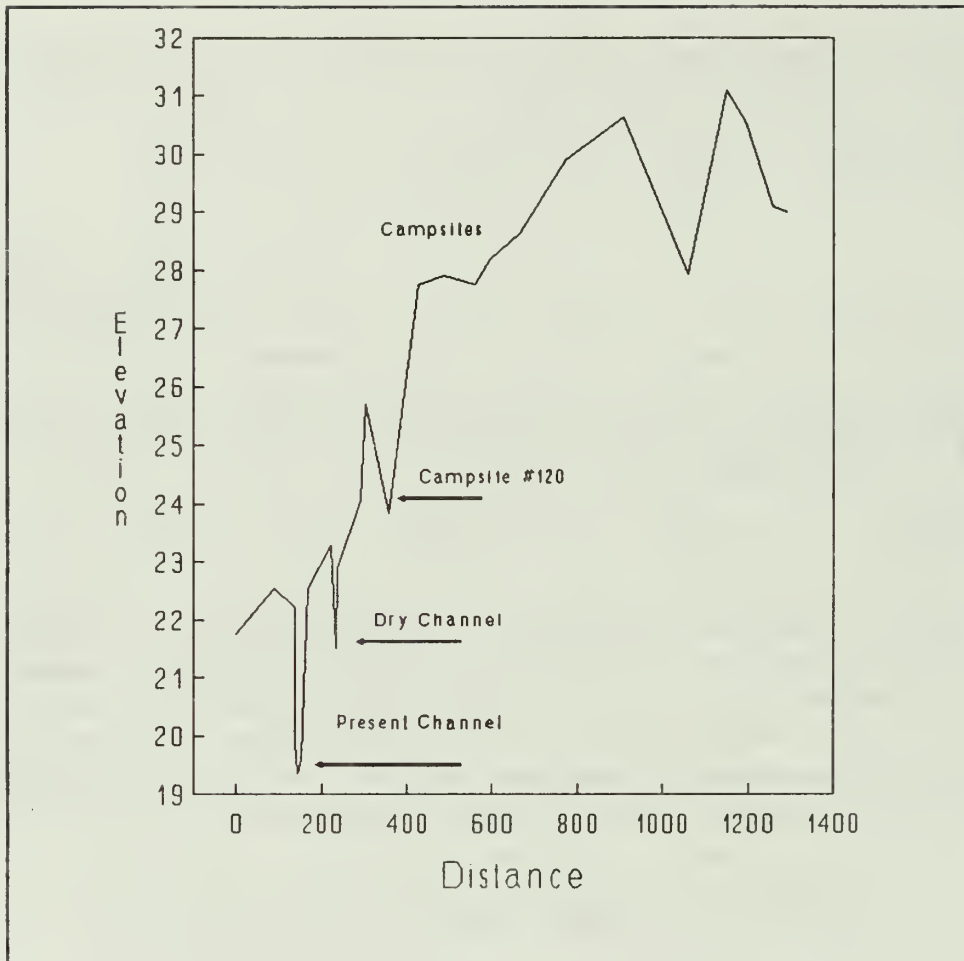
During the field trip two representative cross sections were surveyed through the floodplain in the campground area. One of these cross sections is shown in Figure 4. These cross sections reveal that much of the campground is well above

Figure 4. Profile of St. Mary Campground and Wild Creek

the Wild Creek channel and in little danger of flooding. Portions of the campground located near the channel, however, are susceptible to flooding particularly if aggradation encourages stream channel instability.

Hydraulic modeling was performed using HEC-2 to estimate the flow capacity of the existing channel. The present channel in the vicinity of the campground is estimated to be capable of passing approximately 500 cfs. This flow value is much lower than estimates of the 100-year flood which range from 980-1,350 cfs as derived from the same methods used in the Divide Creek analysis. With sediment deposition in the channel, flooding would occur at a much lower discharge indicating that flow outside of the channel can be expected on a fairly frequent basis in this area. Evidence of overbank flow is present in the eastern portion of the campground where an overflow channel has recently cut into the development. This channel directs flow toward the lower-lying area in the southeast part of the campground and may cause flooding in this area. Additional survey information is

Hazard to humans from flooding can be mitigated non-structurally by not using the flood prone areas of the campground during the peak snowmelt season. Also, the stream should be observed during unusually large summer thunderstorms and the lower portion of the campground evacuated when streamflow rises rapidly.
