9 ROXBURY ROAD SCARSDALE, NEW YORK

WINDOWS

NUMBER 19

Repairing Steel Casement Windows

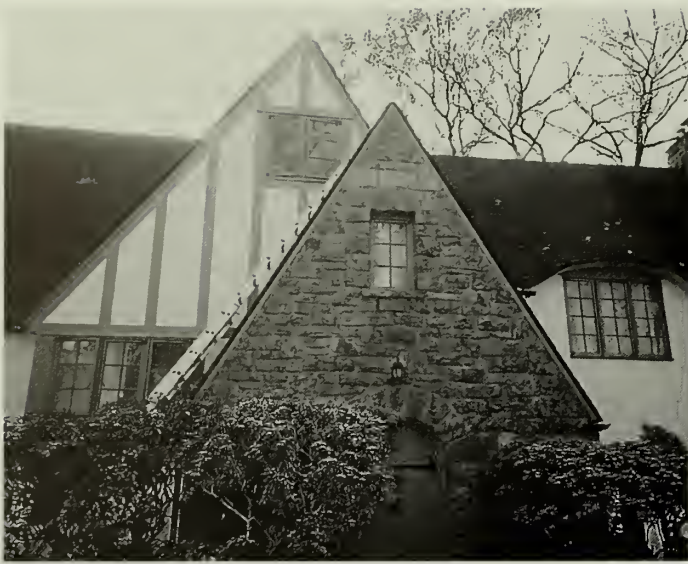
Figure 1. Steel casement windows were placed in various configurations throughout the house. Grouped windows open in opposite directions from each other, assuring that breezes can be captured, and a sash opened during rainy weather, regardless of the wind direction.

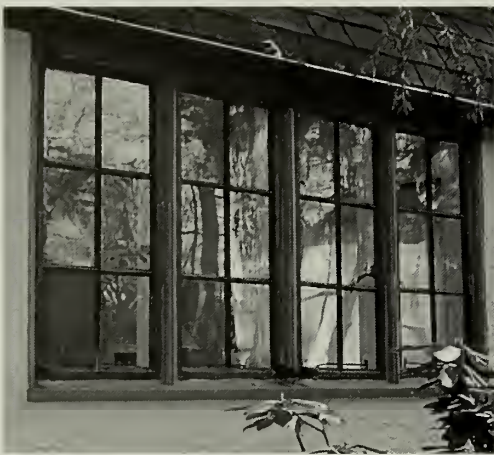
Figure 2. Each casement sash had six lights with projecting hinges that allowed the unit to open outward. Note the variation among glass panes as seen in the reflections. Caused by small differences in the positioning of panes within the sash and minor imperfections in the glass itself, this appearance is an important characteristic of historic windows.

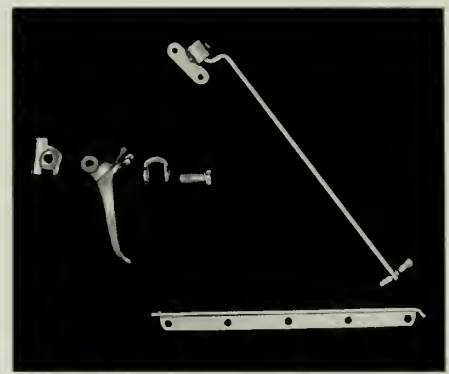
Figure 3. The window hardware at 9 Roxbury Road included a two-part "lift and stay" operator (right) and a common locking handle (disassembled at left). The hinged portion of the lift and stay (upper right) is attached to the sash while the perforated length is connected to the frame. To open the window, the pin is lifted from the hole on the far right, the sash is pushed open and the pin reset in one of the adjacent holes.

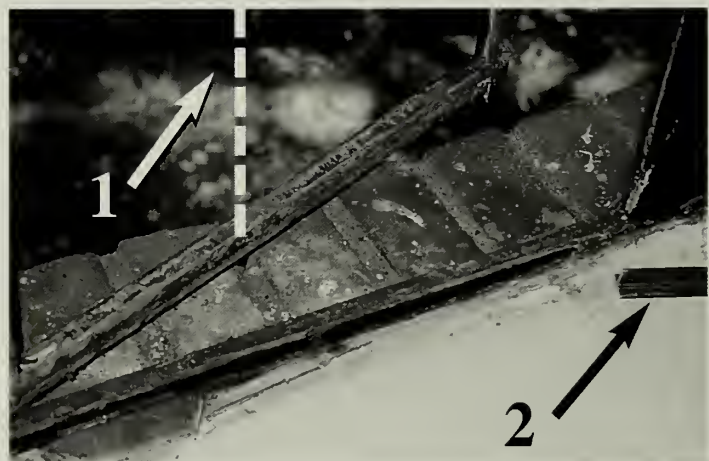
The windows on 9 Roxbury Road showed deterioration and damage typical of historic steel casements. In the course of over seventy-five years, corrosion, wear and some distortion of the sash and frame had occurred. Rust was particularly prevalent along the lower parts of the sash and frame where water had penetrated the distorted opening and the cracked perimeter

caulk (see figure 4). Originally tight fitting, all of the sash were bent out of alignment with resulting gaps from 1/16" inch to 3/4" inch between sash and frame. Hardware was corroded, stiff, and in some windows, seized shut. Prior attempts to force the distorted windows closed had also bent some of the locking handles and other hardware.

Figure 4. The sash and frame were most severely corroded along lower, horizontal members. A vertical glazing bar had previously been removed from the sash above to fit a window air conditioning unit (1). A replacement "T"-shaped length of steel that will be spliced in can be seen on the right (2).

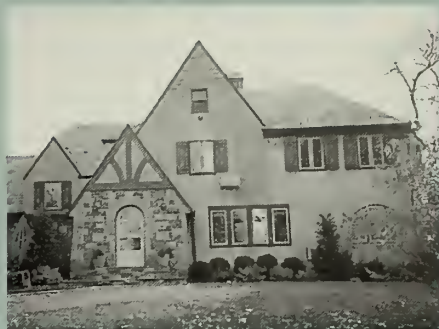
Inappropriate replacement windows dramatically affect the appearance of a historic home that once featured steel casement windows.

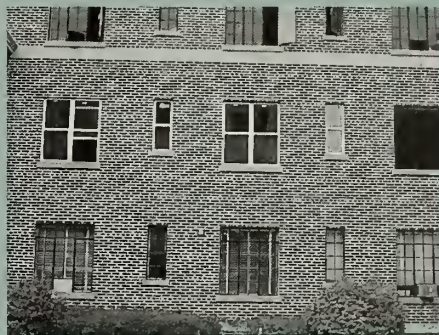
Historic steel casement windows are in the process of being replaced with new units that compromise the character of this building facade.

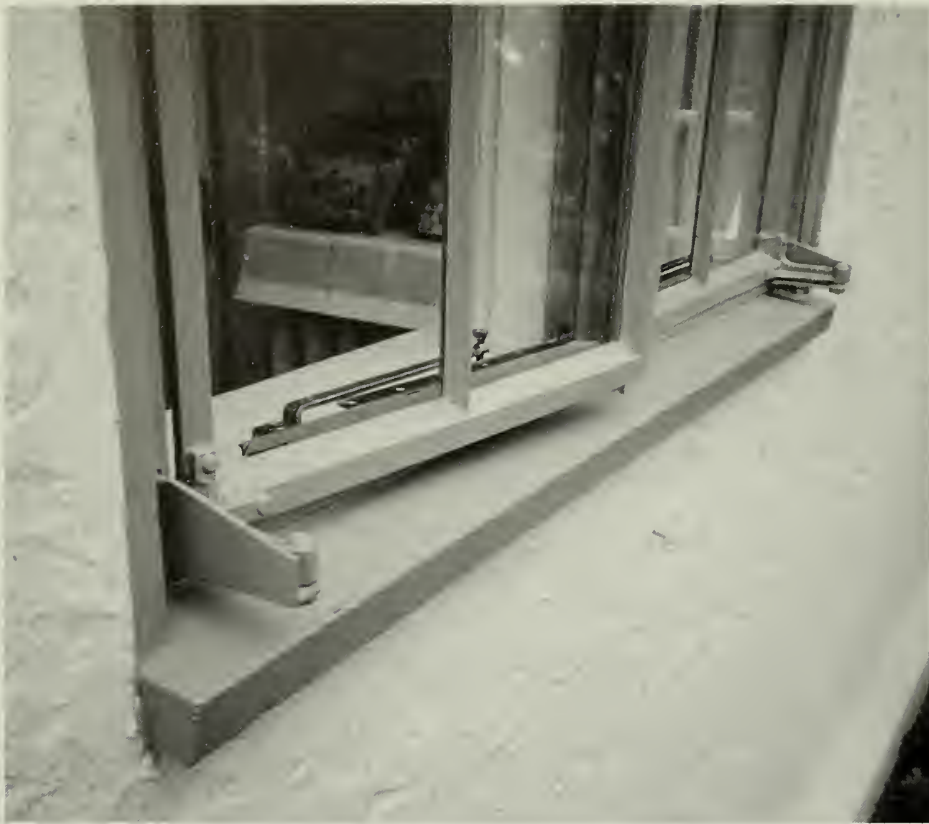
Figure 10. Detail of complete windows, repaired, serviced, reglazed and repainted.

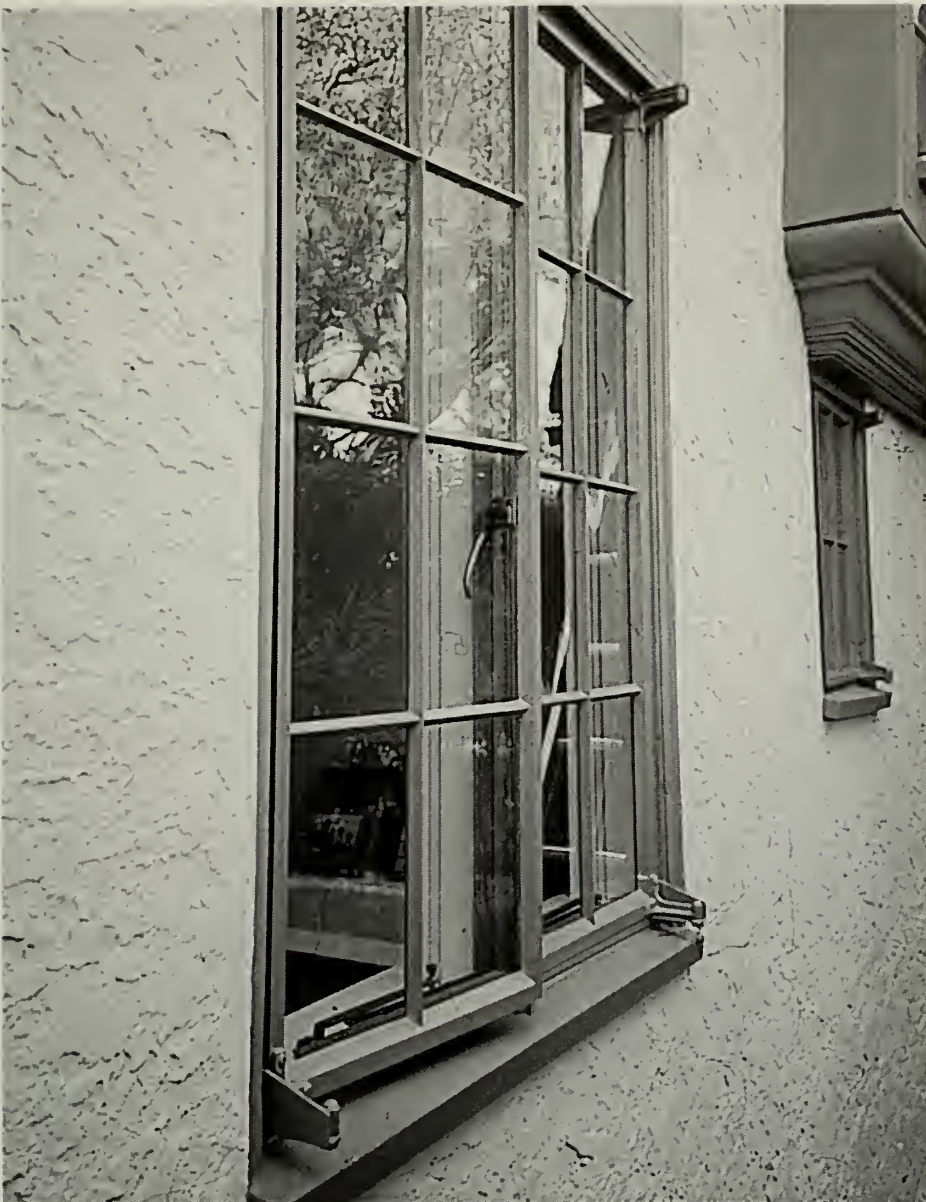
Figure 11. The completed work reveals the aesthetic appeal of the historic casement window – qualities appreciated both past and present.
