ROCK CREEK PARK

HORSE TRAIL STUDY

National Park Service • Department of Interior

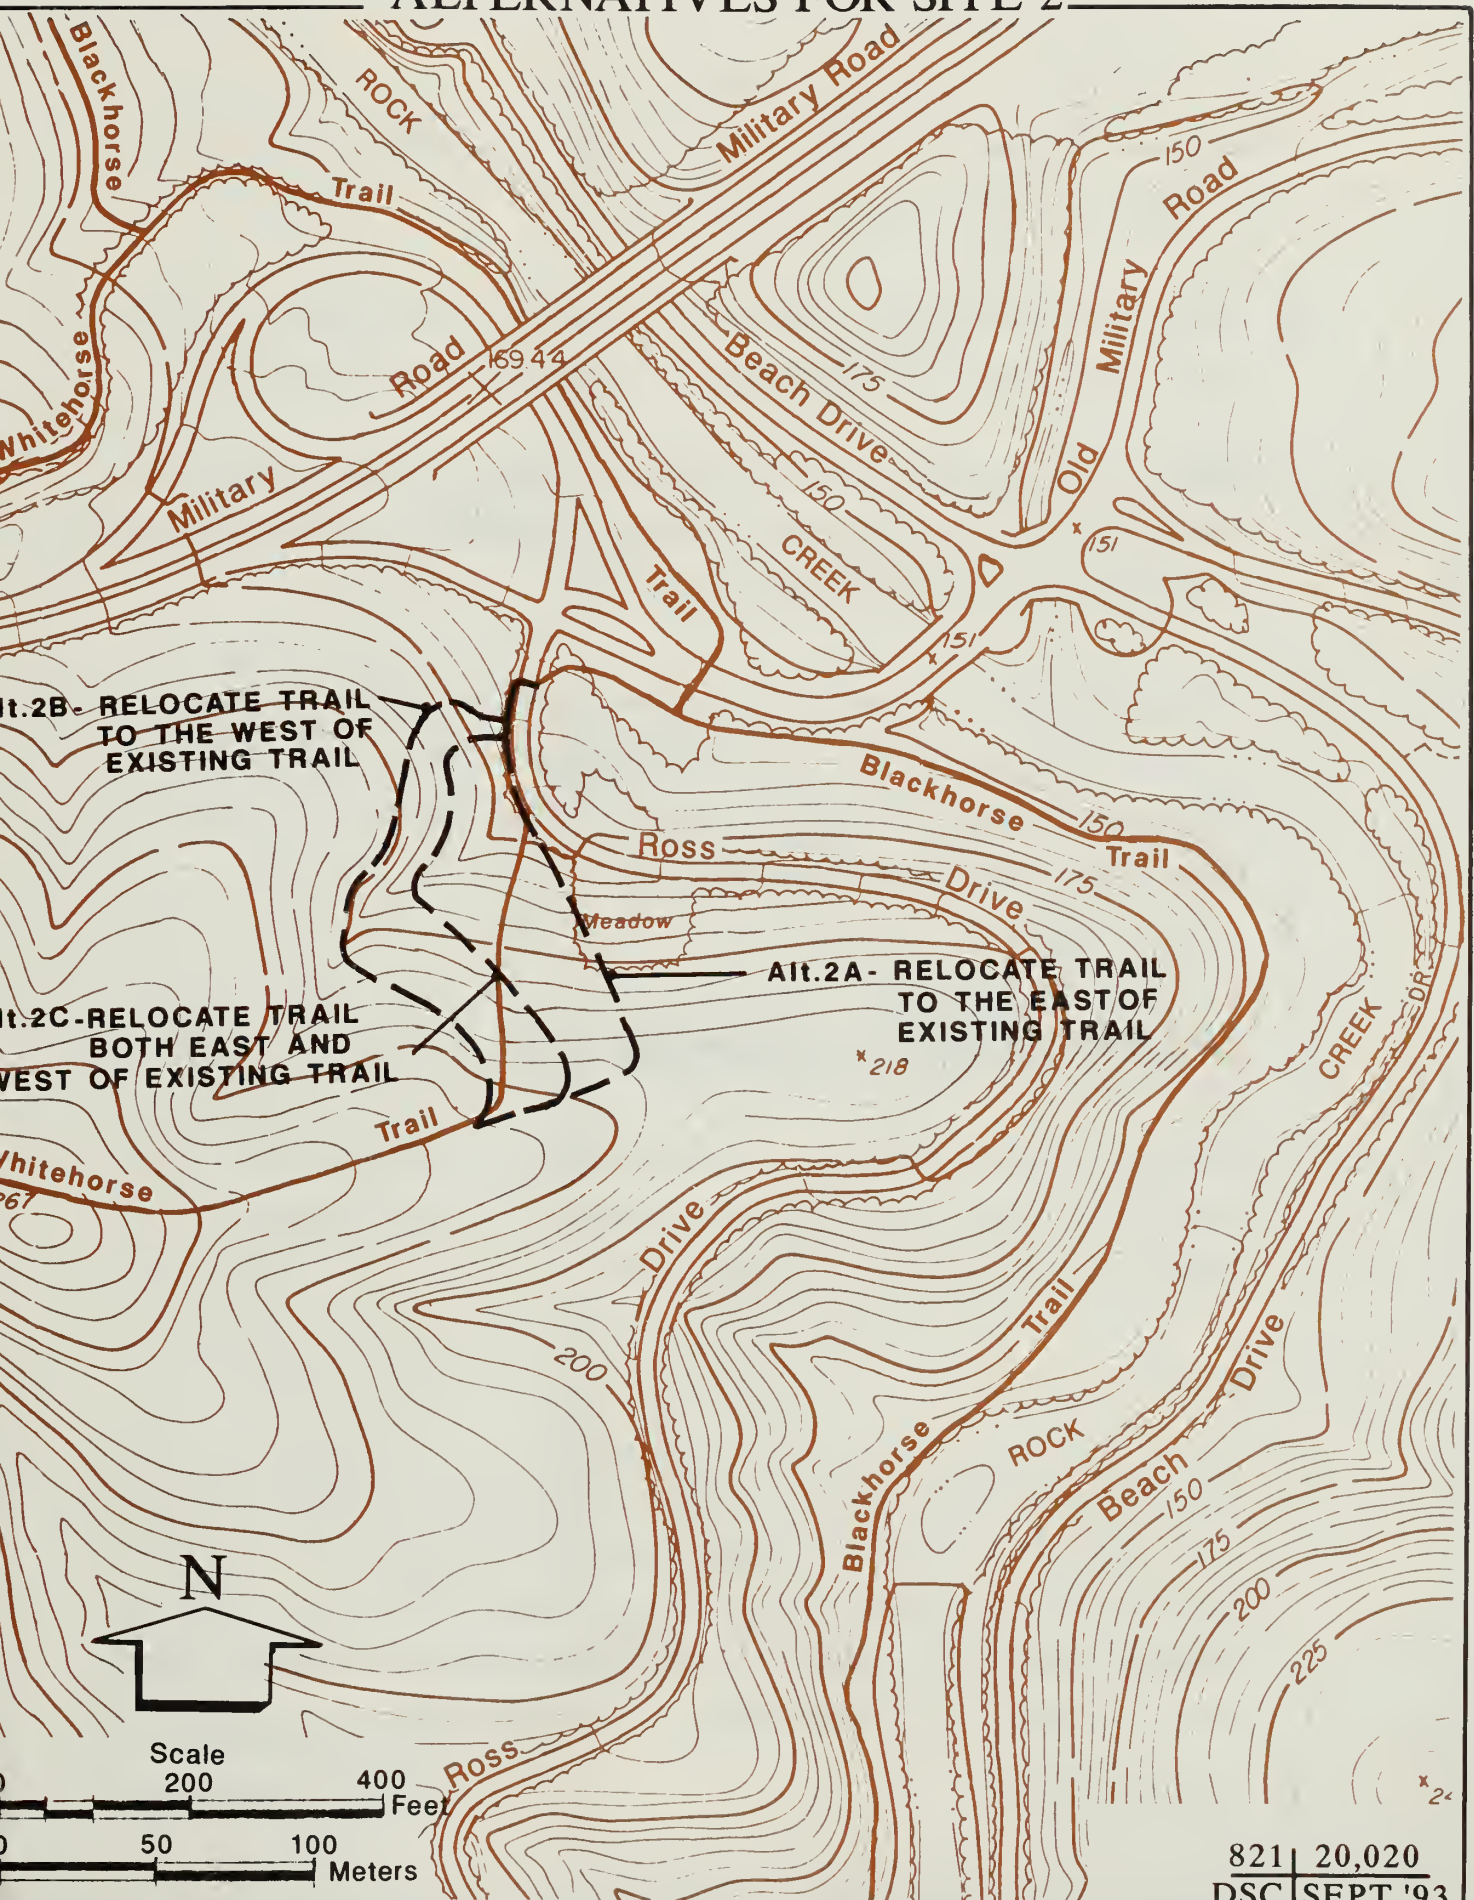
ALTERNATIVES FOR SITE 2

- 2A. Relocate trail to east.** Topographically, it is feasible to dramatically reduce the most severe (20%) lower slope of this trail with a relocation to the east. However, an

important park meadow adjacent to Ross Drive would have to be crossed, making this alternative undesirable. Estimated cost: \$3,000.

2B. Relocate trail to west. This is a more difficult design, and a relocation to the west would require a wooden bridge across a 15' wide gully. Estimated cost: \$4,000

2D. Maintain trail on existing slope. The park maintenance staff refilled this gully in FY 83. The existing waterbars should be lengthened as noted in the work logs. After making drainage improvements, the margins of this trail should be rehabilitated to reestablish native plant life and narrow the 20' wide tread.

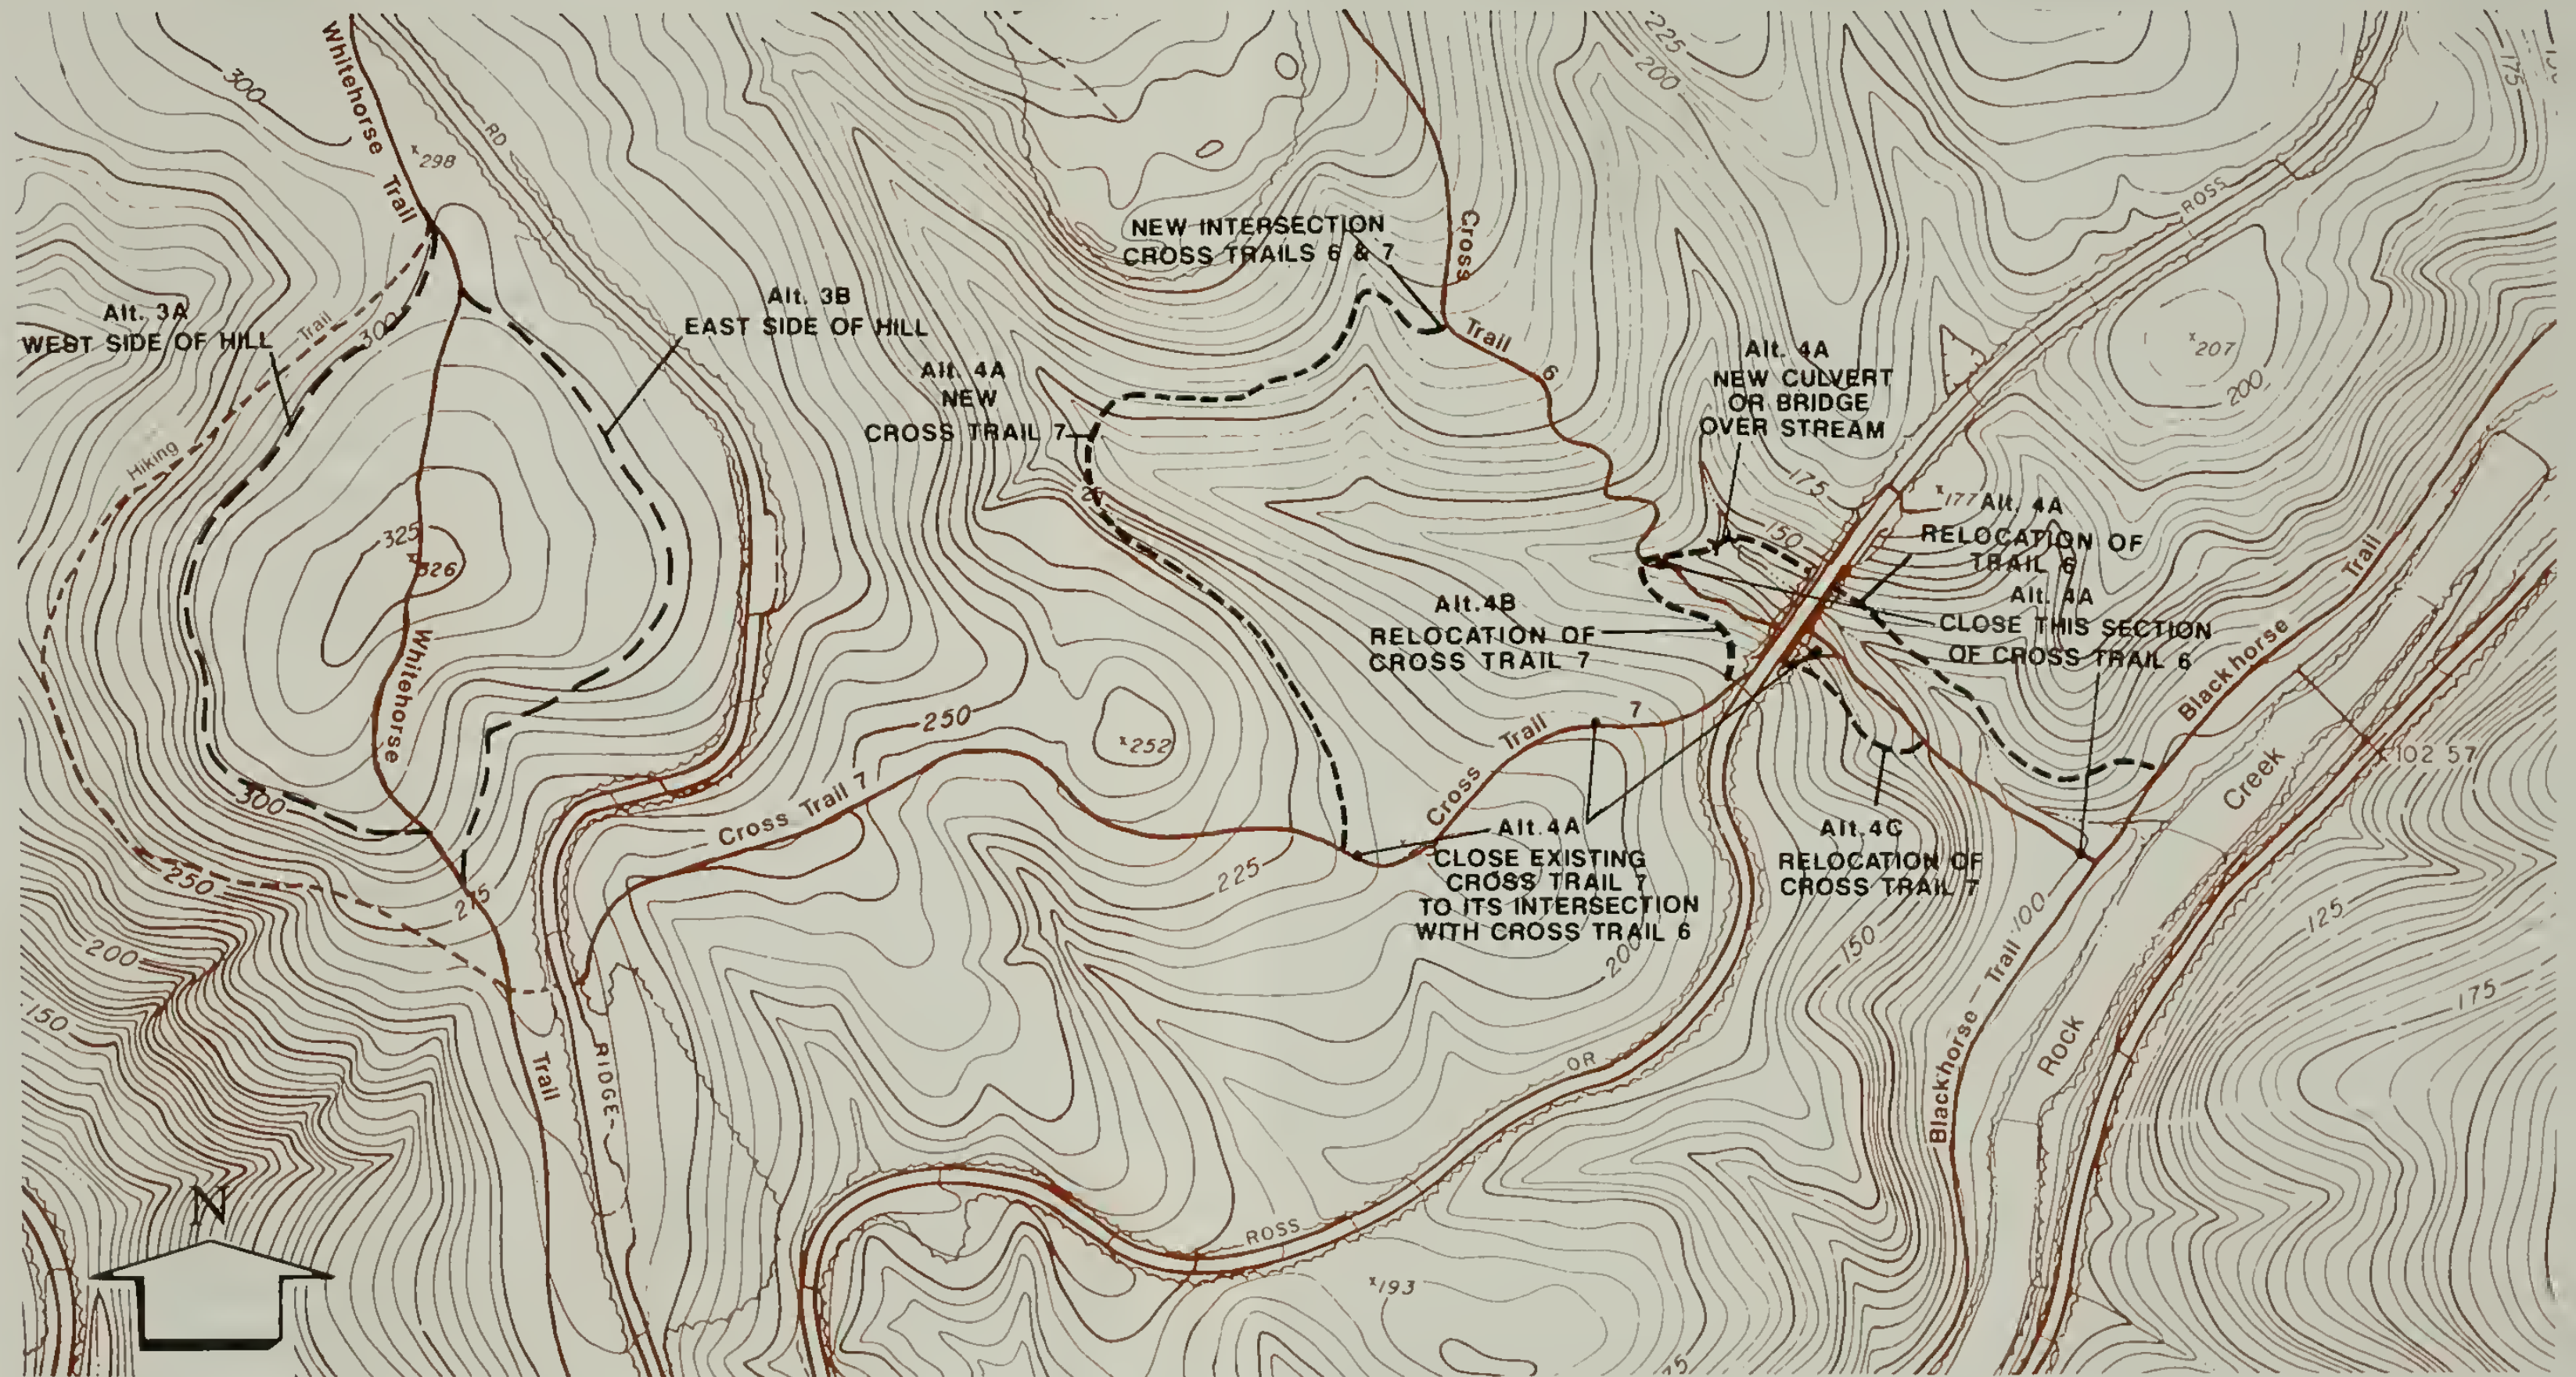
ALTERNATIVES FOR SITES 3 AND 4

3A. West of Hill. The study team flagged with blue surveyor's tape an alternate trail location from the junction of an unnamed hiking trail around the west side of the hill parallel to and above the existing hiking trail. This relocation would require substantial excavation because of steep side slope. Resource Manager Bob Ford expressed concern for a small spring water habitat in the watershed below this relocation alternative. Estimated Cost: \$6,000.

3B. East of Hill. Terrain east of the hill adjacent to Ross Drive is more gradual, making a relocation feasible. However, the probability of uncontrollable crossover traffic from horses using both the trail and roadside makes this alternative a potential safety hazard and resource problem. Estimated cost: \$6,000.

It would replace the steepest section just below Ross Drive with a more gradual climbing turn. Estimated Cost: \$2,200.

- 4D. Reconstruction on existing location.** Waterbars should be installed as noted in the work logs if the relocation is not installed.

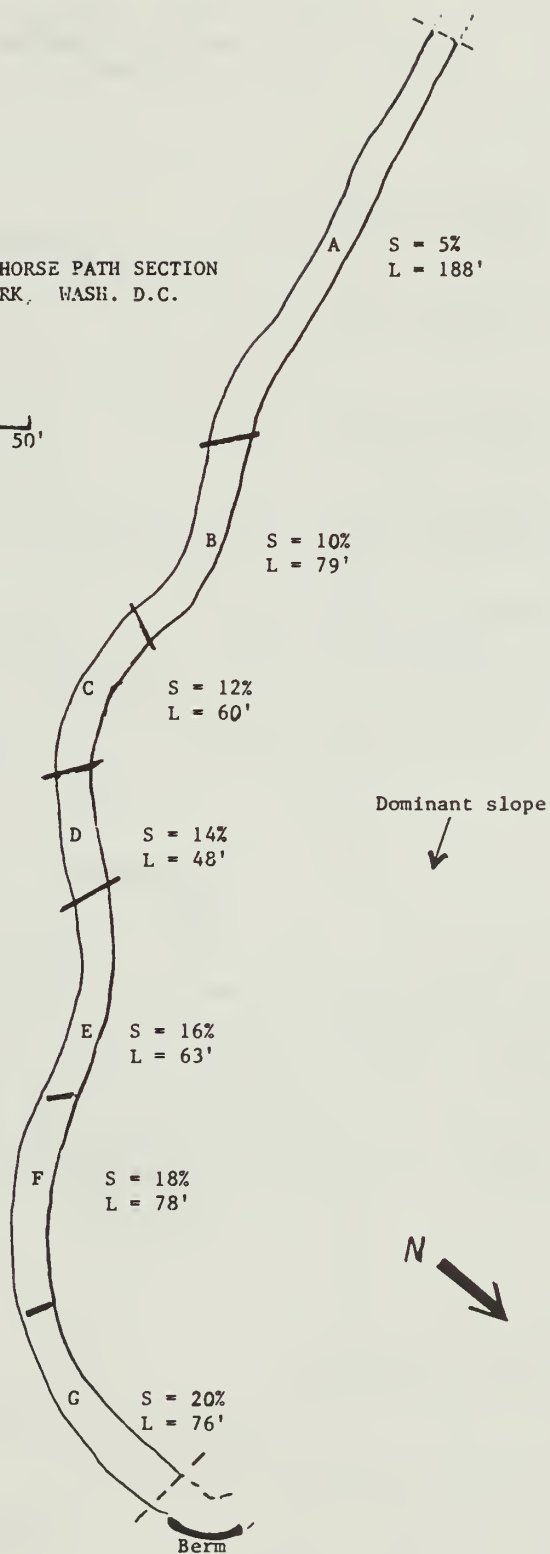
SKETCH OF WHITE HORSE PATH SECTION
ROCK CREEK PARK, WASH. D.C.

Due to the high rate of erosion on this path, earth fill (compacted) has been applied to the tread periodically as a standard maintenance practice; the latest application prior to the field study was in the Spring of 1985. To prevent sediment deposition from entering the Rock Creek drainage, a berm has been constructed at the bottom of this section, which directs all tread drainage into a natural depression. On the date of field observation (8/10/85), loose fill was the dominant tread surface in the upper subsections, and compacted fill with or without a stone mulch was found on the tread of the lower subsections.

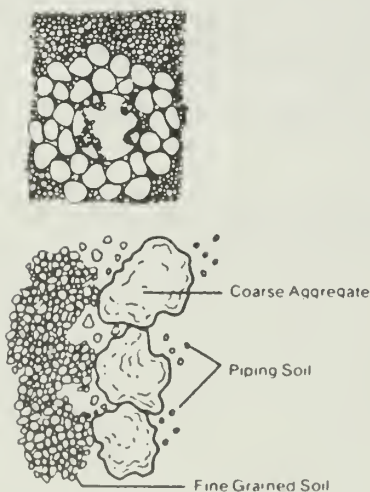
Unprotected, Clogged Trench Drain

Low initial cost, ineffective, high maintenance costs

Soil piping results when soil particles cannot bridge large gaps between coarse aggregate particles at the soil/aggregate interface
